NATIONAL ADVISORY COMMITTEE FOR AERONAUTICS

February 1945 as
Advance Restricted Report E5B07

EFFECT OF PROGRESSIVE RING FAILURE ON PISTON DESTRUCTION

By Max J. Tauschek and Lester C. Corrington

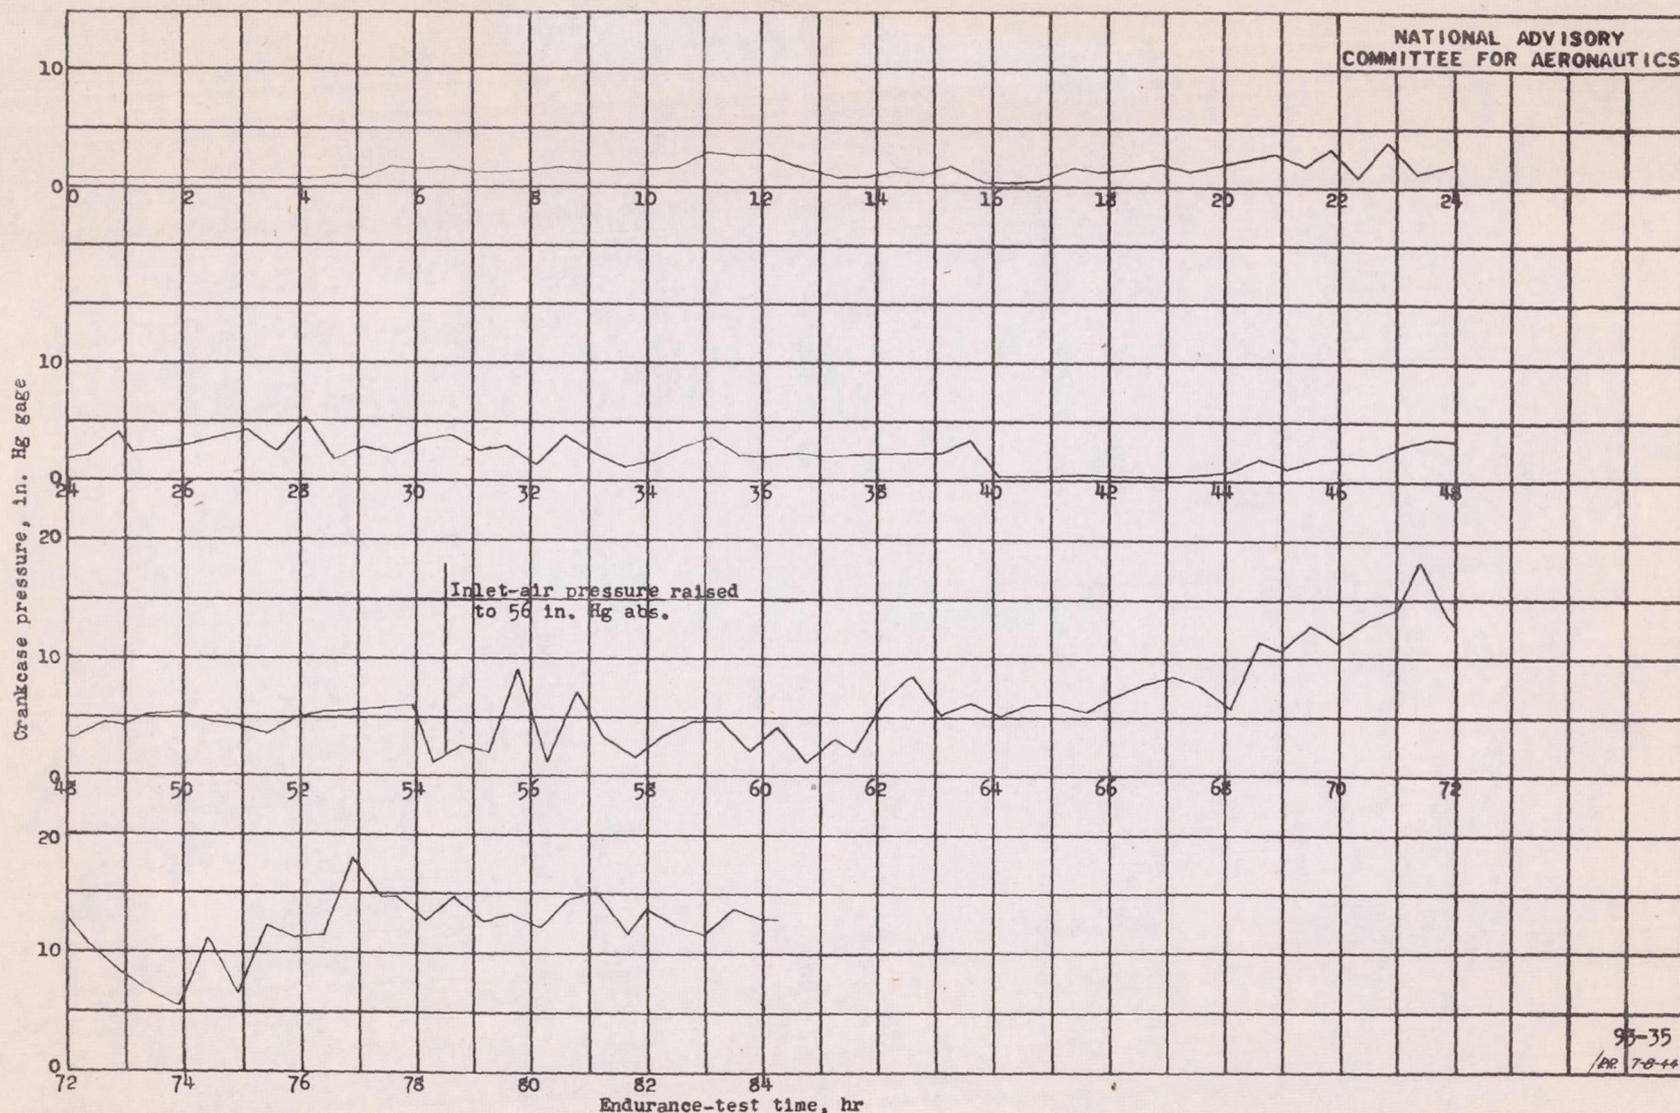
Figure 11. - Effect of running time on crankcase pressure for second endurance test. Engine speed, 2600 rpm; inlet-air pressure, 50 inches of mercury absolute (except as noted); inlet-air temperature, 200° F; fuel-air ratio, 0.085; oil flow to piston, 0.5 pound per minute.

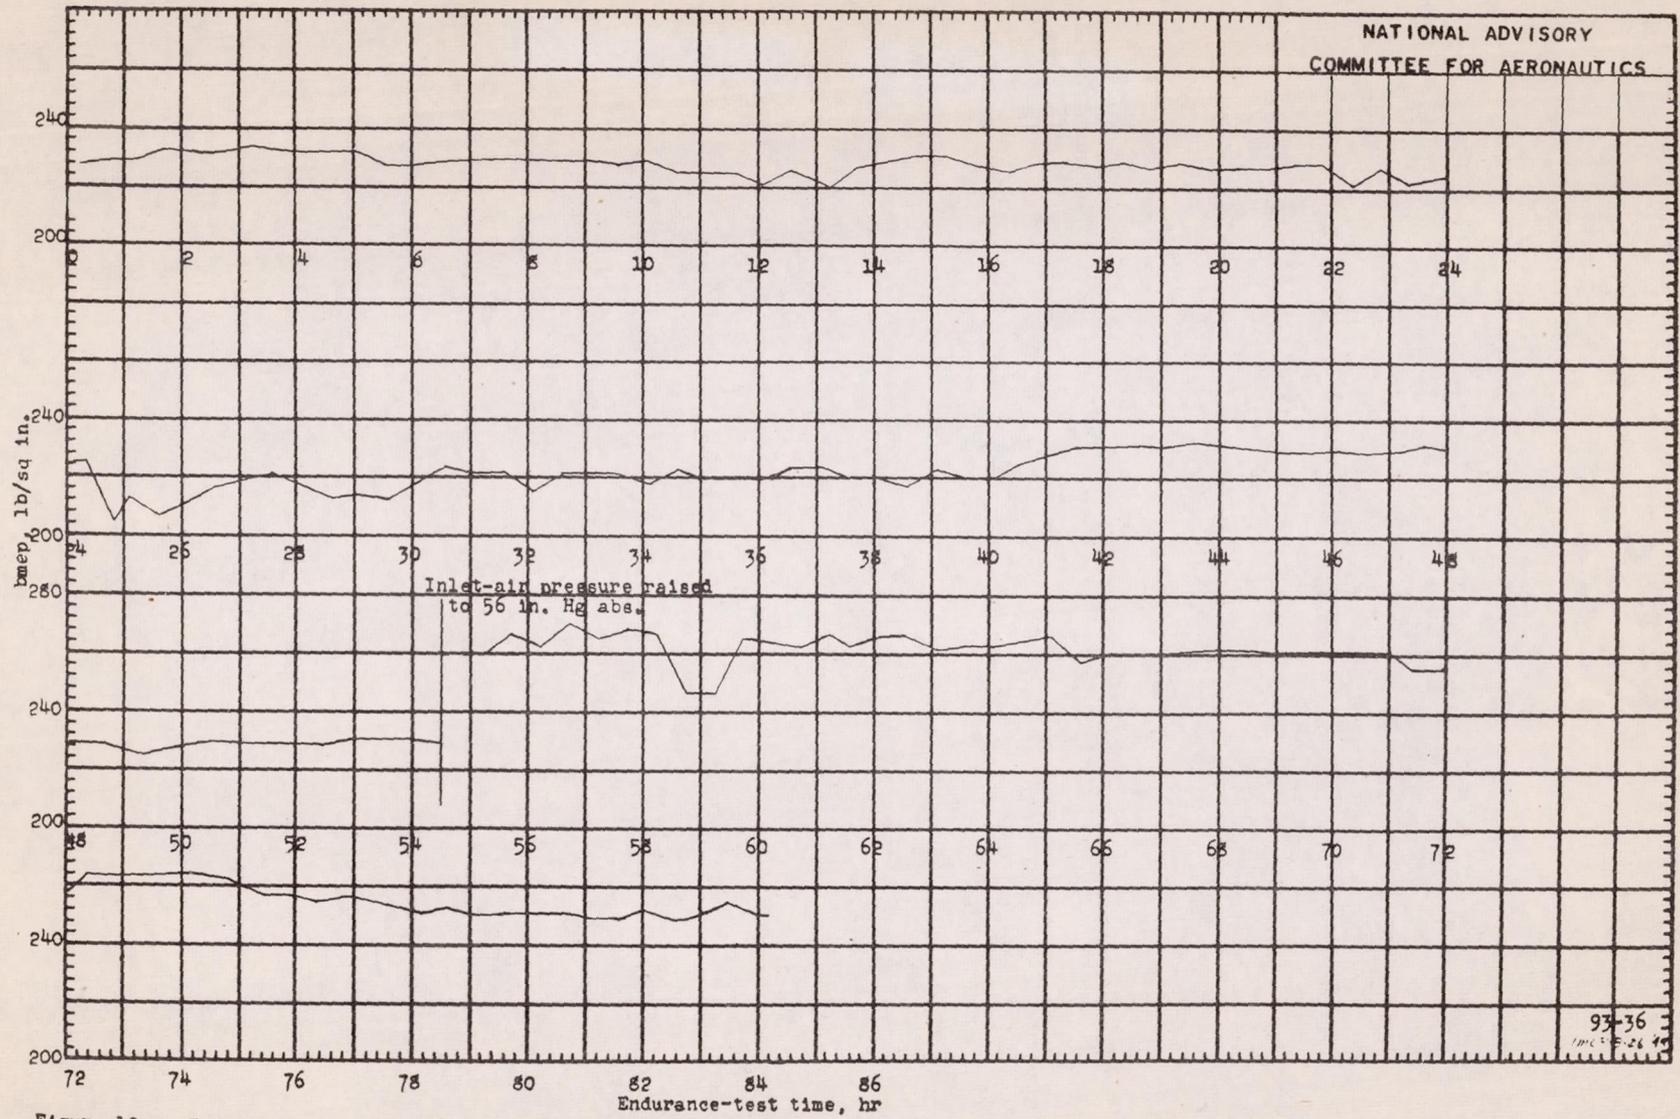
Figure 12. - Effect of running time on brake mean effective pressure for second endurance test. Engine speed, 2600 rpm; inlet-air pressure, 50 inches of mercury absolute (except as noted); inlet-air temperature, 200° F; fuel-air ratio, 0.085; oil flow to piston, 0.5 pound per minute.
