THE EFFECT OF LIQUID AND ICE PARTICLES ON THE
EROSION OF A SUPERCHARGER-INLET COVER
AND DIFFUSER VANES

By Vern G. Rollin

MEMORANDUM REPORT

Air Materiel Command, Army Air Forces

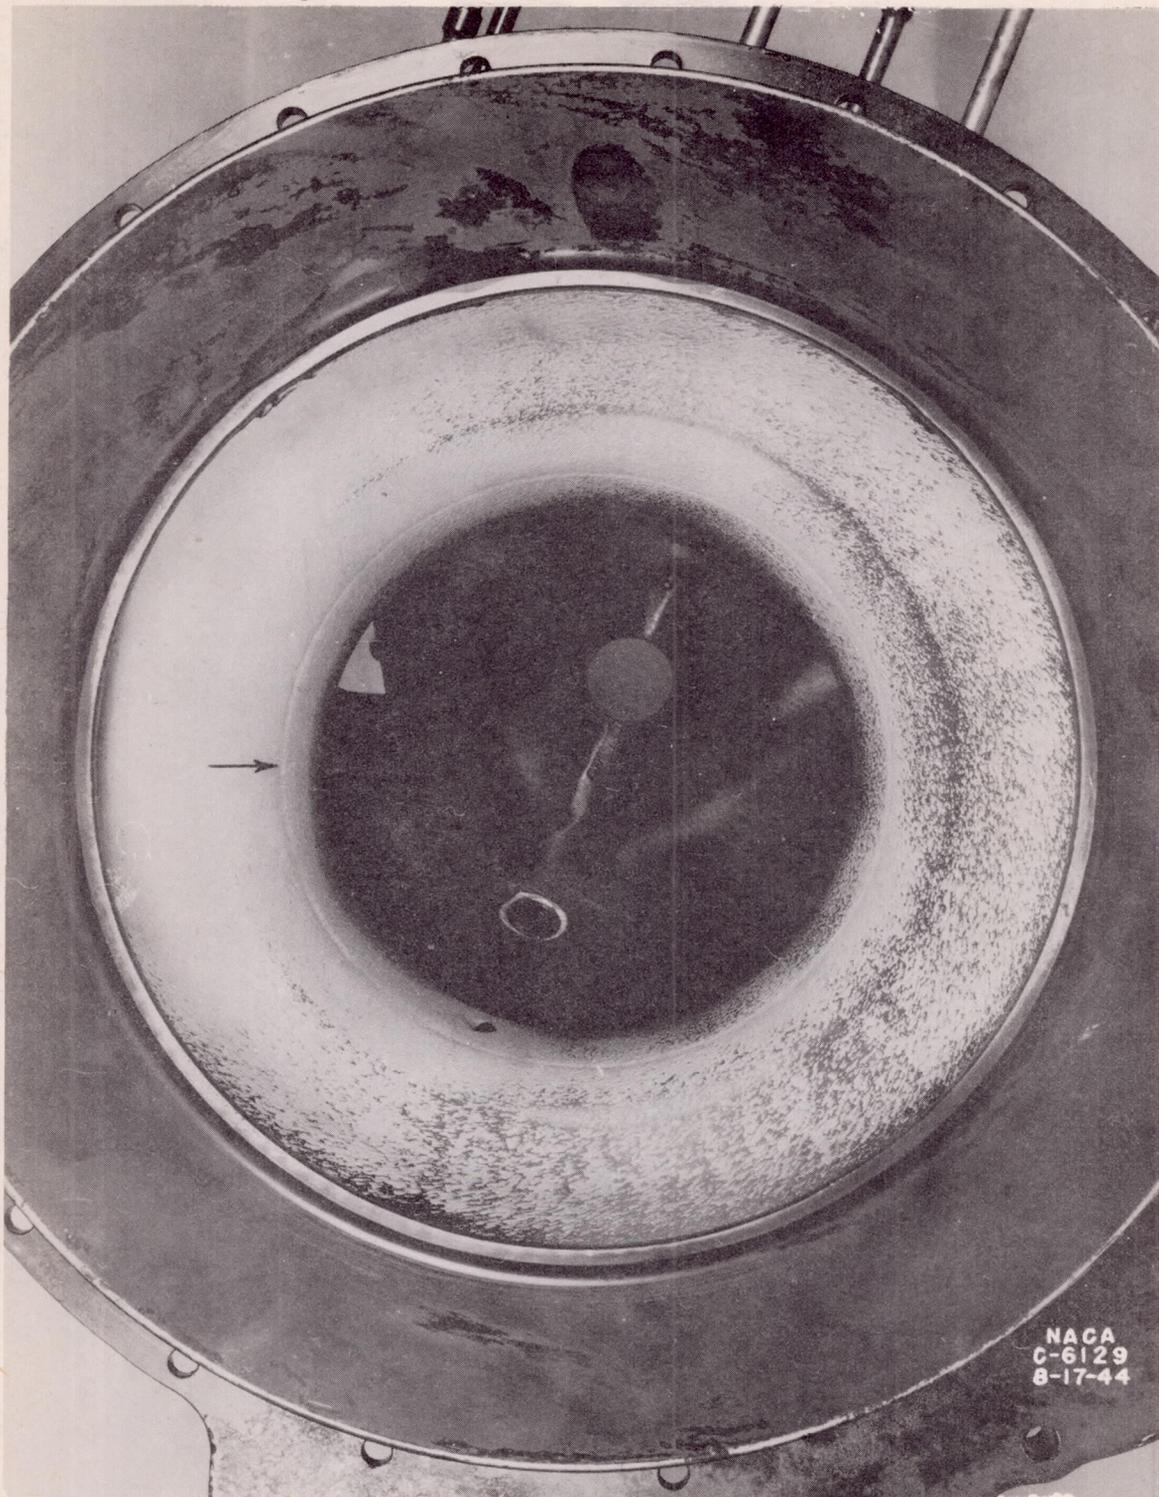
During an overhaul of the setup used for the icing investigations described in references 1 and 3, the inner surface of the supercharger-inlet cover in close proximity to the impeller was observed to be badly eroded. Erosion reached a depth of approximately 0.030 inch and was much worse on the left side than on the right side of the inlet cover, as seen in figure 1(a). The deeper annular depression noted by the arrow was located just opposite the point where the steel inducer joins the aluminum impeller. The

erosion was more uniform on the portion of the cover shown at the left of the photograph; ice that formed in the bottom of the elbow would first strike this area when loosened during the de-icing process because the supercharger impeller rotated in a clockwise direction as viewed from the front of the engine. The leading edges of two of the six diffuser vanes are shown in figure 1(b). Erosion removed about three-eighths inch of metal from the leading-edge portion of the diffuser vane near the curved surface of the cover.

Consideration of the seriousness of this problem prompted a survey of the running time and test conditions for the setup. It was found that the total running time for this setup prior to inspection had been 861 hours, which included 110 hours operation with rain ingestion simulated by spraying water into the air stream about $6\frac{1}{2}$ feet above the carburetor top deck at an average rate of 46.3 pounds per hour. During the determination of icing characteristics, $8\frac{1}{4}$ hours of the running time had been at simulated operation with water injection in the inlet elbow by means of a special nozzle large enough to accommodate the combined volume of fuel and water. These runs were made at air flows simulating take-off power with an average rate of water injection corresponding to a water-fuel ratio of 0.4. The amount of the observed erosion caused by passage of ice through the supercharger could not be determined.

(a) Surface erosion at entrance to impeller.

Figure 1. - Effect of liquid and ice particles on erosion of supercharger-inlet cover resulting from 110 hours of operation under various icing conditions.

Erosion of the diffuser-vane leading edges may be prevented by use of an erosion-resistant metal. Elimination of the discontinuity where the steel inducer joins the rest of the supercharger would prevent grooving the cover at that point. A more durable corrosion-resistant surface would reduce inlet-cover erosion. Erosion caused by ice could be materially reduced by excluding water drops from the system before they reach the carburetor and by changing the method of fuel injection to prevent fuel-evaporation icing (reference 4). Erosion caused by water or water-alcohol injected with the fuel could be eliminated by injecting the water downstream of the supercharger. This factor may become increasingly important with extended use of water injection for increased power ratings of aircraft engines.

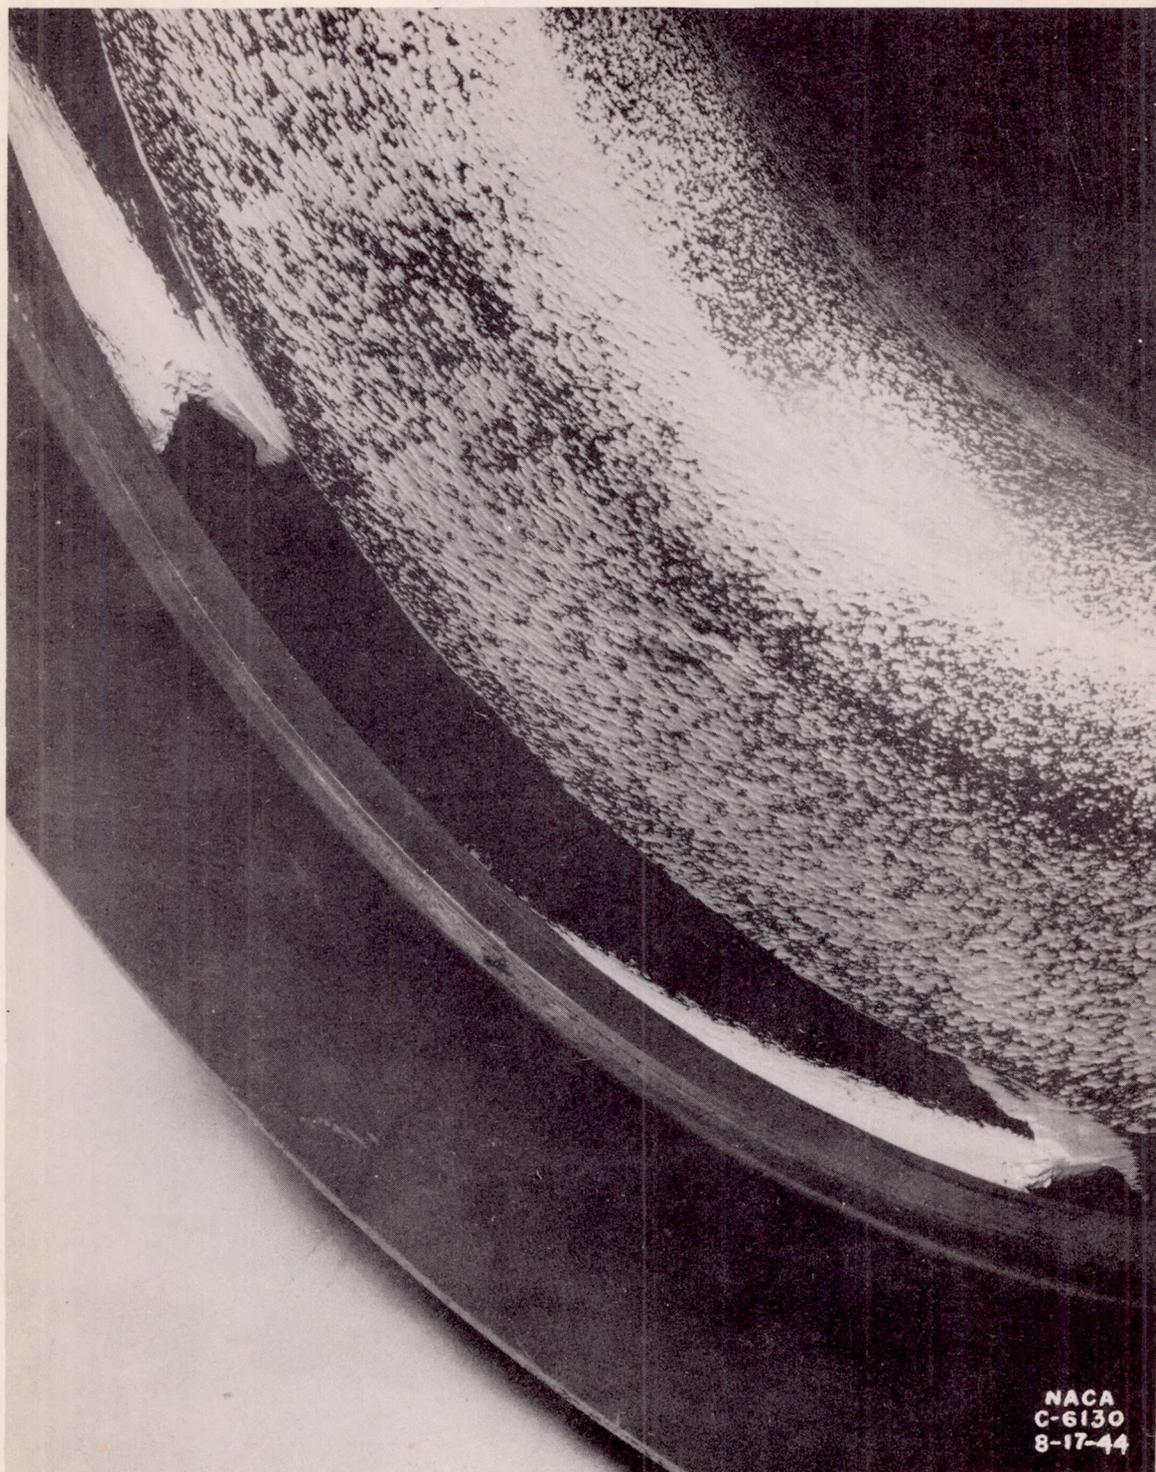
erosion of the diffuser vanes by liquid is greater near this surface. (See figs. 1(b), 2(b), 3(b), and 4(b).) Another factor contributing to the erosion of the diffuser vanes is the effect of the water drops thrown off the tips of the impeller. It was also observed that, of the six diffuser vanes, erosion was greater on vanes 2 and 3, counting clockwise from the top looking from the front of the engine.

(b) Erosion of diffuser vanes 2 and 3.

Figure 1. - Concluded. Effect of liquid and ice particles on erosion of supercharger-inlet cover resulting from 110 hours of operation under various icing conditions.

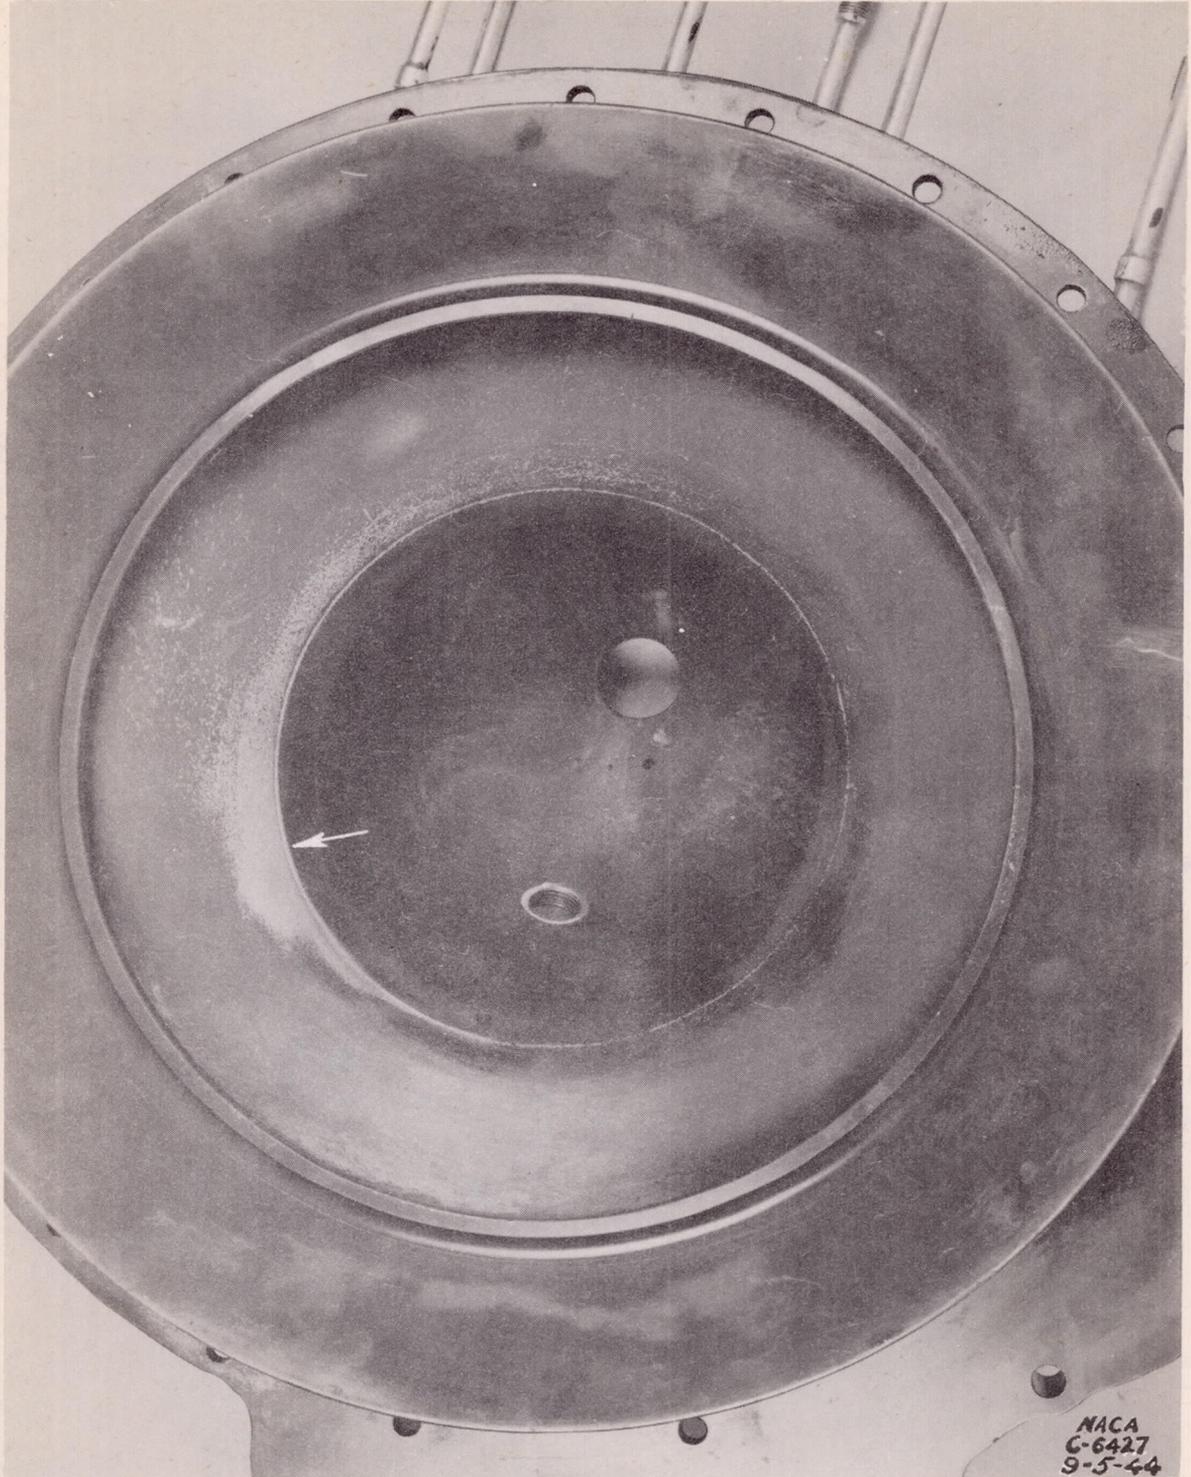
In the attempt to isolate the causes of erosion, the next two tests were made at take-off power conditions for $8\frac{1}{4}$ hours during which the liquid and air temperatures were maintained at about 75° F to prevent ice formation in the system. The erosion effect of liquid injected at a rate corresponding to a fuel-air ratio of 0.08 and a water-fuel ratio of 0.6 is shown in figure 2. The erosion effect of water alone on another inlet cover injected at a rate of approximately 485 pounds per hour for $8\frac{1}{4}$ hours is shown in figure 3.

(a) Surface erosion at impeller entrance.

Figure 2. - Erosion of supercharger-inlet cover caused by water and fuel injection. Rate of liquid injection, 1300 pounds per hour; duration of test, $8\frac{1}{4}$ hours.

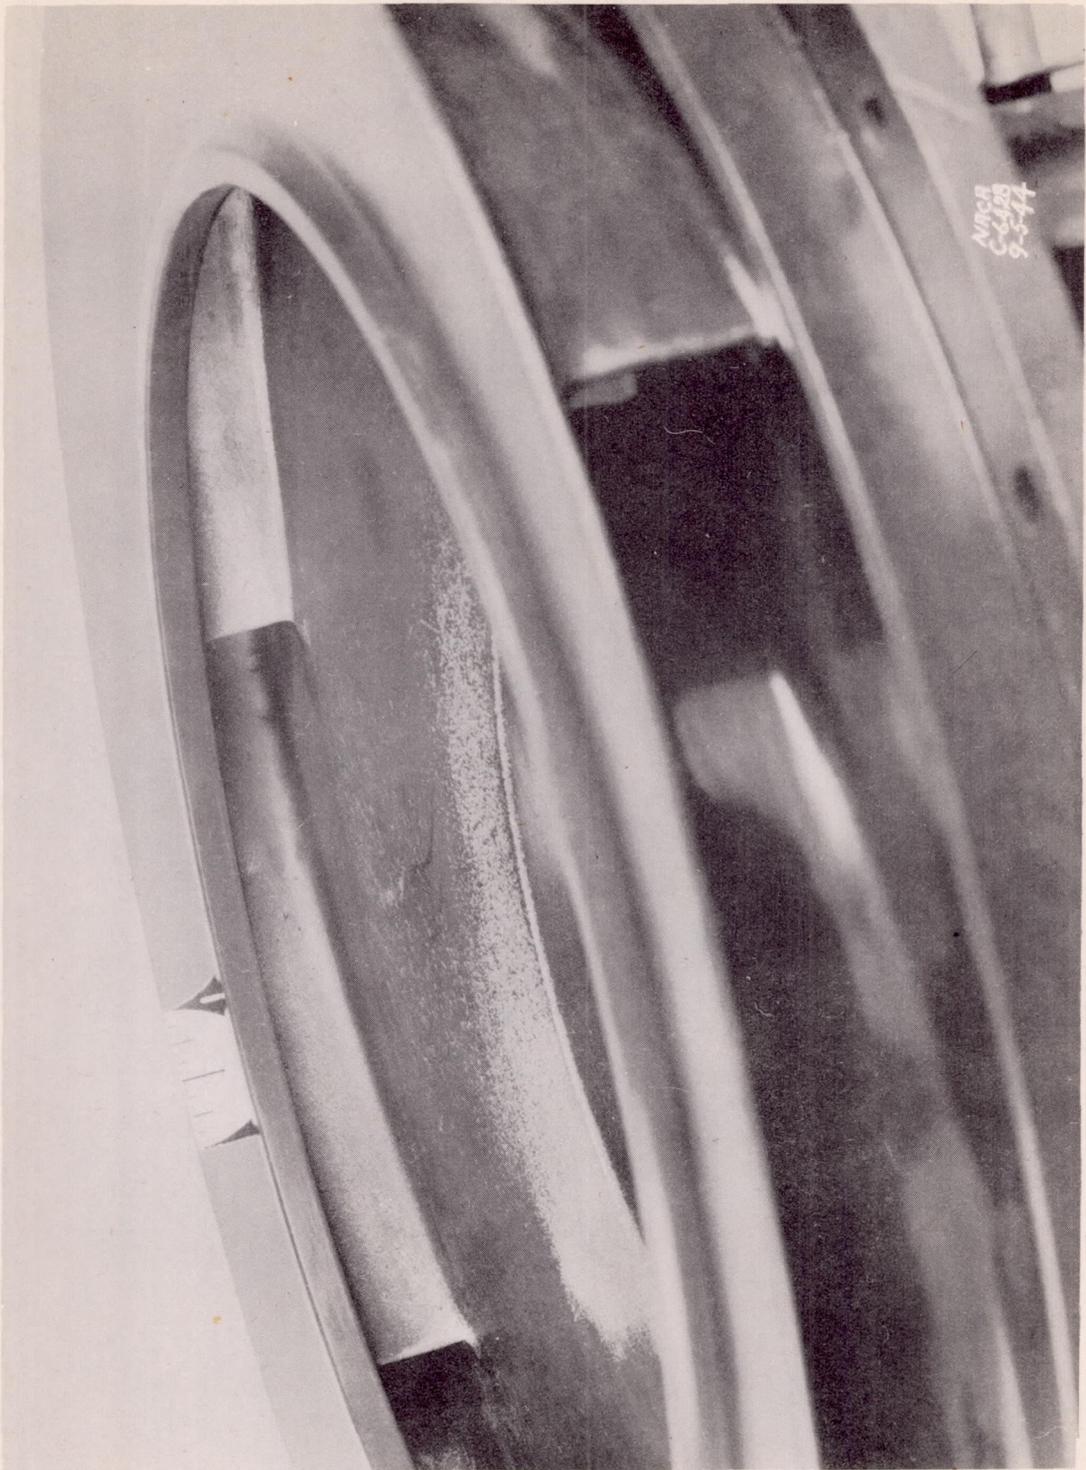
(b) Erosion of diffuser vanes 5 and 6.

Figure 2. - Concluded. Erosion of supercharger-inlet cover caused by water and fuel injection. Rate of liquid injection, 1300 pounds per hour; duration of test, $8\frac{1}{4}$ hours.

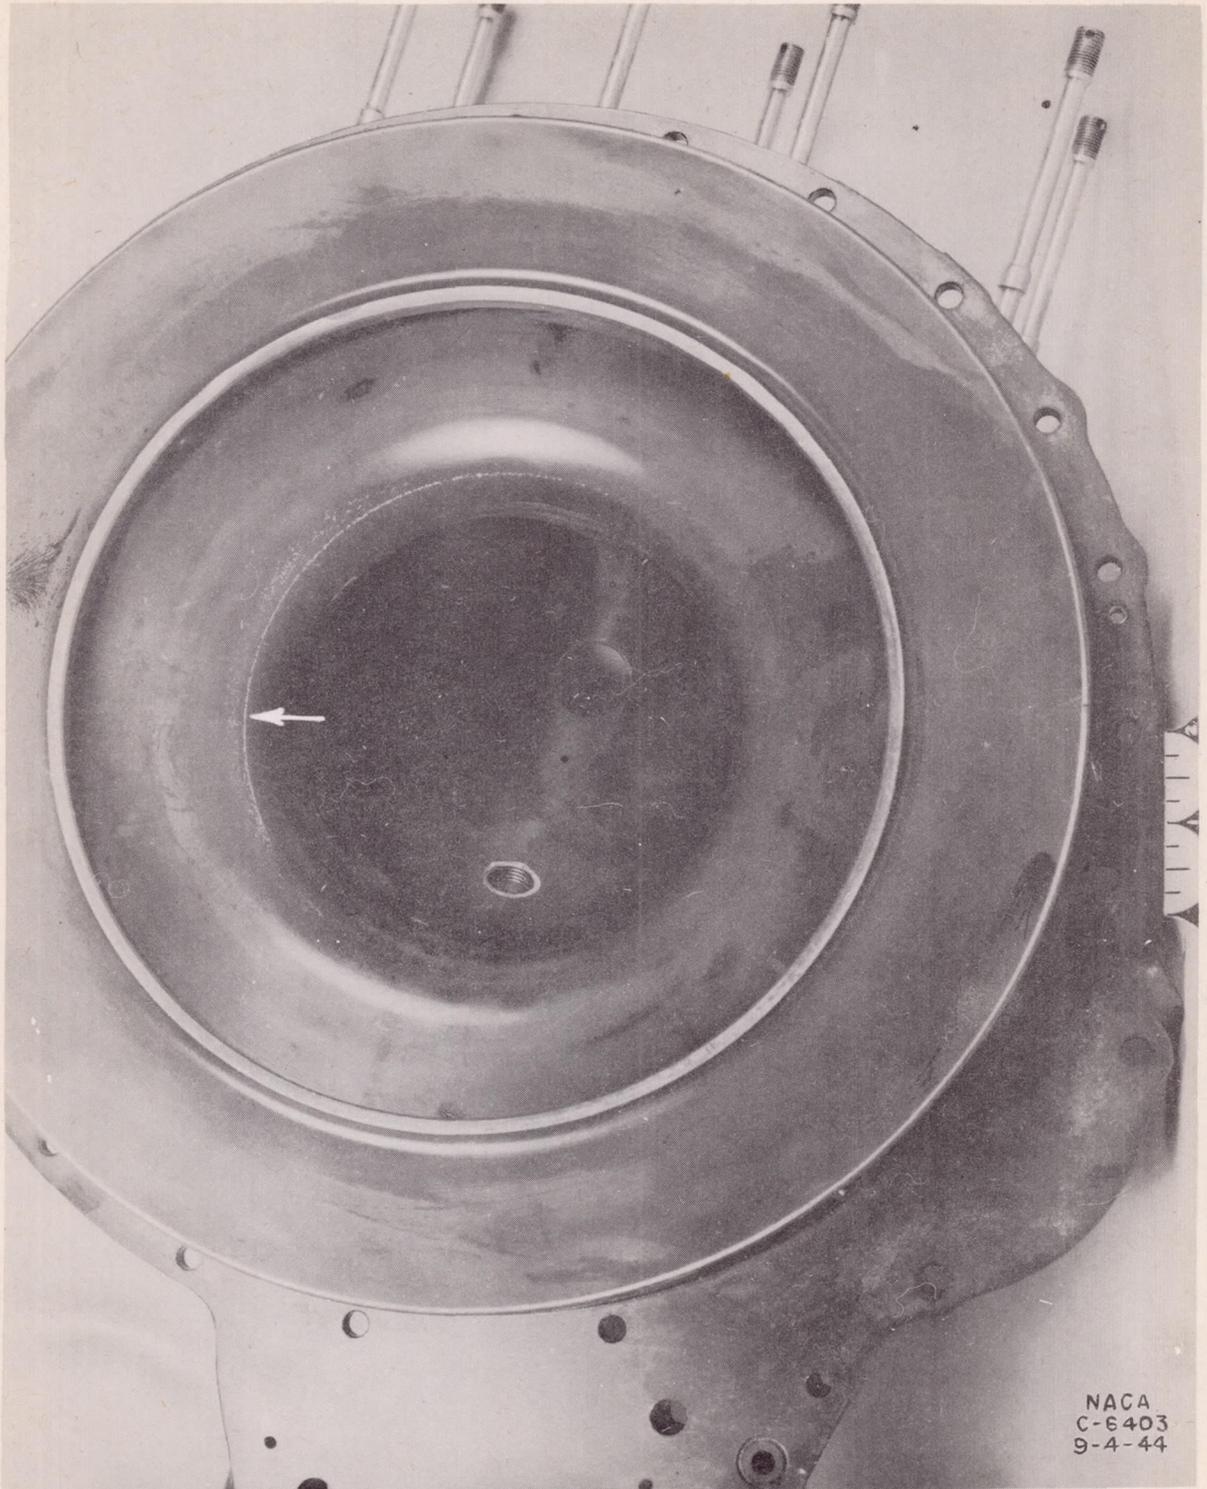
(a) Surface erosion at impeller entrance.

Figure 3. - Erosion of supercharger-inlet cover caused by water injection. Rate of water injection, 485 pounds per hour; duration of test, $8\frac{1}{4}$ hours.

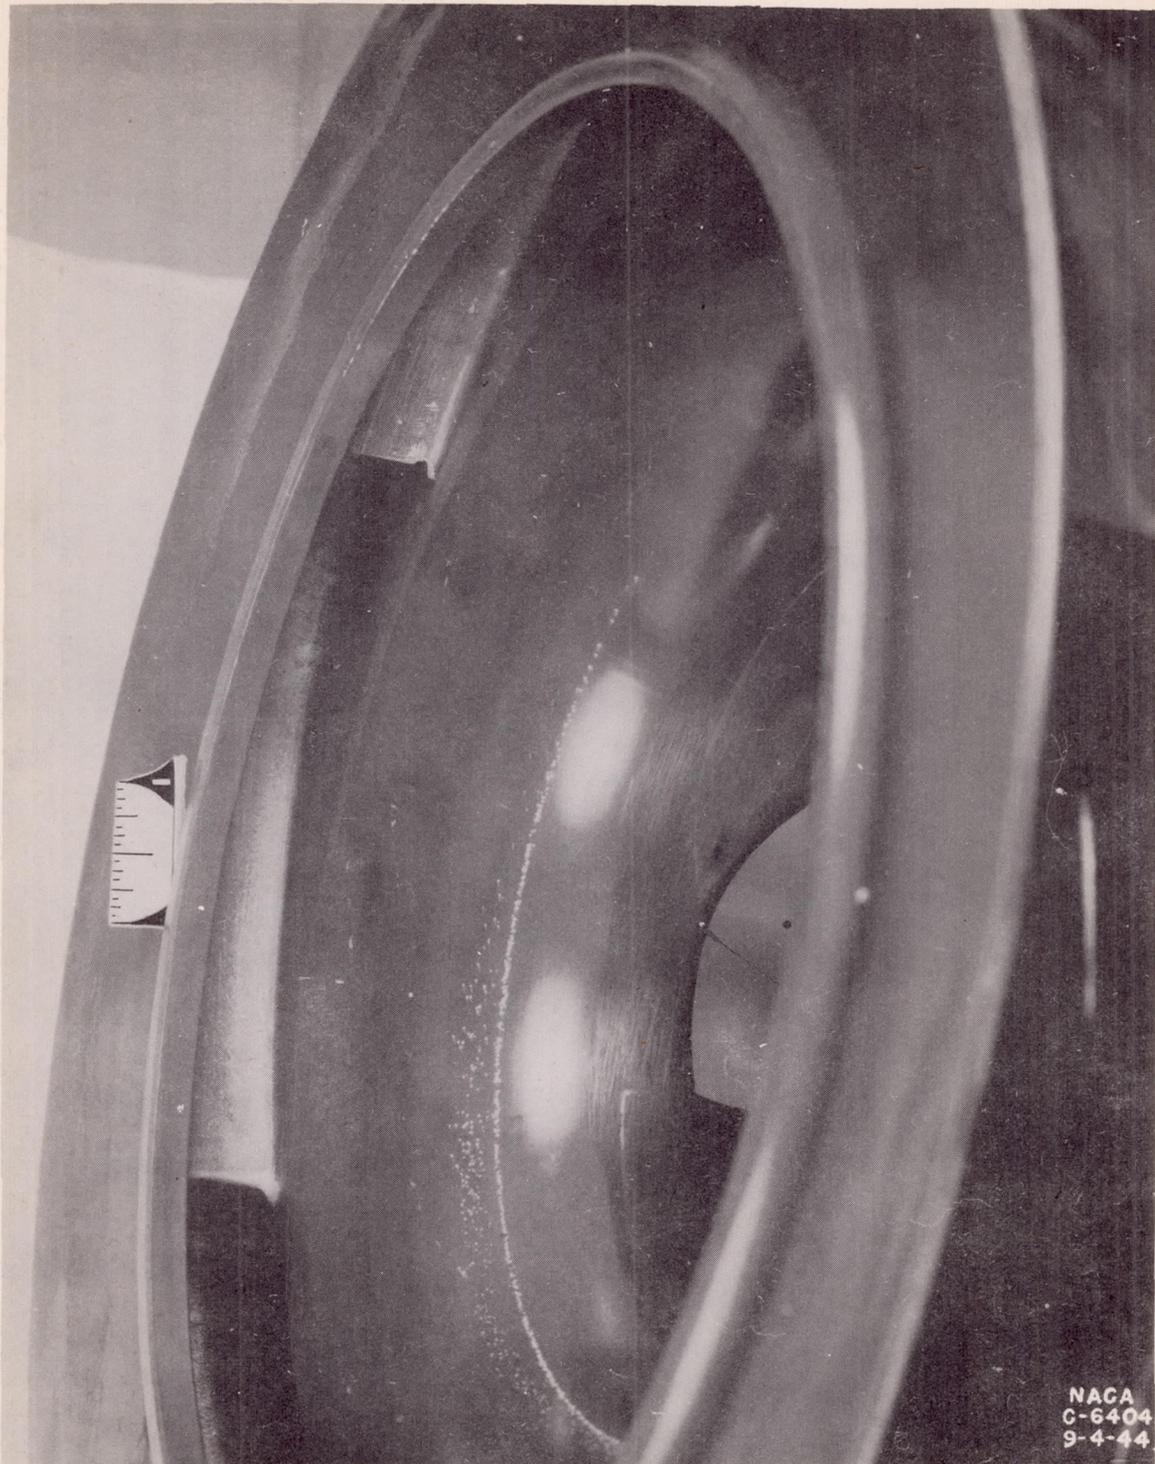
(b) Erosion of diffuser vanes 6 and 1.

Figure 3. - Concluded. Erosion of supercharger-inlet cover caused by water injection. Rate of water injection, 485 pounds per hour; duration of test, $8\frac{1}{4}$ hours.

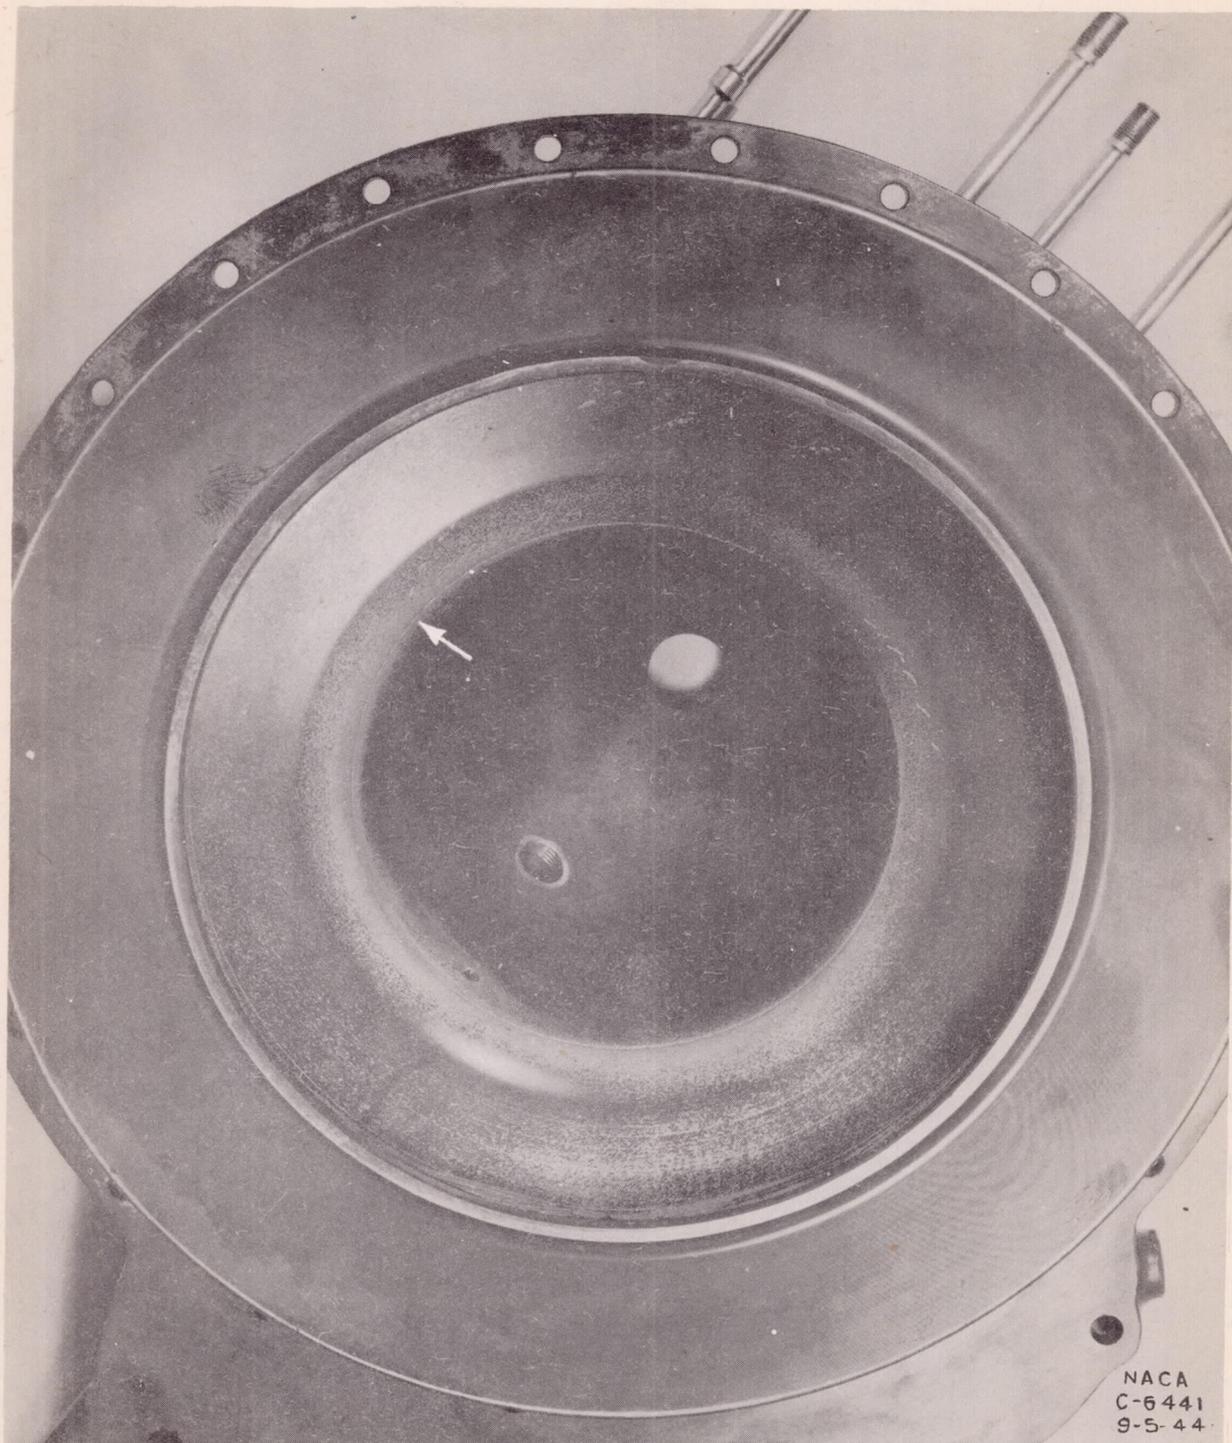
The results of the third accelerated erosion test of $8\frac{1}{4}$ -hour duration (fig. 4) indicate that the passage of ice through the supercharger caused most of the damage. In this case the inlet cover had been reconditioned after the mild erosion shown in figure 3. Ice, alternately formed and shed upstream of the supercharger at low carburetor-air temperatures, is apparently responsible for most of the erosion shown in figure 1.

(a) Surface erosion at entrance to impeller.

Figure 4. - Erosion of supercharger-inlet cover caused by water and fuel injection and ice particles. Rate of liquid injection, 1300 pounds per hour; duration of test, $8\frac{1}{4}$ hours.

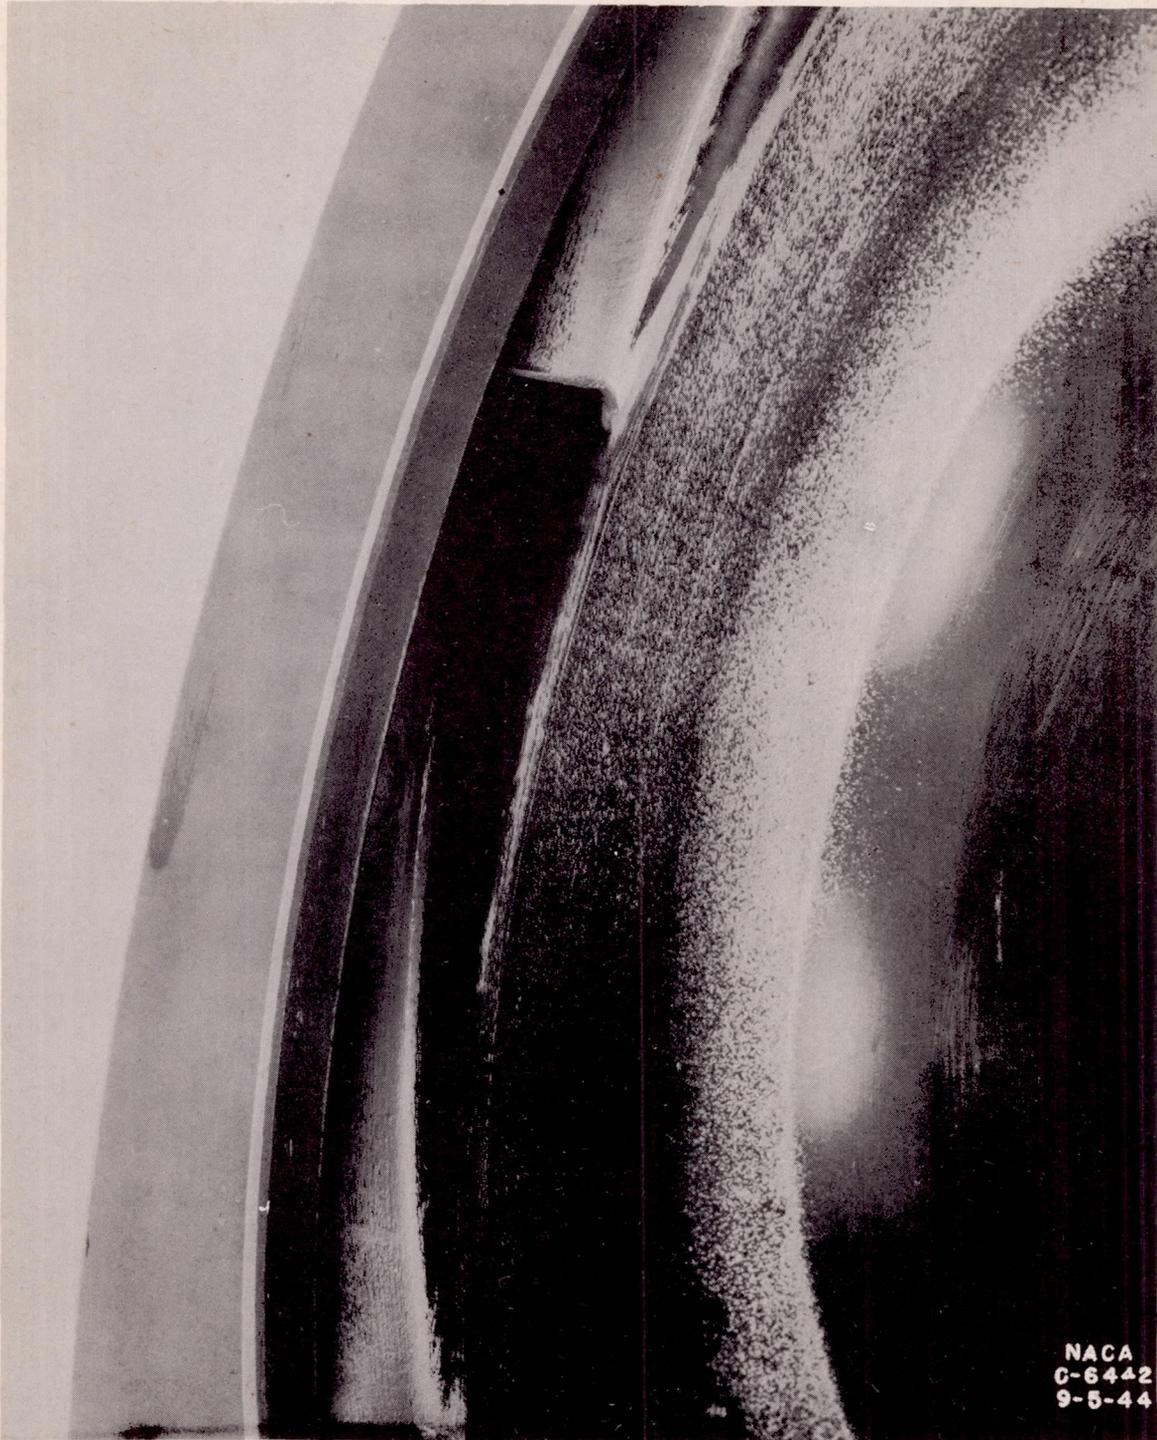
(b) Erosion of diffuser vanes 2 and 3.

Figure 4. - Concluded. Erosion of supercharger-inlet cover caused by water and fuel injection and ice particles. Rate of liquid injection, 1300 pounds per hour; duration of test, $8\frac{1}{4}$ hours.
