NASA Technical Memorandum 106188

# NDE of Titanium Alloy MMC Rings for Gas Turbine Engines

# NDE OF TITANIUM ALLOY MMC RINGS FOR GAS TURBINE ENGINES

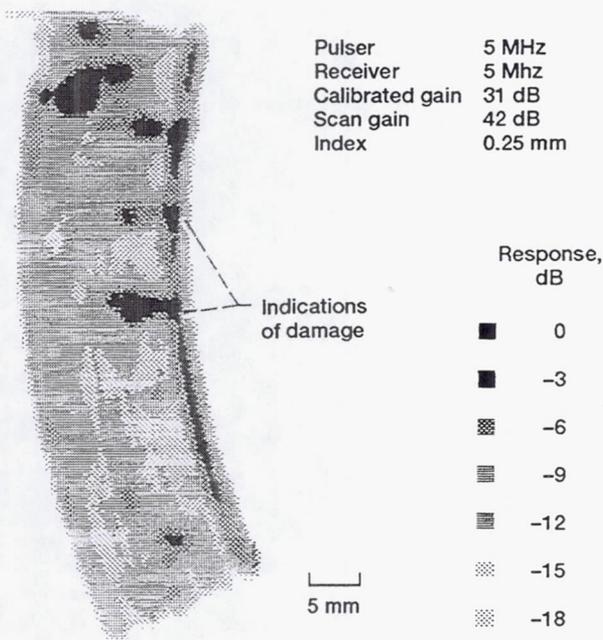
Figure 2 shows the post test ultrasonic c-scan result of a portion of the SCS-6/Alloy-C ring R4 that was static-tested to failure at 427 °C (800 °F). This ring segment, which is located approximately 180° from the burst location, contains internal damages due to the burst test. Metallography identified the "black" regions near the inner diameter of the ring in Fig. 2 as areas of damaged fibers. Figure 3 shows a metallographic cross section at a typical black region where a "notch" corresponding to ultrasonic findings guided metallographic sectioning. This cross section shows 18 damaged fibers, all located near the ID

FIGURE 2.—SELECTED SECTION OF AN ULTRASONIC P-E SCAN OF SCS-6/ALLOY-C RING R4. BLACK REGIONS INDICATE MATERIAL DAMAGE.

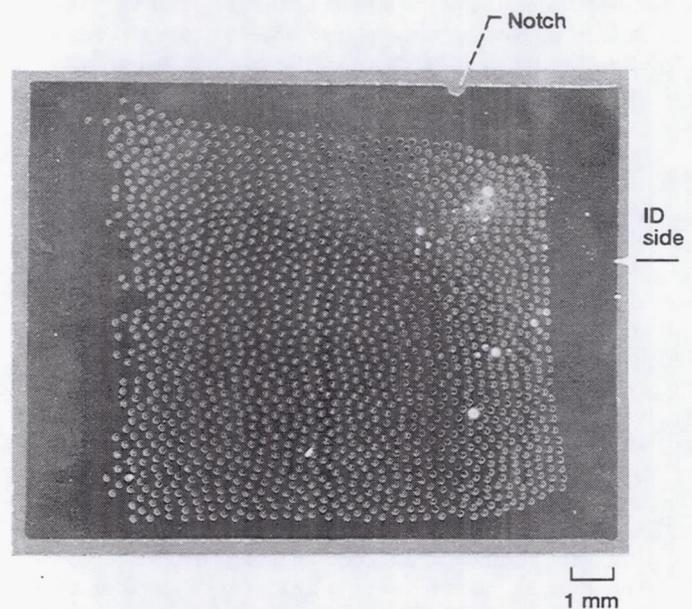
FIGURE 3.—TYPICAL METALLOGRAPHIC CROSS SECTION SHOWING FIBER DAMAGE WHERE ULTRASOUND EXHIBITED BLACK REGIONS IN RING R4. THE NOTCH WAS USED TO PINPOINT ULTRASOUND-INDICATED DAMAGE. BRIGHT WHITE FIBERS ARE THE DAMAGED FIBERS.

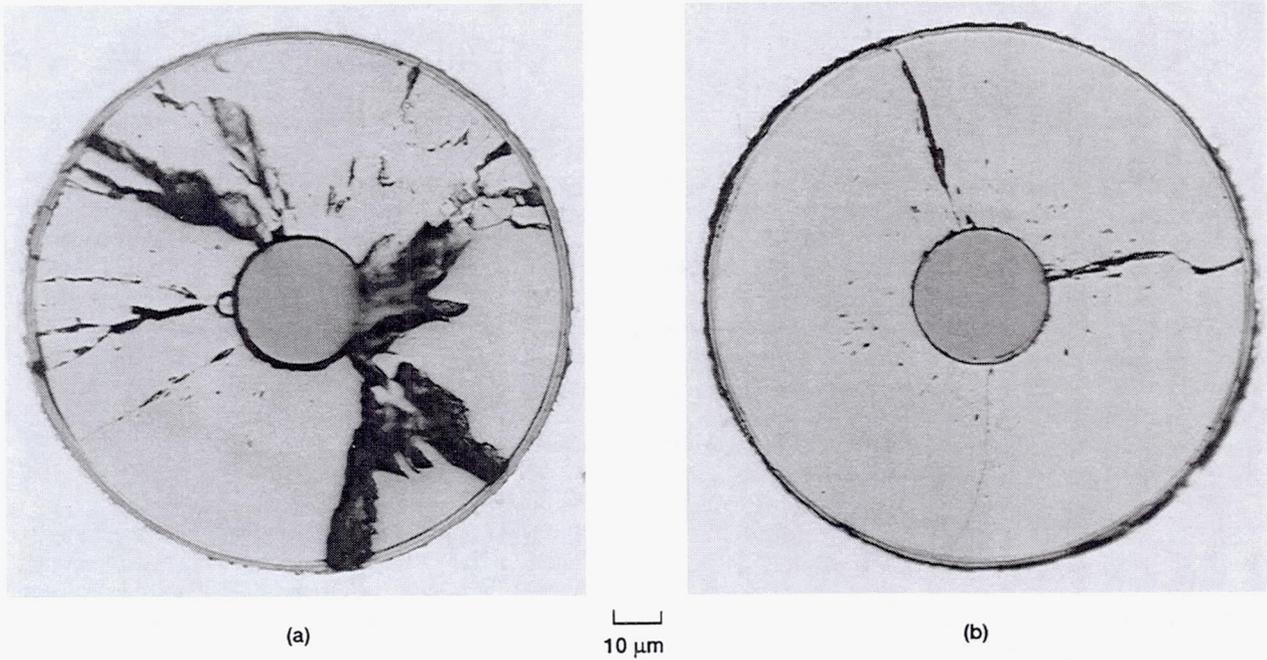
of the ring section. Higher magnifications of two of these fibers show varying degrees of damage (Fig. 4).

FIGURE 4.—PHOTOGRAPHS OF DAMAGED FIBERS FROM FIGURE 3 DEPICT (a) A CRUSHED FIBER AND (b) A CRACKED FIBER.

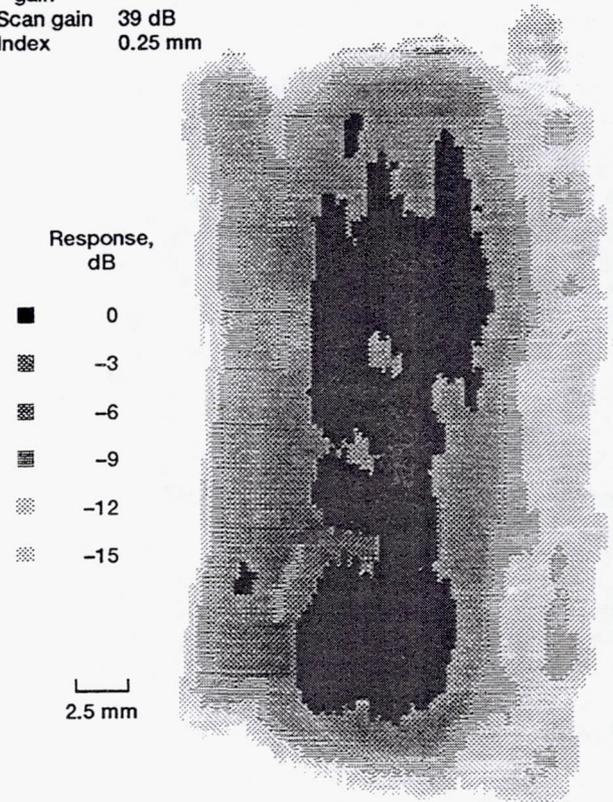
Figure 5 is an ultrasonic c-scan of a portion of ring R5. The matrix of this ring showed an increased ultrasonic response relative to other rings that were scanned at the same sensitivity before burst tests. This ring was not burst-tested. Ultrasonics, destructive testing, and metallographic sectioning revealed a great number of matrix pull-away conditions throughout the ring. Apparently, greater ultrasonic backscatter is produced by poor consolidation of the matrix material. Figure 6 is a micrograph of a polished typical area within the ring. Most of the fibers in Fig. 6 depict the matrix pull-away condition at the fiber matrix interface. Figure 7 shows higher magnification of this matrix pull-away condition. The cause of this condition has since been identified and successfully eliminated by a change in the consolidation sequence.

FIGURE 5.—SELECTED SECTION OF AN ULTRASONIC P-E SCAN OF SCS-6/ALLOY-C RING R5. BLACK REGIONS INDICATE MATERIAL DAMAGE.

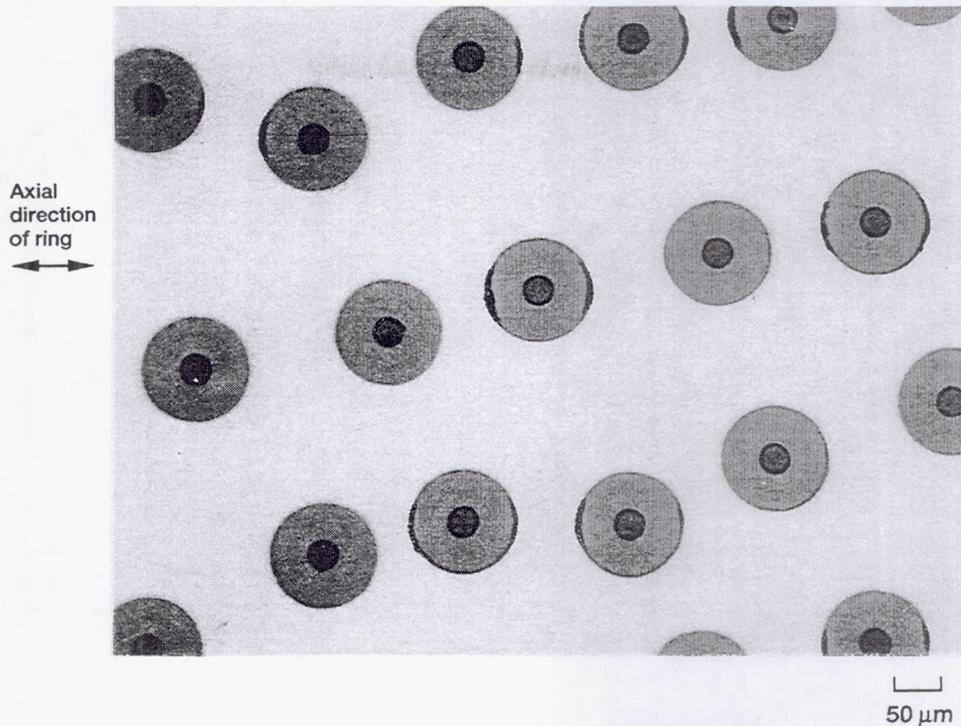
FIGURE 6.—SELECTED MICROGRAPH SHOWING MATRIX PULL-AWAY CONDITION OF MATERIAL DAMAGE CHARACTERIZED BY ULTRASOUND IN FIGURE 5.

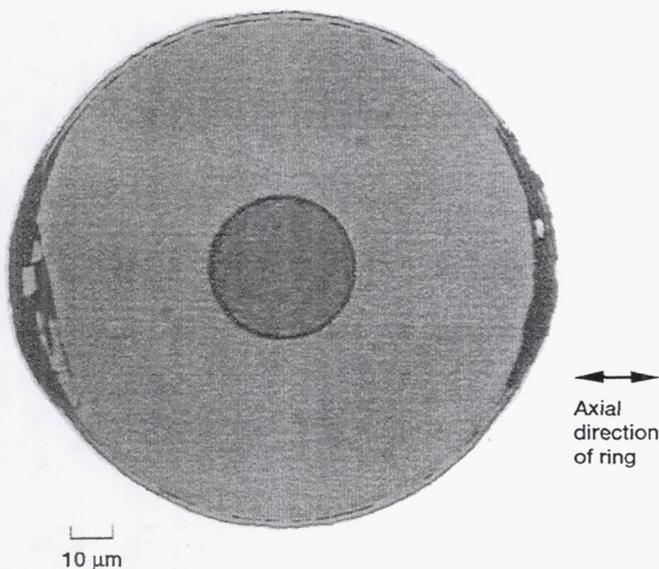
FIGURE 7.—HIGH MAGNIFICATION MICROGRAPH OF TYPICAL MATRIX PULL-AWAY CONDITION IN RING R5.

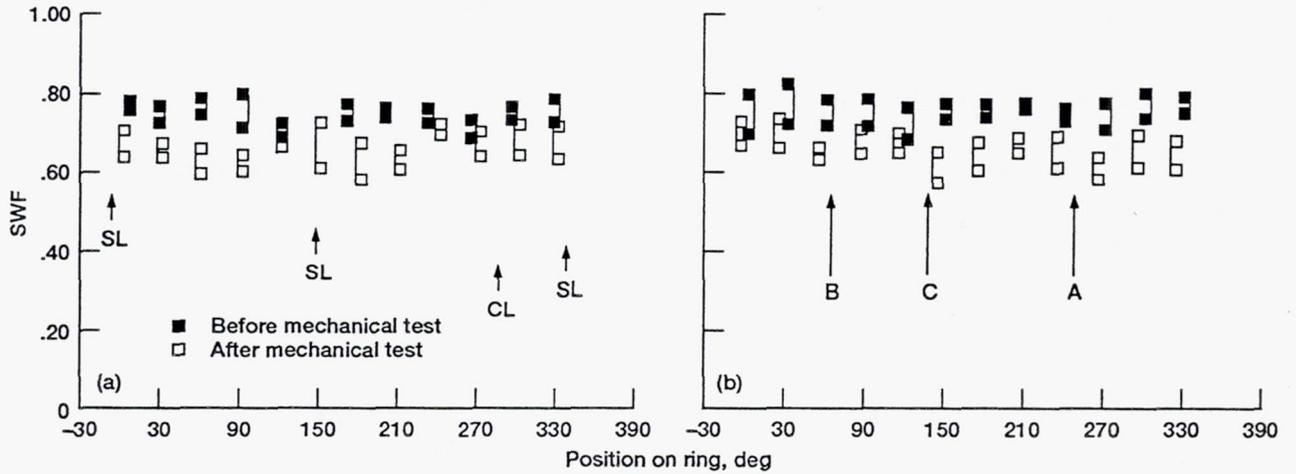
Parts (a) and (b) of Fig. 8 show the SWF's for a 5-MHz sender and 2.25-MHz receiver coupled to the outer surface of rings R1 and R3, respectively. The sender and receiver were ±10° apart with respect to a fiducial mark. For both rings R1 and R3, the SWF was greater after the burst test. This is evidence that the burst test strained the cladding-composite interface and caused greater reflection of ultrasound back into the

cladding. This reflected energy was less attenuated going from sender to receiver, thereby giving a greater SWF.

FIGURE 8.—SWF OF THE HIGHER FREQUENCY COMPONENT OF SIGNAL IN (a) RING R1 AND (b) RING R3. (SWF = RATIO OF INTEGRATED AREA OF MAGNITUDE SPECTRUM OF [0.8 TO 3 MHz] TO THAT OF [0 TO 5 MHz]; SL = SEPARATION LOCATION; CL = CRACK LOCATION; A, B, C = ANOMALY LOCATIONS IN RADIOGRAPHS.)

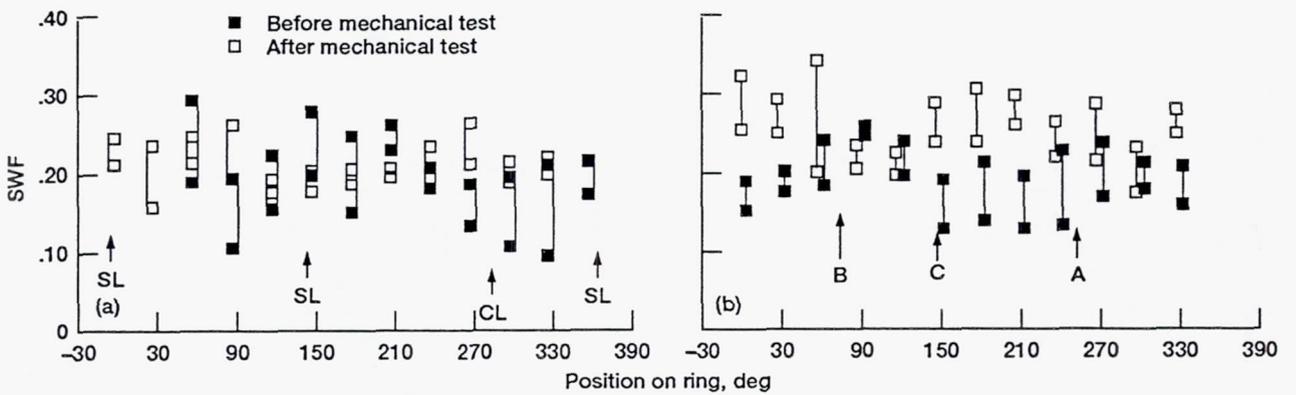
Similarly, Fig. 9 shows the SWF for only the initial portion (lower frequency) of the signals used in Fig. 8. This portion is strongly weighted by ultrasound that has passed in and out of the composite and thus does not show the increase in SWF after the burst test. Although there is more scatter in these data, Fig. 9(b) seems to indicate an actual decrease in SWF after the burst test.

FIGURE 9.—SWF OF THE LOWER FREQUENCY COMPONENT OF SIGNAL IN (a) RING R1 AND (b) RING R3. (SWF = RATIO OF INTEGRATED AREA OF MAGNITUDE SPECTRUM OF [0.2 TO 0.8 MHz] TO THAT OF [0 TO 5 MHz]; SL = SEPARATION LOCATION; CL = CRACK LOCATION; A, B, C = ANOMALY LOCATIONS IN RADIOGRAPHS.)

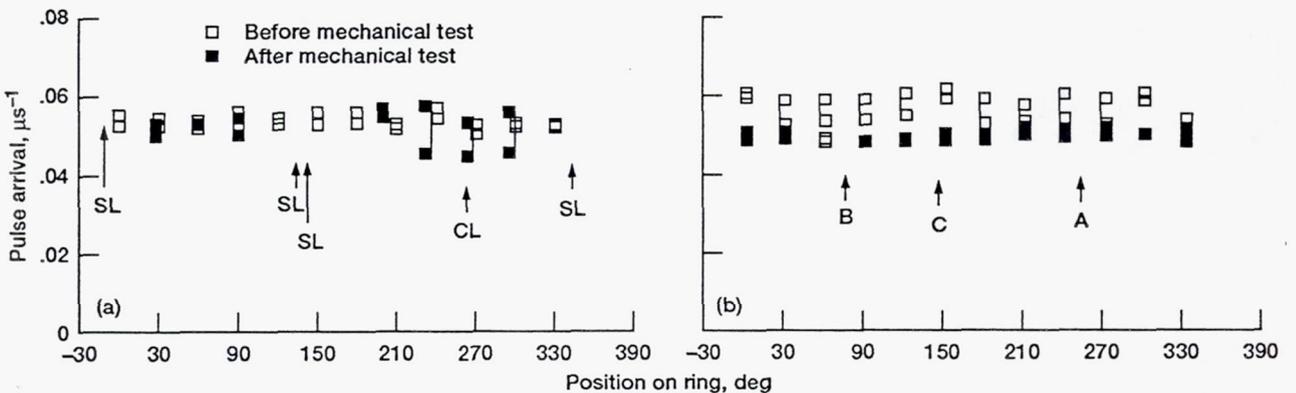
FIGURE 10.—PULSE ARRIVAL VERSUS POSITION ALONG THE OD OF (a) RING R1 AND (b) RING R3. (SL = SEPARATION LOCATION; CL = CRACK LOCATION; A, B, C = ANOMALY LOCATIONS IN RADIOGRAPHS.)

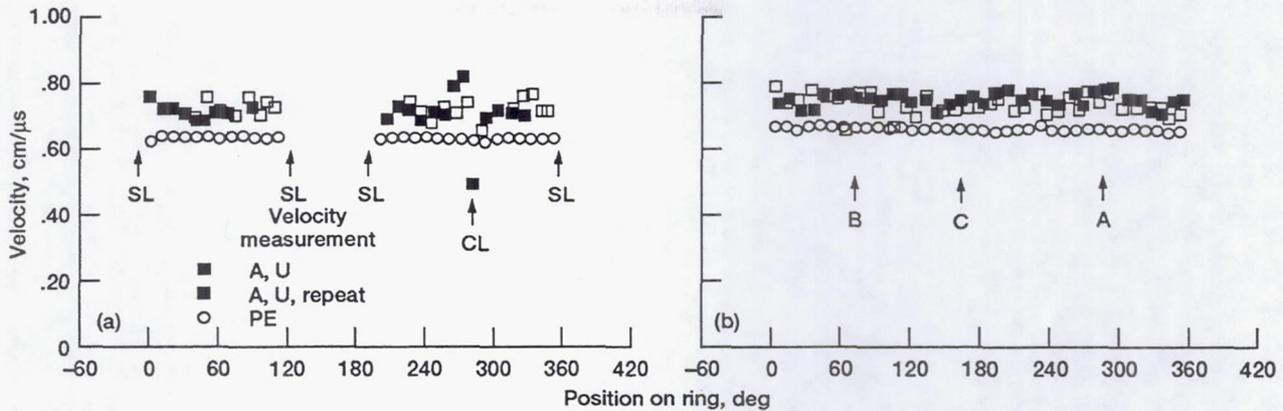
Figure 11 shows results obtained with 1-MHz transducers, but only after the burst test. These data were collected on the flat face of the rings. For these, it was possible to calculate velocity. The magnitude of these velocities is in the range 0.6 to 0.8 cm/ $\mu$ s, as would be expected for the first symmetric Lamb mode mentioned previously. Figure 11 also includes the 10-MHz pulse-echo results. All the velocities in Fig. 11(a) exhibit degradation in the vicinity of the crack in ring R1 as noted also with Fig. 10.

Velocities in ring R3 (Figs. 10(b) and 11(b)) do not show sensitivity to anomalies A, B, or C that were found with radiography to be low density regions.

FIGURE 11.—VELOCITIES IN (a) RING R1 AND (b) RING R3. (SL = SEPARATION LOCATION; CL = CRACK LOCATION; A, B, C = ANOMALY LOCATIONS IN RADIOGRAPHS.)

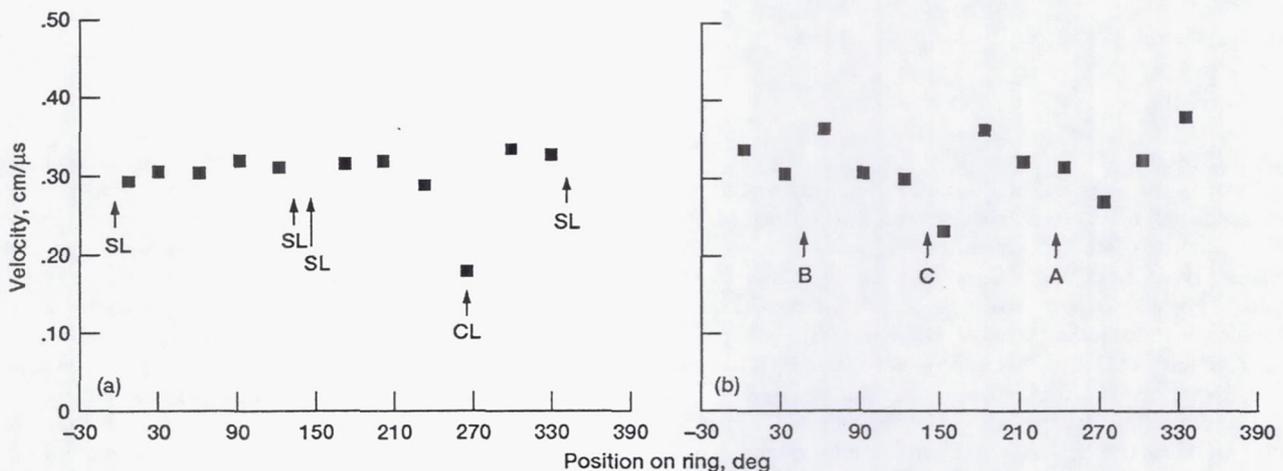
tive to shear and flexure stiffness in the propagation direction. Figure 12 shows velocities from pairs of 0.5-MHz transducers coupled to the flat sides of the rings. These velocities ranged from 0.3 to 0.4 cm/μs. This supports the assumption that these are shear wave velocities. Figure 12(a) indicates degradation of the shear velocity in the vicinity of the crack in ring R1. Unlike the axial cases, Fig. 12(b) suggests some degradation in the shear velocity in the vicinity of anomalies A, B, and C that were identified by radiography.

FIGURE 12.—SHEAR VELOCITIES FOR (a) RING R1 AND (b) RING R3. (SL = SEPARATION LOCATION; CL = CRACK LOCATION; A, B, C = ANOMALY LOCATIONS IN RADIOGRAPHS.)

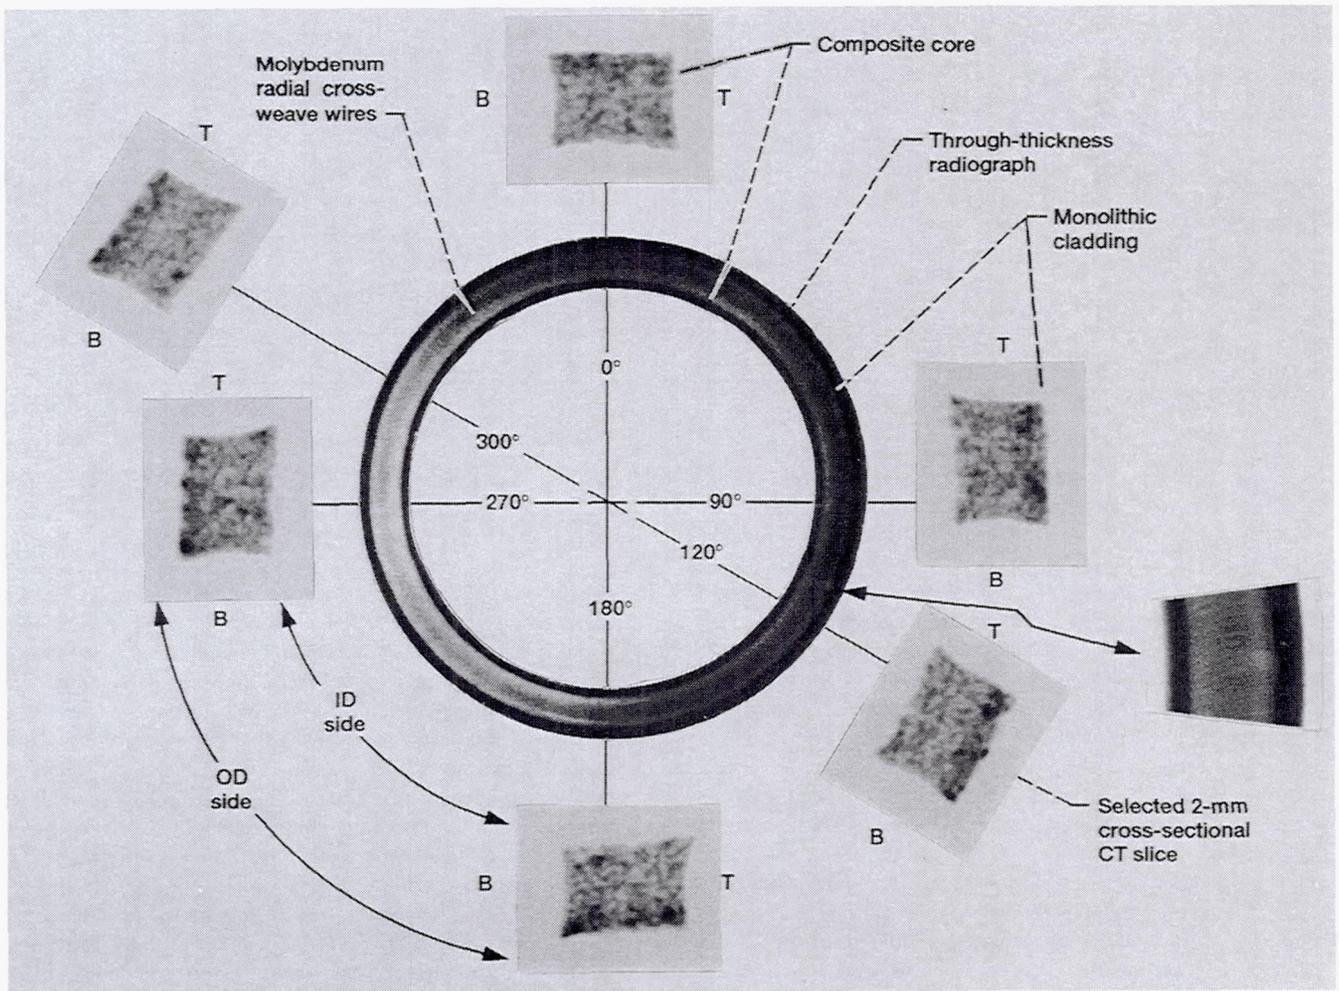
Figures 13 and 14 show through-the-thickness conventional radiographs of rings R2 and R3 along with selected XCT slices. Conventional radiography showed a thinner cladding toward the ID of ring R2 than toward the OD. Similarly, the four XCT slices not only show a smaller cladding on the ID side than on the OD side, but also detail the density variations within each slice. Conventional radiography also shows the density variations within the composite core and features the presence of sizeable low density anomalies such as the one highlighted in Fig. 13 before the 120° marker.

The XCT slices in Figs. 13 and 14 depict the presence of a protruding cusp in the core, located near the top side and toward the ID of the ring. XCT slices further demonstrated a lower fiber volume fraction and/or poorer consolidation in the core area toward the OD side than is seen toward the ID side. The core of the composite was supposed to be rectangular, uniform, and surrounded by uniform cladding.

FIGURE 13.—RADIOGRAPHY AND X-RAY COMPUTED TOMOGRAPHY OF RING R2. (ANNULUS DIMENSIONS: OD, 171 MM; ID, 133 MM; THICKNESS, 24 MM; ANNULUS MATERIALS, SCS-6/TI-15V-3CR-3AL-3SN. T IS TOP SIDE; B IS BOTTOM SIDE.) LIGHTER REGIONS INDICATE HIGHER DENSITY IN TOMOGRAPHY (DARKER IN RADIOGRAPHY).

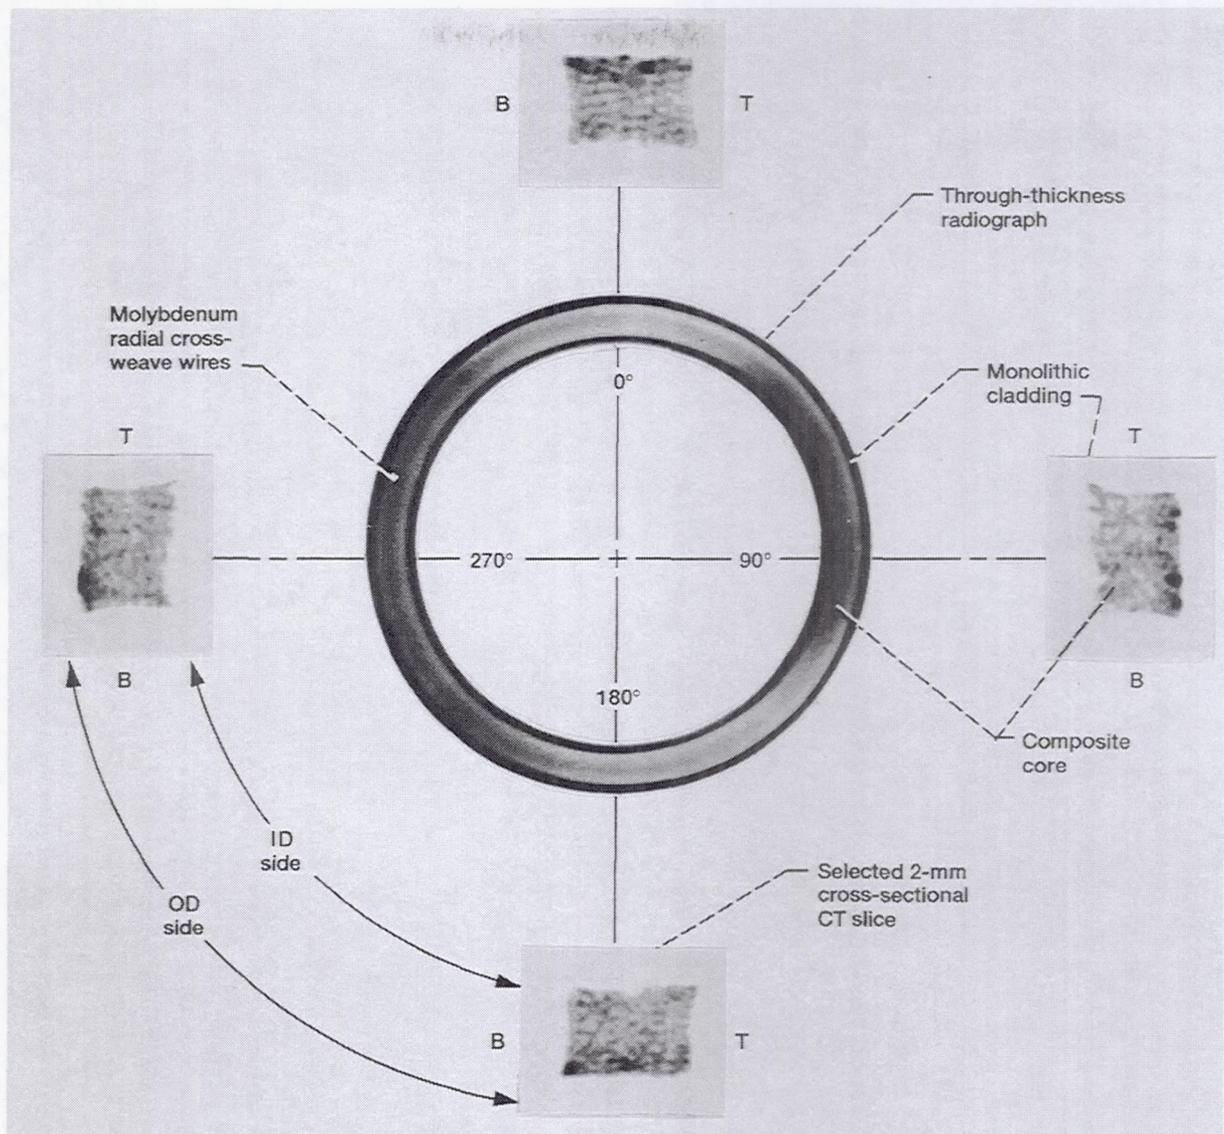
FIGURE 14.—RADIOGRAPHY AND X-RAY COMPUTED TOMOGRAPHY OF RING R3. (ANNULUS DIMENSIONS: OD, 171 MM; ID, 133 MM; THICKNESS, 24 MM. ANNULUS MATERIALS, SCS-6/TI-15V-3CR-3AL-3SN. T IS TOP SIDE; B IS BOTTOM SIDE.) LIGHTER REGIONS INDICATE HIGHER DENSITY IN TOMOGRAPHY (DARKER IN RADIOGRAPHY).

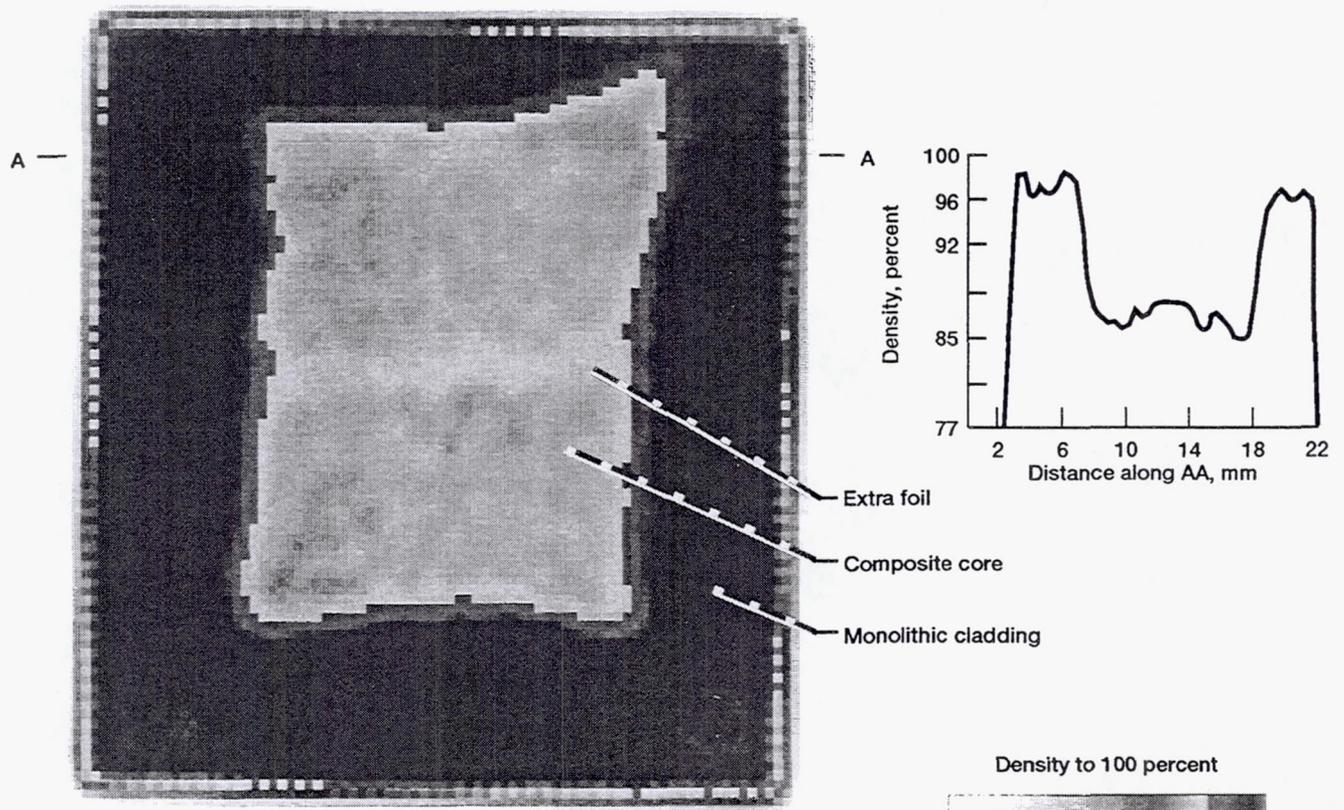
A magnified XCT image in Fig. 15 shows density variations in a slice of ring R1 before testing. The density variations along line AA show a 10-percent change between the case and the core of the ring and a 3-percent change within the composite core. Figure 15 reveals the processing/consolidation problems that resulted in the protruding cusp seen previously in rings R2 and R3. The horizontal white band in the core section indicates a manufacturing flaw (i.e., an extra foil layer).

FIGURE 15.—SELECTED XCT CROSS-SECTION FROM RING R1 SHOWING DENSITY VARIATIONS.

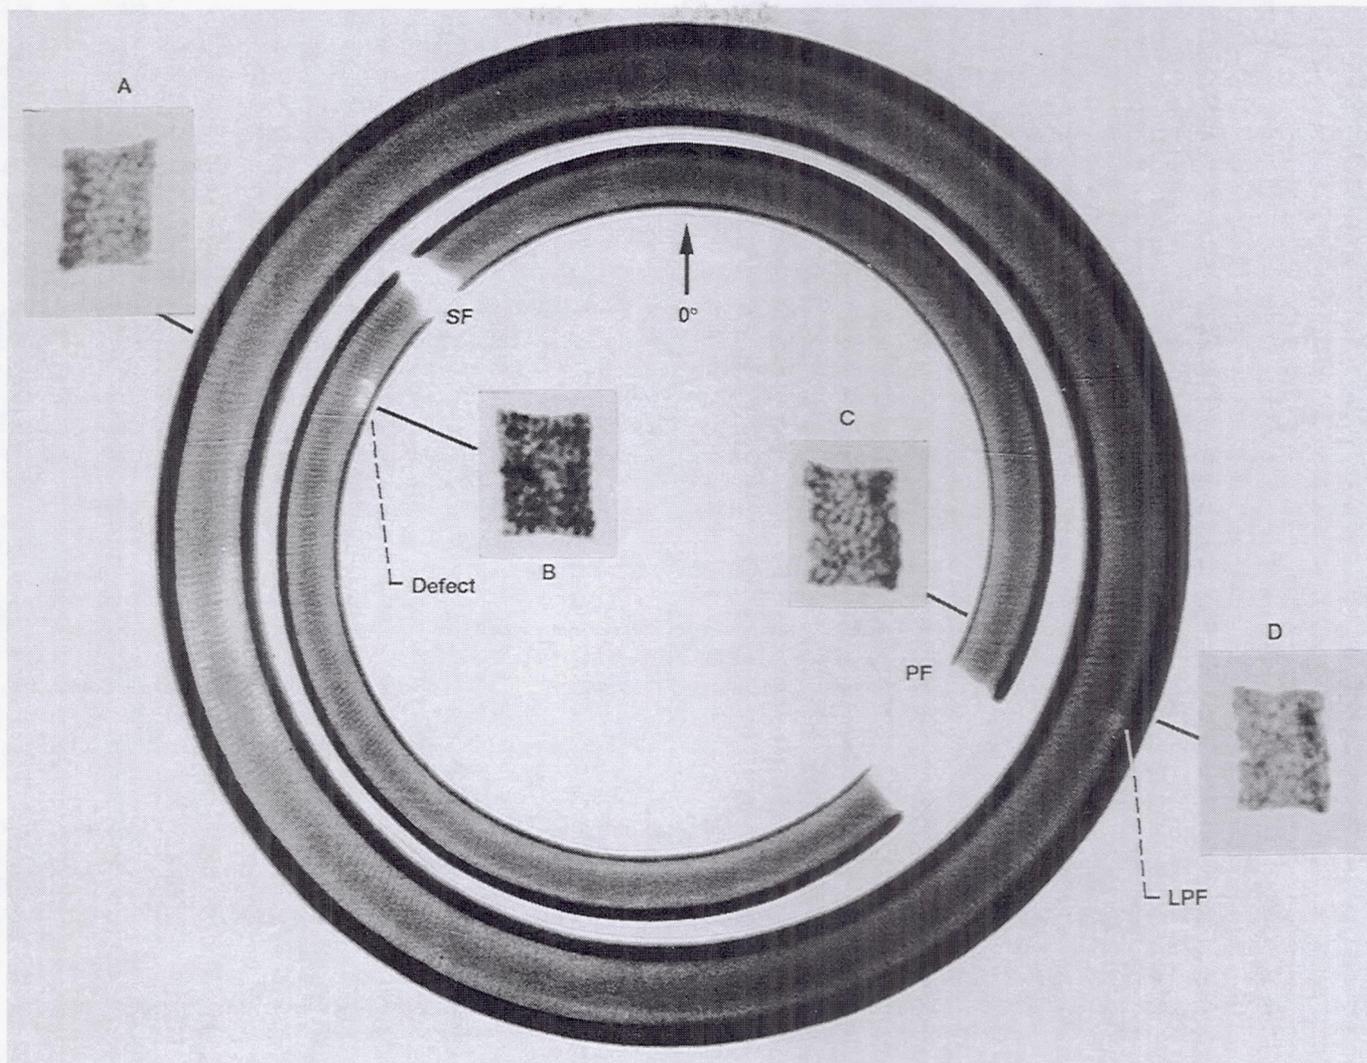
Figure 16 presents radiographs with different magnifications of R2 before and after the burst test in order to compare results on the same figure. XCT slices taken before (A and D) and after (B and C) the burst test at approximately the same locations are

also shown in Fig. 16. One location was near the burst area (i.e., the primary fracture (PF) area), and the other was near the secondary fracture (SF) area that is diametrically opposite the PF. Radiography of ring R2 before testing detected a defect condition that may have lead to the primary failure, because the location of that defect coincides with the location of the primary fracture designated LPF in Fig. 16. The defect has a low radiographic density that may indicate poor consolidation in the composite core and poor cladding-composite interface bonding. Radiography also showed poor consolidation and/or higher fiber volume fraction in the OD side of the core before and after testing. A defect appears in the radiograph taken after testing. This type of defect was also found with ultrasonics. Characterizing the defects, the difference in the degree of damage that is seen between XCT slices B and C, and the damage evolution that is seen between slices A and B and between C and D requires further work. Future work will correlate NDE findings and detailed metallographic characterization.

FIGURE 16.—RADIOGRAPHY AND SELECTED X-RAY TOMOGRAPHIC SLICES OF RING R2 BEFORE (OUTER RING) AND AFTER (INNER RING) BURST TEST. SLICES A AND D WERE TAKEN BEFORE BURST TESTING; SLICES B AND C, AFTERWARD. (PF = PRIMARY FRACTURE; SF = SECONDARY FRACTURE; LPF = LOCATION OF PRIMARY FRACTURE.) LIGHTER REGIONS INDICATE HIGHER DENSITY IN TOMOGRAPHY (DARKER IN RADIOGRAPHY).
