Flight Service Evaluation of Composite Components on the Bell Helicopter Model 206L

Final Report

Henry Wilson

CR-191499

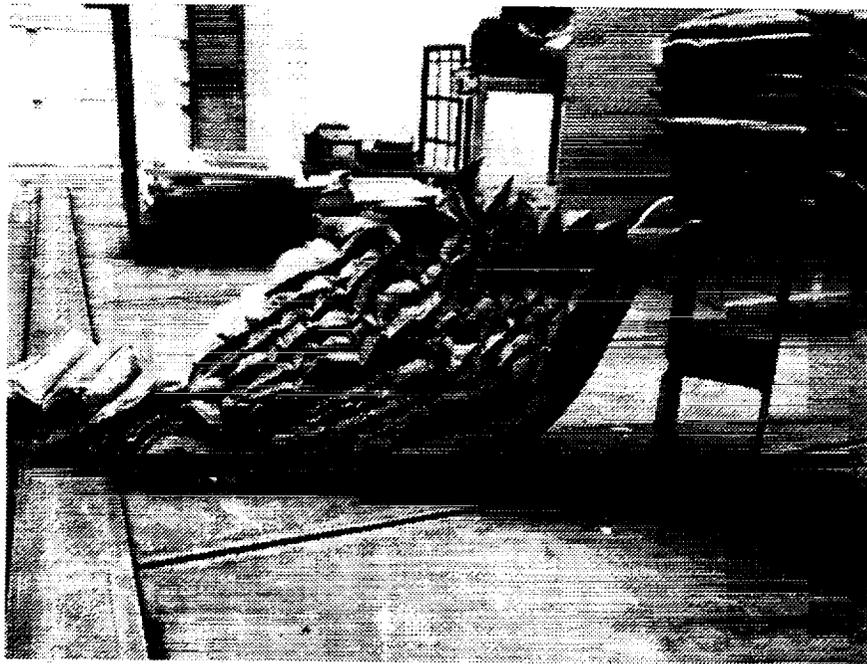
2-L509

Figure 12. Vertical Fin Static Failure Mode

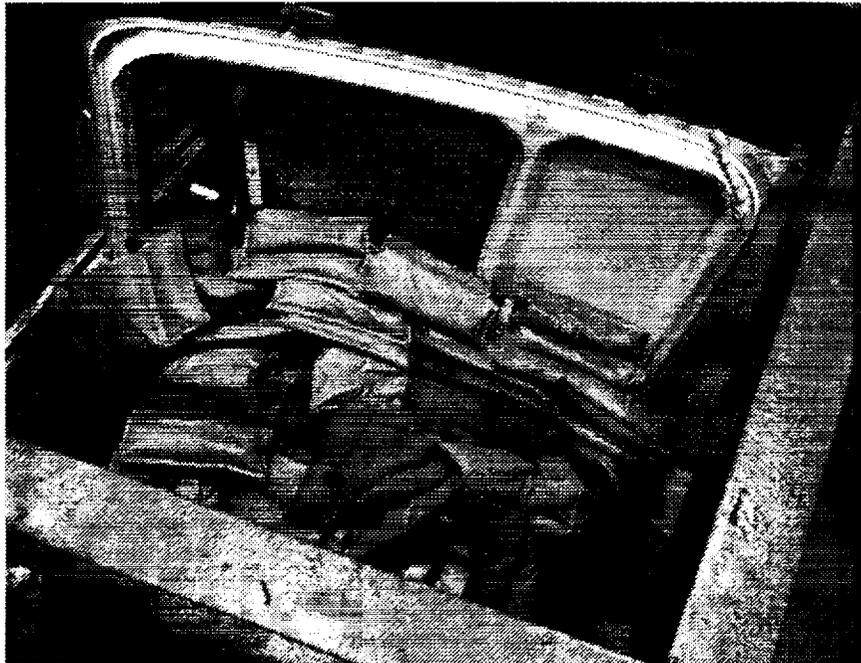
2-L513

Figure 16. Litter Door Static Failure Mode

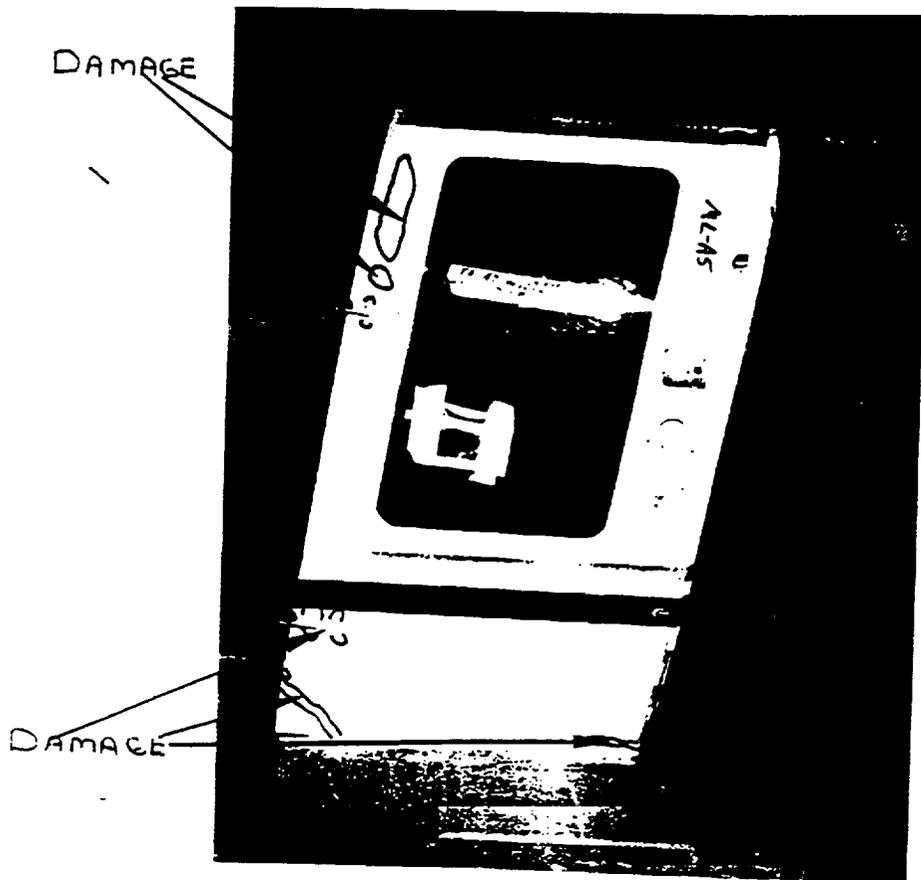
Photograph 2. Litter Door ML-A5 With Service Damage Identified

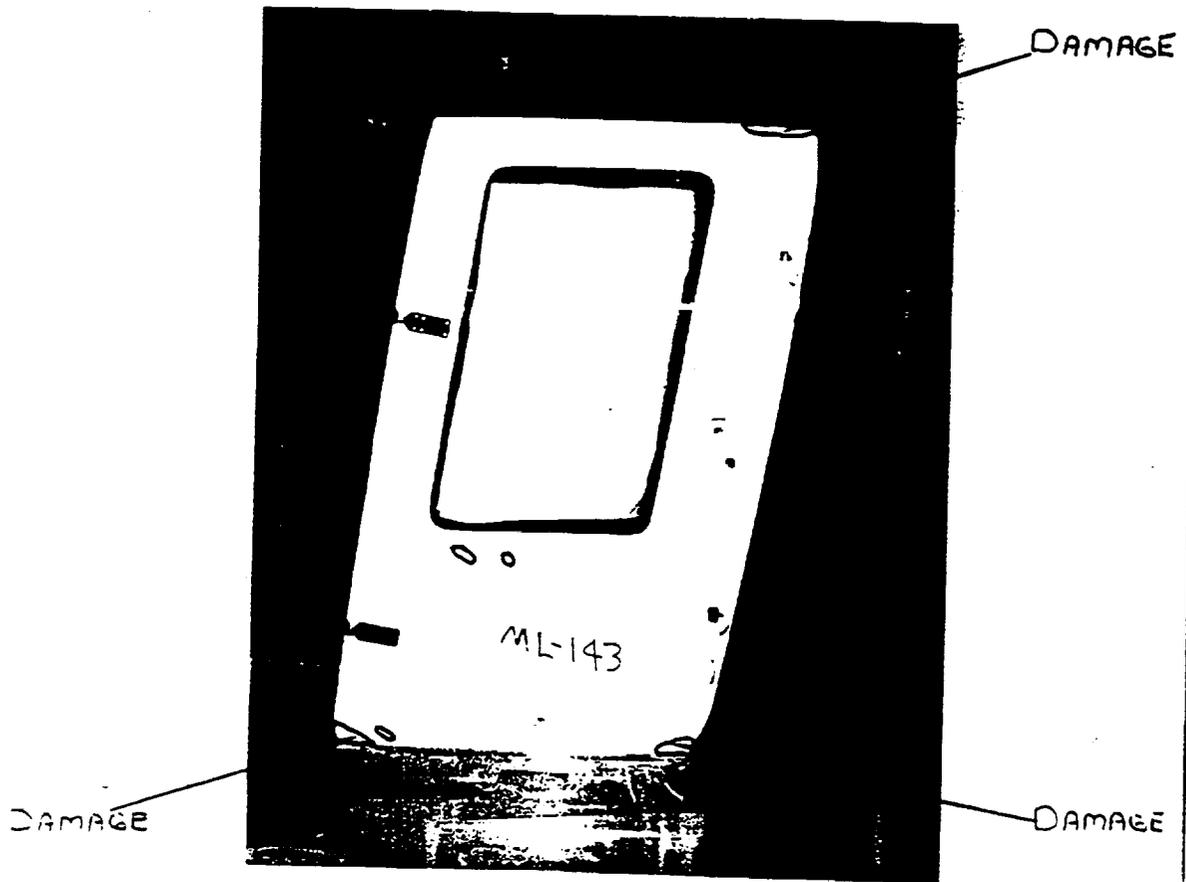
Photograph 4. Litter Door ML-143 With Service Damage Indentified
