**"Physical Interpretation and Development of Ultrasonic Nondestructive  
Evaluation Techniques Applied to the Quantitative Characterization of Textile  
Composite Materials"**

Semiannual Progress Report: March 15, 1993 - September 14, 1993

NASA Grant Number: NSG-1601

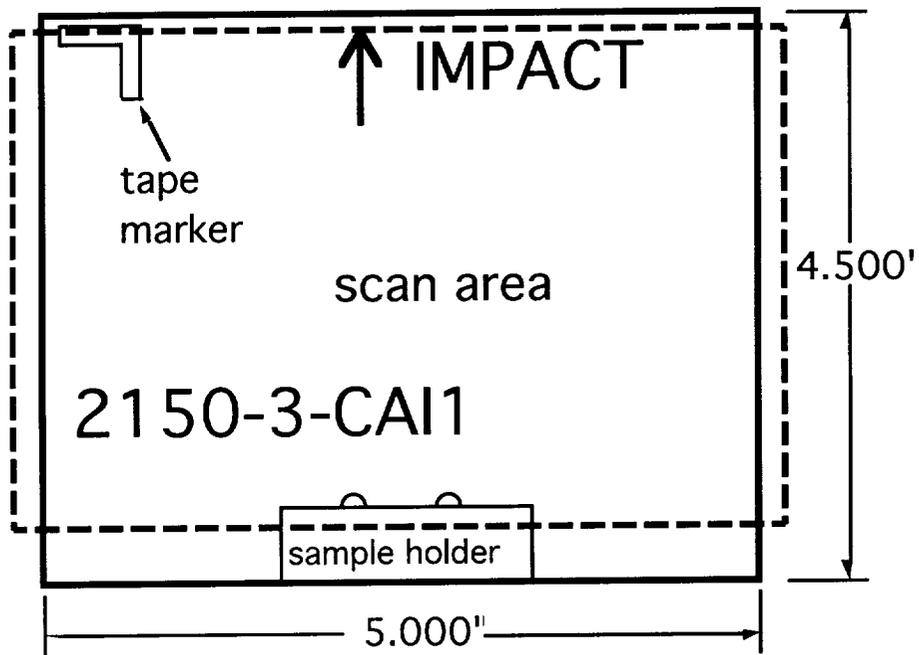
**Figure 2.** Sample: 2150-3-CAI1, stitched quasi-isotropic composite, 4.5"x5"x0.07", surfaces ground smooth. Through-transmission C-scan, 10 MHz, 0.5" diameter transducers with 4" focal length; 135 x 93 sites, 1mm stepsize. Image shows peak-to-peak values.

less of the signal appeared to get through the Kevlar™ stitched region compared to the amount of signal transmitted through the carbon/epoxy. With the exception of the areas near the stitches, the images all seem to be fairly uniform in gray-scale, suggesting that there are no gross defects (i.e. porosity, delaminations, etc.) in the samples.

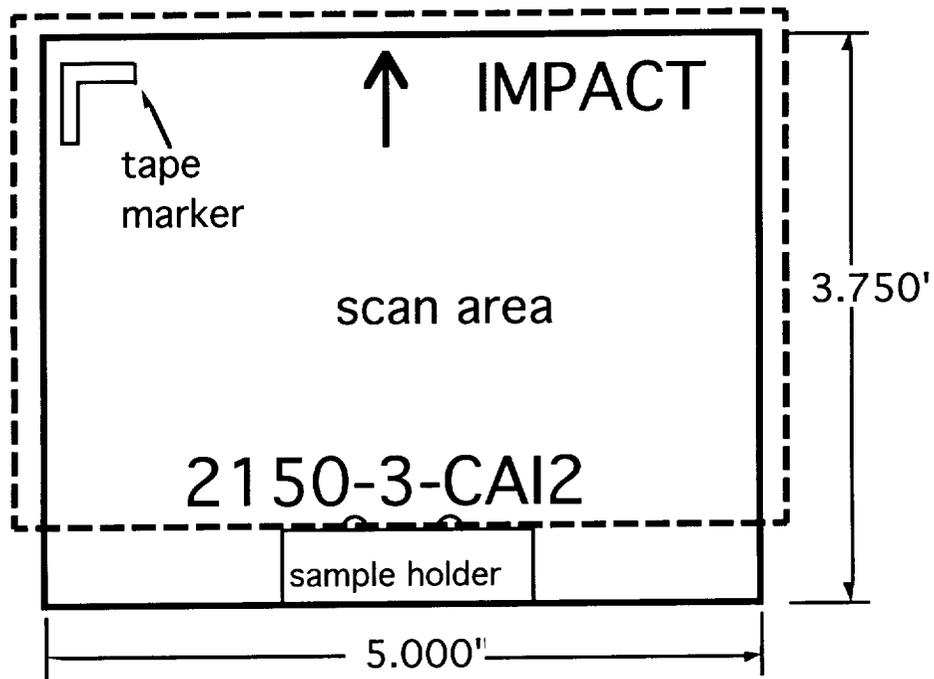
**Figure 3.** Sample: 2150-3-CAI2, stitched quasi-isotropic composite, 3.75"x5"x0.07", surfaces ground smooth. Through-transmission C-scan, 10 MHz, 0.5" diameter transducers with 4" focal length; 139 x 82sites, 1mm stepsize. Image shows peak-to-peak values.

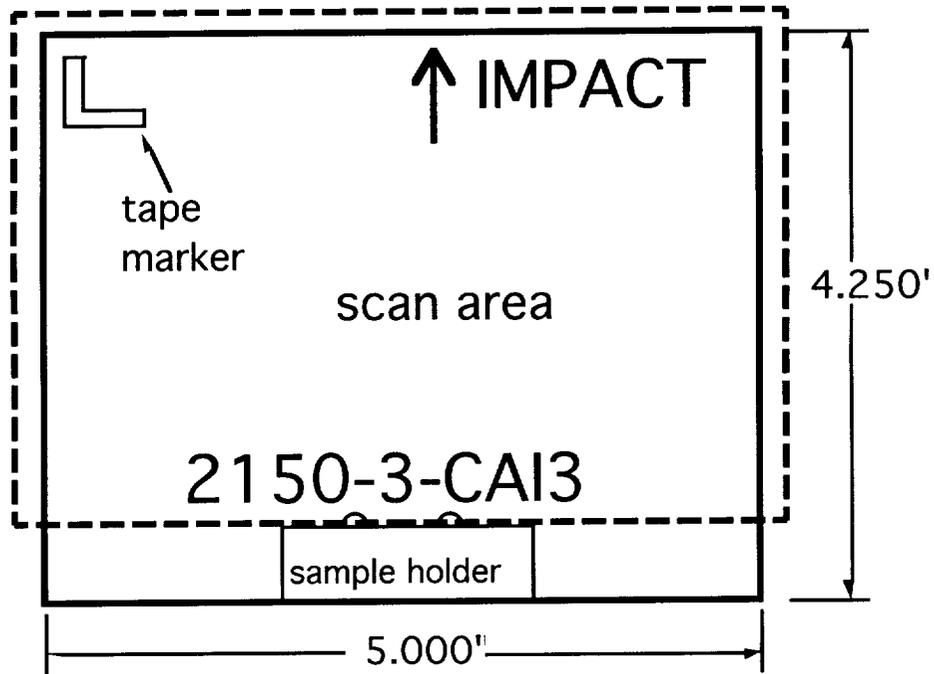
**Figure 4.** Sample: 2150-3-CAI3, stitched quasi-isotropic composite, 4.25"x5"x0.07", surfaces ground smooth. Through-transmission C-scan, 10 MHz, 0.5" diameter transducers with 4" focal length; 139 x 96 sites, 1mm stepsize. Image shows peak-to-peak values.

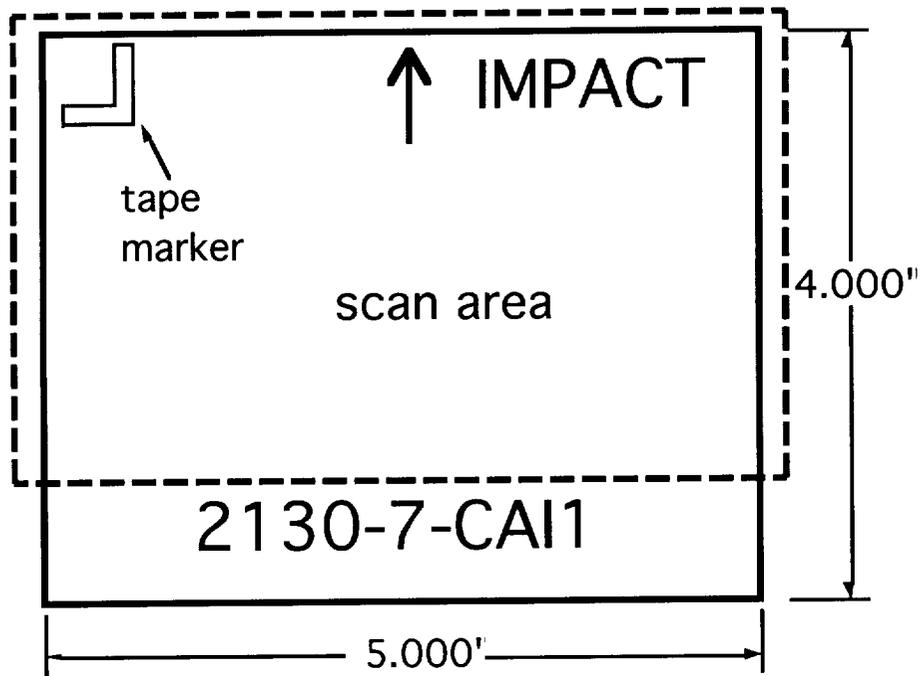
**Figure 5.** Sample: 2130-7-CAI1, stitched quasi-isotropic composite, 4"x5"x0.25", surfaces ground smooth. Through-transmission C-scan, 10 MHz, 0.5" diameter transducers with 4" focal length; 135 x 83 sites, 1mm stepsize. Image shows peak-to-peak values.

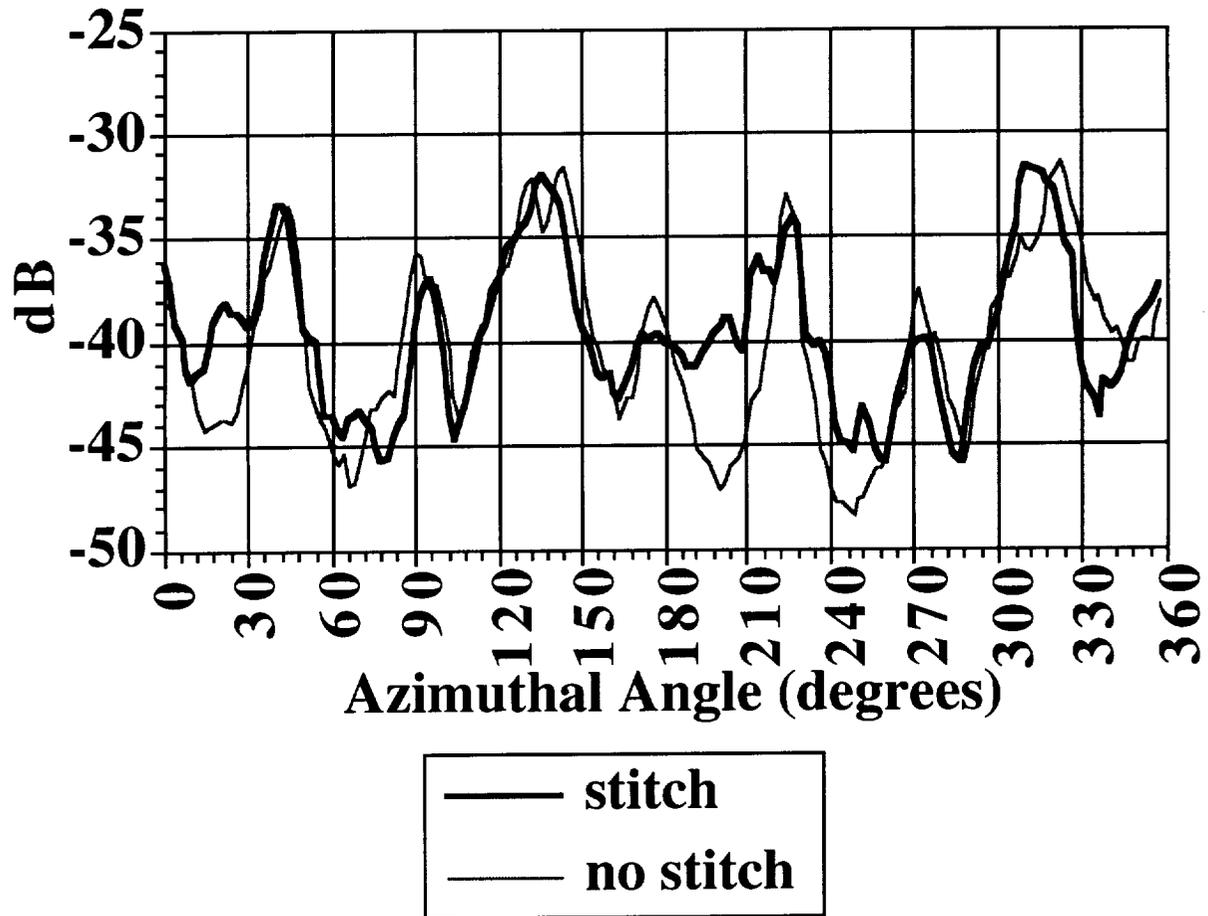
Anisotropy scans were performed on a stitched region and a non-stitched region of sample 2150-3-CA11 with a polar angle of 30°. At every azimuthal angle (varied in 2° steps), nine site averages were taken. Figure 7 shows integrated backscatter (4 to 8 MHz) plotted vs azimuthal angle for both regions (stitched and non-stitched). The curves appear similar except at the angles 22° and 202°, where the contrast between the stitches and fibers is greatest.

**Figure 7.** Integrated backscatter (4 to 8 MHz) plotted vs azimuthal angle for both regions (stitched and non-stitched).
