TWR-64204

Final Postflight Hardware Evaluation Report 360T026 (RSRM-26, STS-47)

May 1993

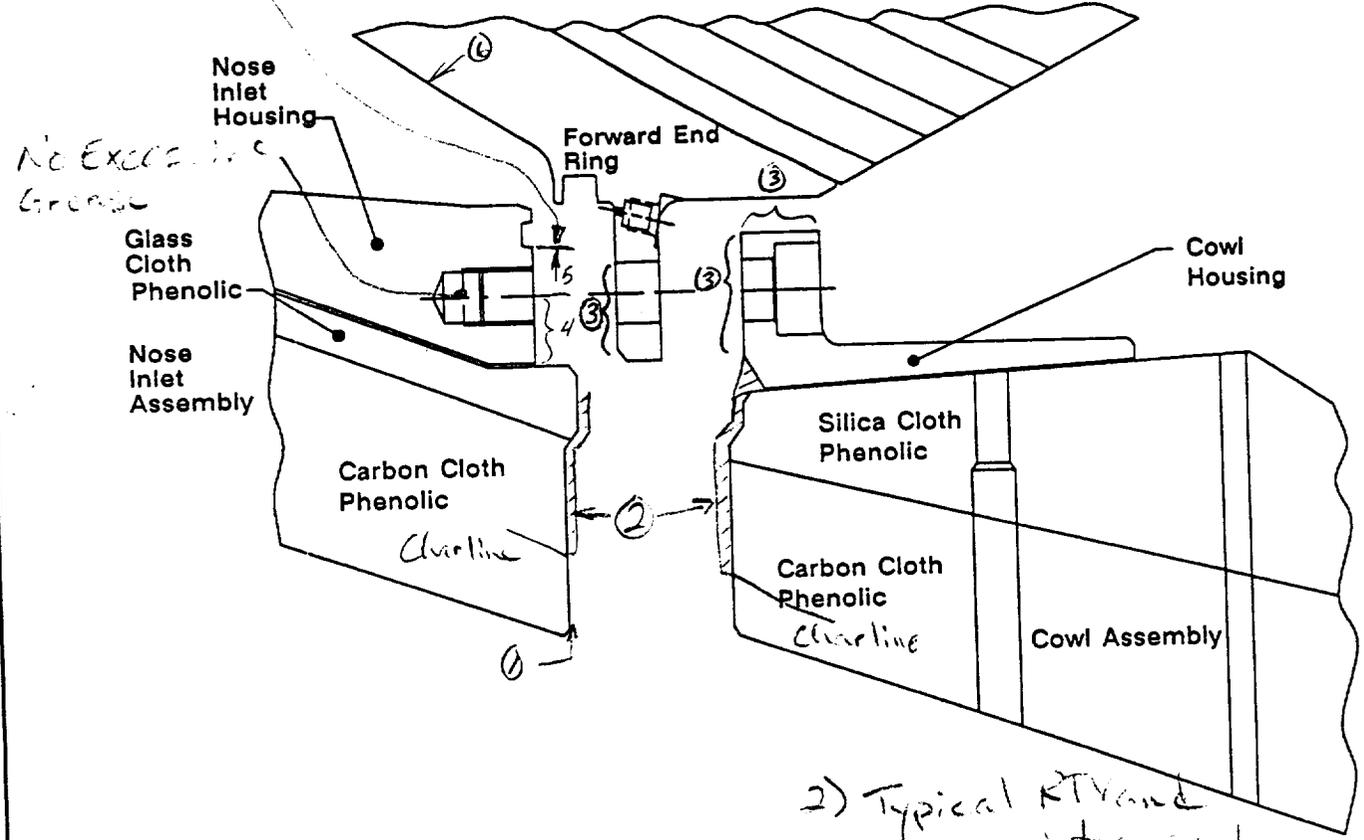
6) Intermittent bubbled
Paint on fwd end ring
O.D. surface at 175°-325°
Bubble extends from fwd end
to within 1" of SECONDARY
O-ring groove, Clear fluid
in bubbles, Sample taken

1) Pry Bar used at 5° and 110°
to facilitate separation

2) Typical RTV and
adhesive intermixed
with soot entering
between layers.

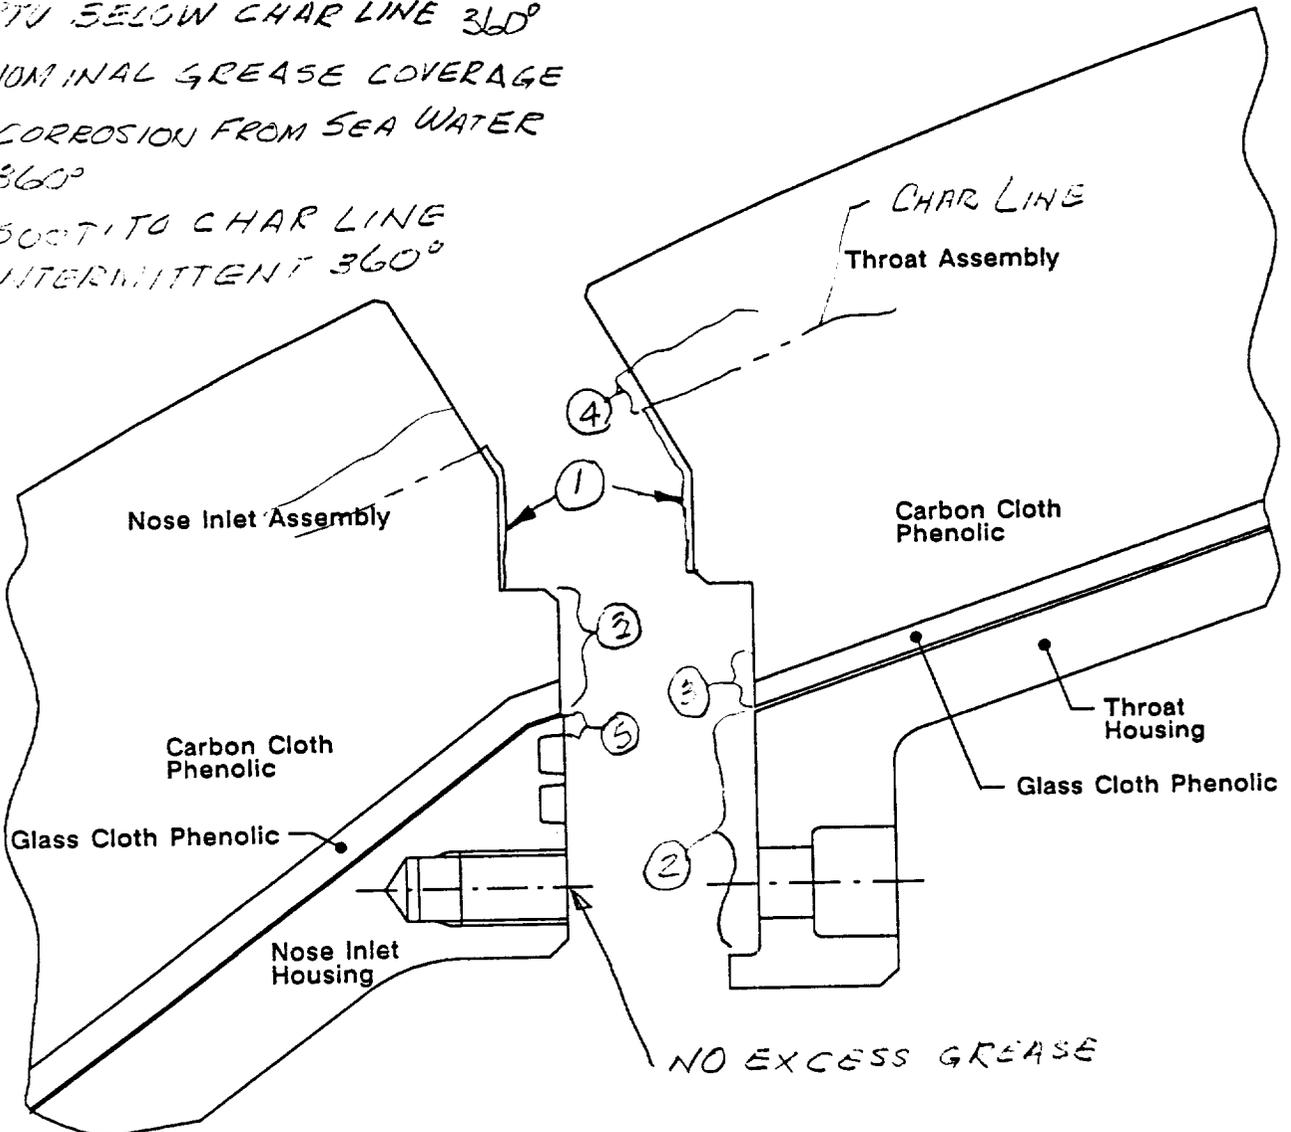
- ① RTU BELOW CHAR LINE 360°
- ② NOMINAL GREASE COVERAGE
- ③ CORROSION FROM SEA WATER 360°
- ④ SOOT TO CHAR LINE INTERMITTENT 360°

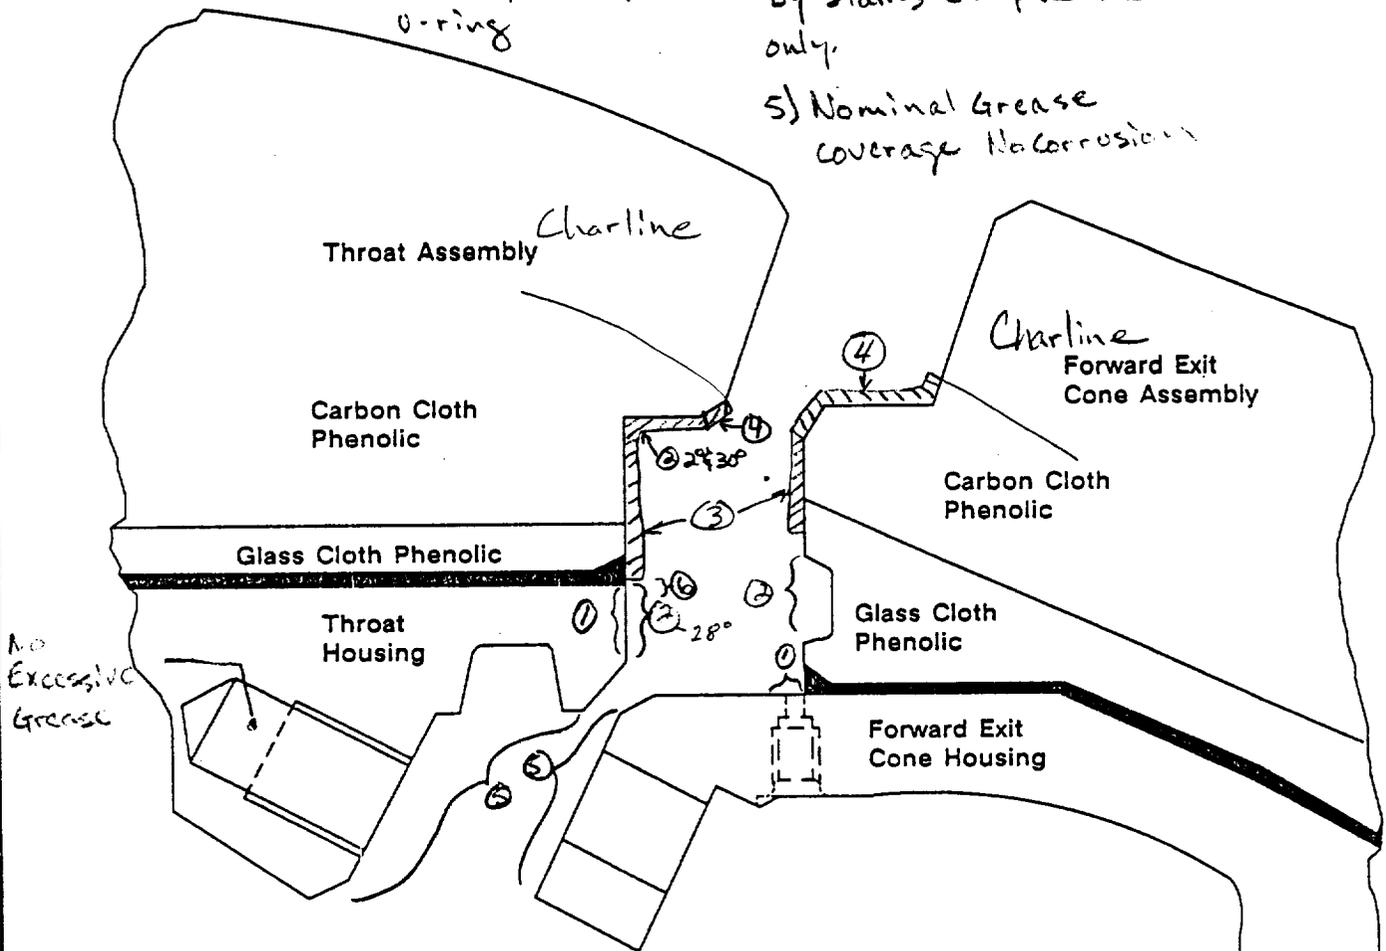
1) 235°-270° medium corrosion
0-360° Light intermittent
corrosion
on Throat and FEC.
6) Medium corrosion in-board of
o-ring footprint

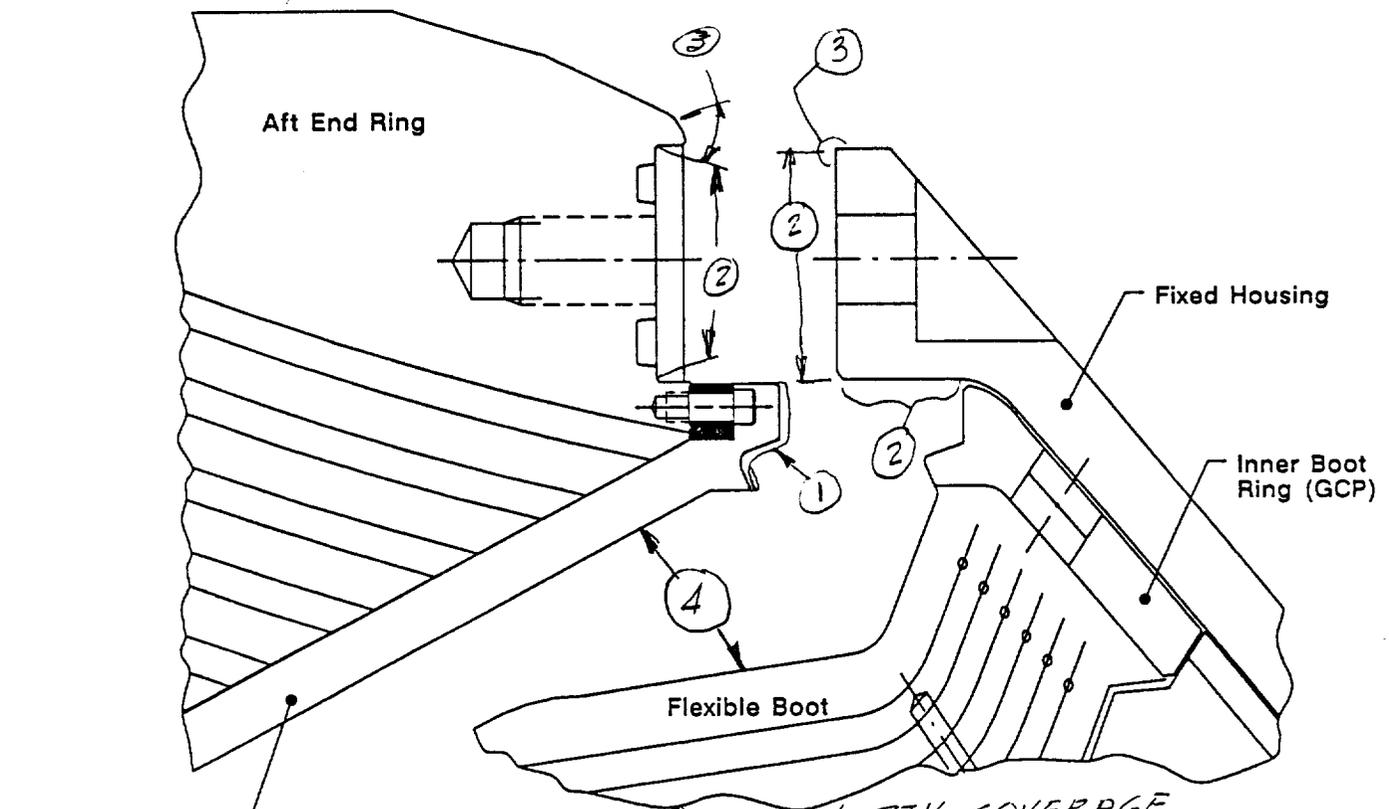
Flexible Bearing Protector

SCRAPE MARKS FROM SPLASH DOWN FROM 155° THRU 305° 7.0" AXIAL AT LOC. 150° LIGHT CORROSION ON SCRAPE MARKS.

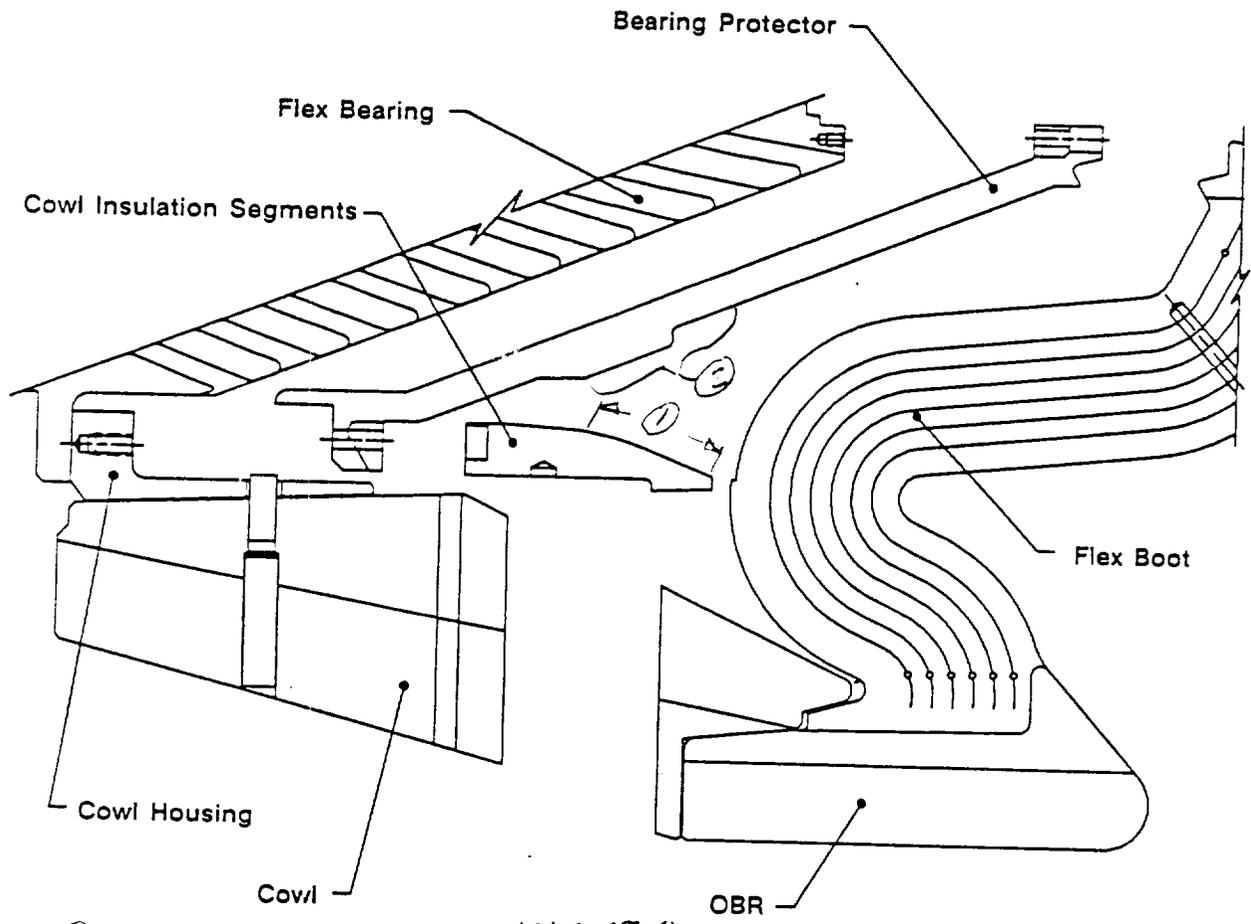
- ① NO BUBBLES ON INSULATION SEGMENTS
- ② HEAVY COATING 360 WHICH IS NORMAL
- ③ CAVITY BETWEEN BRG PROTECTOR & COWL INSUL SEGMENTS WAS FULL OF WATER

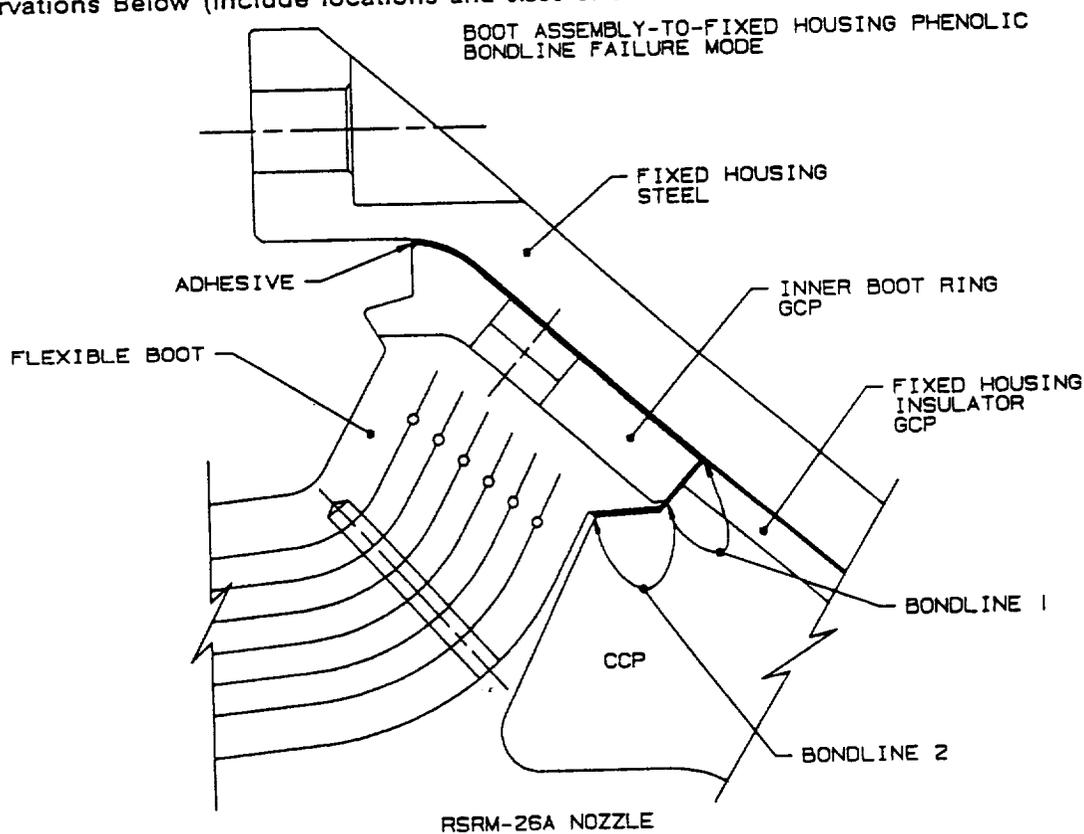
BONDLINE 1 FAILURE MODE IBR-TO-FIXED HSG PHENOLICS	PERCENT OF CIRCUMFERENCE
FIXED HSG-TO-ADHESIVE	10
WITHIN ADHESIVE	5
IBR-TO- ADHESIVE	85

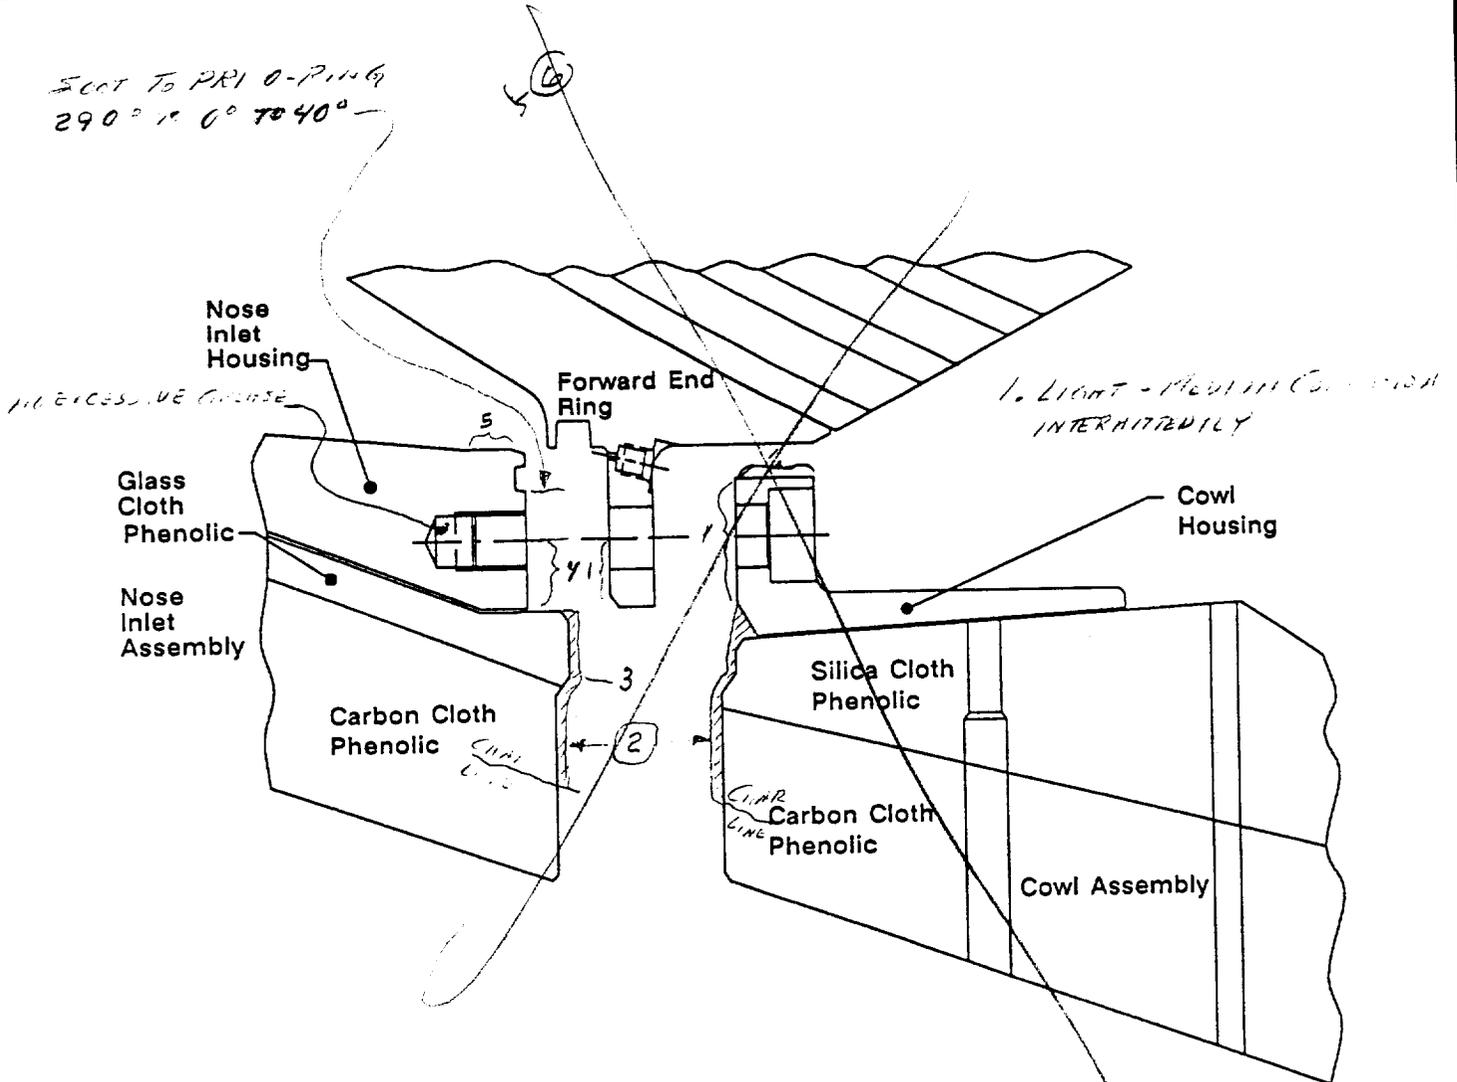
- 1. LIGHT-MEDIUM CORROSION INTERMITTENTLY
- 2. TYP REV & ADHESIVE INTERMIXED WITH SEST ENTERING BETWEEN LAYERS
- 3. GAS PATH AT 350° Reference C-30A WITH HEAT AFFECTED CCP & GCP/SLP
- 4. TYP SECTIONS, LIGHT/MEDIUM INTERMITTENTLY
- 5. TYP LIGHT BURNISHING INTERMITTENTLY
- 6. WASHER WAS FOUND AT THE INTERSECTION OF FLEX BRG CORE AND FWD END RING 205° (47C-10)

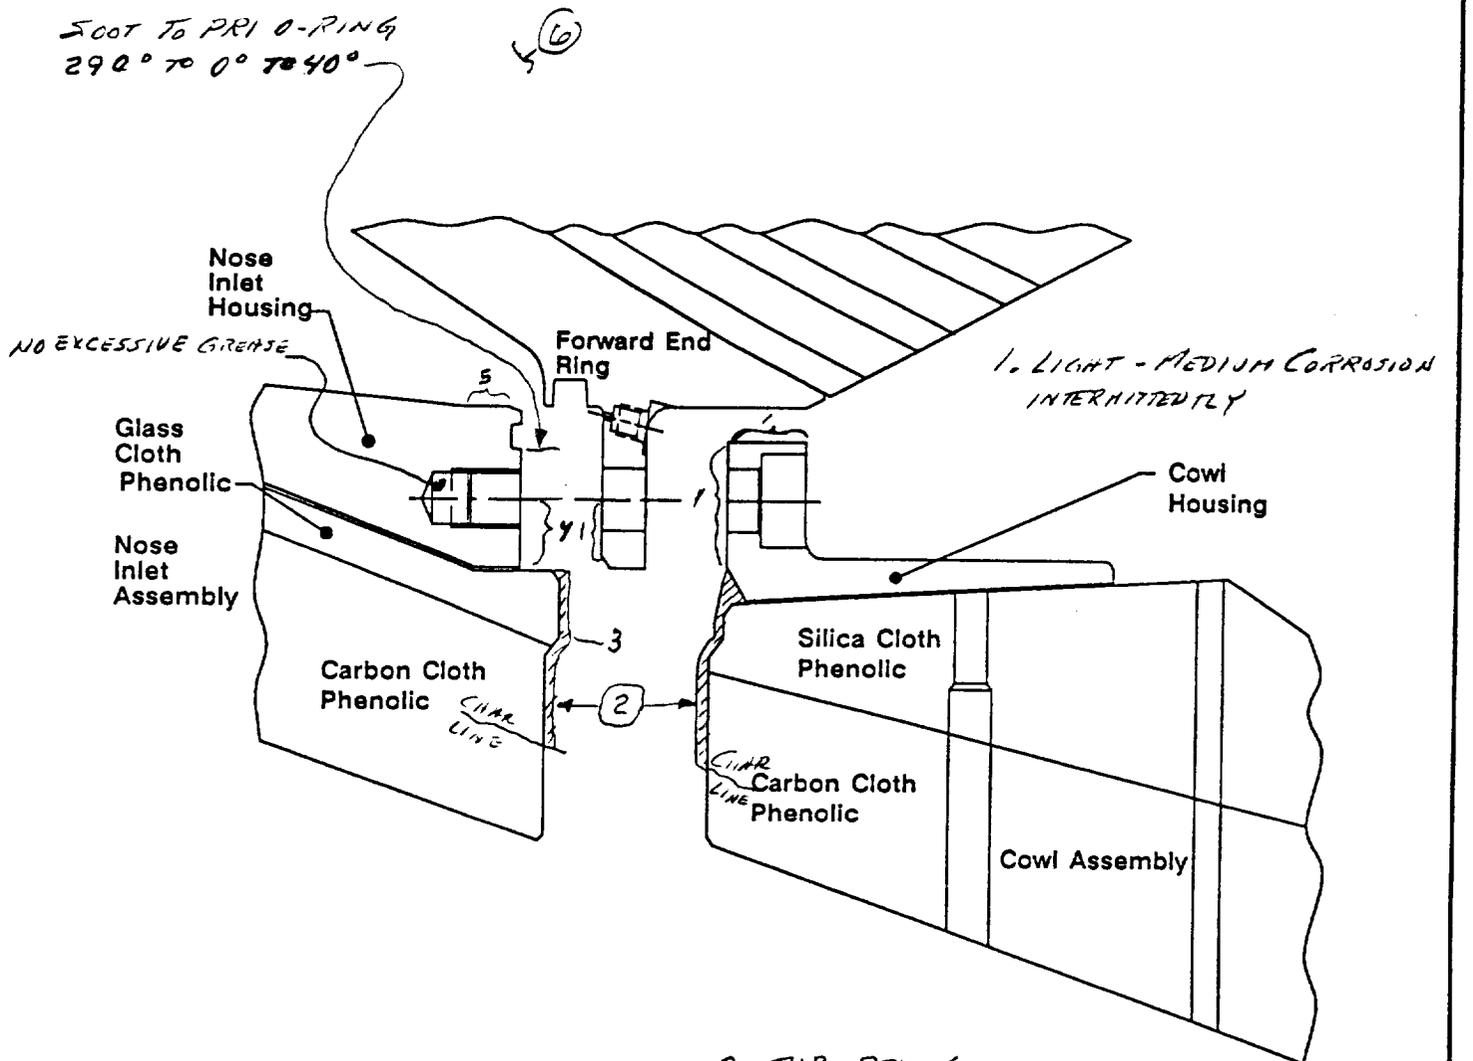
- 2. TYP RTV & ADHESIVE INTERMIXED WITH SOOT ENTERING BETWEEN LAYERS
- 3. GAS PATH AT 350° Reference C-30A with heat affected CCP & GCP/SLP
- 4. TYP SOOTING, LIGHT/MEDIUM INTERMITTENTLY
- 5. TYP LIGHT BURNISHING INTERMITTENTLY
- 6. WASHER WAS FOUND AT THE INTERSECTION OF FLEX BRG CORE AND FWD ENDRING 265° (ATC-10)

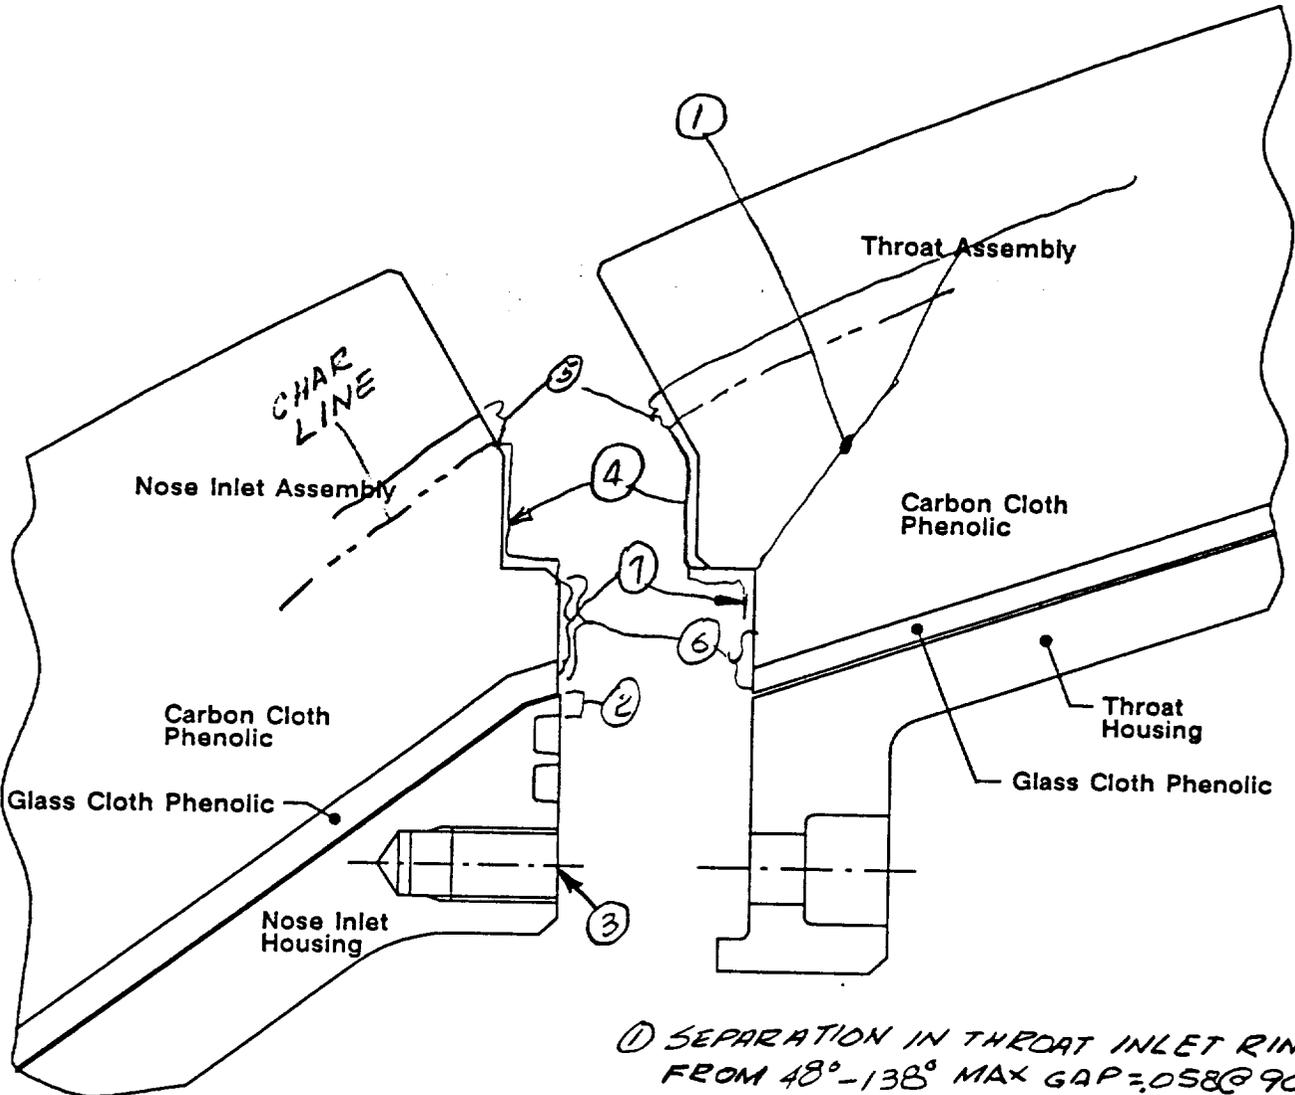
- ⑥ CORROSION FROM SEA WATER 360°
- ⑦ RTV AT LOC 50°-60°, 65°-90°, 100°-130°

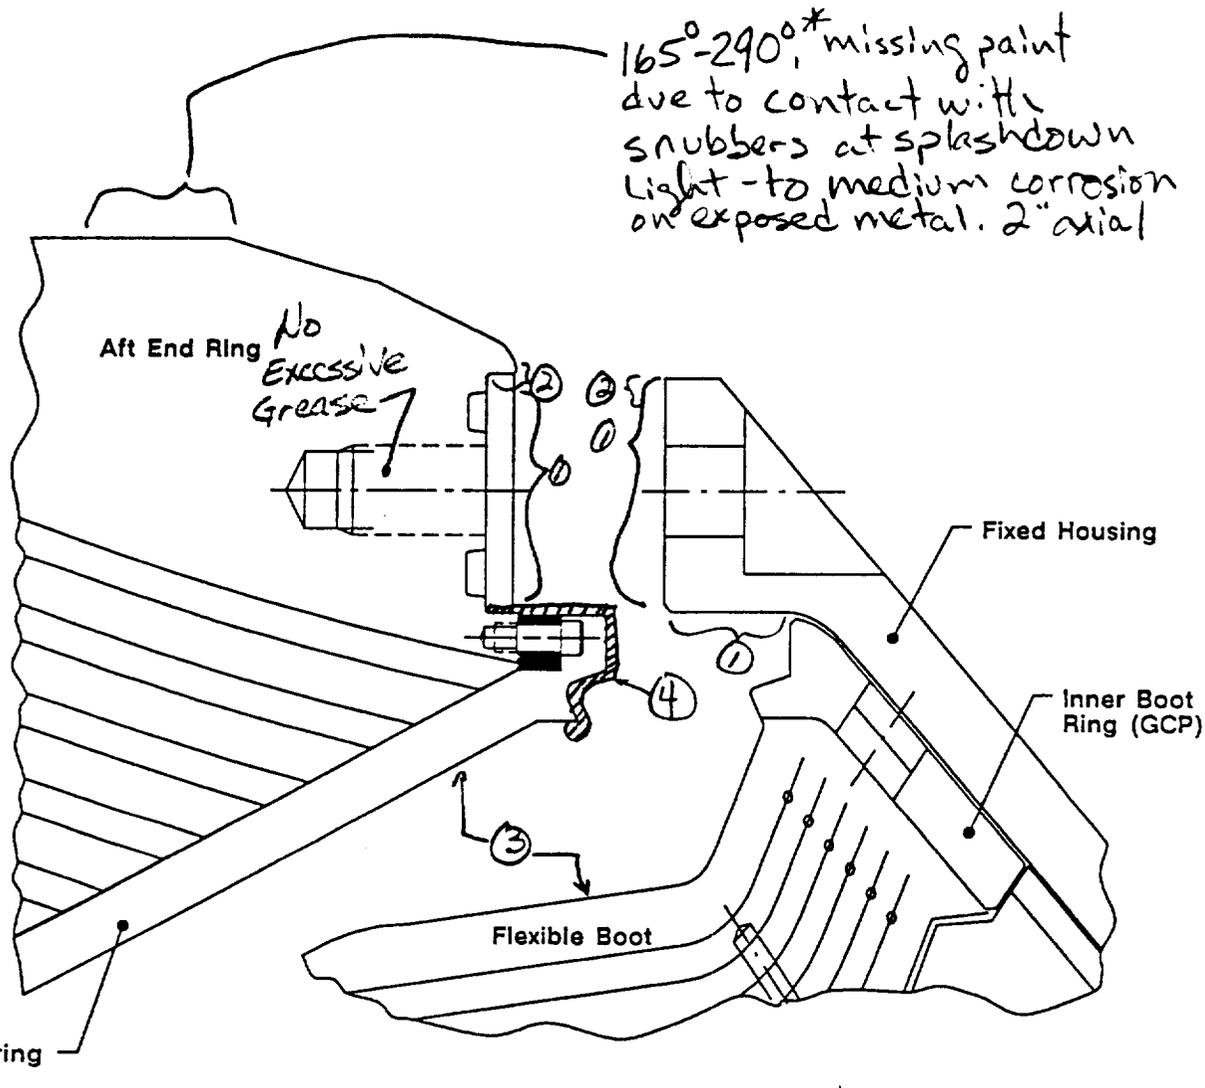
- 1) Nominal Grease
No Corrosion
- 2) Intermittent + Light-to-medium corrosion
- 3) Typical coating of soot

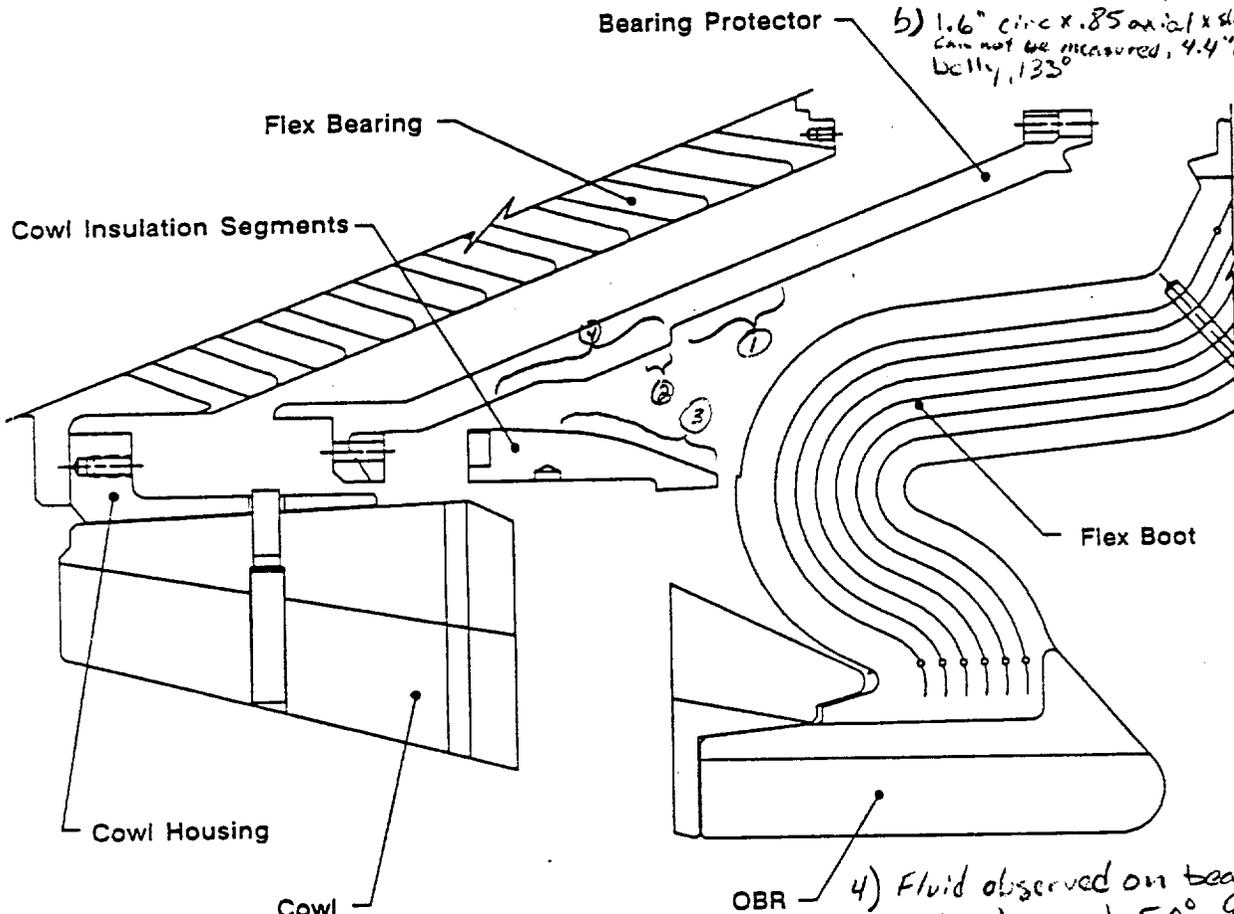
- 1) Erosion areas not at the vent hole impingement
 - a) 4.8" circ x 1.8" axial x .12" deep 1.4" aft of belly Band, 132°
 - b) 1.6" circ x .85" axial x shallow depth. Can not be measured, 4.4" aft of belly, 133°

2) Deepest erosion on belly band occurred at 10°. The cowl vent hole was open with plugging with slag when it was removed from segment
