NASA Contractor Report 194439

A Review of Wiring System Safety in Space Power Systems

Mark W. Stavnes and Ahmad N. Hammoud
Sverdrup Technology, Inc.
Lewis Research Center Group
Brook Park, Ohio

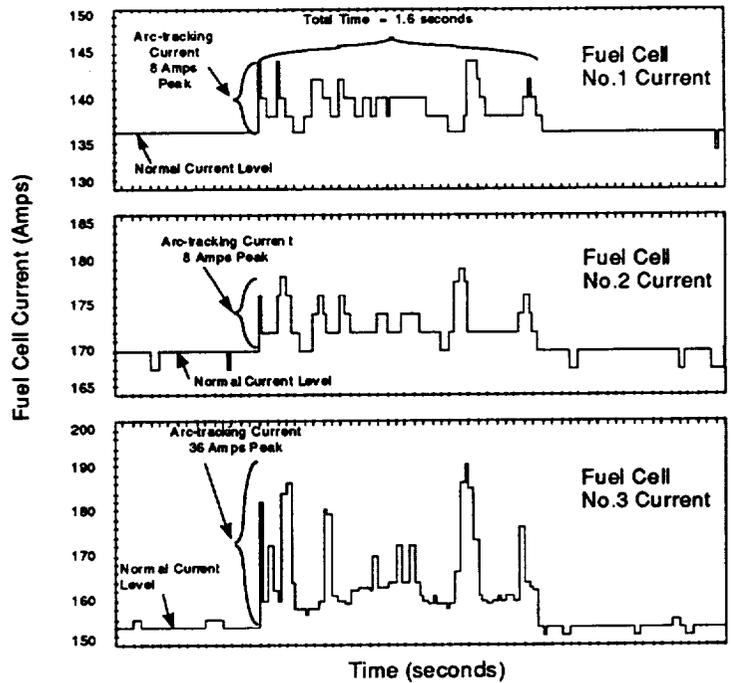
Figure 2. Fuel Cell Current During Arc-Tracking [6]

As previously stated, failures often have resulted from multiple factors which when combined result in a wiring fault. For example, under certain conditions the circuit protection devices currently in use may be ineffective in interrupting an arc-tracking fault. However, arc-tracking will not occur unless previously degraded polyimide insulation is being used [5,6,7]. In the case of the STS-28 Teleprinter cable short, a short circuit resulted due to polyimide insulation degradation (factor 1) which was caused by a bad connector design (factor 2). The short was not detected by the circuit breaker which was designed to protect the orbiter wiring from a continuous fault current (factor 3), because of the characteristics of the arc-tracking fault which occurred [6,8]. If the peak currents which occurred during this arc-tracking fault had been constant, their magnitude might have been high enough to trip the circuit breaker, which was rated at 10 Amps, and had a trip characteristic as shown in Figure 1. The total current of the arc-tracking fault, which is inconsistent as shown in Figure 2, because of intermittent arcing across the gap

between conductors, averaged 30 Amps with spikes up to 50 amps [6]. Based on the total thermal energy in the circuit, current would have to flow through the breaker at a 30 Amp level for approximately 2.0 seconds to trip the circuit breaker, while a 50 Amp current would trip the circuit breaker after 0.5 second [9]. The teleprinter cable short did not trip the circuit breaker in this case because there was not enough thermal energy generated by the arc-tracking fault before it eventually extinguished itself [6].

In response to the ineffectiveness of this circuit breaker in detecting this fault, a test program at Johnson Space Center investigated the characteristics of the various circuit breakers, fuses, and Remote Power Controllers (RPC's) used for the shuttle program. The circuit protection limited the arc-tracking propagation to lengths of less than 1" up to 6" [5,10,11]. Due to the redundancy requirements of the space shuttle orbiters this level of protection is acceptable [12]. However, applying new technologies of fault detection to future spacecraft may improve the system safety.

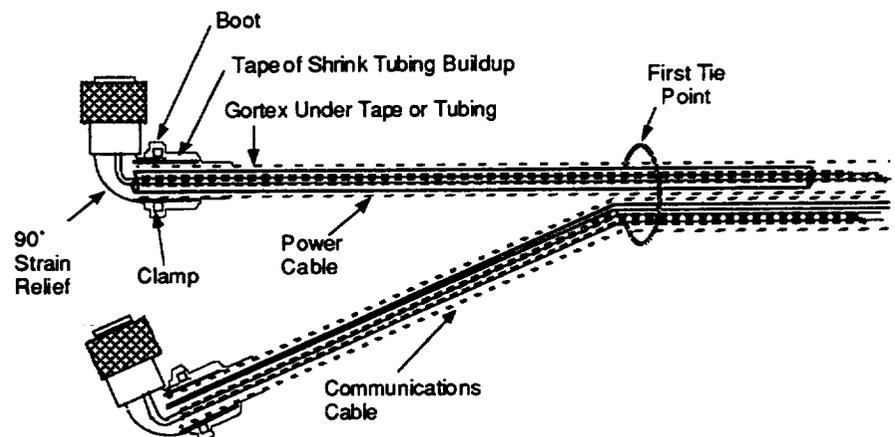
Figure 3. Teleprinter Cable Reconfiguration [6].

Damage to the polyimide insulation of the teleprinter cable was the result of the connector which extended straight out from the power panel requiring a sharp bend in the cable [6]. The repeated sharp bending of the wires over the back edge of the connector strain relief led to a circumferential break in the insulation [6].

The space shuttle program determined that because the failure was not detectable through pre-flight inspection or continuity and isolation testing, the connector was inappropriate for this application [6]. Therefore, changes were made and incorporated in subsequent missions. The

connectors which interface with the power supply panel were changed to have a 90° strain relief as shown in Figure 3. Additionally, the connectors were changed to a "clamp type" to accommodate strain relief sheathing, and the insulation was changed to Teflon to improve flexibility [5,6].

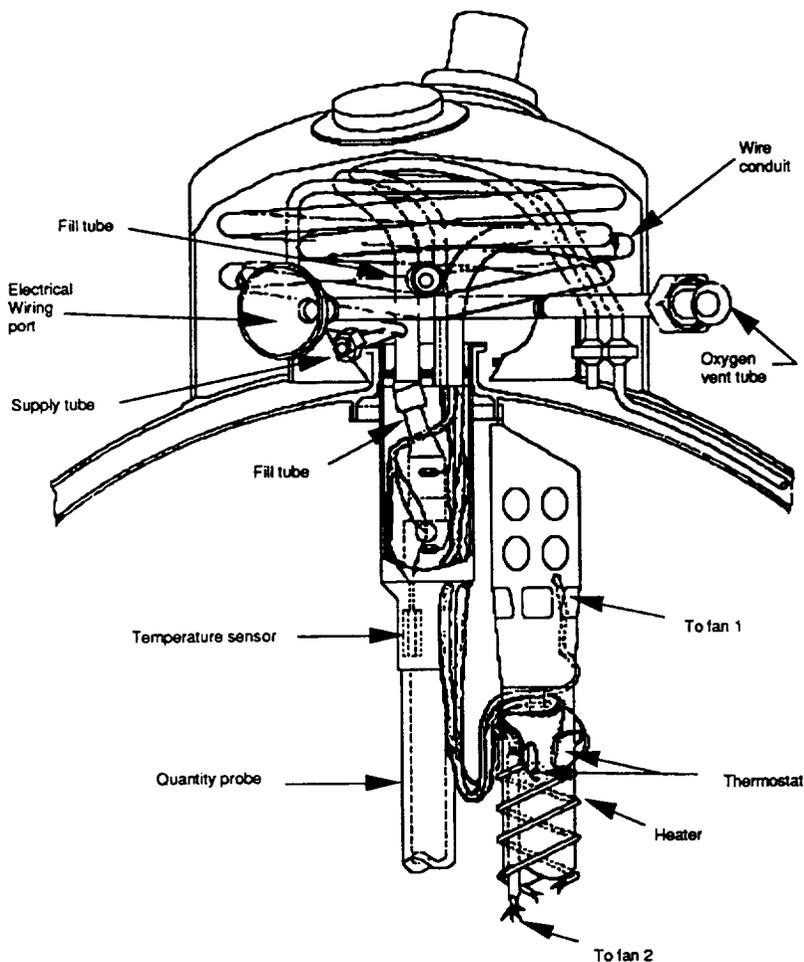
Figure 4. Oxygen Tank Wiring and Lines [13]

The wiring system design and a special "detanking" procedure required to empty the Apollo 13 oxygen tank led to wiring insulation degradation during ground testing. Failure of the wiring during the mission caused the oxygen tank to explode and threaten the lives of the three astronauts. Upon reviewing the failure, the Apollo 13 review board concluded that while the major features of the oxygen tank design were appropriate (Figure 4), specific design features were susceptible to failure [13]. The tanks contained potential ignition sources and excessive amounts of combustible materials which were present in the oxygen environment [13].

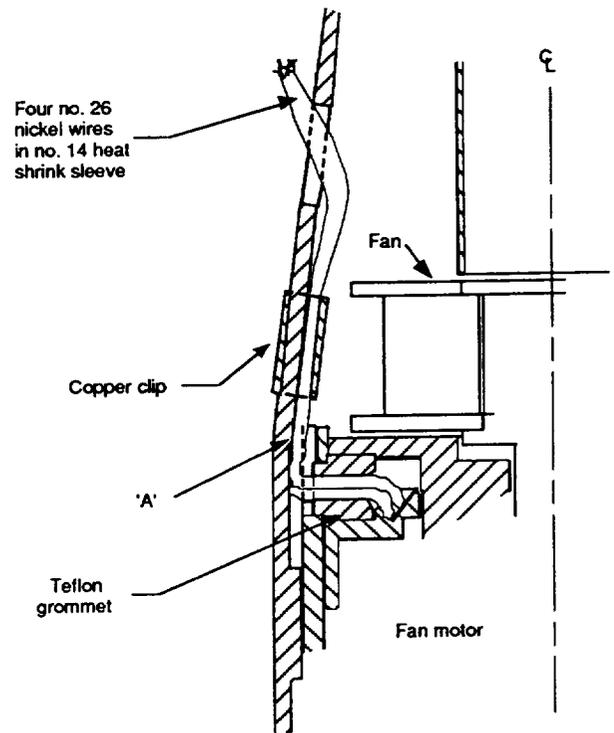
Figure 5. Typical wire routing for fan motor [13].

The design of the wiring for the oxygen tank fans was such that "cold flow" of the insulation (Teflon) when pressed against metal corners within the tank for an extended period of time, could eventually result in the degradation of the insulation [13]. As shown in Figure 5, a shrink fit Teflon tubing was used to encase the four 26 AWG wires which powered the fan motors and ran from the motor housing to outside the heater fan tube. This tubing provided protection for the wire bundle as it crossed the sharp machined edges of the heater tube access hole. However, the strain of the 90° bend of the wires at the motor housing was not eased by such protection. In addition, when the fan support tube was assembled, the wires may have been forced against the support tube edges at point 'A' in Figure 5 [13]. Furthermore, during the assembly process, the insulation of the electrical wiring inside the cryogenic storage tanks was exposed to relatively sharp metal edges. Finally, while wiring the tank, three bundles of six wires each were pulled sequentially through the conduit in the oxygen tank dome (Figure 4). The board found the size of this conduit was such that the last wires had to be forcibly pulled through the conduit [13]. As a result, damage to the wires in the conduit could have resulted which would not be detected without physical inspections (which were not possible with this design) [13]. Wiring system designs such as these can lead to failures not detectable by normal testing [13]. Fully considering wiring system failure in the system design process may improve the safety of wiring systems.

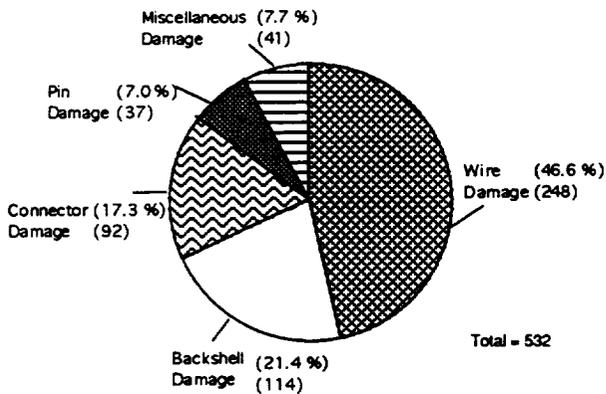
Figure 6. Breakdown of Wiring System Problems [14]

There have been many occurrences of wiring system damage on the space shuttle orbiters, including an average of 1 short circuit per turnaround period attributable to the maintenance processes [19]. For example, between 1984 and 1985, there were 532

cable and connector problems reported on the fleet of shuttle orbiters [19]. These problems included damage to the electrical connectors, connector pins, backshells, and wires. The distribution of these problem occurrences are shown in Figure 6. In most cases, the shuttle maintenance practices led to the problems, with poor access, faulty connector design, and lightweight backshells also contributing to the failures [14].

Various inspections of the space shuttle wiring revealed that in general, the condition of the orbiter wiring was good, except for the areas with high levels of personnel traffic. In an effort to reduce wiring damage, formal training programs on the proper methods for handling, installing, and protecting the wiring have been developed for all the technicians, quality control inspectors, and electrical power system engineers who come into contact with the wiring systems [7,14,19,20]. It has been recommended that the assembly and maintenance procedures be analyzed and improved where necessary to further reduce the potential for wire damage [7,19].

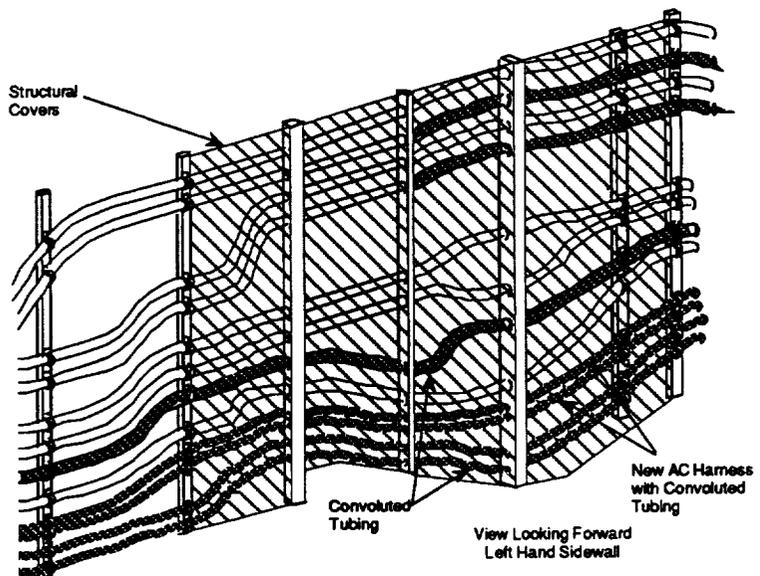
Figure 7. Aft Fuselage External Tank Sidewall [5]

Equipment bays in the orbiters (i.e. ECLSS bay) have large quantities of wire, which are installed in wire trays. The equipment bays are also covered, further protecting the wires from damage. Therefore, the damage in the ECLSS bay was not extreme, and additional convoluted tubing was considered sufficient [21]. However, the aft fuselage wiring is routed directly on the sidewalls, as no wire trays were used due to their additional weight [19]. As a result, the aft fuselage areas required major modifications due to insulation damage. The aft fuselage External Tank (ET) sidewall (Figure 7) required replacement harnesses with convoluted tubing, split convoluted tubing to existing wires, and structural covers to shield the wiring from additional damage [5]. Other areas which required

structural covers in the aft compartment were the Vertical Engine Support System (VESS), the Main Engine Heat Shield, the Aft Fuselage Floor Area (OV-102 only), and the Aft Sidewalls [5,6,14].

Inspections performed after the physical protection was added revealed that the additional protection, rerouting, and elimination of sharp edges was sufficient to stop further damage from occurring. However, insulation degradation in high-traffic areas continued to be a safety issue for the space shuttle orbiters [19,22]. There was still concern regarding cases of misrouting, excessive tension on wires and connectors, improper installation, inadequate protection, and abuse during maintenance procedures. To continually assure that the space shuttle orbiters were safe, inspections were included as a part of the close-out process for all areas requiring maintenance during turnaround [7,19,20].
