Debris/Ice /TPS Assessment and Integrated Photographic Analysis for Shuttle Mission STS-61

January 1994

DEBRIS/ICE/TPS ASSESSMENT
AND
INTEGRATED PHOTOGRAPHIC ANALYSIS
OF
SHUTTLE MISSION STS-61

December 2, 1993

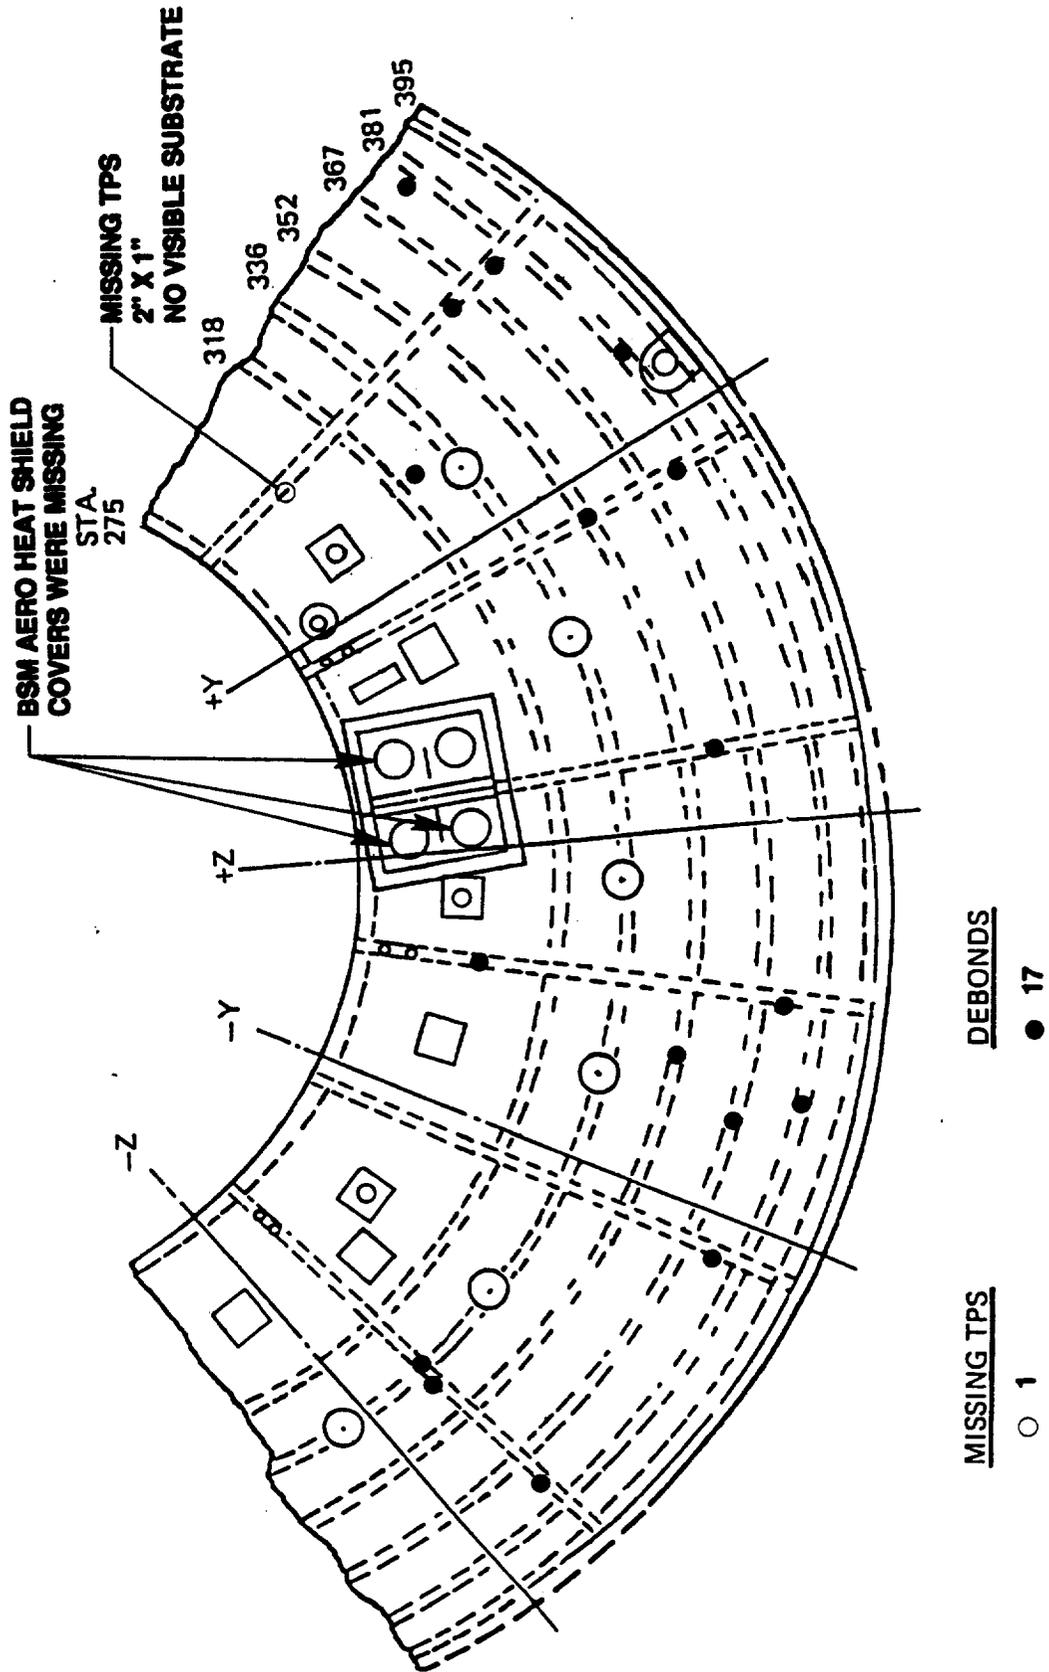
STS-61
 FIGURE 9. LEFT SRB FRUSTUM

The LH frustum had 17 MSA-2 debonds over fasteners. A 2"x1" divot in the MSA-2 occurred between the +Y/-Z axes and the 275/318 ring frames (Figure 9). Minor blistering of the Hypalon paint had occurred in localized areas. The lower right BSM aero heat shield cover was locked in the fully opened position. The other three BSM aero heatshield covers were missing. Preliminary post flight assessment revealed the covers had opened and locked properly. The fracture planes on the cover attach rings were not sooted, which may indicate the covers were lost late in flight or at water impact.

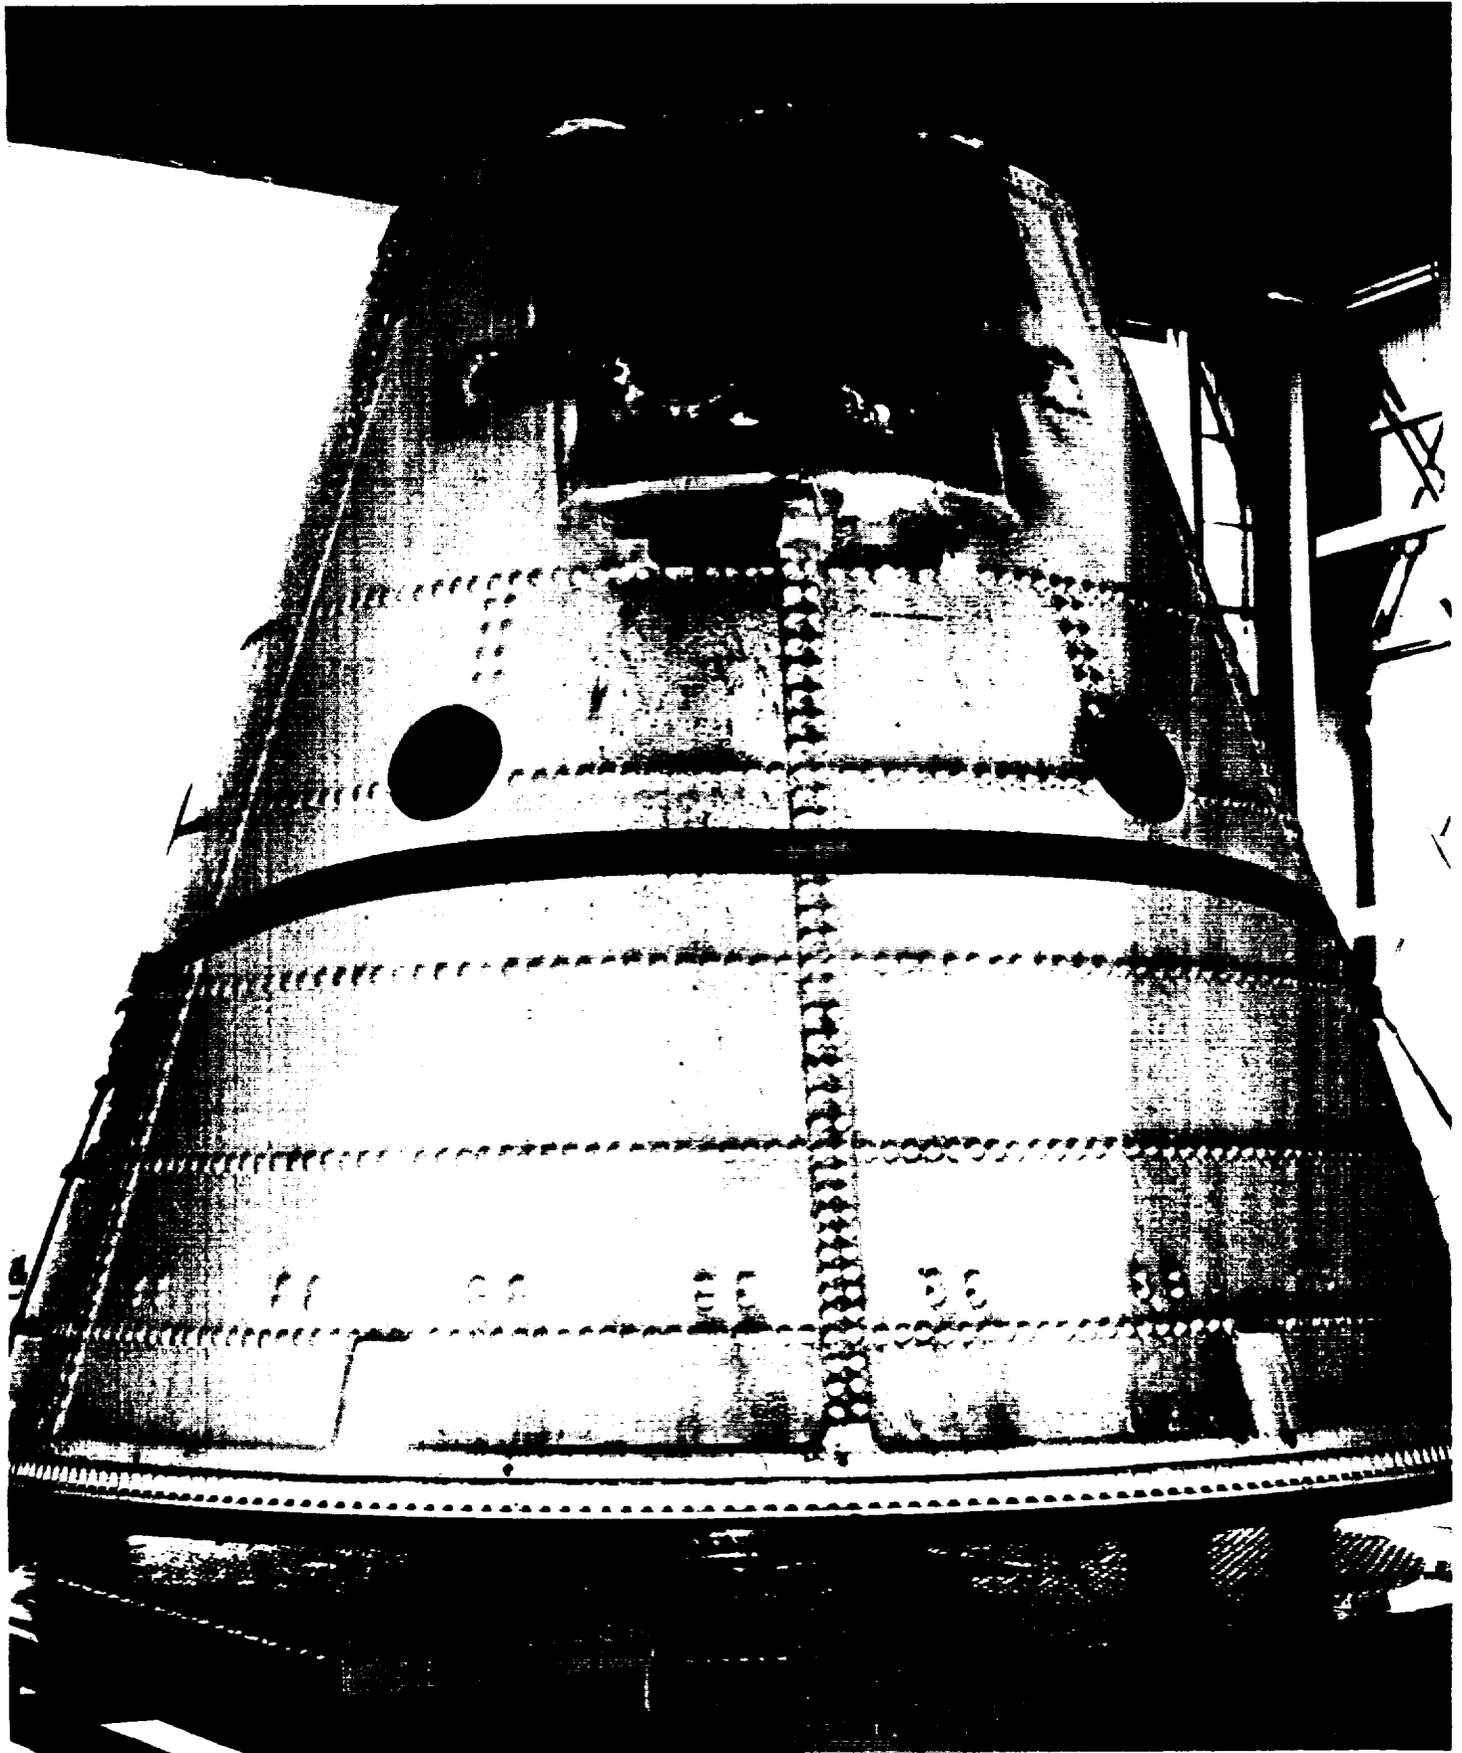
The LH frustum had a total of 17 MSA-2 debonds over fasteners. The lower right BSM aero heatshield cover was locked in the fully opened position. The other three covers were missing.

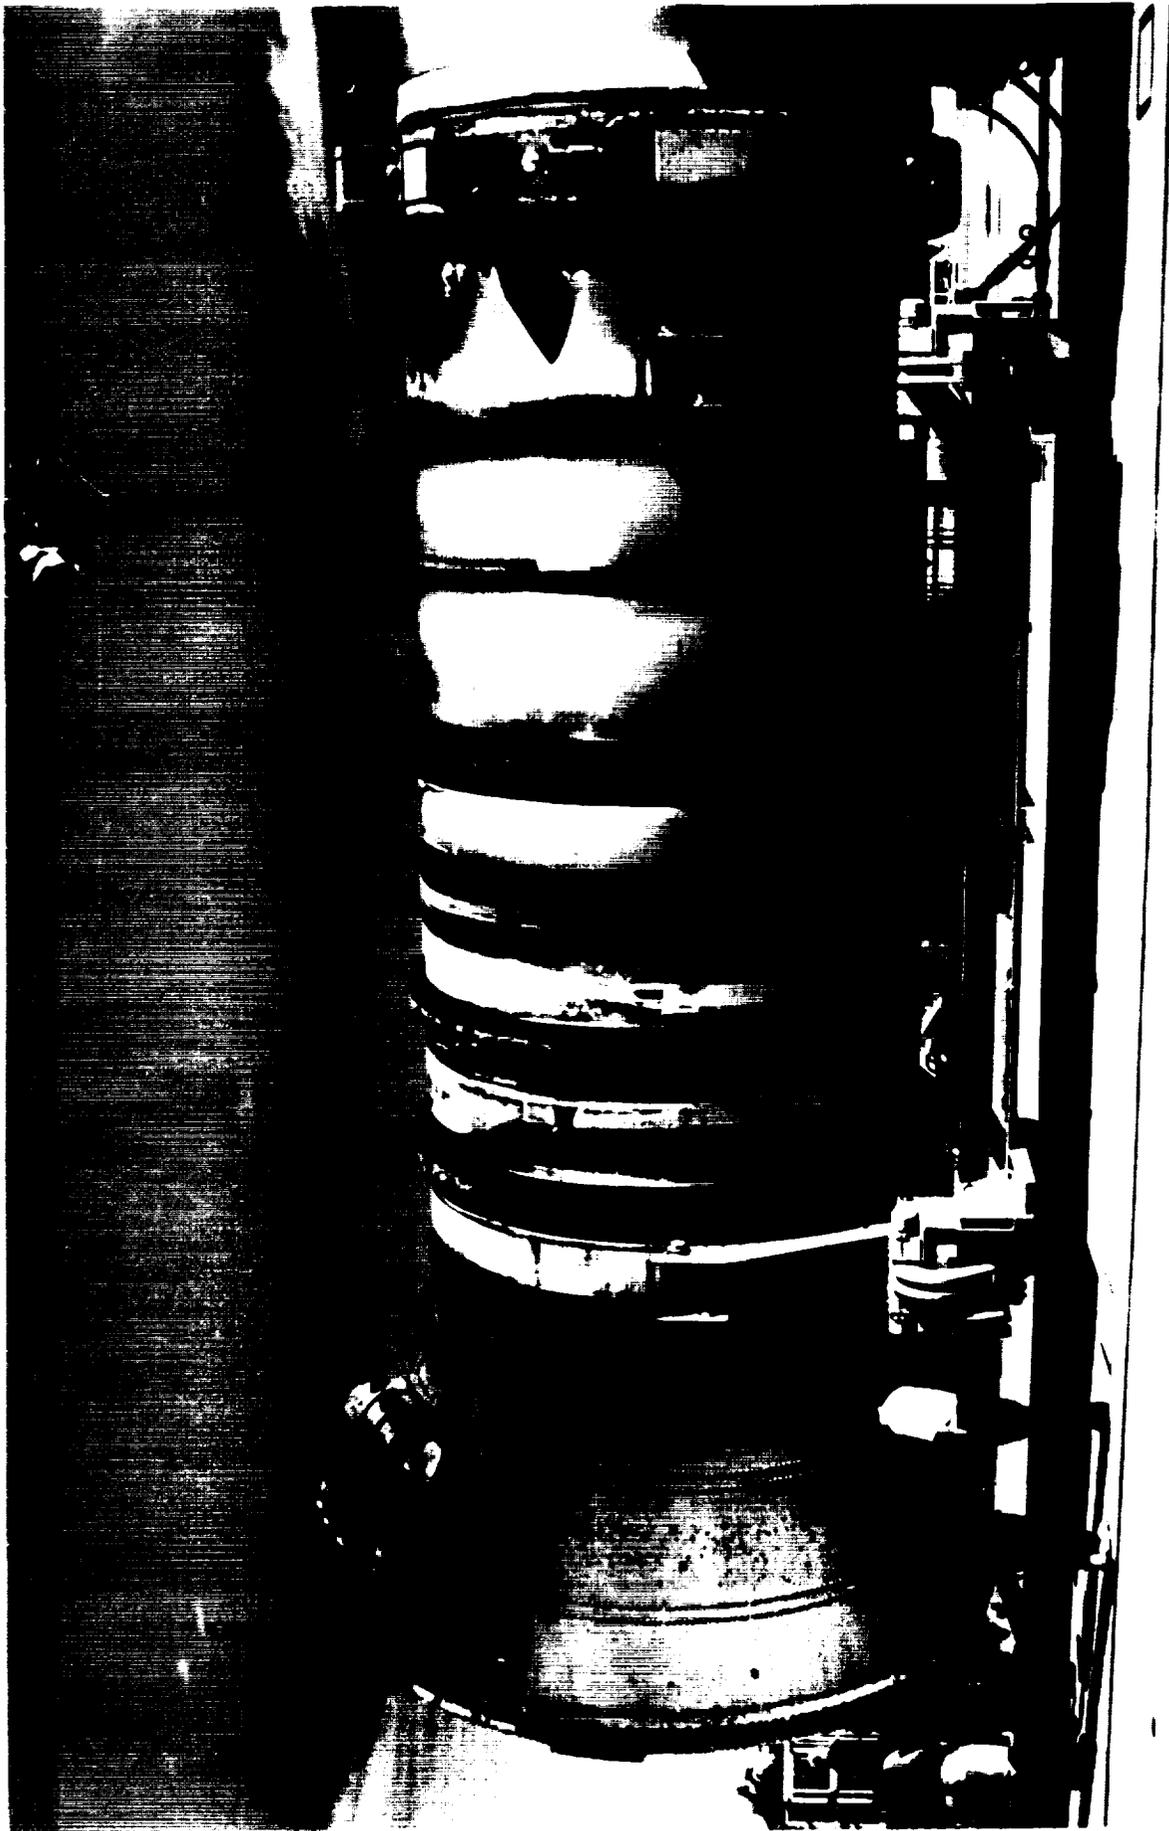
Post flight condition of the LH aft booster and aft skirt. The ET/SRB aft struts, ETA ring, IEA, and IEA covers appeared undamaged. The stiffener ring splice plate closeouts were intact and no K5NA material was missing.

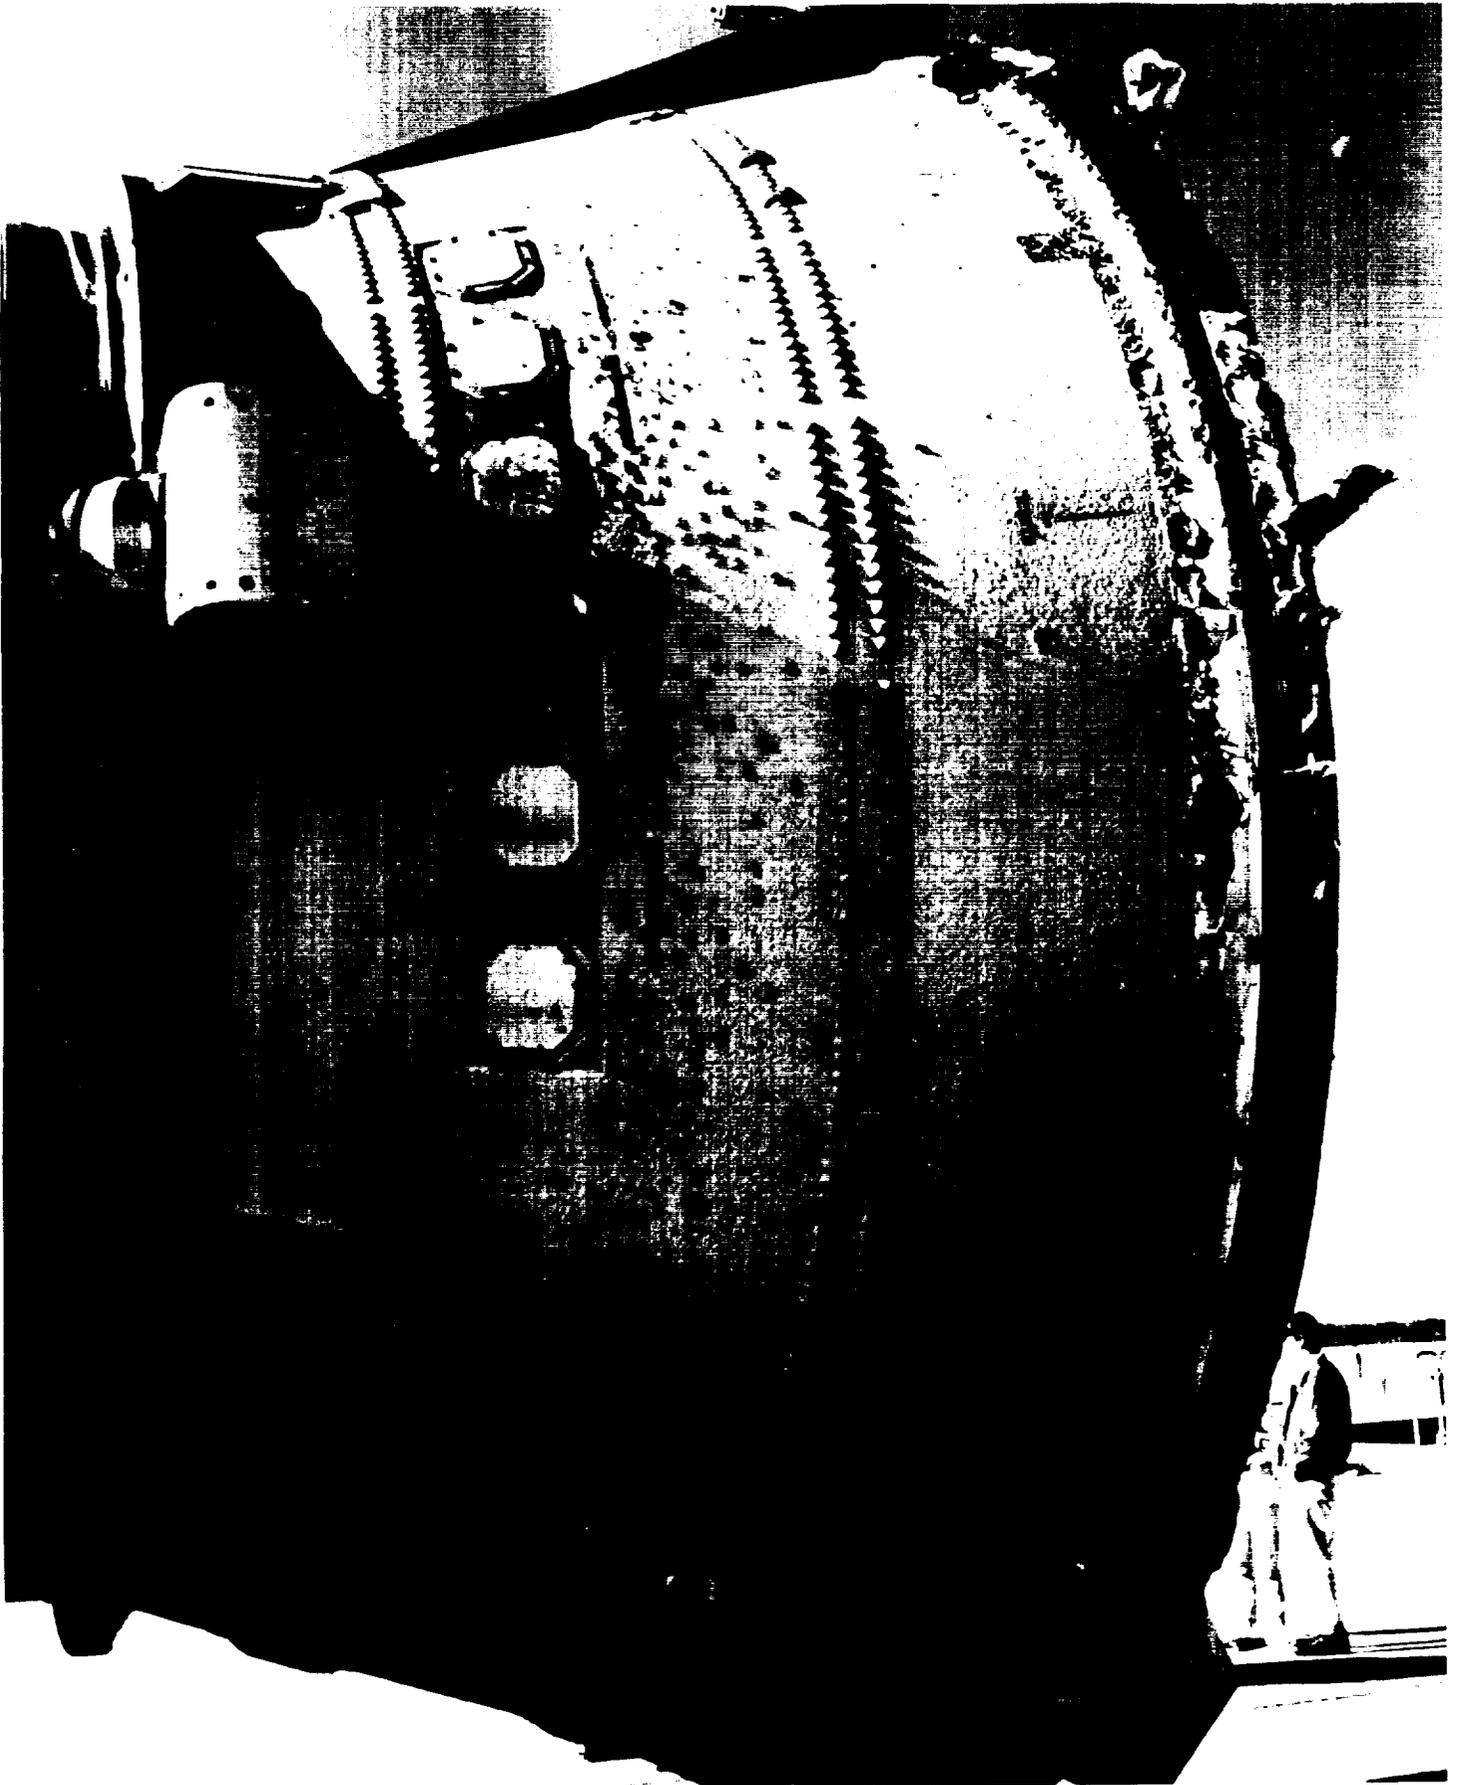
Aft skirt acreage TPS was generally in good condition. Hypalon paint was blistered and/or missing from the Booster Trowellable Ablator (BTA) closeouts.

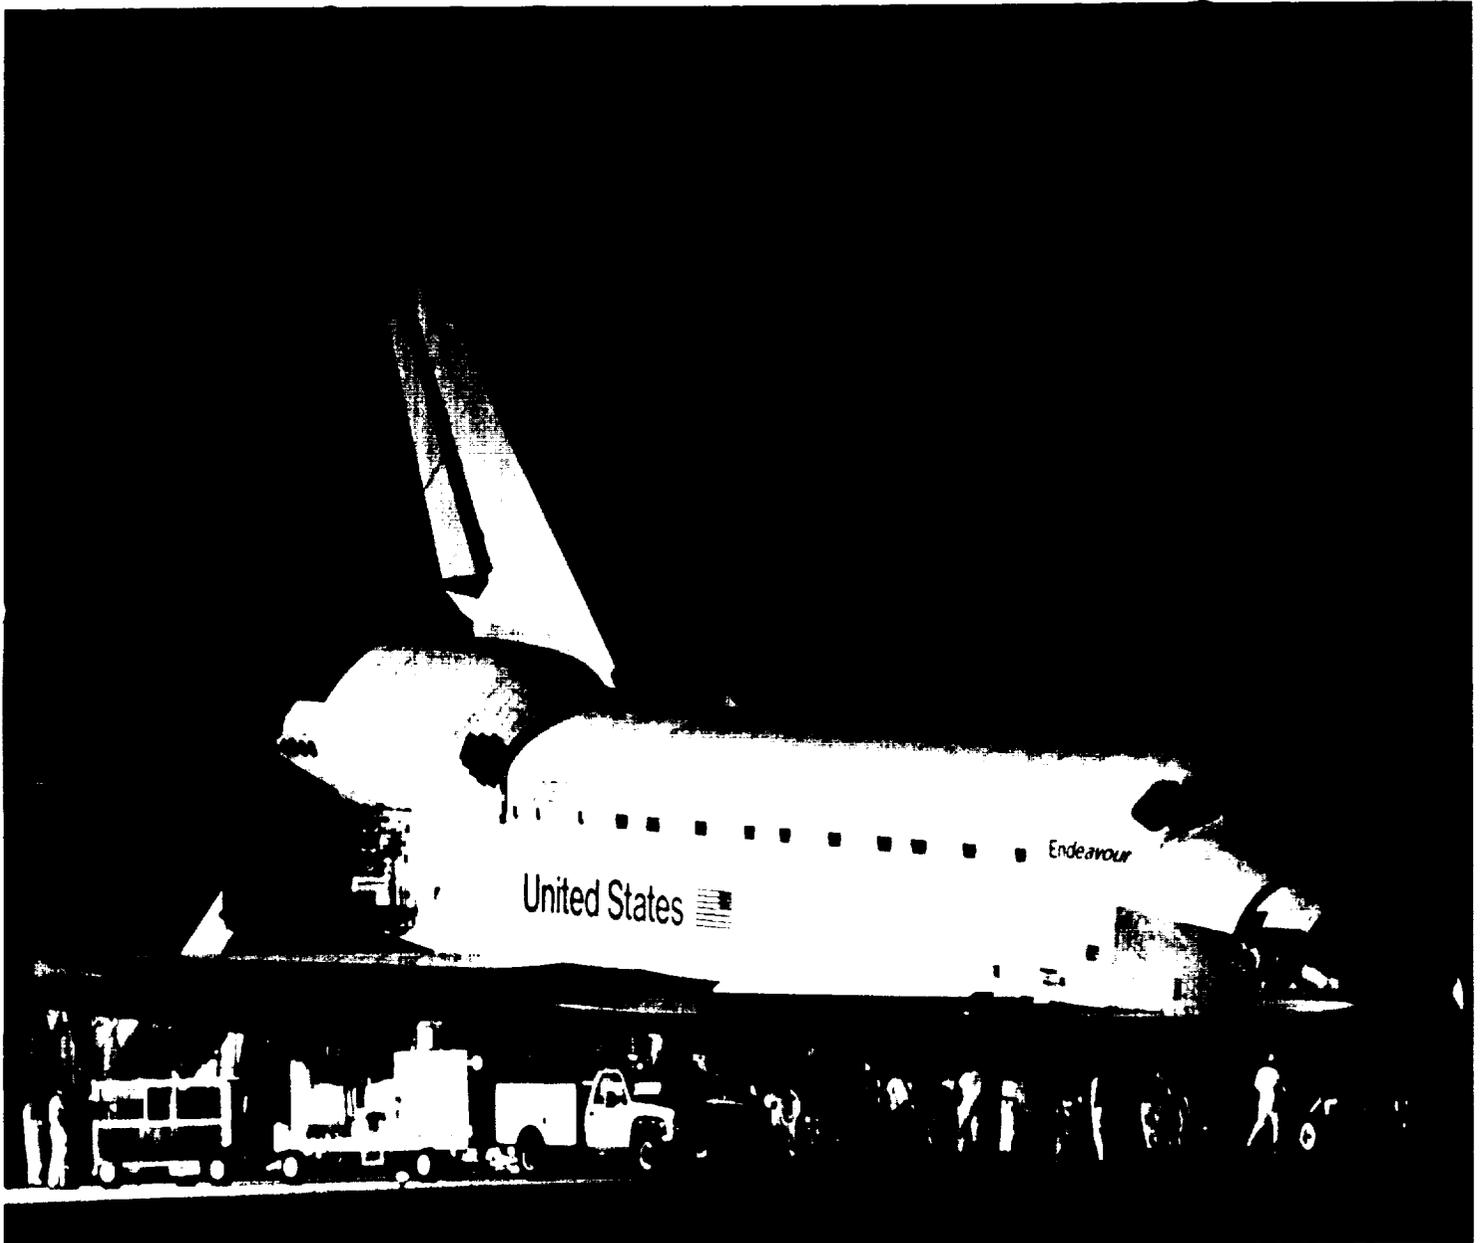
Overall view of the Orbiter right side
Note damage to a tile on the RH wing chine area

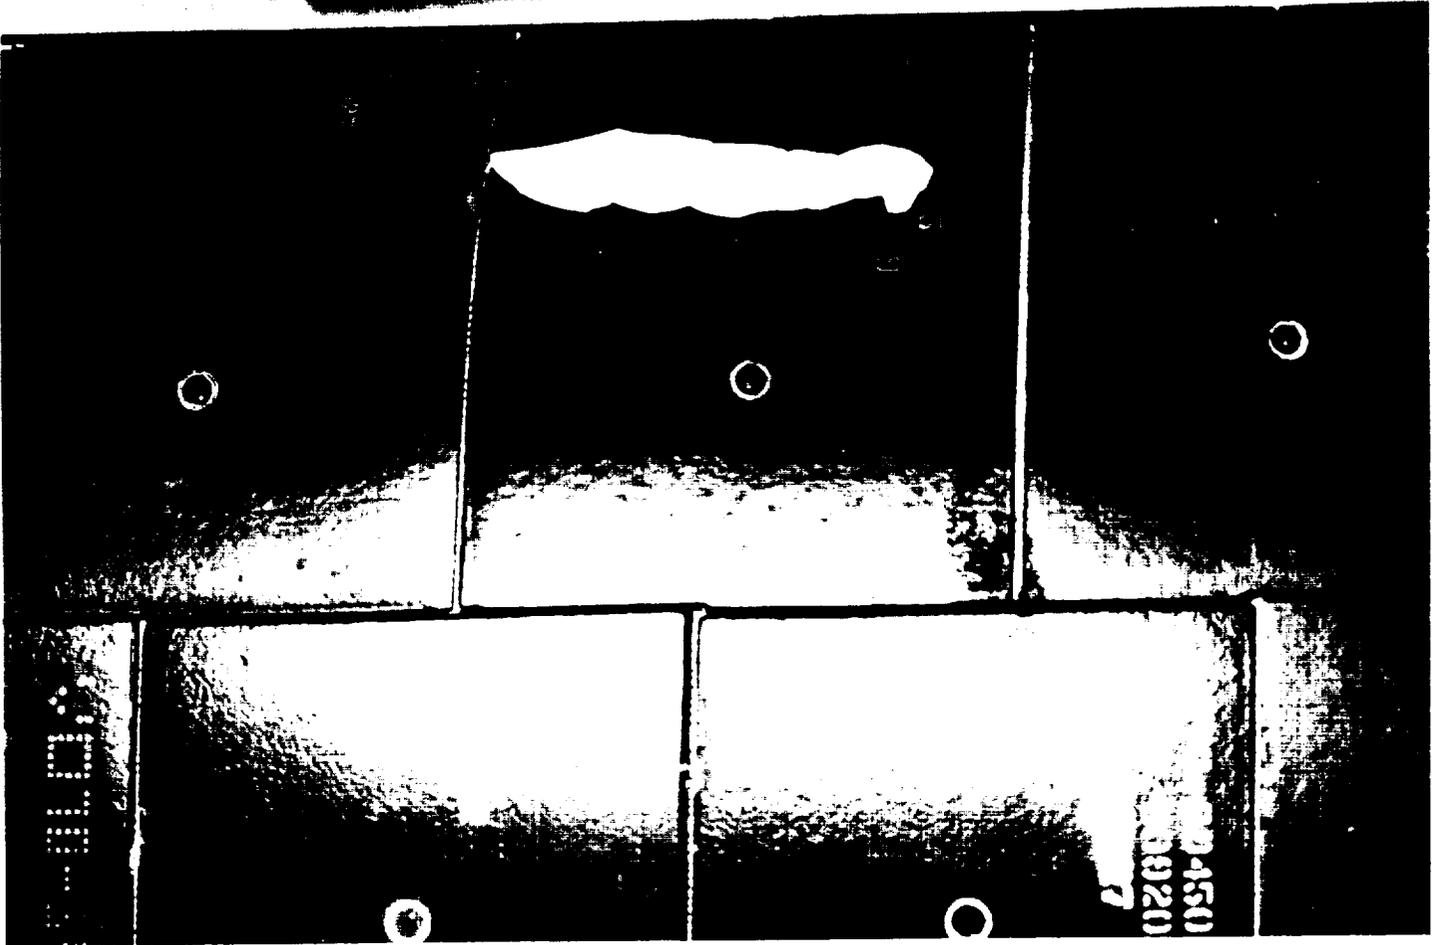
The Orbiter lower surface tiles sustained a total of 59 hits, of which 7 had a major dimension of 1-inch or greater. The largest tile damage site on the lower surface was on the RH wing chine and measured 5" x 1.5" x 0.125".

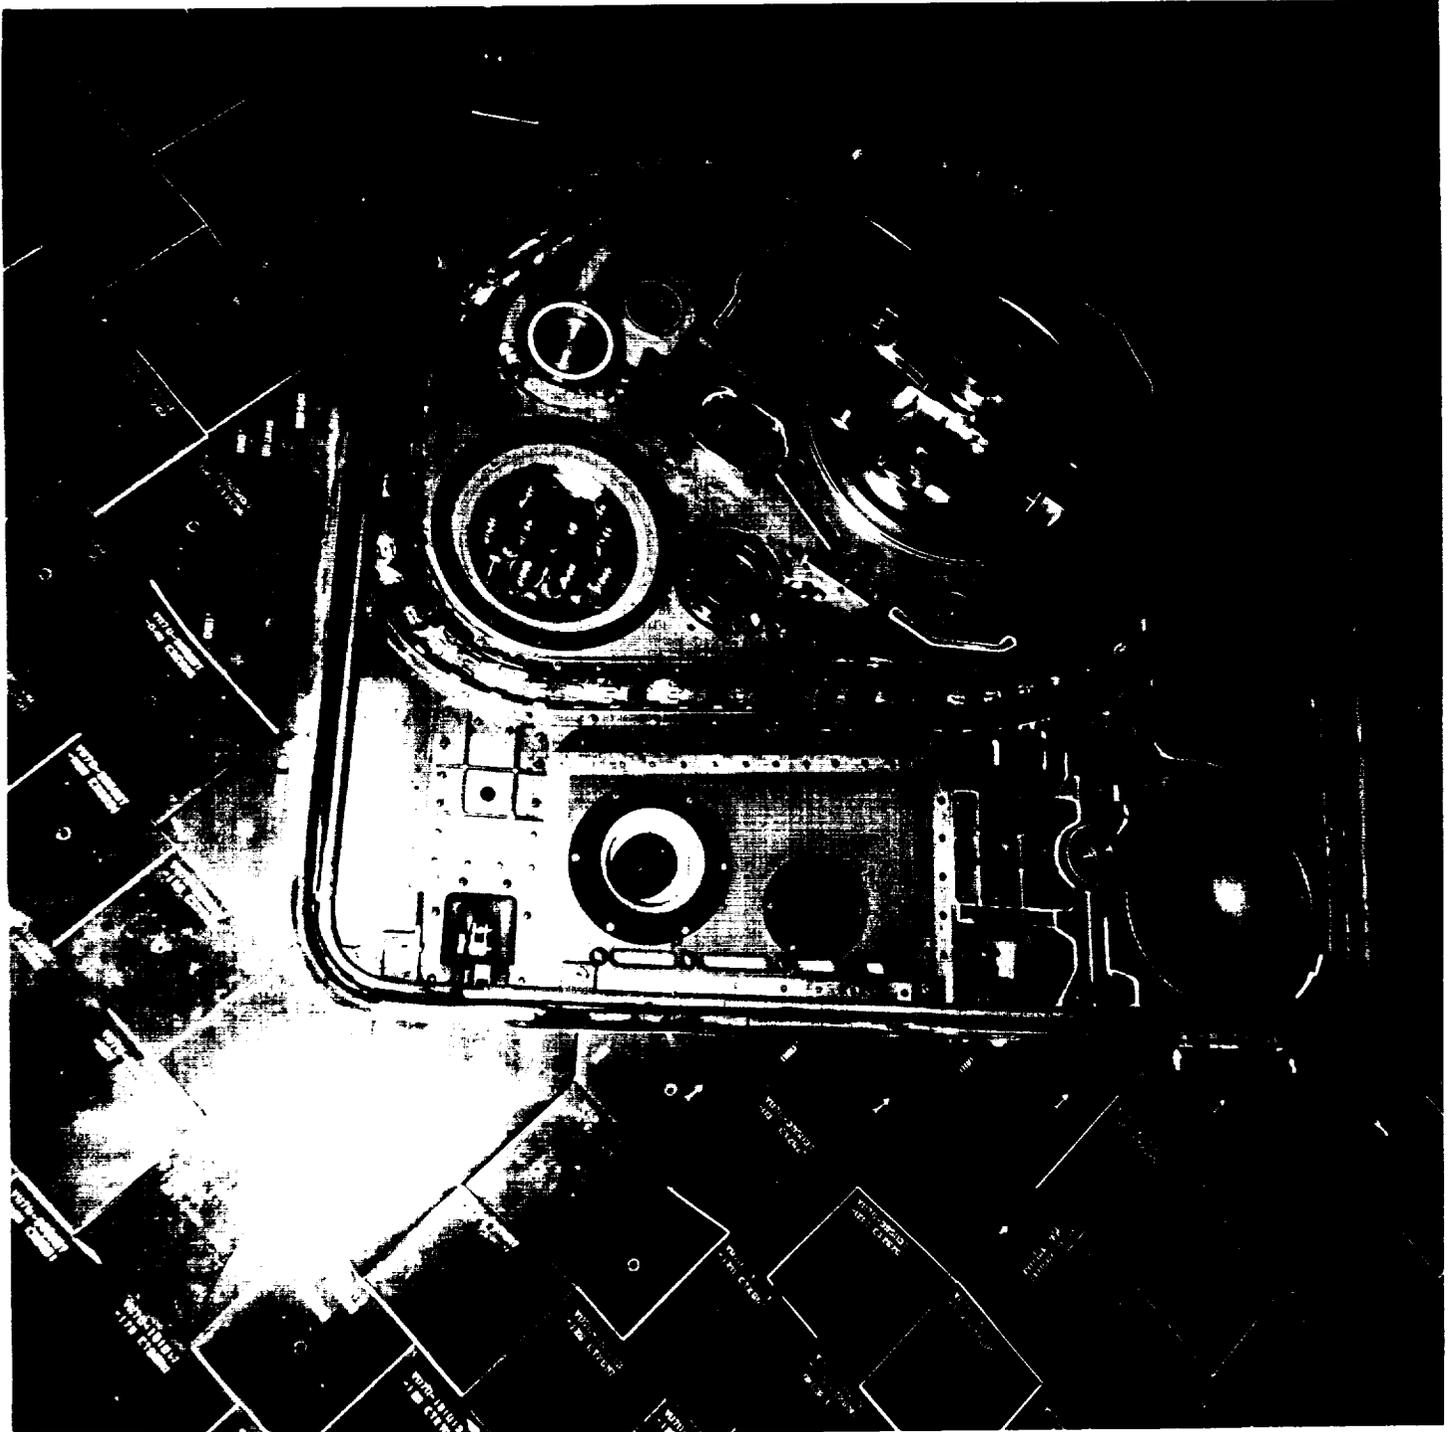
Overall view of the LH2 ET/ORB umbilical. All separation ordnance devices functioned properly. No flight hardware was found on the runway below the umbilical when the ET door was opened.

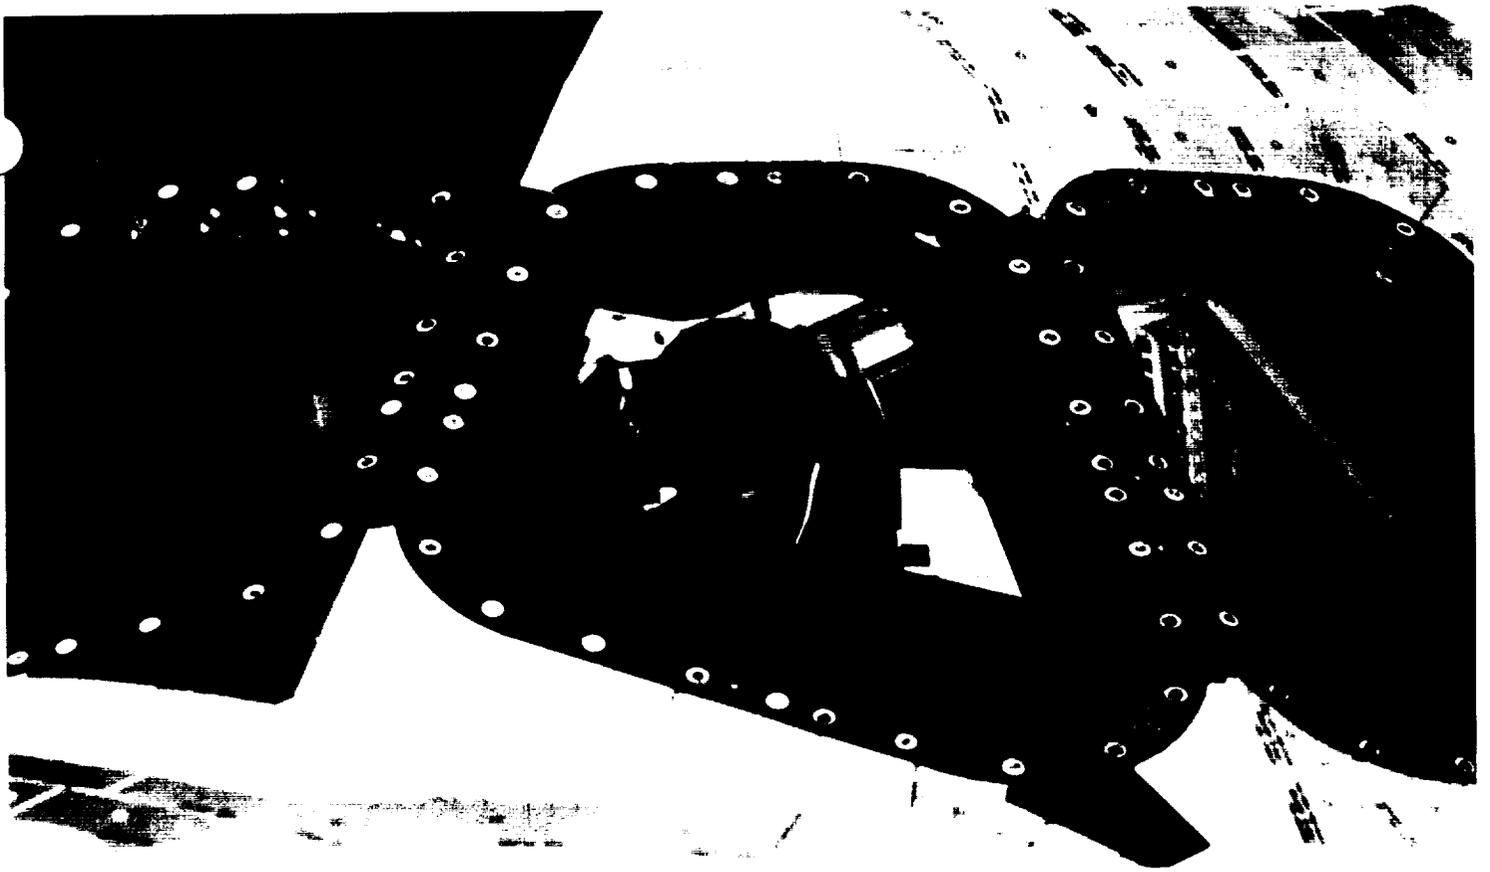
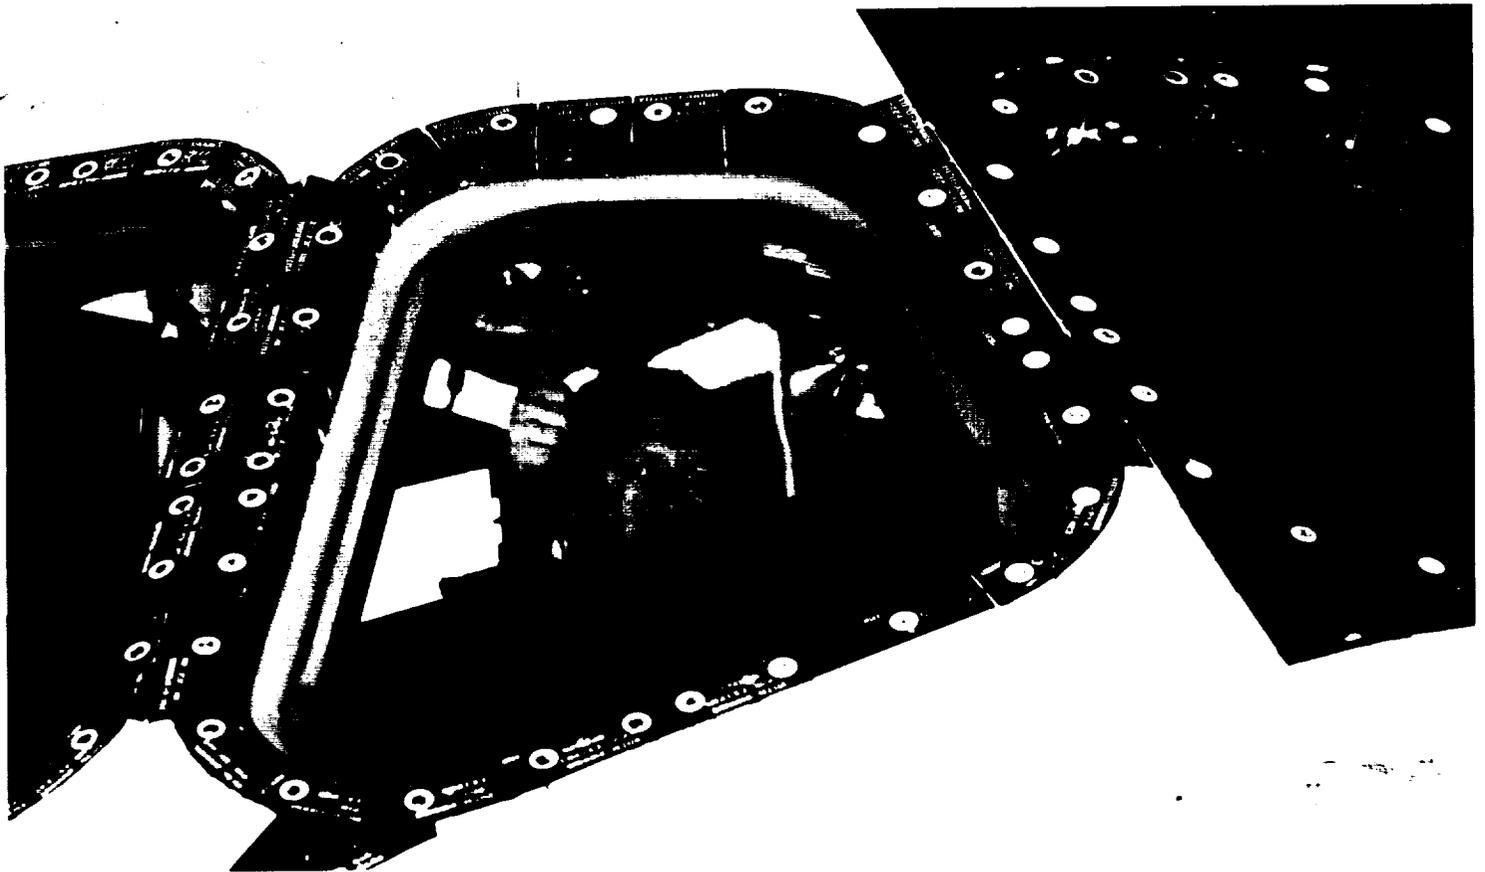
Orbiter windows #3 and #4 were moderately hazed. Some streaks were present on window #4. Damage to window perimeter tiles was typical.
