THE CHARACTERIZATION OF WIDESPREAD FATIGUE DAMAGE 113056
IN FUSELAGE STRUCTURE

Robert S. Piascik
NASA Langley Research Center
Hampton, VA

Scott A. Willard
Lockheed Engineering and Science Company
Hampton, VA

Matthew Miller
Boeing Commercial Airplane Group
Seattle, WA

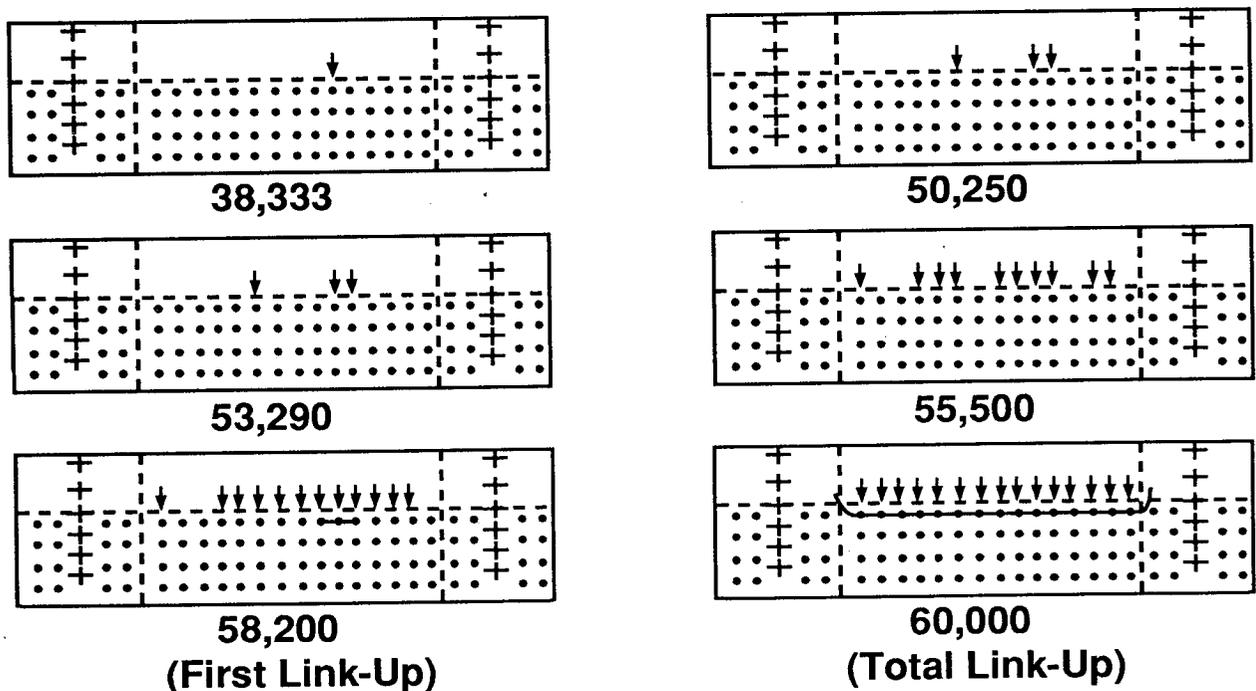
Figure 1 is a schematic of bay #1 summarizing the results of *in situ* visual examinations conducted during fuselage pressure testing. After 20,000 pressure cycles, inspections were conducted at intervals of approximately 1700 cycles. The small arrows in Figure 1 mark the upper row rivet locations that contained visible cracks. The first evidence of cracking was observed near the mid-bay after 38,333 cycles. No further cracking was observed in bay #1 until 50,250 pressurizations, when three mid-bay cracks were noted. At 55,500 cycles, ten rivet locations contained cracks. The first evidence of crack link-up was observed after 58,200 cycles. An additional 1800 pressurizations were performed, totaling 60,000 cycles, before cracks at all upper row rivet locations had linked-up. A single long crack, 47.9 cm (18.85 inch) in length, had formed along the upper row of rivets, terminating at the adjacent tear straps. After completing the three lifetime test, the four bay region containing wide spread fatigue damage was removed for detailed teardown inspection at LaRC. Upon completion of pressure testing and *in situ* inspections, a four bay panel of lap splice joint containing WSFD was removed from the fuselage test article for a detailed teardown inspection at LaRC. Reported herein are the results of examinations conducted on one (bay #1) of the bays from that four-bay panel.

Prior to destructive examination, bay #1 was examined visually (10X) and by eddy current techniques. These laboratory inspections yielded results similar to that obtained by *in situ* examination. With one exception, all outer skin fatigue cracks were observed in the upper row rivet locations shown in Figure 1. The single exception was observed in the most

Figure 1. A schematic of bay #1 summarizing the location of outer skin fatigue cracks identified during visual in situ examinations.

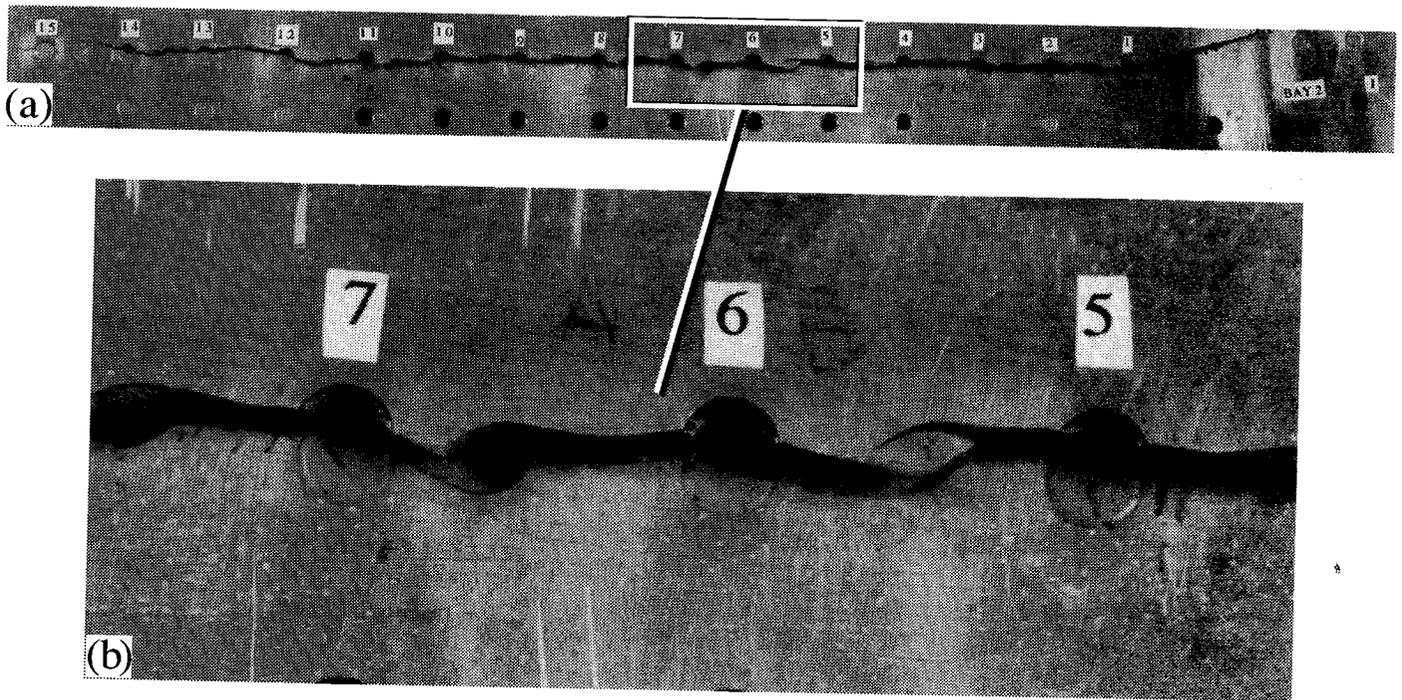
forward rivet of the second row. The location and description of this outer skin crack was confirmed later by the destructive examination. Subsurface or inner skin fatigue cracking was not detected by NDE. Figure 2 is a photograph showing the long outer skin crack located along the upper row of rivets in bay #1. Figure 2b details the link-up crack path for fatigue cracks propagating from rivets 5, 6, and 7. Interacting "curved" cracks shown in Figure 2b have been observed in the laboratory and modeled by Ingraffea et al. [5].

3. The upper surface of the long crack was displaced outward, "pillowed". Here, the outer skin was no longer captured by the rivet head. This observation and destructive examination results, discussed later, suggest Mode III displacements had occurred after crack link-up between many rivets, possibly 8 to 10 rivet lengths. Presumably, at long crack lengths, the outer skin can no longer be restrained by the rivet heads and forces due to internal pressure resulted in pronounced out-of-plane displacements. This Mode III effect has been studied by Hui and Zehnder [6].

Figure 2. Photographs showing the fatigue cracking after link-up in bay #1 lap splice joint.

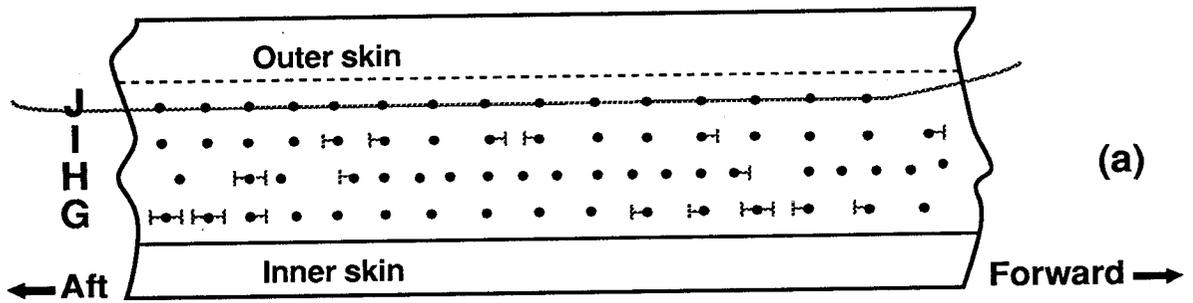
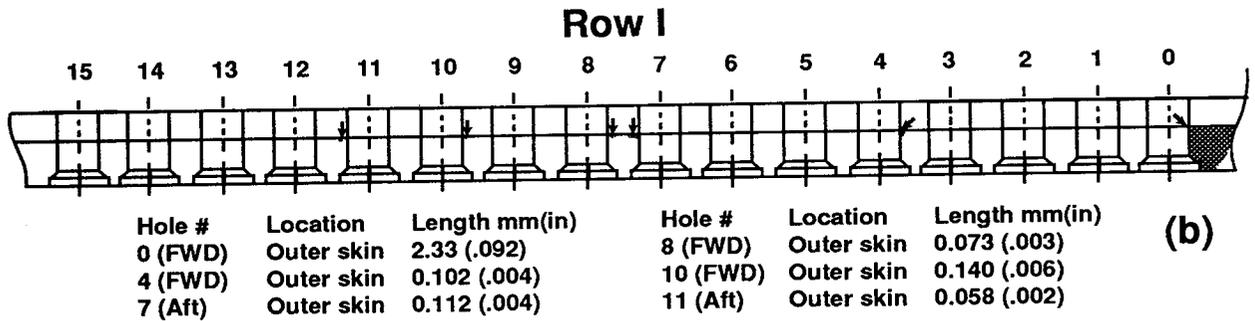
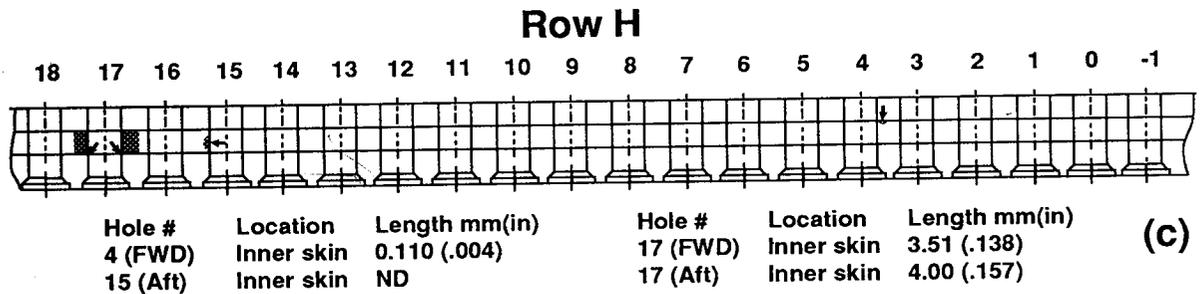
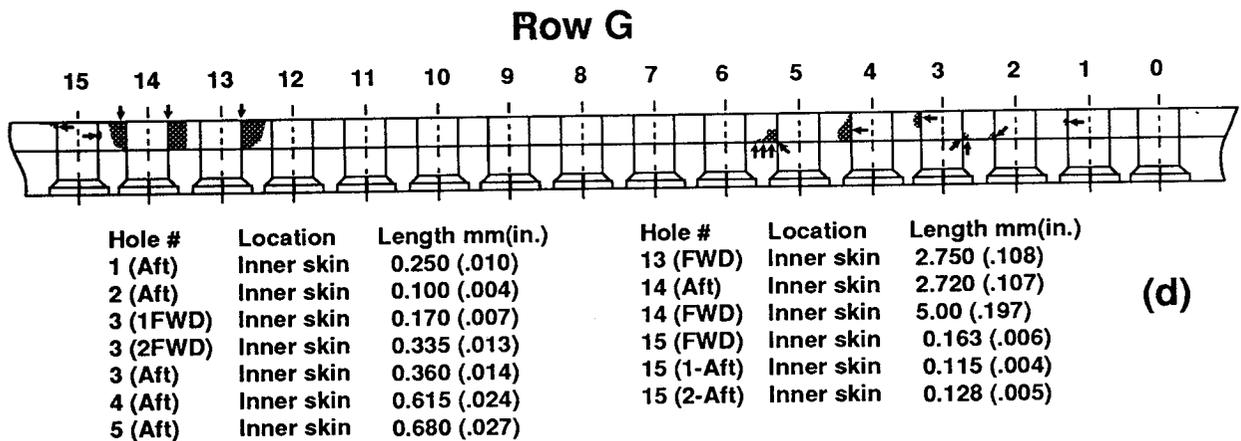
Figure 4 summarizes the results of the destructive examination. Figure 4a is a schematic of bay #1 identifying the four rows of rivets (rows G, H, I and J), the location of the long crack along row J and the location of smaller cracks found in rows G, H and I during the destructive examination. Figures 4b, 4c and 4d are schematics (not drawn to scale) of each rivet row detailing the location, initiation site (arrow) and length of each fatigue crack. Crack depth was computed from the point of initiation to the point of greatest crack depth (length) or, for through-thickness cracks, from the rivet hole surface to the point

of greatest crack depth. In rows G, H and I, 17 holes of the 52 examined were found to contain fatigue cracks. A total of 23 fatigue cracks were found in rows G, H and I. Row I contained six outer skin cracks; the crack located at hole position "0" was detected by eddy current inspection. All other fatigue cracks in row I were small and located under the rivet head. Row H contained four inner skin fatigue cracks, two through-thickness cracks located at positions 17 and 18 and small cracks at positions 4 and 15. Row G exhibited cracking in eight rivet holes. Hole locations 13 and 14 contained through-thickness fatigue cracks. The remaining six holes contained smaller surface and corner cracks. The site of crack initiation varied; Row I contained outer skin cracking that primarily initiated along the mating surface between the outer and inner skin, Row H contained inner skin cracks that initiated at rivet hole corners, rivet hole surface and outer/inner skin surface, and Row G contained cracks that initiated at rivet hole corners, rivet hole surfaces and outer/inner skin surface.

Figure 4. Illustrations showing the location of fatigue cracks in bay #1.

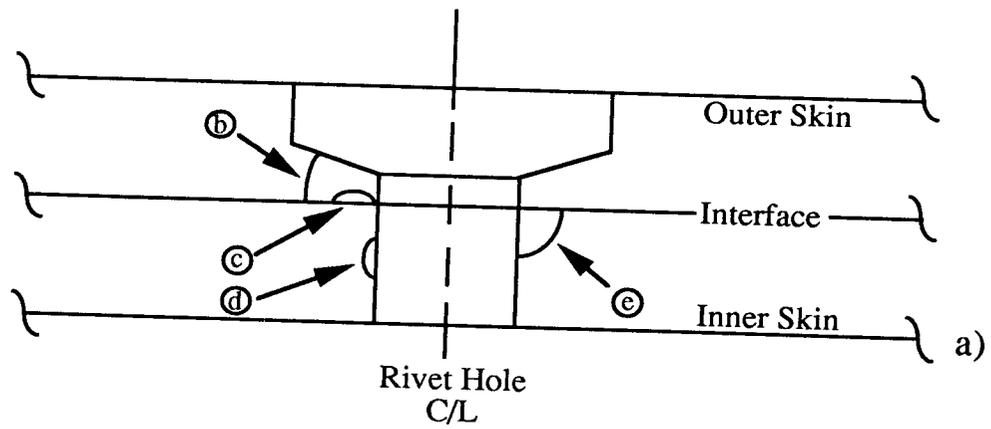
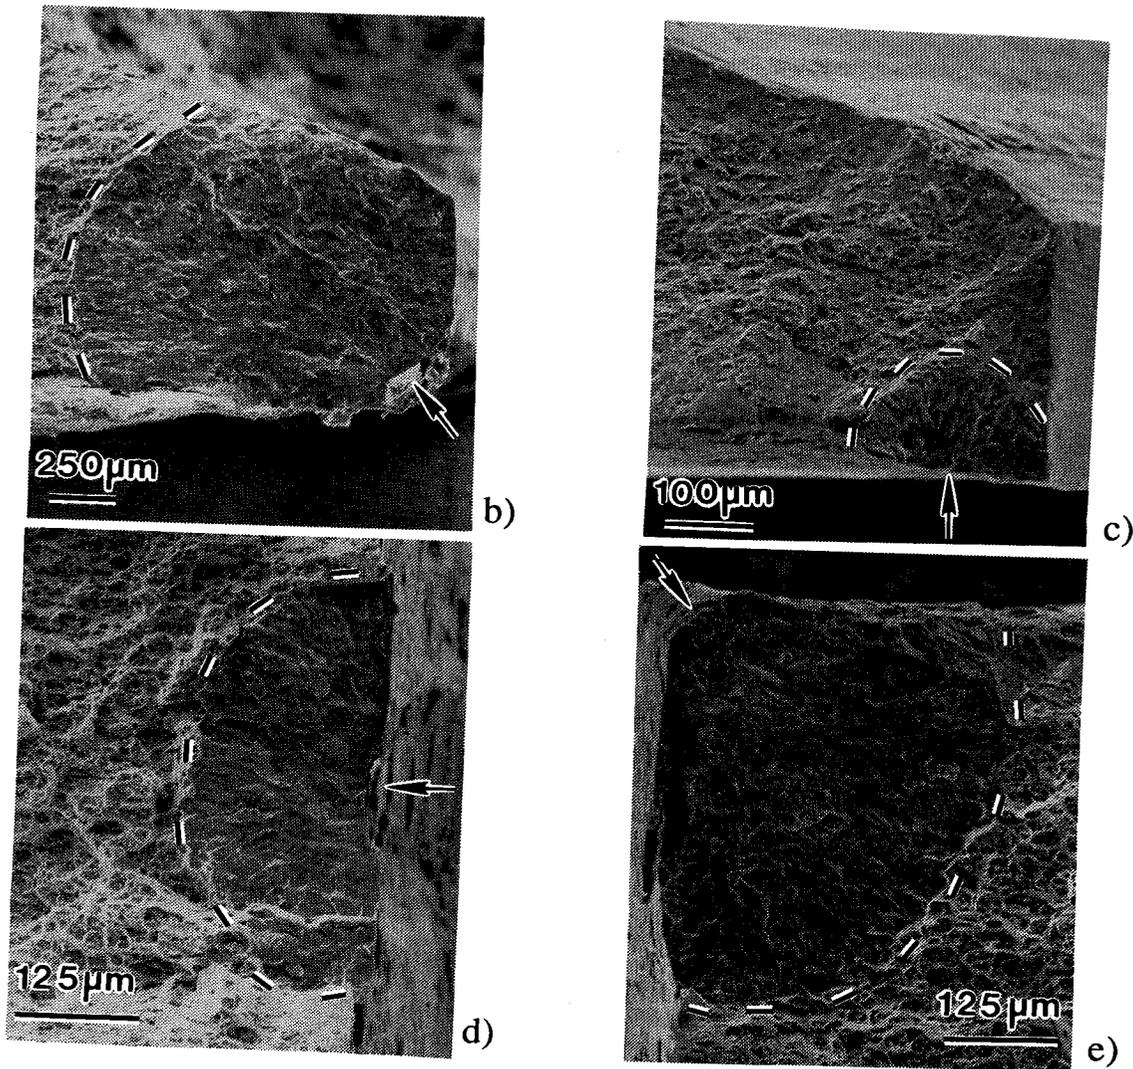
The SEM micrographs shown in Figure 5 illustrate the typical transgranular morphology and location of fatigue cracks observed in the outer and inner skin of bay #1. Outer skin countersink cracking, located in region b in Figure 5a, is shown in Figure 5b. Typically, countersink cracks initiate at the inboard corner of the rivet hole marked by the arrow in Figure 5b. Here, the inboard corner of the countersink exhibits disturbed metal and possible evidence of local clad thinning. The outer skin surface cracks, shown in Figure 5c, initiate at surface clad discontinuities marked by the arrow. These surface cracks are located at the outer/inner skin interface near the rivet hole countersink identified by region c in Figure 5a. Evidence of surface clad abrasion (fretting) was observed at the point of crack initiation, i.e., clad surface disturbed metal, black oxide debris at the outer/inner skin interface and secondary microcracks at the clad metal interface in some cases. Rivet hole surface cracks, region d in Figure 5a, typically initiate at surface discontinuities identified by the arrow (fig. 5d). Inner skin corner cracks, located at region e in Figure 5a, initiate at corner discontinuities identified by the arrow in Figure 5e.

Figure 5. Schematic and SEM micrographs showing the location of fatigue cracking, crack initiation site (arrows) and fracture morphology of fatigue cracks in bay #1.

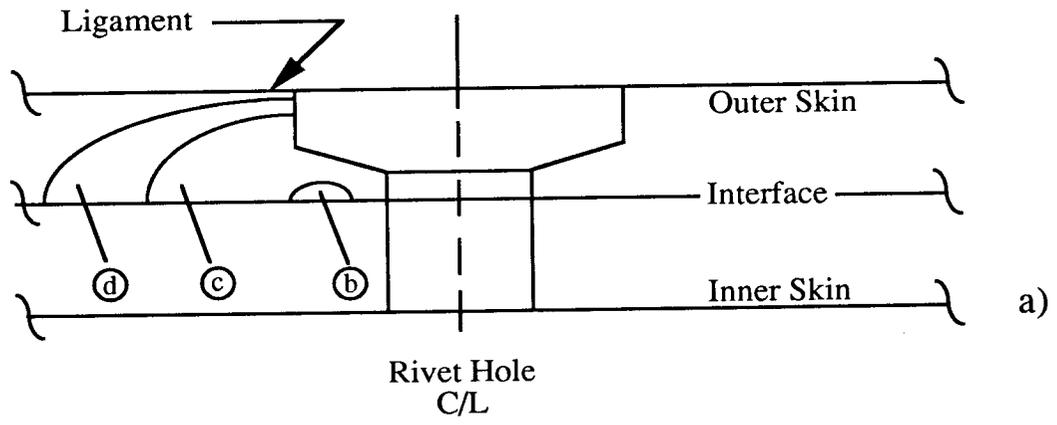
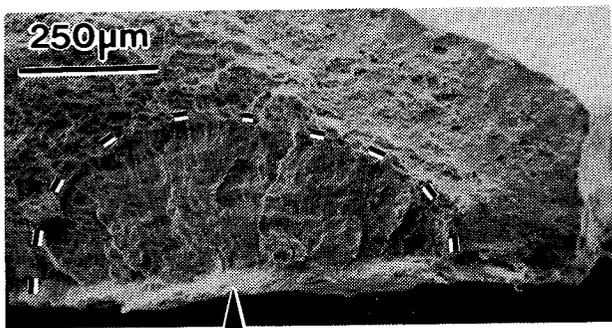
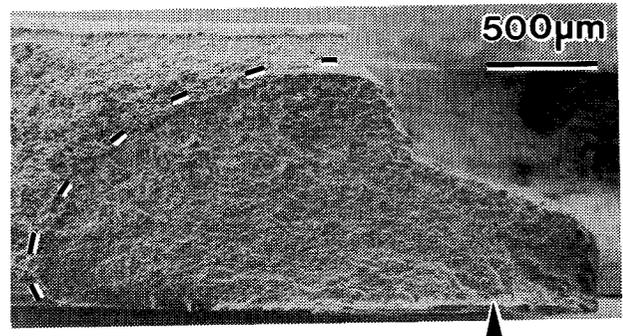
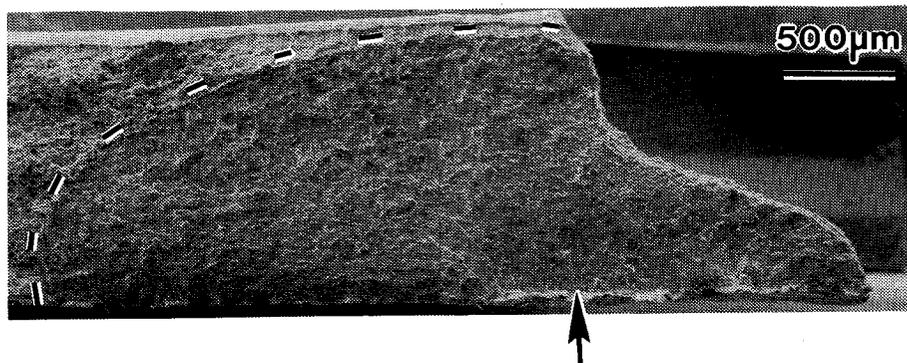
Detailed examination of the fracture surface from the long crack contained in upper row J (Figure 4a) revealed that outer-skin fatigue cracks initiated along the lap splice joint interface, identical to that shown in Figure 5c. Further examination of the fatigue fracture surfaces from each rivet hole revealed a thin region (ligament) exhibiting evidence of ductile tearing located along the outboard surface of the outer skin. Figure 6 shows the fracture morphology of upper row fatigue cracks at different stages of propagation from rivet holes located in adjacent bay #2. From Figures 6b, 6c and 6d, a pattern of fatigue crack propagation has been derived for the upper row locations and illustrated in Figure 6a. Figure 6d shows a third outer skin crack of approximately 3.8 mm (0.150 in) in length. Here, the subsurface crack had formed an outboard surface ligament similar to that observed in the upper row on bay #1. These results show that outer skin cracks initiate at the inner/outer skin interface (arrows in Figures 6b, 6c and 6d) and propagate in a subsurface manner depicted in Figure 6a.

Laboratory fatigue tests conducted at LaRC have confirmed that the fatigue crack morphology shown in Figure 6 is indicative of out-of-plane bending loads. Tension-bending (T/B) constant amplitude fatigue tests were conducted using 2.1 mm thick center-cracked alloy 2024T3 sheet specimens. The fatigue crack fracture morphology from a specimen tested at a T/B ratio of 1.5 is shown in Figure 7. Figure 7a is a SEM micrograph showing the fatigue crack front (dashed line) at region A in Figure 7b. The remaining ligament, shown in Figure 7a, exhibits a ductile tearing morphology produced when breaking the specimen by overload after fatigue testing. The fatigue crack/ligament morphology was formed on the compressively-loaded surface while substantial fatigue crack growth continued on the tension surface, thus forming a crack geometry similar to that observed along the lap splice upper row rivet holes.

Figure 6. Schematic and SEM micrographs illustrating the location of fatigue crack initiation (arrows) and sequence of crack propagation in the lap splice upper rivet row.

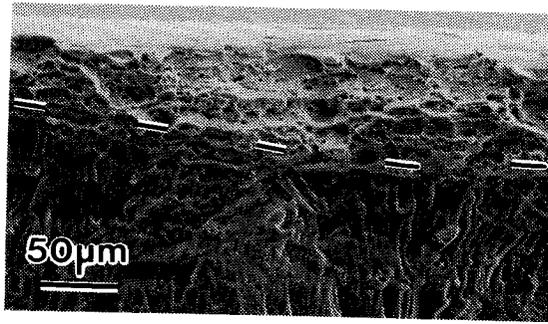
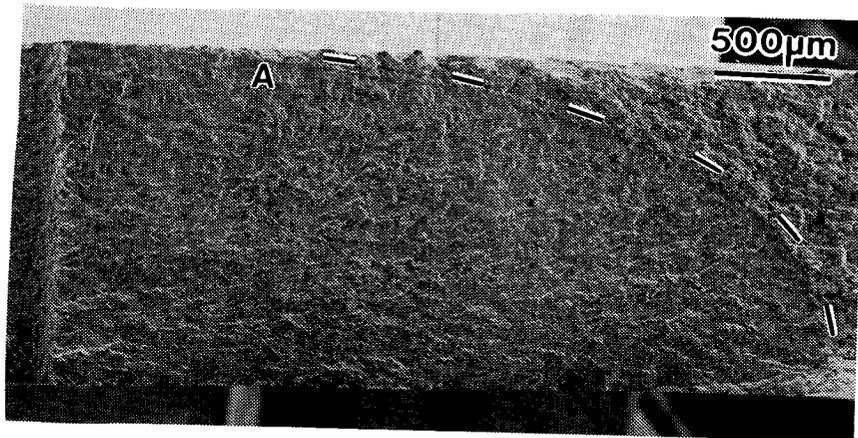
Figure 7. SEM micrograph illustrating the fatigue crack path produced as a result of tension/bend constant amplitude testing.

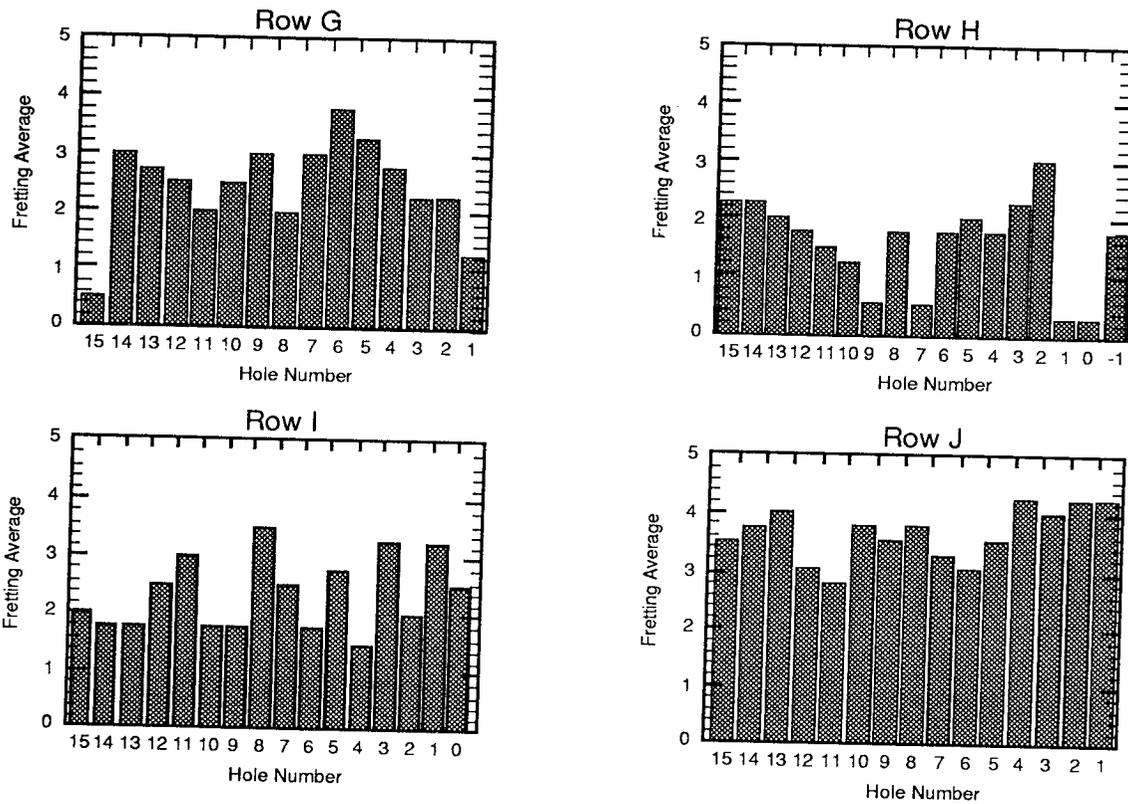
Upper rivet row fatigue cracking at the inner/outer skin interface shown in Figures 5c and 6 suggests that crack initiation is associated with localized damage due to fretting [8]. Evidence of fretting fatigue was noted by a black oxide deposit on the mating surface between the inner/outer skin around each rivet hole. Depicted in Figure 8 is the extent (area drawn to scale) of fretting debris (black oxide) observed on the inboard surface of bay #1 lap splice joint outer skin by estimating the area of fretting debris at each hole location. The amount of fretting was estimated by determining an arithmetic average of fretted surface area per the procedure shown in Figure 9. Here, a scaling factor was assigned to estimate the amount of fretting in each quadrant shown in Figure 9. The value 0 was assigned when no fretting was observed and 5 represented the highest degree of fretting. A "fretting Average" (FA) was calculated for each rivet position. A direct correlation of "fretting average" with rivet hole cracking was not conclusive, i.e., all fretting initiated cracks were observed in holes that exhibited a relatively high $FA > 3.00$, but, all holes that exhibited a $FA > 3.00$ did not contain fretting initiated cracks. Figure 10 is a plot of FA versus rivet hole location for the rows G, H, I and J. Here, a distinct correlation is observed for FA and rivet row, i.e., upper row J which contains the greatest number of fretting fatigue cracks, also exhibits the greatest evidence of fretting damage (highest FA level).

Figure 10. A plot of fretting average value versus rivet hole number is given for each rivet row (G, H, I and J) contained in bay #1.

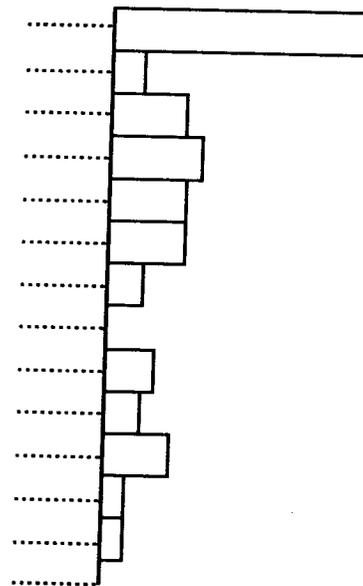
The detailed destructive examination of bay #1 has shown that localized regions of fuselage lap splice joints do contain WSFD after 60,000 full cycle pressurizations. A summary of fatigue cracking contained in bay #1 is shown in Figure 11. Illustrated is the crack length distribution for the 53 fatigue cracks found in bay #1. The majority of cracks having lengths greater than 1.2 mm (30 of the 36 fatigue cracks) were contained in upper

row J. The majority of fatigue cracks observed in the remaining lower three rivet rows exhibited crack depths of less than 1.2 mm. Rows I and J, the two upper rivet rows, exhibited outer skin cracking. Only inner skin cracking was observed in lower rows G and H. Fatigue crack initiation occurs in regions of high K_T located at or near rivet holes. Typically, cracks were found to initiate at rivet hole corners, surface discontinuities (burrs, dents, etc.) and abraded (fretted) surfaces.

Figure 11. A plot showing the fatigue crack length distribution in bay #1.
