# Orbital impacts and the Space Shuttle windshield

Karen S. Edelstein

NASA/Lyndon B. Johnson Space Center (JSC)  
ES2/Structures and Dynamics Branch  
Houston, TX 77058

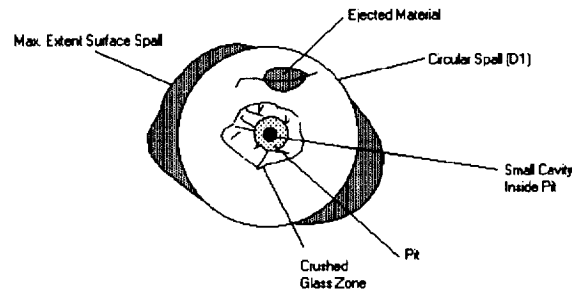
Hypervelocity impact pits in fused silica have very specific characteristics. The visible crater is roughly circular, with a central pit identified by denser crazing. Figure 2 shows a sketch of a typical crater.

Typical hypervelocity crater in fused silica glass

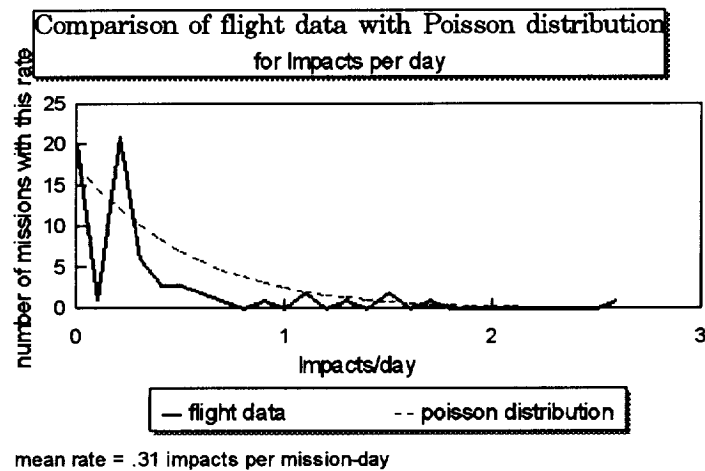
Figure 3

A total of 177 impacts has been reported since STS-1. The number of reported impacts per flight day fits a Poisson distribution reasonably well, as shown in Figure 3. All impact events are not reported, because many craters are too small to detect with our current techniques and because flight safety is not affected by impact craters smaller than .0006" in depth.

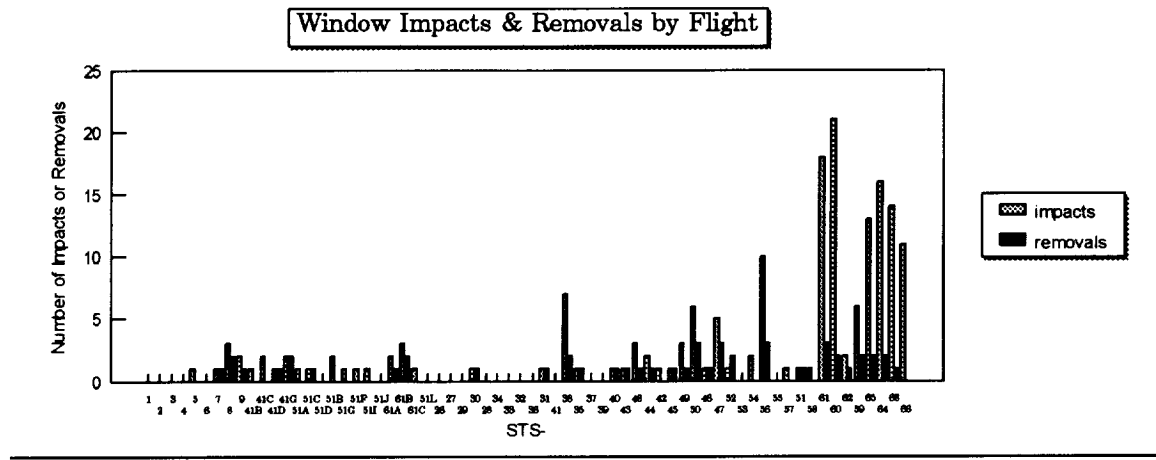
Figure 4 shows the program history of impacts and removals. The noticeable increase in reported impacts may be due to recently improved inspection procedures at KSC. Some of the impacts reported in recent flights may be artifacts from earlier missions.

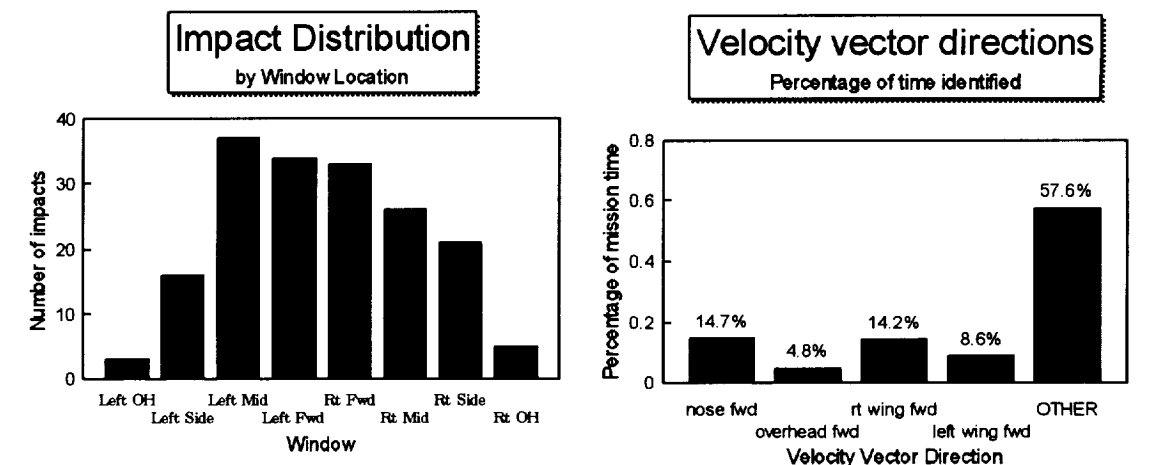
Figure 5 shows the flight data, which demonstrates this expected impact distribution, except for the left middle and side windows, which have more and fewer impacts compared to the right windows, respectfully. A review of the Shuttle program's flight history<sup>1</sup> indicates that the right wing is directed into the velocity vector more frequently than the left, and the nose is in the velocity vector the most of any identifiable direction (see Figure 6). The "other" directions in Figure 6 comprise tail forward, bottom forward, and random or varied orientations. The discrepancies for the left side of the vehicle could be due to inspection errors; possibly the "other" velocity vector orientations are responsible for the unexpected distribution.

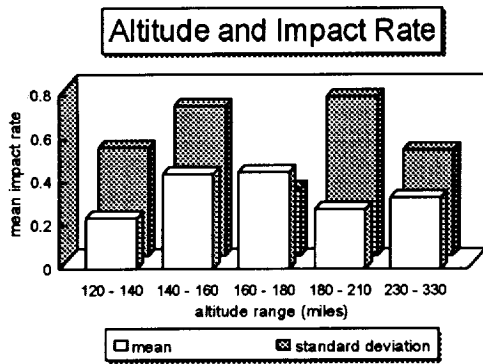
Figure 7 and Figure 8 plot the mean impact rates by altitude and inclination. The altitude does not appear to be a factor in determining impact rate, but the high inclination missions have significantly higher impact rates than the 28.5 degree flights. Environment models predict that debris impacts at high inclinations will result in deeper craters than the same particle at a lower inclination, because of the differing relative speeds at the different inclinations.

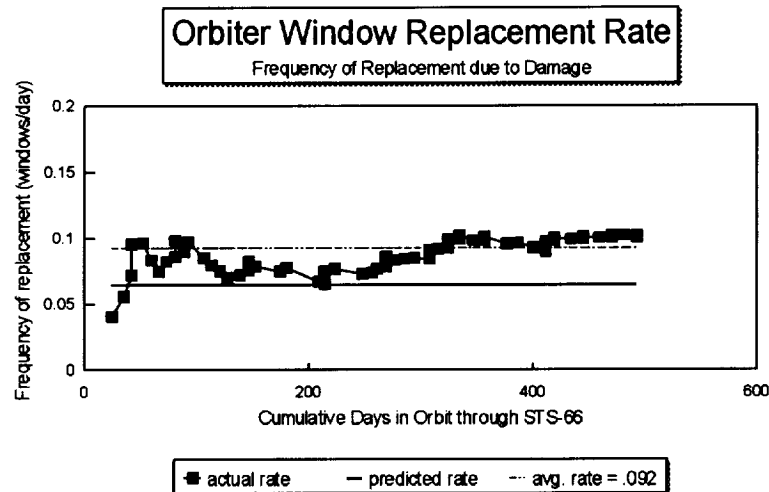
Figure 9

As shown in Figure 4, the replacement rate has not varied much over the history of the Shuttle program. The rate is plotted in Figure 9, which shows the flight-by-flight variations, the average for the whole program, and the predicted rate. The replacement rate predicted by the contractor at the beginning of the program only considered micro-meteoroid impacts, but used a penetration equation for fused silica that has since been shown to predict much deeper craters than more recently developed equations<sup>2</sup>. Therefore, the predicted rate of replacement, which includes consideration of the impact rate as well as the effects of the damage on window strength, is reasonably close to the actual rate, which is due to the micrometeoroid and the man-made debris environments.

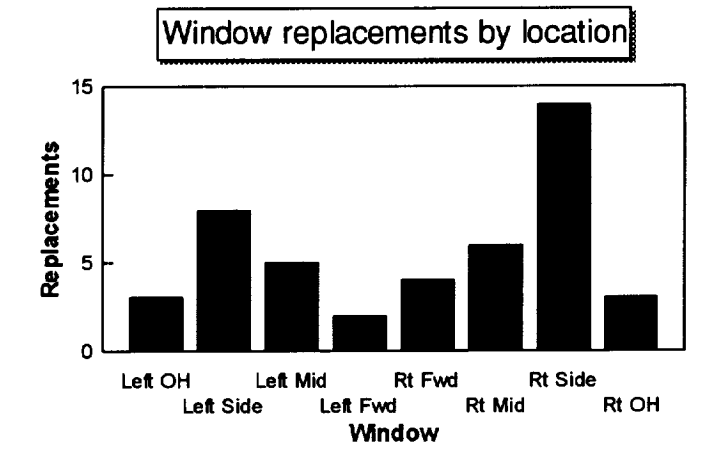
Figure 10 shows that the side windows have been replaced the most frequently. The sensitivity of these windows is especially obvious for the overheads, where almost every impact damage has resulted in a window replacement. Figure 11 shows the distribution of impact depths for all impacts and for impact pits that resulted in window replacement.
