# Orbital impacts and the Space Shuttle windshield

Karen S. Edelstein

NASA/Lyndon B. Johnson Space Center (JSC)  
ES2/Structures and Dynamics Branch  
Houston, TX 77058

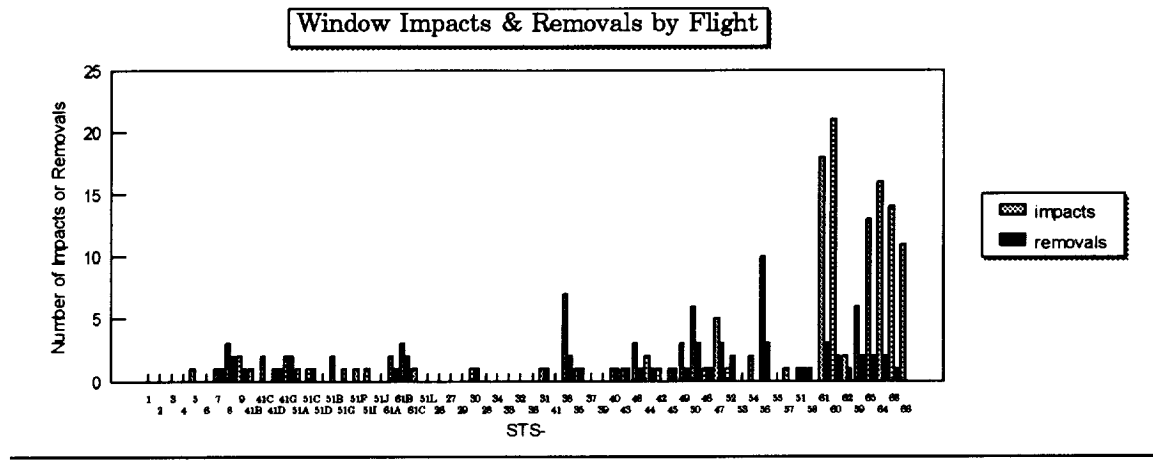
Figure 4 shows the program history of impacts and removals. The noticeable increase in reported impacts may be due to recently improved inspection procedures at KSC. Some of the impacts reported in recent flights may be artifacts from earlier missions.

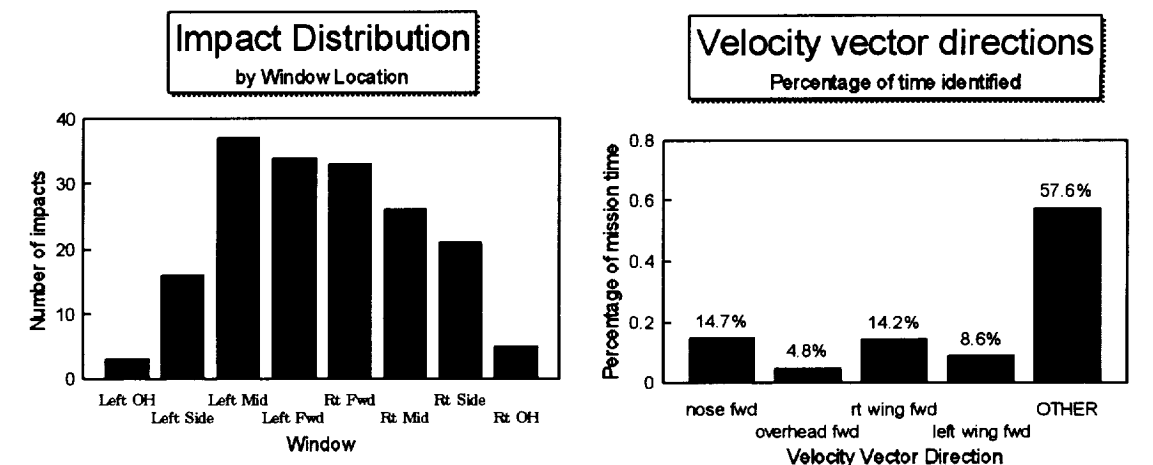
The impacts are distributed among the windows relative to their position on the vehicle. Assuming the vehicle is flying with its nose in the velocity vector, the forward windows are expected to have the highest impact count, since they have the largest projected area when the Shuttle's longitudinal axis is in the velocity vector. The overhead and side hatch windows are expected to have the fewest impacts.

Figure 5 shows the flight data, which demonstrates this expected impact distribution, except for the left middle and side windows, which have more and fewer impacts compared to the right windows, respectfully. A review of the Shuttle program's flight history<sup>1</sup> indicates that the right wing is directed into the velocity vector more frequently than the left, and the nose is in the velocity vector the most of any identifiable direction (see Figure 6). The "other" directions in Figure 6 comprise tail forward, bottom forward, and random or varied orientations. The discrepancies for the left side of the vehicle could be due to inspection errors; possibly the "other" velocity vector orientations are responsible for the unexpected distribution.
