Debris/Ice/TPS Assessment and Integrated Photographic Analysis of Shuttle Mission STS-67

Gregory N. Katnik, Barry C. Bowen, J. Bradley Davis

Technical Memorandum 110651

April 1995

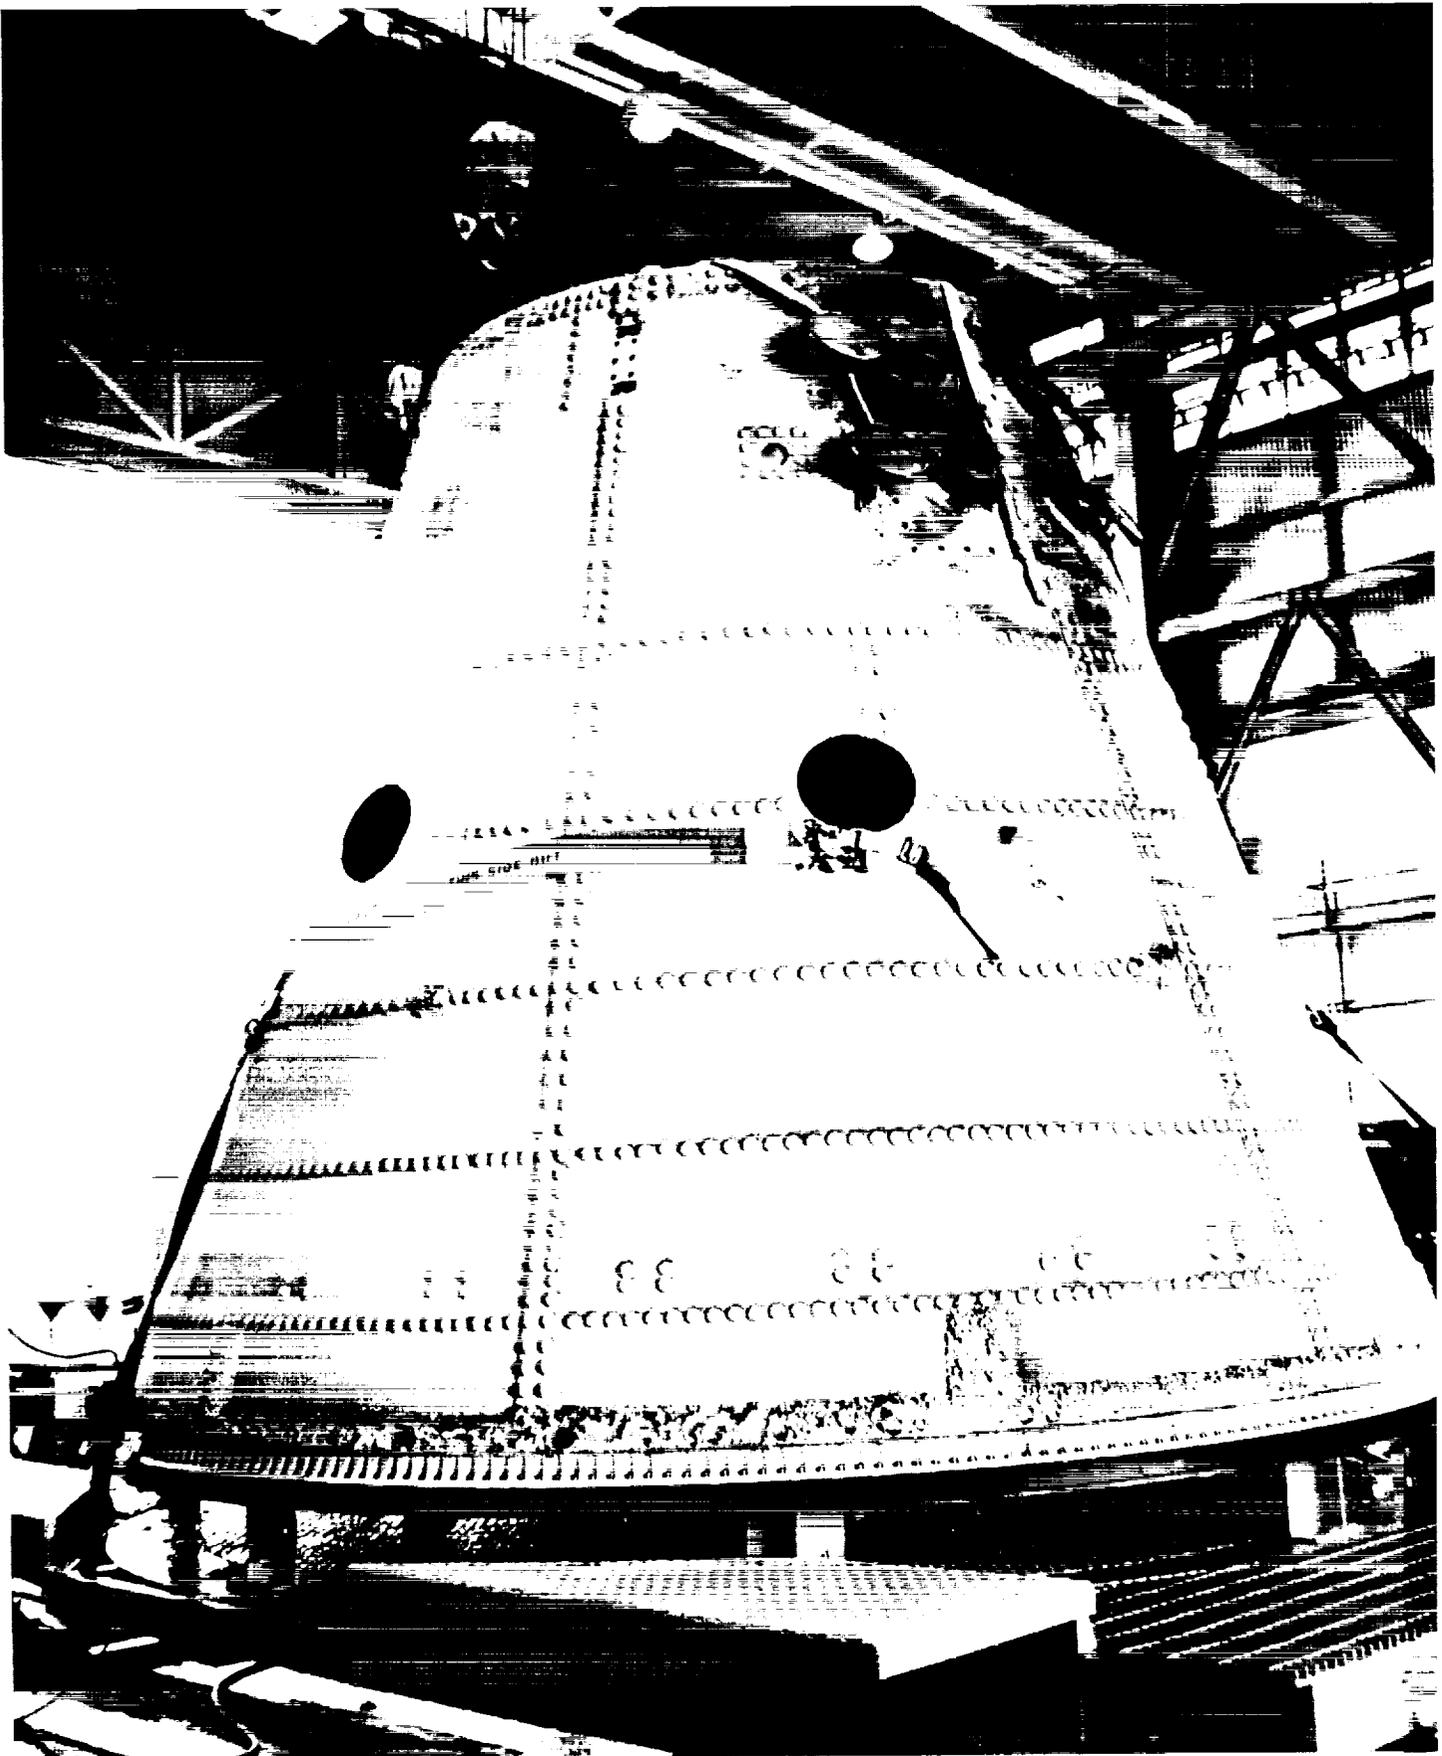
Photo 12 : RH Frustum

The number of debonds over fasteners was average. Hypalon paint was blistered/missing along the XB-395 ring frame where BTA had been applied. Some of the underlying BTA was sooted.

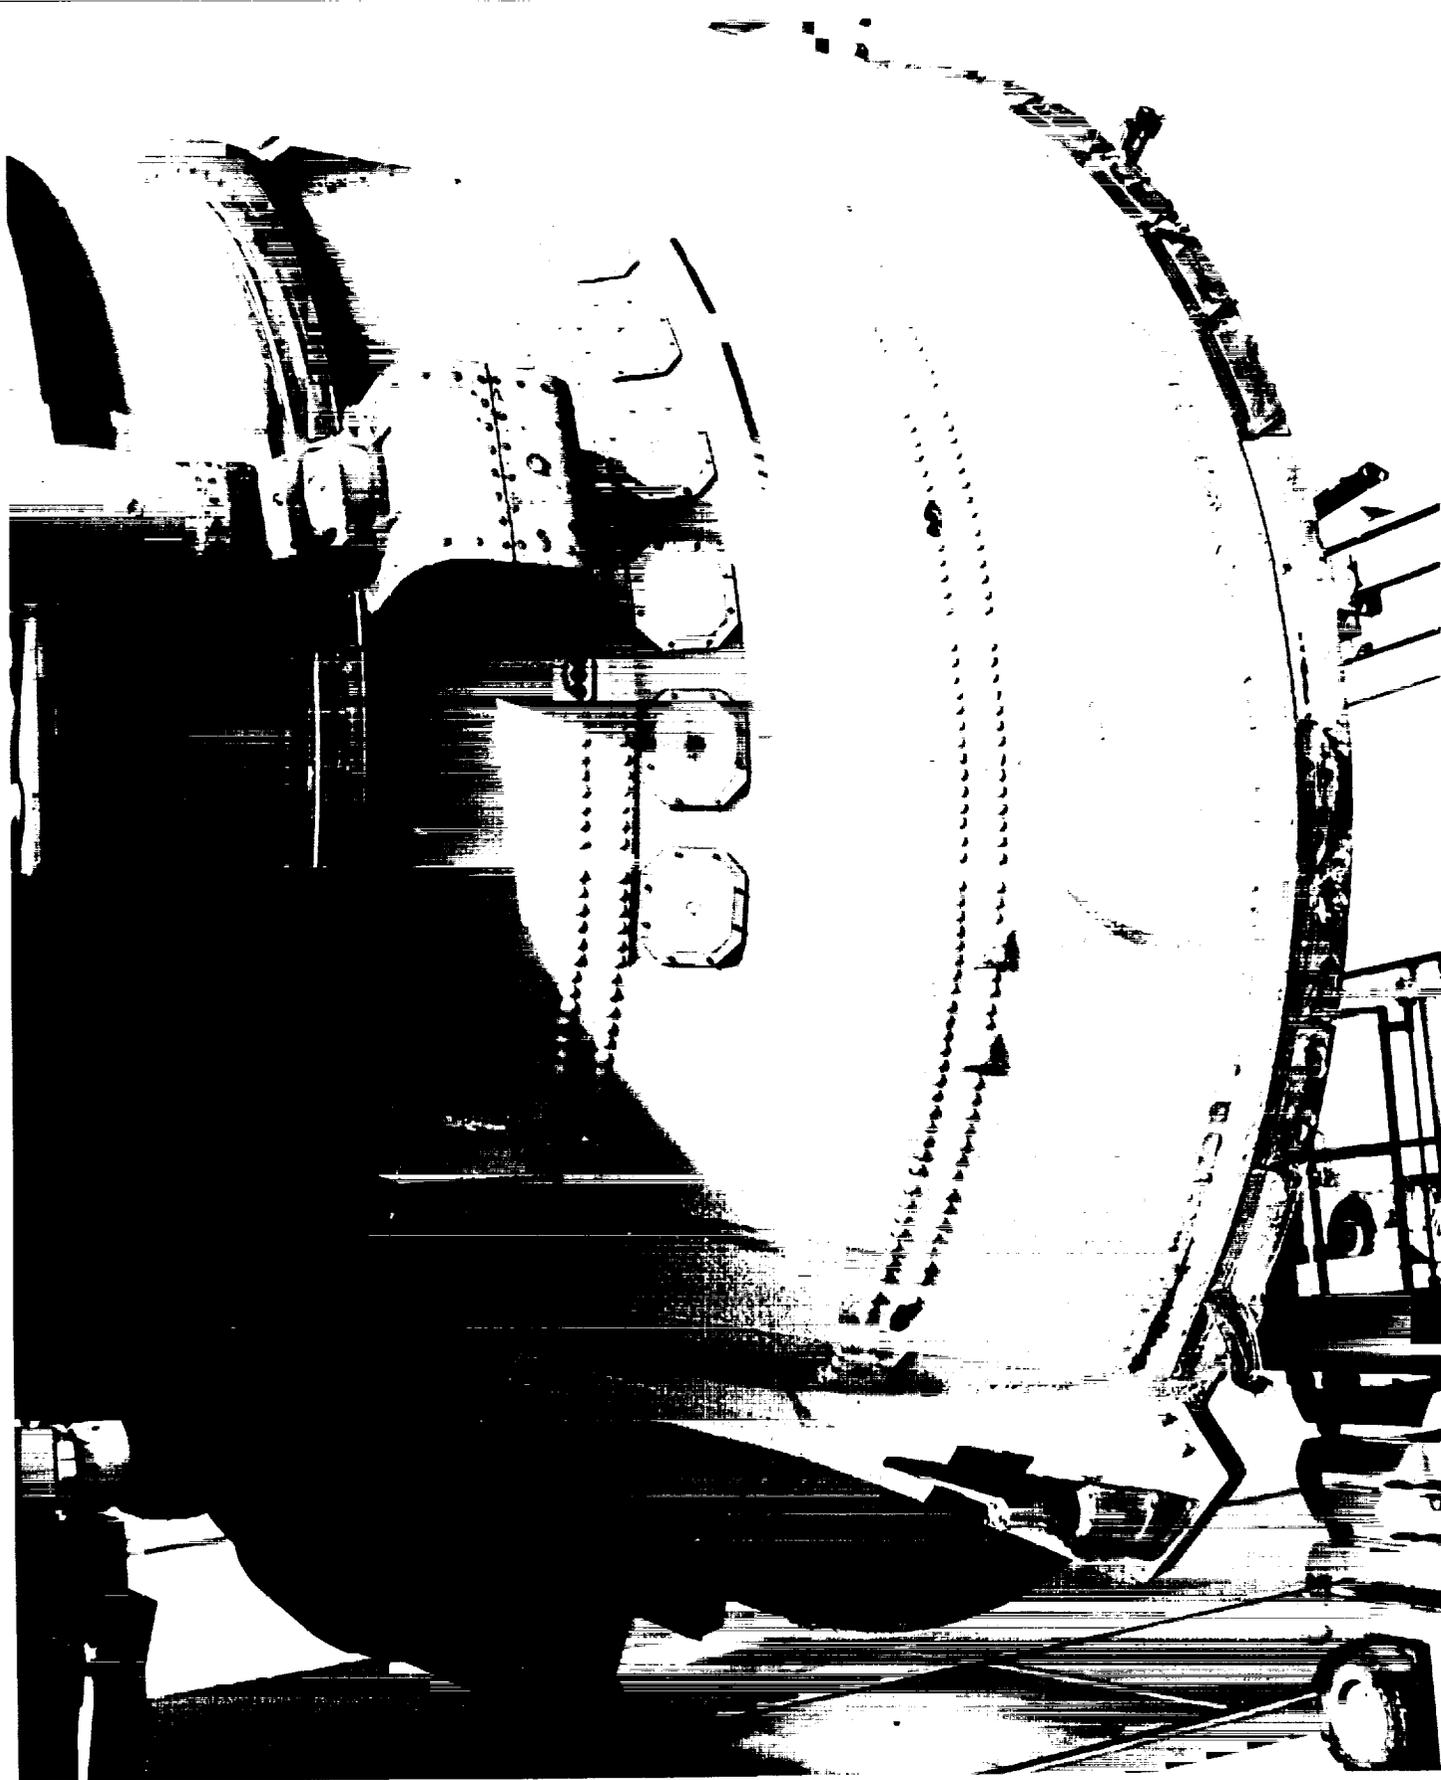
Photo 15 : RH SRB Aft Skirt

MSA-2 was missing from aft skirt acreage in seven places. Most of the MSA-2 divots, which averaged 3-inches by 3-inches in size, appeared to expose lightly-sooted substrate. Hypalon paint was blistered/missing over the areas where BTA closcouts had been applied.

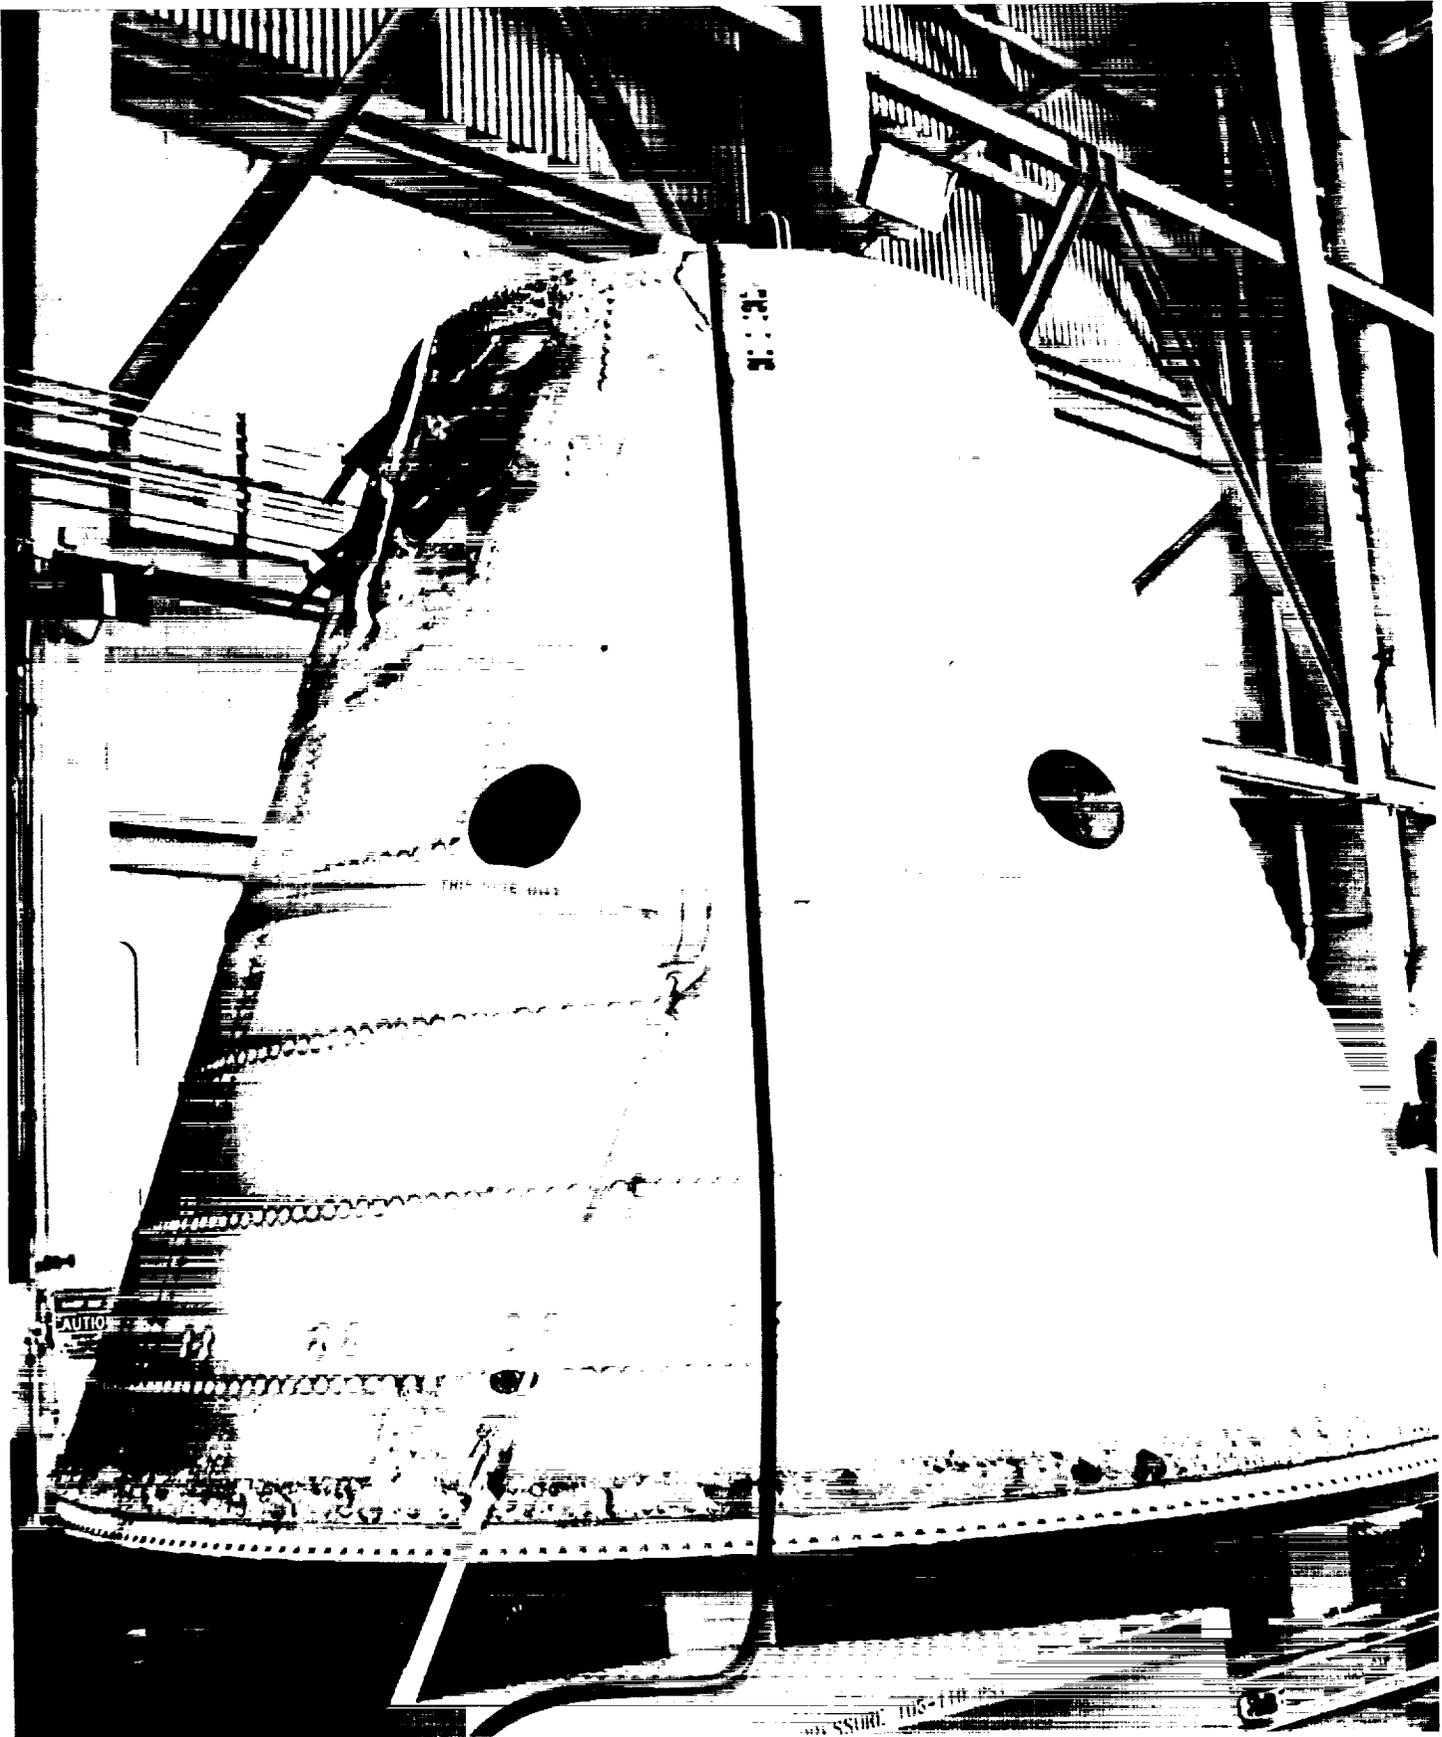
Photo 16 : LH Frustum

The number of MSA-2 debonds over fasteners was average. Hypalon paint was blistered/missing along the XB-395 ring frame where BTA closeouts had been applied. Some of the underlying BTA was sooted.

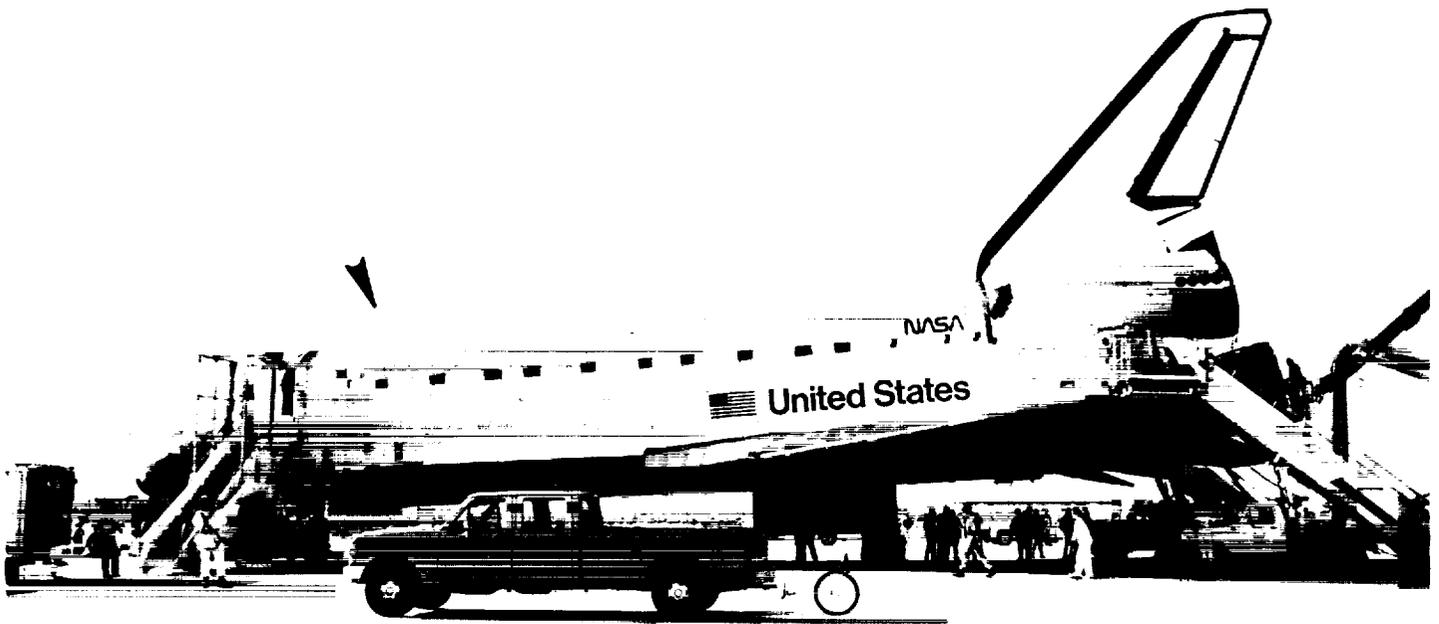
Photo 20 : Overall View of Orbiter Left Side

Note discoloration on leading edge of left payload bay door

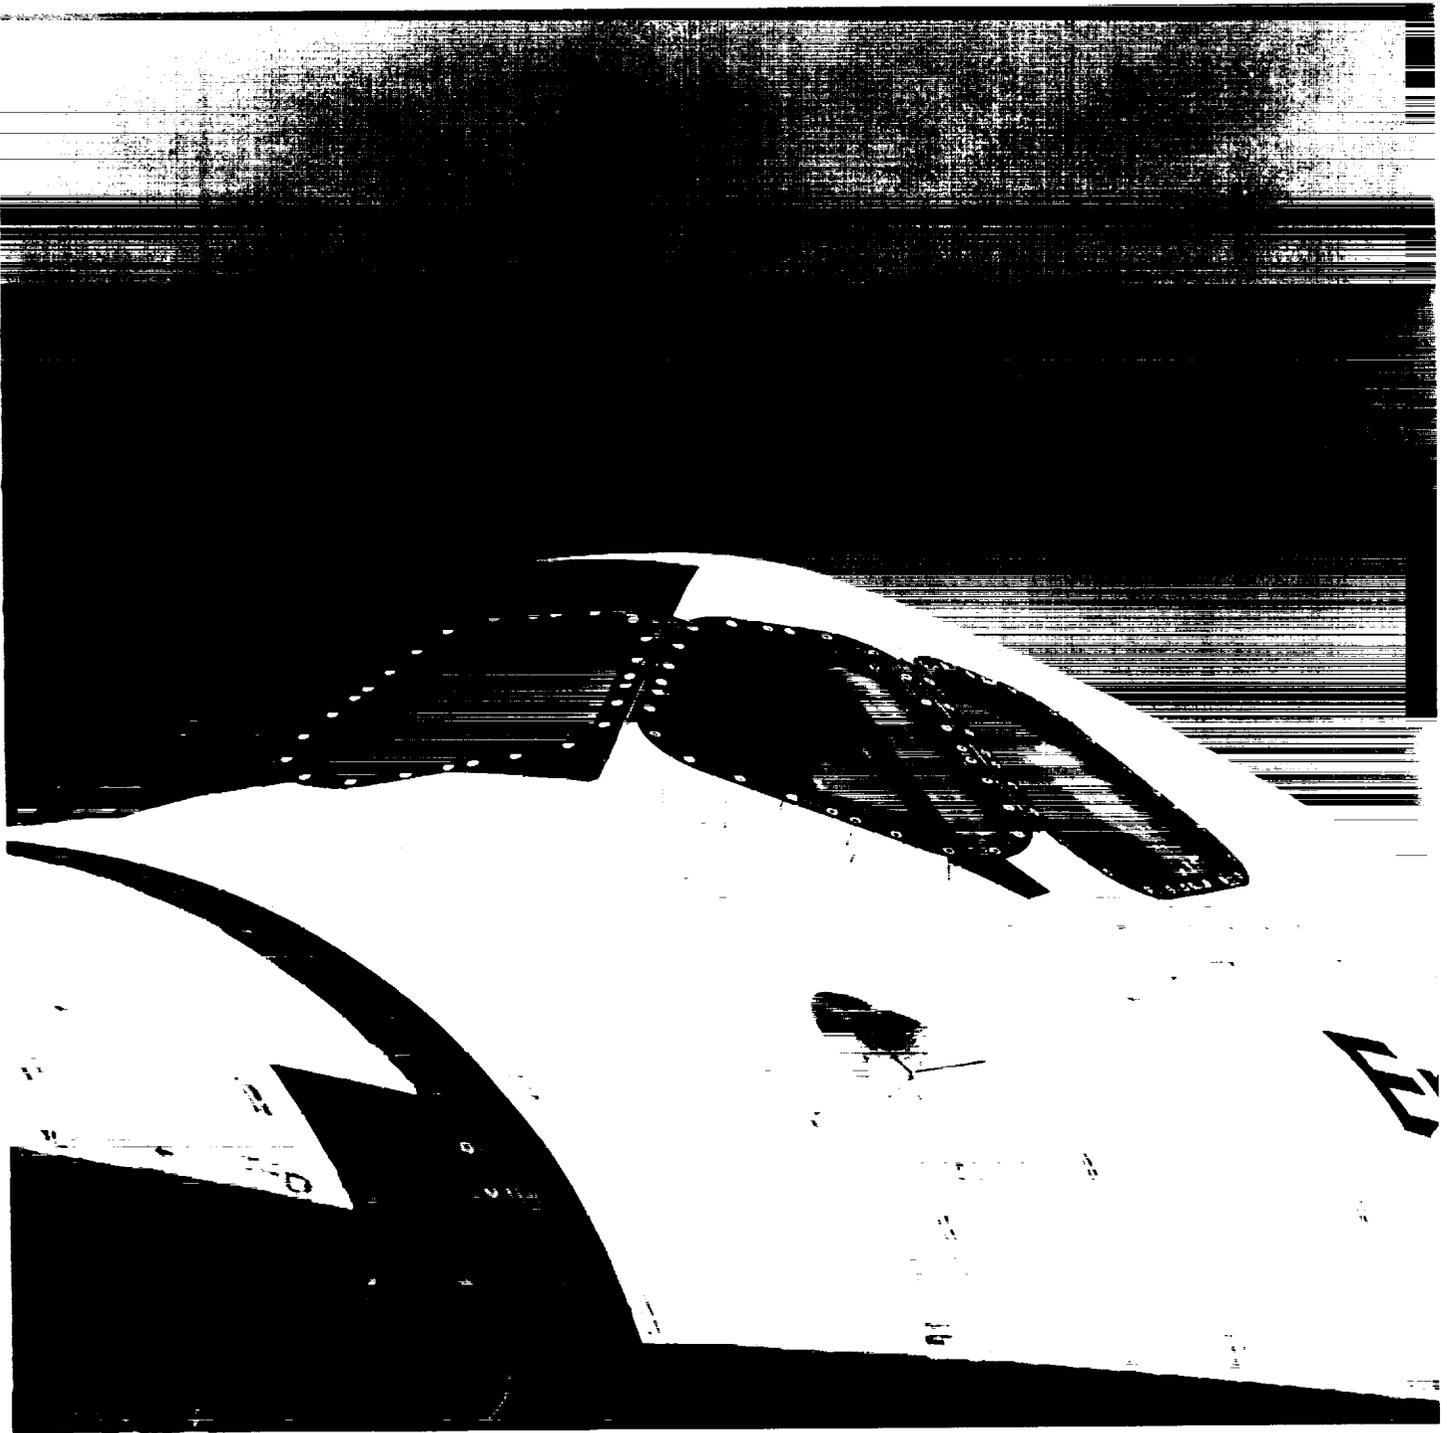
Photo 27 : Orbiter Windows

Orbiter windows #3 and #4 exhibited heavy hazing and streaks. Only a light haze was present on the other windows. Tile damage around the Orbiter windows was less than usual.

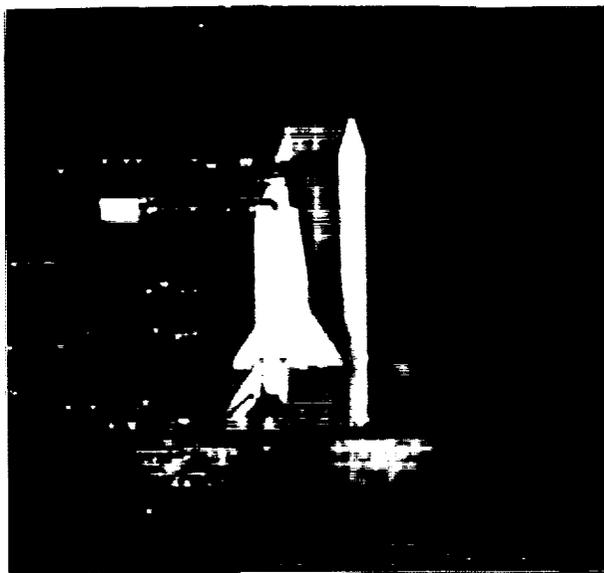
Figure 2.2.1: White Vapor near the RH SRB Aft Skirt at T-21 Seconds

White vapor was noted rising from the MLP area just to the east of the Shuttle Launch Vehicle at approximately T-21 seconds. The vapor was first seen near the RSRB aft skirt. KSC reported the white vapor to be smoke from the RH SRB hydraulic power unit. No follow-up action was requested.
