**TECHNOLOGY INTEGRATION BOX BEAM FAILURE STUDY:  
STATUS REPORT**

M. J. Shuart, D. R. Ambur, D. D. Davis, Jr.,  
R. C. Davis, G. L. Farley, C. G. Lotts, and J. T. Wang

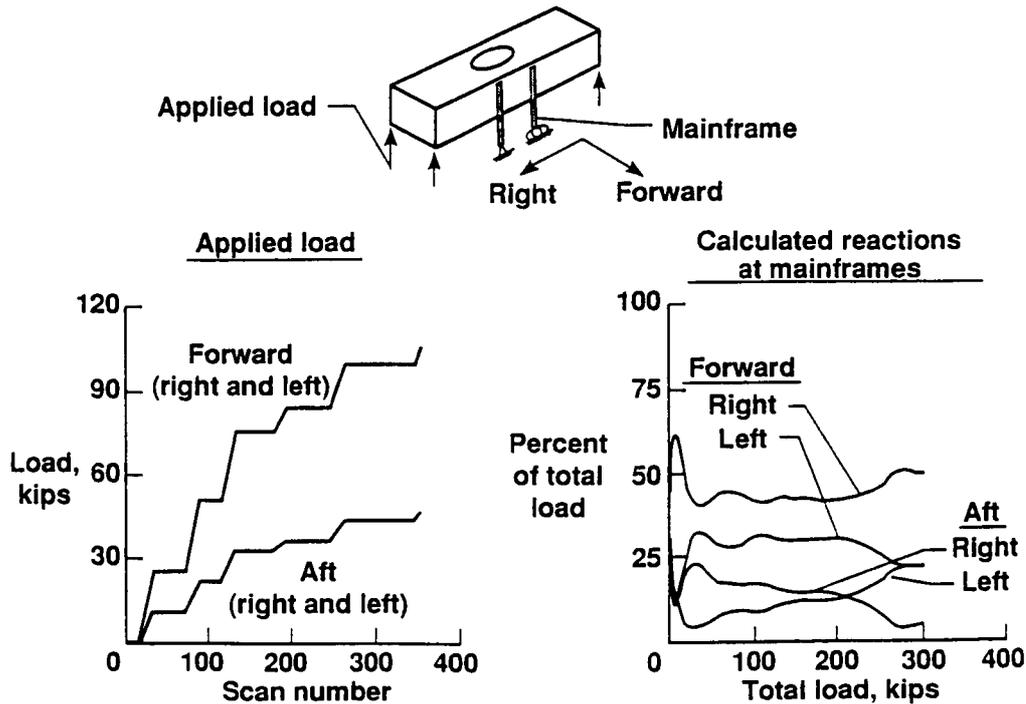
Figure 1

The TIBB loading conditions were thoroughly examined as a precursor to understanding the TIBB response and failure mechanism. The TIBB was loaded at both ends of the beam and was supported by mainframes in the middle of the beam as illustrated at the top of figure 1. Loads were applied to the TIBB using hydraulic actuators located at four corners of the TIBB. Applied loads measured during the test are shown on the left side of the figure. The applied loads for the forward right and left actuators were equal, and the applied loads for the aft right and left actuators were equal. The applied loads for the forward actuators were 230 percent greater than the applied loads for the aft actuators to simulate a combined upbending and torsion wing-loading condition. This loading condition will be referred to herein as the failure load case. Loads were applied to the TIBB incrementally during the test, and selected strain and displacement results were evaluated at each load level. The "stair-step" trend for the applied load data is a result of the applied loading procedure.

Results for the reaction forces in the TIBB mainframe supports are shown on the right side of figure 1. Each reaction force was calculated using results from strain gages located on the corresponding mainframe support. Results for the reaction forces are shown on the figure as percentages of the total load. The percentage of the total load for each reaction force varied significantly for total loads below 50 kips. The variations are due to settling of the test fixture and TIBB during loading. At failure (i.e., 301 kips total applied load) the forward right and left reaction loads were approximately 50 and 20 percent, respectively, of the total load, and the aft right and left reaction loads were approximately 20 and 5 percent, respectively, of the total load. The calculated reaction forces were expected to have a load distribution similar to that for the applied loads. The results for the calculated reaction forces may be affected by the boundary conditions at the supports, deformation of the test fixture, and/or rigid body motions of the TIBB.

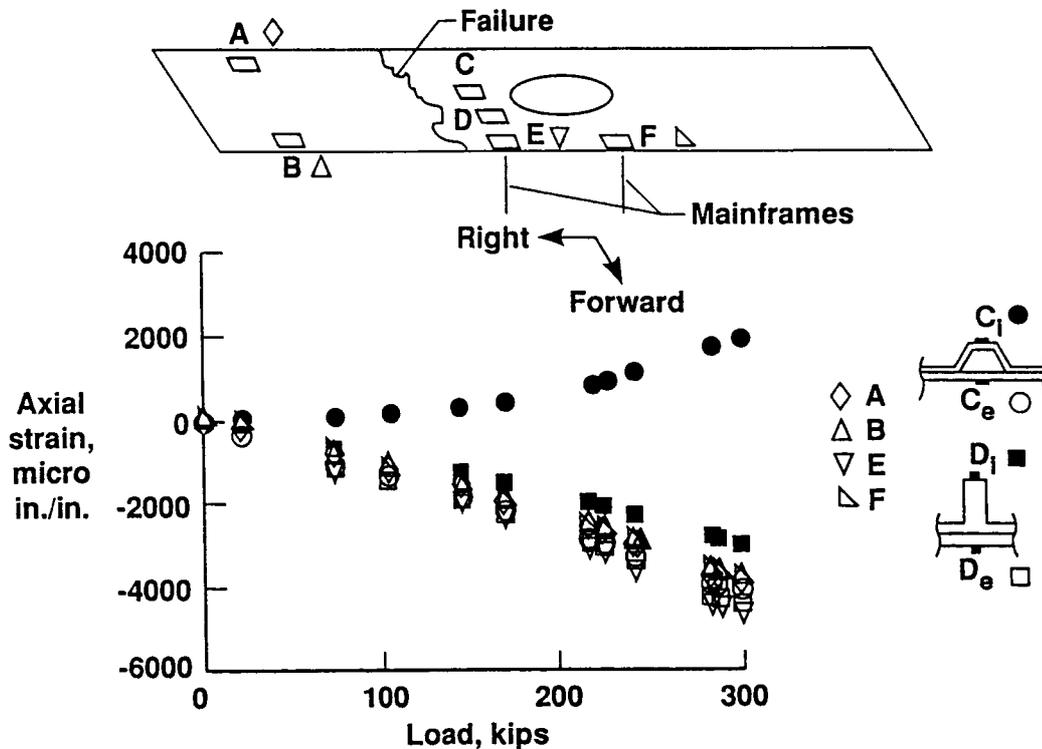
Figure 2

Measured axial strains for the failure load case from the upper cover of the TIBB are shown in figure 2. Strain gage locations are identified by the letters A through F and are indicated by a parallelogram on the schematic at the top of the figure and by the sketch of stiffener cross sections at the lower right of the figure. The approximate location of the TIBB failure across the upper cover is also indicated on the schematic. The strain gages at location C are in the vicinity of a hat stiffener, and the strain gages at location D are in the vicinity of a blade stiffener. The subscripts i and e for the letters C and D designate strain gage locations on the interior and exterior surfaces, respectively, of the TIBB.

Axial (spanwise) strain results are plotted on the figure as a function of the total applied load. The strains at locations A, B, E, and F are consistent with the expected deformation of the TIBB for this load case. The largest axial compressive strain is approximately -0.0045 in./in. and occurs at location E. The differences between the interior surface strains and the exterior surface strains at locations C and D indicate stiffener bending. Severe bending in the hat stiffener at failure is caused by local bending moments near the termination of the hat stiffener.

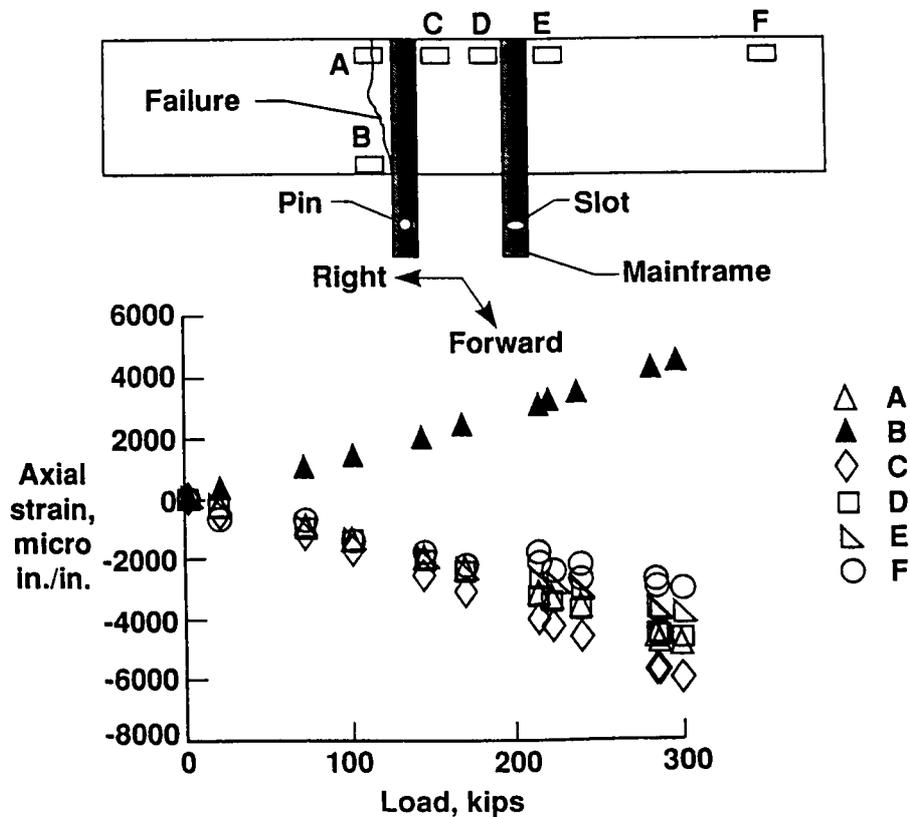
Figure 3

Measured axial strains for the failure load case from the forward spar of the TIBB are shown in figure 3. Strain gage locations are identified by the letters A through F and are indicated by a rectangle on the schematic at the top of the figure. The schematic also includes the approximate location of the TIBB failure across the forward spar. Strain results are plotted using the symbol identified for each letter in the legend on the right side of the figure. The open symbols correspond to results for gages located near the upper cover of the TIBB, and the filled symbols correspond to results for the gage located near the lower cover. Strain results for locations A and B indicate upbending of the spar which is consistent with this load case. The maximum compressive strain at location A is approximately -0.0046 in./in. The maximum measured compressive strain for the forward spar is at location C and is approximately -0.006 in./in. This maximum compressive strain is too low to cause failure of this undamaged structure. Furthermore, the TIBB failure propagates through a region of the spar where the compressive strains are even lower. These experimental results and similar results for the aft spar indicate that the TIBB failure may have initiated in the upper cover.

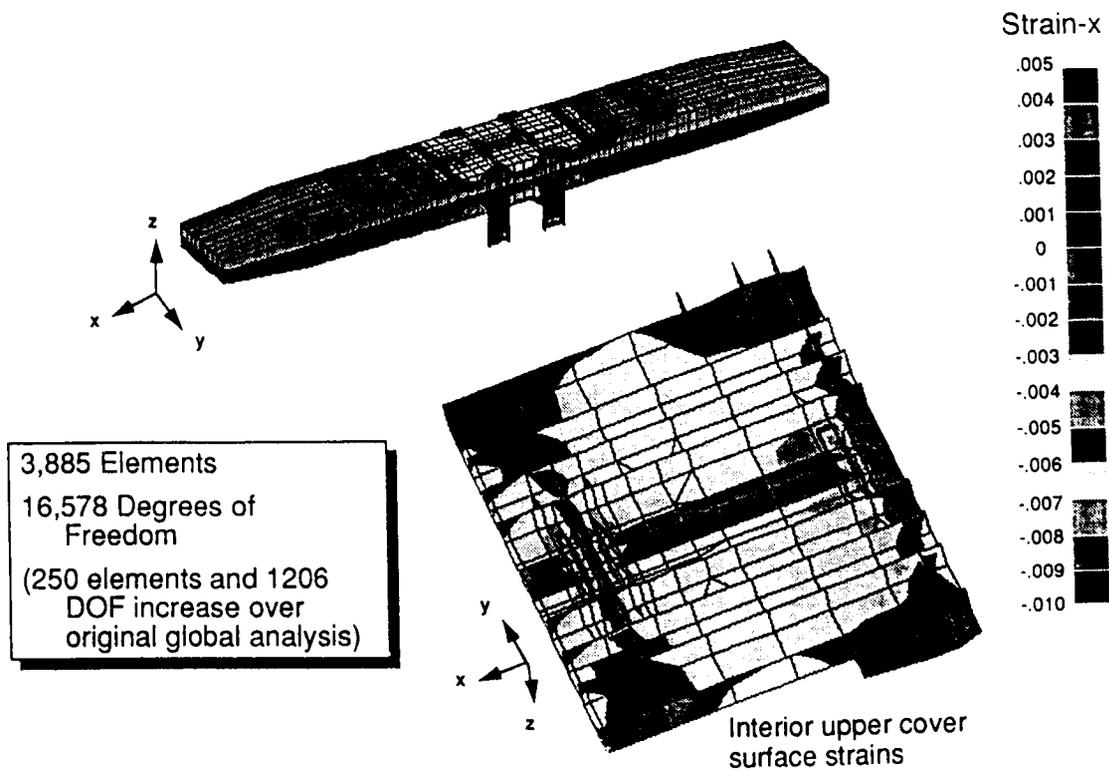
Figure 5

Axial surface strain distributions obtained from a modified MSC/NASTRAN global model of the TIBB are shown in figure 5 for the failure load case. The model used for the present analysis was based on a model developed by Lockheed for the TIBB and has been modified to include stiffener runouts and flanges of hat stiffeners. The present global finite element model is more detailed than the original Lockheed model. The present model contains 3,885 quadrilateral, triangular, and bar elements and has 16,578 degrees of freedom.

The global analyses were used to calculate strains in regions near the observed failure. The exterior surface strain distribution is shown on the TIBB global model near the top of the figure. These results do not indicate any unusually high exterior surface strains. A portion of the interior surface strain distribution is shown in the lower half of the figure. The interior surface strain distribution is presented for the upper cover region near the observed failure. These results show strains for the skin of the upper cover that are greater than  $-0.01$  in./in. in the region of the hat stiffener termination. The high skin strains are caused by an eccentric load path that induces local bending. The observed TIBB failure extends through the region of the hat stiffener termination.

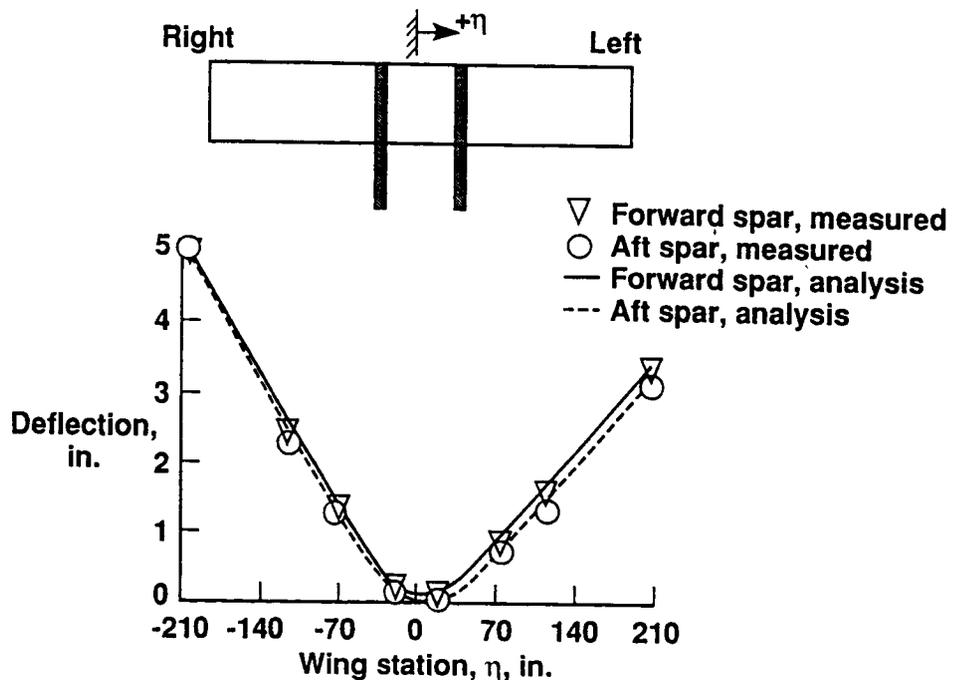
Figure 6

The vertical deflections for the forward and aft spars predicted by the global analysis are compared with experimental results in figure 6. Measured deflections for the left and right ends of the TIBB ( $\eta = \pm 206.6$  in., respectively) and for the mainframes were used as boundary conditions for the global analyses. The composite test section of the TIBB is located between wing stations  $\eta = \pm 75$  in. Correlation between the measured and predicted deflections is excellent.

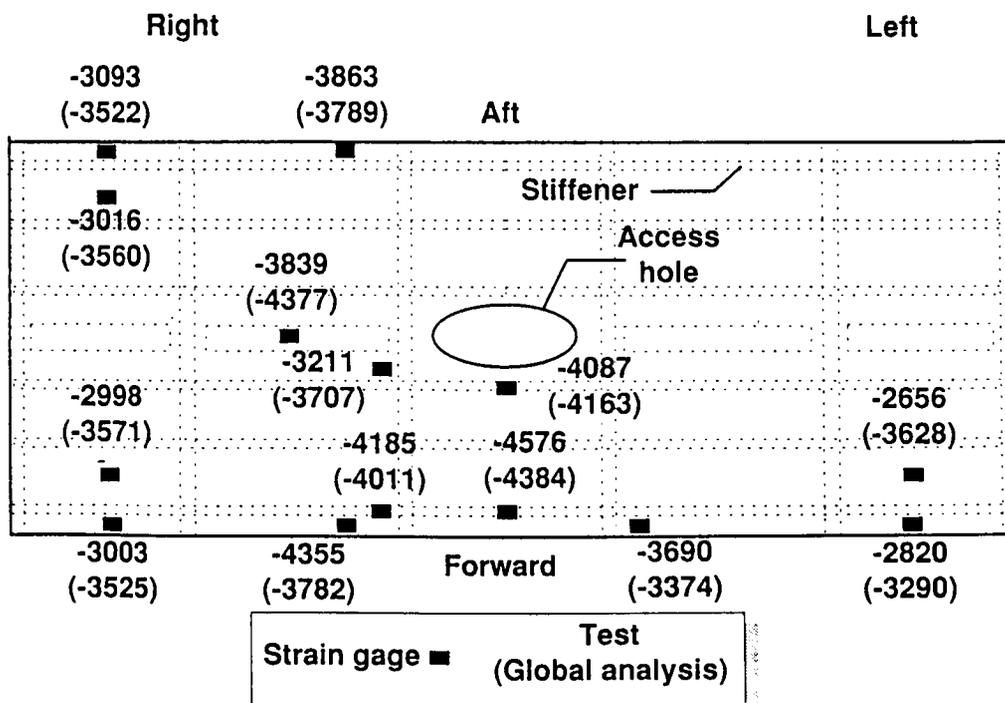
Figure 7

A comparison of upper cover strains at failure of the TIBB is presented in figure 7. Measured strains are compared to predicted strains from the global analysis, and all strains are given in units of micro-in./in. The experimental and predicted strains are shown in the figure at the approximate strain gage location on a schematic of the upper cover. The results on the figure indicate good agreement between test and analysis strains for gages located near the center of the upper cover. The results indicate poor agreement between test and analysis strains for gages located near the ends of the upper cover. These differences between experimental and predicted results may be due to modeling approximations for the TIBB load introduction structure. The results on the figure also indicate poor agreement between test and analysis strains for gages located near the mainframe supports that may be due to modeling approximations for the mainframe, spar, and upper cover connections. Despite the modeling approximations, the experimental and analytical results for the global model agree reasonably well in the center of the upper cover.

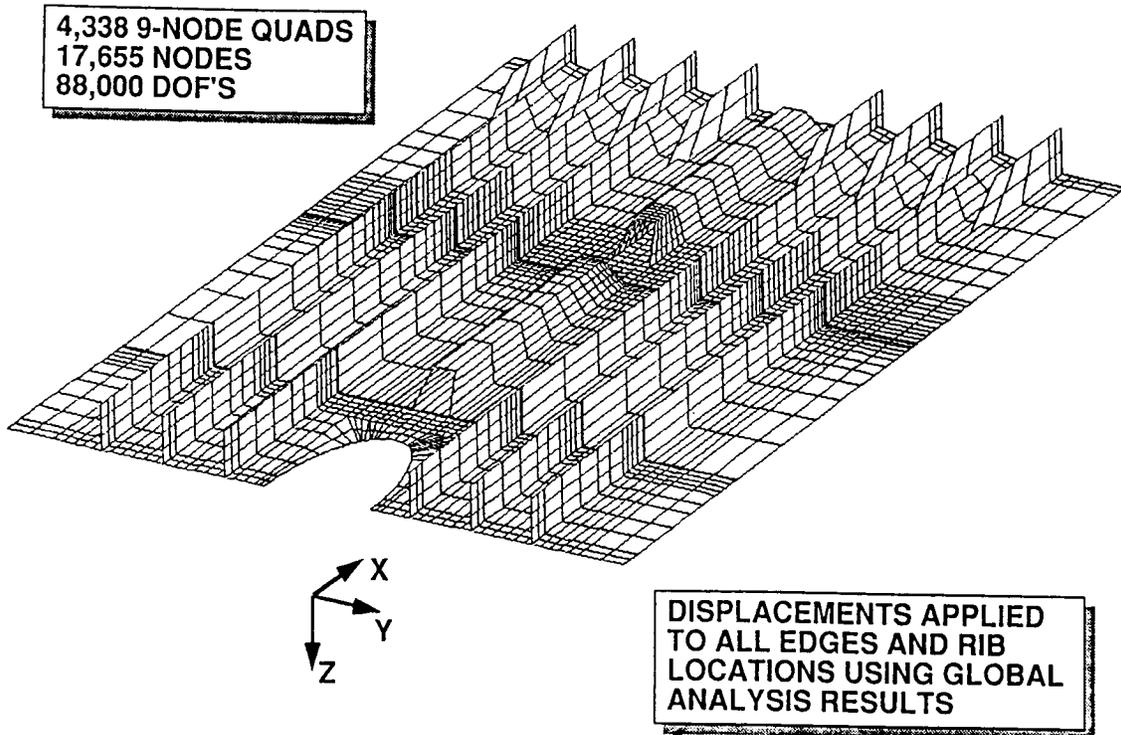
Figure 8

A detailed local finite element model of half of the upper cover was developed to determine the deformations and strains near the TIBB failure. The local model shown in figure 8 consists of 4,338 9-noded assumed natural-coordinate strain elements (ref. 6) resulting in approximately 88,000 degrees of freedom. Several loading conditions will be used to investigate the behavior of the upper cover. Displacements and rotations from the global analysis will be applied along all four edges of the local model and at the locations where the transverse ribs attach to the cover skin.

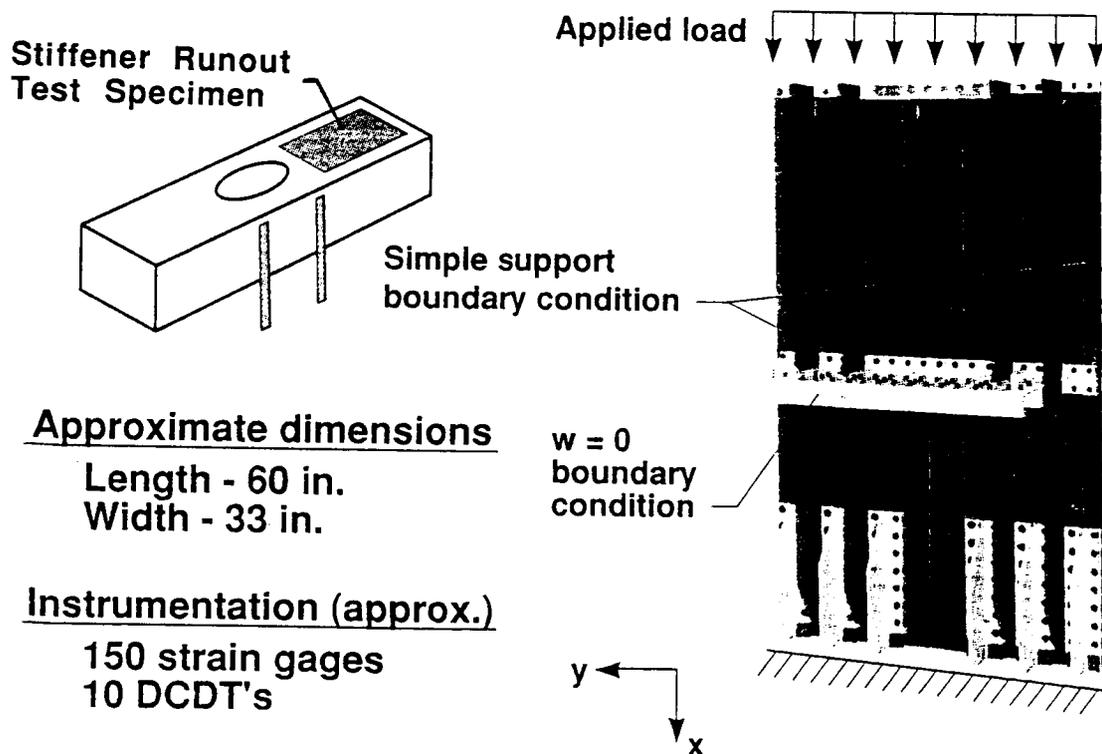
Figure 10

A stiffener runout test specimen (SRTS) was cut from the undamaged portion of the TIBB upper cover as illustrated by the schematic in the upper left of figure 10. The SRTS is approximately 60 in. long and 33 in. wide and will be tested in uniaxial compression to verify the preliminary failure scenario. The unloaded edges of the SRTS will be constrained with knife edges to simulate a simple support boundary condition. The out-of-plane deflection  $w$  will be constrained to be zero along the transverse rib connection located near the center of the specimen. Approximately 150 strain gages and 10 direct current differential transformers (DCDT's) will be used to measure the SRTS response to the applied load. Strains in the critical region of the unsupported skin between the hat stiffener termination and the transverse rib flange will be measured using strain gages and full-field laser interferometry techniques.

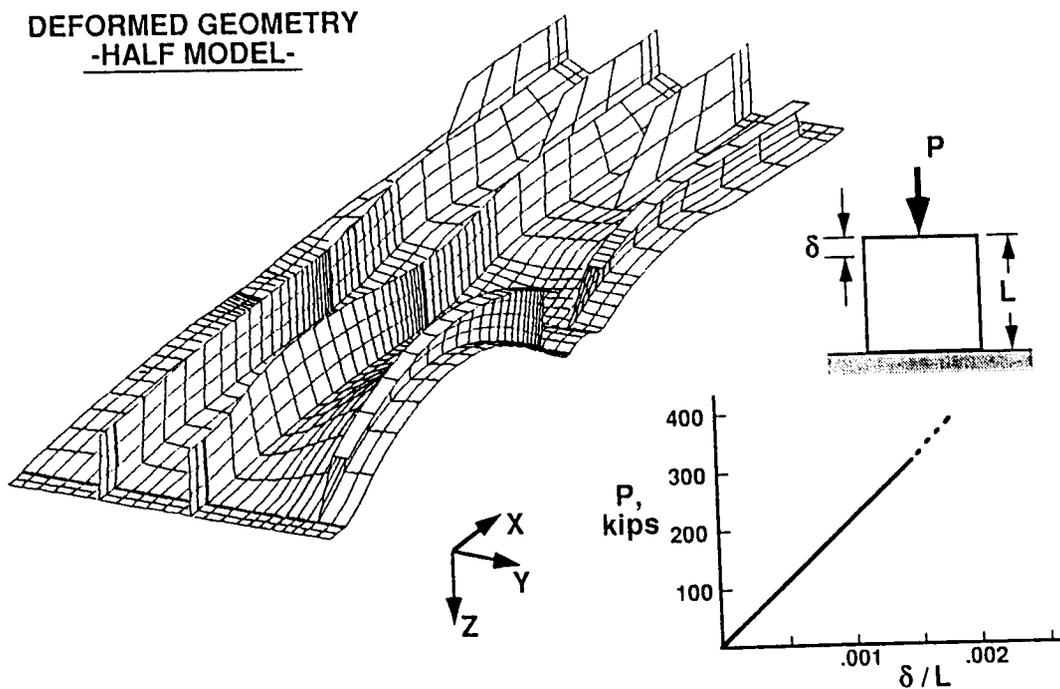
Figure 11

The stiffener runout test specimen (SRTS) will be tested to simulate the TIBB response and failure mechanisms and thereby verify the TIBB failure scenario. A finite element analysis of the SRTS is being conducted to study the effects of specimen geometry, intermediate supports, end fixity, and depth of end potting on the specimen behavior. A half-model of the SRTS is being developed. Preliminary results from these analyses indicate that regardless of end fixity or depth of end potting, very high strains exist in the unsupported skin near the hat stiffener termination. A typical response for the SRTS is shown in figure 11. Deformed geometry and load-shortening response are shown on the figure. Significant bending deformation of the hat stiffener and the upper cover skin are illustrated.
