# Debris/Ice/TPS Assessment and Integrated Photographic Analysis of Shuttle Mission STS-80

*Gregory N. Katnik  
Jill D. Lin*

*Process Engineering/Mechanical System Division/ET-SRB Branch,  
Kennedy Space Center, Florida*

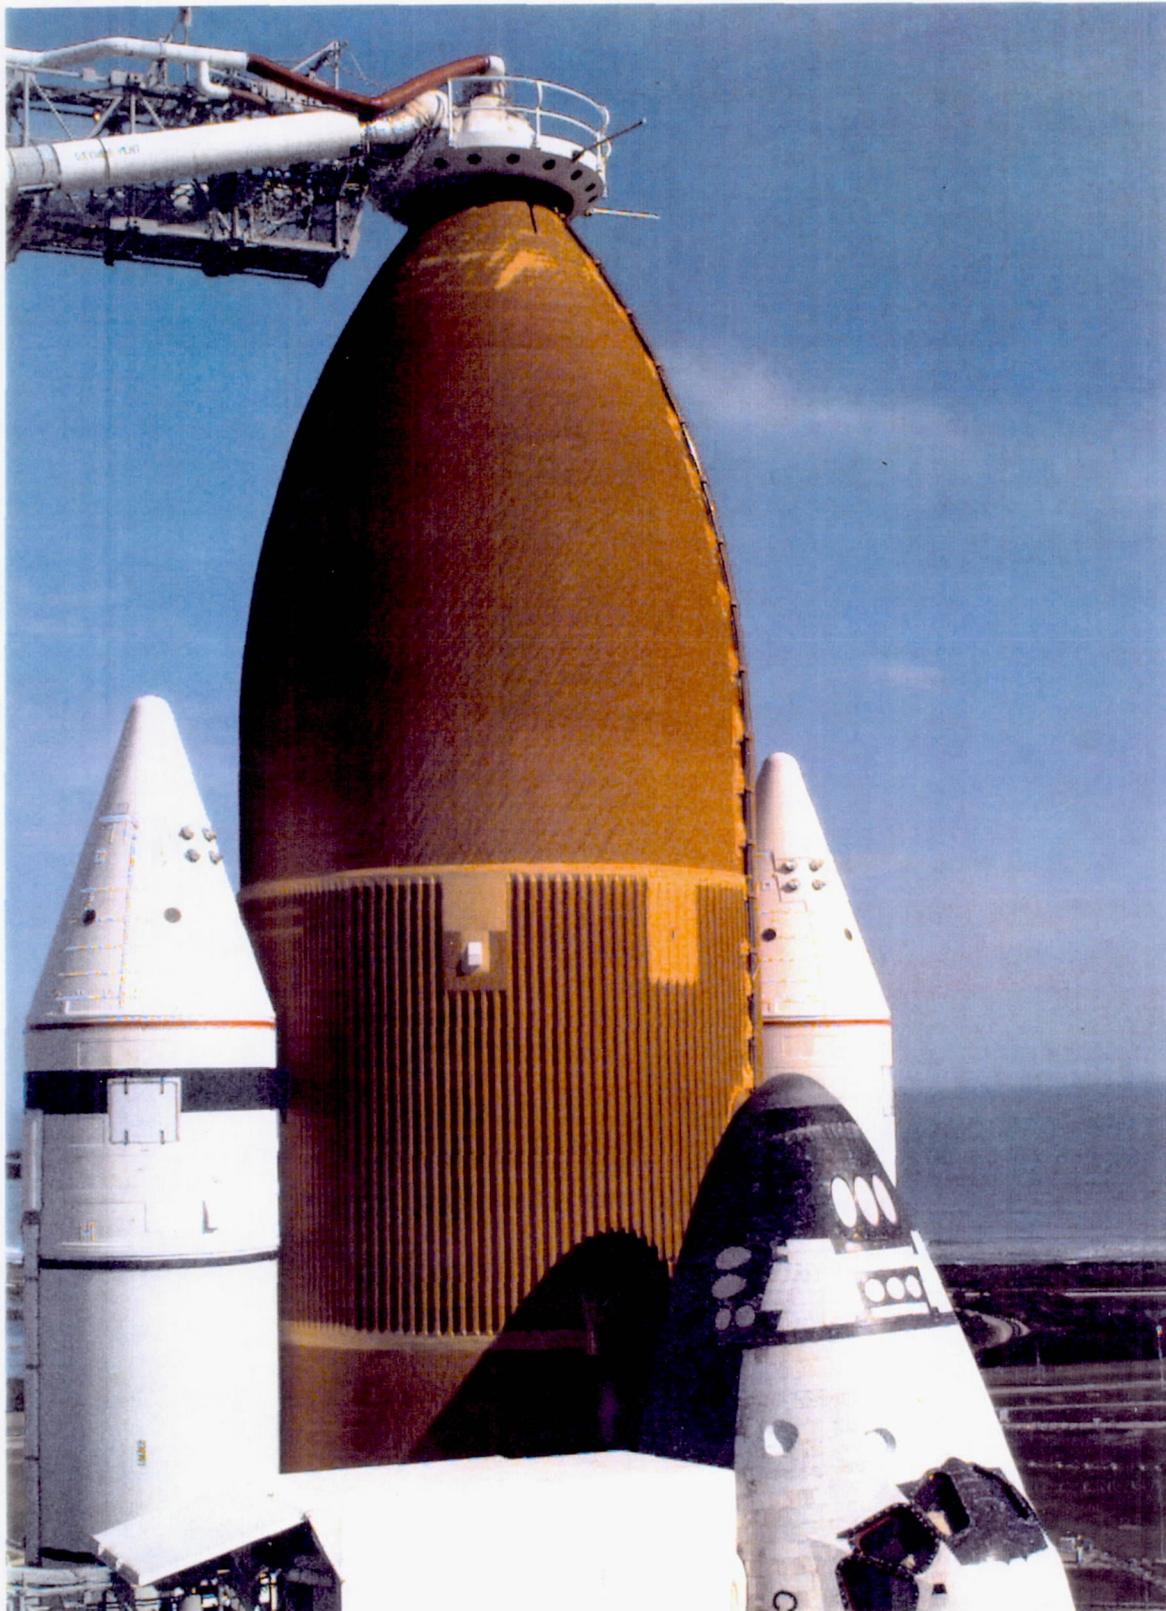
**Photo 4: ET LO2 Tank and Intertank**

Very light condensate, but no ice or frost accumulations, was observed on the LO2 tank. TPS surface temperatures ranged from 61-64 degrees F. The intertank acreage exhibited no TPS anomalies.

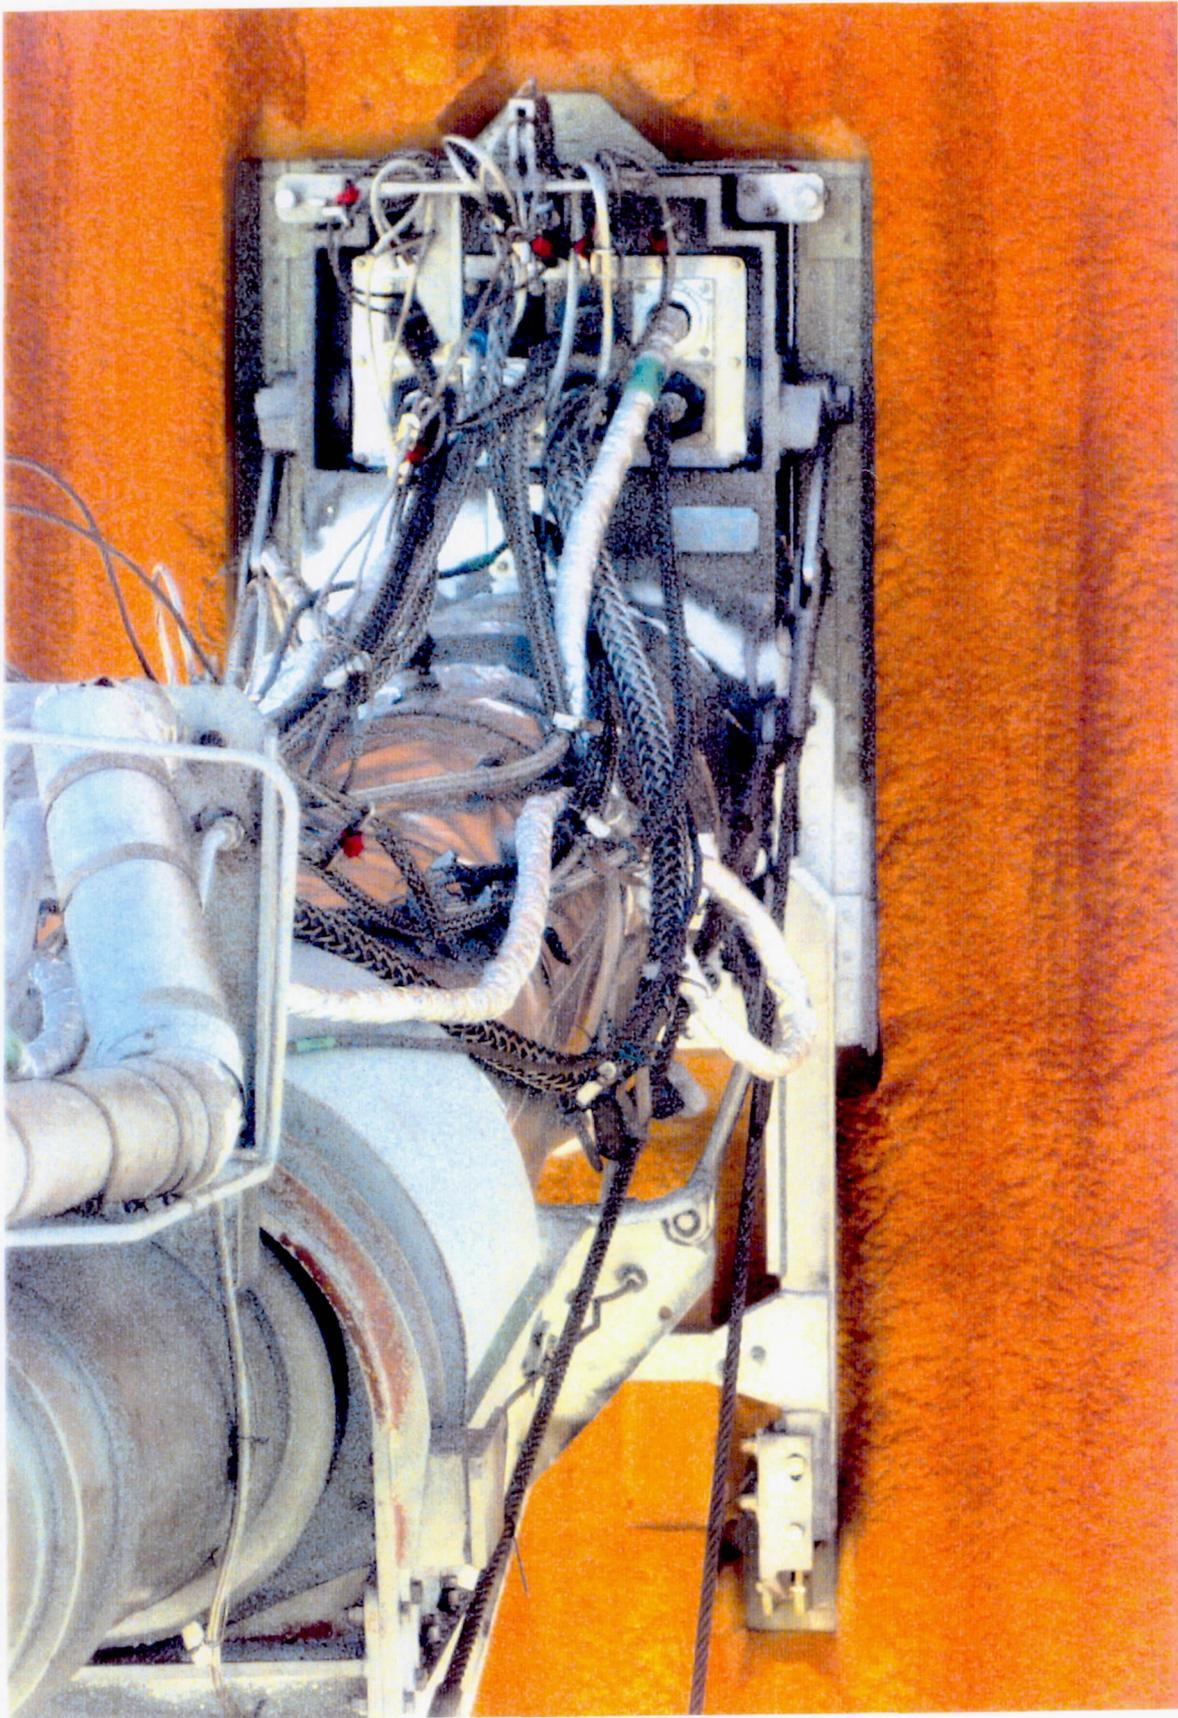
**Photo 5: GUCP**

Ice/frost accumulation on the GUCP appeared typical even with the leak detected during cryoload.

During launch countdown, a leak was reported in the GUCP. Postflight analysis of the GUCP showed that the leak was caused by low compression loads in the 7-inch quick disconnect bellows. There were no visible signs of leaks, unusual vapors, or ice buildup detected during the final inspection.

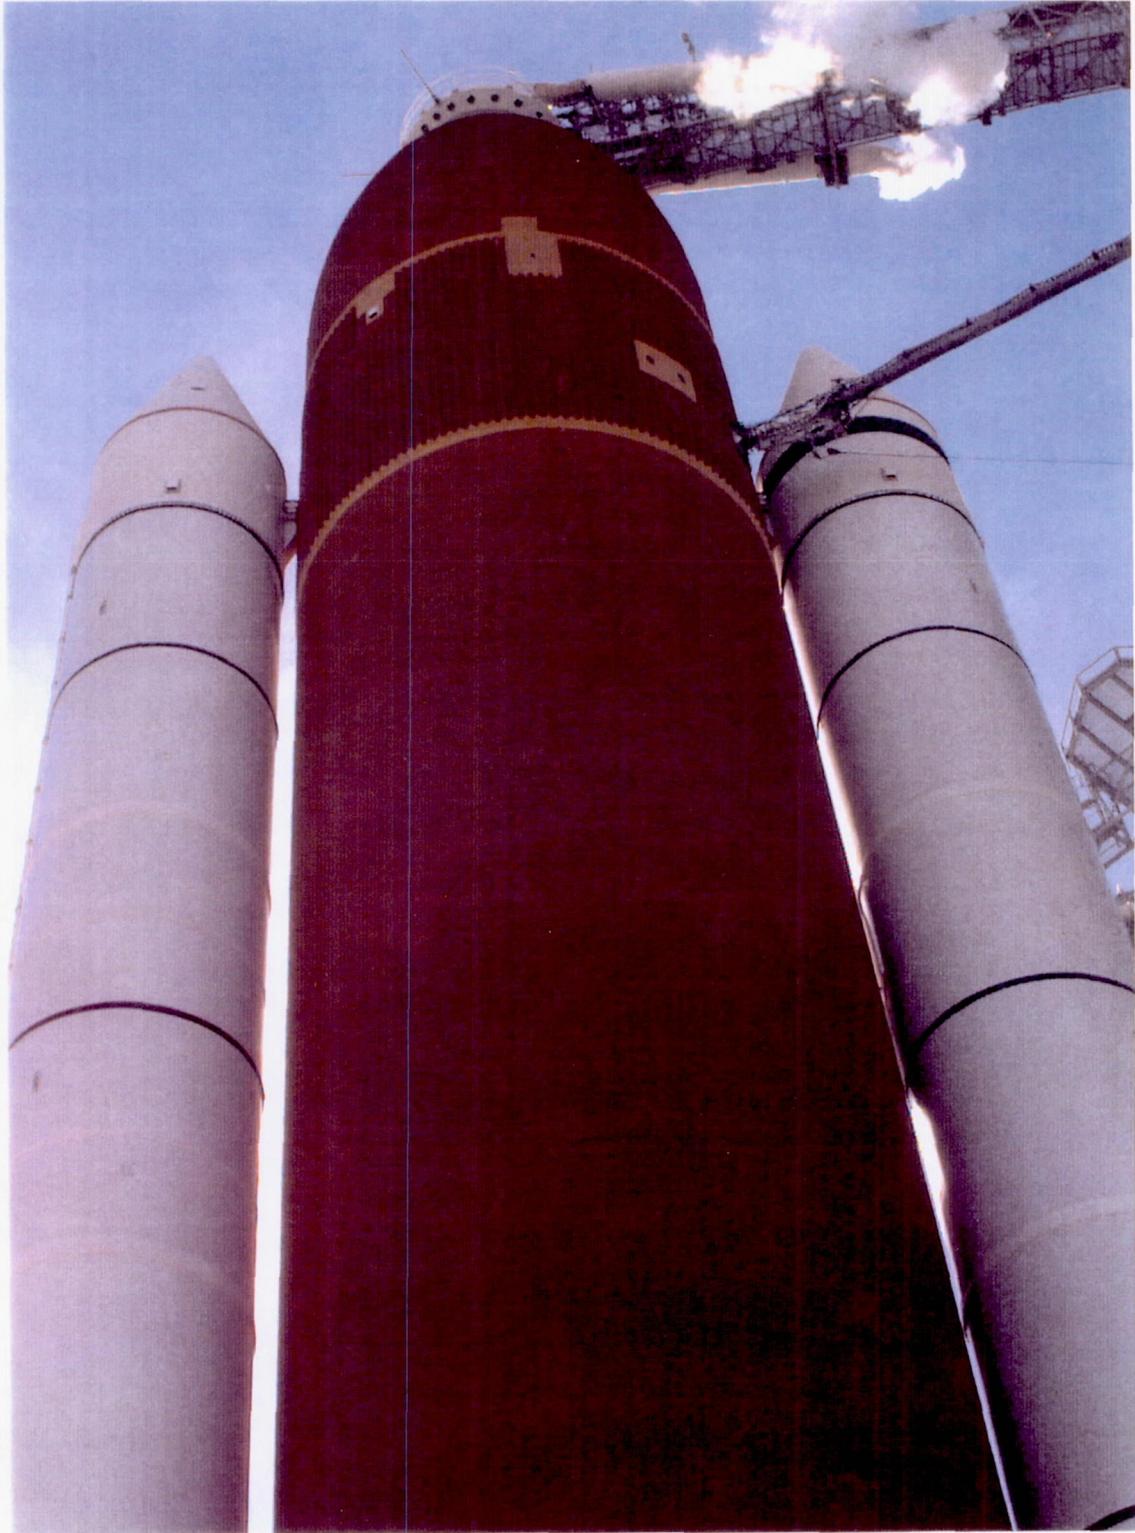
**Photo 6: ET LH2 Tank**

Very light condensate, but no ice or frost accumulations, was observed on the LH2 tank. TPS surface temperatures ranged from 53-63 degrees F.

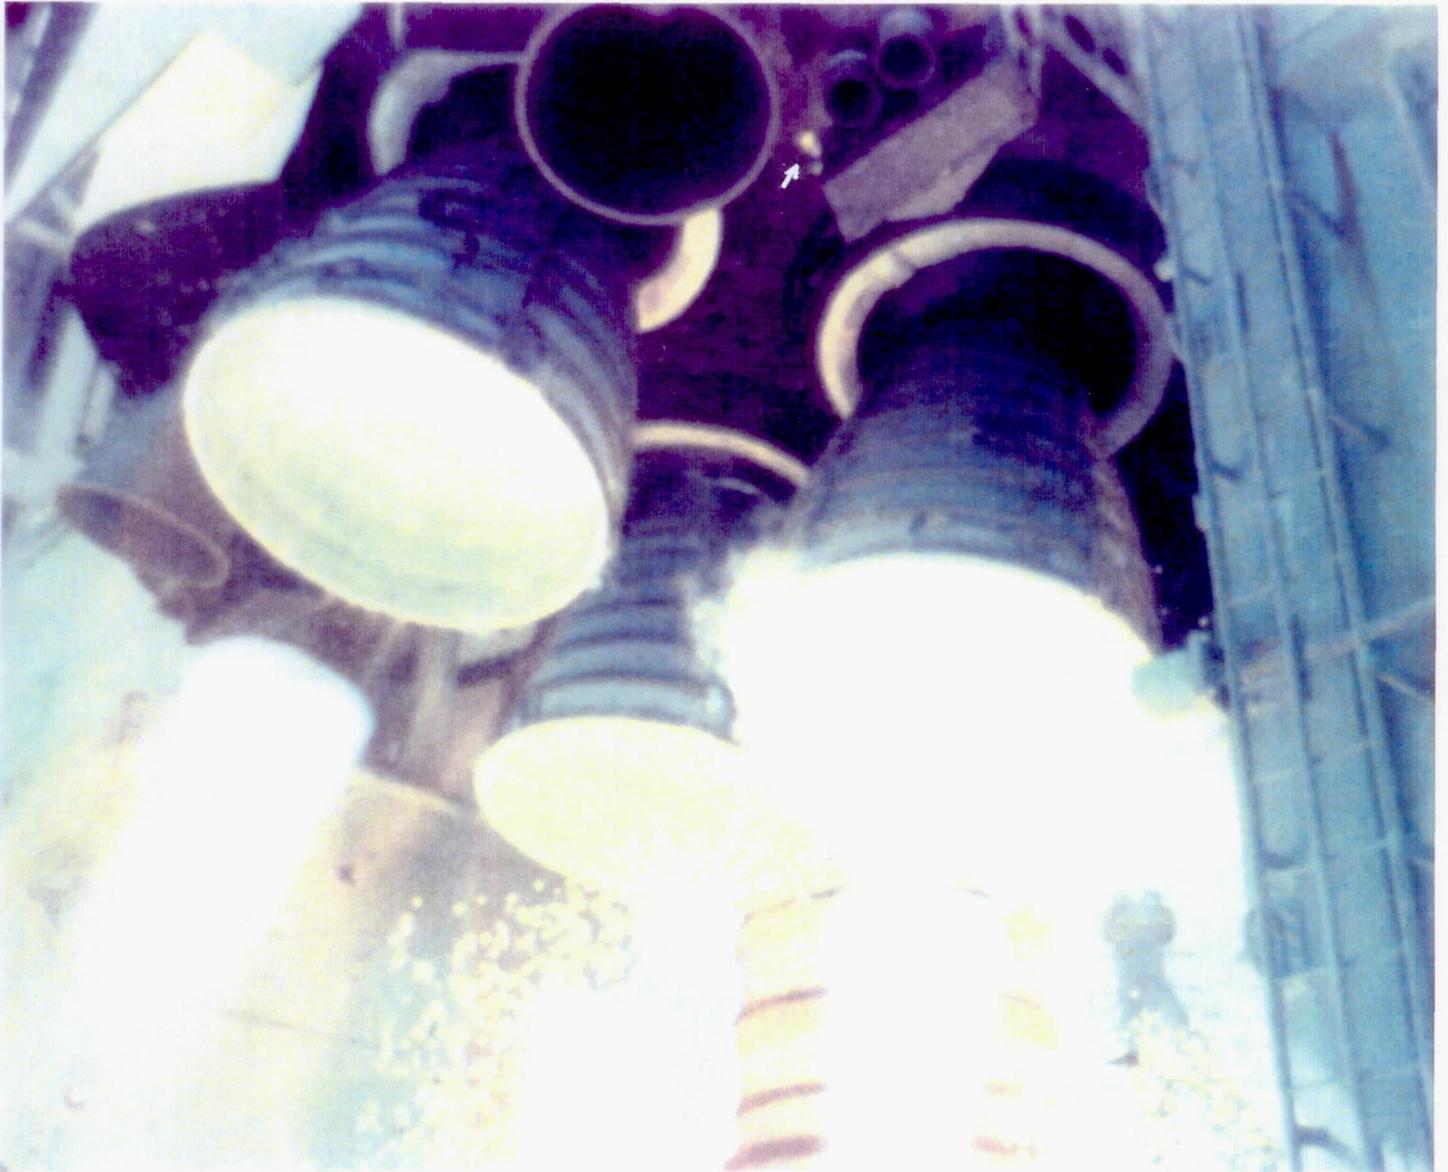
**Photo 7: Base Heat Shield Tile Damage**

Pieces of tile surface coating material were lost from four places on the base heat shield between SSME #1 and #3..

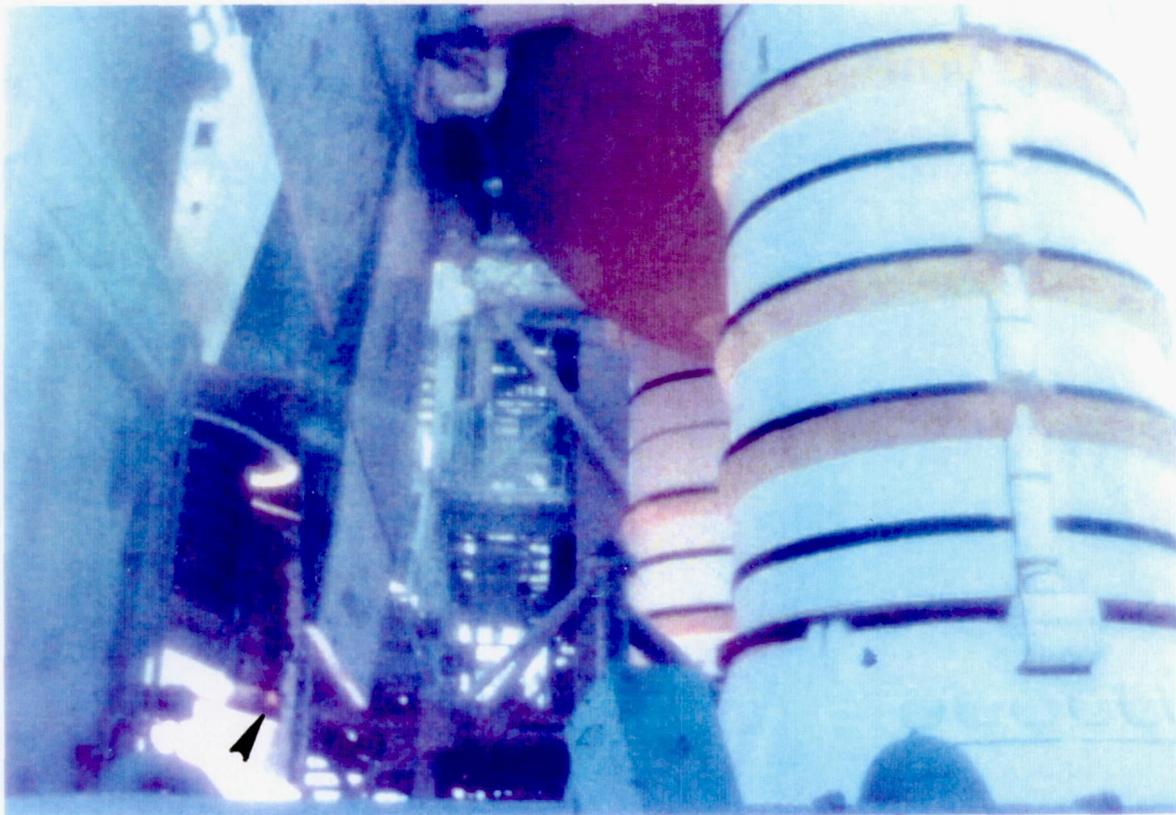
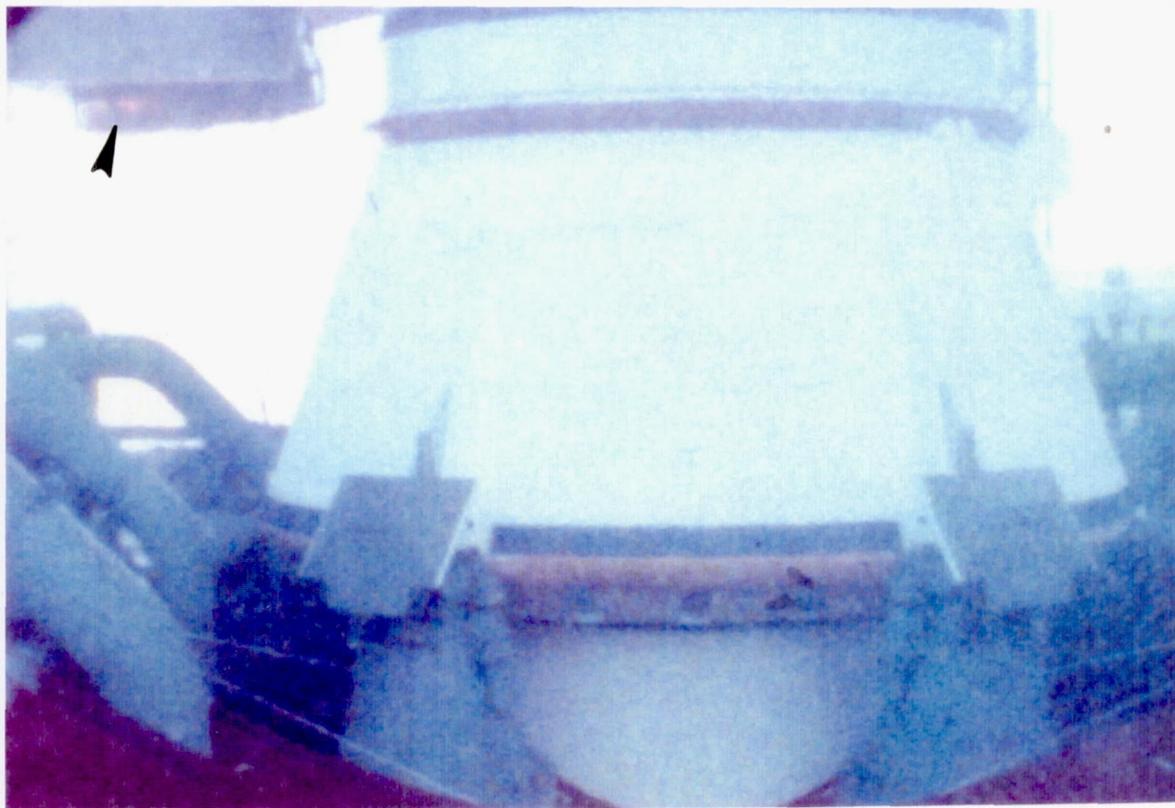
**Photo 8: SSME #2 Cold Wall Leak**

A cold wall leak occurred on SSME #2 (-Z side near the #9 hatband) after the Mach diamond had formed 19:55:44.5 UTC (E-1, -5, -16). Otherwise, SSME ignition appeared normal (OTV 151, 163, 170, 171, TV-4; E-76).

A cold wall leak occurred on SSME #2 (-Z side near the #9 hatband) after the Mach diamond had formed.

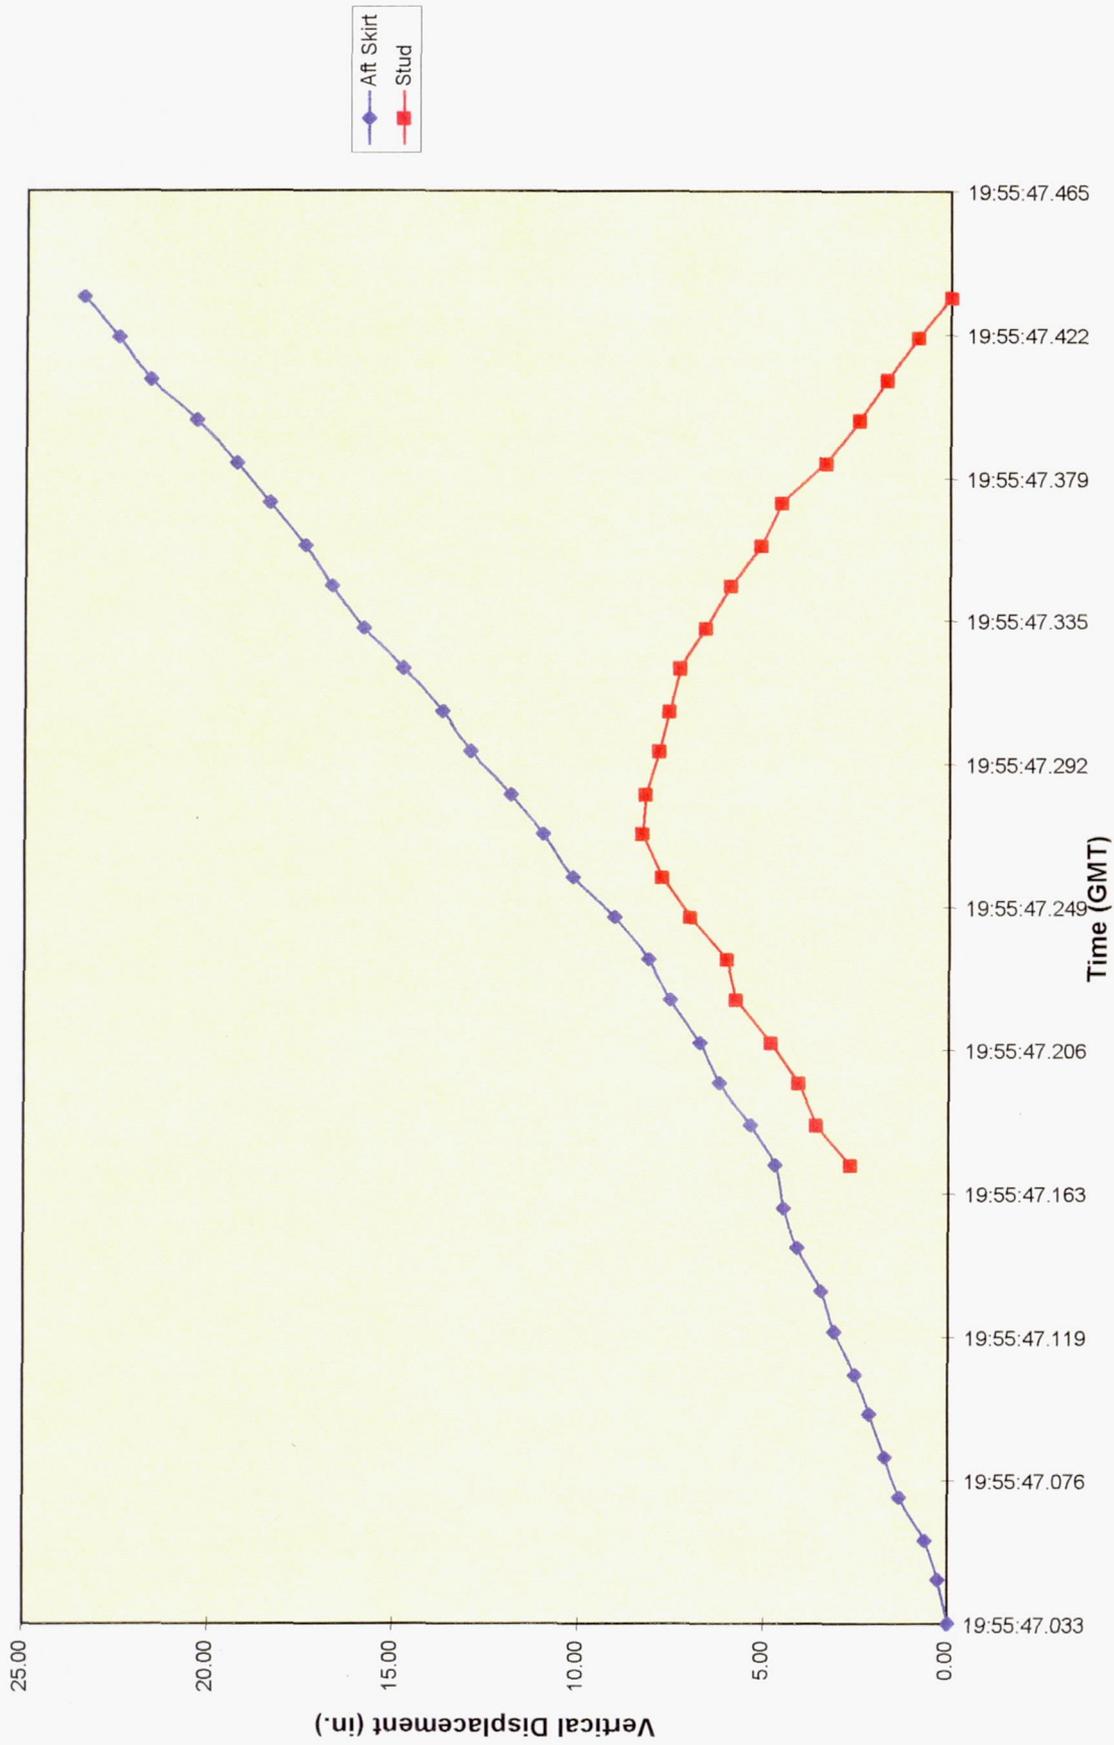
Figure 1: Holddown Post #7 Stud Hang-Up

A stud hang-up occurred on holddown post #7. Two semi-circular objects, believed to be shaved pieces of aluminum from the aft skirt bore, fell aft into the SRB exhaust hole. A piece of ordnance debris, approximately one inch long, fell from the HDP #6 stud hole shortly after lift-off. No ordnance fragments or frangible nut pieces fell from any of the other DCS while in the field of view. No stud hang-ups or frangible nut/ordnance debris was observed on any of the other holddown posts.

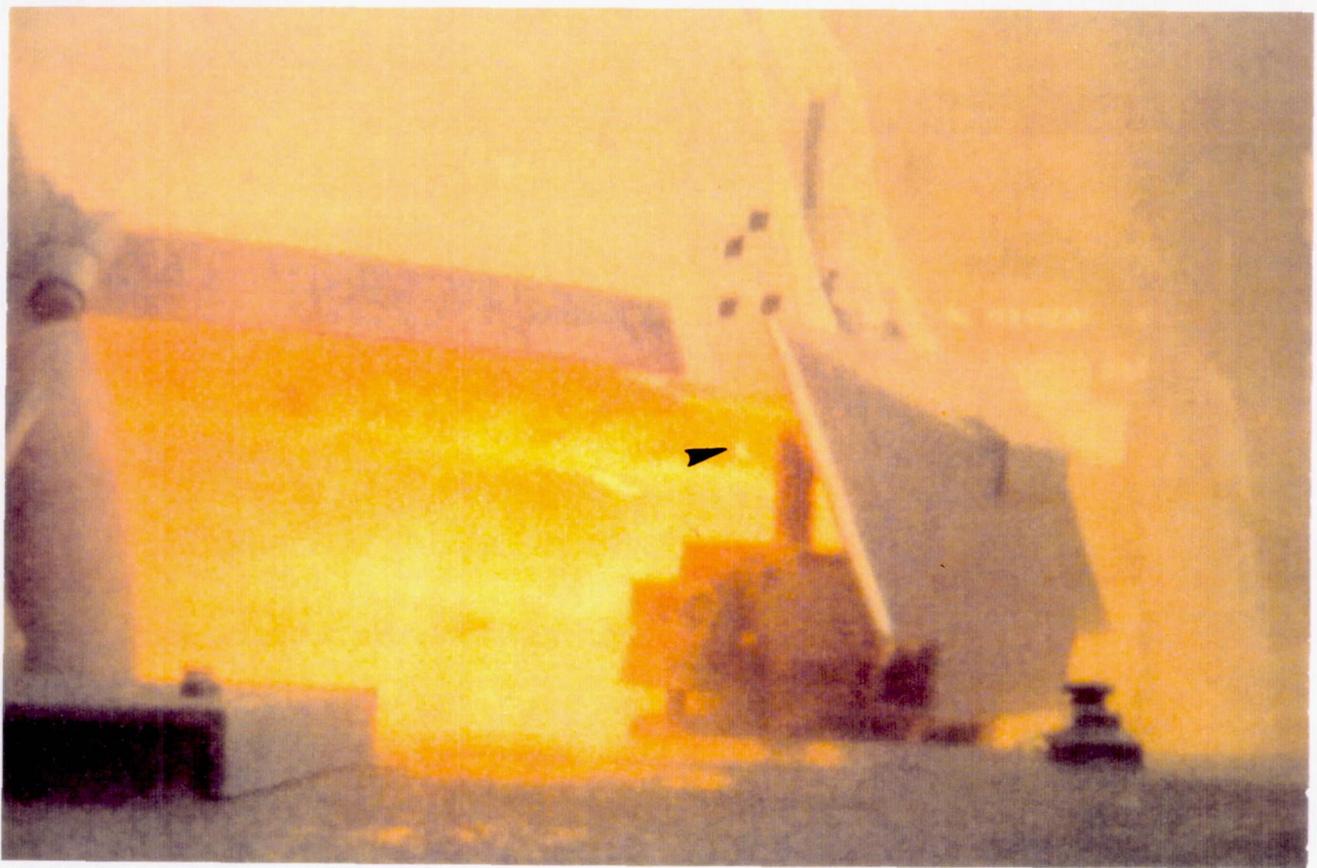
**Photo 9: Holddown Post #7 Stud Hang-Up**

A stud hang-up occurred on holddown post #7. The stud remained fully extended until the aft skirt cleared, then twanged briefly before falling into the holddown post. Two semi-circular objects, believed to be shaved pieces of aluminum from the aft skirt bore, appeared to fall aft into the SRB exhaust hole.

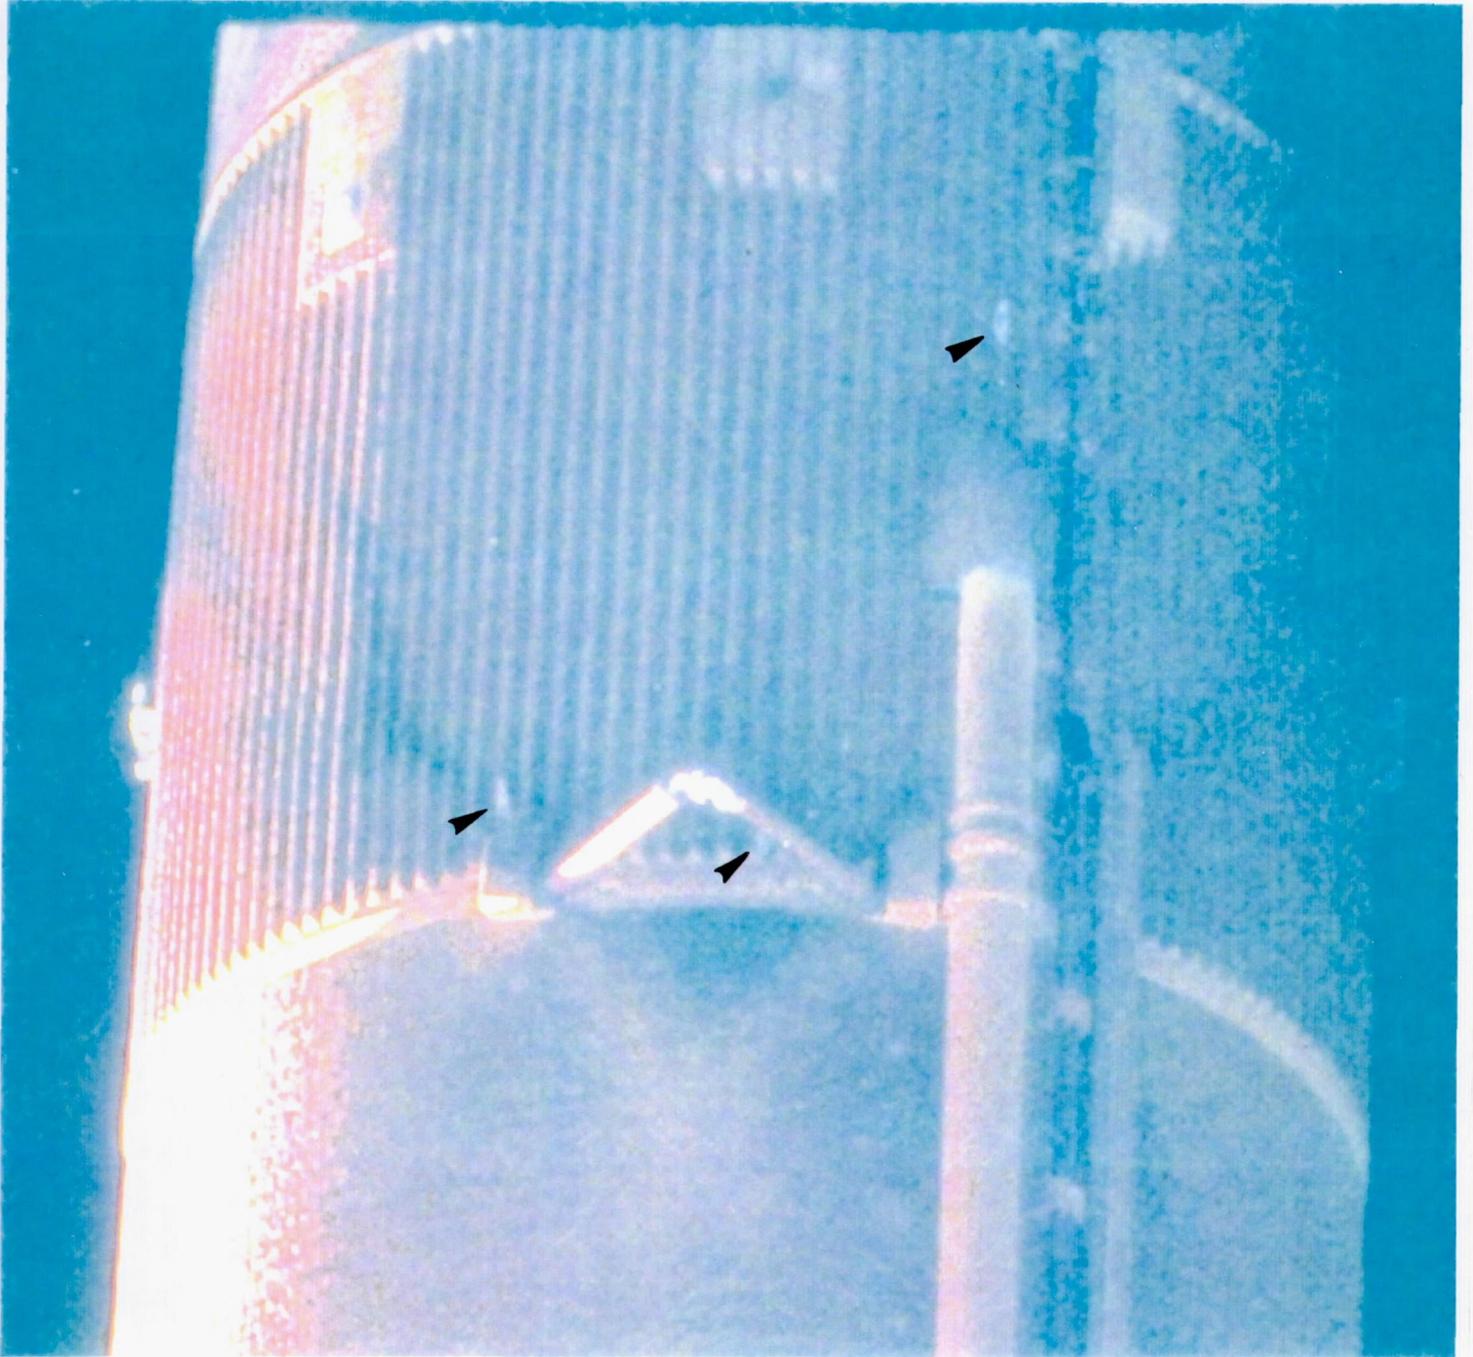
**Photo 11: ET Intertank TPS Divots**

Four TPS divots were detected on intertank stringers: one forward of the -Y bipod ramp approximately 10-inches long and possibly showing primer; two between the bipods just forward of the splice closeout approximately 4-inches in length with one possibly showing a small area of primer; and one forward of the LO2 feedline fairing near XT-930 approximately 15-inches long and showing stringer head primed substrate.

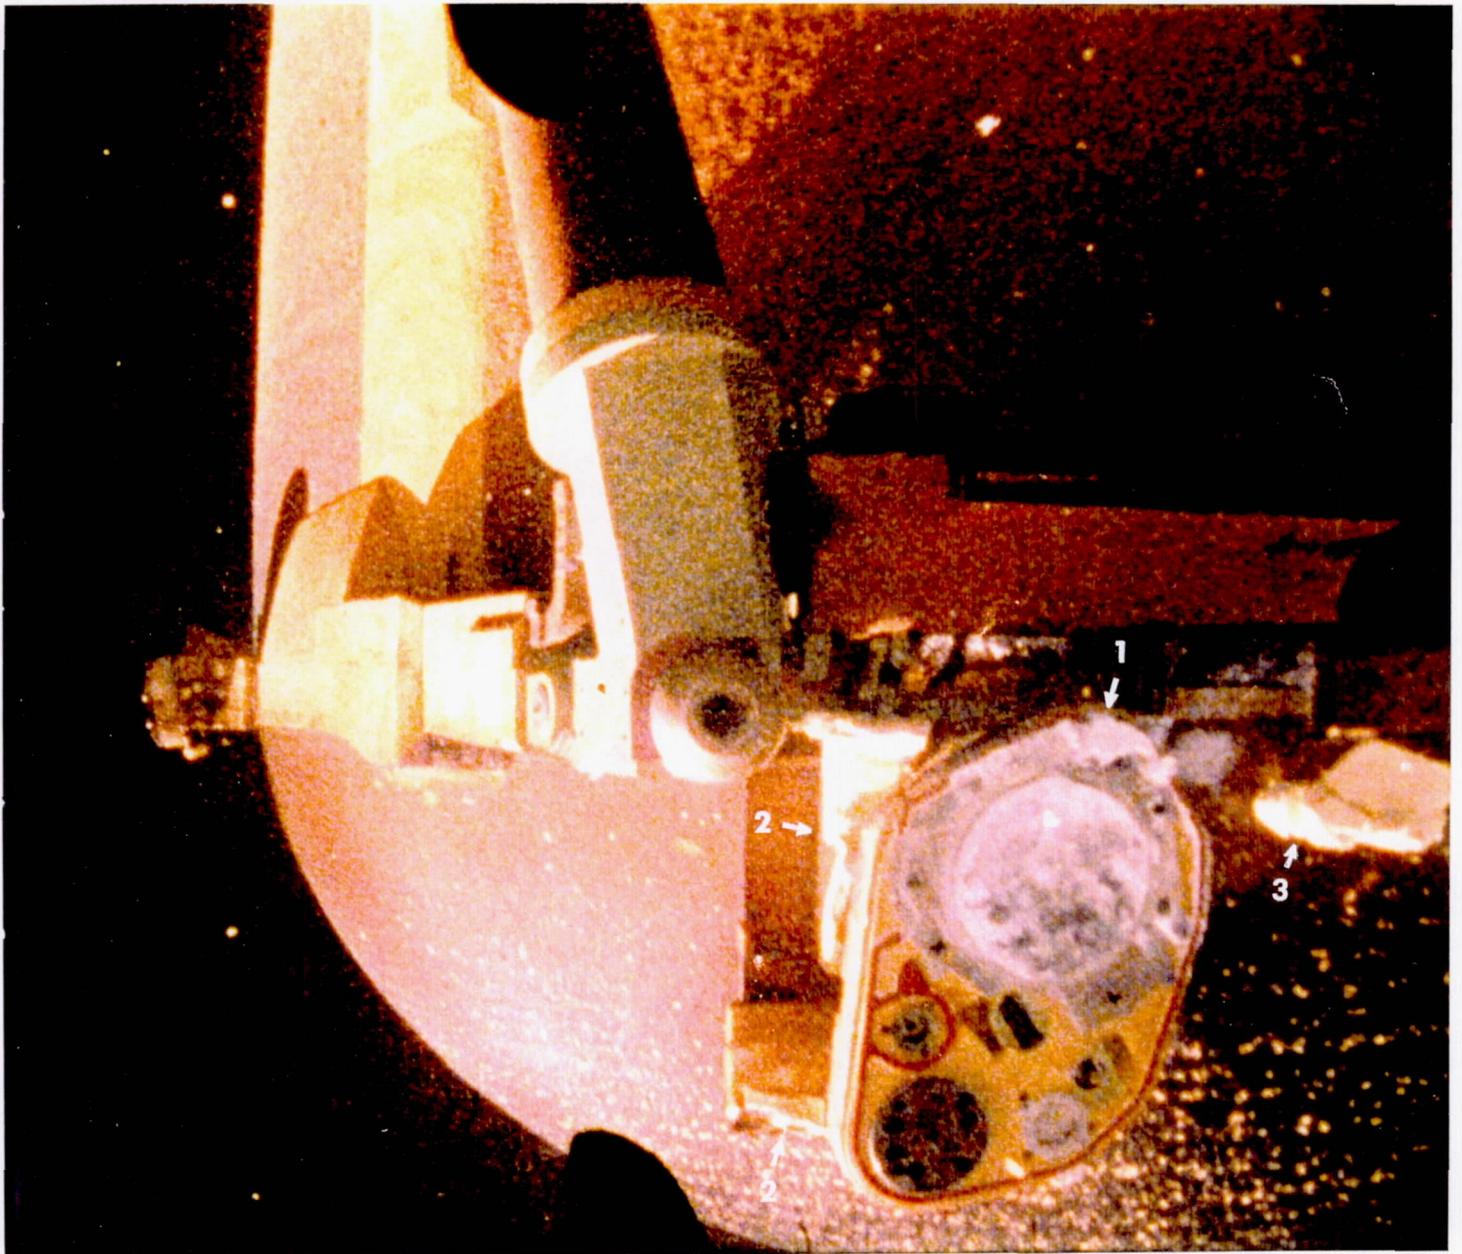
**Photo 12: ET/ORB LH2 Umbilical**

The LH2 ET/ORB umbilical appeared to be in good condition after separation with no TPS damage. Frozen hydrogen adhered to the 17-inch disconnect and parts of the separation interface (1). Typically, foam had eroded from the horizontal (clamshell) section of the cable tray and the LH2 feedline support arm (2). A piece of foam, most likely from the LO2 umbilical forward face, was visible near the LH2 umbilical (3).

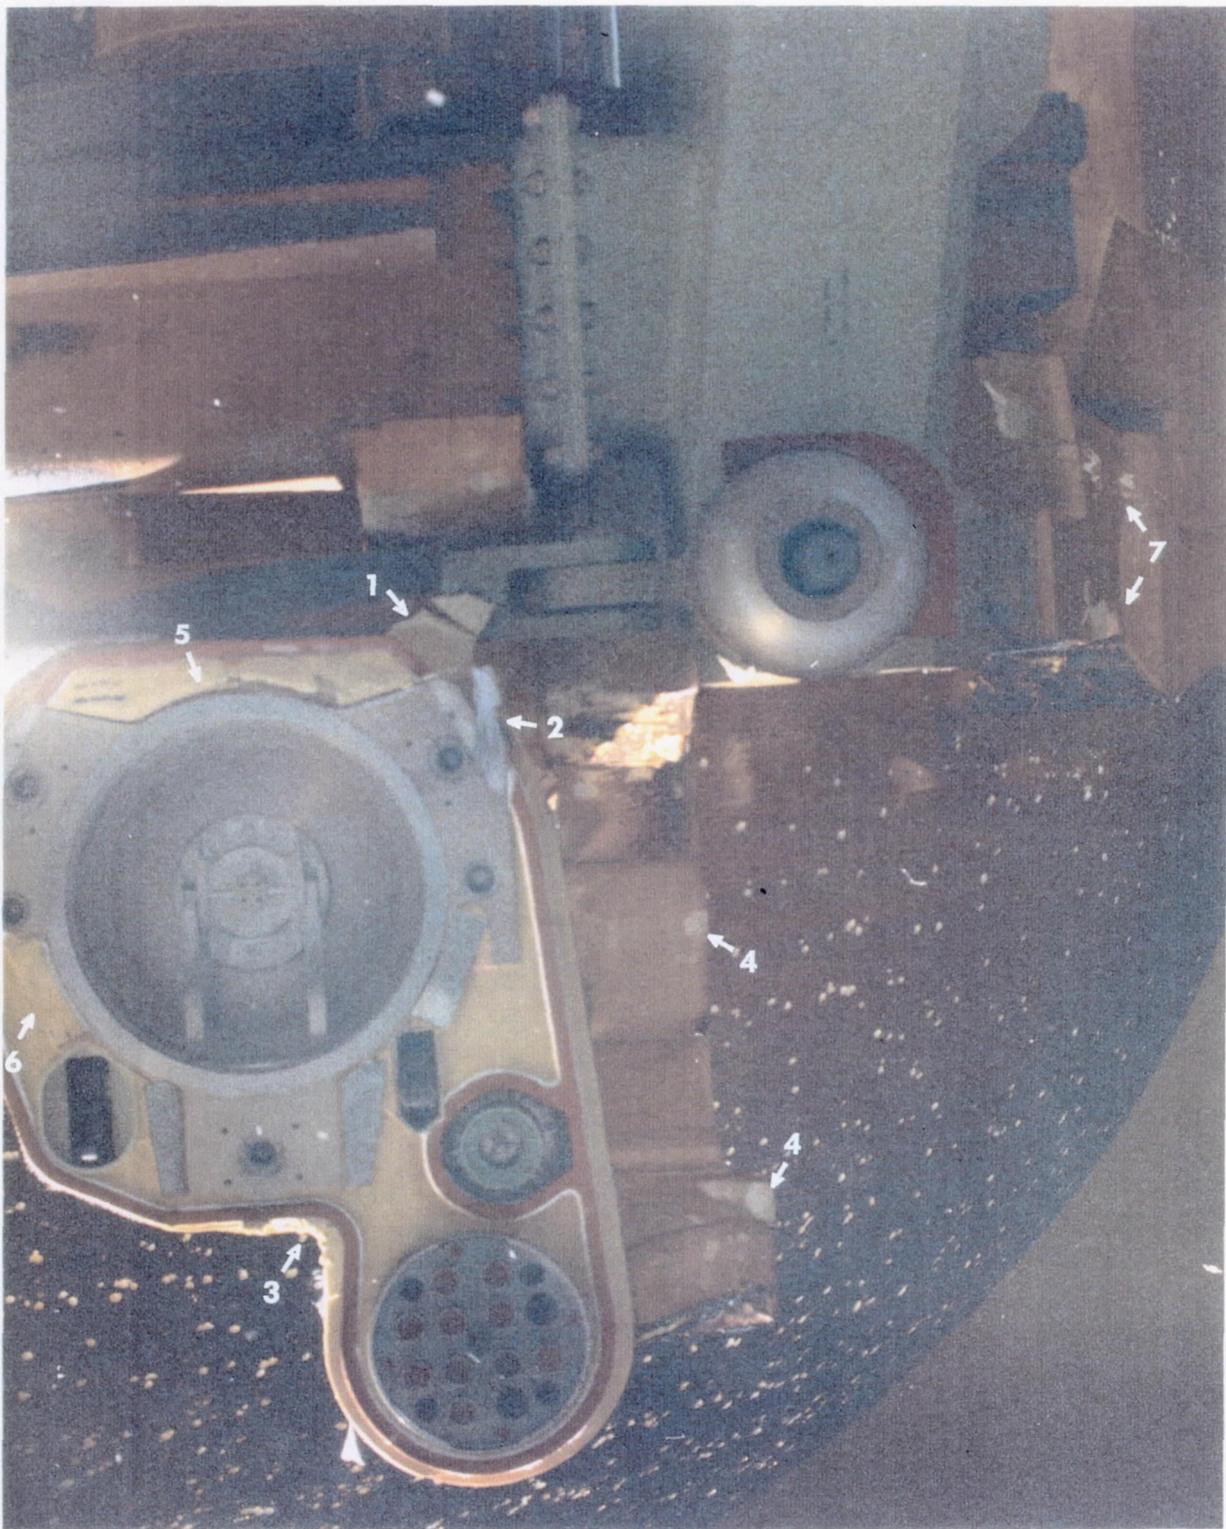
**Photo 13: ET/ORB LO2 Umbilical**

The LO2 ET/ORB umbilical sustained TPS damage during separation at the forward outboard corner. Two pieces of loose foam were visible in that area (1). Part of the RTV purge barrier was detached at the 2:00 o'clock position (2). Minor TPS damage also occurred on the umbilical aft surface near the electrical monoball (3). Numerous divots and eroded areas were visible on the horizontal and vertical sections of the cable tray (4). Lightning contact strips across the forward part of the umbilical (5) and at the 8:00 o'clock position were missing (6). Four shallow divots 2-3 inches in diameter were observed on the +Y vertical strut outboard surface (7).

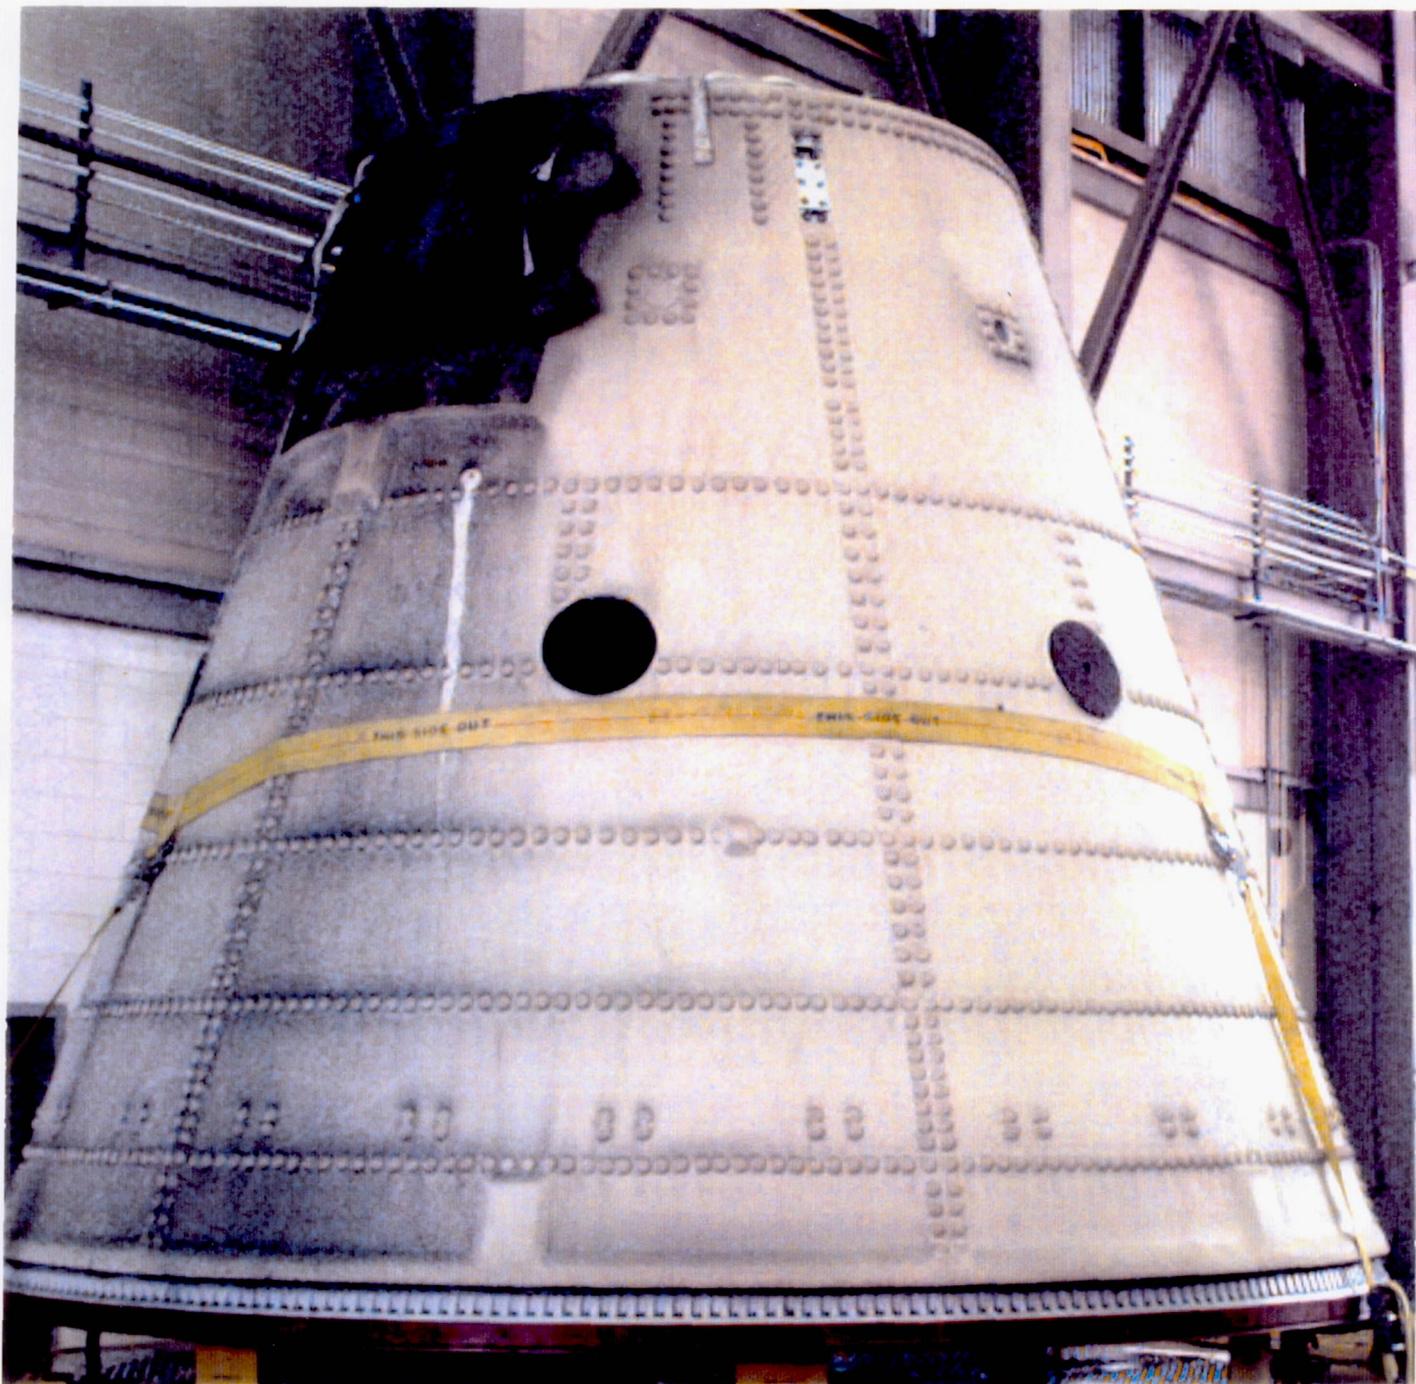
**Photo 14: RH Frustum**

The righthand frustum was in excellent condition. No TPS was missing. No MSA-2 debonds over acreage or fasteners were detected

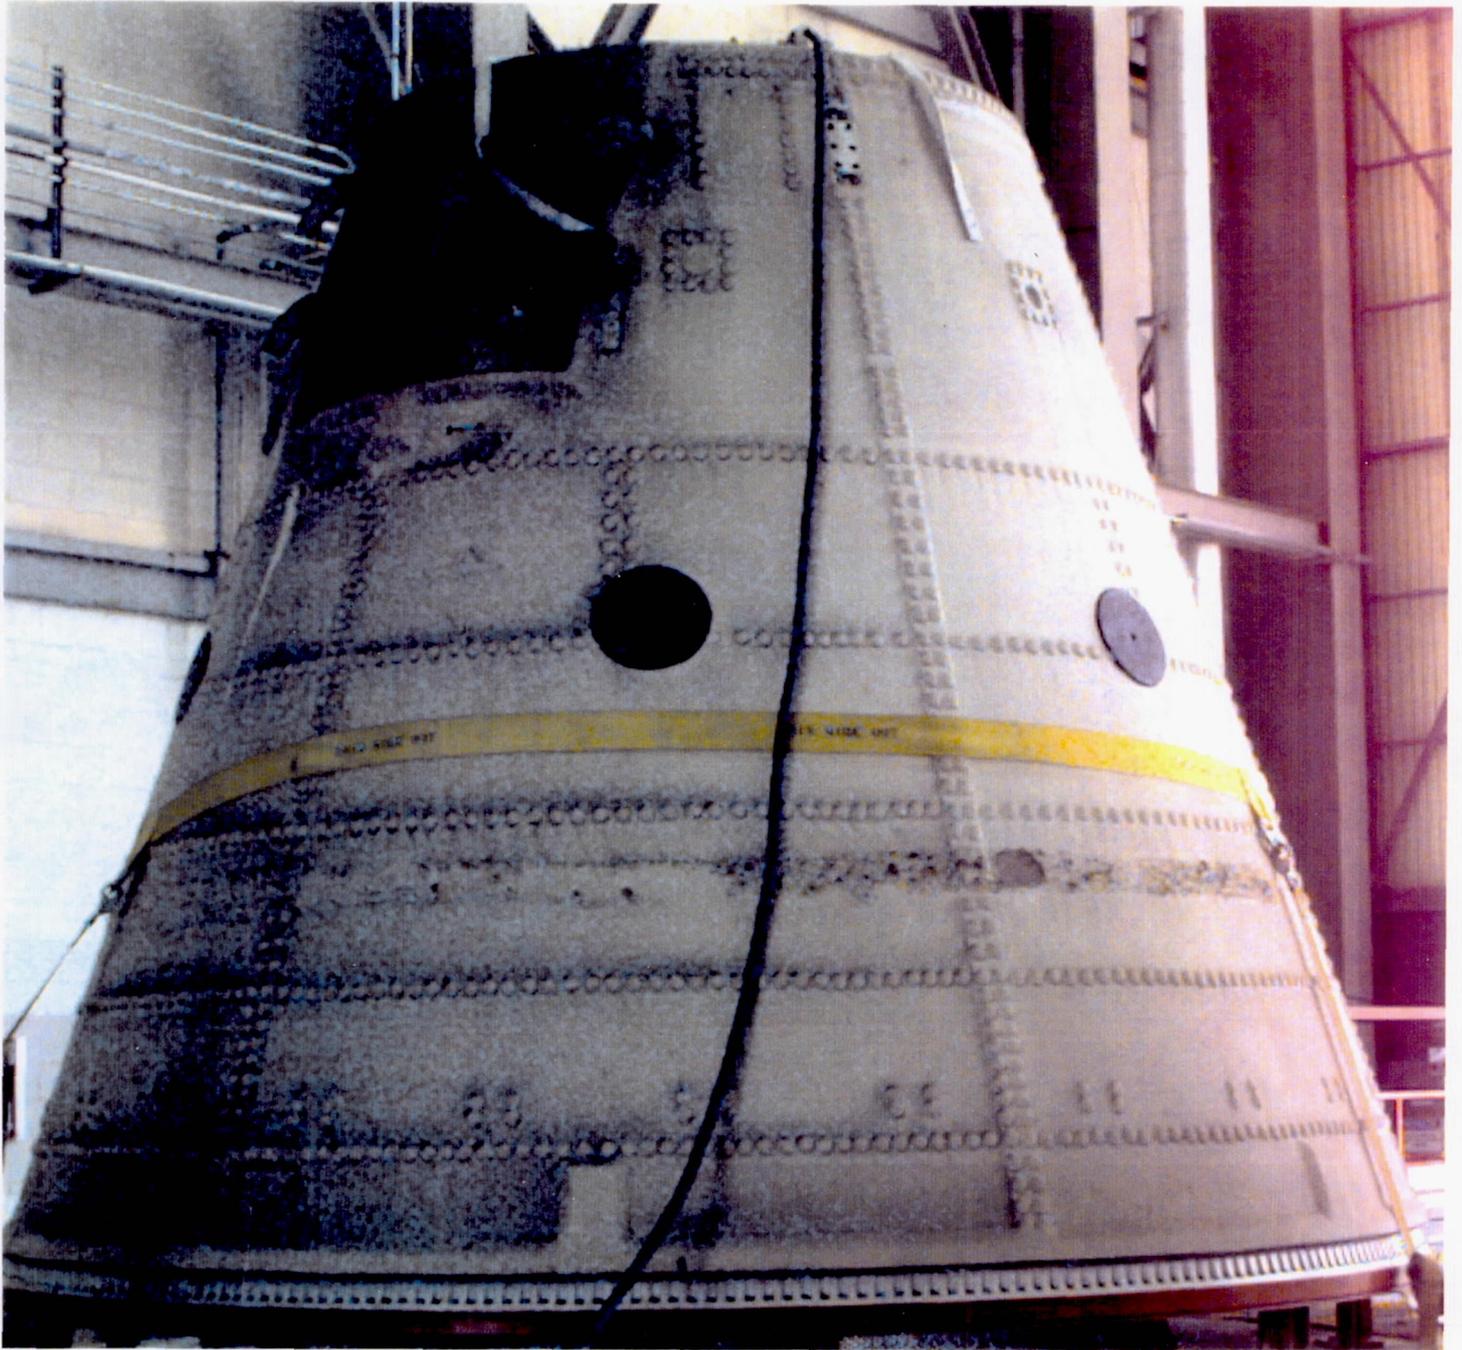
**Photo 17: LH Frustum**

Hypalon paint was blistered in a band between the XB-318 and XB-336 ring frames from the -Z to the +Z axes; and between the XB-352 and XB-367 ring frames generally aft of the BSM's.
