# Debris/Ice/TPS Assessment and Integrated Photographic Analysis of Shuttle Mission STS-80

*Gregory N. Katnik  
Jill D. Lin*

*Process Engineering/Mechanical System Division/ET-SRB Branch,  
Kennedy Space Center, Florida*

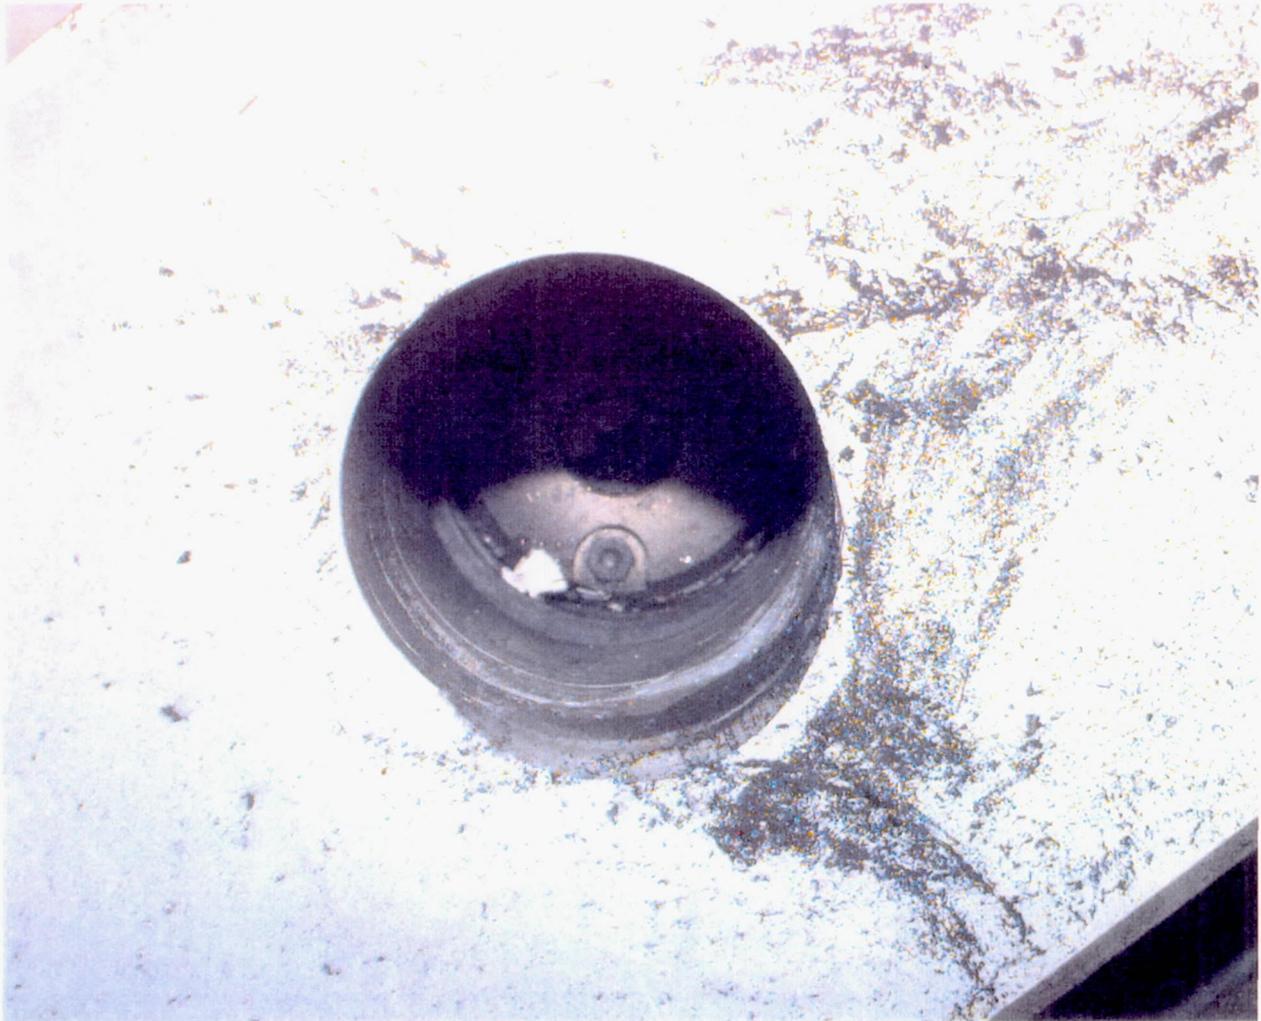
**Photo 20: HDP #7 Stud Hole Broaching**

A stud hang-up occurred on HDP #7 and the hole was broached. The stud hang-up was confirmed in the launch film review on film item E-11.

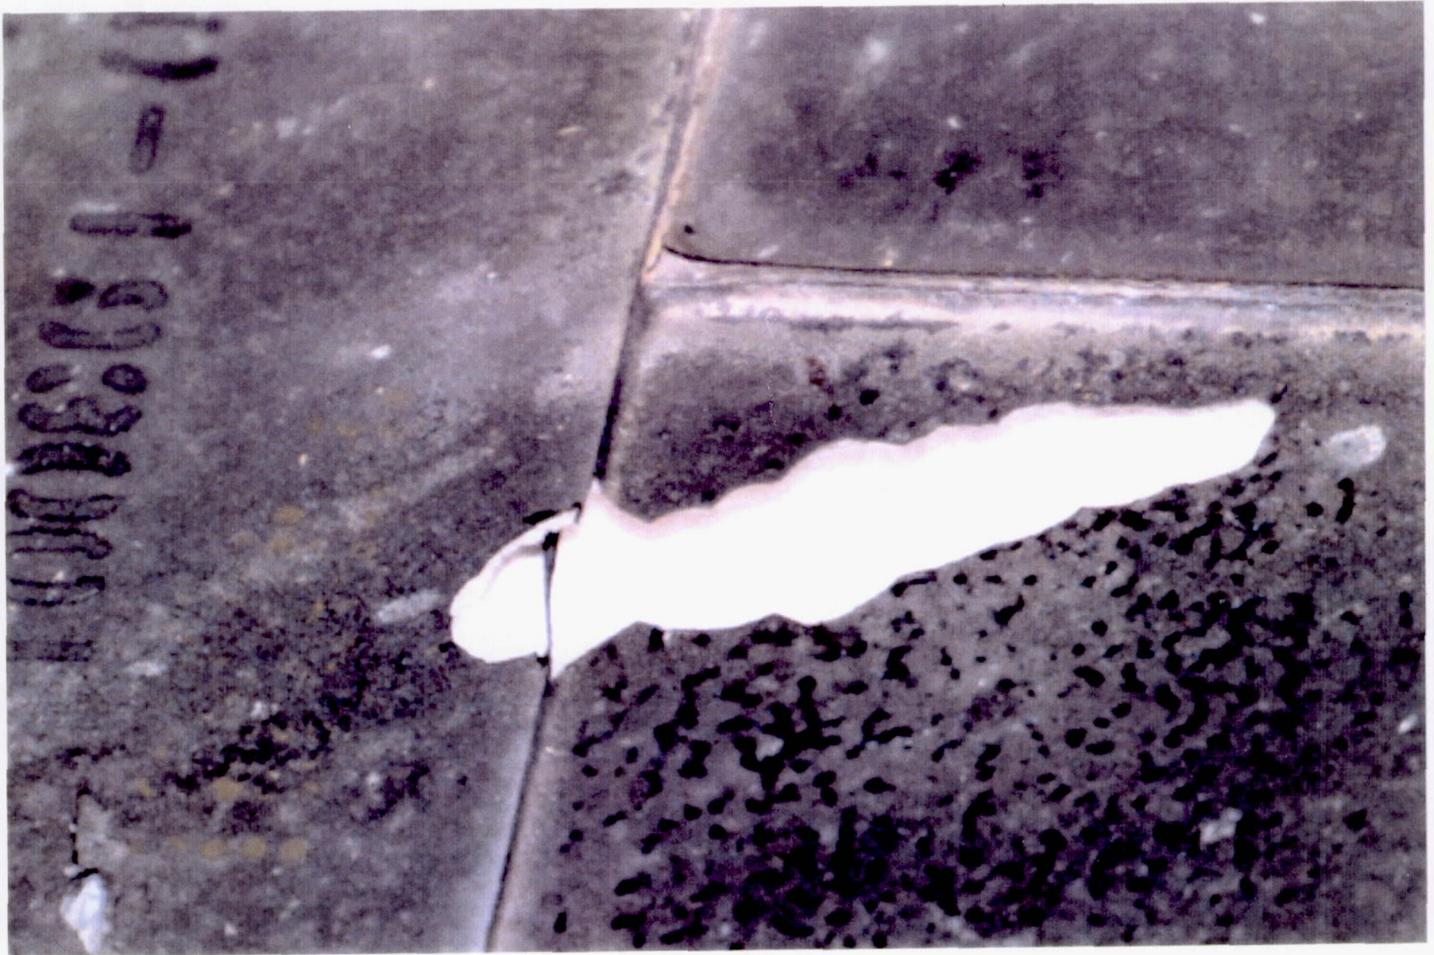
**Photo 25: Lower Surface Tile Damage**

The largest lower surface tile damage site was located aft of the LH2 ET/ORB umbilical and measured 3-inches long by 3/4-inch wide by 1/2-inch maximum depth. The damage was most likely caused by an ice impact from the umbilical.

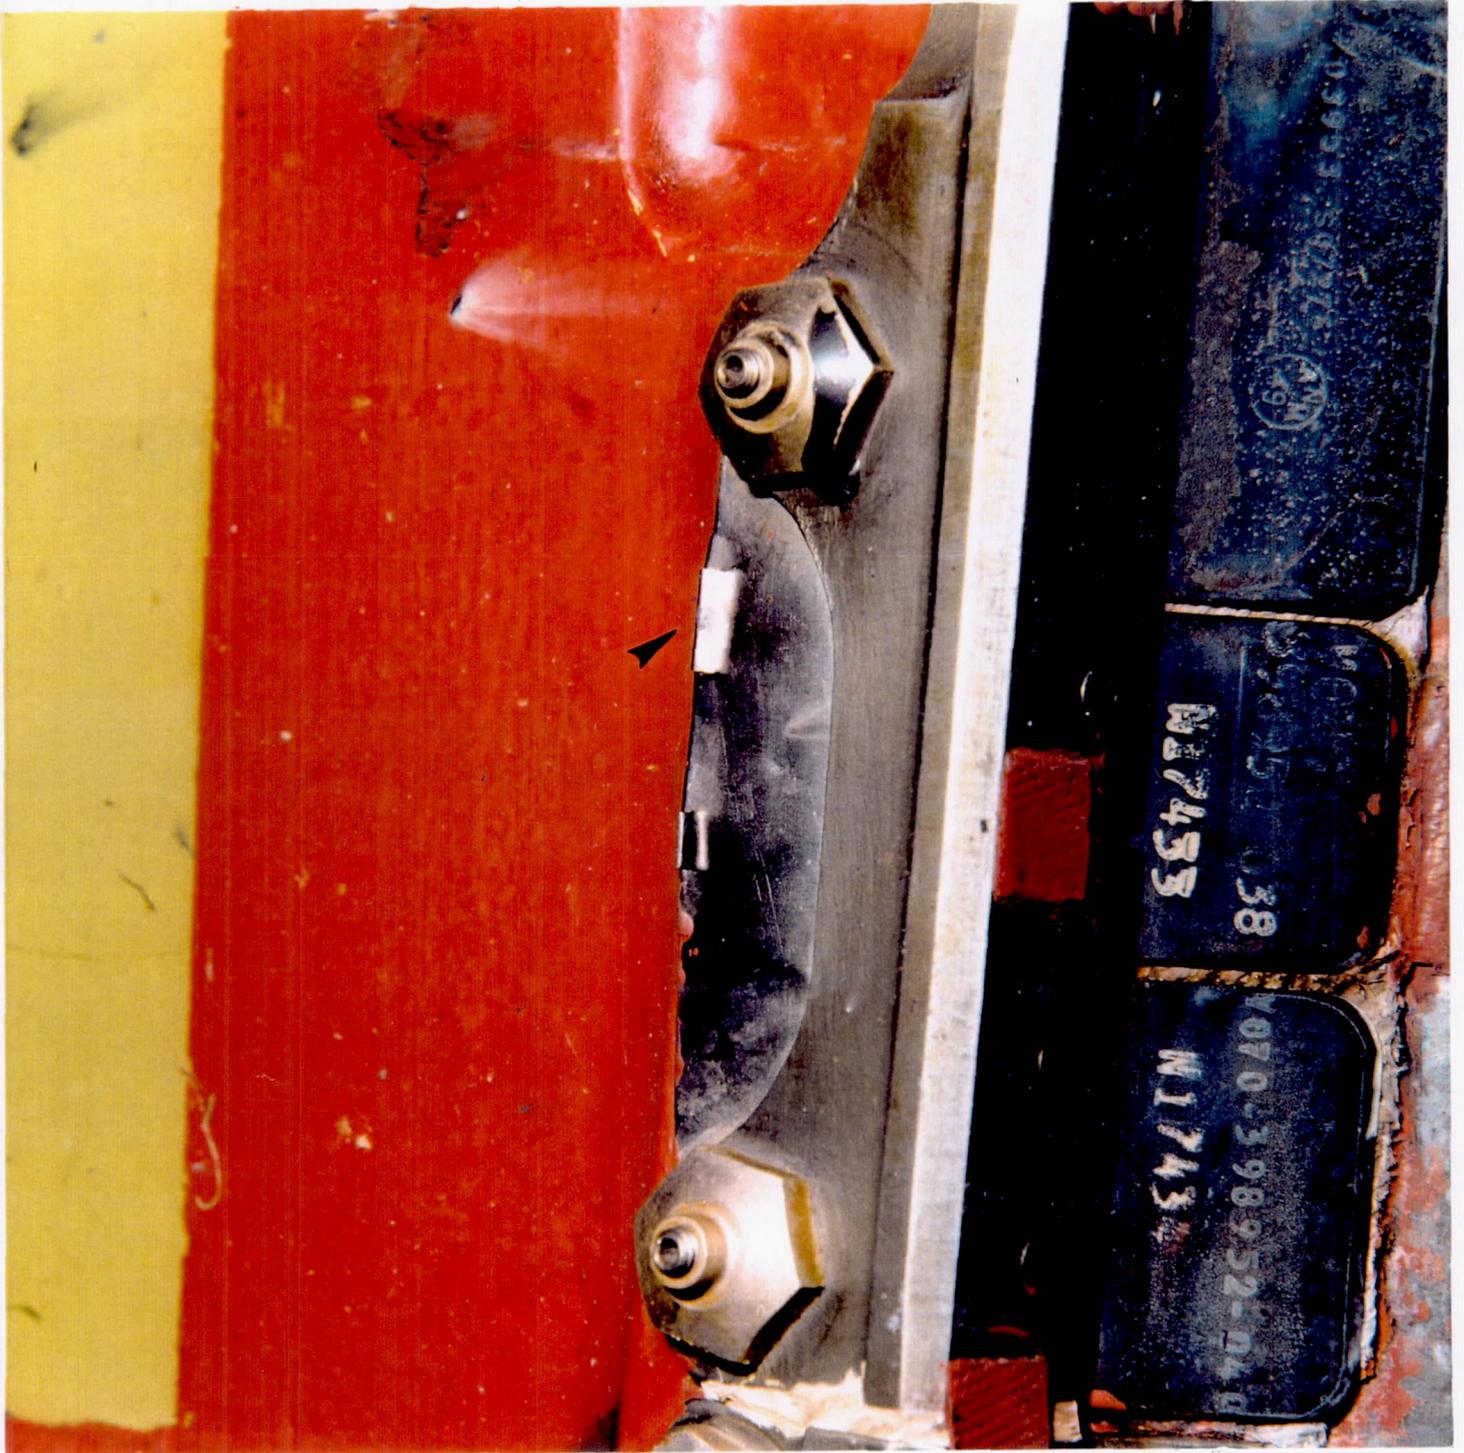
**Photo 28: Bent Metal on LO2 ET Door**

Bent metal, approximately 1-inch in length by 1/8-inch, was visible on the trailing edge of a shim between two bolt heads on the inside surface of the ET LO2 door. The shim was located at the +X+Y corner of the door.

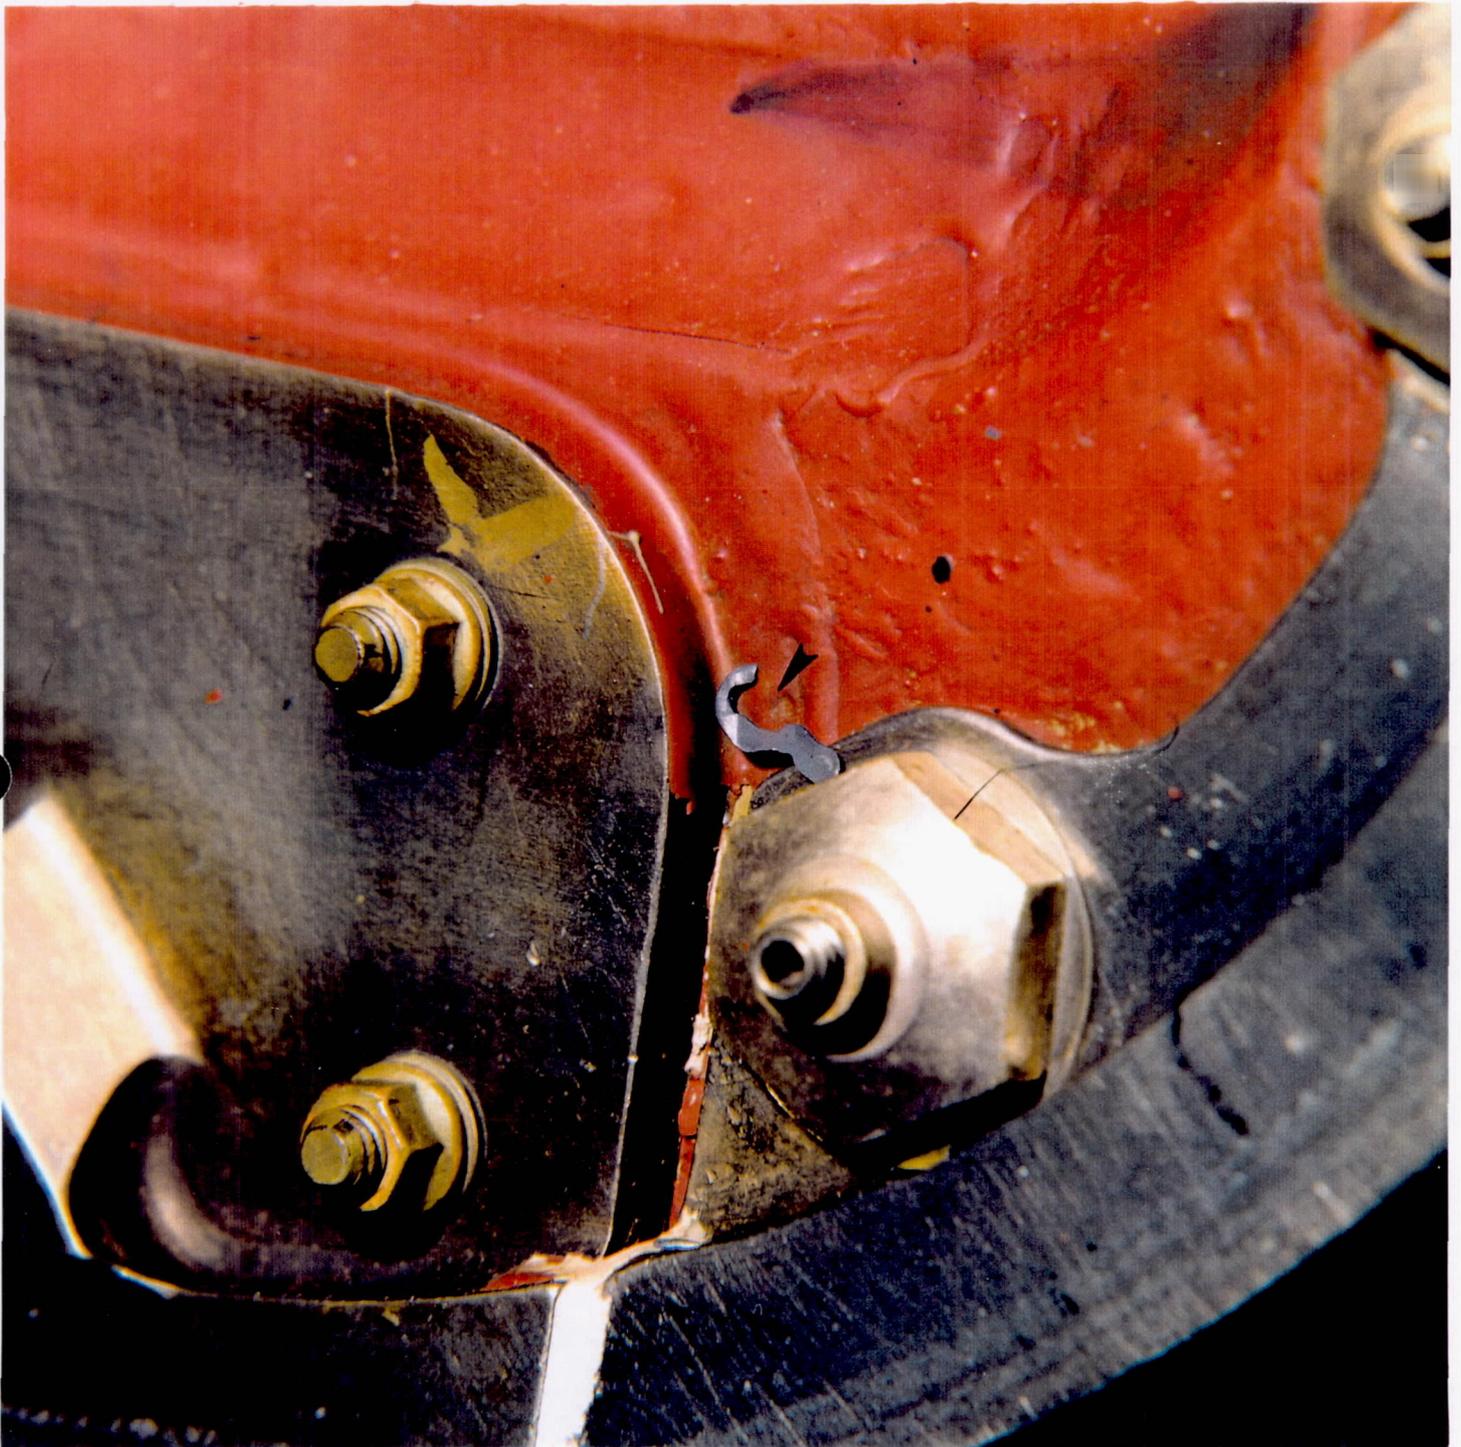
**Photo 29: LO2 ET Door Loose Debris**

A small piece of wire, 3/8-inch long by 1/32-inch diameter, was wedged against a bolt head in the +X+Y corner of the door.

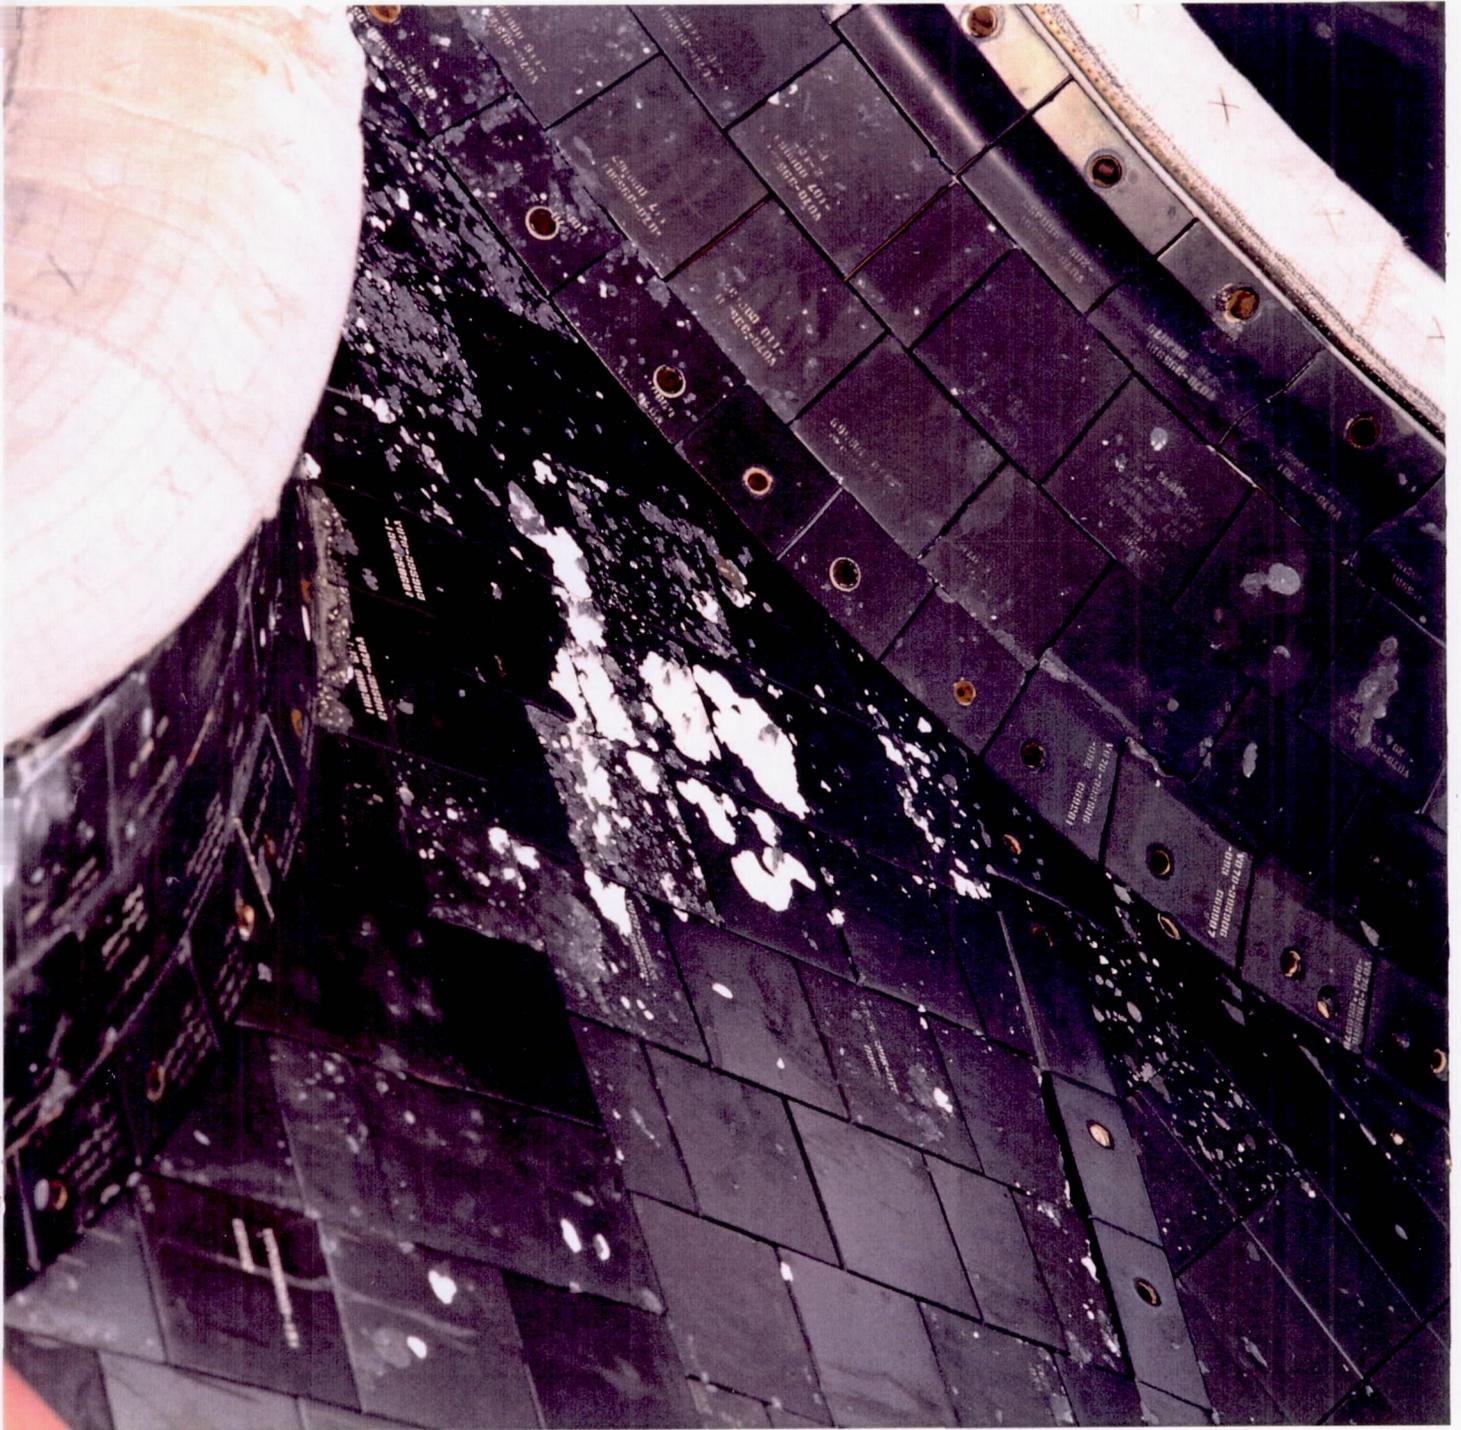
**Photo 30: Base Heat Shield Tile Damage**

A cluster of seven tiles on the base heat shield between SSME #1 and #3 sustained greater than normal damage, which may have been the result of debris impacts rather than plume recirculation effects. The tiles were missing a large percentage of surface area with the average depth measuring  $\frac{1}{4}$ -inch. This damage was observed during liftoff in the postlaunch film review.

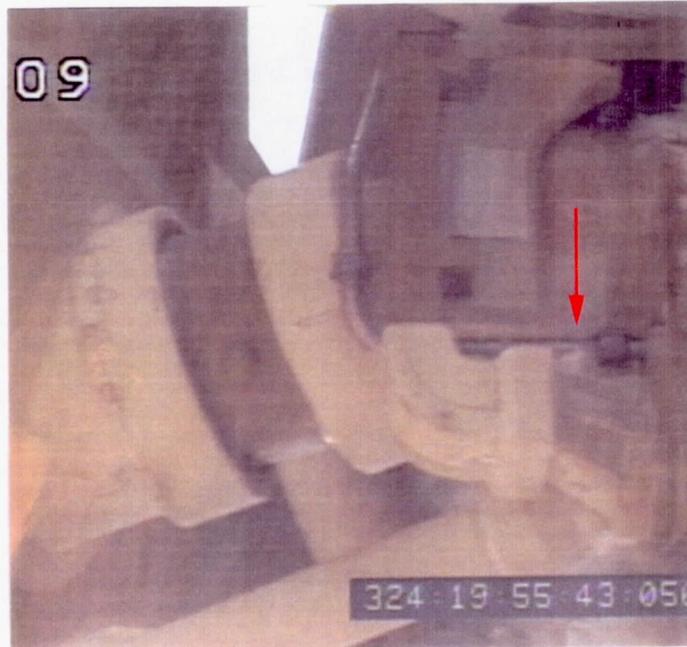
Figure 2.1 (A) Debris Striking LH2 Umbilical Electric Cable Tray

Multiple pieces of ice debris were seen falling from the ET/Orbiter umbilicals during SSME ignition. Ice debris was seen to strike the LH2 electric cable tray (19:55:43.056 UTC) and the LH2 umbilical well door sill (19:55:43.390, 19:55:44.324, and 19:55:45.158 UTC). Ice debris was seen to strike the LO2 umbilical electric cable tray during SSME ignition (19:55:42.489, 19:55:43.857, and 19:55:44.458 UTC). None of the debris seen to contact the vehicle appeared to cause damage. (Cameras OTV109, OTV154 )

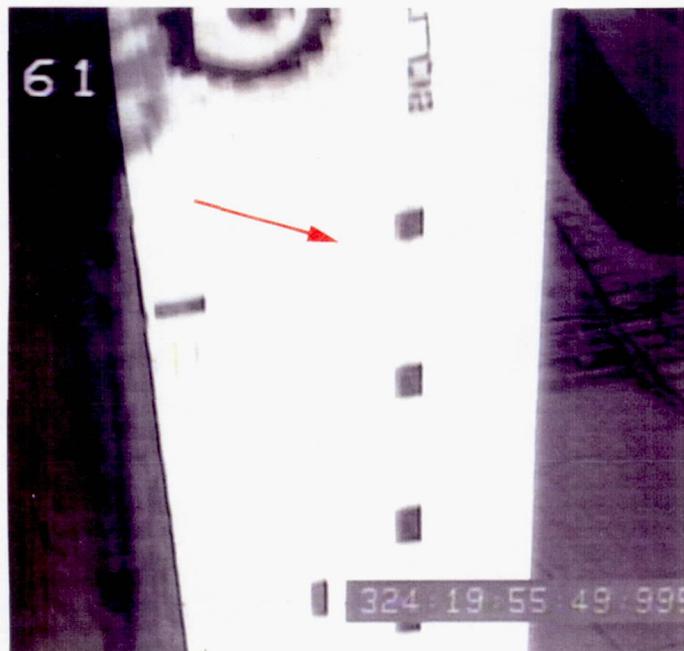
Figure 2.1 (B) Dark Debris At Liftoff

Several pieces of dark appearing debris were seen at SSME ignition. A dark piece of debris was seen falling aft along the vehicle during liftoff. A single piece of debris was seen crossing the left wing leading edge during liftoff. All of these objects were probably birds. None of the objects were seen to contact the vehicle. (Cameras OTV161, OTV163)

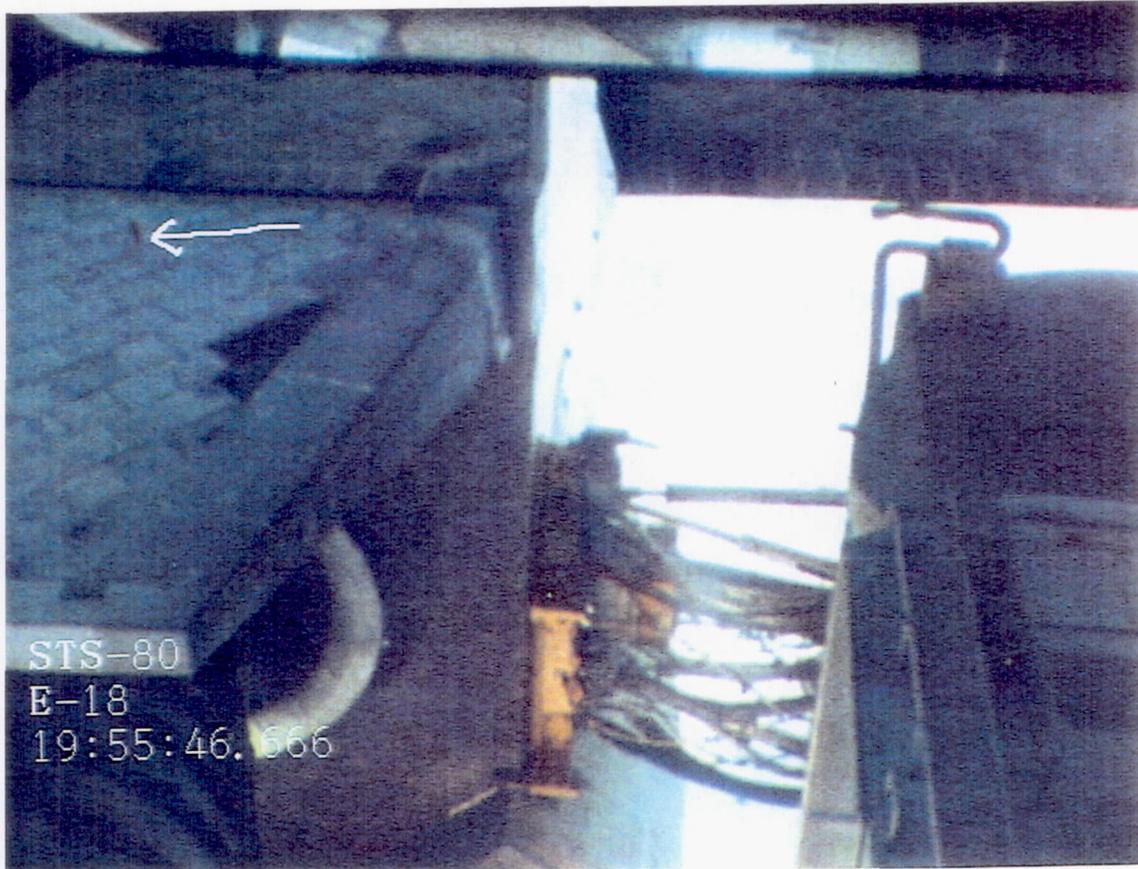
Figure 2.1 (C) Red Colored Debris Near Body Flap

A single, small, rectangular, red colored piece of debris was seen falling along the body flap just prior to SRB ignition (19:55:46.666 UTC). This debris may have been a tile shim or gap filler. (Camera E18)

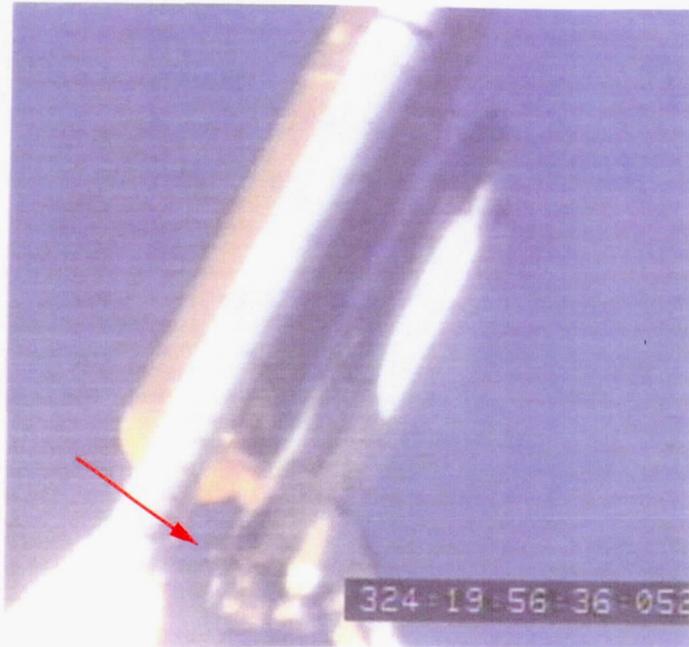
Figure 2.1 (E) Debris Near Body Flap During Ascent

A single light colored piece of debris (probably umbilical purge barrier material) was seen near the body flap during ascent (19:56:36.052 UTC). This debris did not appear to contact the launch vehicle. (Cameras KTV13, ET208)

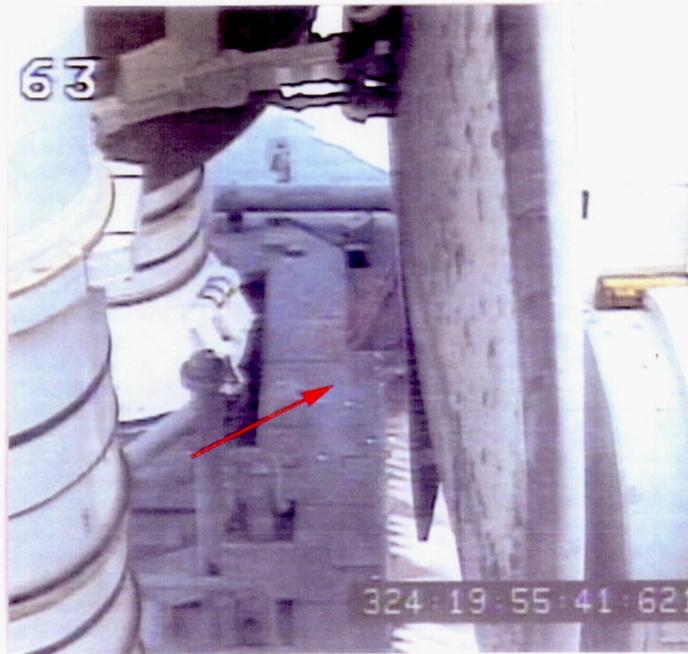
Figure 2.2 (A) Orange Vapor Seen During SSME Ignition

Orange vapor, probably free burning hydrogen, was seen above the SSME rims, near the body flap, and near the base of the vertical stabilizer during SSME ignition (19:55:41.3 UTC). Orange vapors have been seen on previous missions. (Cameras OTV163, OTV171, E2, E4, E5, E17, E19, E20, E63, E76)

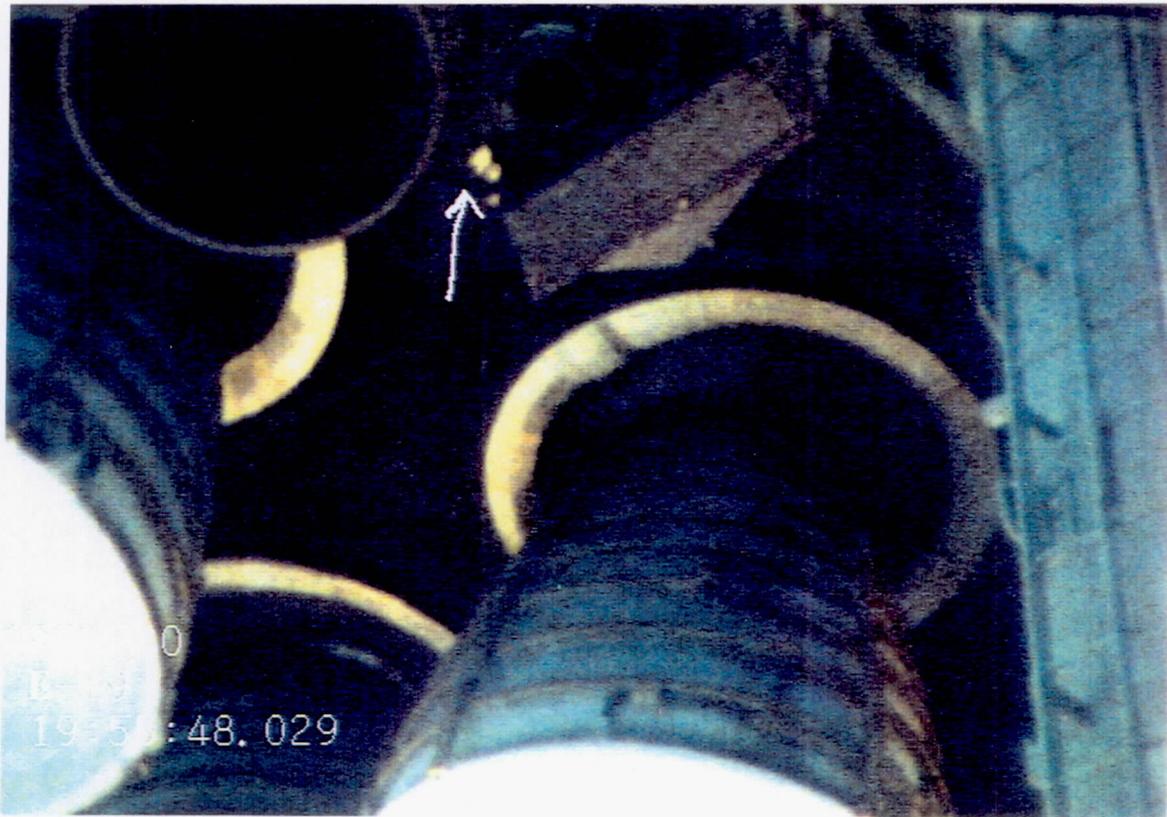
Figure 2.2 (B) White Areas On Base Heat Shield

A white line (probably frost) was seen at the base of SSME #2 at the juncture of the engine mounted heat shield-to-nozzle interface at liftoff. Accumulations of ice/frost on the heat shield-to-nozzle interfaces have been seen on previous missions. A small white area was also seen on the base heat shield near the inboard side of the right RCS stinger (missing tile surface coating material). (Cameras E18, E19, E20)

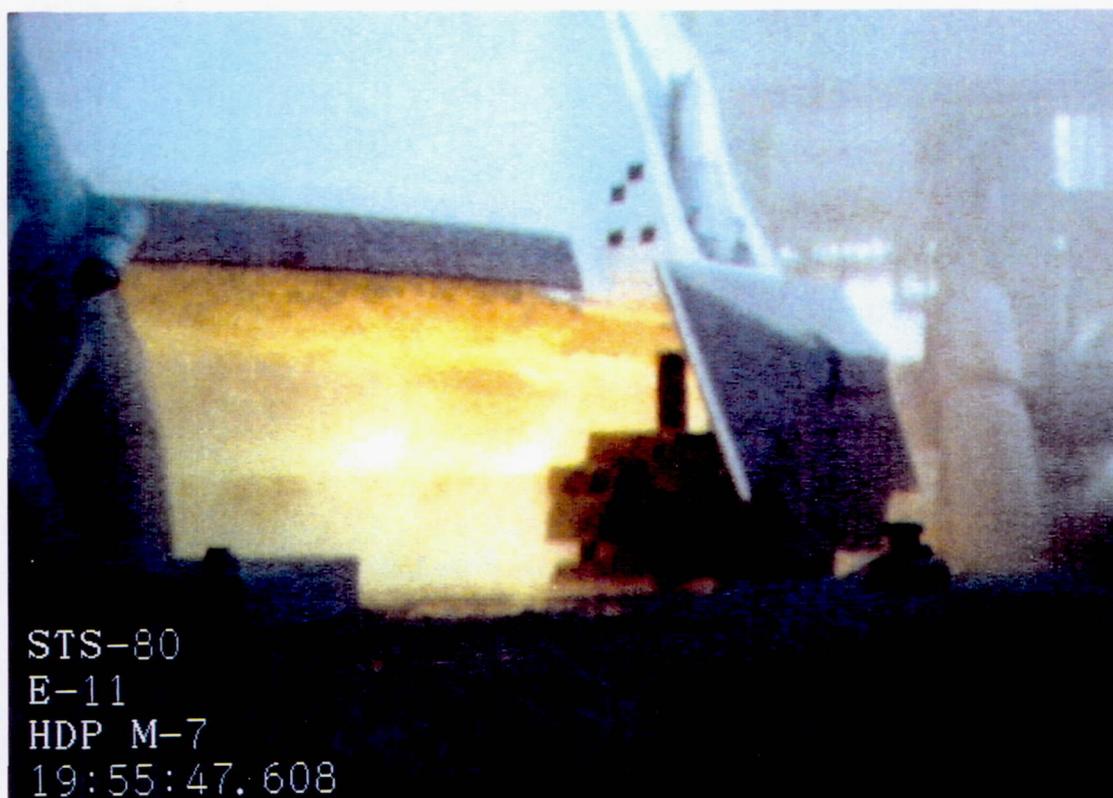
Figure 2.2 (C) Bolt Hang-Up At Holddown Post M-7

A bolt hang-up was seen at the LSRB holddown post M-7 at liftoff (09:54:59.594 UTC). Debris fragments were seen near the DCS during the hang-up and bolt release. SRB holddown bolt hang-ups have been seen on six of the last eight previous missions. See Table 2.2. No follow-up action was requested. (Camera E11)

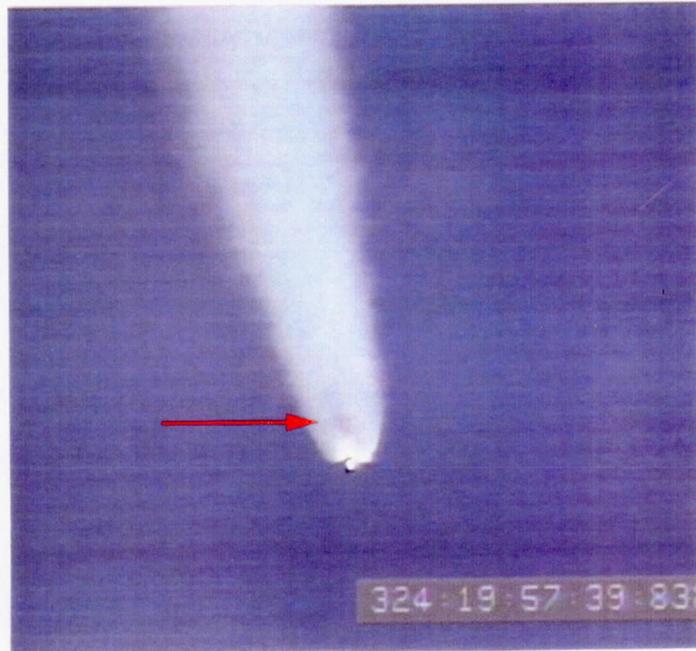
Figure 2.3 (B) Dark Puff In SRB Exhaust Plume

A dark puff was seen in the SRB exhaust plume at 11.1 seconds prior to SRB separation (19:57:39.8 UTC). (Cameras KTV4B, ET204)

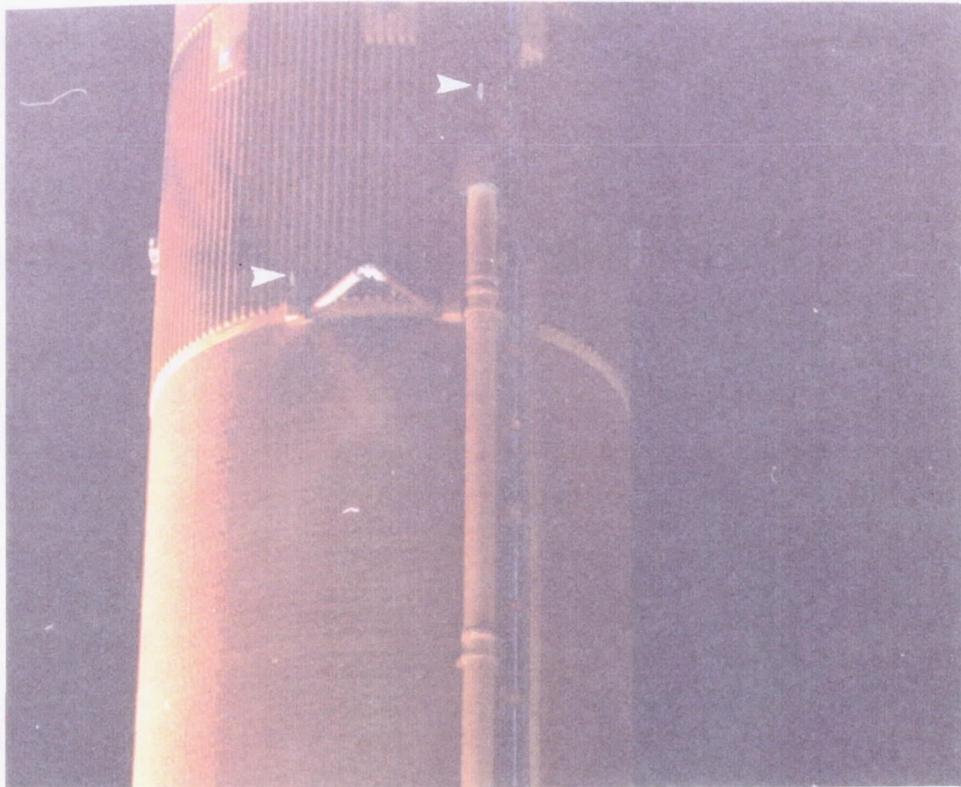
Figure 2.4.1 (A) ET Intertank

Three divots on the intertank stringers on the +Z side of the ET were seen (two divots were forward of the bipod and one was forward of the LO2 feedline).

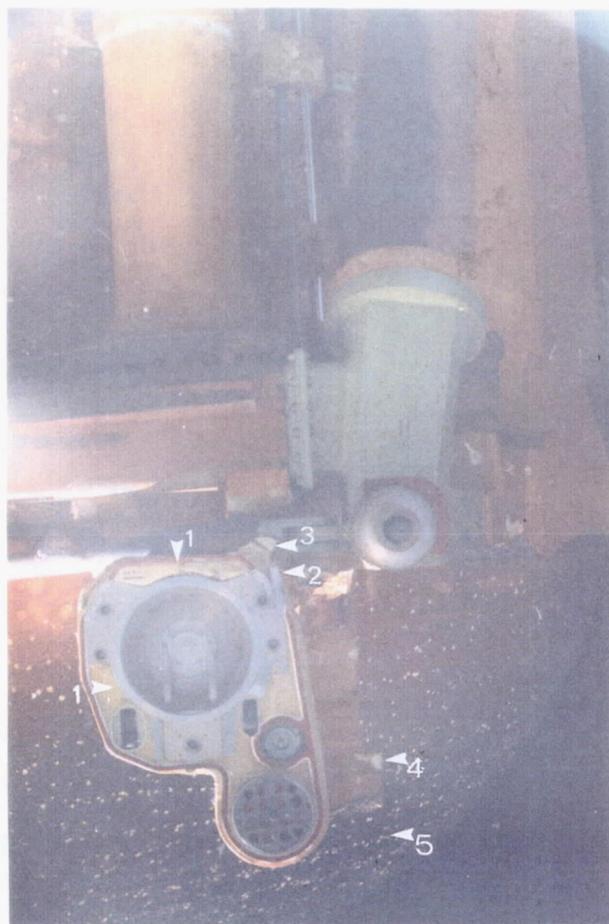
Figure 2.4.1 (B) LO2 Umbilical

Two of the five lightning contact strips (12 and 8 o'clock positions) on the ET/Orbiter LO2 umbilical interface plate were seen to be missing (1). Missing lightning contact strips have been previously seen (as recently as STS-78) and are the subject of an in-flight anomaly (IFA). A separate object (possibly RTV purge barrier material) appeared to be partially detached at the 2 o'clock position of the LO2 umbilical (2). A detached piece of insulation material (TPS) was seen at the forward right corner of the LO2 umbilical (3). TPS surface erosion/divots were noted on vertical section of the LO2 electric cable tray(4). Typical erosion or chipping of the TPS on an aft LO2 feedline flange was noted. A small light-colored string-shaped piece of debris was visible near the ET aft dome on frame 21.
