**SOHO Mission Interruption Joint NASA/ESA
Investigation Board**

Final Report

August 31, 1998

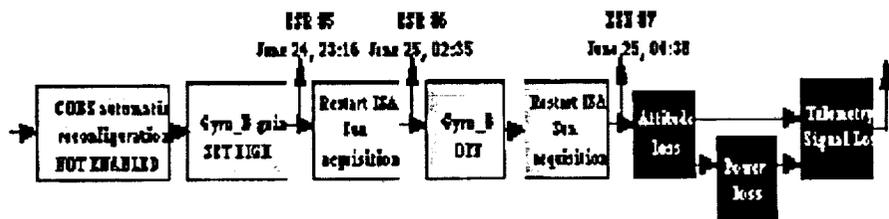
Diagram 1. Failure Event Tree - Top Level

The first two errors were contained in predefined command sequences executed from the Ground System, while the last error was a decision to send a command to the spacecraft in response to unexpected telemetry. The sequence of these errors and their relationship to the triggered-ESRs are graphically depicted in Diagram 1.

Since the gyro calibration in the compressed timeline is immediately followed by the execution of momentum management, the previously employed procedure to despin the gyros at the end of the gyro calibration and to re-enable the on-board software gyro control function was not required. Following gyro calibration, Gyro A was specifically deactivated (despun) in order to conserve its life, while Gyros B and C remained fully active. Due to an omission in the modified predefined command sequence actually used, the onboard software function that activates the gyro needed by ESR was not enabled. **This omission resulted in the removal of the functionality of the normal safe mode and ultimately caused the catastrophic sequence of events.**

Following the momentum management maneuver, Gyro B, which is used for fault detection, was erroneously left in its high gain setting, resulting in an indicated roll rate of 20 times greater than actual. **The incorrect gain was due to an error in another predefined command sequence; this error resulted in an on-board fault detection output that triggered an ESR.** This ESR, the 5th since launch, occurred at 7:16 PM EDT (23:16 UT), June 24, 1998.
