HUBBLE SPACE TELESCOPE METALLIZED TEFLON® FEP THERMAL CONTROL MATERIALS: ON-ORBIT DEGRADATION AND POST-RETRIEVAL ANALYSIS

J.A. Townsend¹, P.A. Hansen¹, J.A. Dever², K.K. de Groh²,
B. Banks², L. Wang³ and C. He³

1. NASA Goddard Space Flight Center, Greenbelt, Maryland, 20771 USA
2. NASA Lewis Research Center, Cleveland, Ohio 44135 USA
3. Unysis Corporation, Lanham, Maryland 20705 USA

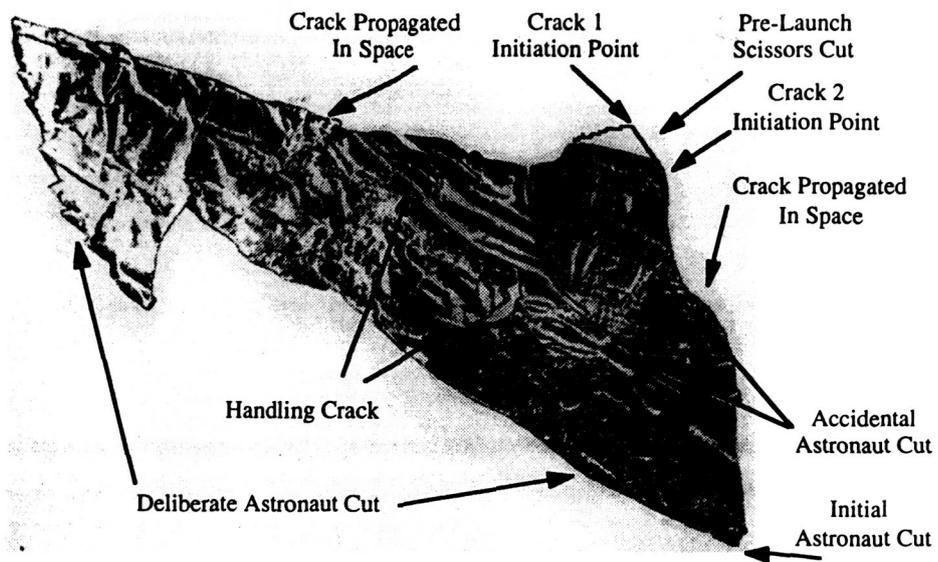
FIGURE 4: SM2 LS SPECIMEN POST-RETRIEVAL

The first task was to document the SM2 LS specimen and assemble the four pieces received into the single specimen that was cut in orbit. Both SEM and optical microscopy were used in this effort. Once the original configuration had been determined, the edges were identified as either a deliberate cut, a handling artifact, or an on-orbit fracture (Figure 4). From this information, the fracture initiation site became apparent.

The image above was taken during post-retrieval analysis, when the SM2 LS specimen was uncurled and placed between glass plates. The edges of the specimen are identified as scissors cut, handling crack, or orbit crack. The top-right corner of the specimen contains the crack initiation sites.

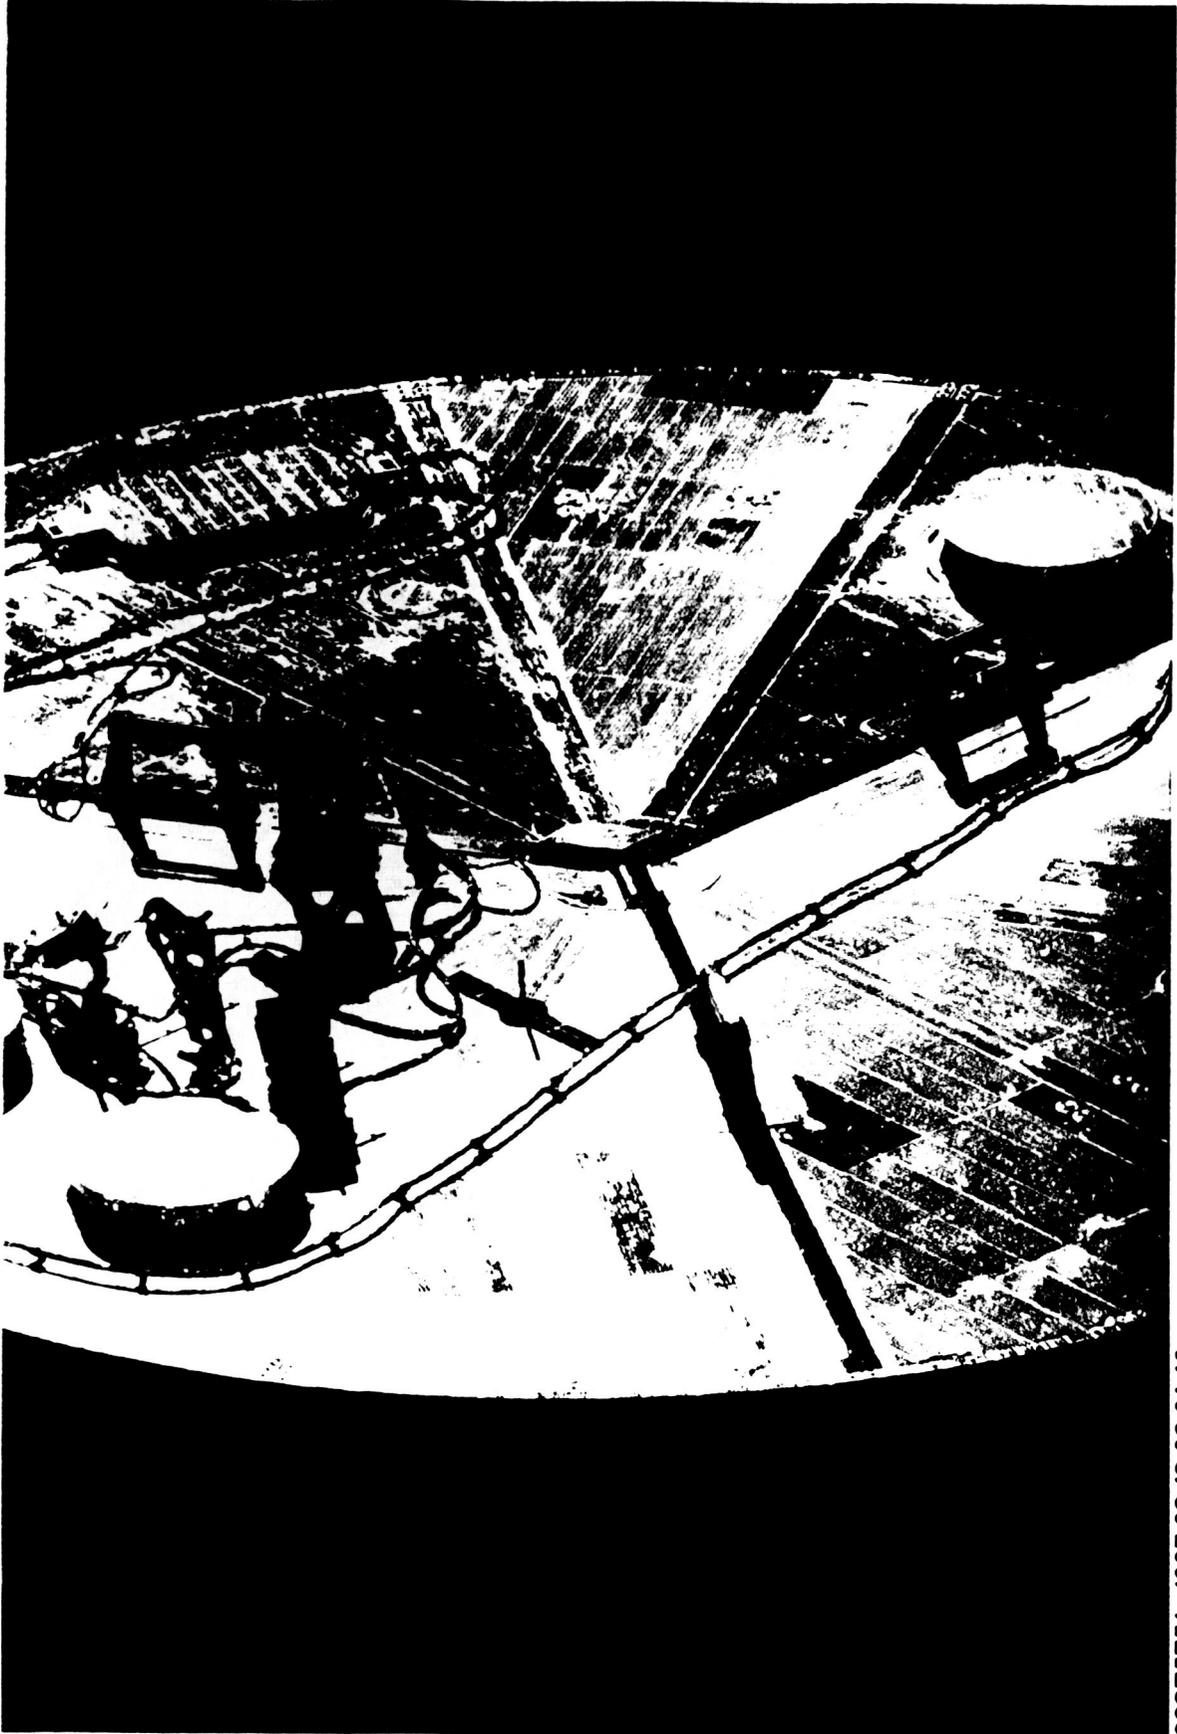
FIGURE 7: SM2 AFT BULKHEAD

Literature values for solar absorptance of pristine FEP/VDS were found between 0.06 to less than 0.09 [10]. The increase in the solar absorptance of the SM2 CVC specimen was attributed to darkening of the acrylic adhesive that was used to bond the material to the spacecraft. During the bonding process, the material was repeatedly bent with a high angle of attack, which created the mud tiling cracks in the silver deposit. The adhesive bled through these cracks in the silver and was exposed to sunlight. Acrylic adhesives are known to darken when exposed to UV [2, 6, 10].

The radiator surfaces of the telescope had this mottled appearance showing localized increases in solar absorptance from UV darkening of the acrylic adhesives.

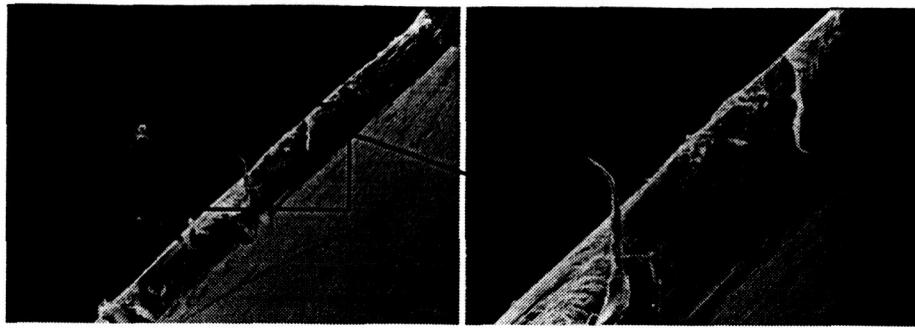
Figure 8: SM2 LS Specimen Scissors Cut Features

Edge-on view of shear fracture near the crack initiation point. This region of the blanket was cut during installation in order to fit around a handrail. This fracture surface has common shear and tear features, indicating the material was cut. Astronaut cuts that occurred on-orbit during specimen retrieval had a similar appearance.

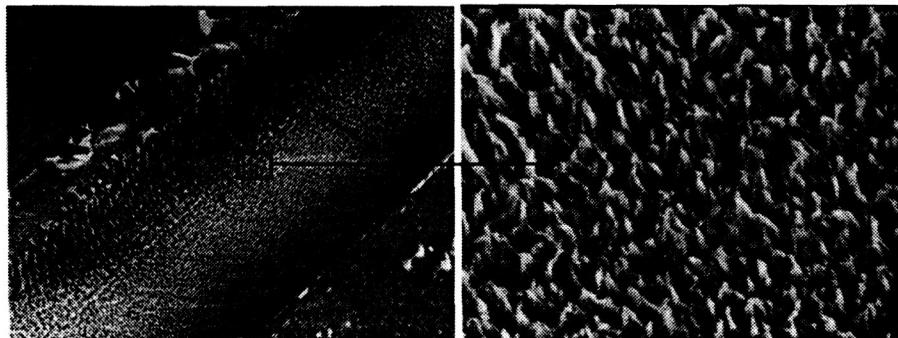
Figure 10: SM2 LS Specimen Handling Features

Edge-on view of a crack that occurred due to specimen handling. The fibrous features of this crack surface showed ductile peaks that formed as the two surfaces of the crack pulled away from one another. Cracks that occurred from tensile and bend testing had a similar appearance.
