Final Report
STUDY METHODS TO CHARACTERIZE AND IMPLEMENT THERMOGRAPHY
NONDESTRUCTIVE EVALUATION (NDE)

Contract Number: NAS8-97095
Task: H-28166D

James L. Walker
Center for Automation and Robotics
University of Alabama in Huntsville
Huntsville, AL 35899
(256)-890-6578*207

October, 1998

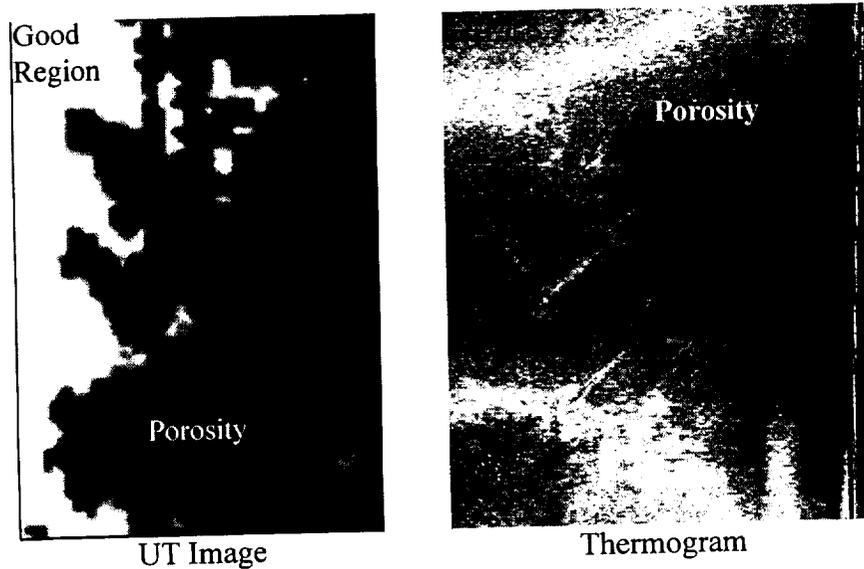
Figure 6. Comparison of Actual Porosity detected by UT and Thermography

between the UT image and thermogram. In Figure 6 the porosity shows up as a dark patch for the UT image and as a white "hotter" zone on the thermogram. The single thermogram does not show all the details of the UT image since the porosity actually resides throughout the thickness. The UT image measures the complete thickness of the panel while the thermogram shows only the effects from a single slice the cross-section. When several thermograms are viewed over time though, by rastering through the scan history, most if not all of the details in the UT plot can be seen on the thermography image.

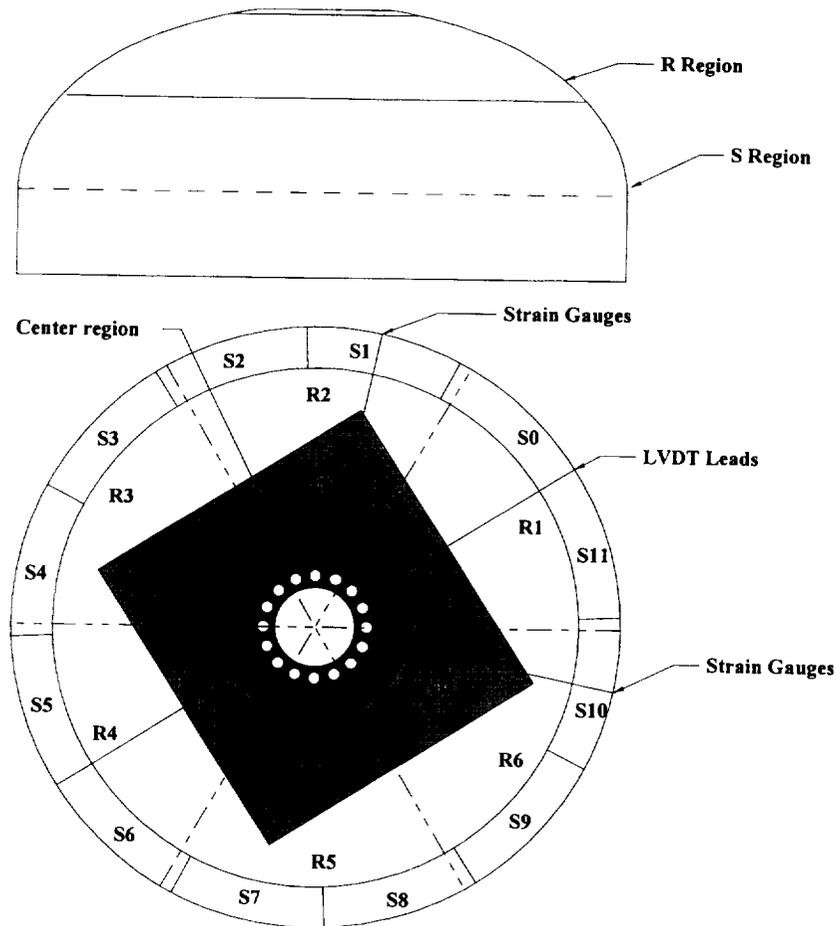
Figure 36. Thermogram map for the dome.

Some thermal abnormalities were found at visible surface wrinkles as shown in the following thermograms. Due to the severity of the visible surface features it is difficult to identify individual subsurface defects.
