Debris/Ice/TPS Assessment and Integrated Photographic Analysis of Shuttle Mission STS-93

*Gregory N. Katnik
Process Engineering/Mechanical System Division/ET-SRB Branch,
Kennedy Space Center, Florida*

23 July 1999

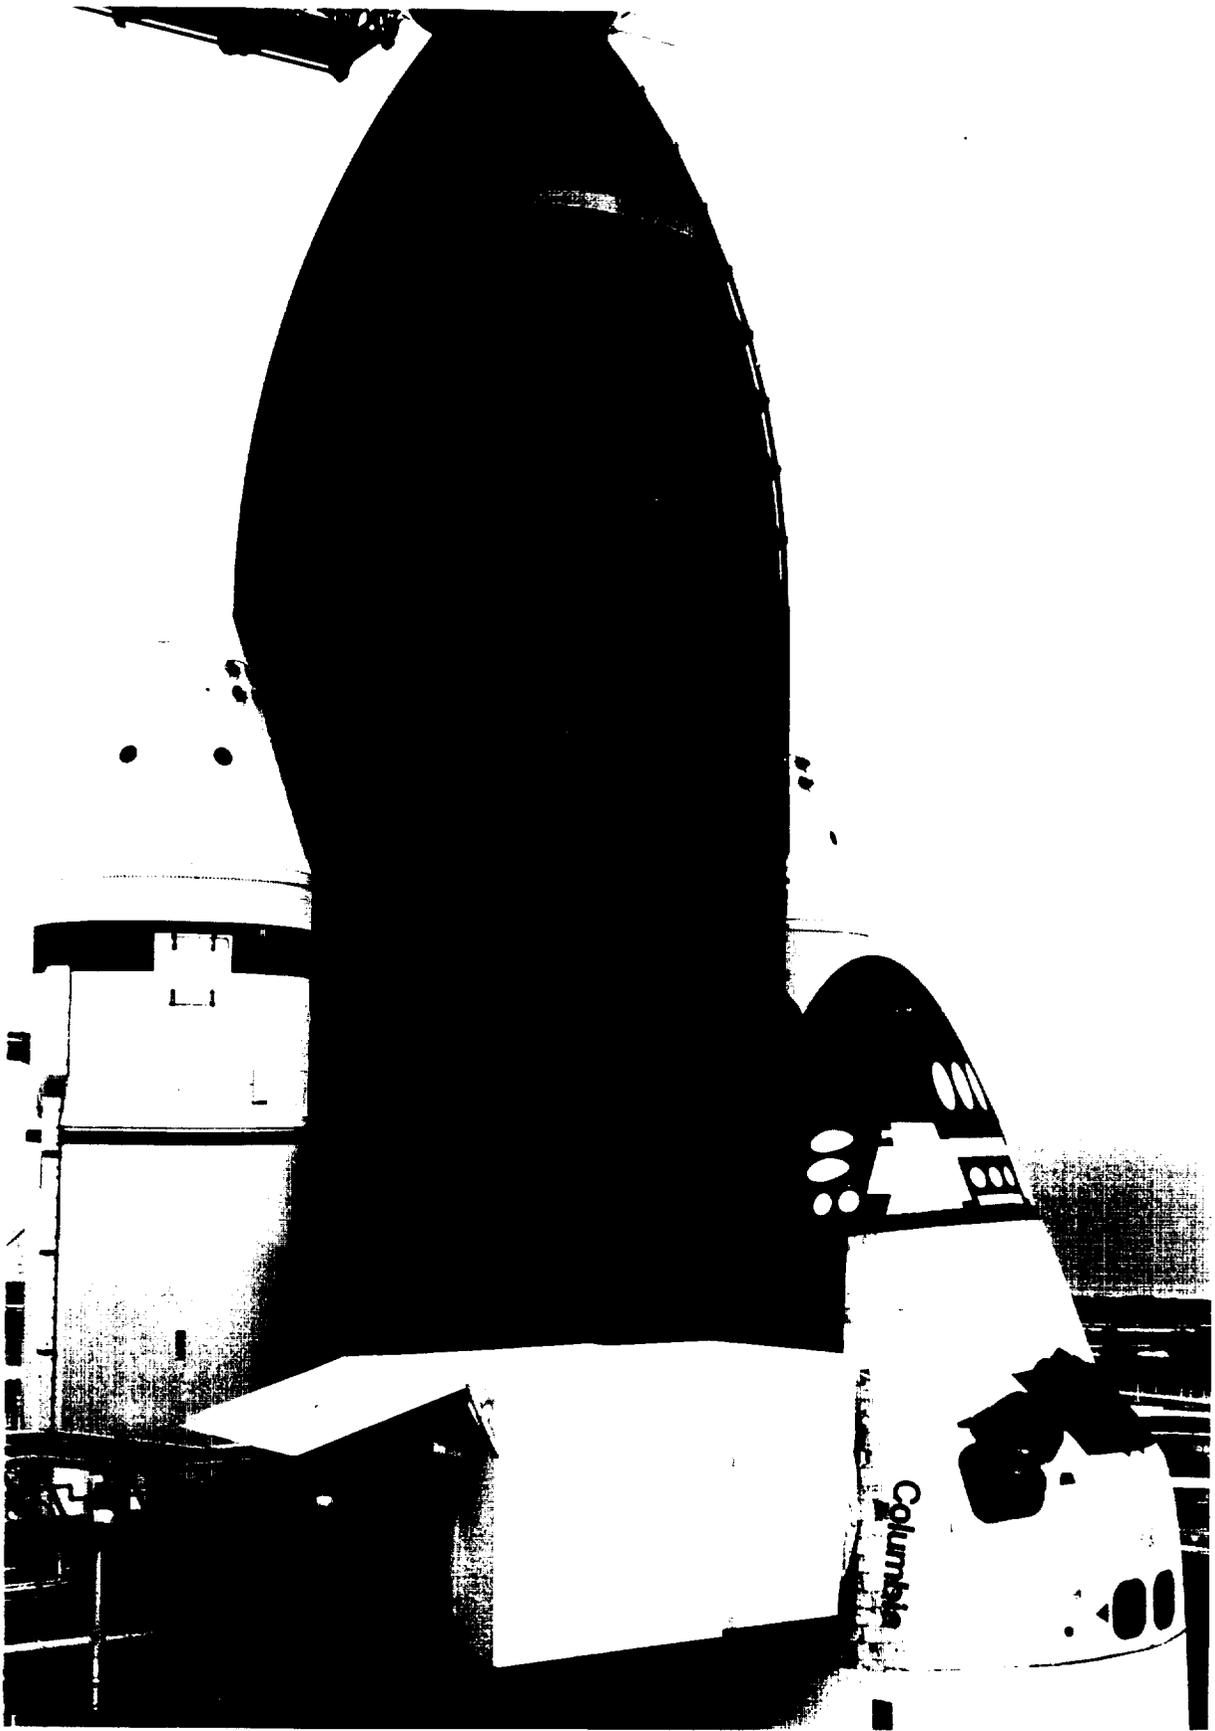
Photo 4: ET LO2 Tank and Intertank

The Thermal Protection Systems performed nominally during cryoload. LO2 tank acreage TPS was wet due to light condensate, but no ice or frost accumulations. No anomalies were detected in the intertank TPS though numerous small frost spots had formed on the intertank-to-LH2 tank and -LO2 tank flange closeouts.

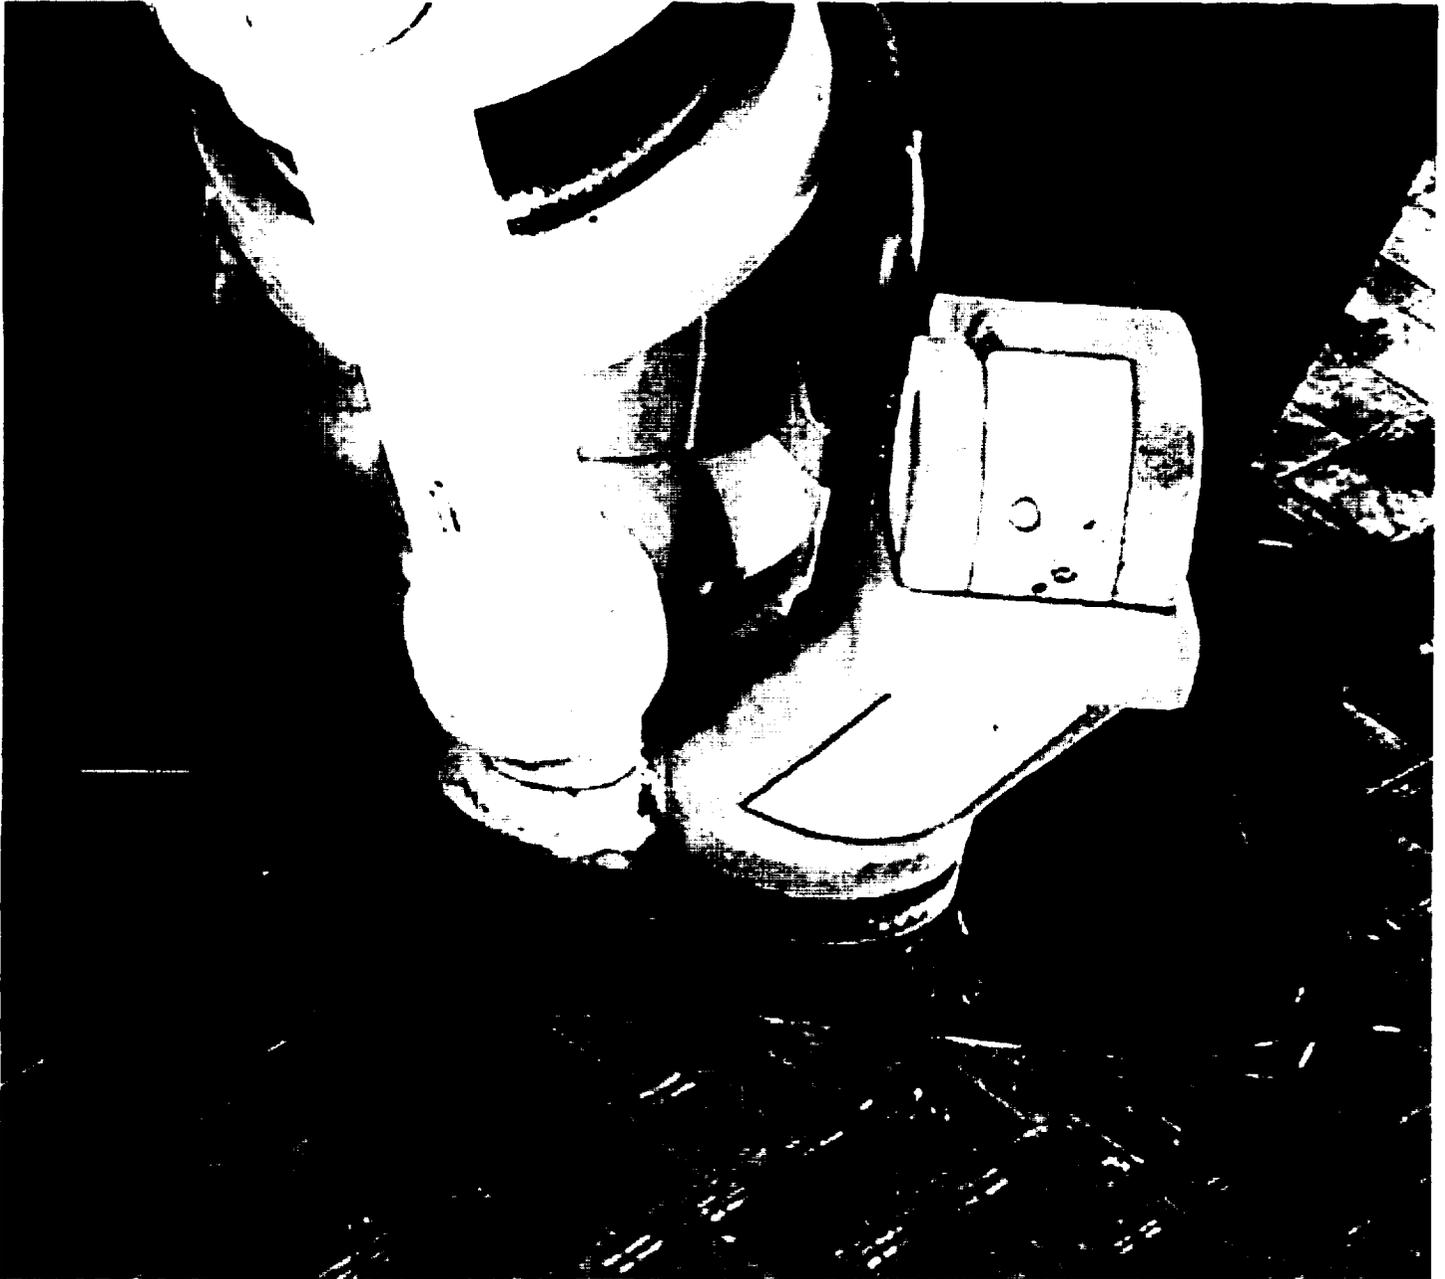
Photo 7: LH2 Feedline and Recirculation Line

Ice/frost had formed in the LH2 feedline bellows. Ice and frost in the LH2 recirculation line bellows and on both burst disks was typical. However, a more unusual finding was ice/frost on the bond line of the recirculation line-to-umbilical interface.

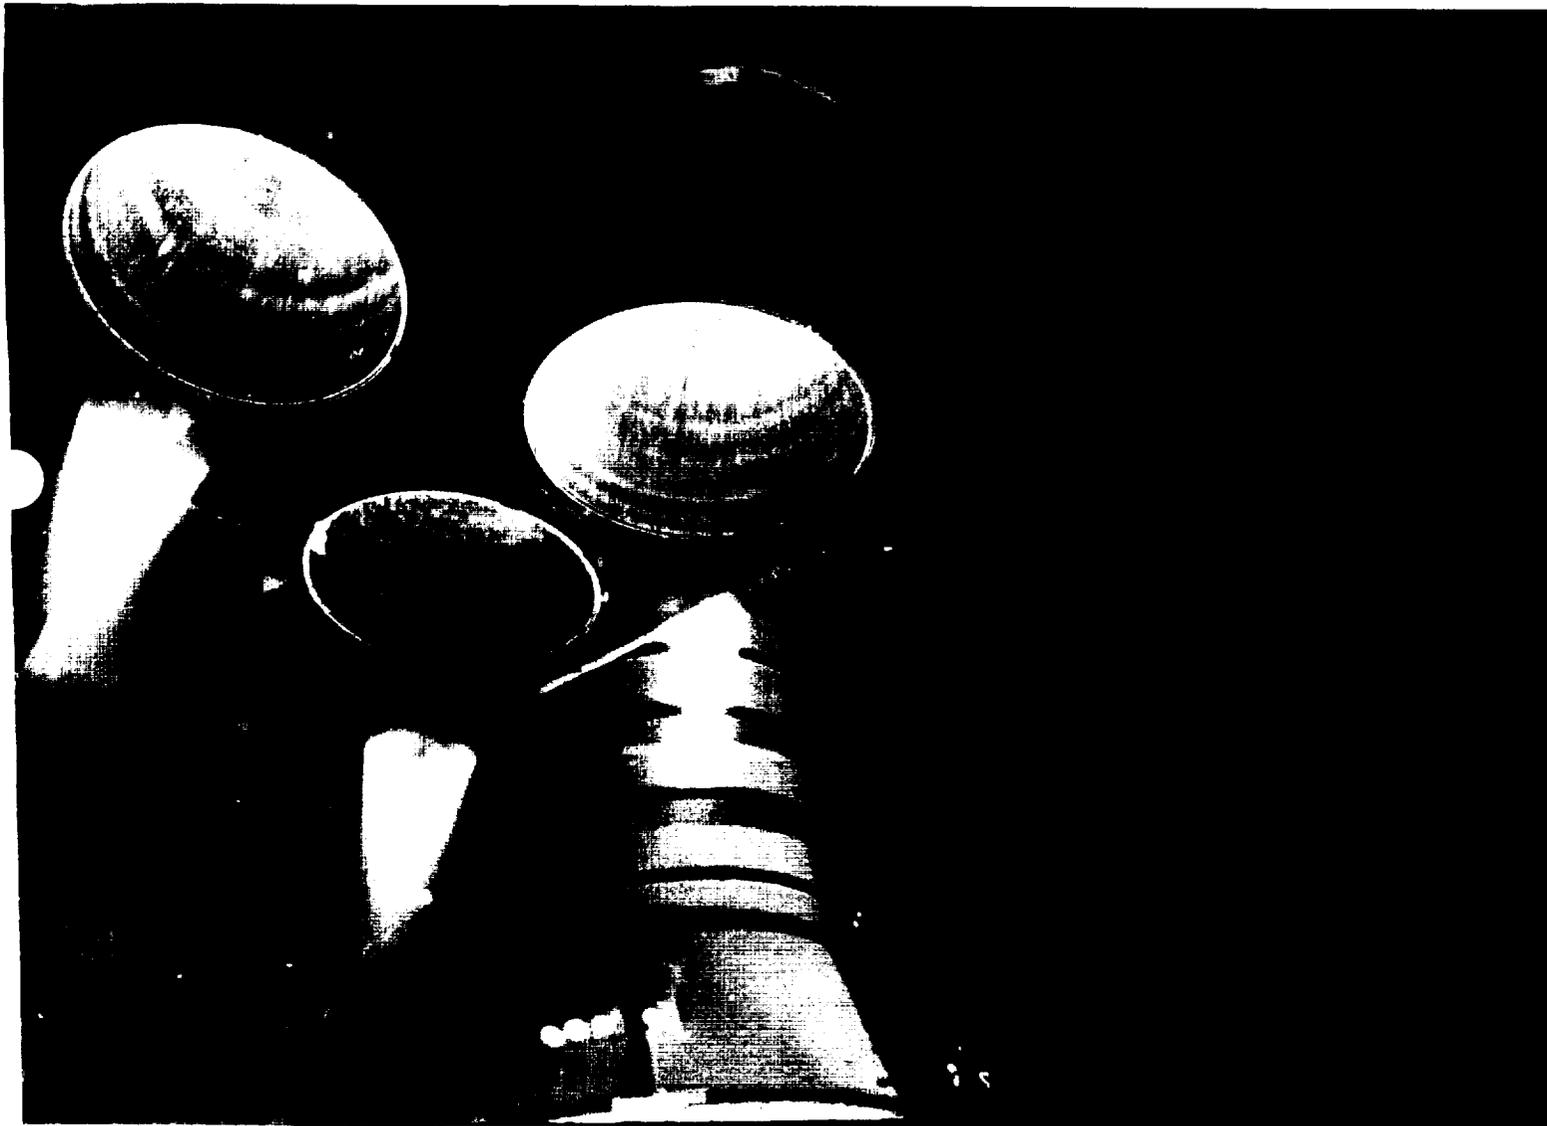
Photo 11: SSME #3 Hot-Wall Leak at Liftoff

MLP deck camera view (E-19) showing location and size of hot-wall leak in the SSME #3 nozzle just after liftoff

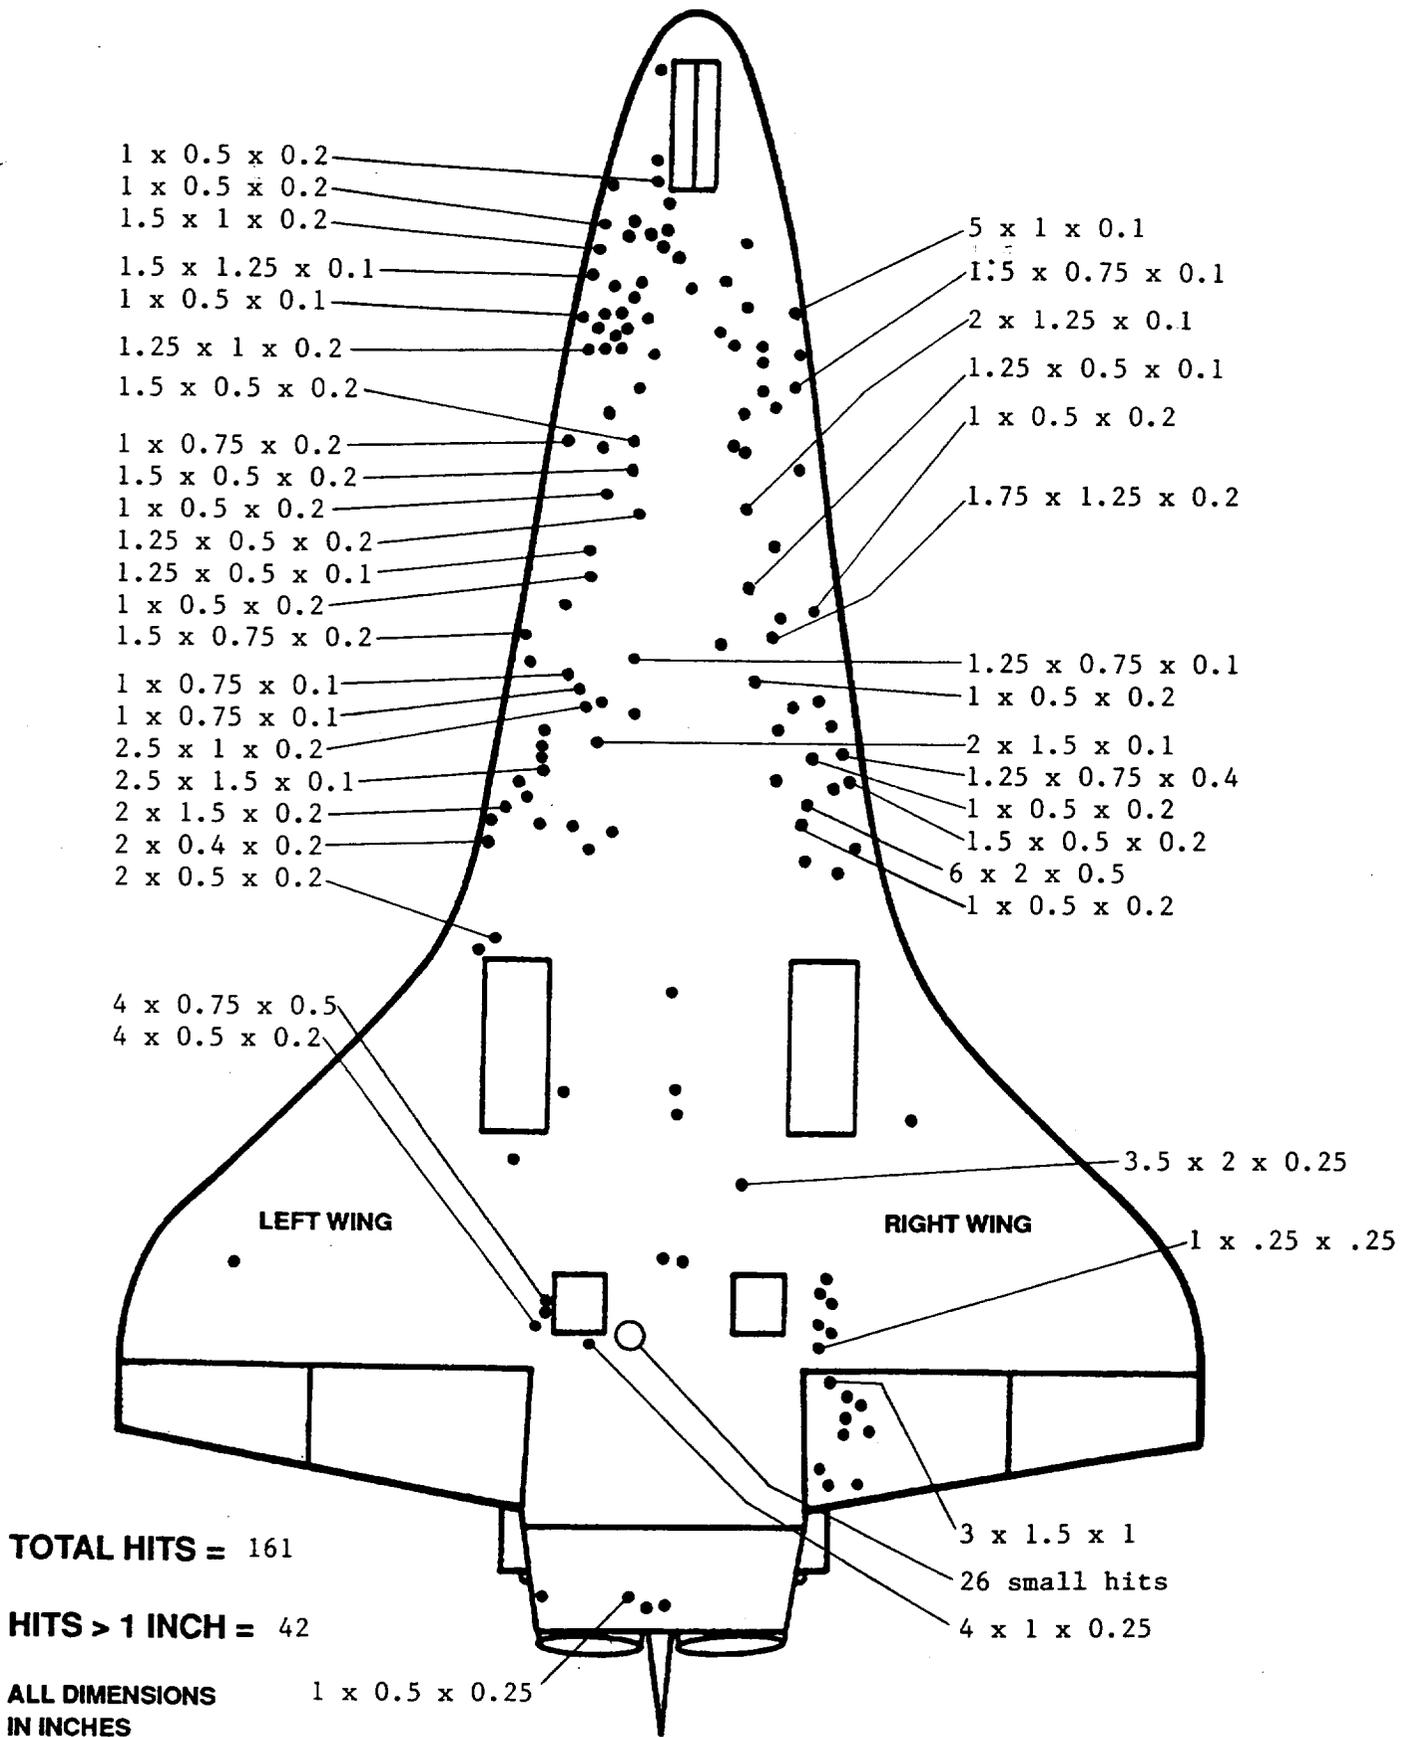
Figure 1: Orbiter Lower Surface Debris Damage Map

Post landing inspection revealed the Orbiter lower surface sustained 161 total hits, of which 42 had a major dimension of 1-inch or larger. Most of this damage was concentrated from the nose gear to the main landing gear wheel wells on both left and right chines. The outboard damage sites on the chines followed a similar location damage pattern documented on flights starting with STS-86.

The External Tank Project continues to work IFA STS-87-T-01 to prevent loss of foam from the External Tank and preclude further damage to Orbiter tiles.

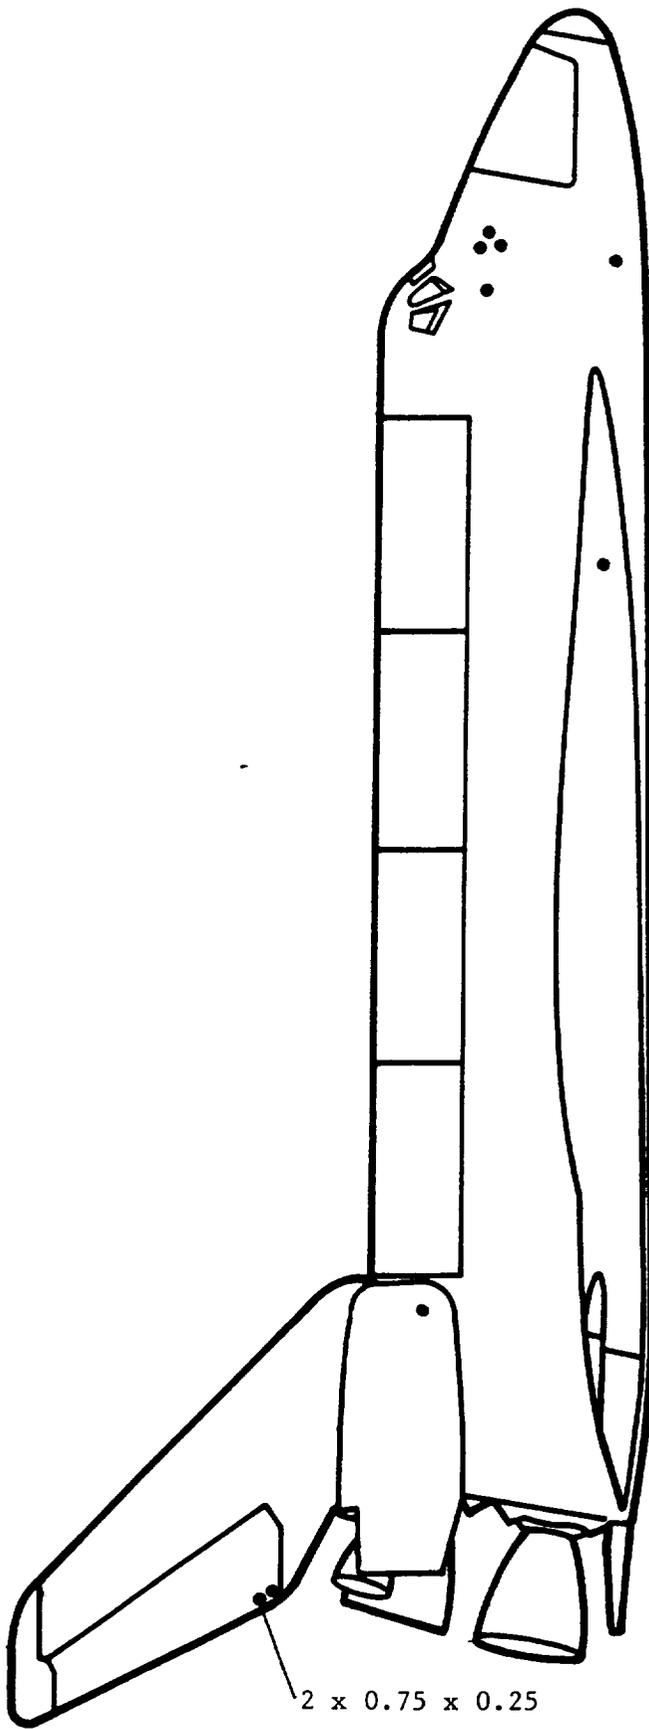
Figure 3: Orbiter Right Side Debris Damage Map

TOTAL HITS = 9
HITS > 1 INCH = 1

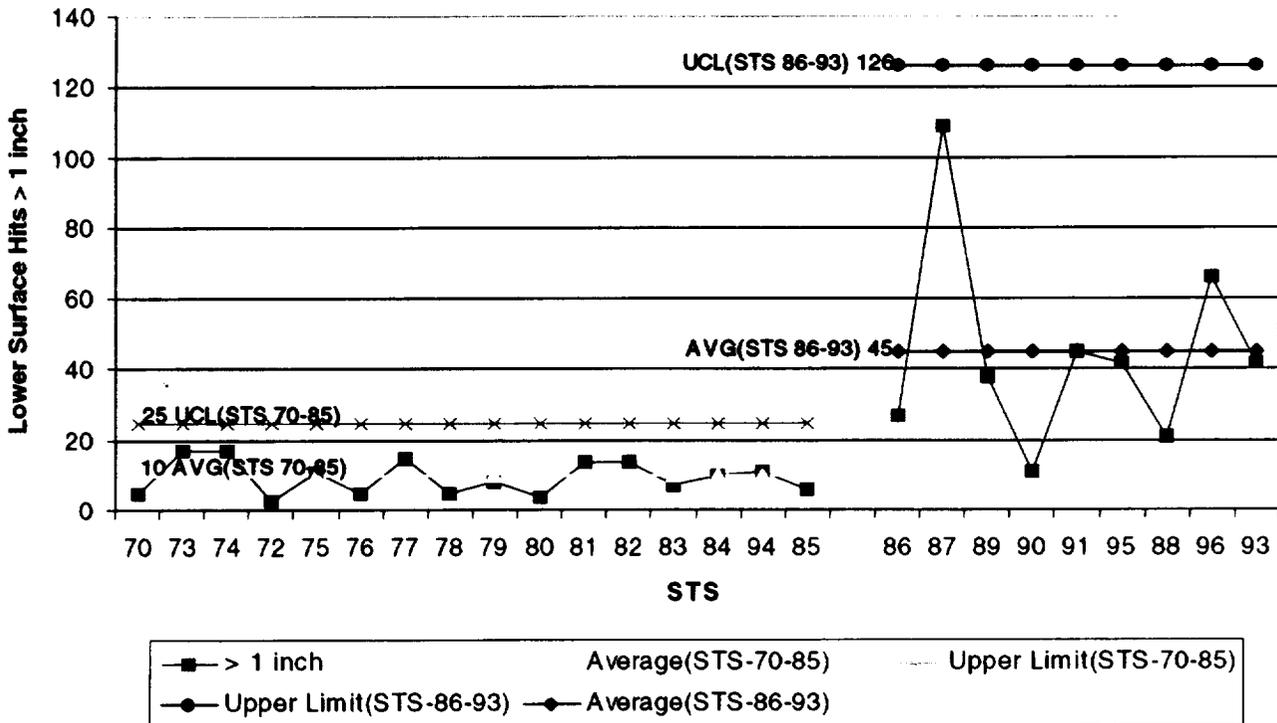
Figure 6: Control Limits for Lower Surface Hits

With data from these flights showing out-of-family damage to Orbiter tiles, control limit analyses show a marked change starting with STS-86. Data from STS-72 through STS-85 consistently illustrate a relatively low average and reasonable upper control limit. These data represent an environment where the significant debris issues affecting the vehicle had been identified and corrected. However, a few earlier missions were also included to show the downward trend in debris damage representing corrective action still in progress. With the loss of TPS from the External Tank beginning on STS-86, the analysis clearly documents the increase in Orbiter tile damage as an out-of-family condition. Both the average and the upper control limit are significantly higher, and outside the 3-sigma value, for these flights.

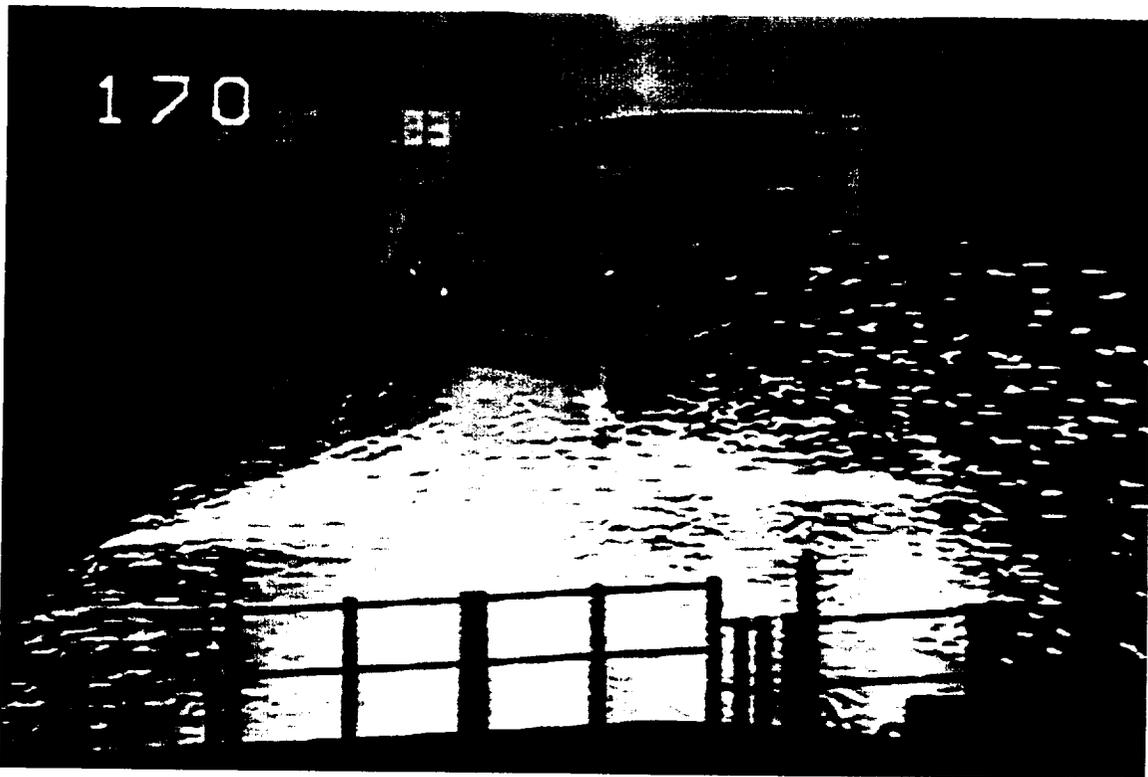
Figure 2.3.1 (D) Orange Vapors Forward of SSME Rims

An extensive amount of orange vapor (possibly free burning hydrogen) was seen forward of the SSME rims, forward of the base of the OMS pods, and near the base of the vertical stabilizer during SSME ignition (04:30:54.66 UTC). Orange vapors are typically seen on night launches, but possibly not to the extent seen on this mission. (Cameras OTV163, OTV170, OTV171, KTV7, KTV21B, E2, E5, E15, E17, E18, E19, E20, E36, E52, E54, E63, E76, E77)
