Debris/Ice/TPS Assessment and Integrated Photographic Analysis of Shuttle Mission STS-103

**DEBRIS/ICE/TPS ASSESSMENT
AND
INTEGRATED PHOTOGRAPHIC ANALYSIS
OF
SHUTTLE MISSION STS-103**

19 December 1999

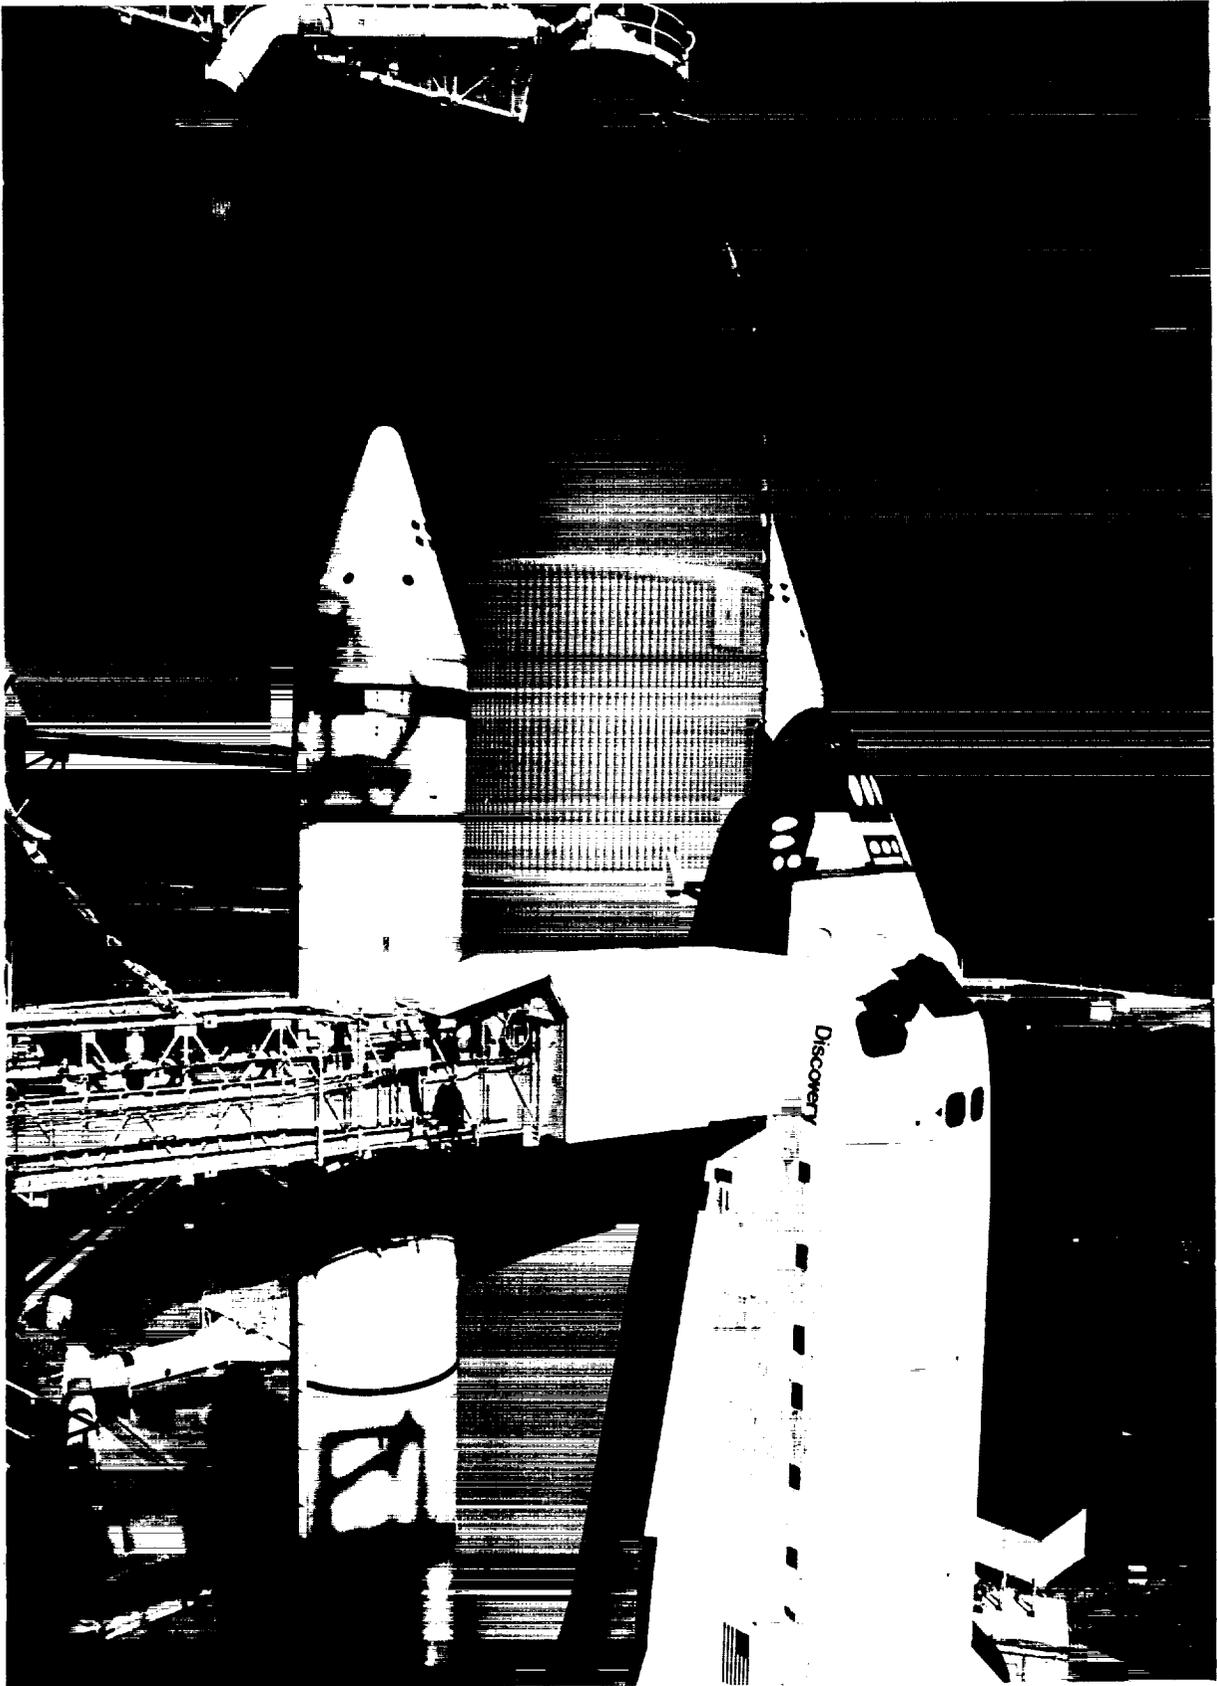
Photo 2: ET LO2 Tank and Intertank

The Final Inspection Team observed some wet TPS on the LO2 tank acreage due to light condensate, but no ice or frost accumulations. No anomalies were detected in the intertank TPS though numerous small frost spots had formed on the intertank-to-LH2 tank and -LO2 tank flange closeouts.

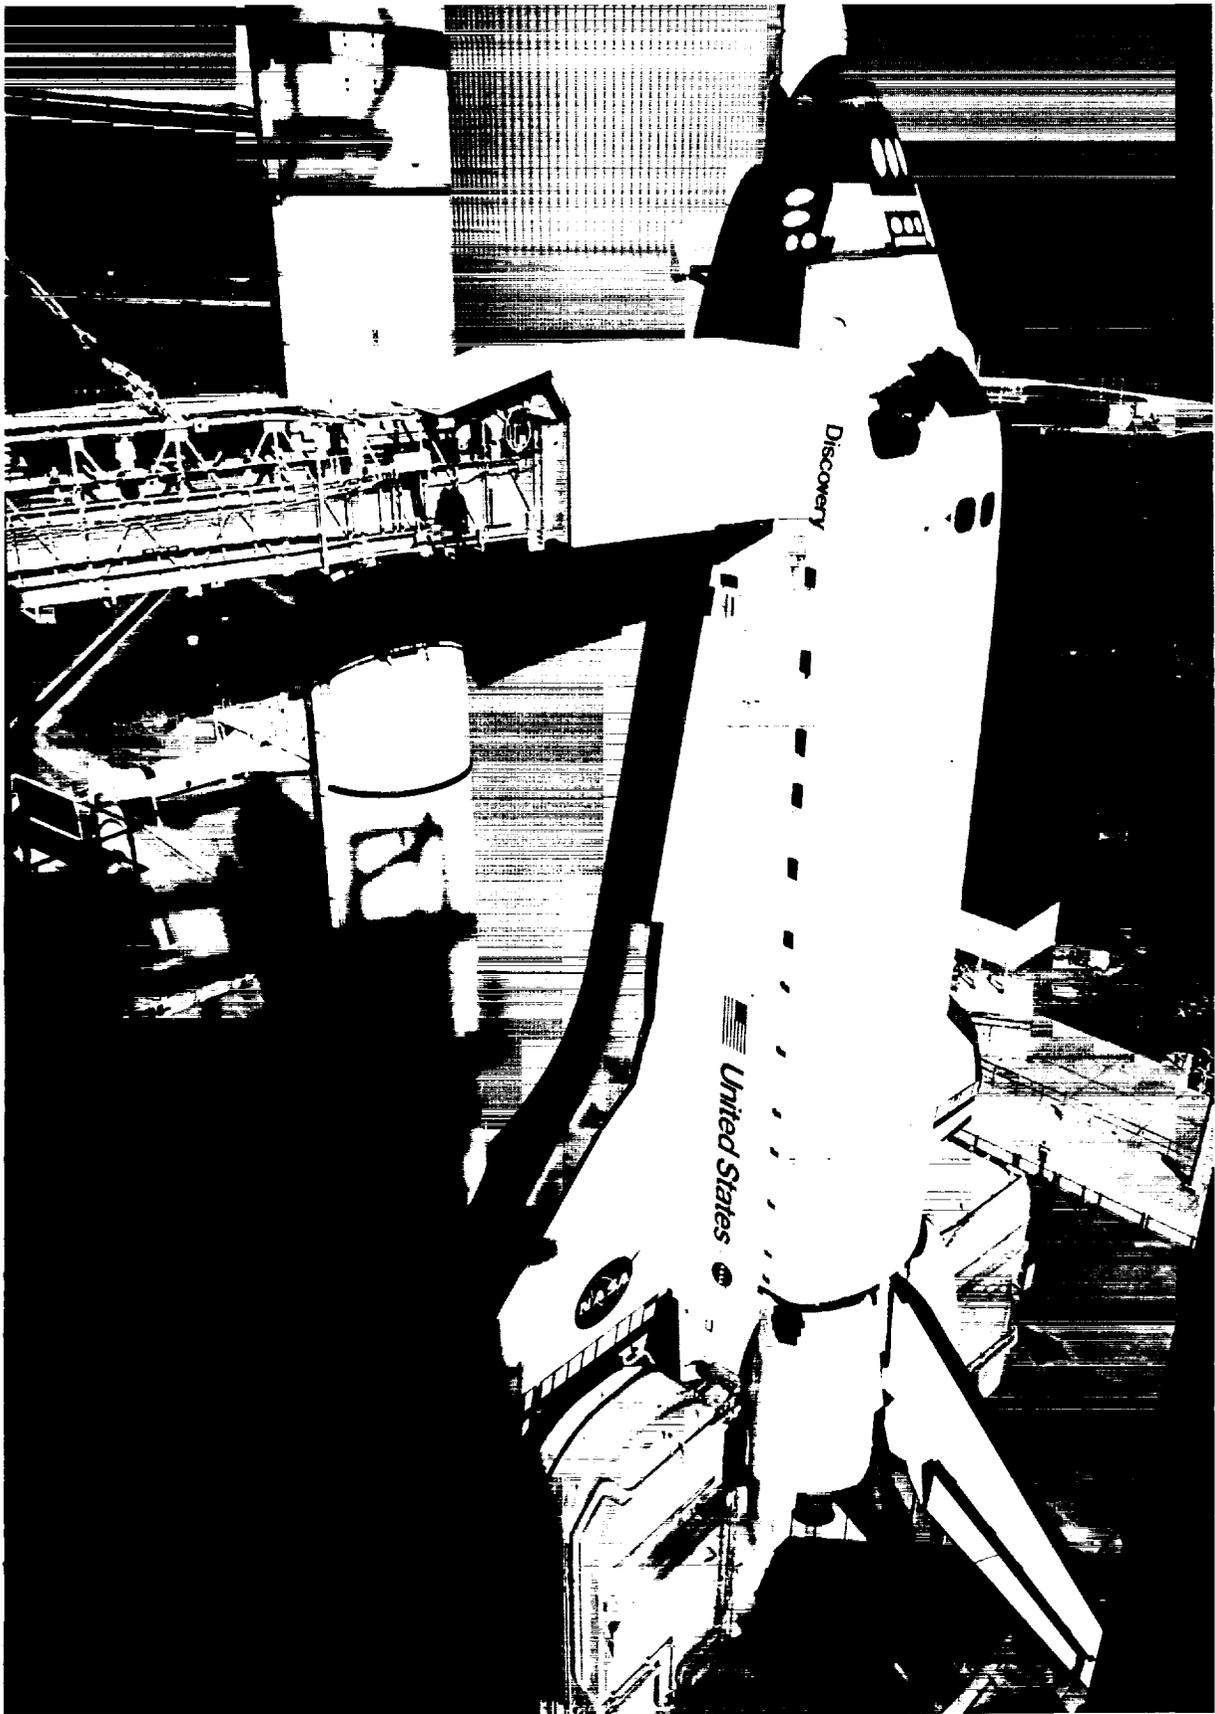
Photo 3: LH2 Tank and Orbiter

The Final Inspection Team observed some wet TPS on the LH2 tank acreage due to light condensate, but no ice or frost accumulations. No Orbiter tile or RCC panel anomalies were observed. The paper covers on the FRCS had been replaced.

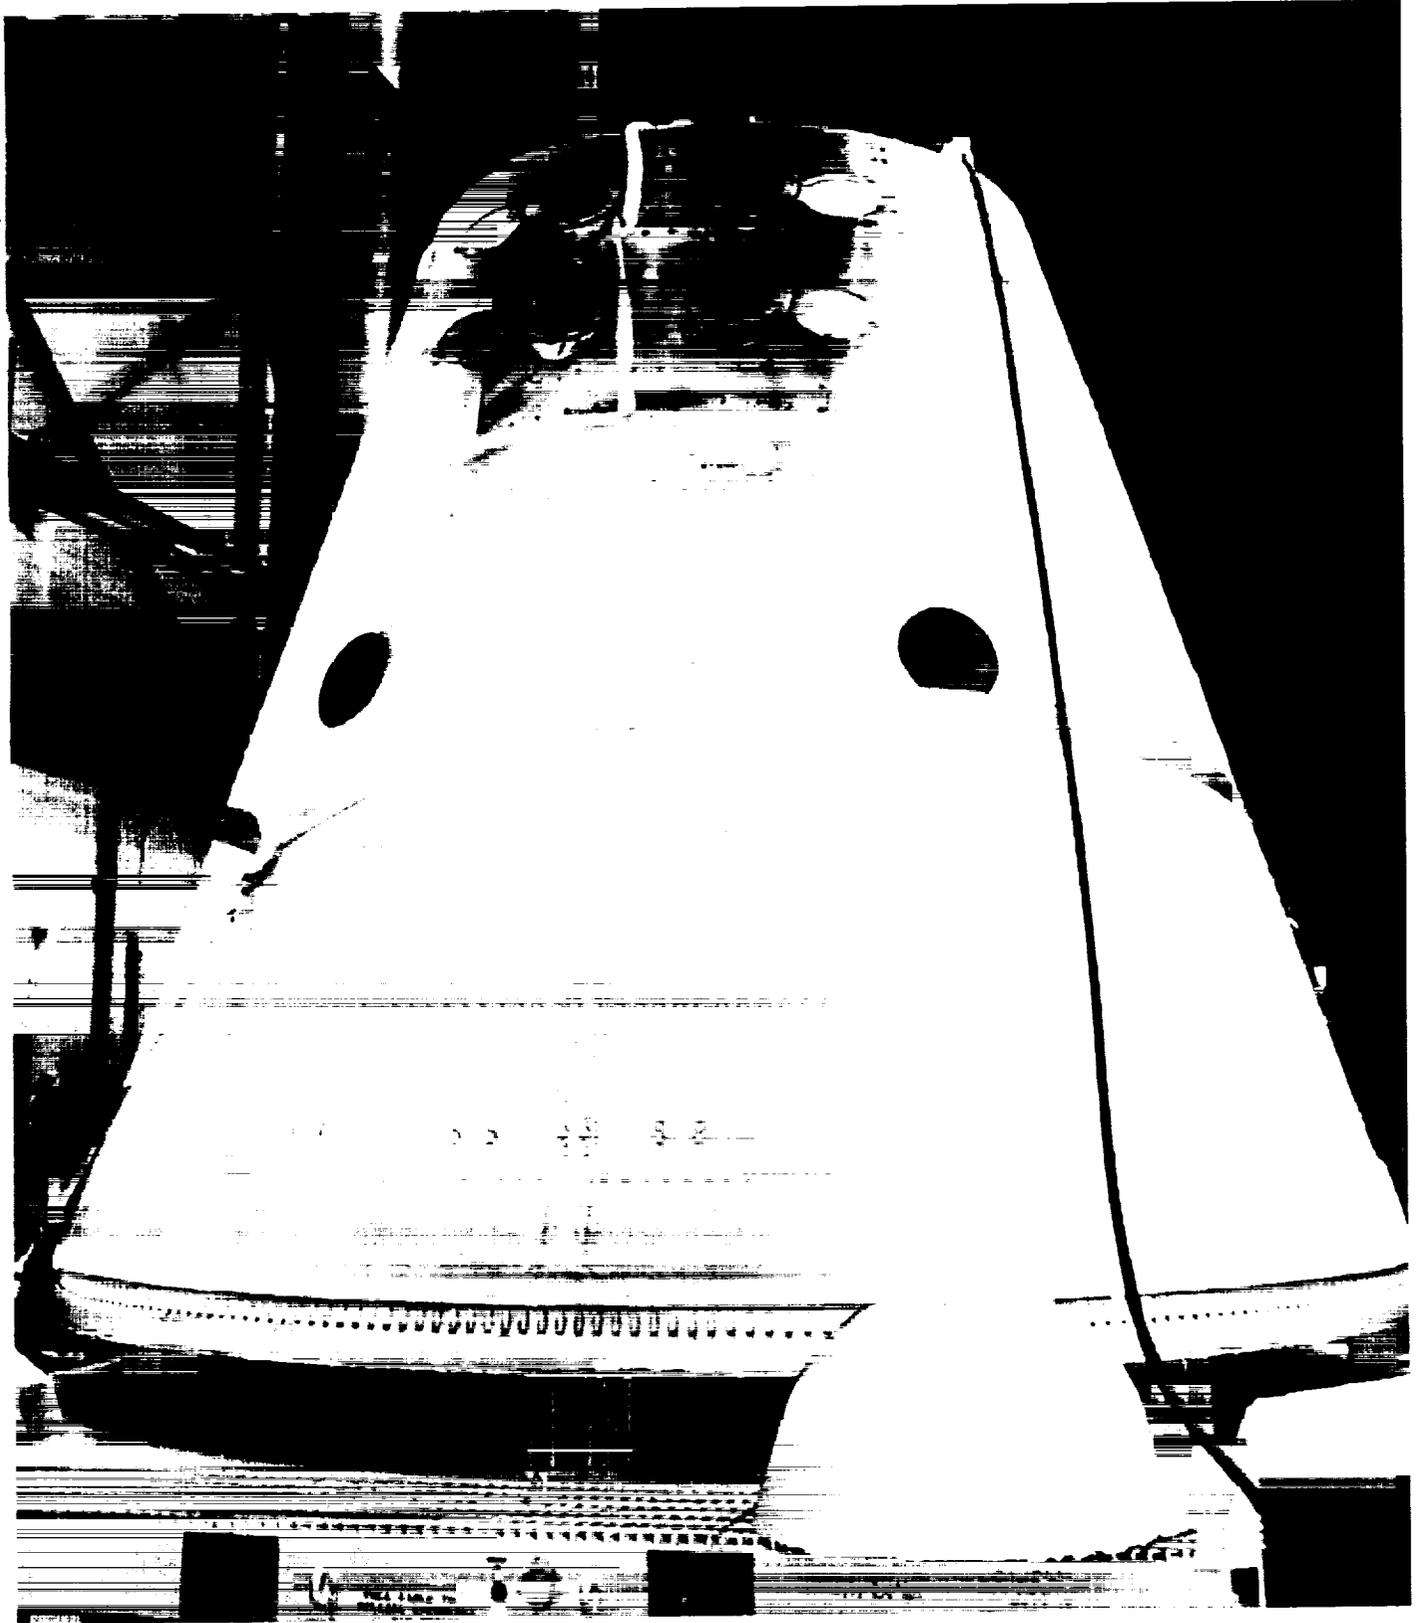
Photo 9: Frustum Post Flight Condition

Both frustums were in excellent condition. No TPS was missing and no debonds/unbonds were detected over fasteners or acreage. All eight BSM aero heat shield covers had locked in the fully opened position.

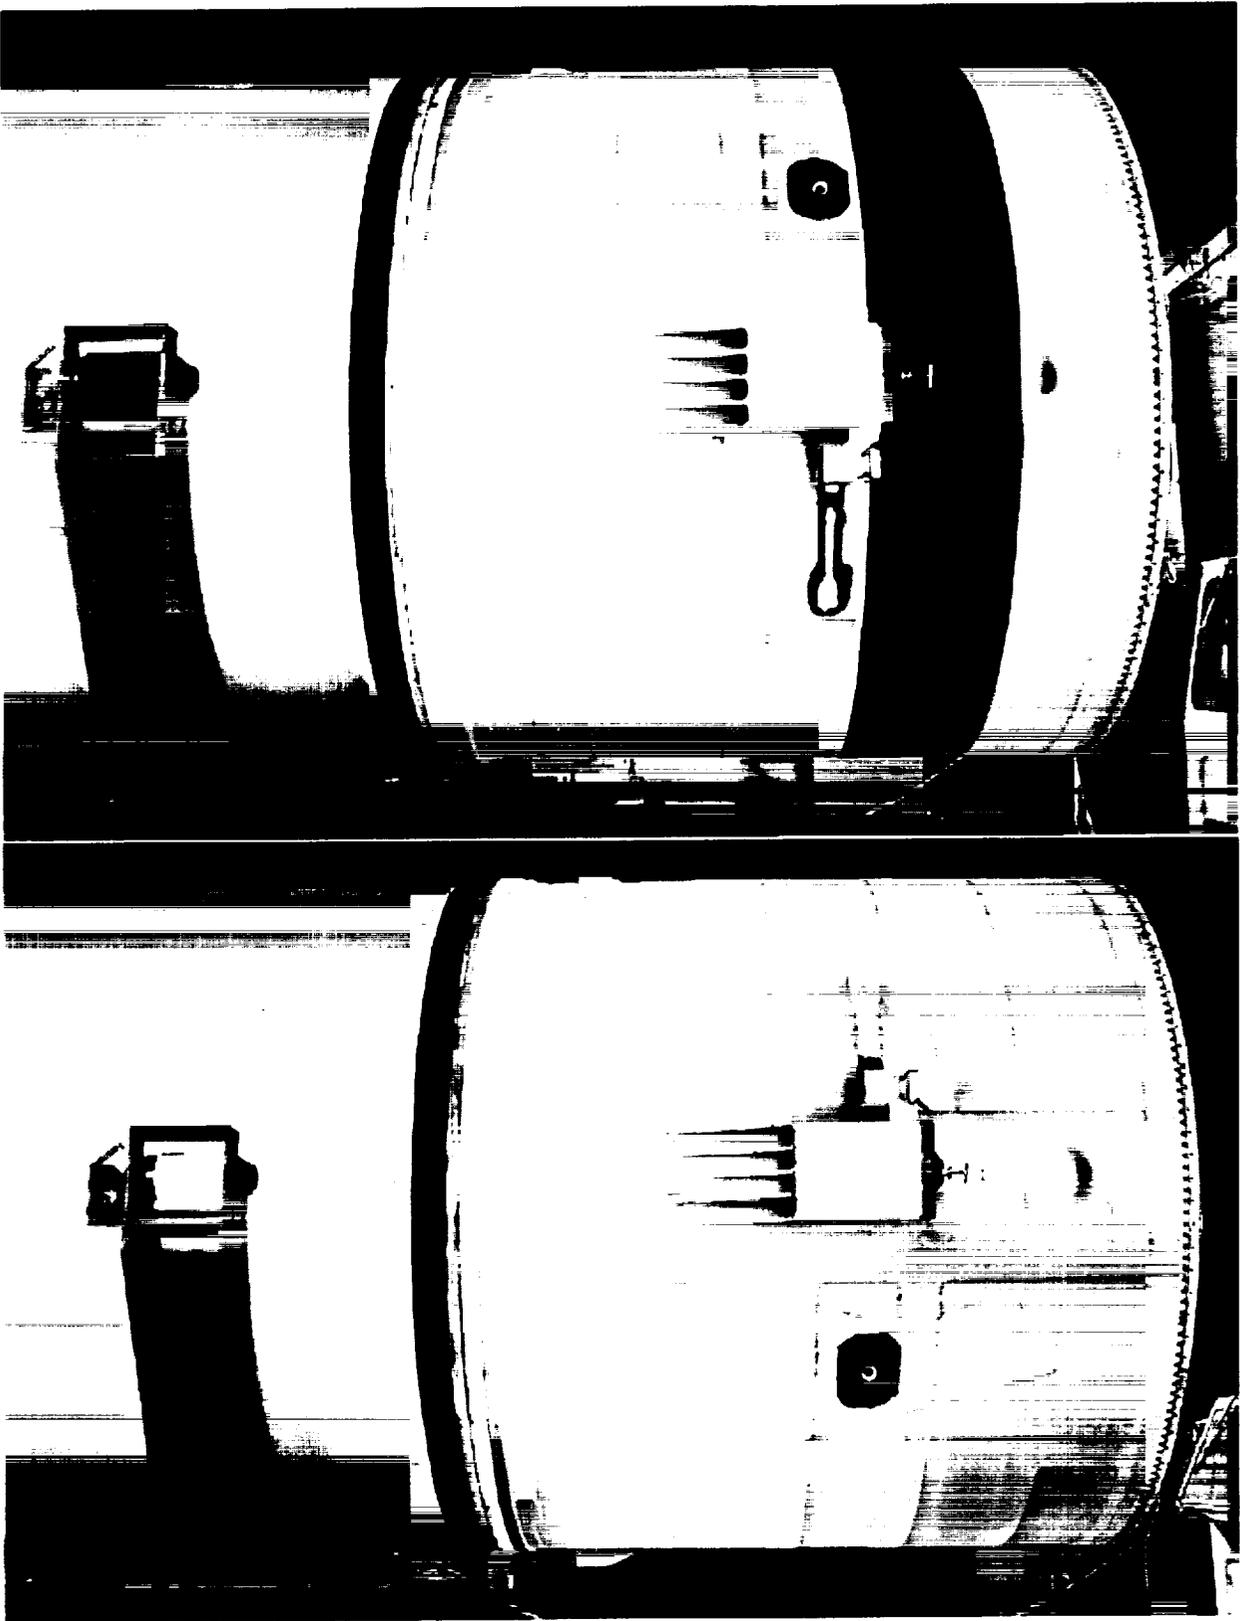
Photo 11: Forward Skirt Post Flight Condition

The forward skirts exhibited no debonds or missing TPS. RSS antennae covers/phenolic base plates were intact. All primary frustum severance ring pins and retainer clips were intact with the exception of one missing retainer clip on the left SRB pulled loose by the parachute risers.

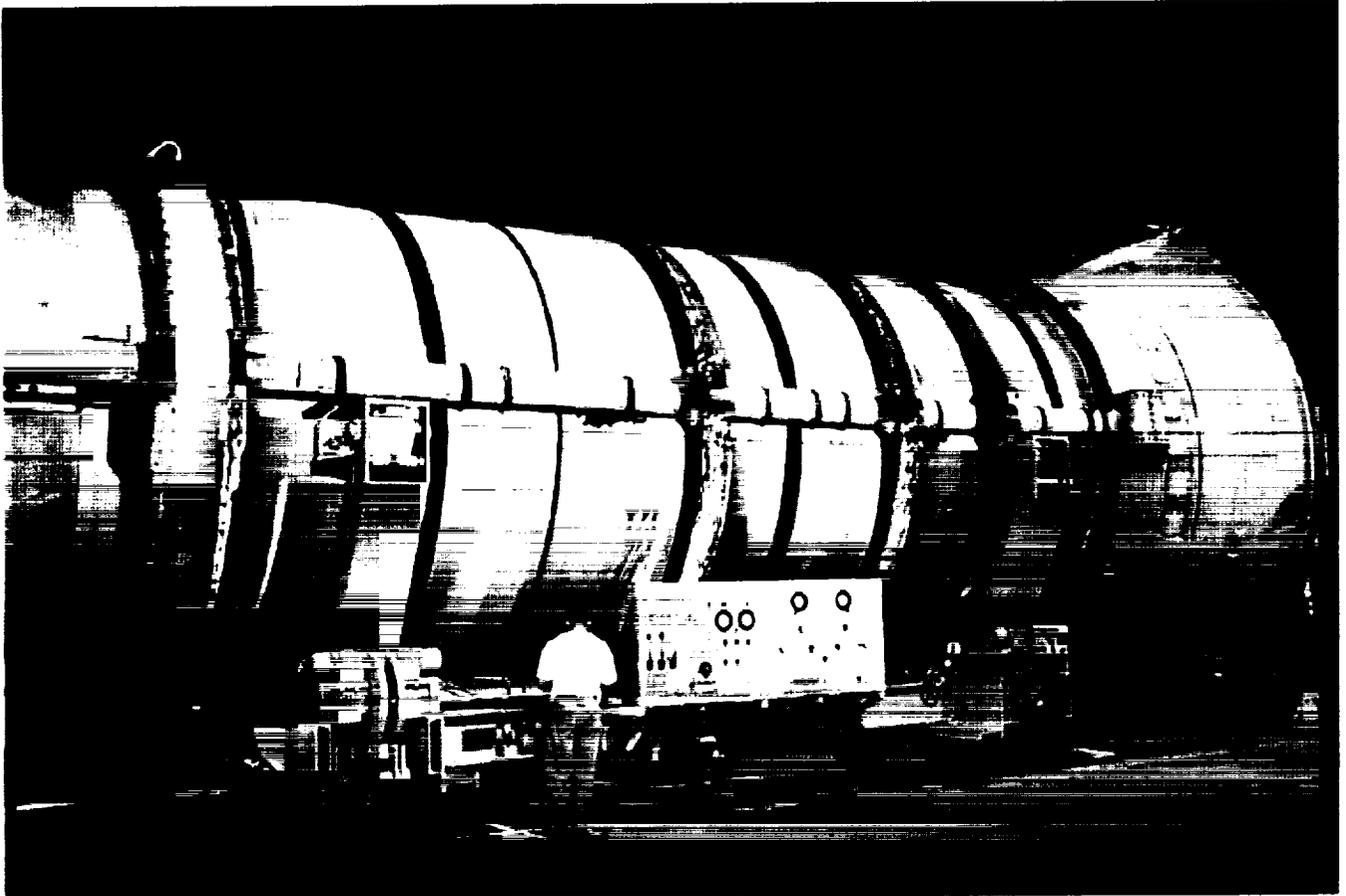
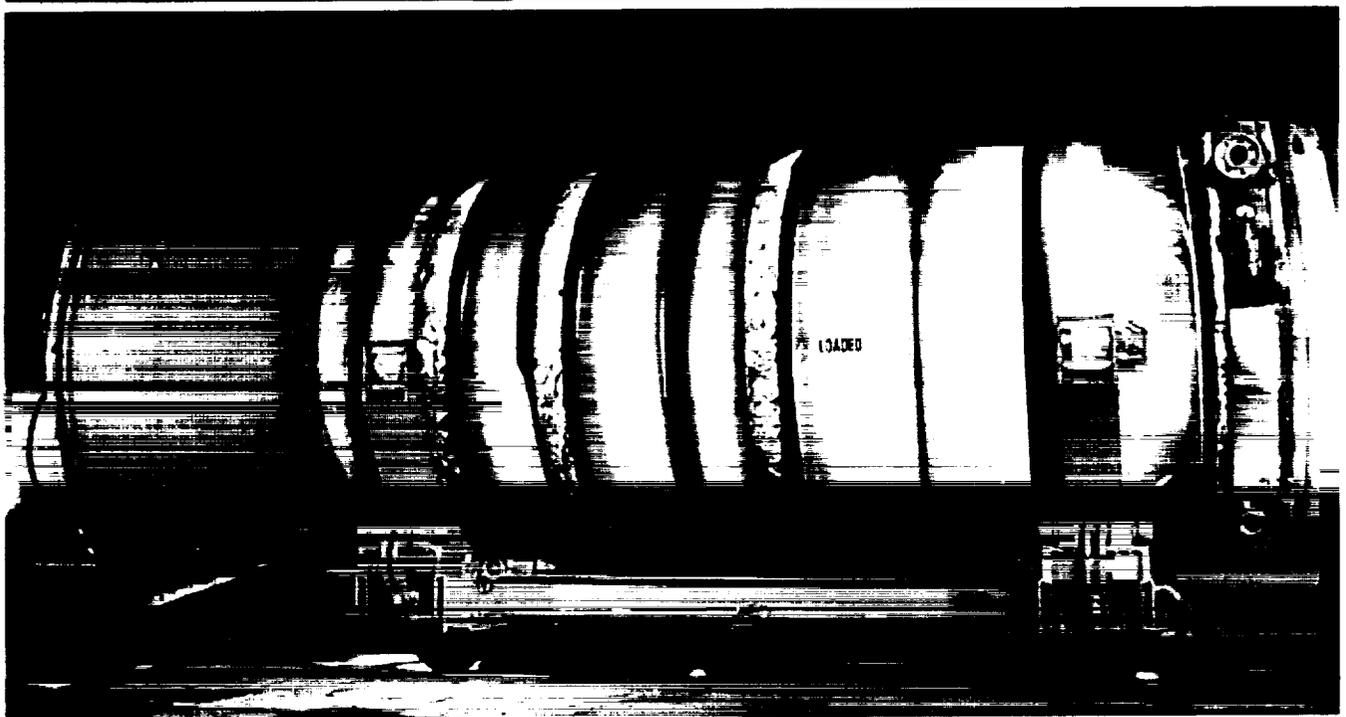
Photo 12: Aft Skirt Post Flight Condition

TPS on the external surface of both aft skirts was intact and in good condition

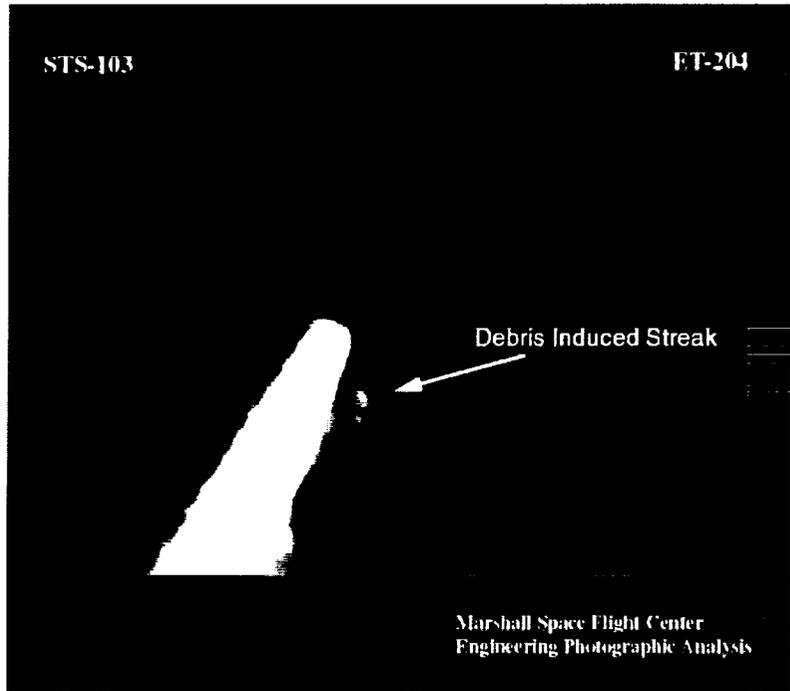
Figure 7. Debris Induced Streak Observed by ET-204

A debris-induced streak was observed in the SSME plumes at time 354:00:50:33.789 UTC from video camera ET-204.
