Debris/Ice/TPS Assessment and Integrated Photographic Analysis of Shuttle Mission STS-99

**DEBRIS/ICE/TPS ASSESSMENT
AND
INTEGRATED PHOTOGRAPHIC ANALYSIS
OF
SHUTTLE MISSION STS-99**

11 February 2000

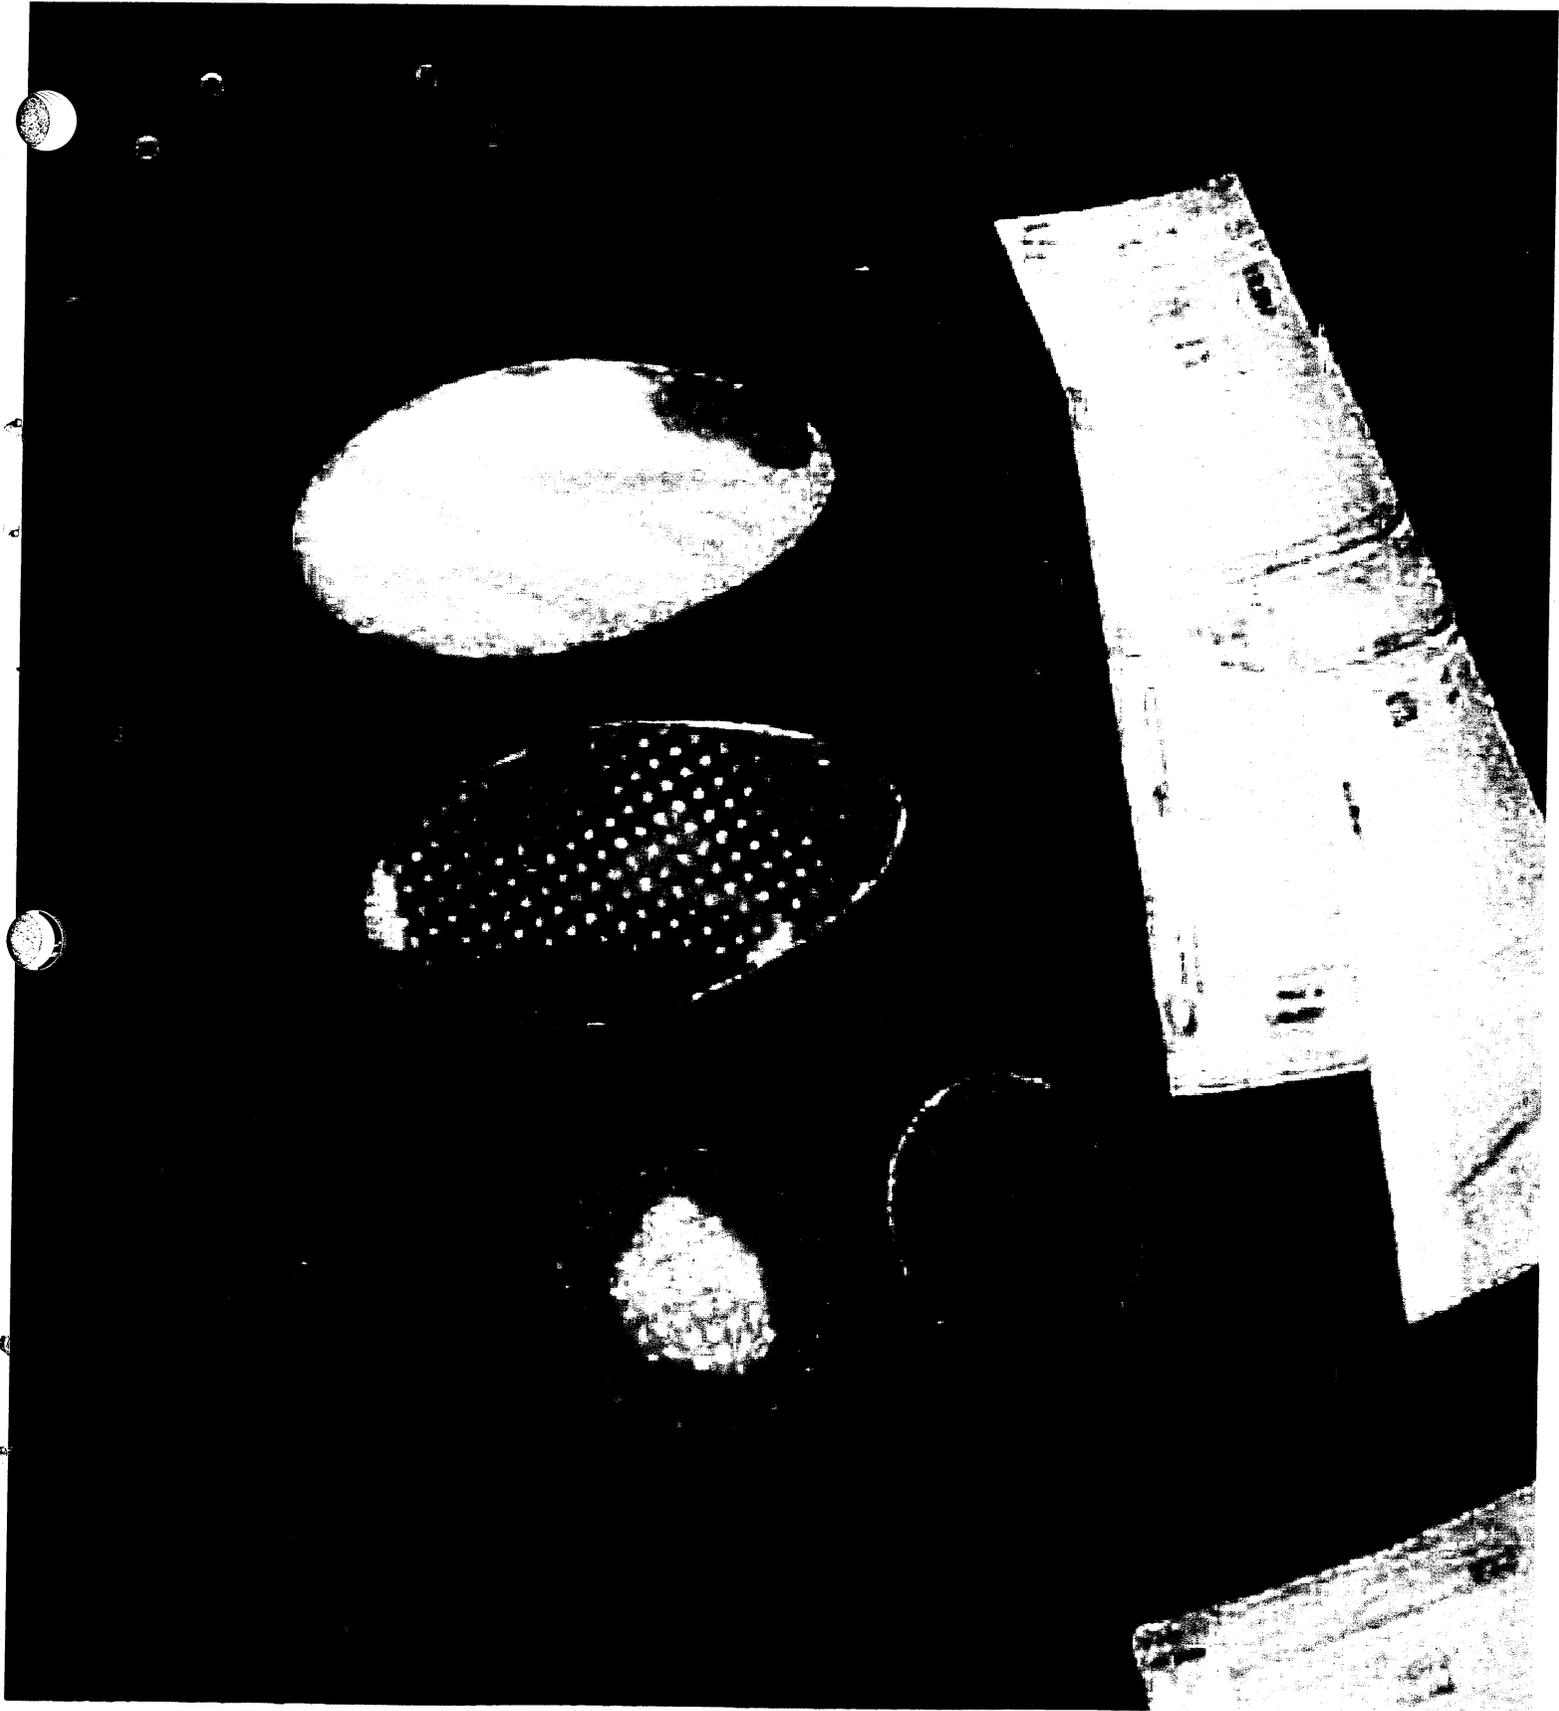
Photo 2: Discolored FRCS Thruster Covers

All RCS thrust paper covers were intact but somewhat wet due to recent rain

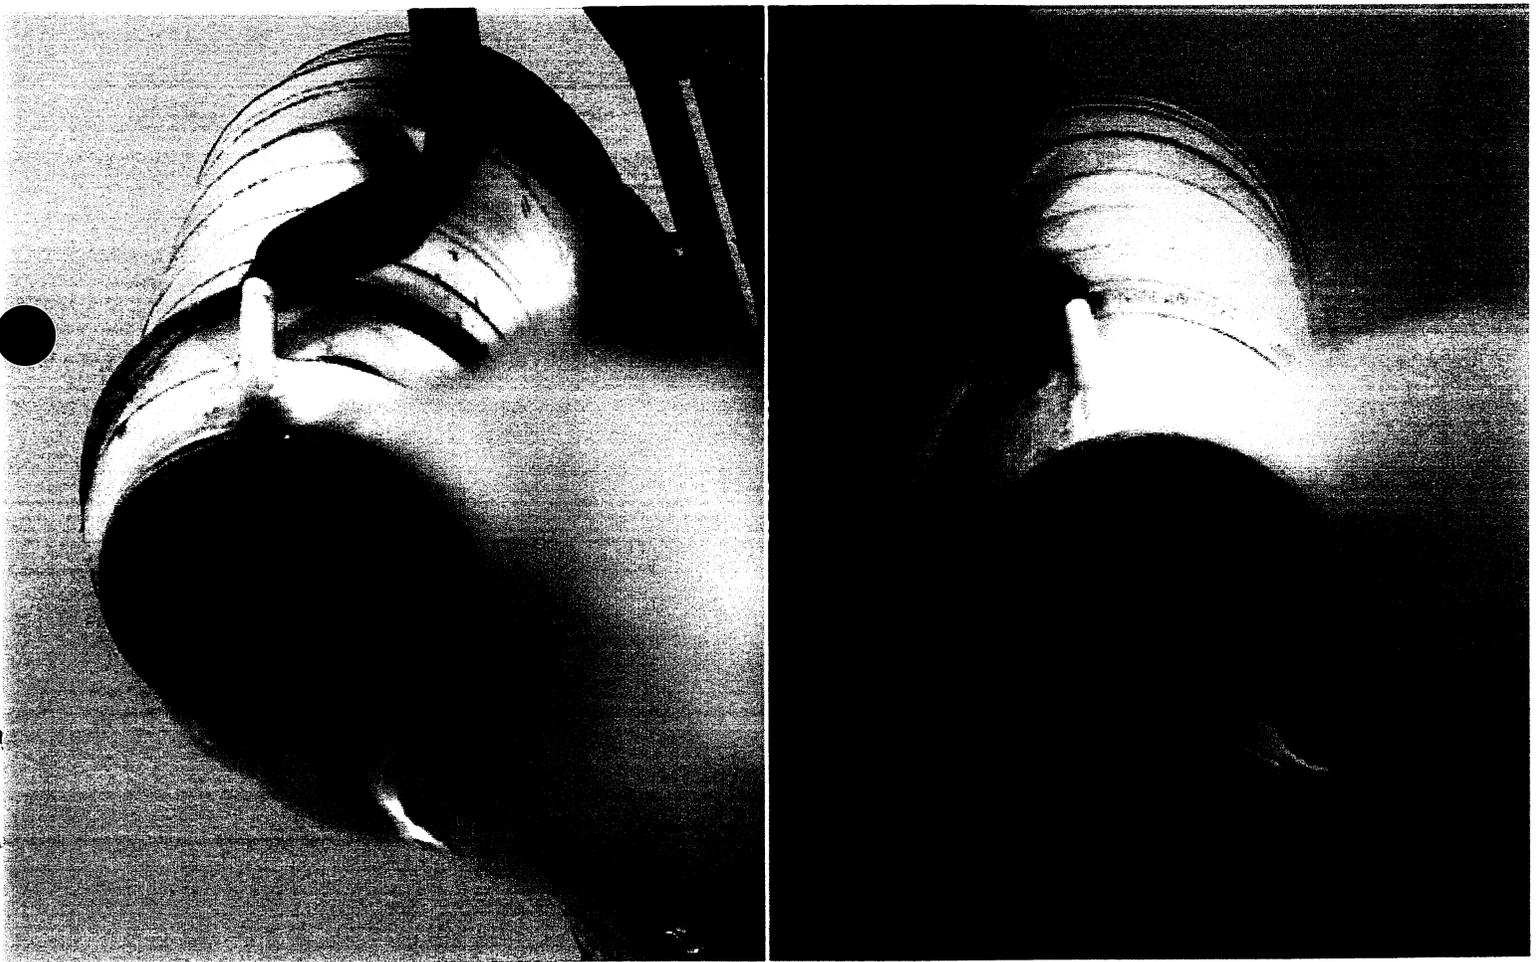
Photo 3: Icicles of GOX Vent Ducts

At 12:25 GMT (0725 local), the Final Inspection Team on the FSS 255-foot level detected icicles on the exit planes of the GOX vent ducts: five on the south duct and four on the north duct. The largest icicles were estimated to be 8 inches long by 1 inch in diameter and approximately 40 pounds per cubic foot density. The weather conditions at the time – relatively cool temperatures, strong northwesterly 14-knot winds, and light rain/mist – were causing the icicles to grow in size as well as create new icicles. These conditions were expected to continue until 1200 hours local. The Final Inspection Team made a determination the icicles would eventually break loose and the falling pieces of ice pose an impact threat to Orbiter left wing tiles. The Launch Team in the LCC was notified accordingly. Disposition of the IPR included a report from Launch Accessories that the GOX vent duct heated nitrogen purge was operating with specification at 180 degrees F.

The Final Inspection Team on the FSS 255-foot level detected icicles on the exit planes of the GOX vent ducts: five on the south duct and four on the north duct. The largest icicles were estimated to be 8 inches long by 1 inch in diameter and approximately 40 pounds per cubic foot density.

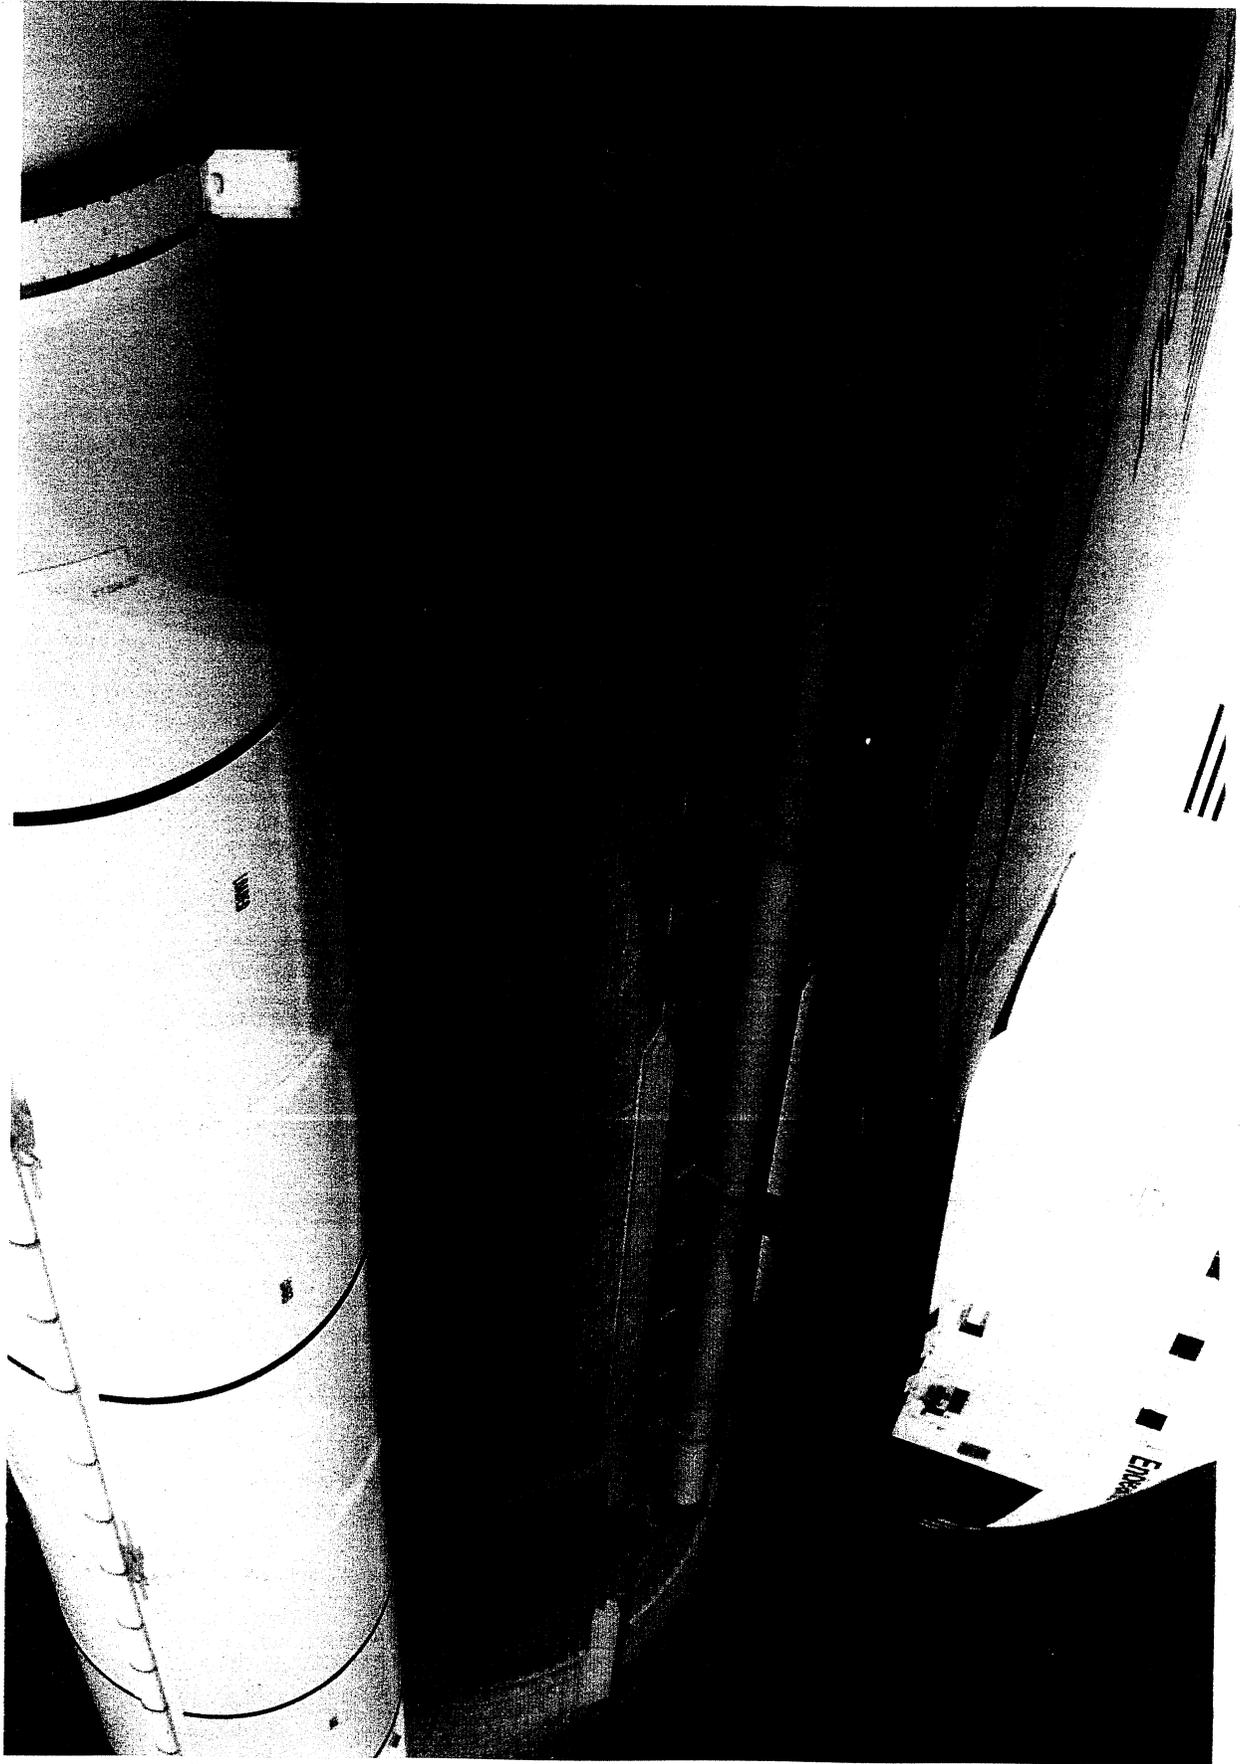
Photo 8: Frost on LH2 Tank

Some patches of frost had formed in the +Y+Z quadrant, but quickly melted. Surface temperatures ranged from 32 degrees Fahrenheit range in the frosted areas to 43 degrees in the sunlit areas. Note frost on LO2 tank barrel section.

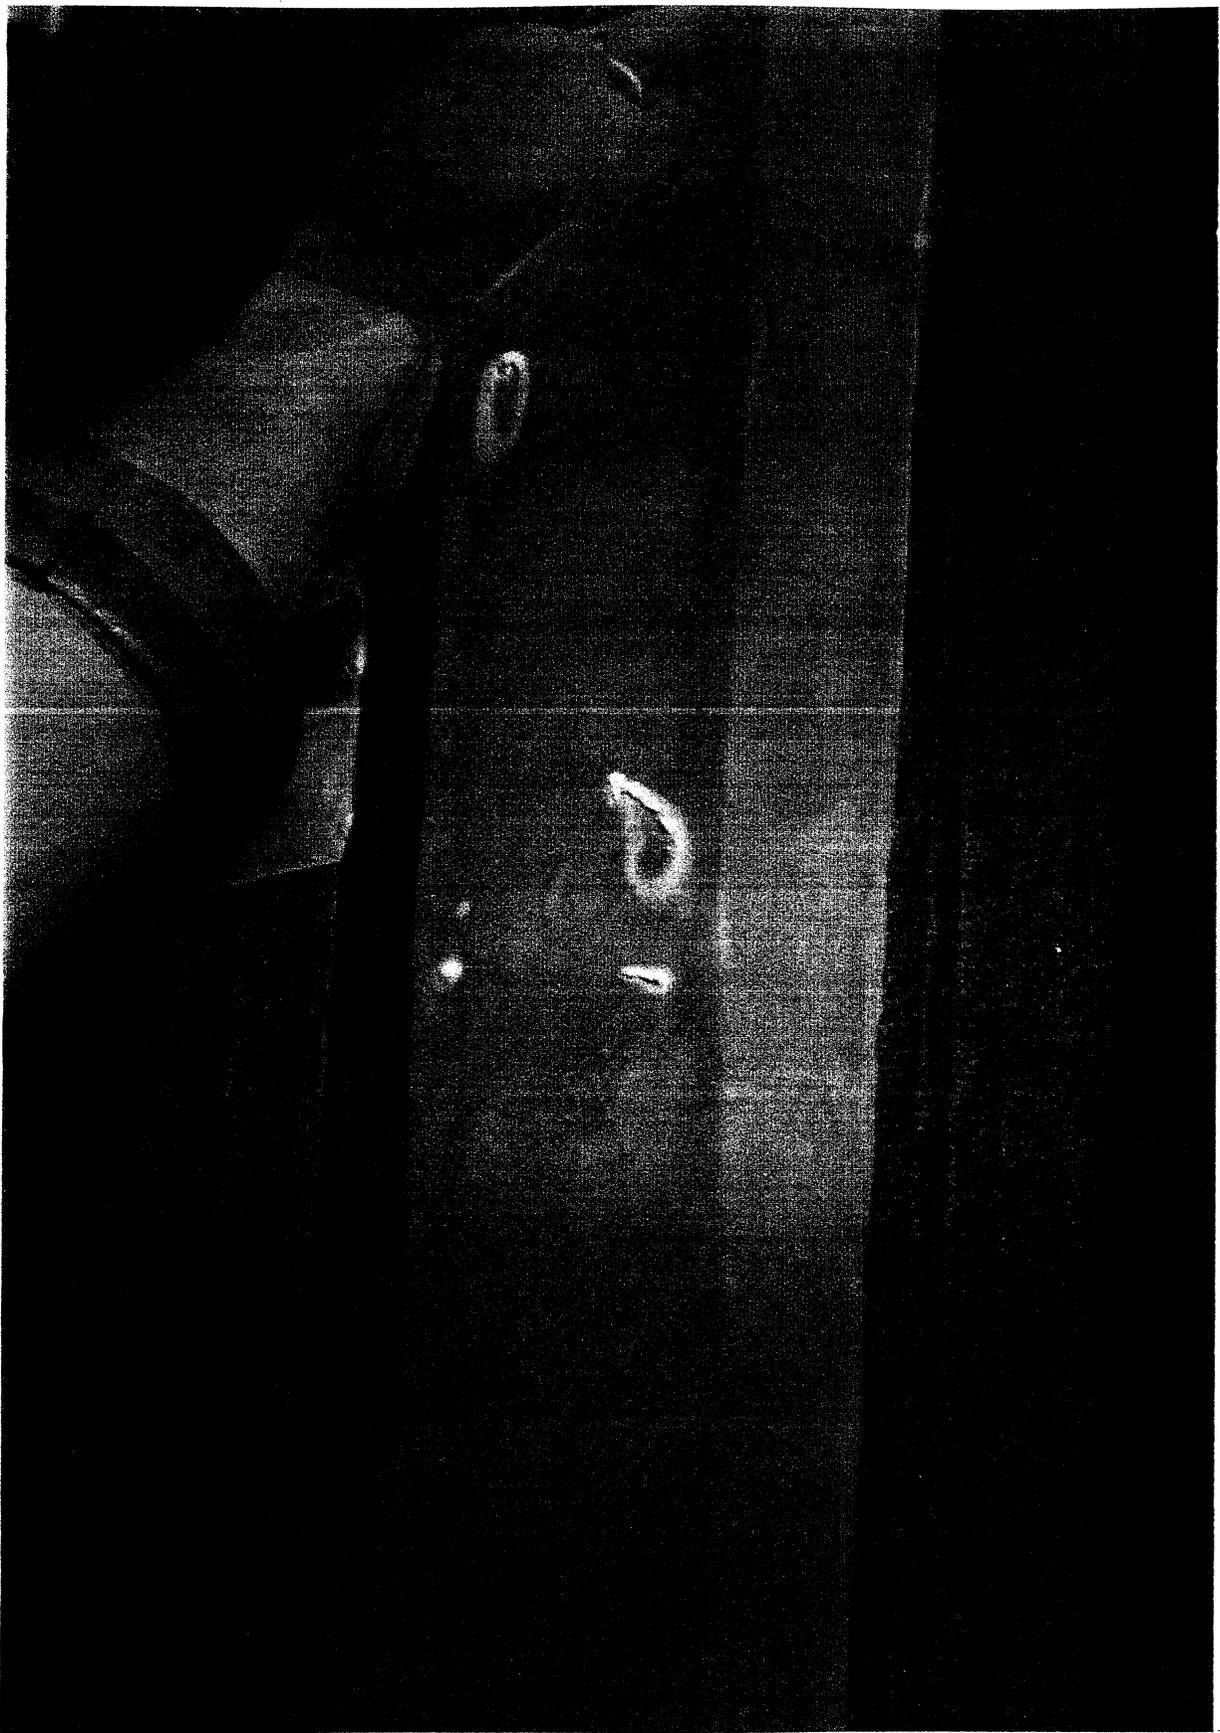
Photo 11: Cracks in Longeron TPS

The cracks most likely resulted from multiple cryogenic loading thermal/mechanical induced stresses in the TPS outer layer and localized defects in the thick BX-250 closeout foam. An assessment was performed that consisted of two parts addressing ET thermal/structural integrity for flight and possible debris threat to Orbiter lower surface tiles. With all the data taken, there was no evidence of debond and the condition appeared to consist of shallow surface cracks only.

Since the cracks exhibited no offset, foam adhesion to substrate and sidewall longeron ribs provide adequate strength, which would preclude large pieces of foam from coming loose. Only normal ablation would occur. Aero/thermal simulation data showed no foam loss when shallow cracks were present in the material. Therefore, there was no threat from TPS debris nor was there any concern about ice debris since frost, but no ice, had formed in association with the cracks.

Prior to the on-pad inspection at T-3 hours, OTV surveillance detected two large frost spots and two possible cracks in the +Y longeron TPS closeout. The Final Inspection Team later discovered a total of four cracks. Since this condition was not an LCC Appendix F violation for acreage icing nor covered by the NSTS-08303 acceptance cases, further assessment was required.

Based upon the integrated assessment, the condition was accepted for flight by MR.

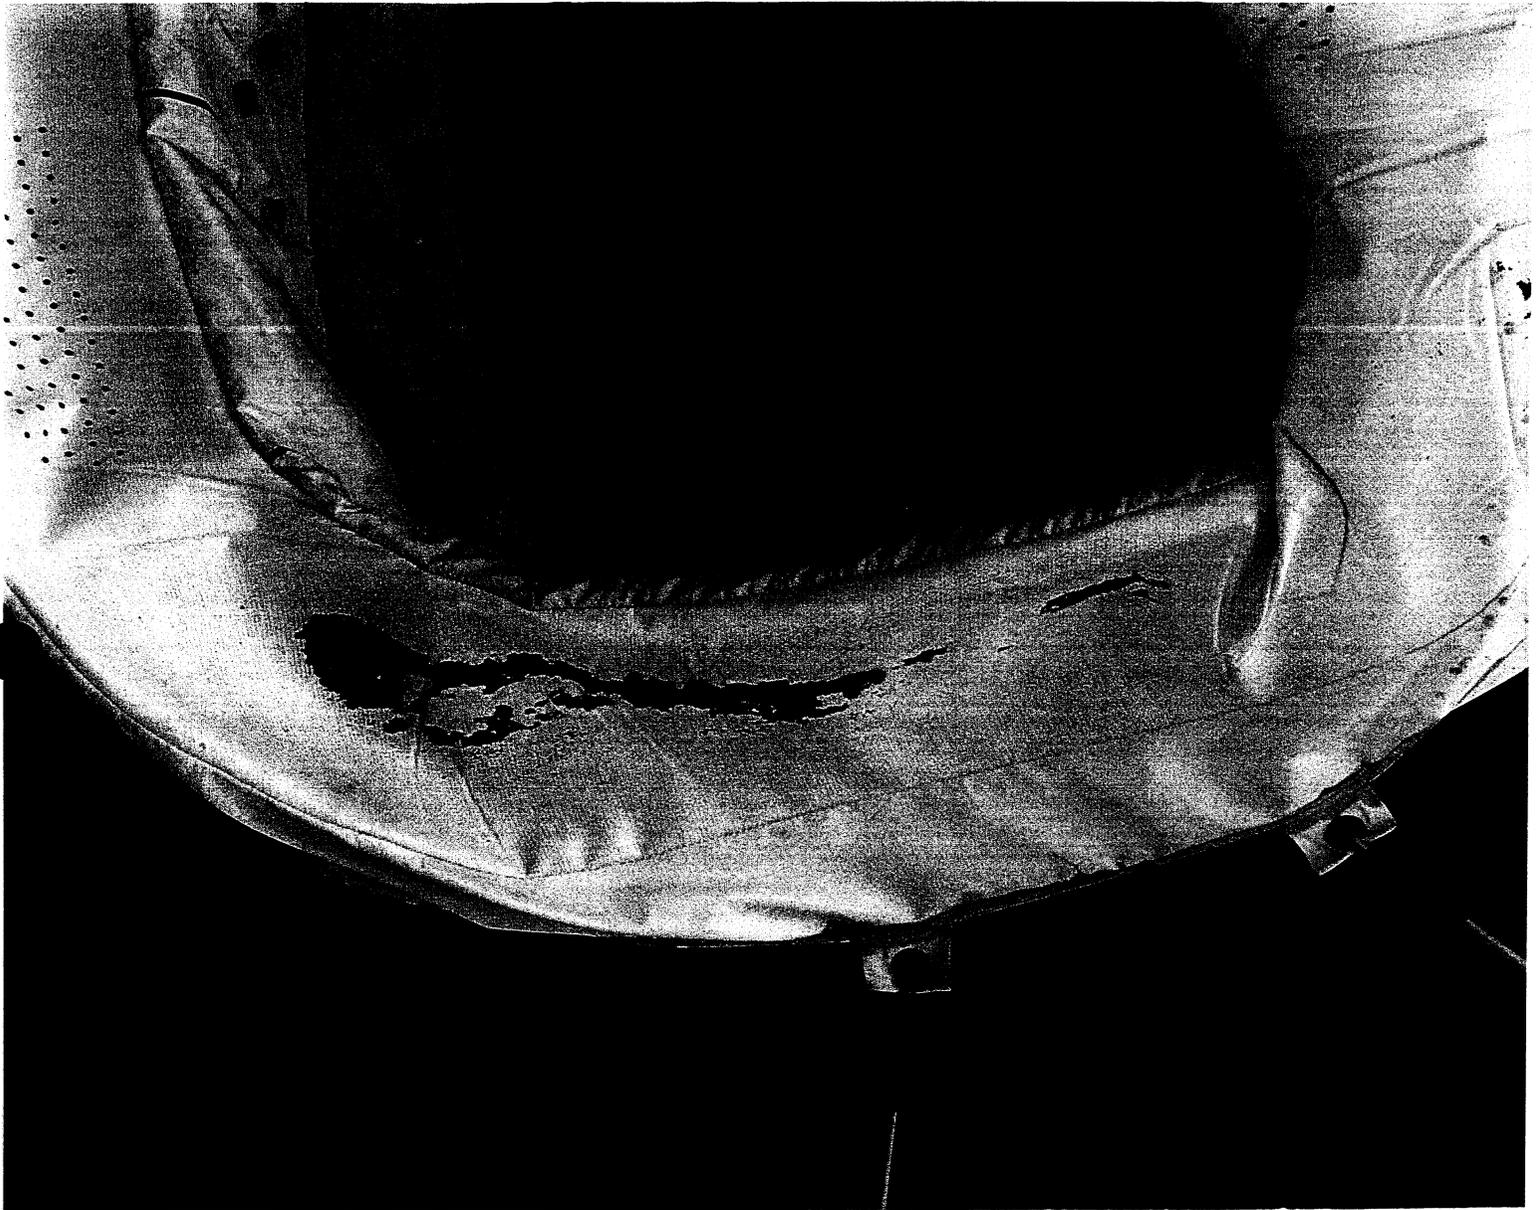
Photo 14: ET Topcoat of GOX Vent Seal

Topcoat adhered to a 12 inch long by 1-1/2 inch wide area on the northeast GOX vent seal. This had occurred during GOX vent hood retraction.

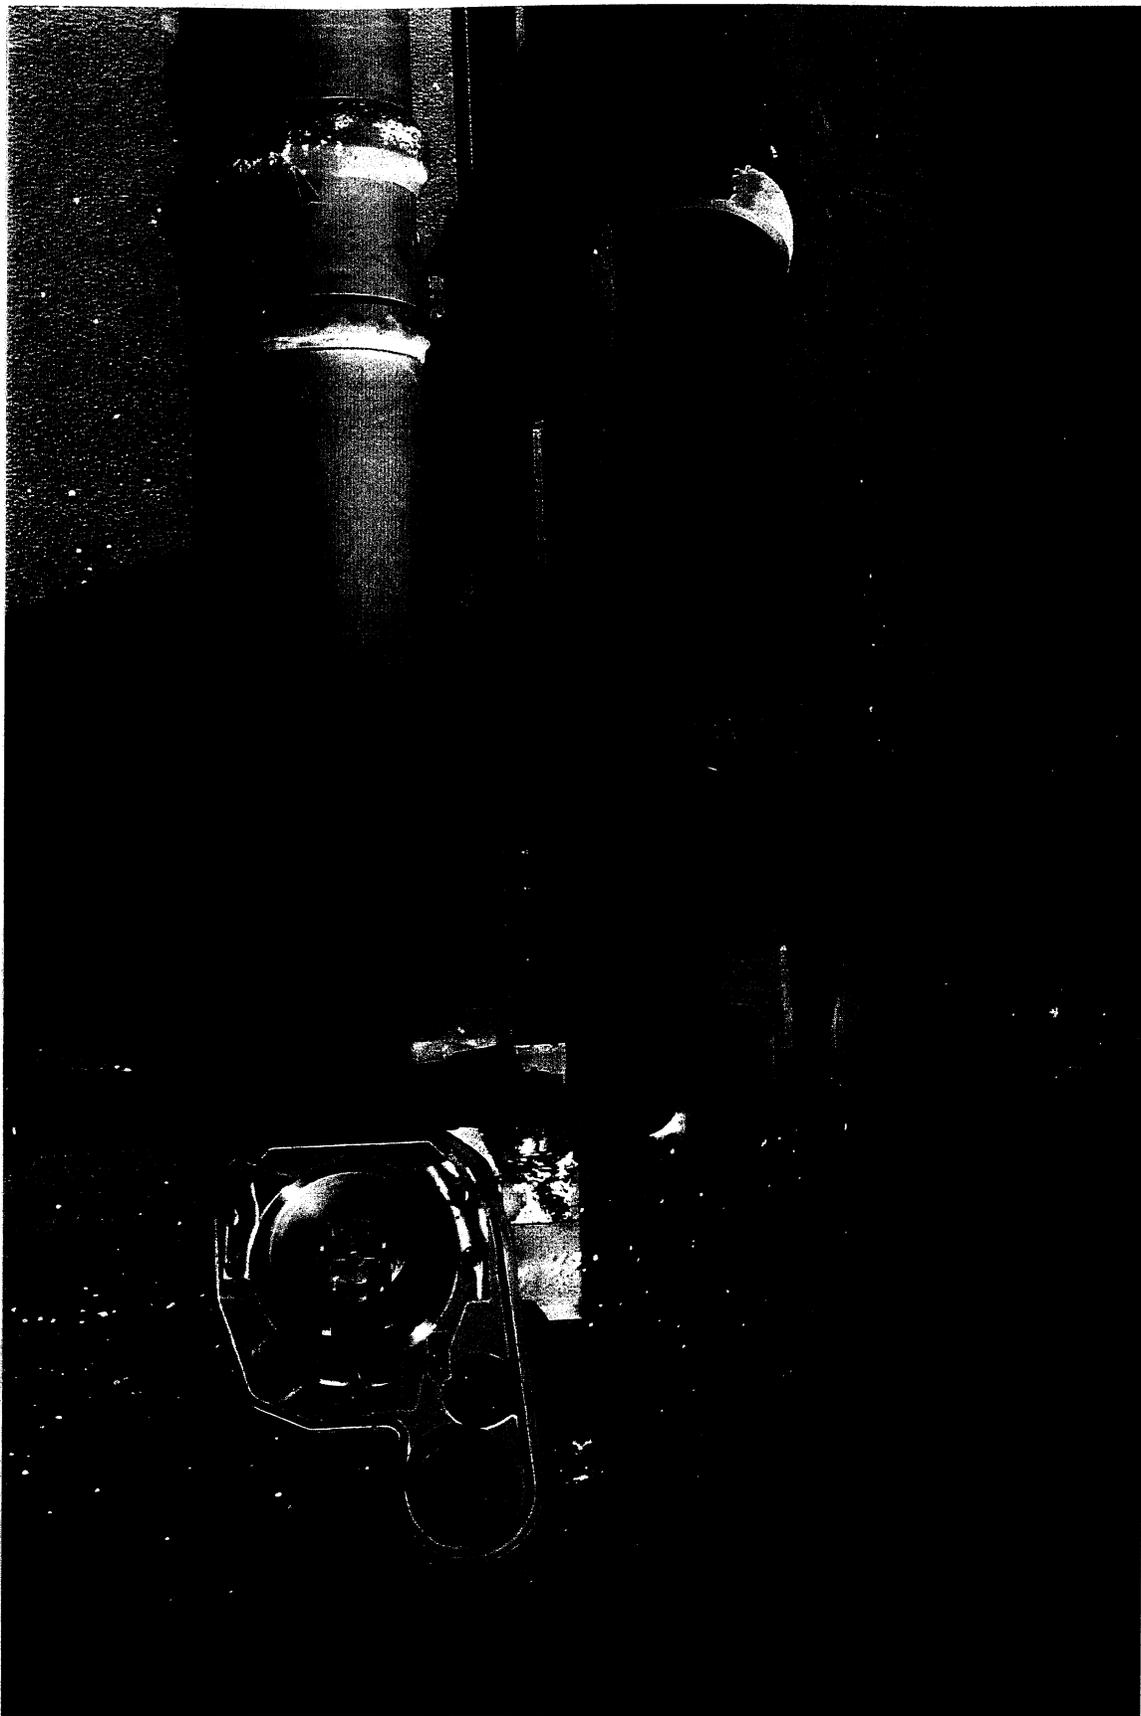
Photo 18: LH2 Tank after Separation

There was no damage to the LO2 ET/ORB umbilical except for typical erosion of cable tray TPS. Erosion of TPS on the LO2 feedline flange closeout was also typical. Note ice still remaining in feedline bellows. Blisters and a 10-inch by 10-inch area of missing surface rind were detected on the +Y thrust strut. This phenomenon had not been seen before in this area. Also, the TPS in the area of the longeron closeout cracks appeared to be intact.

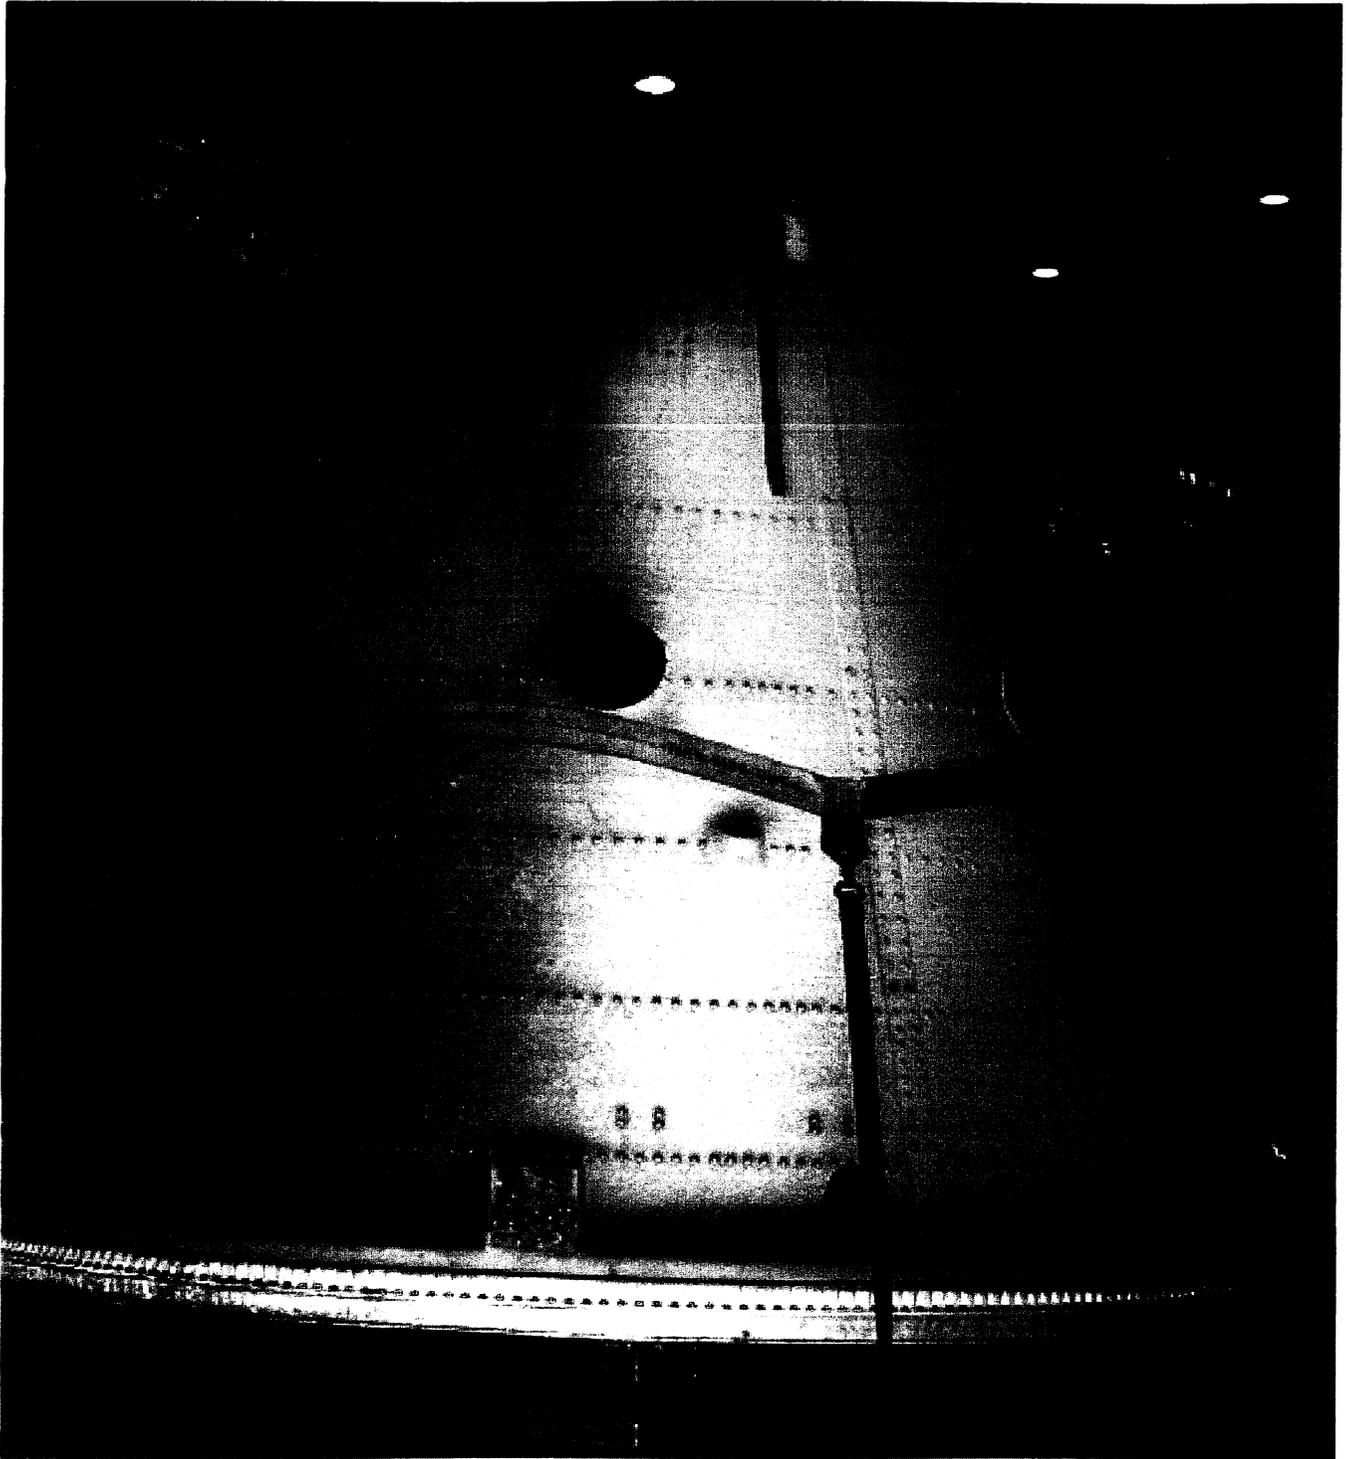
Photo 21: Frustum Post Flight Condition

The frustums exhibited no debonds/unbonds or missing TPS. All eight BSM aero heat shield covers had locked in the fully opened position though the left two cover attach rings on the left frustum had been deformed by the parachute risers.

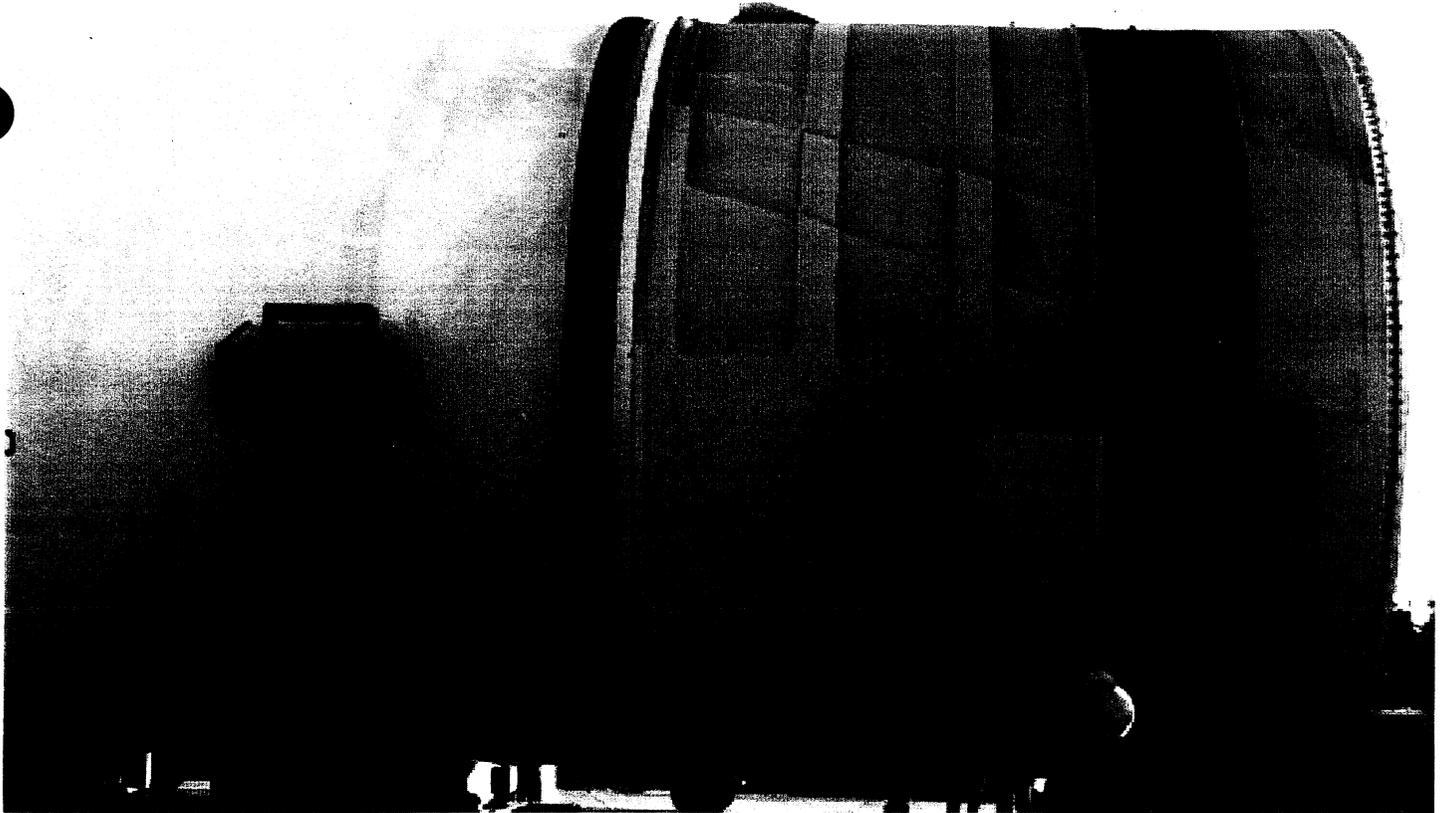
Photo 22: Forward Skirt Post Flight Condition

The forward skirts exhibited no debonds or missing TPS. RSS antennae covers/phenolic base plates were intact.

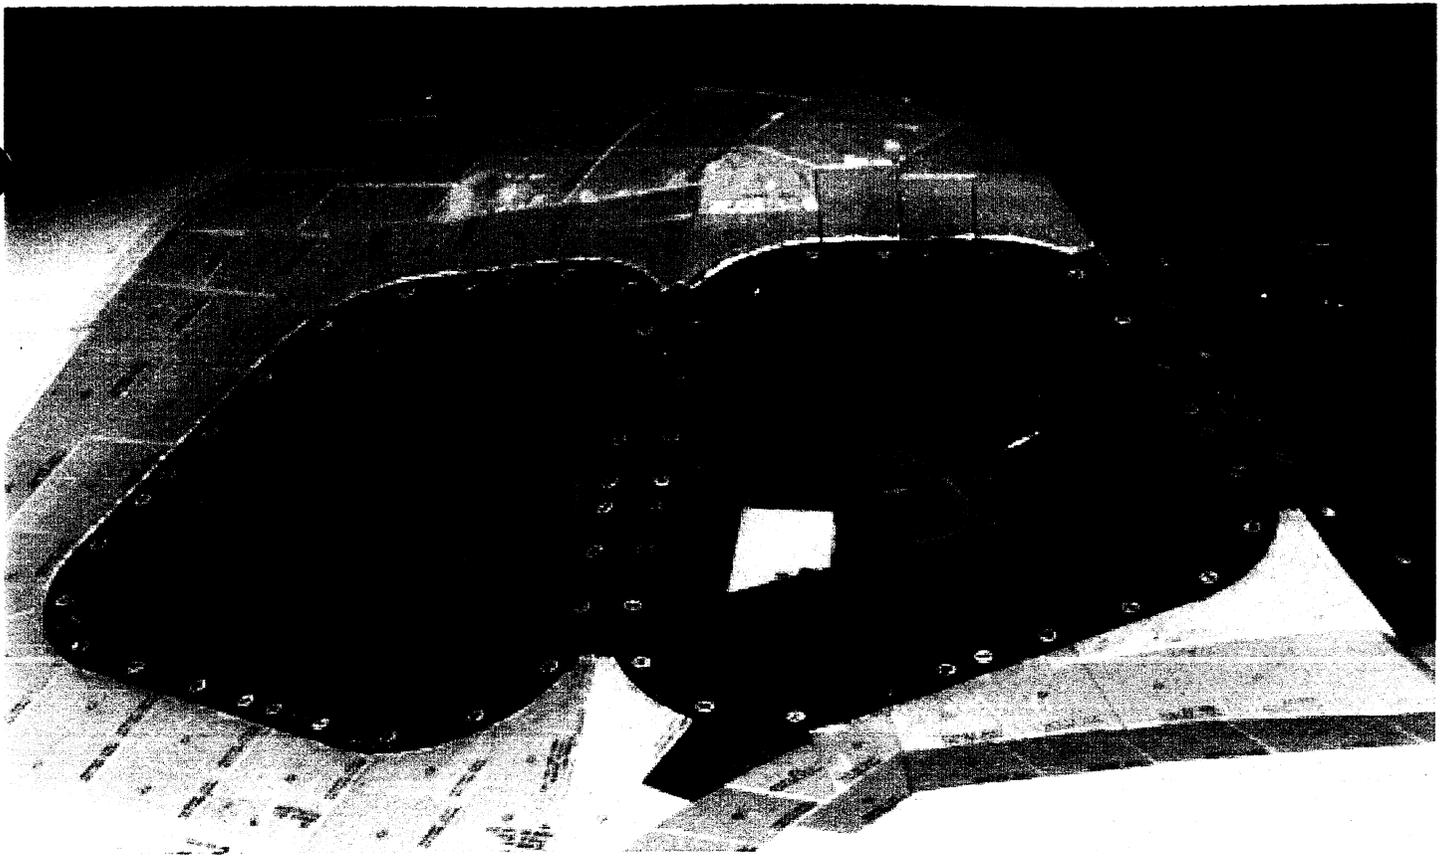
Photo 30: Windows

Damage sites on the window perimeter tiles was less than usual in quantity and size. Hazing and streaking of forward-facing Orbiter windows was moderate. This damage may be attributed to impacts from FRCS thruster paper covers and the RTV adhesive.

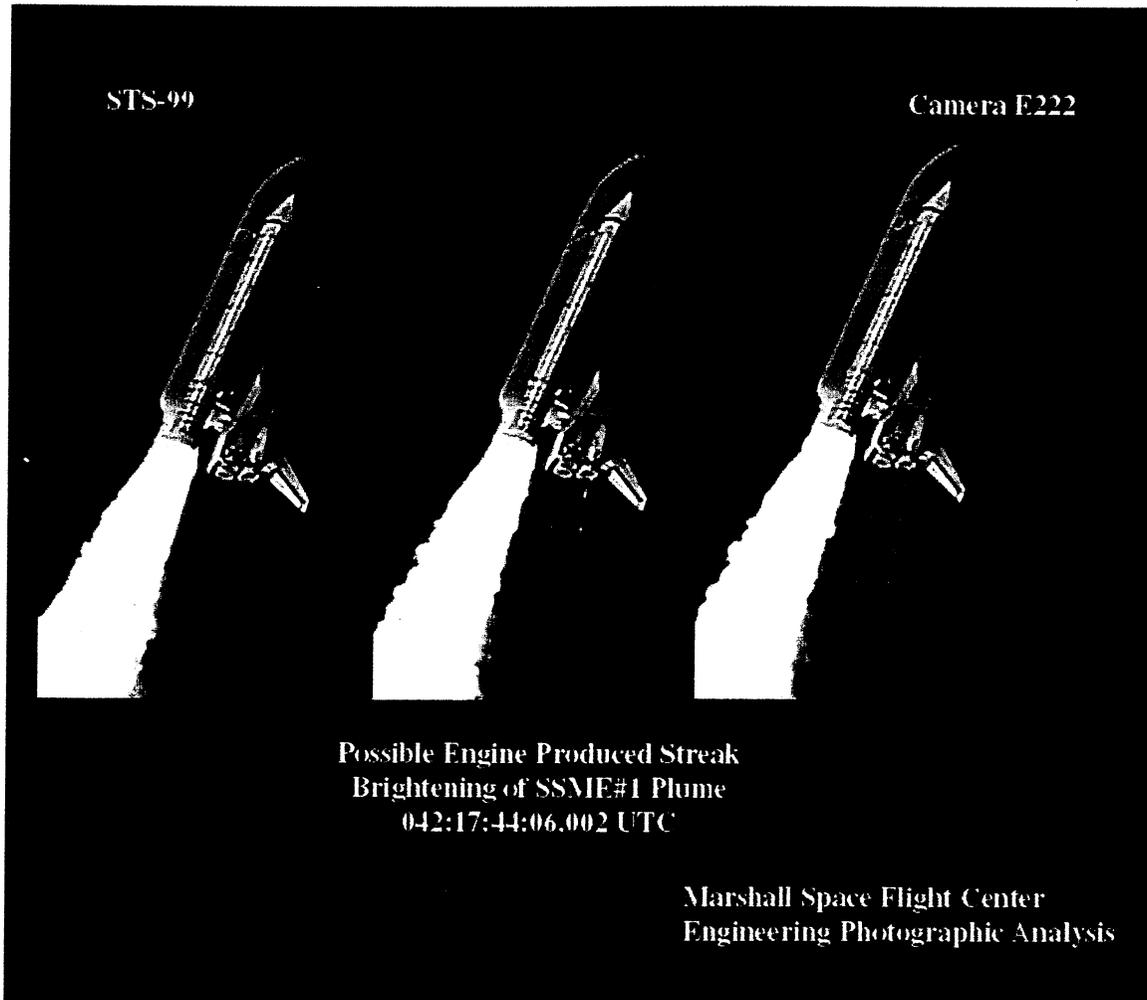
Figure 1. Brightening of SSME Plumes

A brightening of the entire SSME Plume was observed at 042:17:44:06:002 UTC by Film Camera E222. Multiple Mach diamonds are more visible during the brightening of the plume.

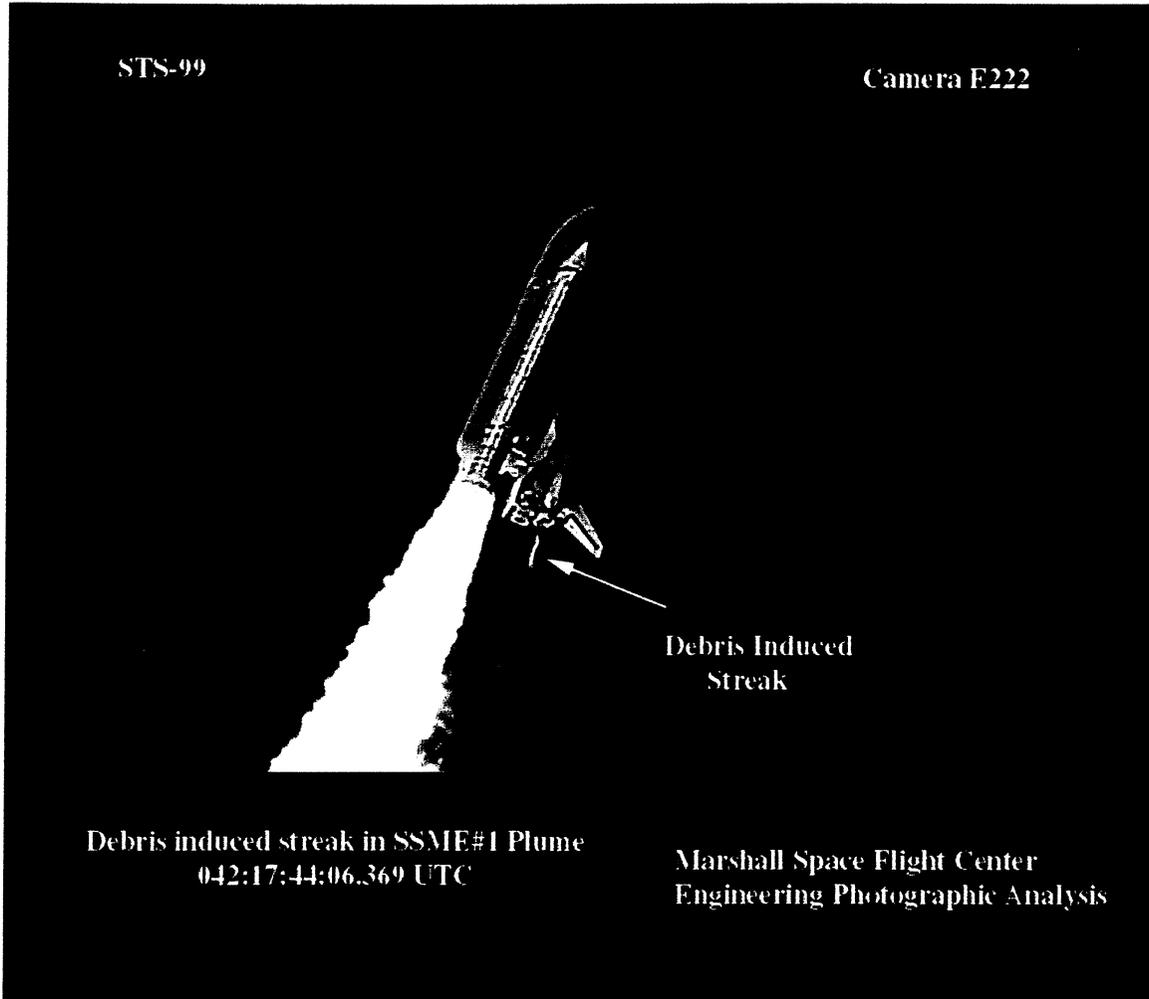
Figure 2. Debris Induced Streak in SSME Plume

A bright debris induced streak during vehicle ascent was observed by Film Camera E222 at time 042:17:44:06.379 UTC.

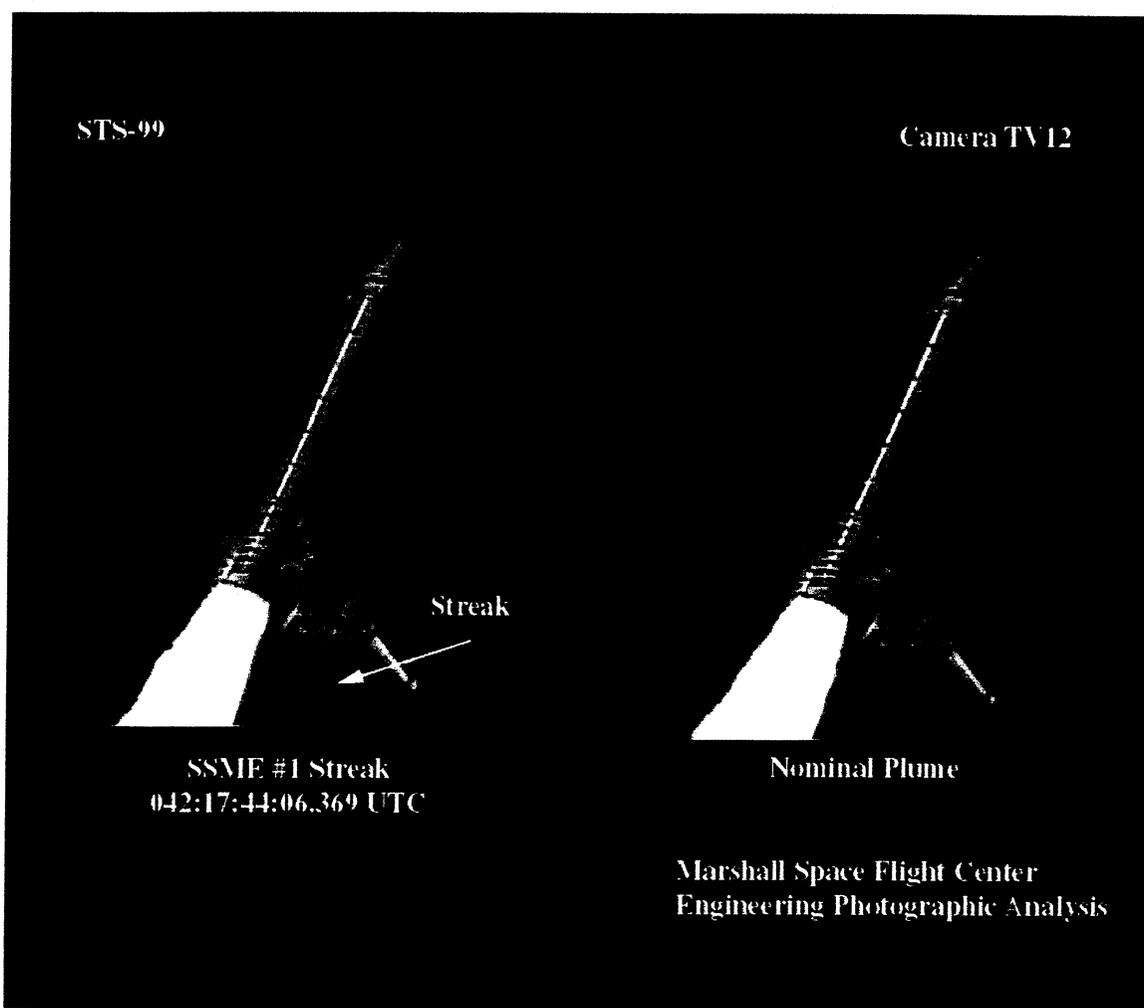
Figure 3. Debris Induced Streak Observed by Video Camera TV-12

Another view of the debris induced streak in SSME#1 plume during ascent captured by Film Camera 222. Film Camera E222 operates at 100 fps while TV-12 operates at normal video capture speeds, 30 fps. Timing from the film cameras is in general more accurate than timing from video cameras and therefore film and video yield differing times for events.

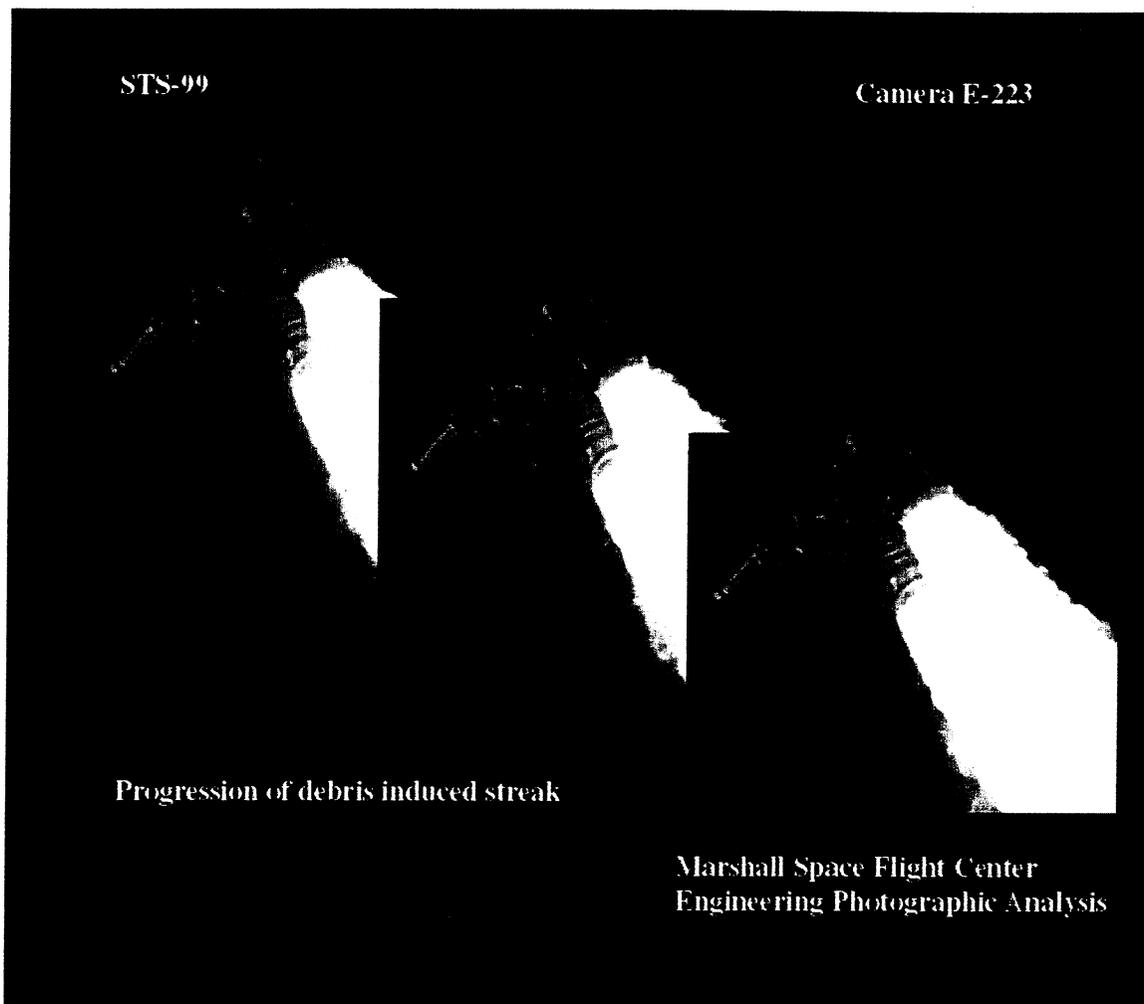
Figure 4. Streaks in SSME Plumes

A sequence of frames from the 35mm Film Camera E223 showing two streaks originating almost simultaneously in the SSME plumes. This event was timed at 042:17:44:23.862 UTC by Film Camera E222.
