Debris/Ice/TPS Assessment and Integrated Photographic Analysis of Shuttle Mission STS-99

**DEBRIS/ICE/TPS ASSESSMENT
AND
INTEGRATED PHOTOGRAPHIC ANALYSIS
OF
SHUTTLE MISSION STS-99**

11 February 2000

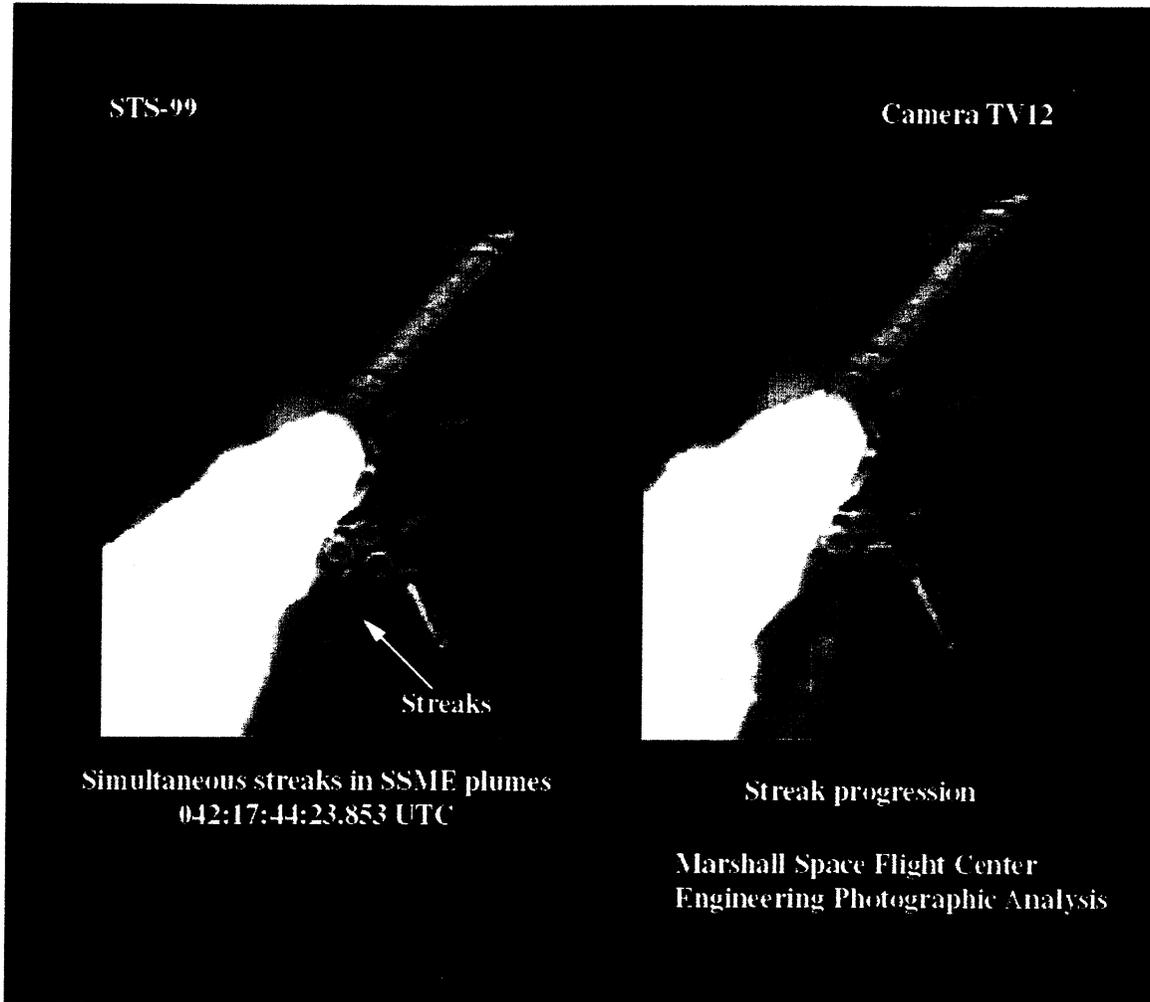
Figure 5. Simultaneous Streaks Observed by Video Camera TV-12

Another view of the simultaneous debris induced streaks in SSME plumes during ascent is shown in Figure 4. This event occurred at approximately 042:17:44:23.853 UTC according to TV-12 timing.

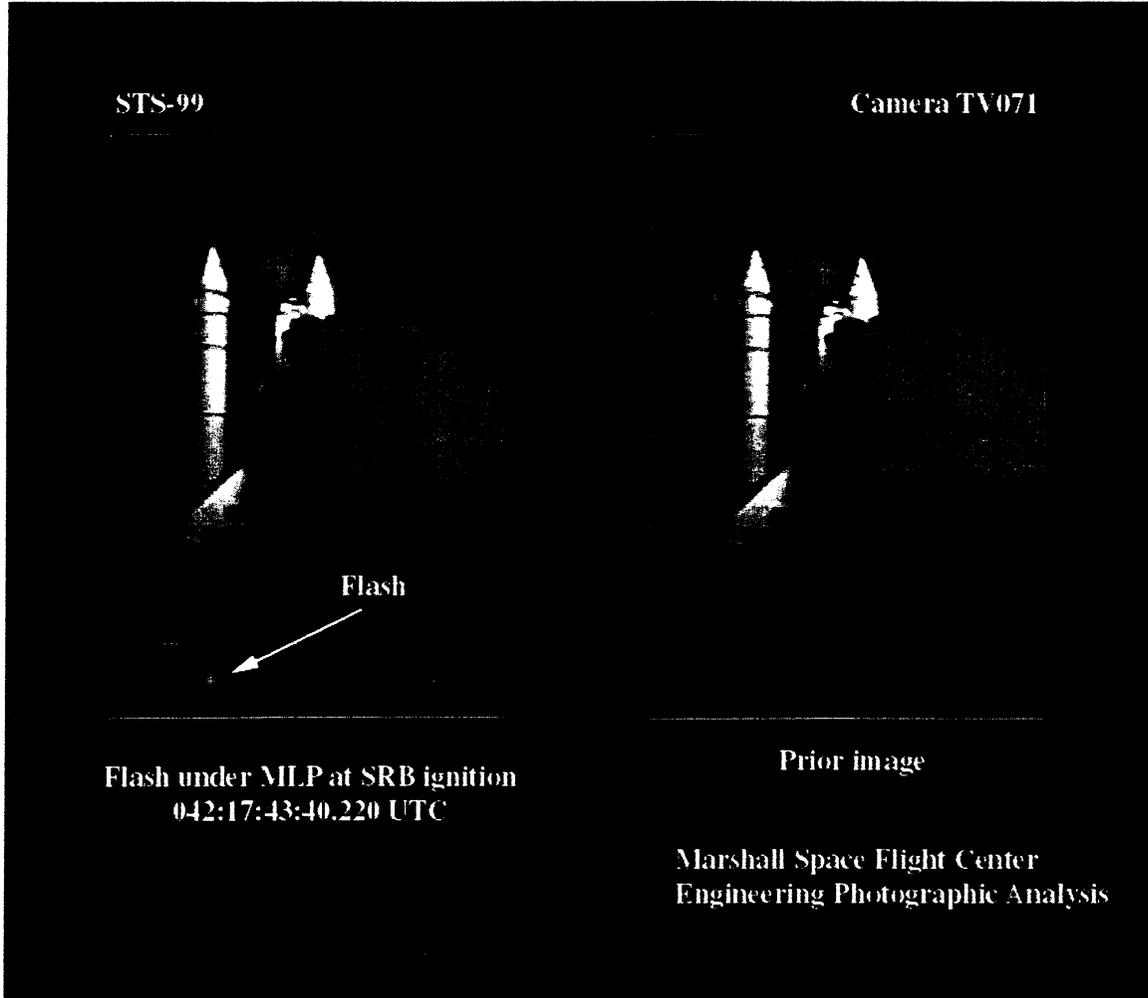
Figure 6 . Flash under MLP at SRB Ignition

A brief flash was observed under the Mobile Launch Platform (MLP) just after SRB ignition, the event shown in Figure 6 was timed at 042:17:43:40.220 UTC.

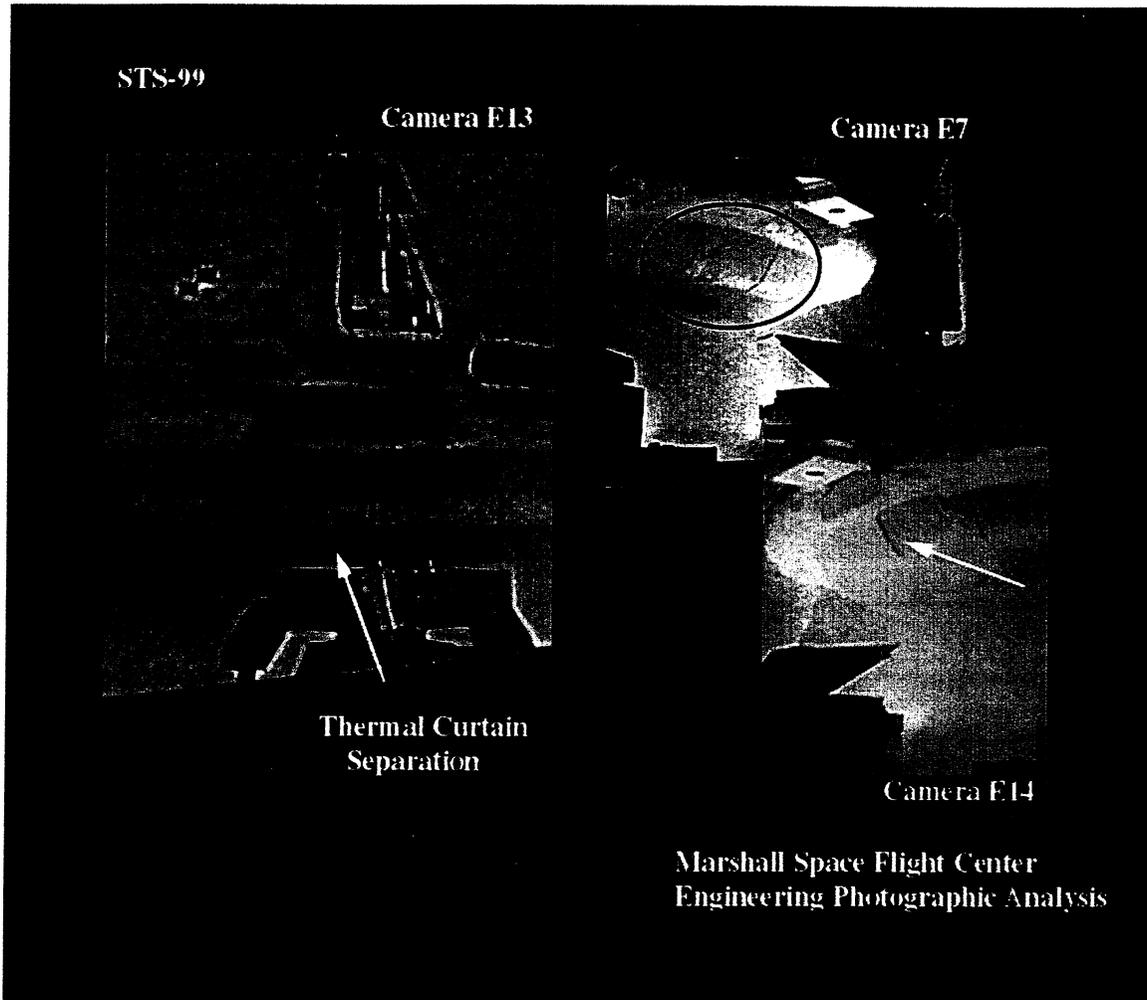
Figure 7. Separated Thermal Blankets

The following views from Film Cameras E7, E13, and E14 show separation of adjacent SRB thermal blankets. Film Camera E13 views SRB Holddown Post M-6. The thermal blanket was separated and stitching could be seen protruding through the separated blankets. Film Camera E7 views SRB Holddown Post M-4 and Film Camera E14 views SRB Holddown Post M-8. The thermal blanket was separated in these views, but no thermal insulation was visible.

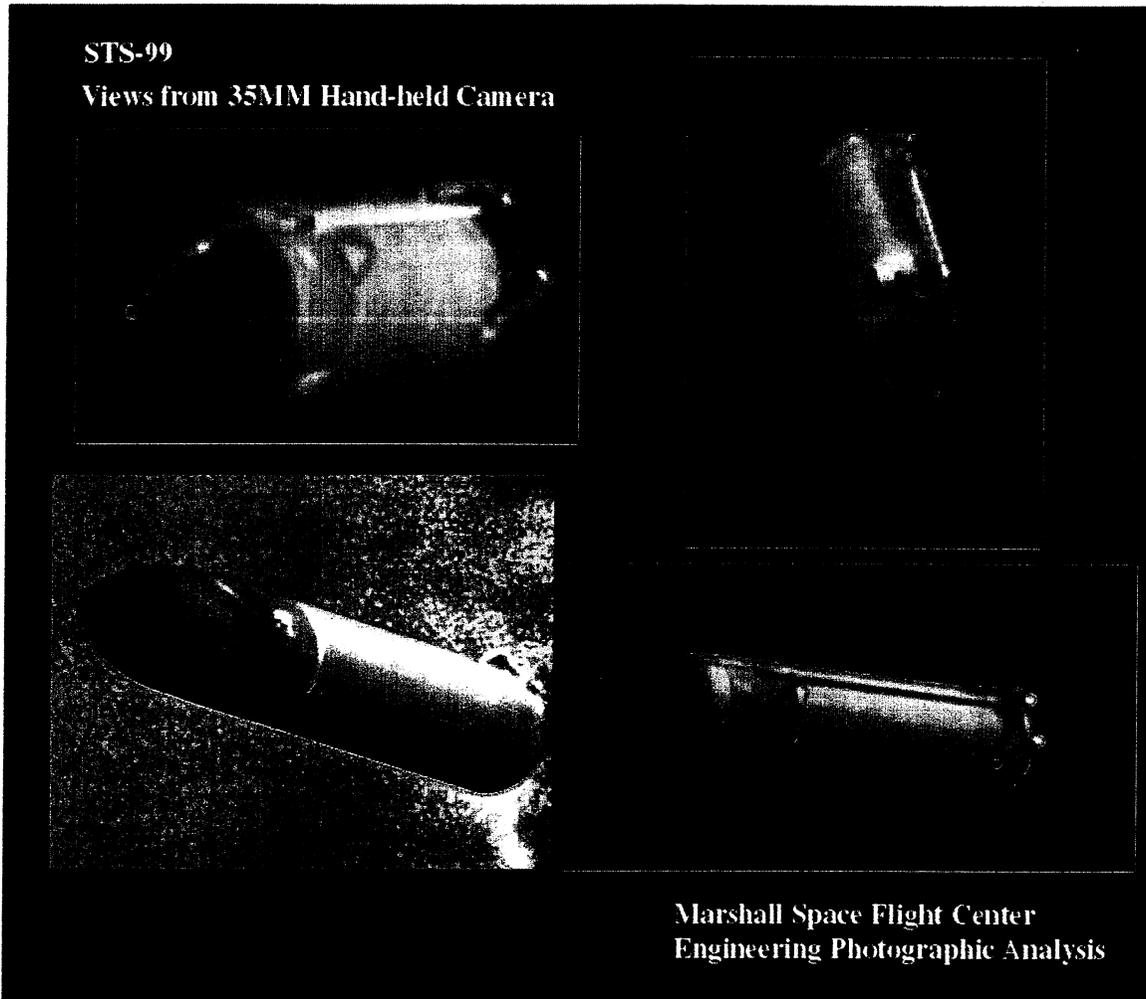
Figure 8. View of the ET from On-board 35mm Hand-held Camera

Views of the External Tank (ET) after separation from vehicle, showing the condition of the Thermal Protective Surface (TPS) and ET venting. No obvious or large scale TPS divoting is observed, scarring of TPS from BSM motor firing appears normal. Typical venting from the GUCP was easily observed due to the lighting conditions at the time of ET separation.

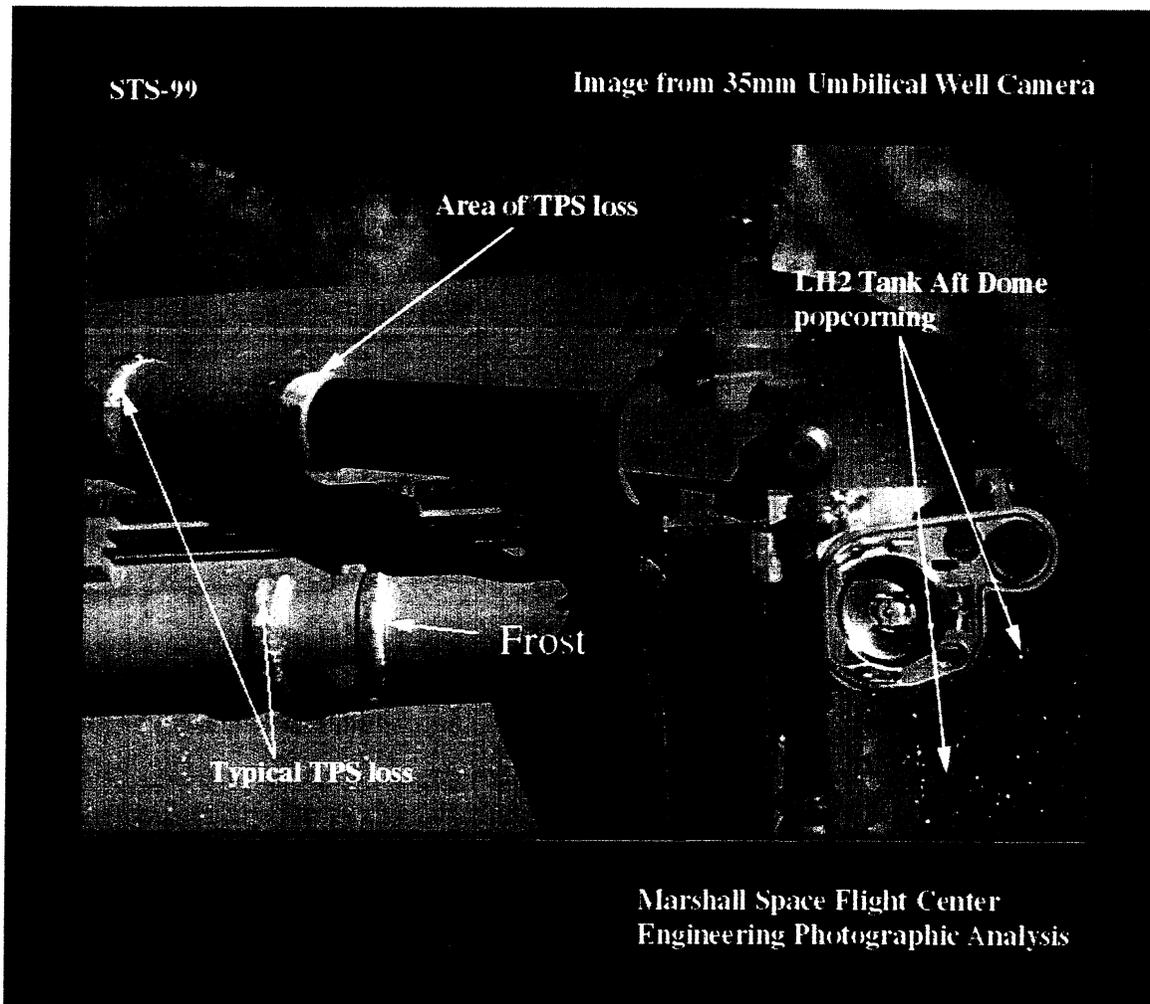
Figure 10. Aft Dome TPS Loss

Areas of TPS loss on the aft of the ET and frost on the LO2 feedline bellows are shown. Typical popcorning was observed on the aft dome, aft thrust struts, and the LO2 feedline. Large area of TPS surface material on the aft right thrust strut is gone.

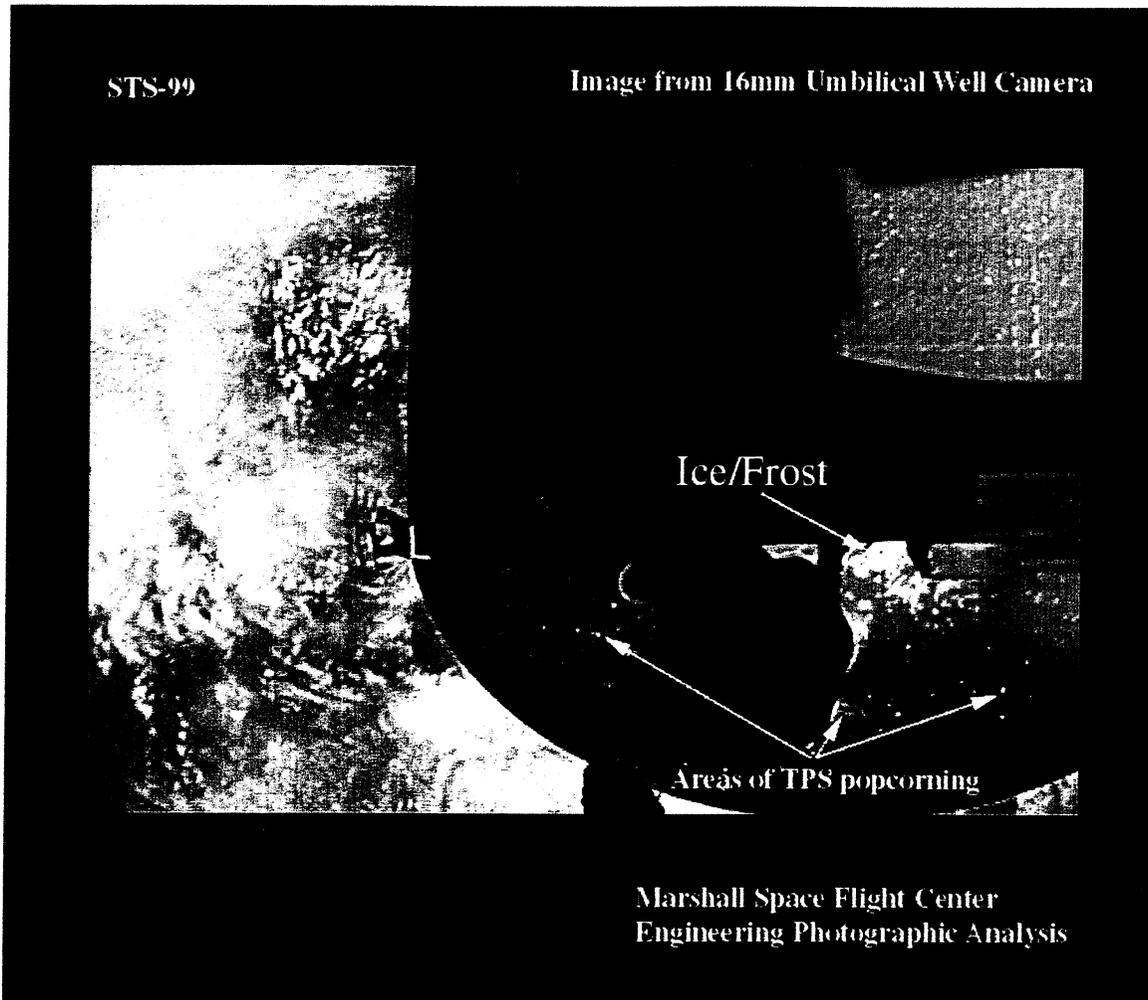
Figure 11. Aft Dome Popcorning

Popcorning was noted on the aft dome. Typical ice/frost formations were observed near aft ET/Orbiter diagonal cross strut attach structure.
