# SUBSCALE COMPOSITE LIQUID OXYGEN TANK TESTING

Lockheed Martin Space Systems Company – Michoud Operations  
New Orleans, LA 70129

## ABSTRACT

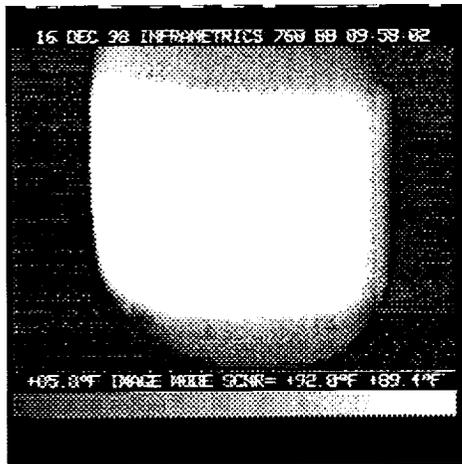
Figure 4: Thermograph of a subscale bottle

These inspections showed no unacceptable defects or anomalies. LM engineers then deemed the bottles acceptable for use.

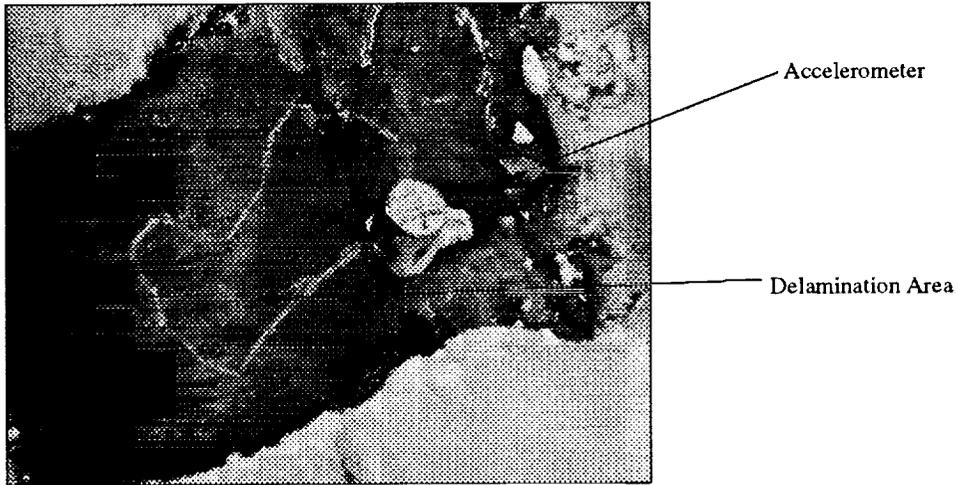
The test bottle was then sent back to LM for additional inspection. A small delamination, approximately 8 cm by 5 cm, was found in the center of the barrel section of the bottle using hand-held ultrasonic inspection. See Figure 9. Figure 10 shows a phased-array ultrasonic inspection photograph showing the delamination. Due to the location of the delamination next to the disbonded accelerometer, and lack of indication of delaminations in earlier NDE, it was determined that the delamination was likely caused by the accelerometer rattling between the foam and bottle. Based on these results, testing was shut down in order to develop and implement a recovery plan.

Figure 9: Photo of the delamination area, marked in yellow--note proximity to the accelerometer (metal cylinder), which became disbonded from the bottle during the first fixture checkout

**2.6 Recovery Plan and LO<sub>2</sub> Vibration Runs:** The recovery plan was developed by the LM-NASA team. First, as stated above, a failure analysis indicated that the bolt bending was likely caused by non-flat endcaps. The first part of the recovery plan was to correct this issue. The bottle endcaps were re-machined flat. The bottle and test fixtures were also re-machined to remove the damaged portions. It was also decided that shear pins would be added on each side, between the fixture and the endplate and between the endplate and the bottle. This would eliminate any movement, and prevent bolt bending. Lockwire was also deemed necessary, under the assumption that the wire would help keep the bolts in place and eliminate the possibility of preload loss.

The third step of the recovery plan was to verify the test bottle was still acceptable for test despite the delamination. A stress analysis showed that despite the delamination, the bottle still had more than adequate safety factors. See Table 3.

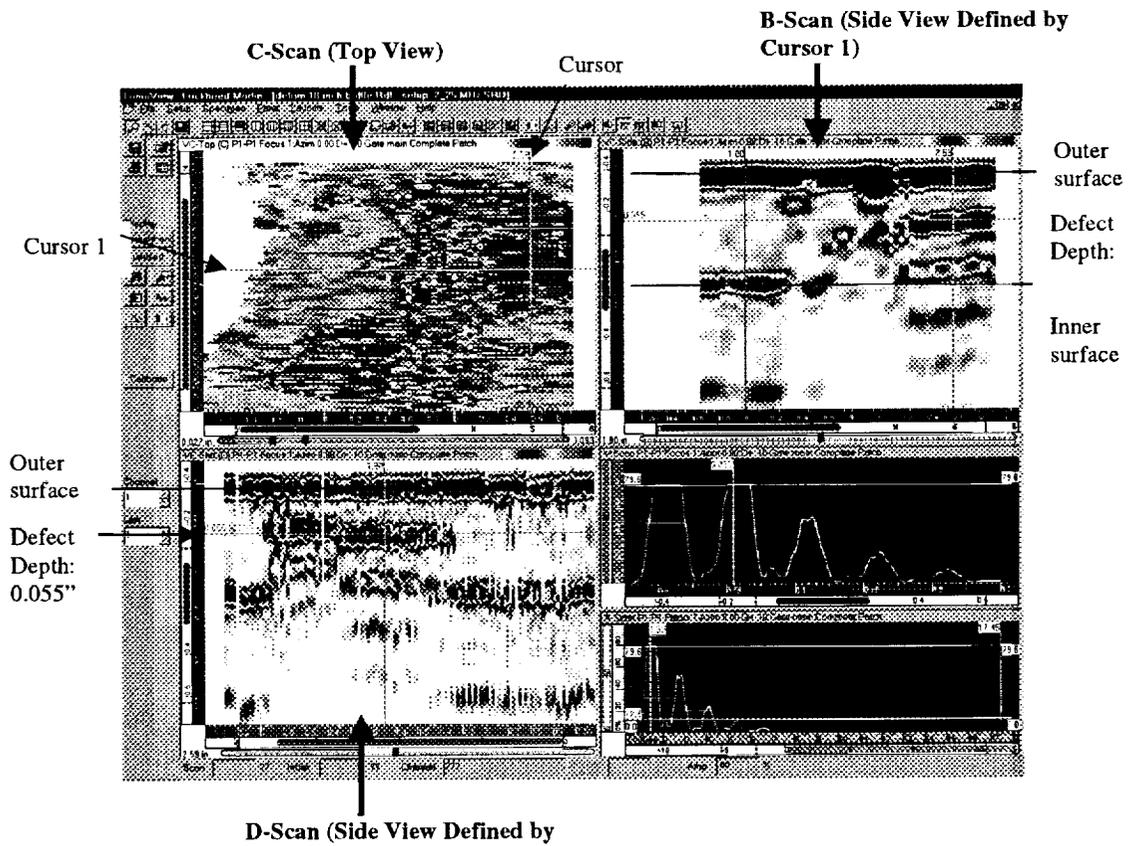
Figure 10: Phased array NDE of delamination
