RESULTS OF THE HESSI TEST MISHAP INVESTIGATION

Daniel B. Worth
NASA Goddard Space Flight Center
Greenbelt, MD 20771
(301)286-5140

Rodney N. Phillips
NASA Marshall Space Flight Center
MSFC, AL 35812
(256)544-4145

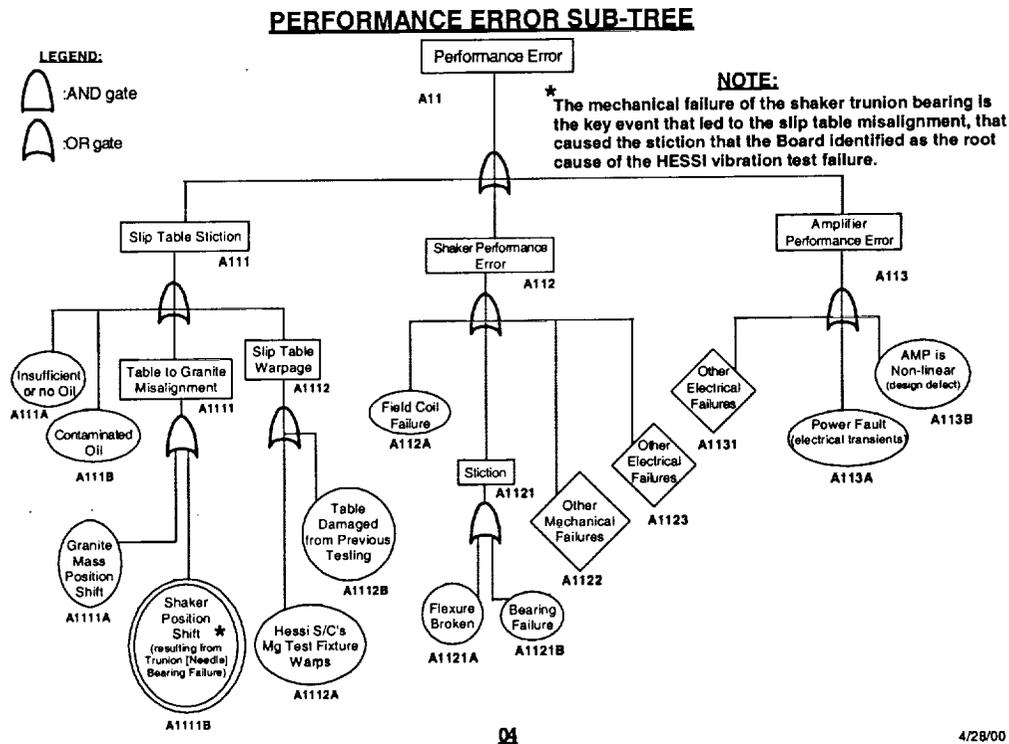
Figure 1
 Fault tree subsection

A detailed fault tree (MIB report, Appendix H-1) was developed. Test and analysis data were utilized to address each probable cause of the overttest. The basis for the fault tree came largely from the experience base of the MIB board members and historical precedent. Data were provided by the facility operating personnel that would support or refute portions of the fault tree. Structured interviews of the personnel involved were also utilized as data to support or eliminate fault tree possibilities. As the fault tree was narrowed to specific areas of concern, diagnostic test plans were generated and executed in an attempt to reproduce the set of conditions that resulted in the overttest in question. The fault tree was used for a structured analysis of the possible causes of the overttest mishap. The probable causes are numbered in a logical hierarchical manner with the highest levels being Facility Failure (A1) or Spacecraft Anomaly (A2). Each branch, with its associated causes, was analyzed and data were used to support or refute it. The critical mishap path was Facility Failure (A1), due to Performance Error (A11), caused by Slip Table Stiction (A111) created by Table to Granite Misalignment (A1111) due to Shaker Position Shift (A1111B). The detailed analysis of this fault path is covered in this section. A portion of the fault tree is shown below in Figure 1.

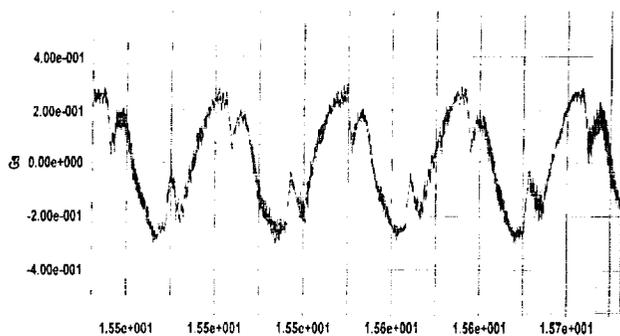
Figure 2
Time-history from run 10

Increased frictional drag in a shaker system causes the moving elements of the system to exhibit a greater than normal coefficient of static friction, or a condition known as stiction. Although this condition will also result in increased drag under dynamic conditions, its effects are greatest when two bodies are at rest. It was concluded from the supporting data and the personal interviews that a stiction condition was present throughout the day's testing on March 21. Time history plots (Figure 2) reveal stiction during the ¼ gpk sine sweep of run 10. The glitches in the acceleration plot that occur immediately after the zero velocity points are indicative of stiction in a system. The acceleration glitches have large amplitudes and show very sharp drop-off rates indicating severe stiction in the system. Interviews of the JPL test operations personnel indicate the condition affected the random equalization as well. Both operators stated that when the exciter control system would begin its equalization process during the low-level random tests the low-frequency spectral content was initially higher than anticipated. This low-frequency anomaly during the initial equalization loops of the random tests resulted from poor system transfer function estimates brought on by stiction in the shaker system. Other test observers stated in interviews that they sensed the low-level random tests were loud at first with decreasing volume as the equalization process progressed for the particular test level. This observation corroborates the visual observation of the test operators. The response of the exciter system will be most affected by stiction in the lower-frequency regime where displacements are relatively large. A review of the control accelerometer PSD from the self-check of run 11, (Figure 3) shows the response of the system was poor in the low-frequency region, actually reaching a minimum at 30Hz.

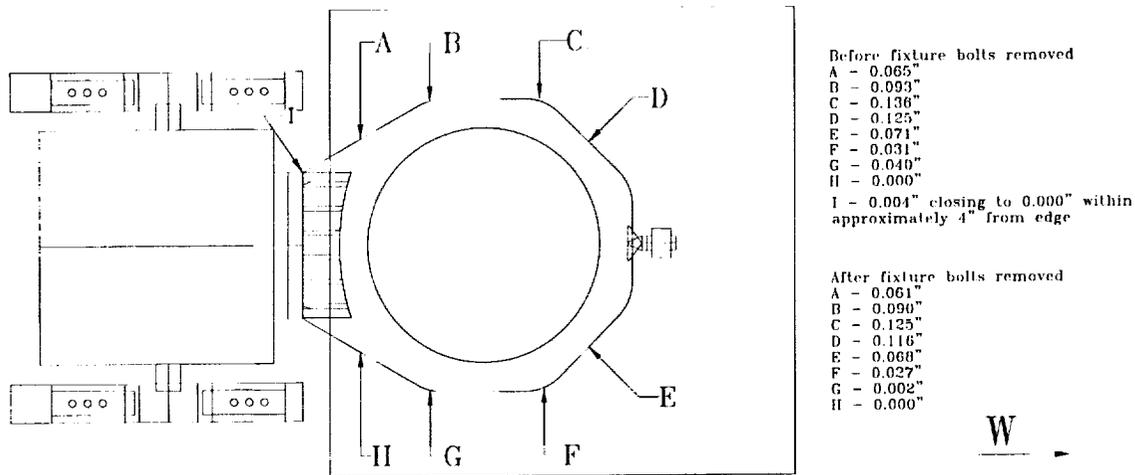
Figure 4
Post-incident gap measurements

The investigation into alignment anomalies focused on the granite mass, the magnesium alloy slip table that rides above it, and the Ling A-249 shaker. Stiction in a shaker system is often the result of some misalignment between two or more of the moving components in the system. These systems require precise alignment to function properly. This shaker system at JPL is used for both horizontal and vertical testing. The shaker must be repositioned from the vertical to the horizontal configuration for each 3-axis test series. Each repositioning of the shaker requires realignment of the slip table system. After the system is aligned, any shift in relative position of any of the major components can result in excessive frictional drag in the system. This drag can result in a stiction condition that is consistent with the data analysis. It is particularly critical that the granite mass and the slip table be in parallel planes and that the gap between them be consistent across the area of the slip table for the oil film type table to function properly. An interview with the JPL test engineer that configured the system for this test indicated that the system was aligned and functioning properly after it was configured for horizontal operation. As a part of the diagnostic testing performed, a series of measurements to quantify the gap distances between the slip table and the granite mass at various locations. These measurements are shown in Figure 4. These measurements show that the slip table and granite are not parallel and are actually in contact with each other at one location. This condition is consistent with the type of anomaly that was suspected as the cause of the stiction condition noted above.

Gap measurements between slip table and granite

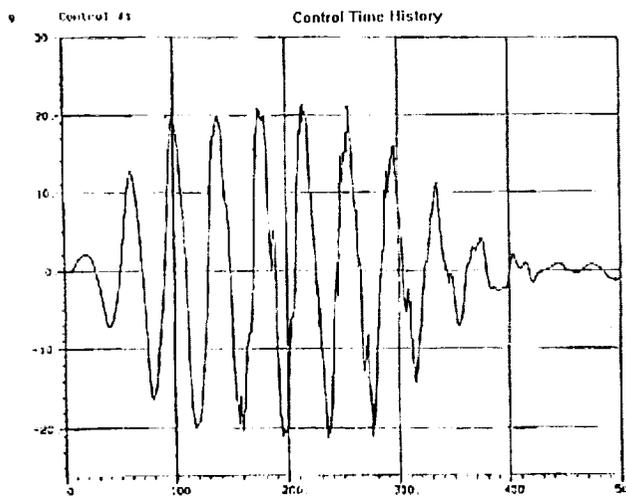
Figure 5
Acceleration time-history, X-axis sine-burst

Analysis of the time-history of the control accelerometer from run 11 (Figure 5) shows an interesting characteristic. The pulse ramps up normally from zero and reaches an amplitude plateau at approximately 21gpk for almost 5 full cycles before ramping back down to zero. Analysis of the target pulse (Figure 6) showed that the desired waveform ramps up from zero to its maximum amplitude, stays at maximum for only one full cycle and ramps back down to zero. The discrepancy in the waveforms is easily explained. At first glance one might interpret the test data as being electrically clipped, however, it is not clipped. Examination of the as-run test setup sheet (MIB report, Appendix I-24) from the sine-burst test reveals that channel 1 (the control accelerometer) for

The body continued to react until the force ramped back down to that same amplitude at which time the shaker body ceased to move. Close examination of the time histories of the control accelerometer (Figure 5) and the force sum in the X axis (Figure 7) for the spacecraft shows that when the spacecraft mounting interface began to slip (i.e., when the force indication began to decrease) the acceleration peak actually rose slightly from 20g to 21.5g. This indicates that the reactive motion of the shaker body was slightly reduced yielding a slight increase in the measured acceleration at the fixture plate. This reaction of the shaker body actually acted to lessen the damage that could have occurred to the spacecraft. If the isolation system had been mechanically locked out, or fixed, the shaker system would have continued to follow the amplitude ramp up until the amplifier or shaker reached a hard limit or the computer drive signal ramped back down. It is noted here that the movement of the shaker body quite possibly exacerbated the misalignment conditions noted, however, it is evident that its movement did not cause the trunion condition.

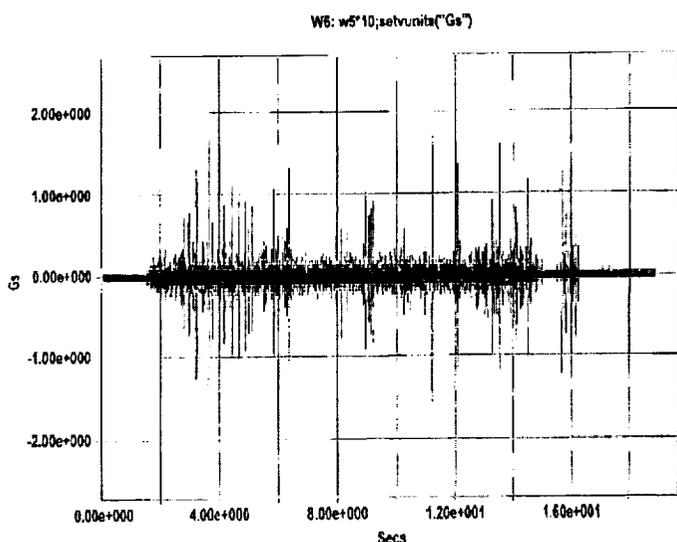
Figure 8
Time-history of diagnostic test 1 self-check

test data from run 11, showed no such transients in the system. The diagnostic test was terminated to obtain the relevant data from the diagnostic run. Analysis of the time history from the diagnostic test (Figure 8) showed several bursts that are consistent with an electrical anomaly. The "spikes" in the data show very sharp rise-times and are of considerable amplitude. These type transient events would tend to excite the resonant modes of the shaker and slip table system and would tend to lessen the stiction effects that were suspected as a contributing factor to the overtest. Since these anomalous conditions did not appear in the actual test data from run 11, it was determined that the condition should be eliminated before continuation of the attempt to replicate the overshoot condition.

troubleshoot the transient problem with minimal disturbance to the system configuration. After executing the steps of this test the anomaly was isolated to the DAC of the vibration control system. The unit was replaced with another unit from a sister machine and the noise was eliminated. The DAC anomaly may have been beginning to develop during the sine-burst testing that damaged the spacecraft. A detailed review of the time history self-check data from run 11 (MIB report, Appendix I-6a) revealed some asymmetrical amplitude characteristics during the final few seconds of the self-check. These asymmetrical bursts could be indicative of an impending DAC failure or they could be RF interference. It is not possible to quantify their cause and it is not believed that they contributed to the incident in any way.
