## **Repair of Corrosion in Air Supply Piping at the NASA Glenn Research Center's 1 by 1 Foot Supersonic Wind Tunnel**

Michael Henry  
Dynacs Engineering under contract to NASA Glenn Research Center  
Cleveland, Ohio, USA

Prepared for the:  
93<sup>rd</sup> Meeting, Supersonic Tunnel Association, International  
April 30 – May 2, 2000  
Hosted by: NASA Ames Research Center  
Sunnyvale, California

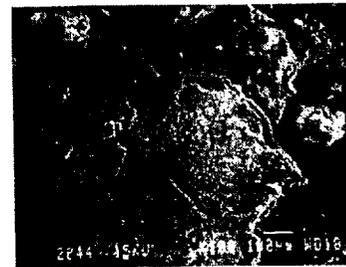
Another particle carbon tape sample was taken from the inside of the 24" carbon steel pipe. Physical access was gained through a service hatch just downstream of the filters. A dispersive X-ray spectroscopy analysis revealed, as expected, that iron and oxygen were the primary components. The largest particles measured approximately 500 microns long. A magnified view of the sample is shown in figure 4.2.

**Figure 4.2 – Rust particles from inside the 24" pipe, magnified 100X.**

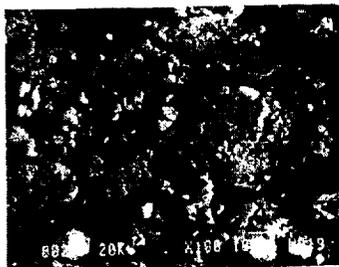
**Figure 4.3 – Particles after impacting carbon tape in the test section at Mach 2.5, magnified 100X.**

minutes at Mach 2.5. The tape captured the sample shown in Figure 4.3. After impacting the carbon tape, the largest particles measured approximately 50 microns long. The dispersive X-ray spectroscopy analysis yielded the same element signature as the rust particles taken from the inside of the 24" pipe with the addition of a small amount of aluminum. Hence, it was determined that pipe corrosion was the primary source of the particles in the air flow.

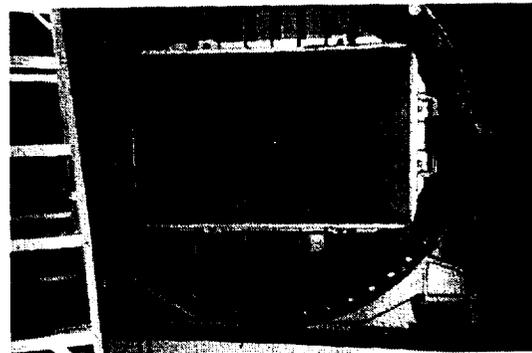
**Figure 8.1 – Center section of surge tank prior to refurbishment.**

Upon inspection, severe corrosion was found in the lower half of the surge tank. It is

believed that this was a result of water left behind after a hydrostatic pressure test that was performed on the surge tank in the late 80's. Also, about a 1/4" thick layer of rust particles carpeted the bottom of the surge tank. Apparently, the particles were blocked by the screens, then fell through the small openings between the screens and flow plates into the bottom of the surge tank. As with the 24" pipe sections, Naval Jelly and Rust Converter were used to clean and coat the interior surfaces of the surge tank.

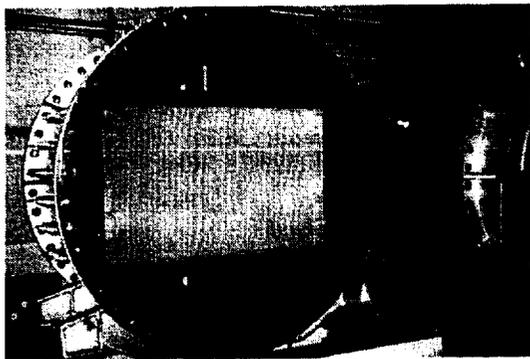
**Figure 8.3 – Refurbished surge tank.**
