## The IRAC Shutter Mechanism: Residual Magnetism and the Rotary Solenoid

### Abstract

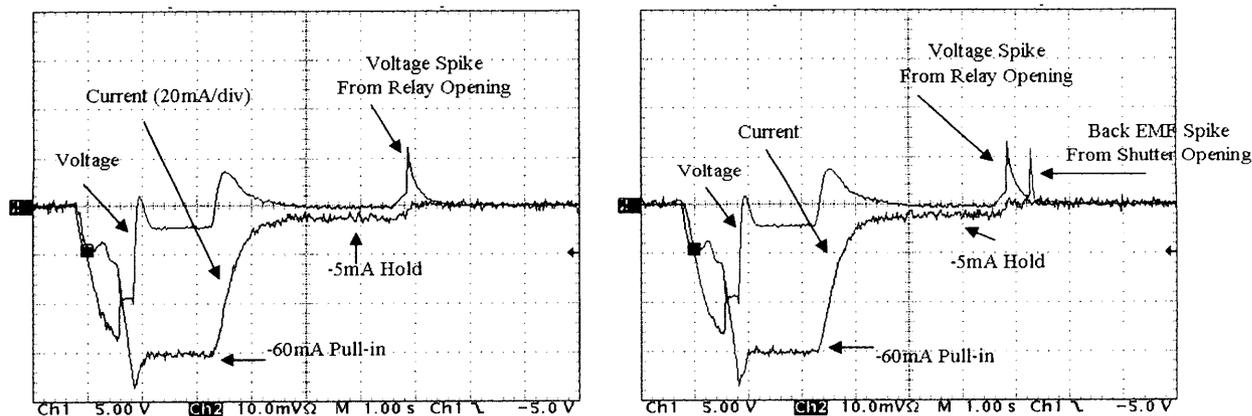
**Figure 6. Current and voltage profiles for an actuator that fails to open at zero current (left) and one that opens properly (right)**

Soon after the implementation of V3.2, the failure occurred. Therefore, the first suspect was the software. However, the investigation showed the software sequence that provided smoother, gentler current profiles simply uncovered the low torque margins upon opening that were due to residual magnetism in the shutter.

A set of tests, run on 6/3/01, instrumented the voltage and current waveforms to verify the functionality of the electronics and to capture the differences in behavior using the various software versions. These waveforms suggested that the electronics were healthy and appropriately responding to all commands sent. They also verified the differences between the command software versions and gave insight to the behavior of the shutter under various conditions. During the attempt to capture full opening and closing waveforms, it was discovered that using a short pull-in and hold cycle would reproduce the failure somewhat consistently. Figure 6 shows the current and voltage profiles of an actuator that fails to open at zero current and one that opens properly. This command sequence proved invaluable in further

Once these tests were completed, a new and final version of the software was written. The new command sequence added a commandable current pulse in the opposite polarity to counteract residual magnetism, more time for current commands to settle, and more flexibility in command parameters. The Version 3.21 opening sequence is as follows:

- Command zero current then wait 1 second
- Send a commandable "kick current", +2.5mA, (Wait a commandable time, 3 seconds)
- Command zero current then wait 1 second
- Read the sensor and store the value
- Open shutter relay and turn off the sensor

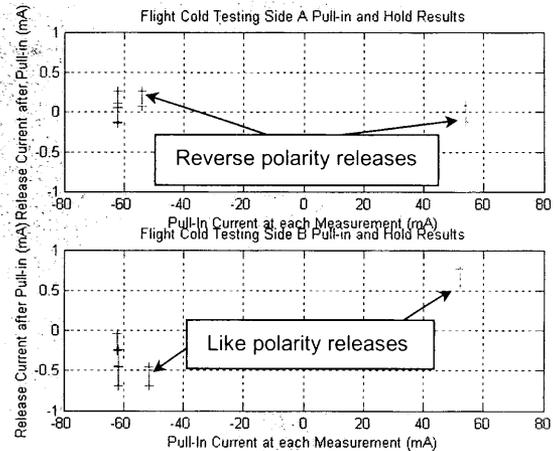
**Figure 7. Release current data for the IRAC flight shutter**

This software version was implemented and the electronics were instrumented on 6/14/01. The waveforms verified proper operation and the failure never repeated. Other tests were run on the flight instrument including reverse polarity closings, unexpected loss of power, and attempting to use Side B to release the shutter after being deliberately stuck closed using Side A. The reverse polarity tests showed pull-in and hold current comparable to the nominal operations. This verified that the magnetic circuit fully saturates regardless of polarity when the high, 60mA, pull-in current is applied. Side B always released during a sudden loss of power, but Side A could be made to stay closed under certain conditions. Unfortunately, Side B operations were unsuccessful in releasing the shutter once Side A was stuck due to residual magnetism. This ultimately became the a concern of SIRTF management and prompted the study into mitigation approaches which could be implemented on the flight system.

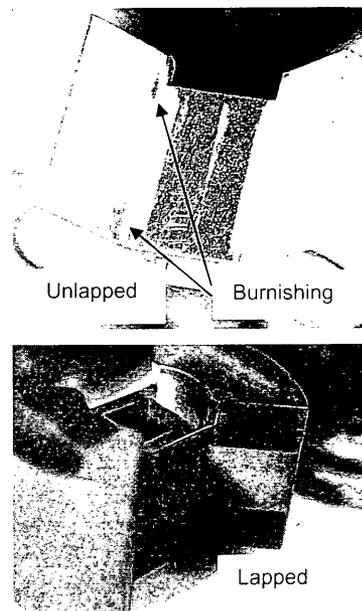
**Figure 8. Rotor pre and post lapping**

placement of the shim revealed that it was not placed optimally and was subject to potential magnetic shorting due to small variations in assembly or shifting of gaps during shutter operation.

Considerable frustration was endured during initial post failure testing which showed very little effect of magnetics on the ability of the shutter to remain closed with zero current. Upon examination of the rotor and stator parts, a slight burnishing of the rotor where it contacted the stator tabs was revealed (Figure 8). Clearly the majority of the tab surface was not in intimate contact with the rotor. Only when the contacting surfaces of a set of actuators were lapped together (Figure 8) did it become apparent that our initial suspicions were most likely correct. Approximately 12  $\mu\text{m}$  (0.0005 in) of material was removed during the lapping process. When these components were assembled into a spare mechanism, the unit consistently failed to open with zero current applied. This was a breakthrough in the testing program. It showed that small variations in the nature of the contact between the rotor and the stator have a significant impact on residual magnetism and, therefore, the residual torque that the actuator could exhibit.

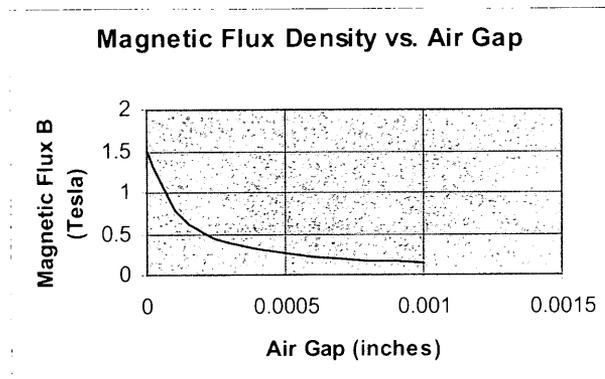
**Figure 9. Analytic solution showing relationship of flux with air gap**

One analytic solution was utilized which assumed all the material, Carpenter Hiperco 50A, was magnetized and that all the reluctance was in the air gap. Another case was run for the case of zero air gap wherein the reluctance of the Hiperco was used to determine the maximum magnetic flux,  $B_{\text{max}}$ . Hiperco 50A, an alloy of nearly 50/50 iron and cobalt and a few other ingredients, was selected due to its ability to carry high flux levels and minimize actuator size and mass. Figures 9 and 10 proved to be interesting showing that the B-field at the tabs, and thus the torque generated by the tabs, rises rapidly as the air gap reduces below 5  $\mu\text{m}$  (0.0002 in).

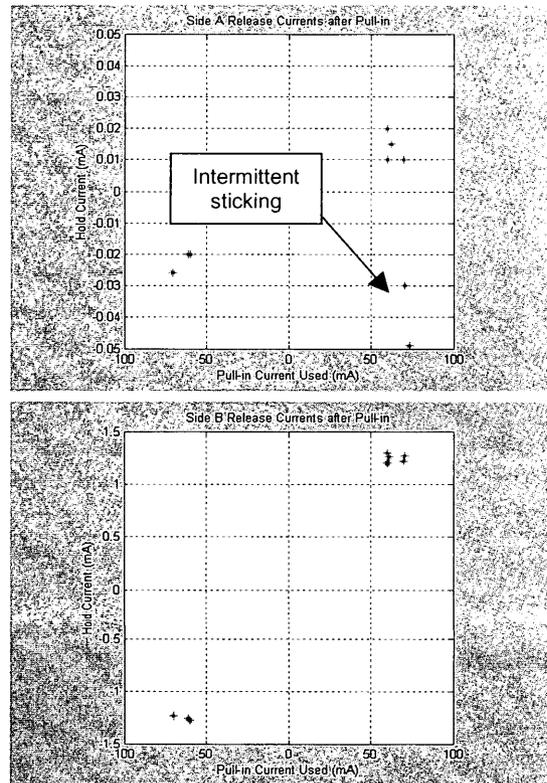
**Figure 11. Spare shutter release currents**

Initial testing of the release currents on the spare units showed lower but acceptable release current values in some cases. None of the spare shutter assemblies or actuator components exhibited enough residual magnetism to overcome the restoring torque of the spring. However, a spare unit was then disassembled and reassembled. It was noted that the assembly process could impact the release current value. After one particular reassembly process, the assembly did fail to open with zero current on rare occasions. Figure 11 shows release currents for Side A and B for the spare unit. It shows the Side A actuator had intimate contact and better alignment between the rotor and stator than Side B. The more “normal” release currents on Side B indicate less tab contact and poorer alignment between the rotor and stator in the closed position.

These measurements were made using a power supply at room temperature. Approximately 60 mA was applied to the actuator causing the shutter to close. The current was then decreased until the shutter opened. The value of the release current was then recorded. It is important to note that on the rare occasions that a mechanism stuck, it always opened when a slight reverse polarity current was applied. These reverse polarity currents reduced the residual magnetism torque to a level below the restoring torque of the spring thus allowing the mechanism to open.

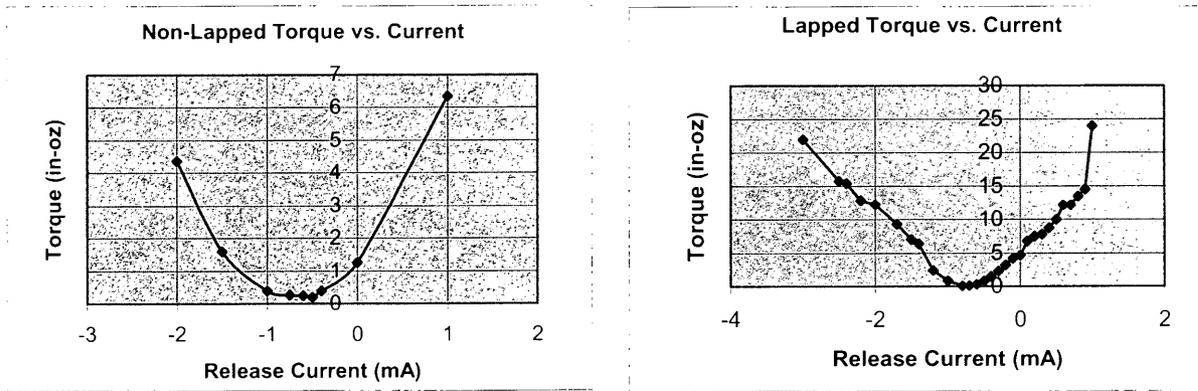
**Figure 12. Torque vs. current for non-lapped (left) and lapped (right) actuators**

After the sensitivity to the nature of the contact between the tab of the rotor to the stator was fully appreciated, we decided to improve this contact by lapping. Lapping caused the spare unit to fail to open at zero current consistently. However, the mechanism still reliably opened upon application of a slight reverse polarity current. We isolated the actuator components in a test set-up to simplify measurement of actuator torque. Measurements of torque generated verses applied current were then made and are shown in Figure 12. These measurements were performed both pre and post lapping. Prior to lapping of the actuator components, intimacy of contact between the rotor and stator was not good enough to generate significant residual magnetism torques. After lapping, measurements showed significant residual magnetism torques. Values of two to three times the restoring torque of the spring were

demonstrated. It is believed that the nature of the contact on the flight unit is somewhere in between the pre and post lapped cases and that these two cases bound the problem. Therefore, the important concept to note is that in the shutter mechanism assembly, the problem is bounded: i.e. higher residual magnetism can still be cancelled with slight reverse polarity currents. The magnetic analysis confirmed this bounding. There is no condition in which the mechanism can remain closed after sufficient reverse polarity current is applied.

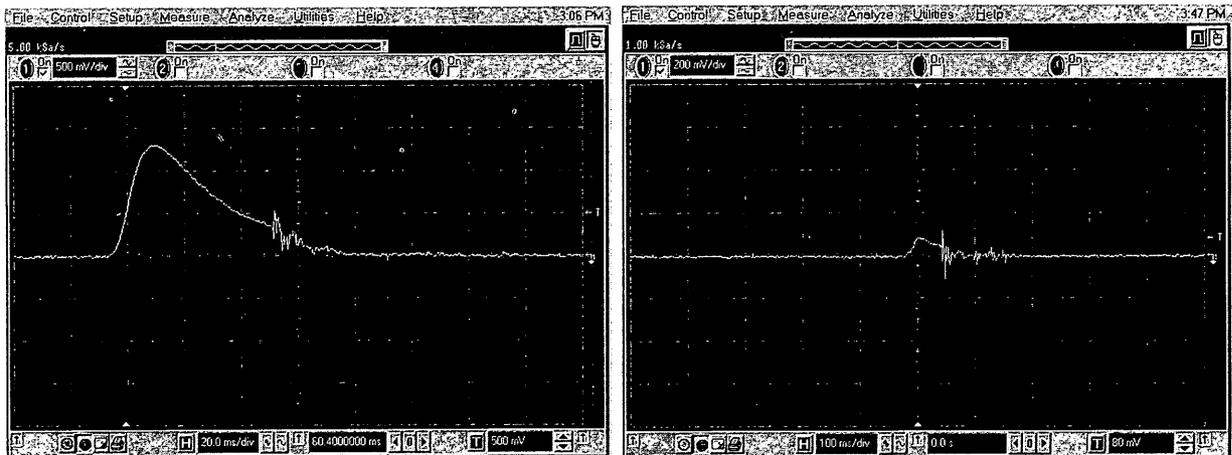
**Figure 13. Back EMF measurements before (left) and after (right) applying a reverse polarity current**

time as in the flight set-up, it is virtually impossible. However, if both Side A and B are energized at the same time it is possible to show that residual magnetism exists in a mechanism. It is also possible to show that this residual can be removed by a slight reverse polarity current. Figure 13 shows the voltage induced on the shutter coil during opening, or Back EMF, before and after a small reverse polarity degauss current is applied. The figure shows that  $\sim 85\%$  of the magnetism is removed. In fact tests at cryogenic temperature showed that the tabs could easily be degaussed if the shutter was held closed during degaussing. However, closing the shutter would re-gauss the tabs and generate the same residual magnetism. Unfortunately, due to SIRTf project management concerns over risk and schedule we were not able to duplicate these tests on the flight unit.

Laboratory measurements indicated that providing a 2.5 mA reverse current, which allows the “stuck” rotor to release, could essentially degauss a lapped unit. Providing too much reverse current resulted in re-magnetizing the Hiperco in the reverse direction resulting, again, in a residual magnetic torque.
