NASA/TM-2002-211732

Thermal Nondestructive Evaluation
Report - Inspection of the Refurbished
Manipulator Arm System in the
Manipulator Development Facility of
Johnson Space Center 10-12 January 2001

*K. Elliott Cramer
Langley Research Center, Hampton, Virginia*

July 2002

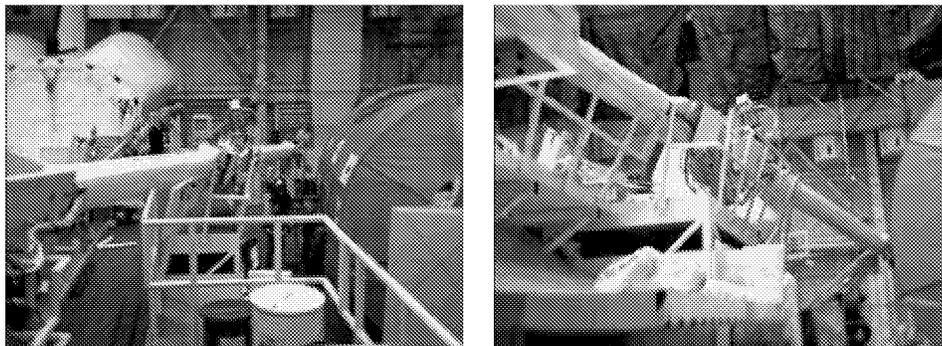
Figure 1 -- Incident photographs showing MDF Arm after yaw hydraulics failure

On 4 December 2000, after repairs were made to the robotic arm's shoulder yaw (SY) joint a hydraulics failure occurred while the MDF Test Director (TD), commanding the robotic arm from the Aft Cockpit, attempted to position the arm properly in the cradle position prior to beginning crew training. When the Test Director commanded a shoulder pitch maneuver to lift the arm from its payload bay pedestal, the yaw controls failed due to bleed valves not being closed properly. This, coupled with gravitational forces (due to the angle of the shoulder joint with respect to vertical), resulted in uncontrolled arm motion. The shoulder yaw joint moved approximately 20 degrees, causing the extended arm to strike (and severely damage) the port side MDF catwalk handrails. The arm motion stopped after impact with the handrails (See Figure 1).

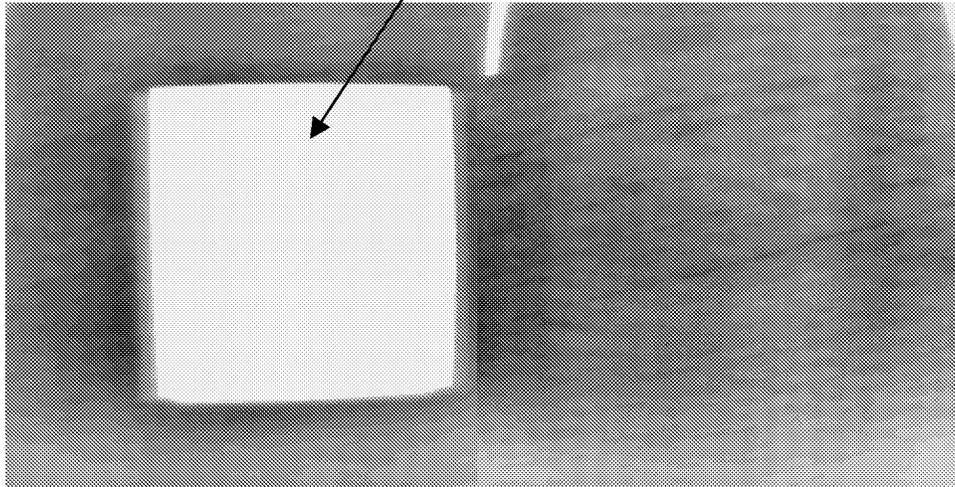
Figure 6 -- Location #1 (No Indications Recorded)

Location #1 (Figure 6):

No indications of material degradation were recorded in the thermal inspection. Note that the fiber lay-up is clearly visible in this image.

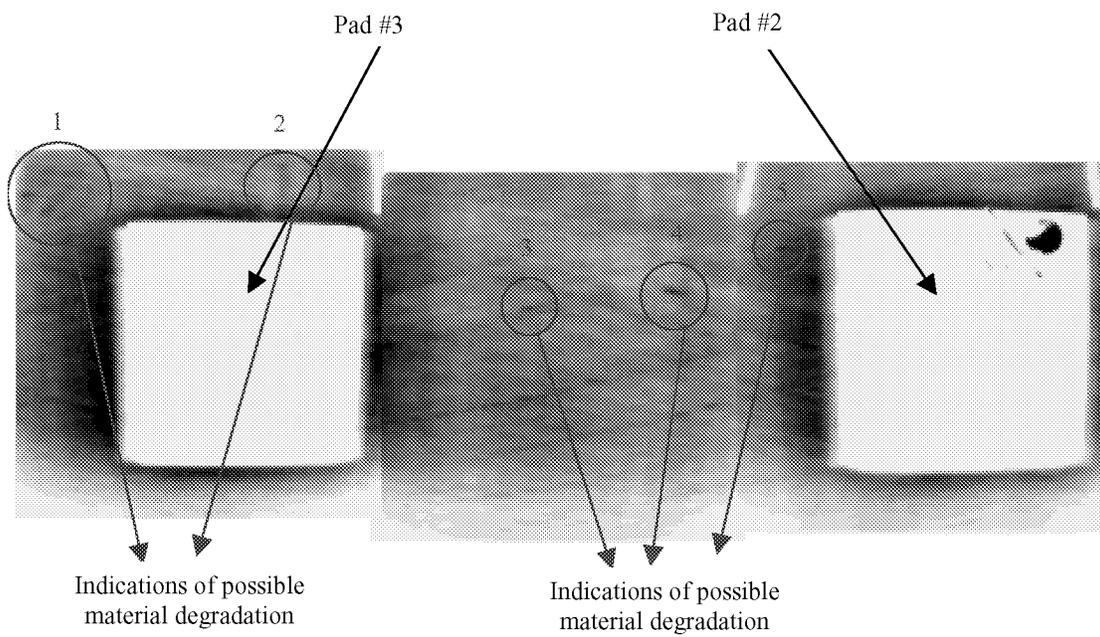
Figure 7 -- Location #2

Location #2 (Figure 7):

Several small indications were recorded, especially between pad #2 and pad #3. These indications are consistent with a reduction in thermal heat flow into the material,

which could be due to a number of factors such as porosity, resin rich regions or localized delaminations[#].

The two indications above pad #3 are also consistent with a reduction in thermal heat flow, but are of a larger extent. The time resolved data reveals that these indications appear to be limited in extent to very close to the surface.

Indication Sizes:

#1 – 1.4 in. wide x 1.1 in. high

#2 – 0.9 in. wide x 0.8 in. high

#3 – 0.3 in. long

#4 – 0.4 in. long

#5 – 0.35 in. long

[#] Note: These small indications are seen throughout the upper and lower arm, even in areas where no impact is suspected, which may indicate that they are a result of the manufacture of the structure.

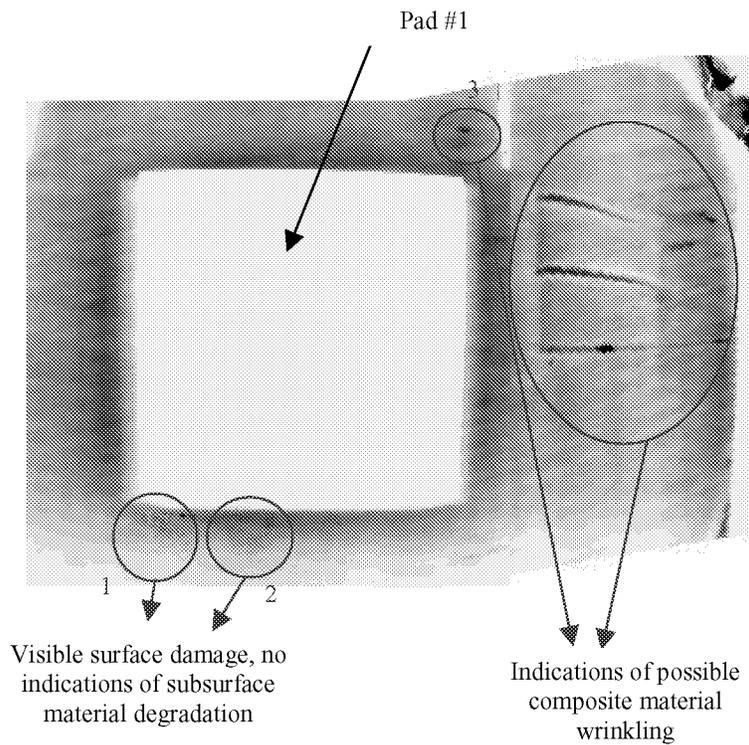
Figure 8 --Location #3

Location #3 (Figure 8):

Directly below pad #1 the visible surface damage can also be seen in the IR images. This damage appears to be limited in extent to the near surface region and does not display thermal characteristics of impact damage that has resulted in subsurface delaminations.

Between pad #1 and the elbow indications were observed which are consistent with wrinkles in the composite material.

Additionally, just above the right corner of pad #1 is a small indication[#] consistent with those seen throughout both the upper and lower arms (see note on location #2).

Indication Sizes:

#1 – 0.9 in. wide x 0.6 in. high

#2 – 0.8 in. wide x 0.7 in. high

#3 – 0.32 in. long

Note: It was not possible to make measurements of the size of the wrinkles because of the large camera angle required to access this location.

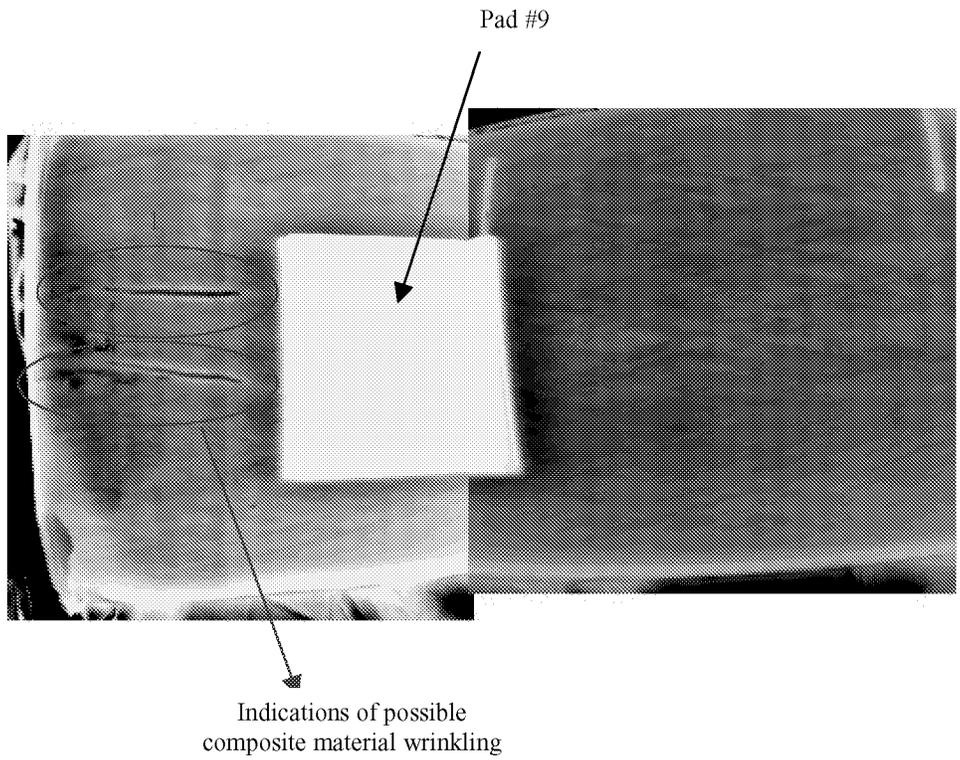
Figure 9 -- Location #7

Location #7 (Figure 9):

Between pad #9 and the shoulder indications were observed which are consistent with wrinkles in the composite material as seen in Location #3.

Indication Sizes:

#1 – 2.8 in. long

#2 – 3.8 in. long

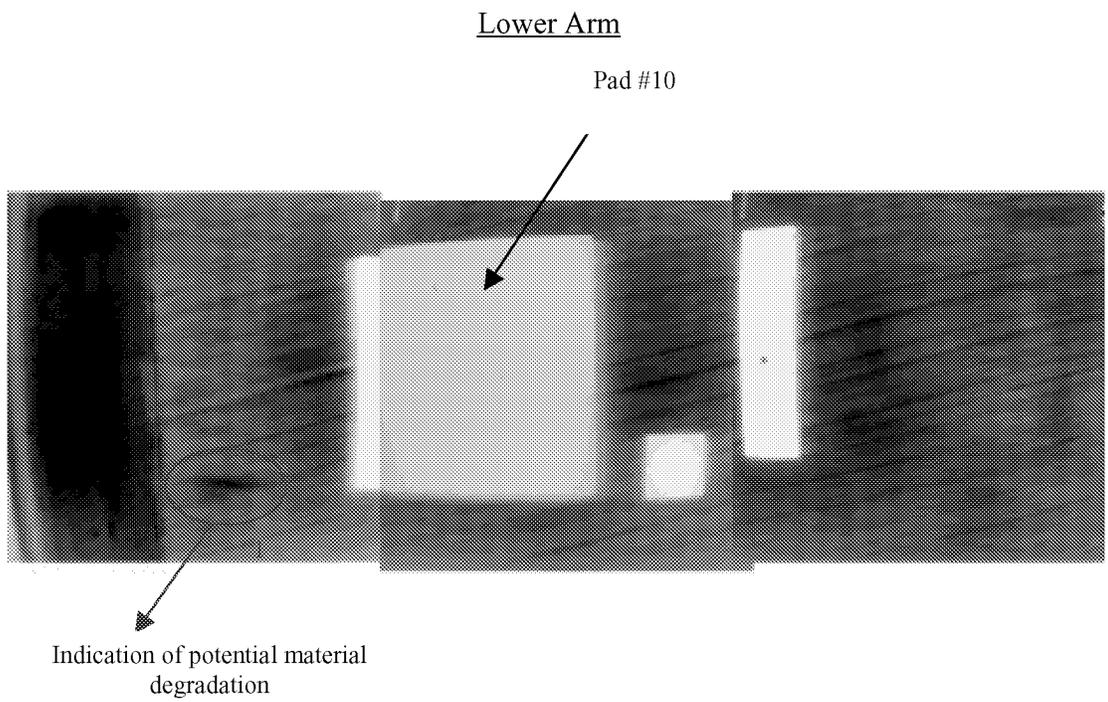
Figure 10 -- Location #4

Location #4 (Figure 10):

One indication was recorded between pad #10 and the elbow. This indication (although larger) is consistent with the small indications[#] seen throughout both arms (see note on location #2).

Indication Sizes:

#1 – 1.35 in. wide x 0.3 in. high

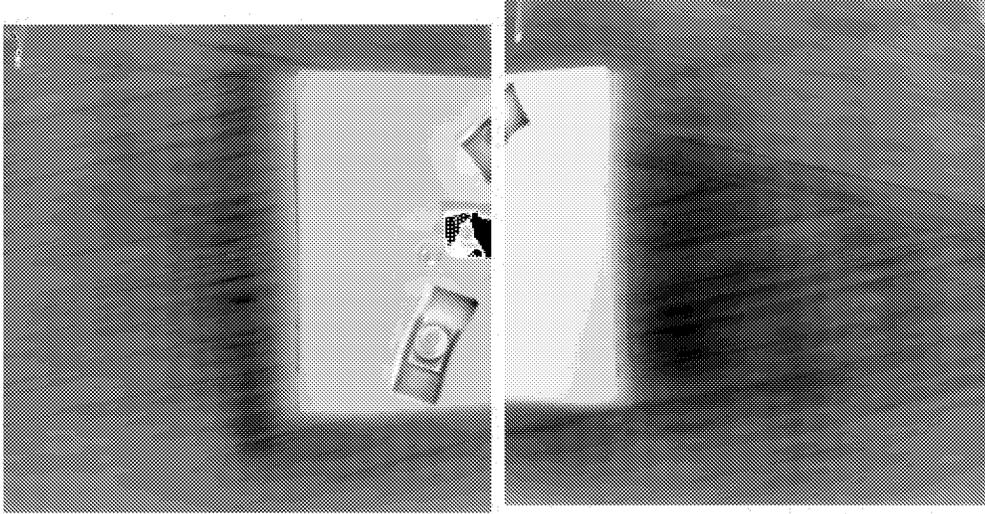
Figure 11 -- Pad #9 No Indications (Recorded for Reference)

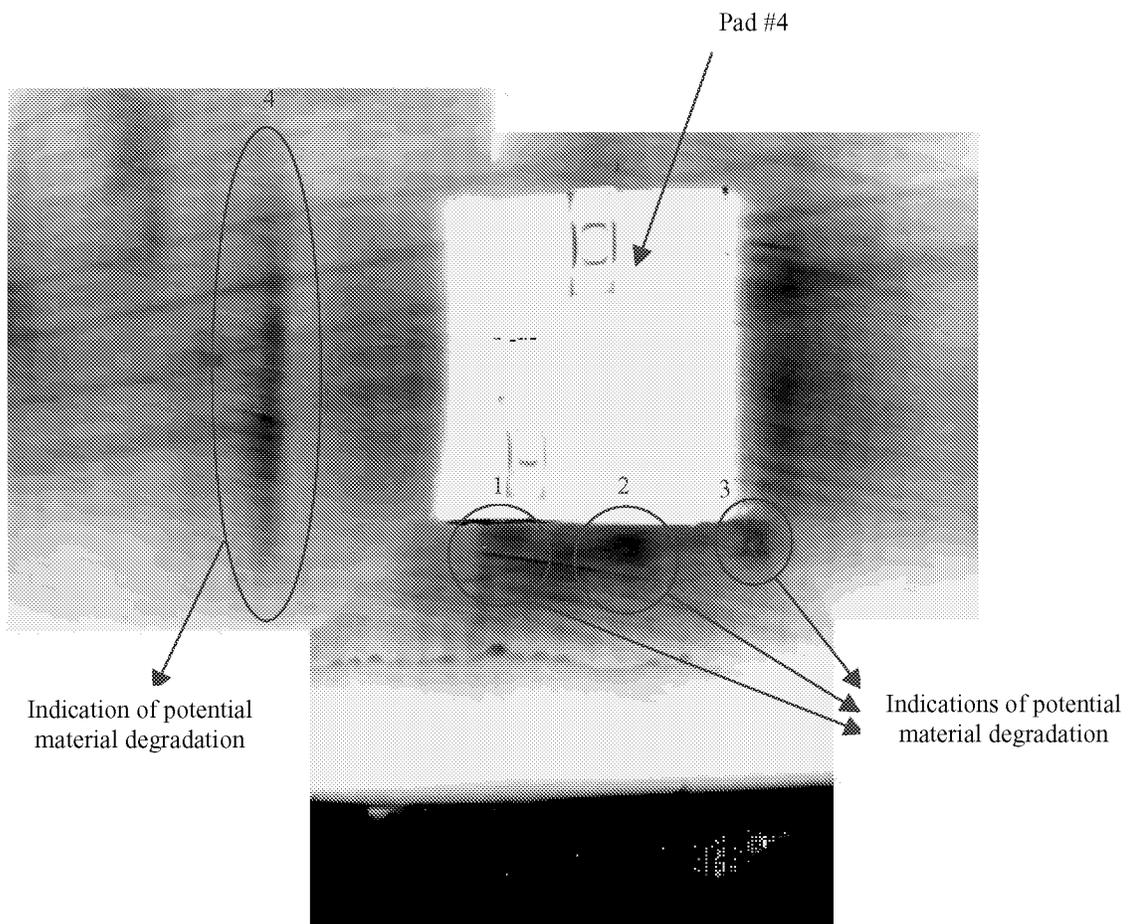
Figure 12 -- Locations #5 & #9

Locations #5 & #9 (Figure 12):

A number of significant indications were observed in these locations. First, a large vertical indication parallel and to the left of pad #4 was observed. This indication appears to extend quite deep into the material (at least through ½ the thickness) and also tends to spread parallel to the fibers. Again this is a region that does not allow good propagation of the heat flux and could be attributed to porosity, dry fibers (resin poor regions) or delaminations.

Another series of indications were recorded directly below pad #4. These indications do not appear to follow the fiber layup and also extend quite deep into the material.

Indication Sizes:

#1 – 0.8 in. wide x 0.5 in. high

#2 – 0.8 in. wide x 0.6 in. high

#3 – 0.5 in. wide x 0.8 in. high

#4 – 0.8 in. wide x 6.25 in. high

Certain areas (Locations 5, 8 and 9) showed indications unique enough to warrant further investigation of these with other techniques such as conventional and advanced ultrasound or x-ray.

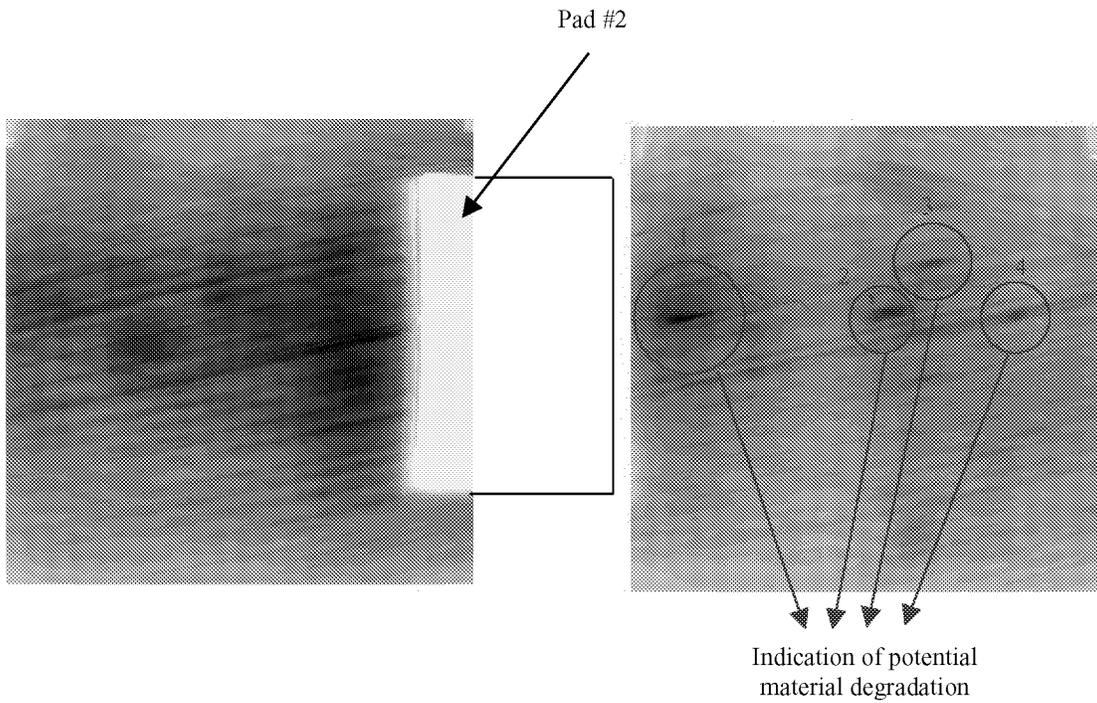
Figure 13 -- Location #6

Location #6 (Figure 13):

Four indications were recorded between pad #2 and pad #1. These indications are consistent with the small indications[#] seen throughout both arms (see note on location #2).

Indication Sizes:

#1 – 1.7 in. wide x 0.3 in. high

#2 – 0.8 in. wide x 0.3 in. high

#3 – 0.8 in. wide x 0.2 in. high

#4 – 0.4 in. wide x 0.3 in. high

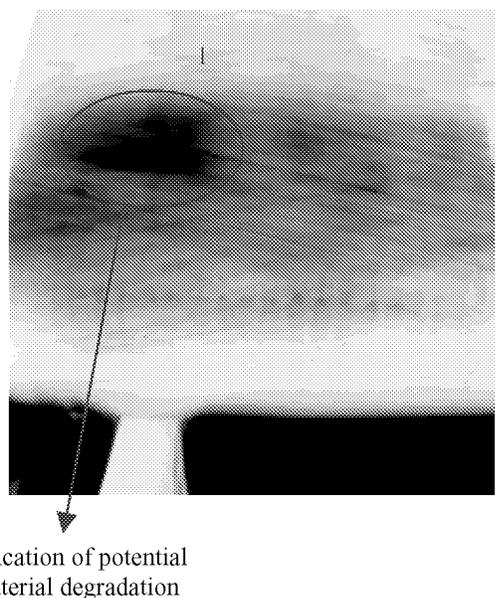
Figure 14 -- Location #8

Location #8 (Figure 14):

Between pads #7 & #8 a single indication was observed which is consistent with impact damage indications that have been observed in other composite materials. This indication is fairly localized on near the surface, but appears to grow in size deeper into the material.

Indication Sizes:

#1 – 2.2 in. wide x 0.6 in. high
