GT2002-XX

Characterization of Ceramic Matrix Composite Fasteners Exposed in a Combustor Liner Rig Test

Michael Verrilli and David Brewer
NASA Glenn Research Center
Cleveland, OH

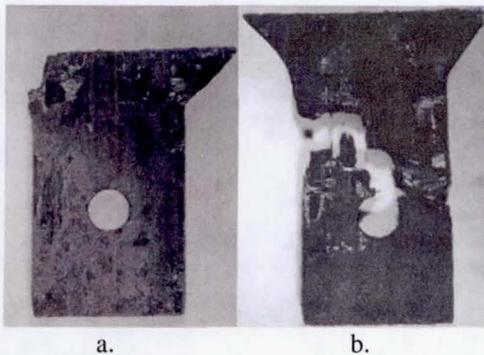
fastener was observed for about 60% of the fasteners removed intact. An extreme example of the observed damage mode is shown in Fig. 4a. This particular fastener could not be subjected to post-exposure destructive testing, but the majority of fasteners with cracks and chipping in the “ears” such as this had less severe damage and thus could be tested. Other fasteners failed in the shank region (Fig. 4b). Damage in the shank was most often observed when difficulties were encountered while removing the metallic nut from the threaded clevis (Fig. 2). About 25 % of the total fastener set was not suitable for destructive testing because of either severe “ear” damage such as in Fig. 4a or failure while attempting to remove them from the rig.

Figure 4 – Damage of fasteners after removal from the sector rig.

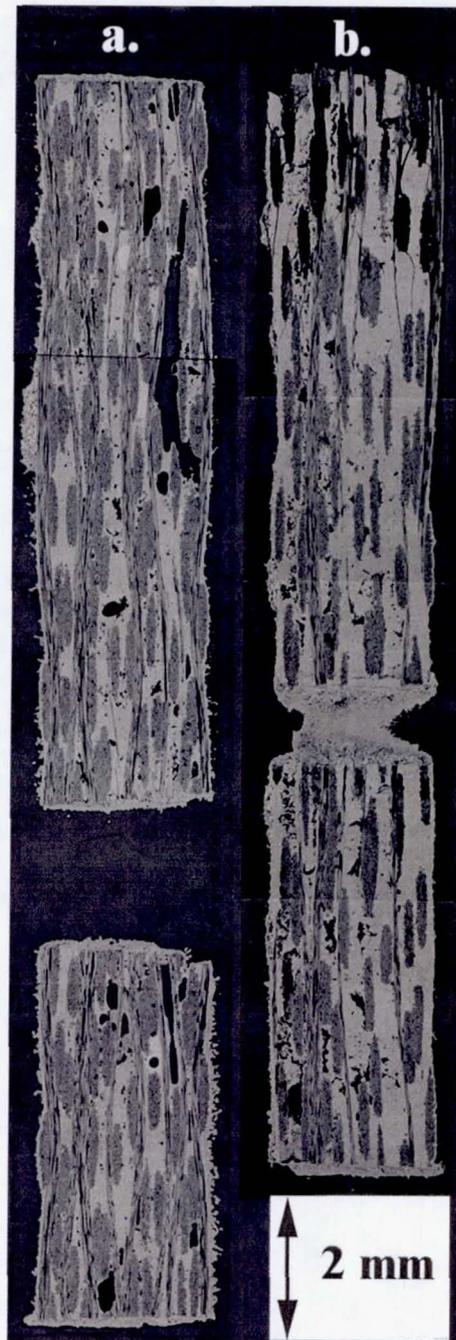
A comparison of the microstructures of an as-manufactured fastener and one that was exposed in the combustion environment for 145 hours is shown in Fig. 5. The longitudinal, through-thickness cross sections reveal porosity in both fasteners. The large pore, in the as-manufactured fastener, exists in the head region. The most notable feature can be seen in the head of the exposed fastener in the form of fiber and composite damage. The dark regions indicate locations where fibers tows are missing due to preferential attack of the Sylramic fibers. This attack is due to the reaction of the boron nitride fiber interface with water vapor, present in the combustion gases [6]. Recession of SiC in a combustion environment can also occur due to SiO₂ scale volatility [7].

Figure 5 – Cross-sections of SiC/SiC fasteners, a) as-manufactured, b) exposed for 145 hours.

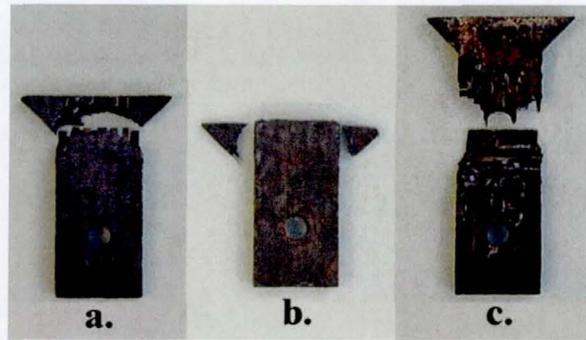
The tensile failure mode observed for all the as-manufactured Miller fasteners is shown in Fig 7a. Approximately 17% of the combustion-exposed fasteners failed in the same manner, which is the desired failure mode [4]. Failure of the fastener through shear failure of the “ears” of the head occurred in 70% of the exposed fasteners (Fig. 7b) and was associated with observed “ear” damage documented prior to destructive testing. The failure mode of the rest of the exposed fasteners was associated with pre-existing cracks, such as seen in Fig. 7c.

Figure 7 – Failure modes of tensile-tested SiC/SiC fasteners, a) as-manufactured material, b) “ear shear failure of exposed material, c) failure associated with pre-existing cracks.

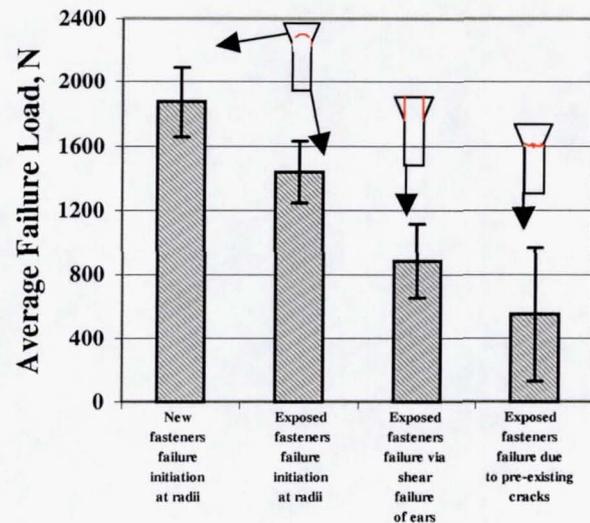
The average failure load for the Miller fasteners as a function of failure mode is shown in Fig. 8. The as-manufactured fasteners failed at an average load of about 1900 N, while combustor-exposed fasteners that failed in the same mode had a 25% lower failure load. Failure of the fastener through “ear” shear failure yielded a failure load of 900 N. Those fasteners that failed due to pre-existing cracks had the lowest average failure load, 550 N.

Figure 8 – Failure mode versus failure load for SiC/SiC fasteners tensile tested at 25 °C.

Comparing data for as-manufactured and for exposed fasteners that failed in the same manner as unexposed ones, an assessment of the material degradation due to combustion exposure can be made. A 25% reduction in failure load was measured for fasteners after 50 hours of exposure (Fig. 8). Additional damage as described above was likely responsible for the switch

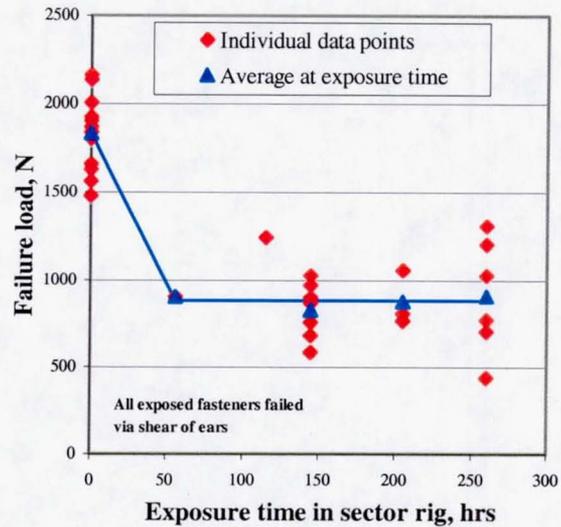
The effect of exposure time can be seen by examining data for fasteners that attached one combustor liner part, the lean transition liner (LTL). The RQL sector rig liner set consisted of twelve LTL's, each held in place with two Miller fasteners, Fig. 9. The exposure temperatures of the different liner parts in the sector rig varied. In addition, combustion gas chemistry and flow rate varied in different regions of the rig. Examination of fastener data for only one part can eliminate potential failure load differences due to varying exposure conditions. During the course of the 260 hours of rig operation, several of the LTL's and their fasteners were removed for reasons described earlier, resulting in the largest number of fasteners exposed for different times from a single part type. To eliminate the effect of failure mode on failure load, only data for LTL fasteners that failed via shear of the “ears” is shown as a function of exposure time in Fig. 10. Data for the as-manufactured fasteners is shown as well. Exposure of 50 hours reduced failure loads by

50% relative to the as-manufactured fasteners. The average fastener failure load of about 900 N was the same for all exposure times, up to the maximum of 260 hours. Note that during sector testing, LTL fasteners reached a maximum temperature of about 1200 °C at the head surface subjected to combustion flow.

Figure 10 – Lean Transition Liner fastener failure loads after exposure in the sector rig.
