# **Unlocking the Mystery of Columbia's Tragic Accident Through Materials Characterization**

**Mississippi State University Materials Working Group**

**October 15<sup>th</sup>, 2003**

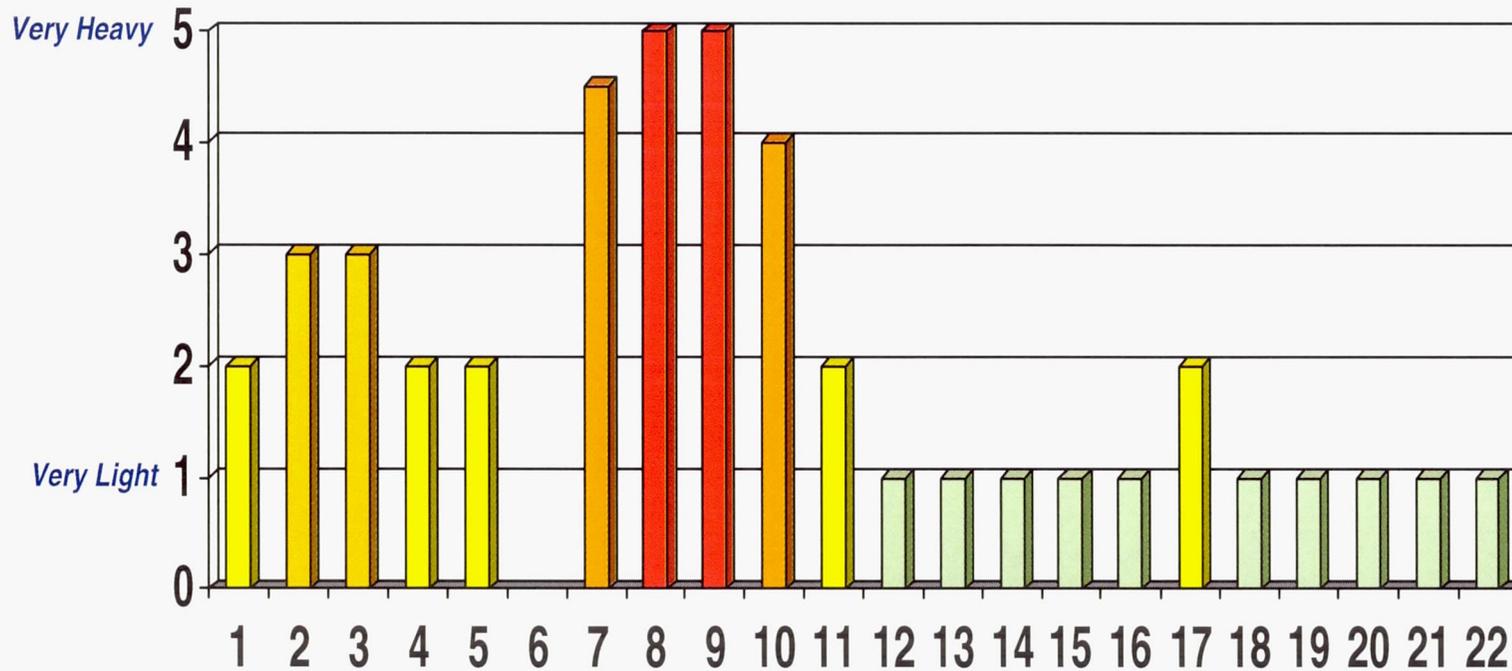
Distribution of “slag” deposition volume  
was centered around panels 8 & 9 on Left Wing Leading  
Edge RCC.

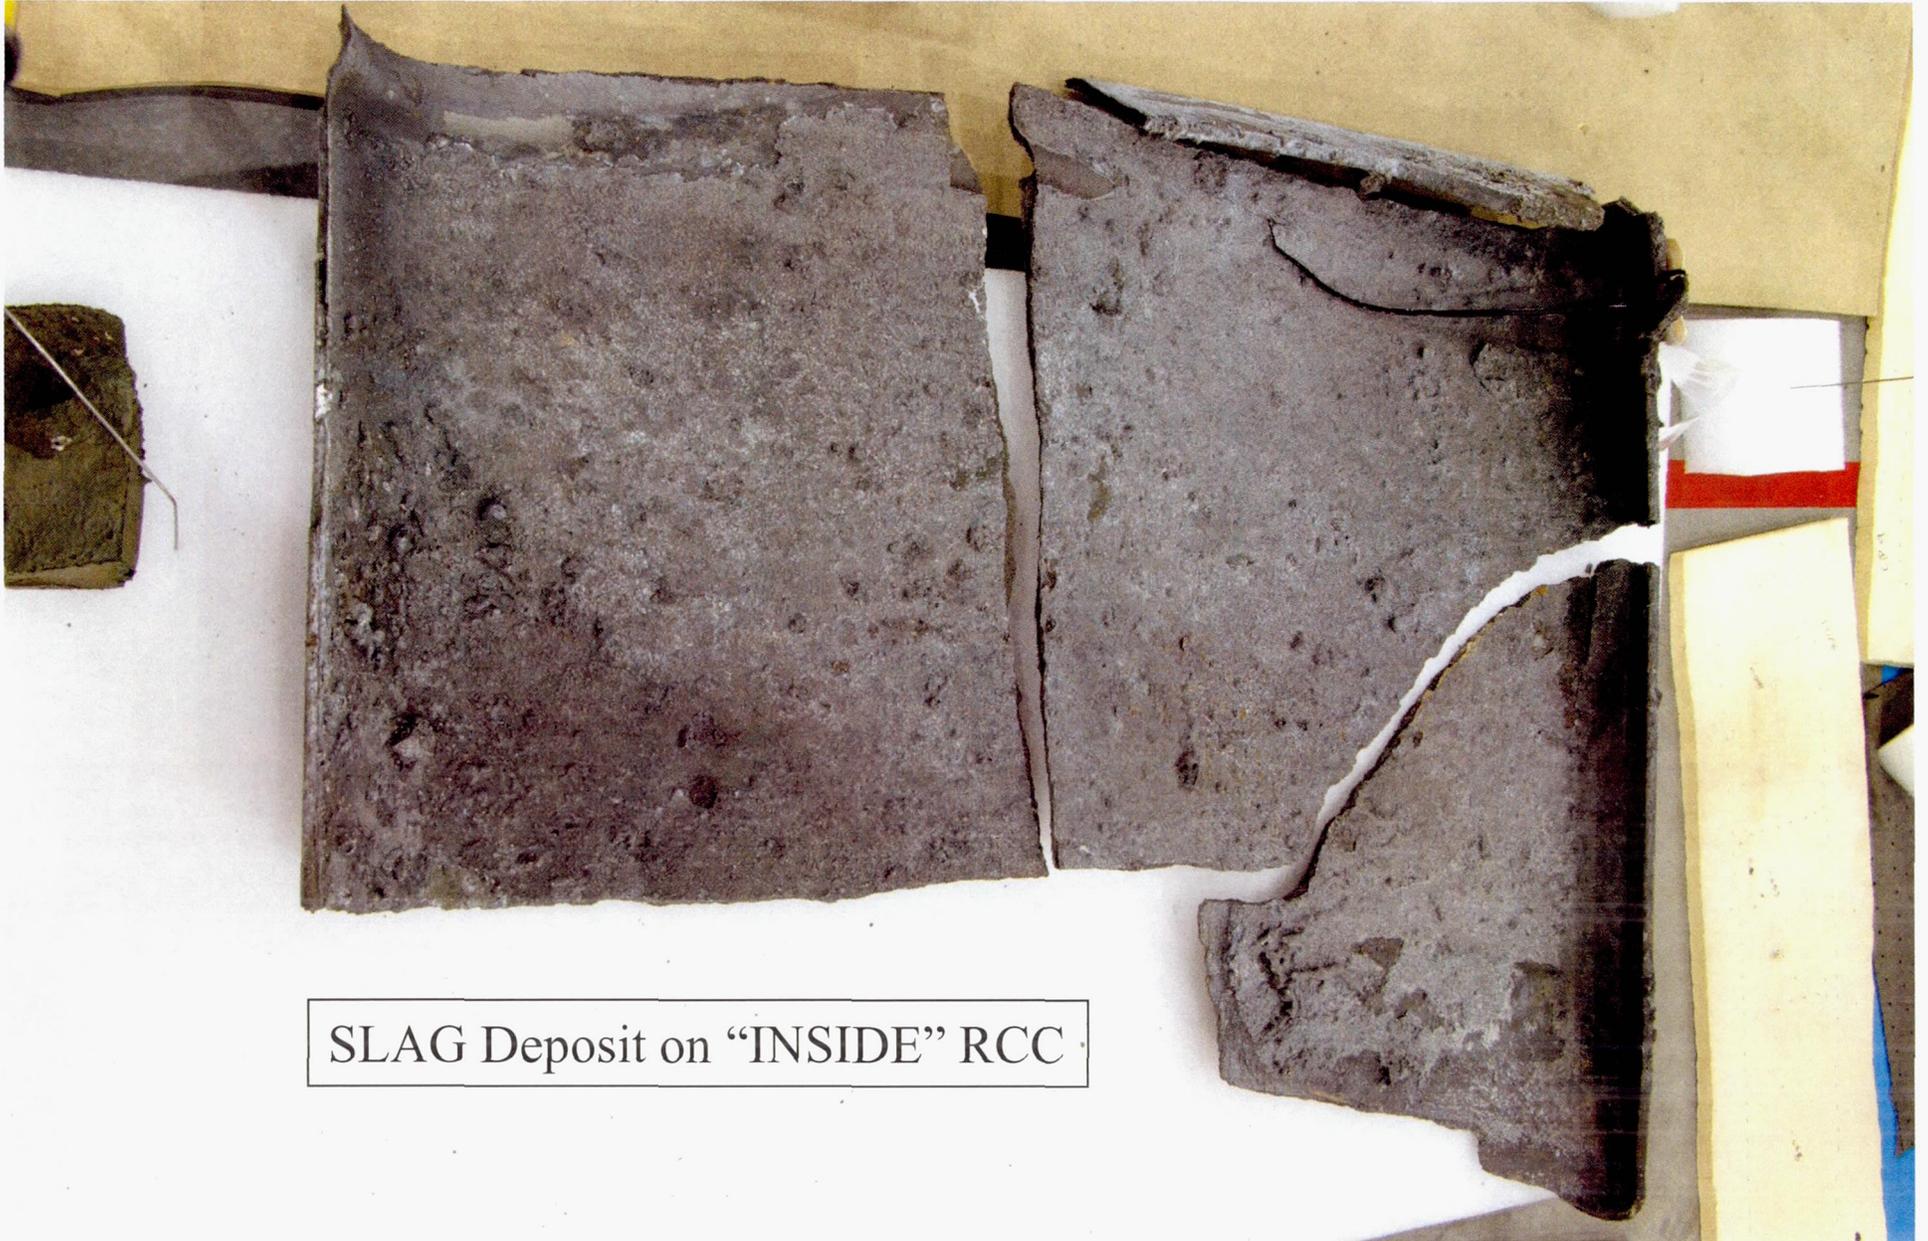
## Example Debris, LH RCC 8

SLAG Deposit on "INSIDE" RCC

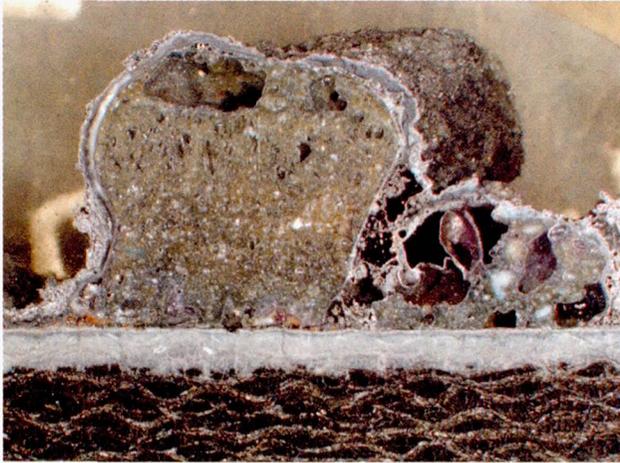
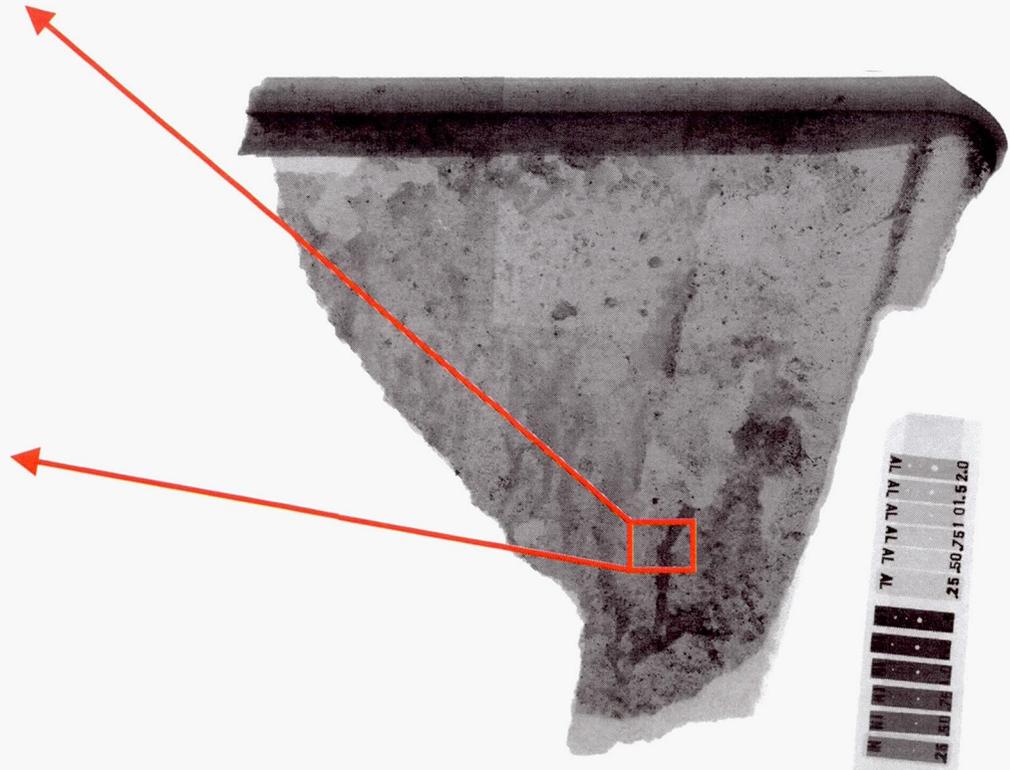
Slag Item 43709, Sample 2A1

# LH RCC #8 - Slag Feature 1

## Thick Tear Shaped

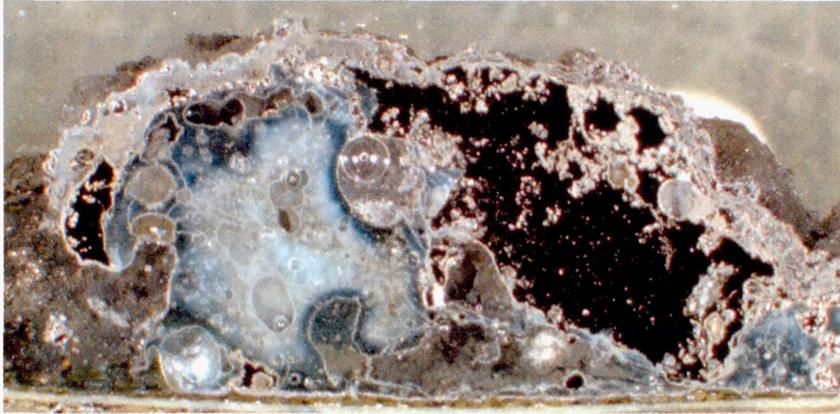
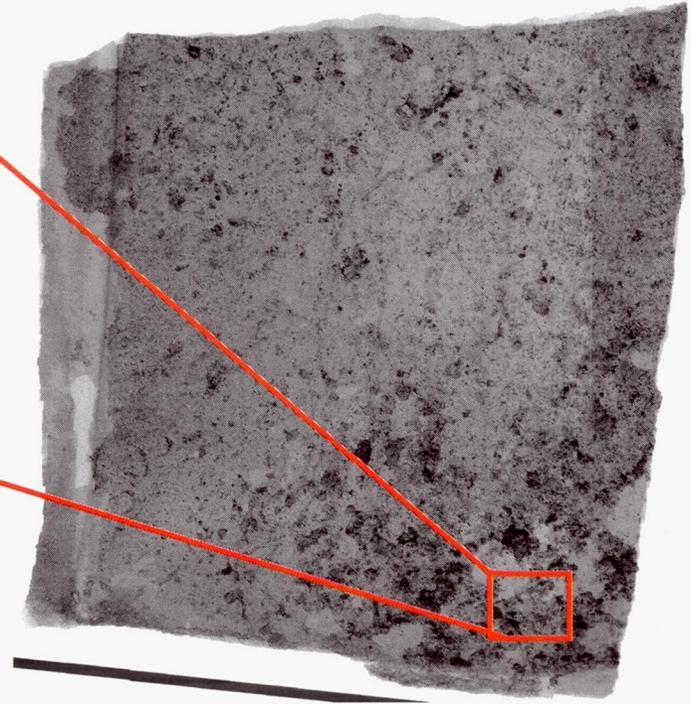
Slag Item 2200, Sample 6A1

# LH RCC #8 - Slag Feature 2

## Thick Globules

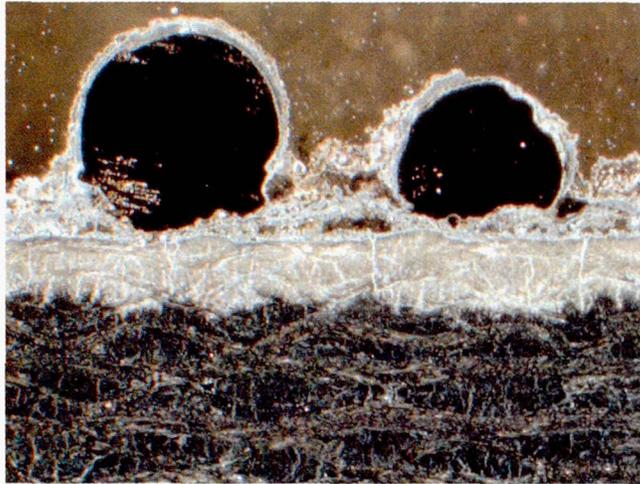
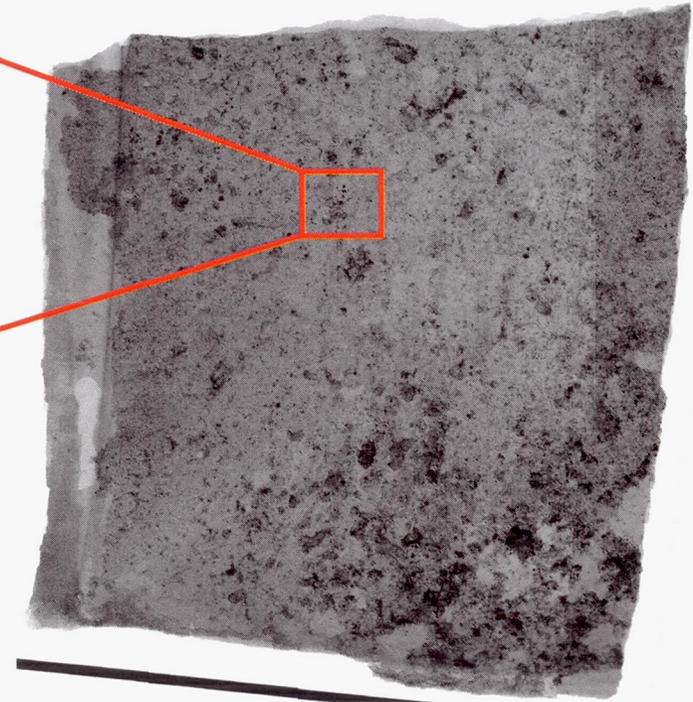
Slag Item 2200, Sample 6C1

# LH RCC #8 - Slag Feature 3 Spheroids

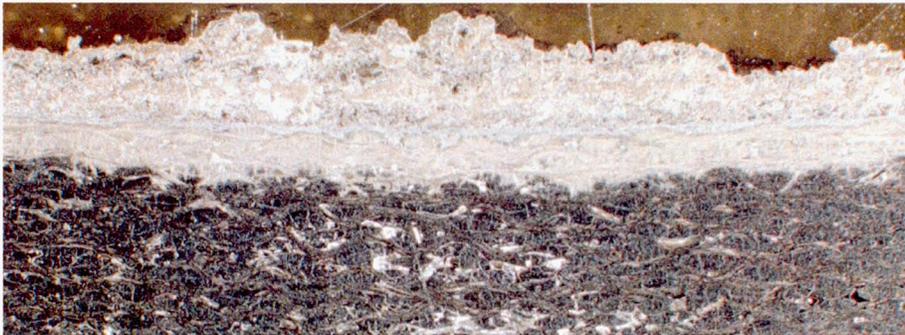
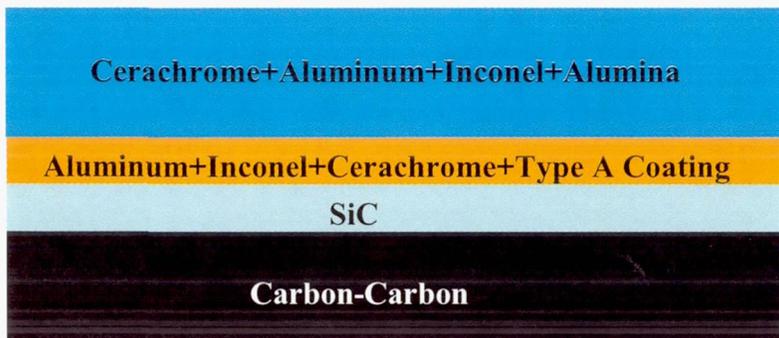
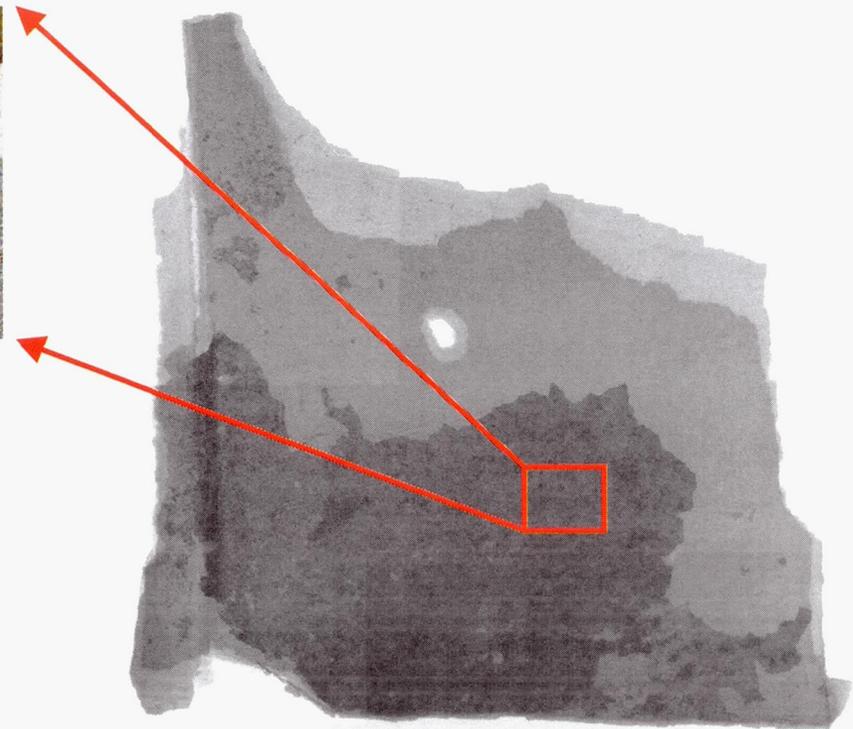
Slag Item 16523, Sample 4A1

# RH RCC #8 - Slag Feature 4 Uniform Deposit

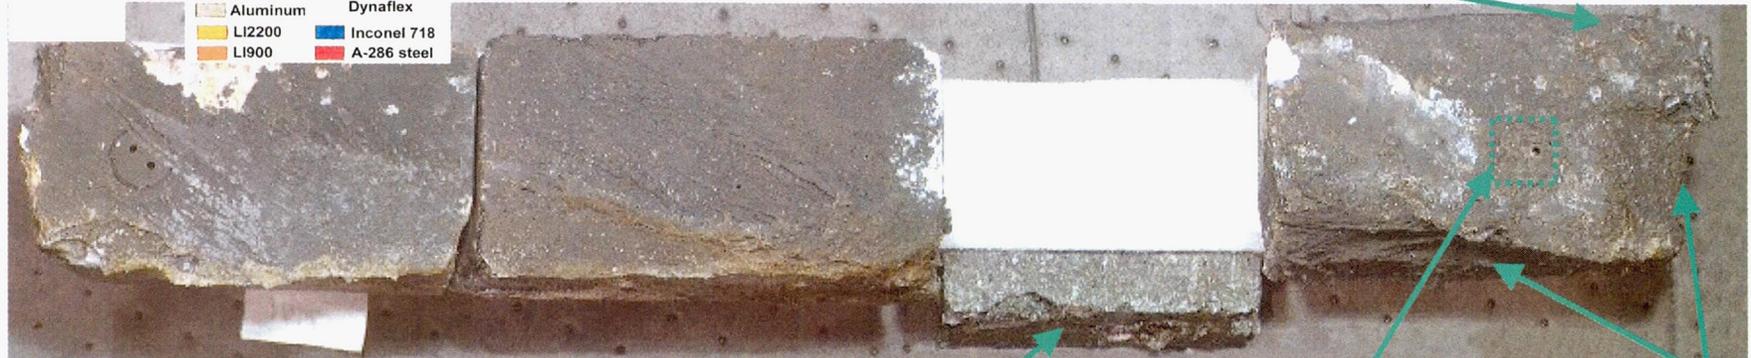
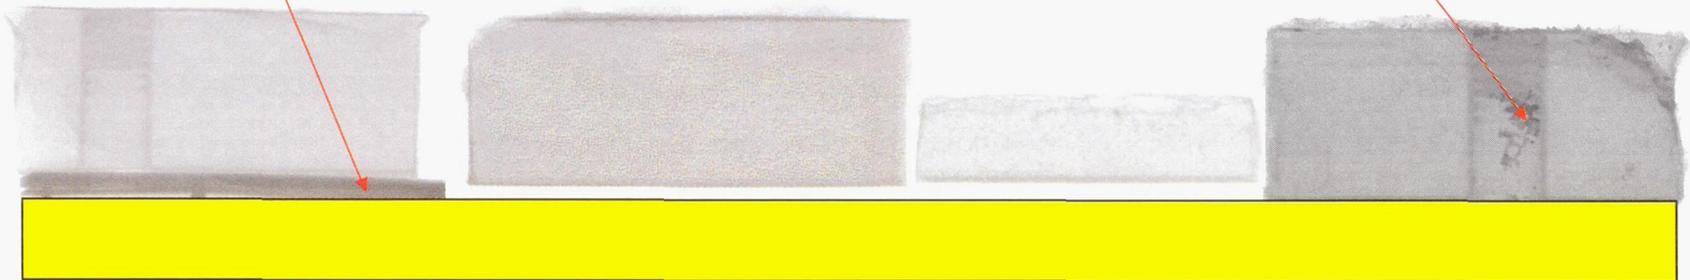
# Reconstructed View LH CPanel 9 Tiles, lower

Horse Collar Fabric Deposit

Molten Slag on Tile

Tile Slumping

High-Z material

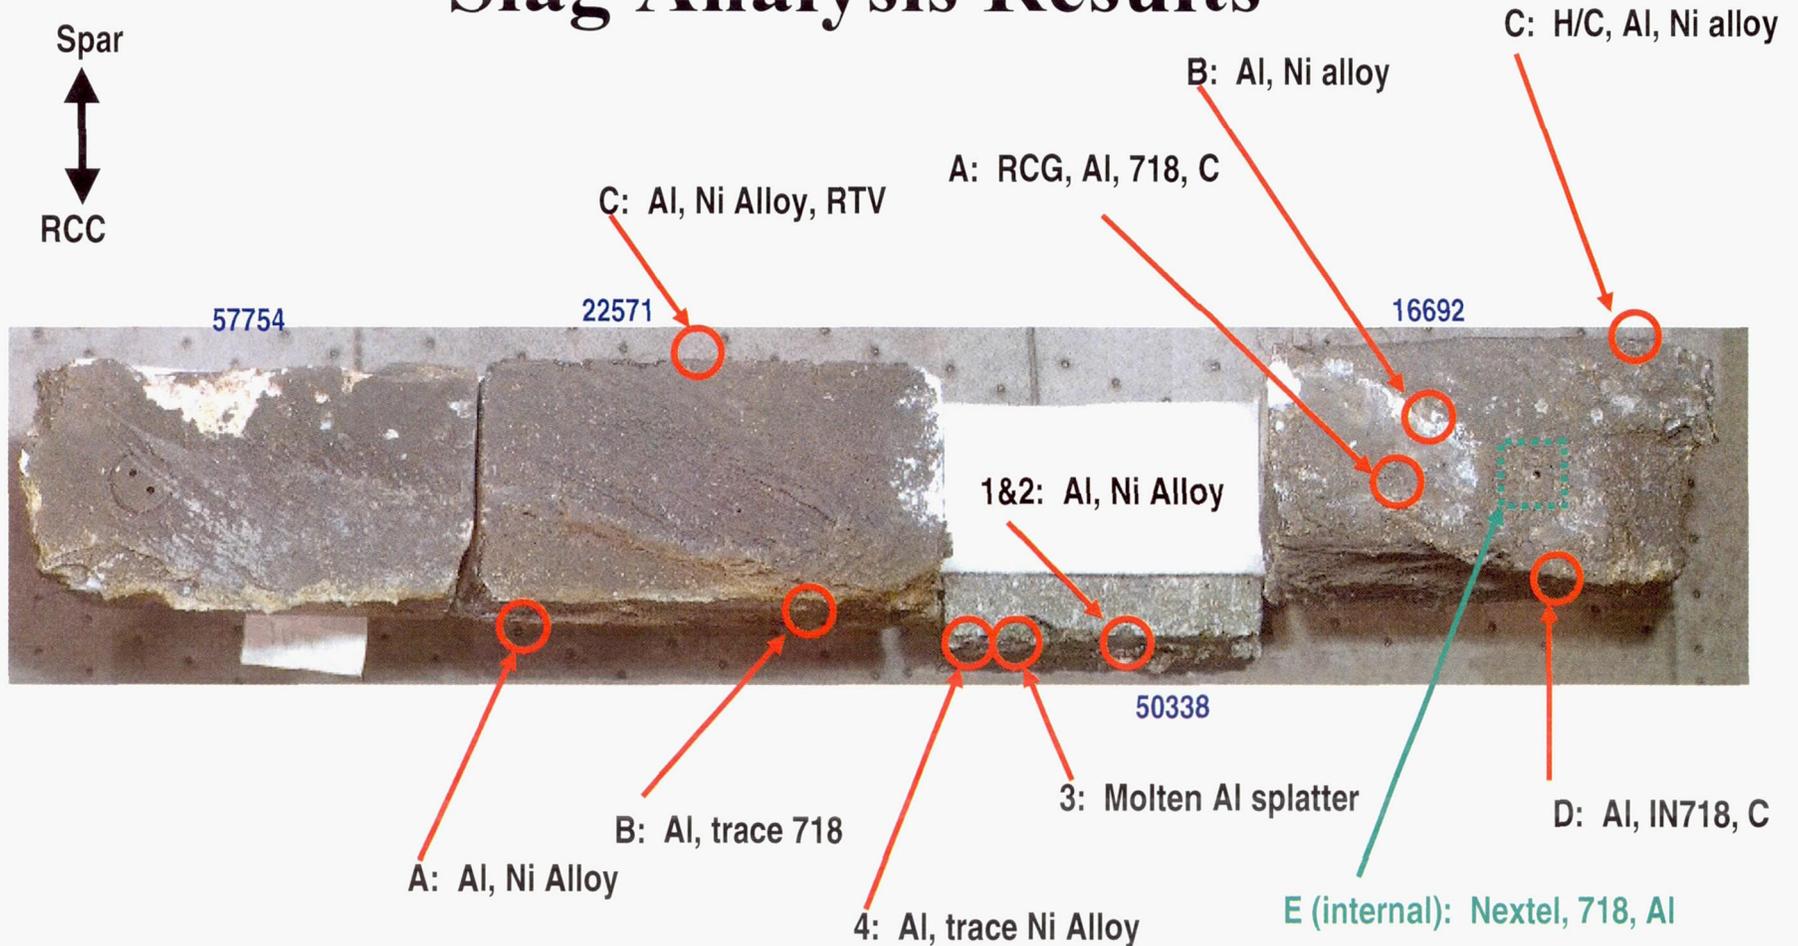
# Reconstructed View LH Carrier Panel 9 Tiles, Lower Slag Analysis Results

**These findings suggest flow of material from inside the RCC out through the upper and lower CP locations.**

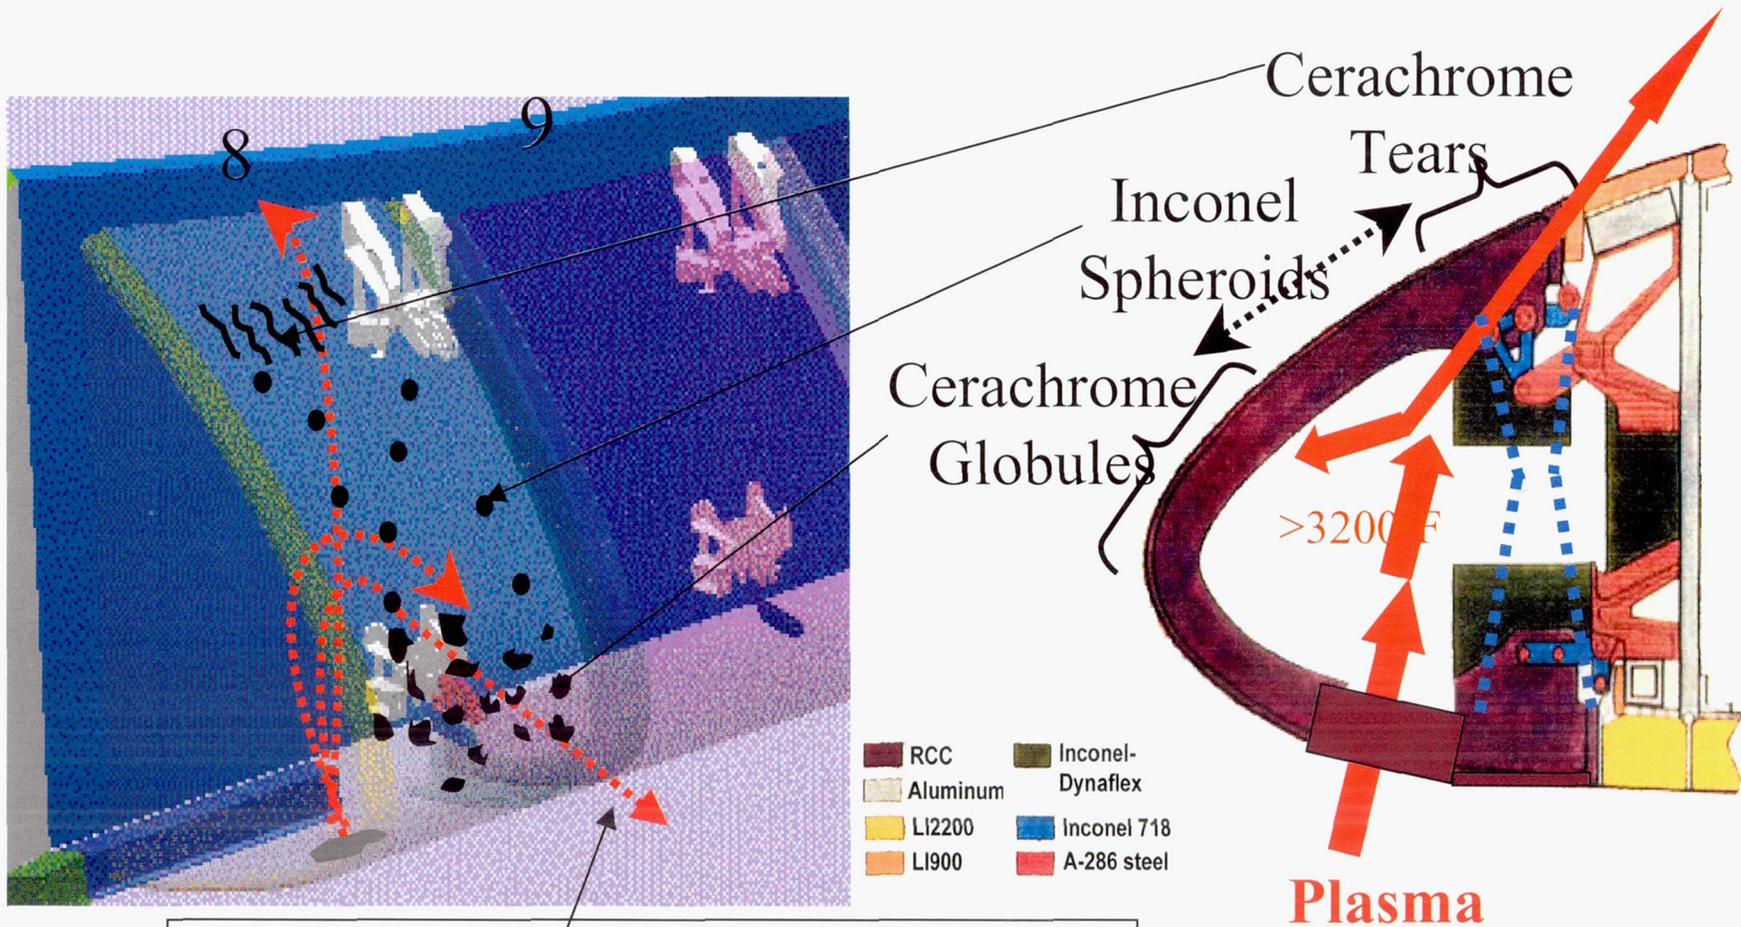
# Proposed Breach Location & Plasma Flow Based On Slag Results

Flow Exiting through RCC 8 on to lower Carrier Panel 9 tiles
