Title: *Failure Investigation & Design Optimization of a Photo-Multiplier Tube Assembly Under Thermal Loading.*

Abstract: Analysis of GLAST ACD Photo-Multiplier Tube (PMT) assembly under thermal loading demonstrates that the glass tube experiences high stresses due to Coefficient of Thermal Expansion mismatch, as well as increased stress due to high stiffness and incompressibility of potting compound. Further investigation shows adverse loading effects due to the magnetic shield, a thin piece of steel wrapped around the PMT. This steel, Mu Metal, contained an overlap region that directly attributed to crack propagation in the outside surface of the tube. Sensitivities to different configurations were studied to reduce the stress and provide a more uniform loading throughout the PMT to ensure mission success. Studies indicate substituting a softer and more compressible potting compound and moving the Mu metal from the glass tube to the outside wall of the aluminum housing yields lower stress.

Glasm Large Area Telescope: AntiCoincidence Detector (ACD) PhotoMultiplier Tube Glass Failure

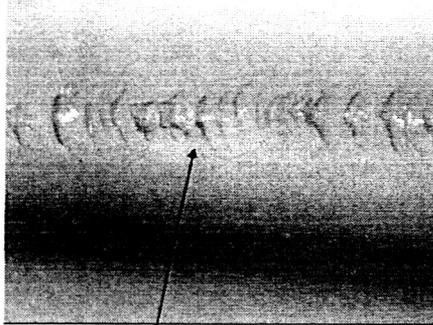
- Inspection of PMTs not yet in housings revealed 4 sets of score marks along inside of all tubes consisting of 2 to 3 thousand microcracks caused by insertion of dynode assembly. Also discovered microscopic air bubbles in tube to window transition area. Inspection of earlier PMT failed by excessive vice force shows it failed at score marks.

Close up of one score line, PMT vulnerable at scores

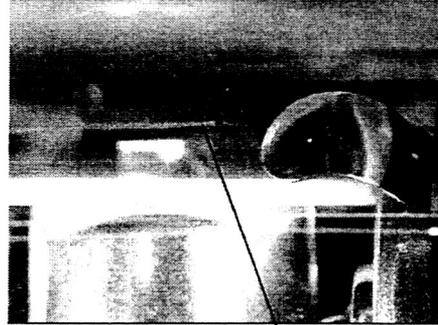
Score line ending at dynode mount

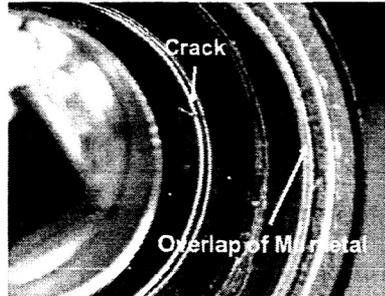
- Crack in failed PMT is aligned with Mu metal overlap. Removal of flight unit to confirm crack origination was not successful despite success of practice unit. Could not identify initiation point of failed PMT. But surprisingly did not appear to fail at one of the scores.

Crack position relative to Mu metal

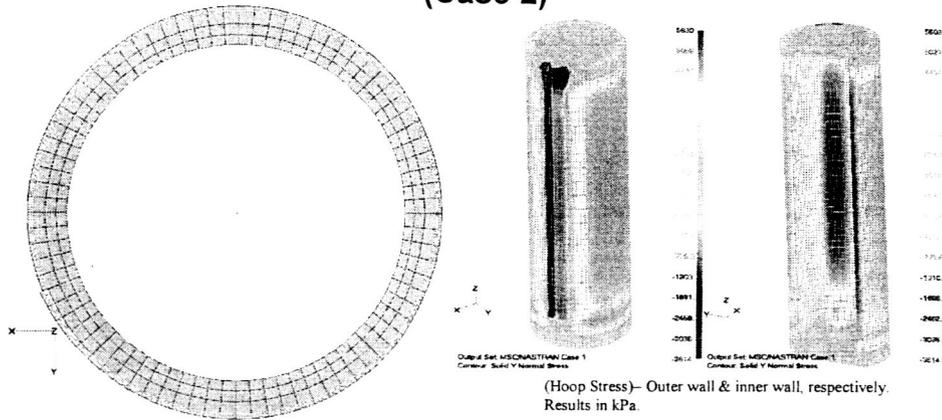
Eliminating Mu Metal Effects with Double Wrap (Case 2)

- Mu Metal effects only. No aluminum housing or potting included in model.
- *Comparable to results from previous slide titled "Mu Metal effects".
- Peak stress due to Mu Metal reduces 50% on inner wall (~1600 psi to ~800 psi) and 67% on outer wall (~1600 psi to ~691 psi).

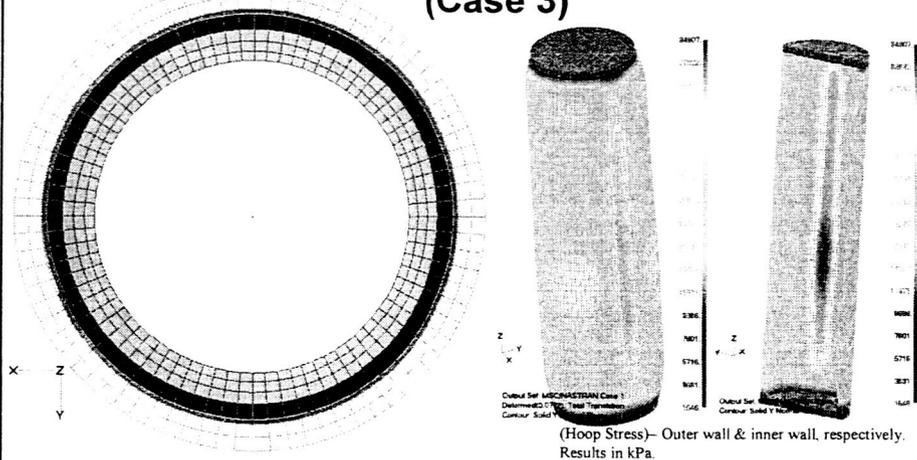
Moving Mu Metal to inside wall of housing (Case 3)

- Mu Metal transition still causing asymmetric loading.
- Potting material causing higher peak stress on PMT inner wall than initial configuration (~5 ksi, approx. 16% increase) !!
- PMT outer surface stresses ~ 3.5 ksi.

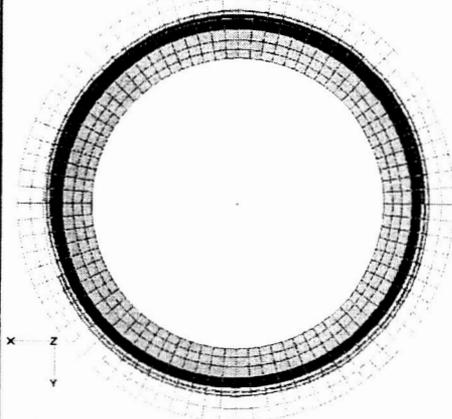
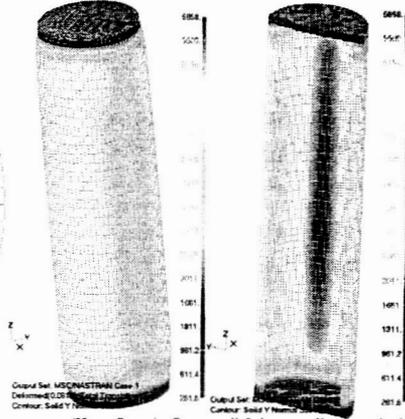
Mu Metal on inside wall of housing, RTV-566 substitution for uralane potting (Case 4)

- Slight adverse reaction due to Mu Metal.
- Softer potting material “dampens” asymmetric effects effects.
- PMT inner surface peak stress ~ 850 psi.
- Outer surface peak stresses ~ 653 psi.

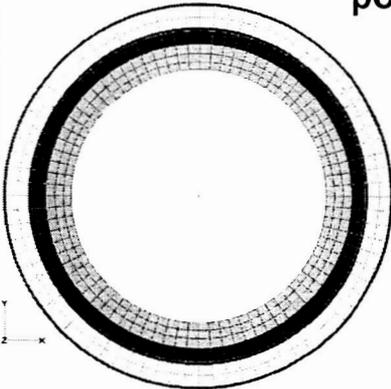
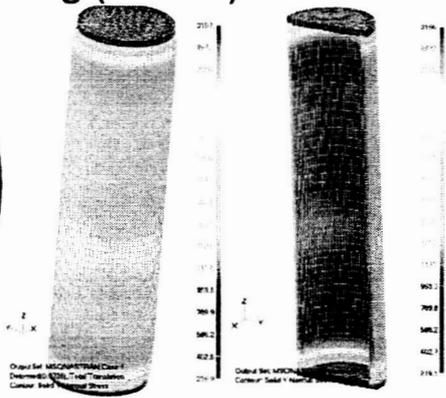
Nickel coated housing with RTV-566 potting (Case 5)

- Inner wall stress ~ 458 psi.
- Outer wall stress ~ 420 psi.
- Nickel coated housing with RTV-566 potting gives favorable results. However, Nickel coating did not meet magnetic shielding requirements.
- Also sensitive to Poisson’s ratio of potting compound (See Plot 1).

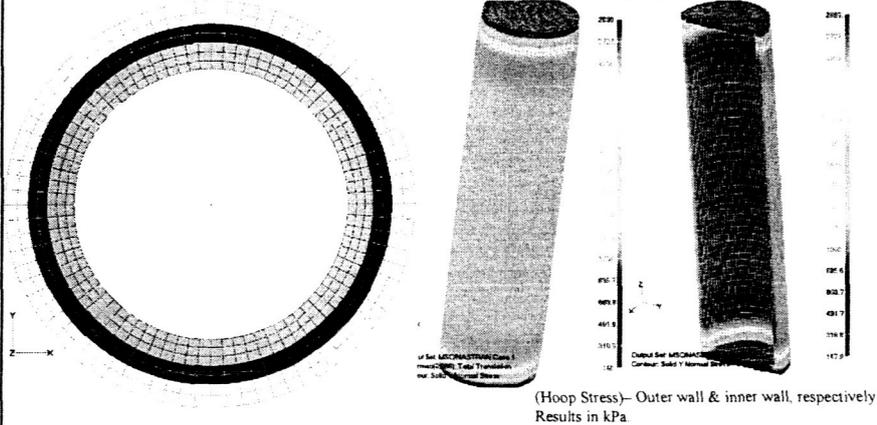
Mu Metal tacked to outside wall of housing, RTV-566 potting (Case 7)

- Assuming tacked Mu Metal does not transfer much load into housing, PMT demonstrates uniform loading.
- PMT inner surface stresses ~ 419 psi.
- PMT outer surface stresses ~ 384 psi

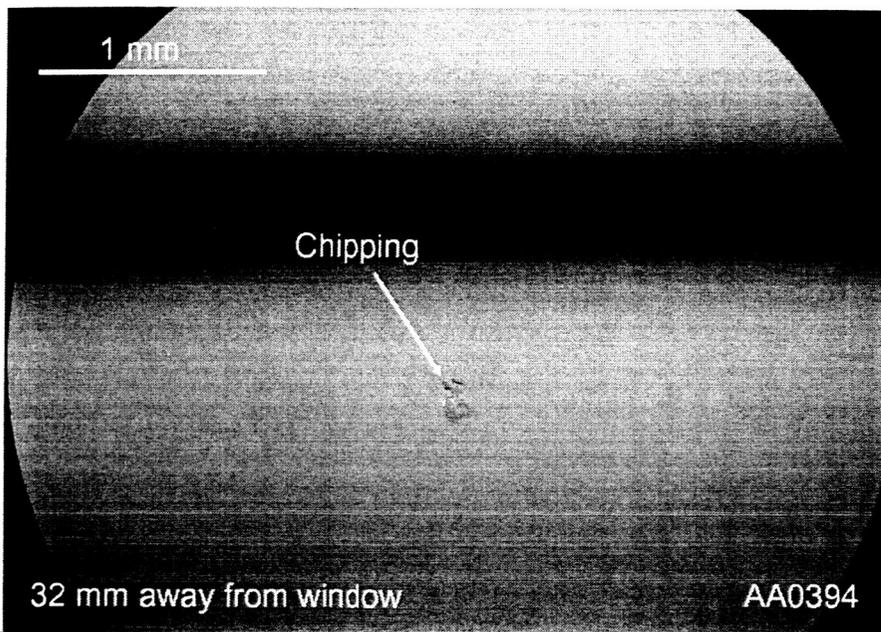
- Predicted stress on outside surface in region of Mu metal overlap is not 4300 psi but around 3200 psi.
- Inspected outer surfaces of 8 NG PMTs. Scores/pits/scratches were found, but are small in size compared to scores on inner surface. NG tubes handled very little at GSFC
- No new strength tests have been performed on the outer surfaces of the PMT.
 - More difficult to test the strength of outer surface.
 - Time constrain
 - PMTs better used for qualification of new designs.
 - The data we have: failed 4 of 23, in an area with calculated stress around 3200 psi

Outer surface flaws on NG and Cal tubes
