Debris/Ice/TPS Assessment and Integrated Photographic Analysis Of Shuttle Mission STS-98

**DEBRIS/ICE/TPS ASSESSMENT
AND
INTEGRATED PHOTOGRAPHIC ANALYSIS
OF
SHUTTLE MISSION STS-98**

February 7, 2001

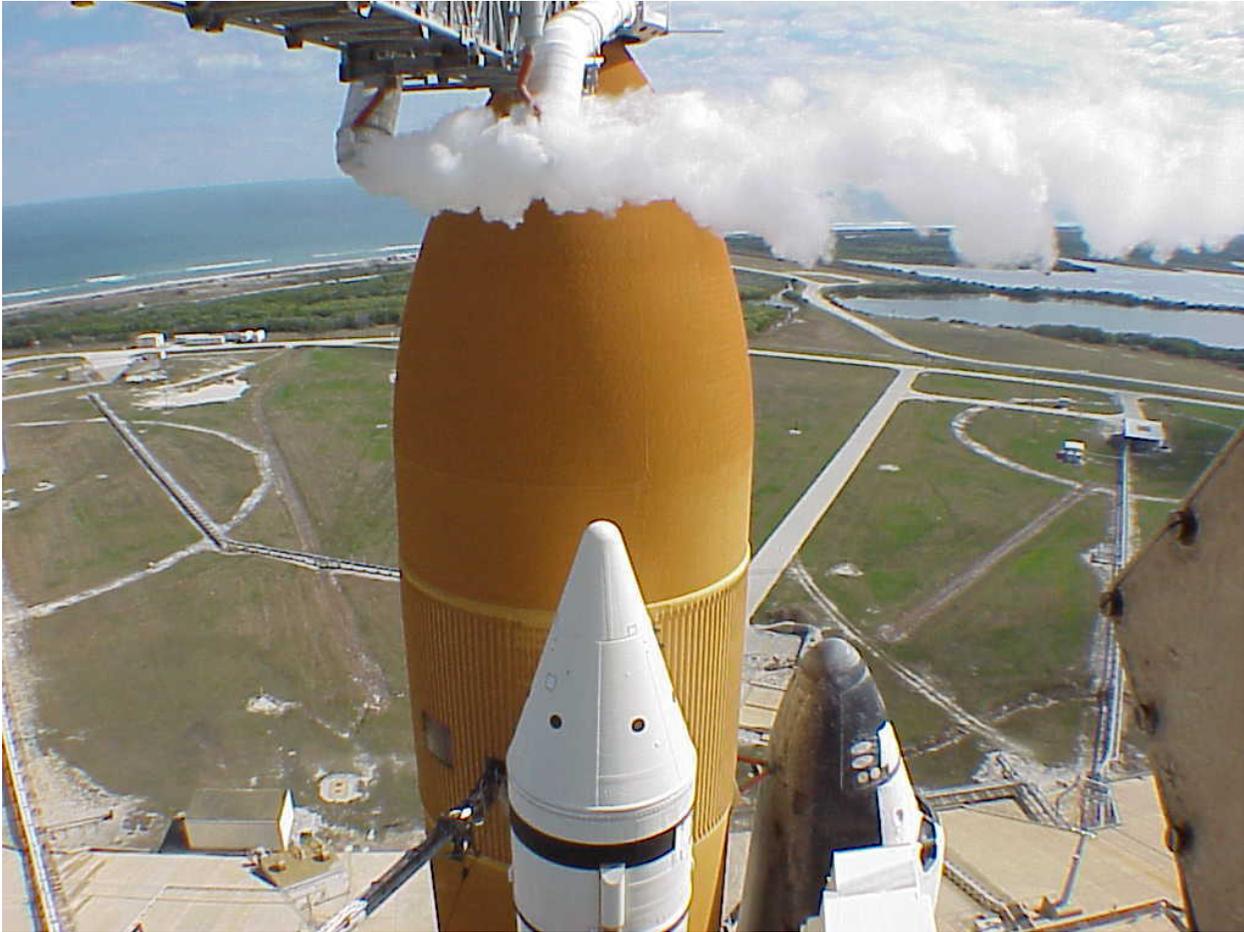
Photo 3: ET LO2 Tank and Intertank

The LOX tank and Intertank acreage foam areas were in excellent condition. No condensate was observed by the Final Inspection Team. Surface temperatures, as measured by Infrared radiometers, averaged 59 degrees Fahrenheit for LOX tank and 65 degrees Fahrenheit for the Intertank.

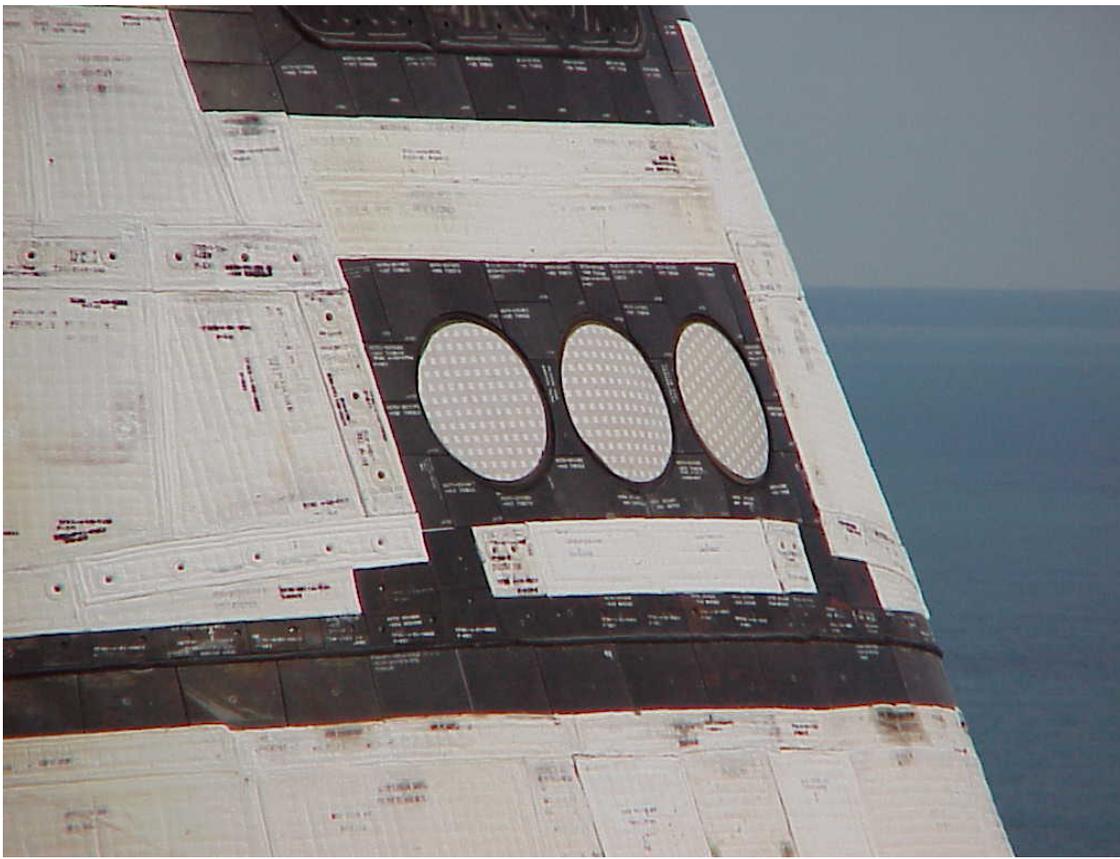
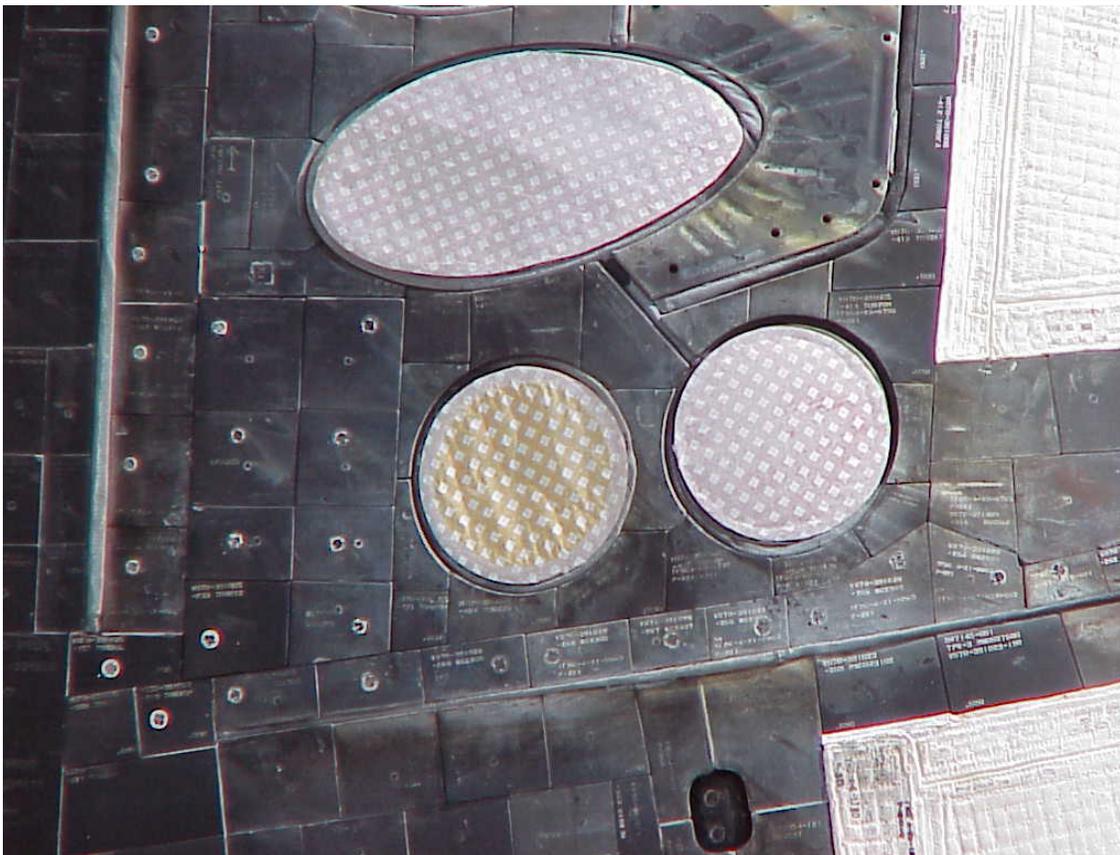
Photo 4 and 5: Orbiter RCS Discolored Thruster Covers
Paper covers for thrusters F2U and F3L were discolored, no liquid was visible behind them.

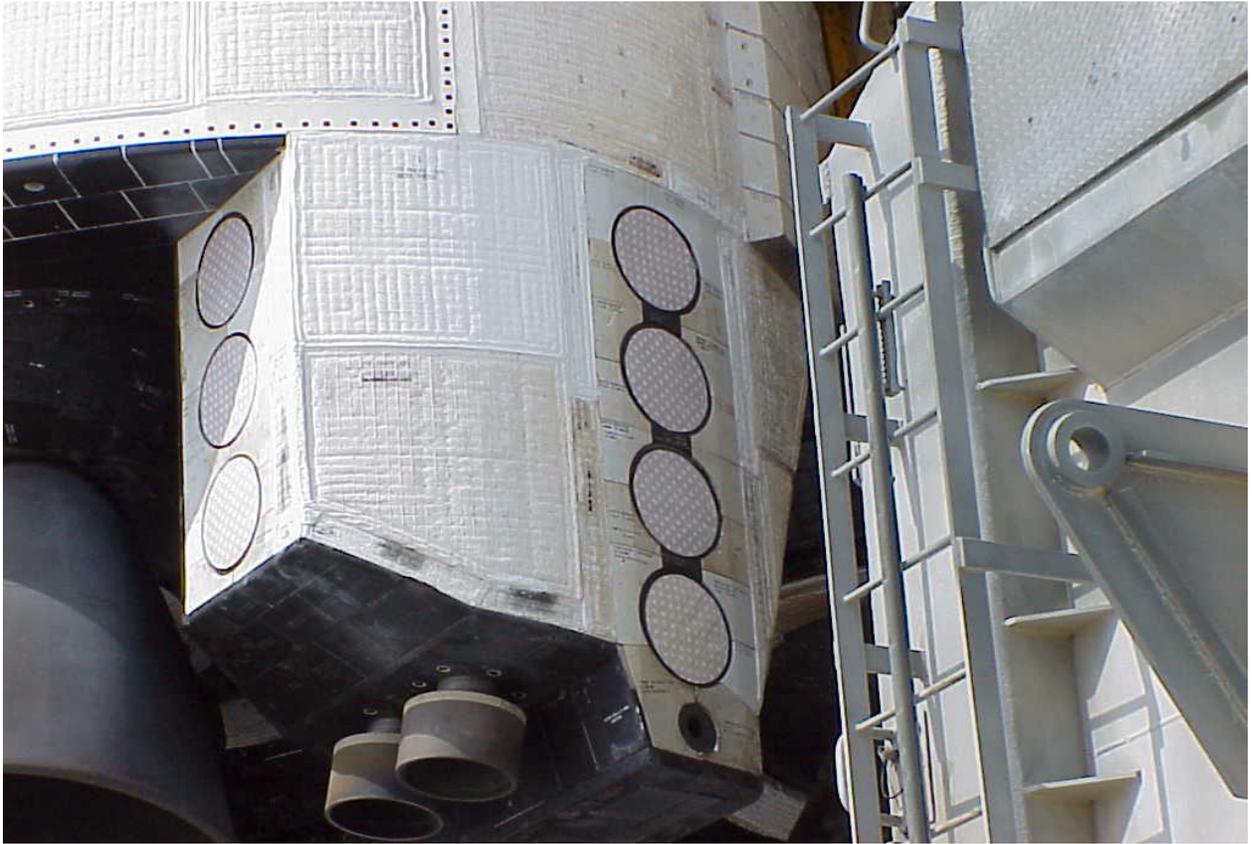
Photo 6: Orbiter RCS Discolored Thruster Cover

Orbiter RCS thruster cover at location R1R is discolored but has no liquid level visible behind it.

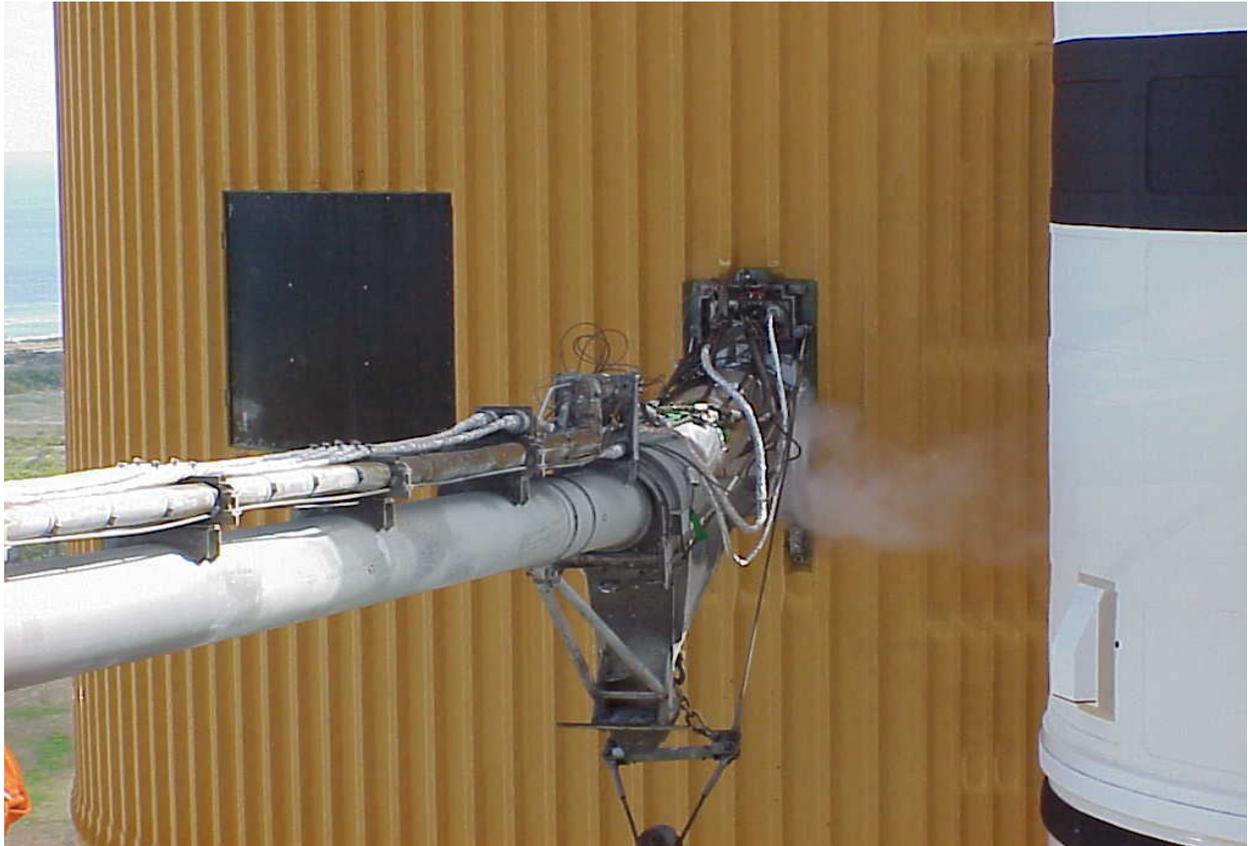
Photo 7: GUCP, Hydrogen Vent Line, and ET Intertank Door

Nominal conditions were visible at the GUCP, Hydrogen vent line, and ET Intertank door when assessed during the Final Inspection Team walkdown. Ice-Frost formation visible at the Ground Umbilical Carrier Plate was noted to be within NSTS 08303 requirements.

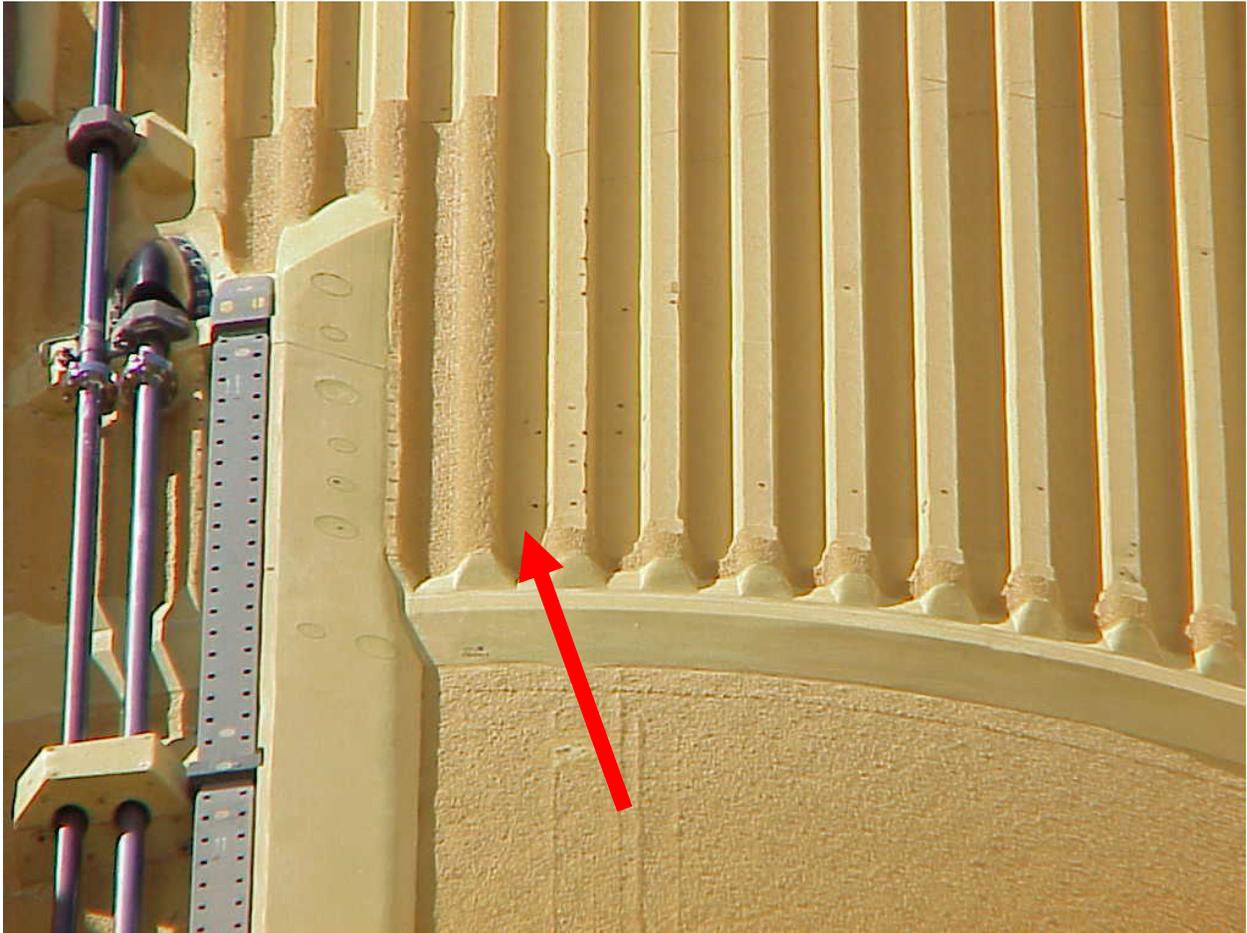
Photo 8: Crack in Intertank Stringer Valley

No significant anomalies were present in the intertank TPS. A 6-inch long hairline width stringer valley TPS crack was visible in the +Z+Y quadrant in the first machined stringer valley +Y of the cable tray PAL ramp. Surface temperature measured 65 degrees F with Infrared. Ice and frost accumulations on the GUCP were typical.

No significant anomalies were present in the intertank TPS. A hairline crack, 6-inches in length, was noted in the first machined valley +Y of the Protuberance Air Load (PAL) ramp. Cracks in the Intertank TPS had been previously observed and attributed to shrinkage from cryogenic loading and “hoop stresses” in the Intertank structure.

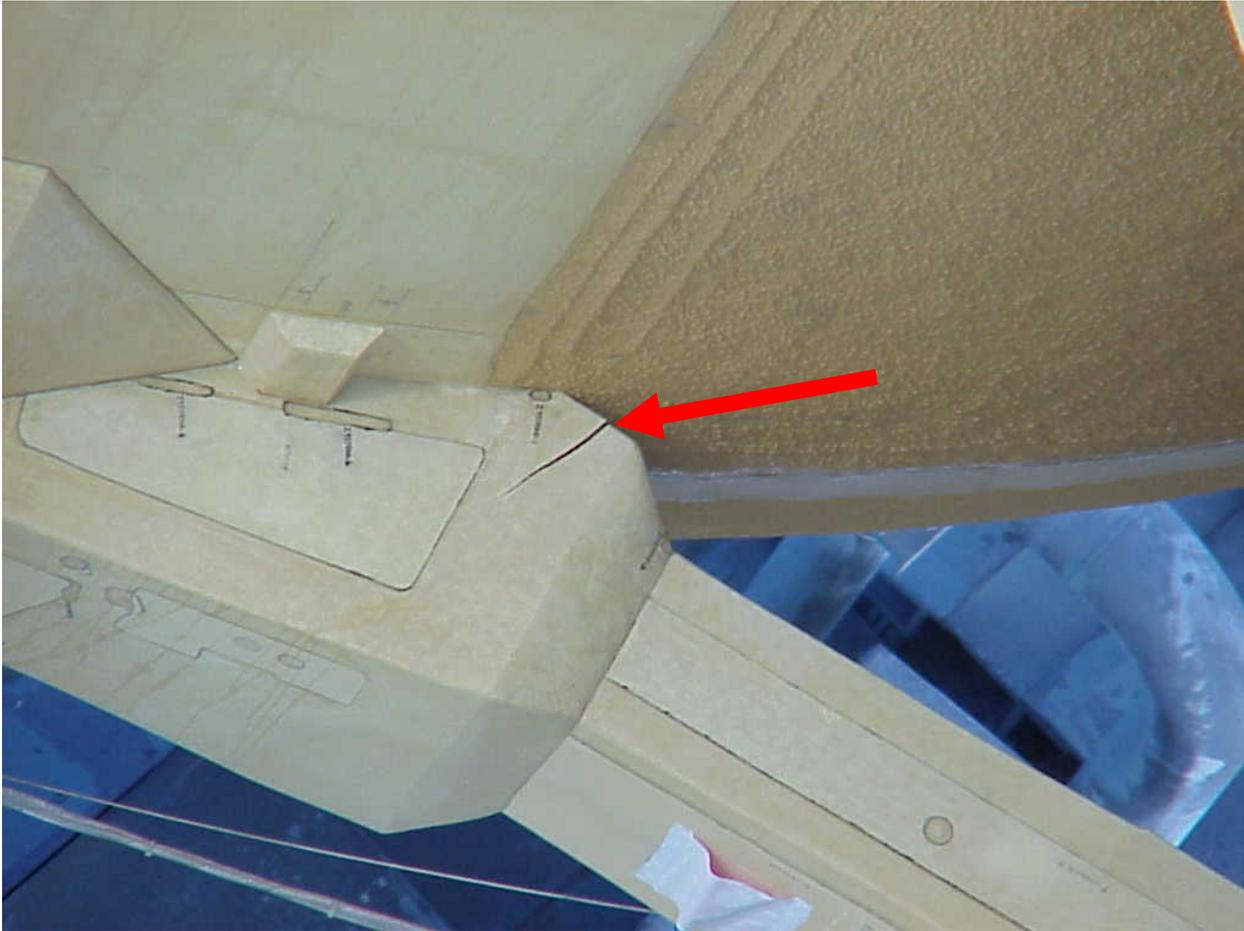
Photo 9: ET -Y Longeron

A 10-inch stress relief crack in the -Y vertical strut TPS forward surface had formed with a width of 1/4-inch. This condition has been accepted for flight on previous vehicles and is documented in NSTS 08303.

As typically observed, a crack in the forward surface insulation of the Longeron to ET/SRB cable tray was present. This crack is due to rotation of the vertical strut as the Hydrogen tank is cryogenically loaded. The crack is approximately 10-inches long and ¼-inch wide, no ice-frost was present. The crack was accepted per the NSTS 08303 criteria. The LH2 tank was observed by the Final Inspection Team and found to be in excellent condition with light to medium condensate visible with measured average temperature of 60 degrees Fahrenheit.

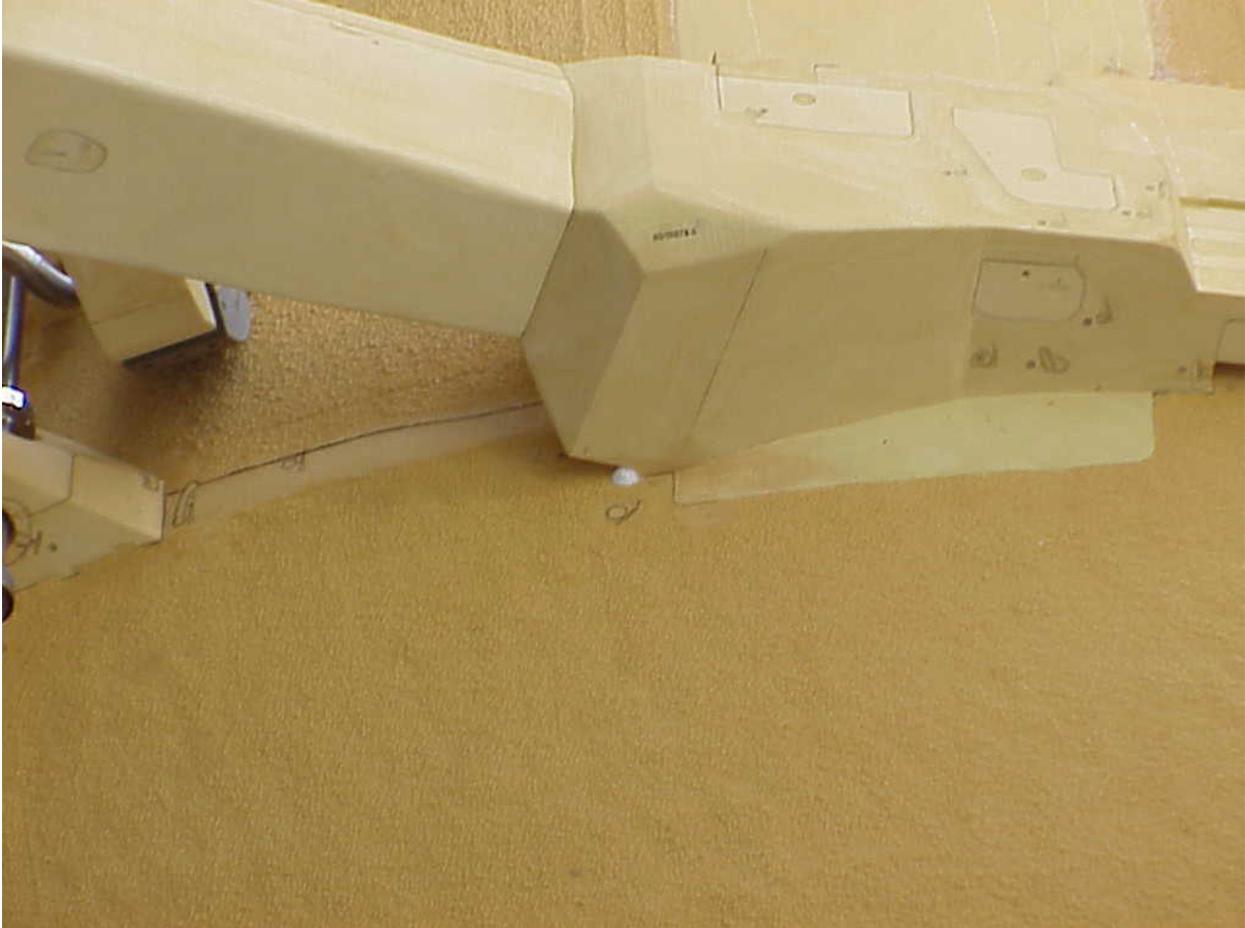
Photo 10: ET +Y Longeron TPS

Typical amounts of ice/frost had accumulated in the LO2 feedline bellows and support brackets. A two-inch diameter frost spot was observed on the aft side of the +Y vertical strut/longeron closeout.

An ice-frost formation, approximately 2-inches in diameter, located aft of the +Y Longeron was observed by the Final Inspection Team. The ice-frost spot is located adjacent to a foam closeout and is likely caused by a thermal short/crack. This condition is acceptable per NSTS 08303.

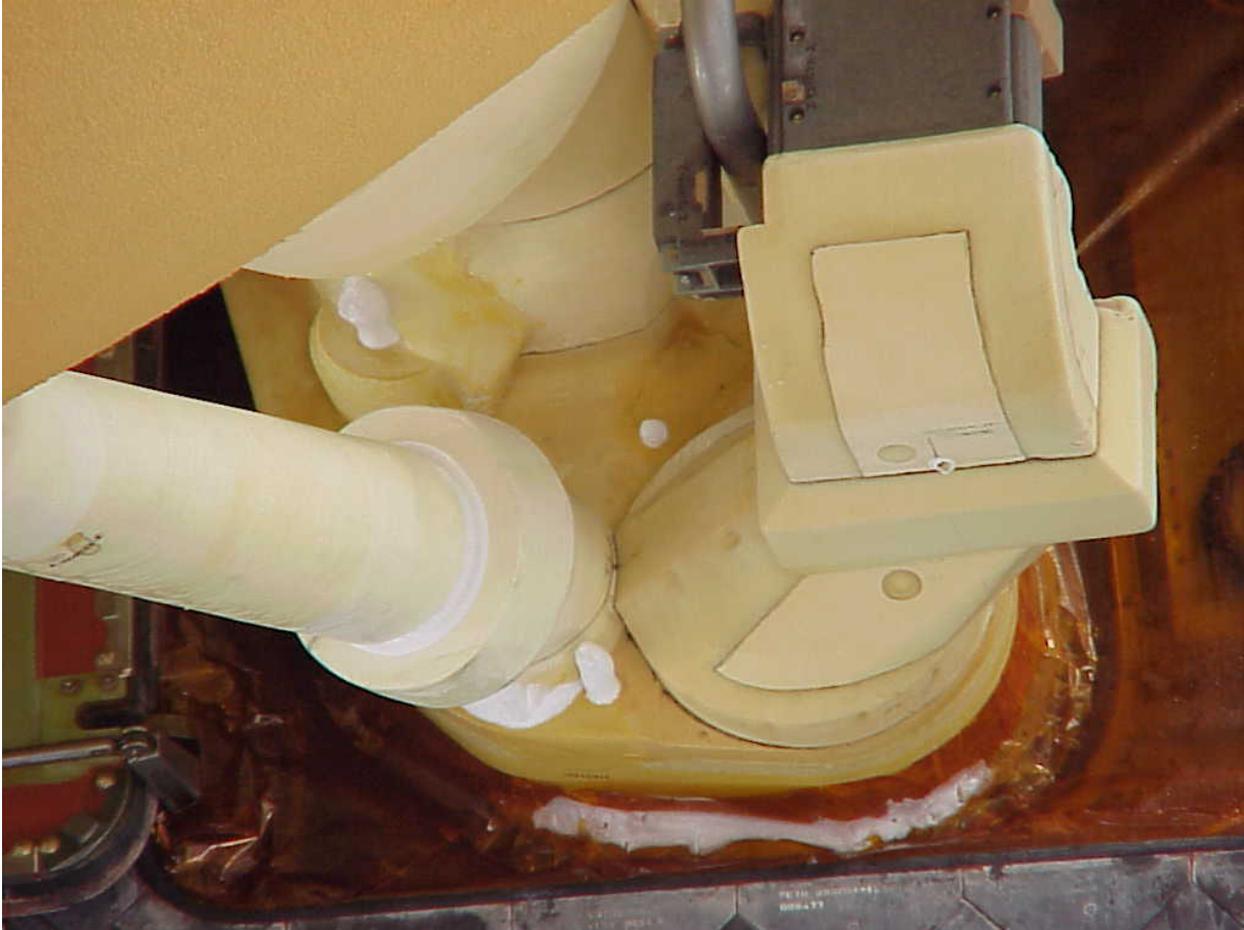
Photo 11: LH2 ET-Orbiter Umbilical

Approximate 6-inch long ice-frost ‘fingers’ were present at the exit points for the pyro-cannister purges and umbilical purge areas with a 1-inch diameter frost spot at the closeout plug for manual actuator access port and is most likely a bond-line thermal short effect. Ice-frost formation was present at the recirculation line bellows and recirculation line to umbilical interface. The purge barrier was wet with condensate and had ice frost formations on the aft, forward, and outboard locations. The LO2 ET-Orbiter umbilical had similar purge exit ‘fingers’ and condensate/ice-frost on the purge barrier at the inboard and lower locations. There were no acreage LO2 or LH2 umbilical TPS anomalies. All observations were within the NSTS 08303 criteria.

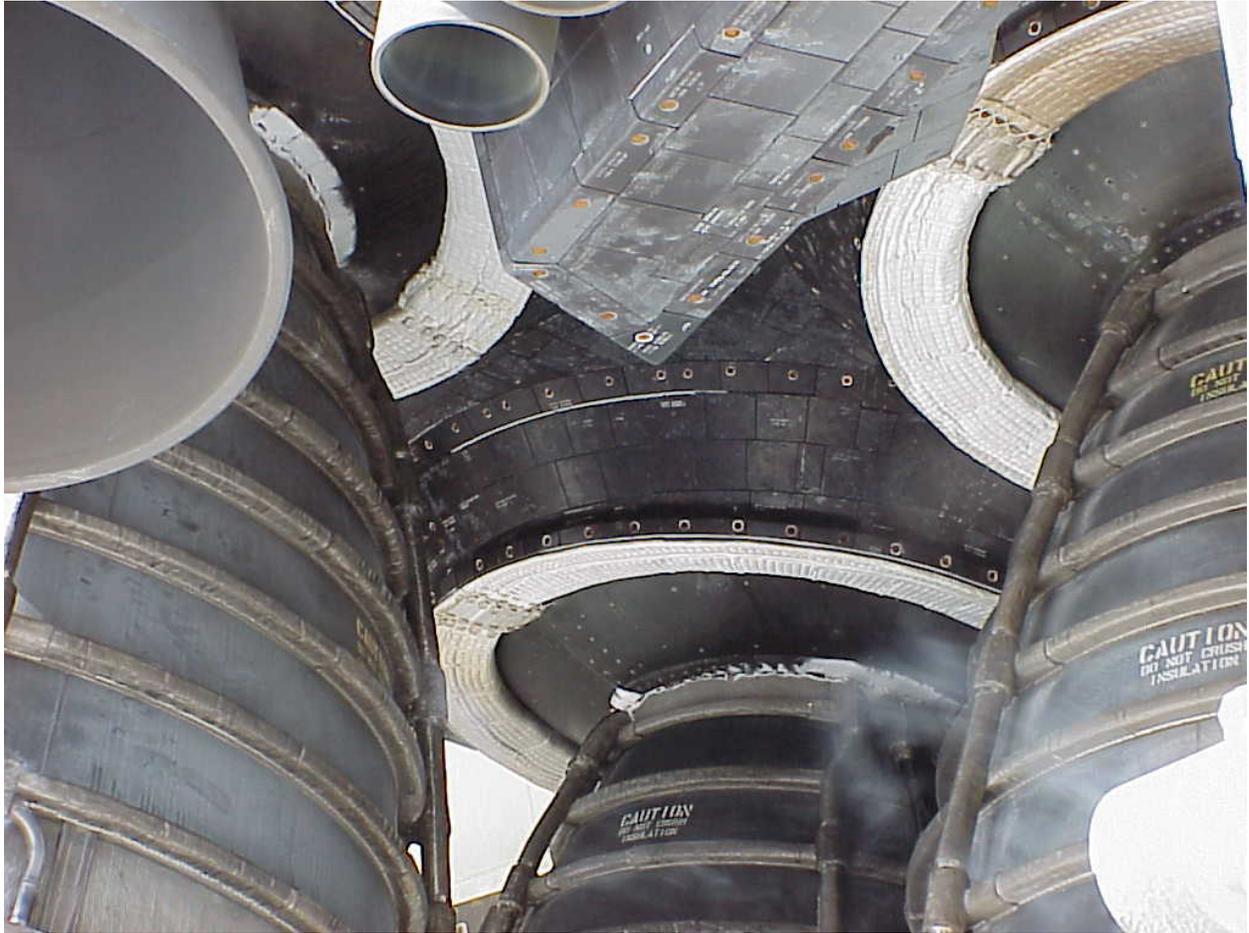
Photo 12: Overall View of SSME Base Heat Shield

The SSME base heat shield is visible and free of defects. Ice-frost formations at the nozzle interface for SSME number 1 and 2 locations were typical.

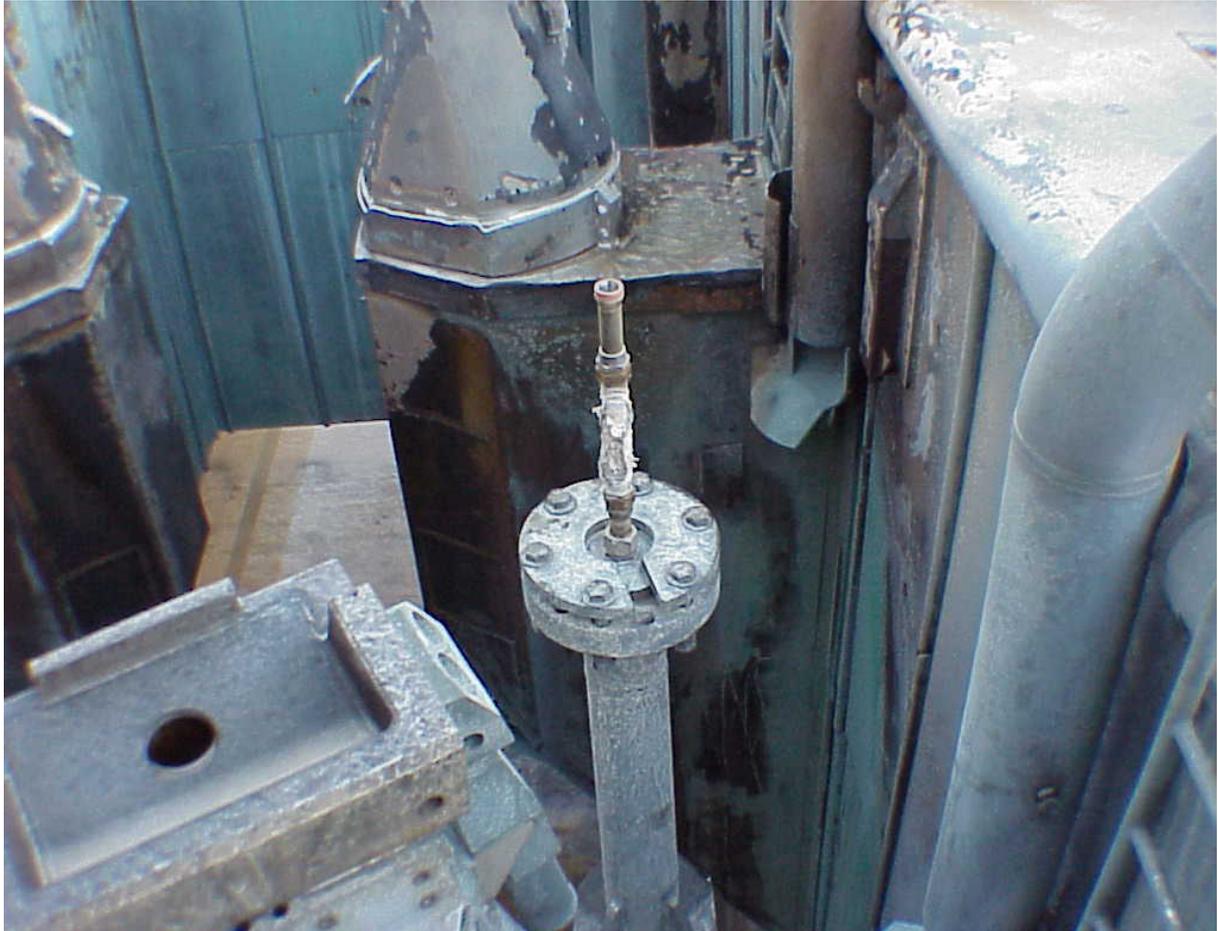
Photo 13: HDP Erosion and GN2 Purge Line

Beach indicated that a hang-up had not occurred. No signs of stud hang-ups were detected in the visual inspection of the four south posts. Erosion was typical for the north posts. HDP-6 shoe shim material was debonded from the RH side. North holddown post blast covers and T-0 umbilical exhibited typical exhaust plume damage. Both SRB aft skirt GN2 purge lines were intact, protective tape layering was partially eroded.

Erosion affect is clearly visible on the east side of the north HDP; the condition of the SRB aft skirt GN2 purge line is tape-wrap damage; and the south HDP indicates only minimal launch damage. Only nominal post-launch debris conditions exist in the SRB exhaust hole areas of the MLP.

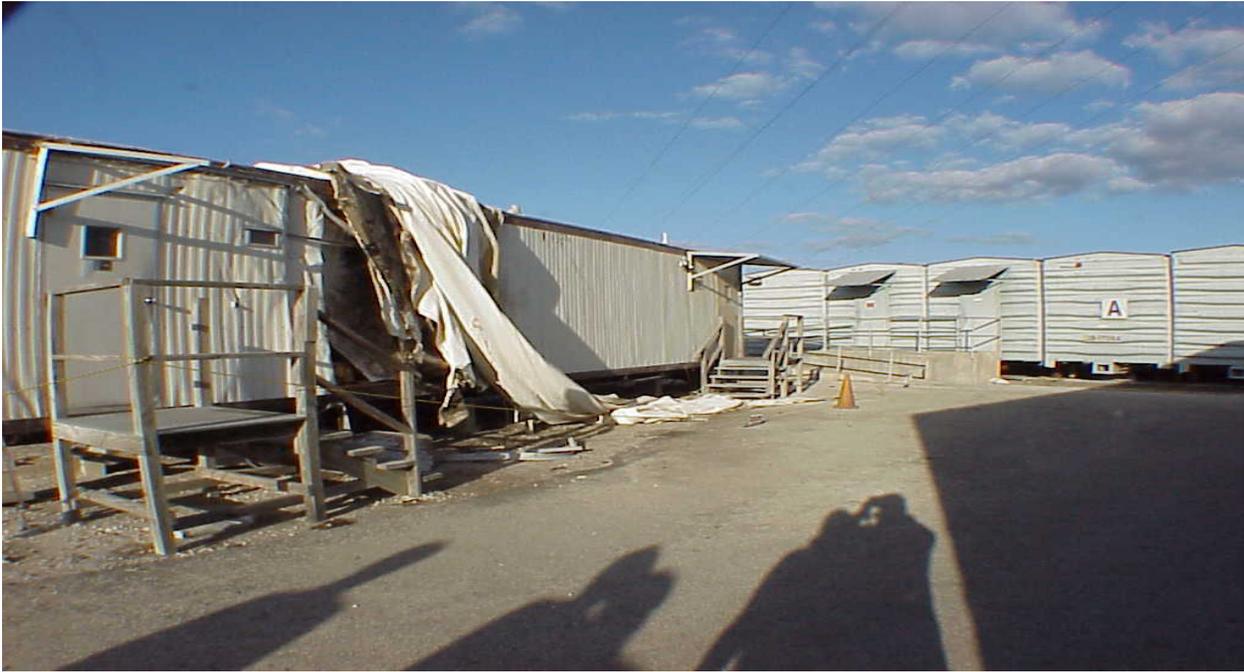
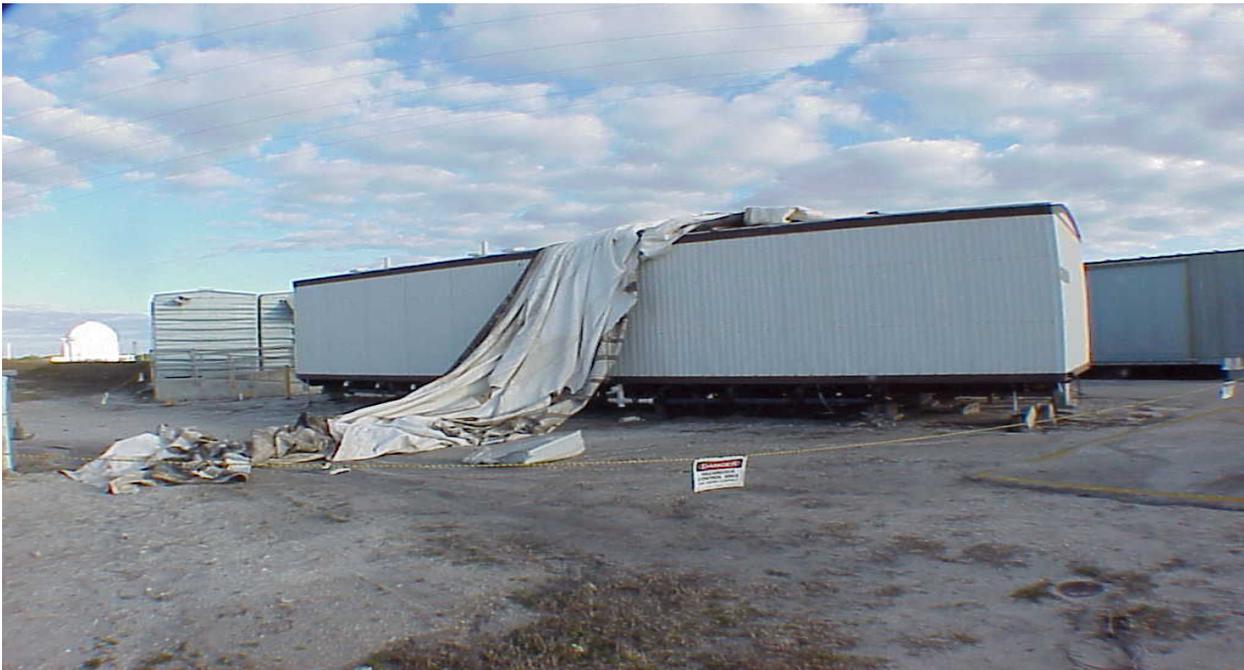
Photo 14 and 15: Trailer Damage, Pad Boxcar Area

Large pieces of roofing material had come off from the top of the power sub-station building just west of the pad apron. This material impacted a trailer in the boxcar area west of the Pad apron causing major damage to that trailer.

Roof material from the top of the power sub-station building located just west of the pad apron came off and impacted this trailer located in the Boxcar area west of the Pad.

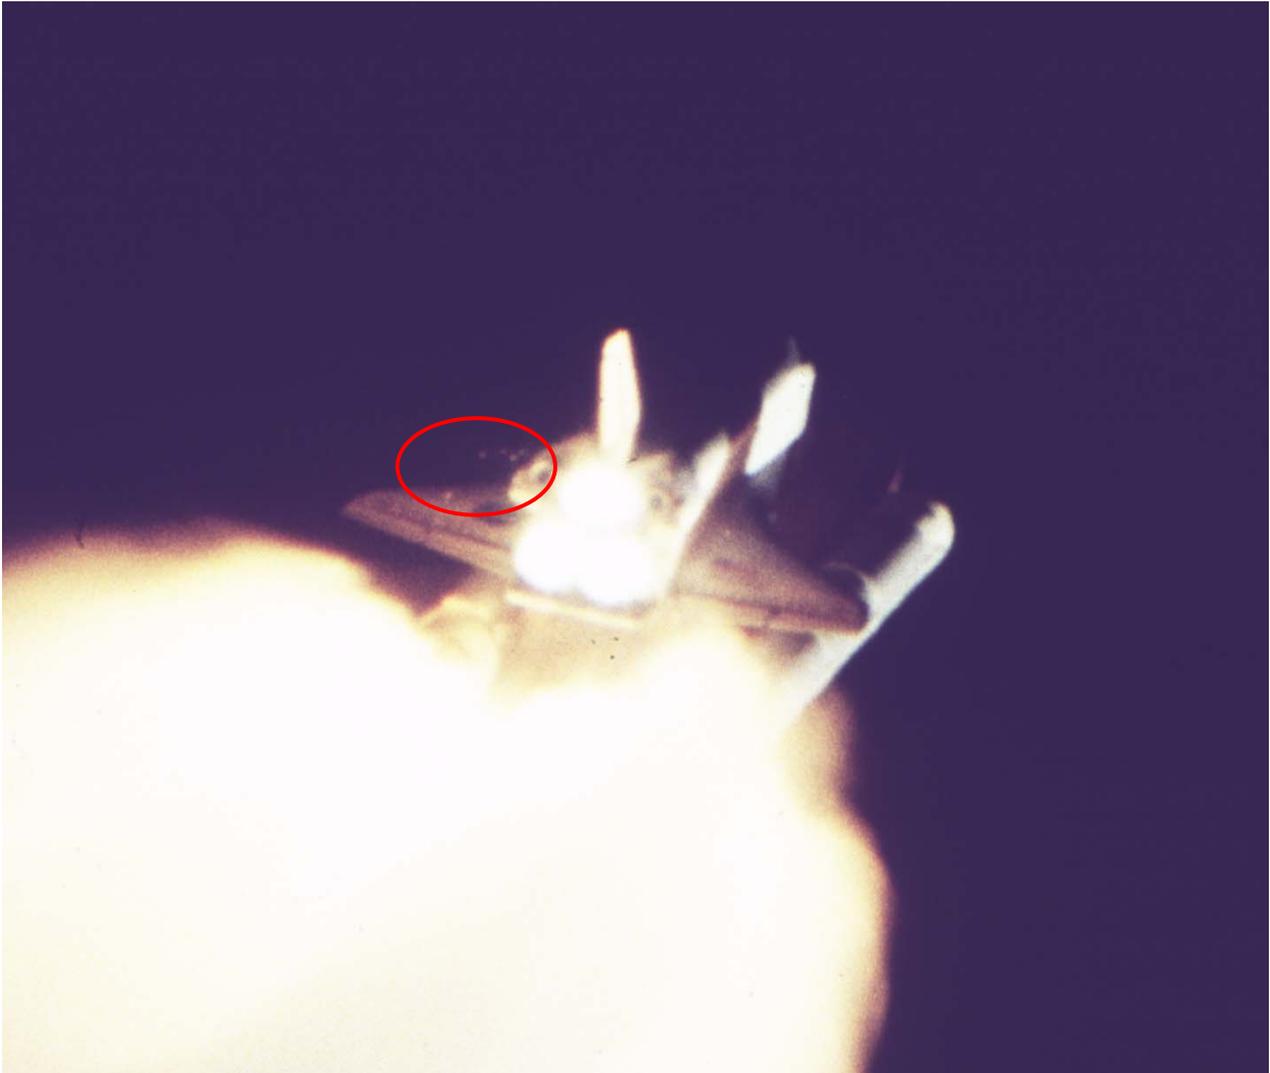
Photo 16: Debris Passing by LH OMS Pod

Approximately 4.6 seconds prior to SRB separation, E-207 shows debris particles passing over the LH wing near the OMS pod. The debris has the profile of RCS paper cover material. No flight hardware damage is visible in these views.

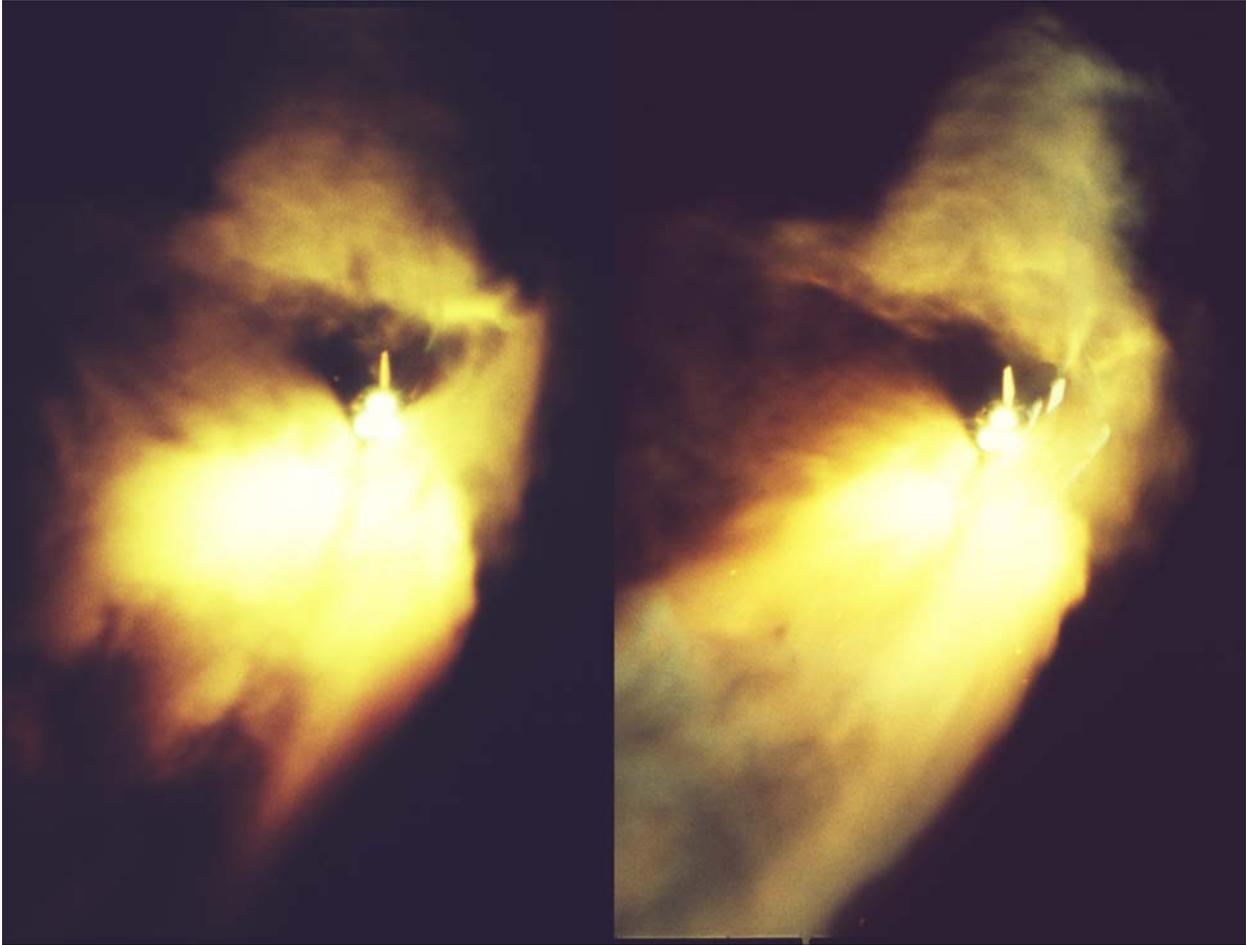
Photo 17: Forward Thruster Firing

These views from E-207 show SRB separation for STS-97 (left) and STS-98 (right) looking for the difference due to FRCS firing. The tracking film does not conclusively show the firing, as can normally be seen for an OMS-assist, only plume effect might be noted.

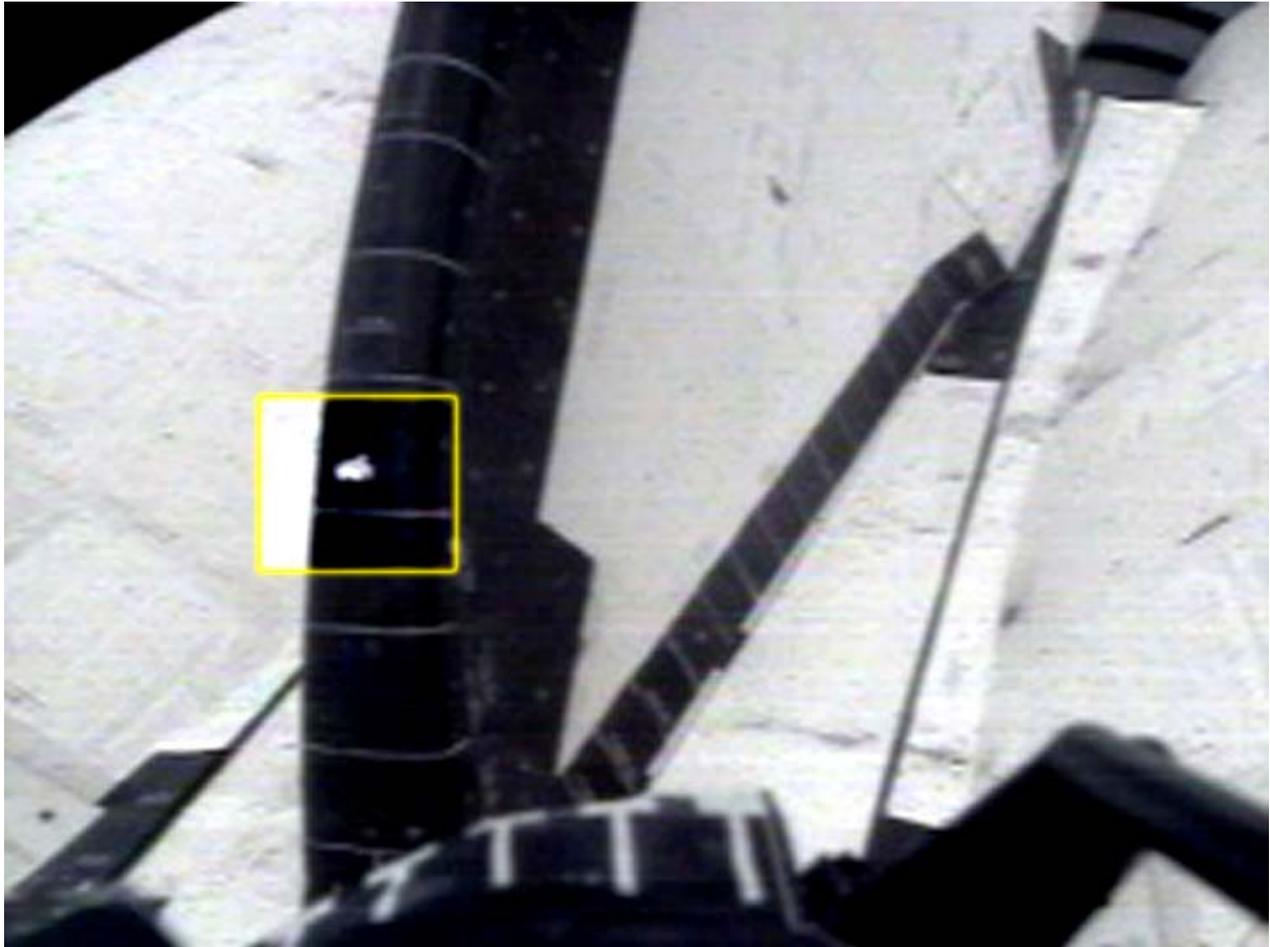
Photo 18: Damage Tile at Vertical Stabilizer

Impact damage to a tile on the leading edge of the vertical tail was seen in on-orbit video. Video analysis was used to estimate the damage size as 2-inches in diameter. The depth of the damage could not be ascertained but was viewed as surface only and thermal analysis indicated sufficient material thickness remained to protect for a nominal reentry.

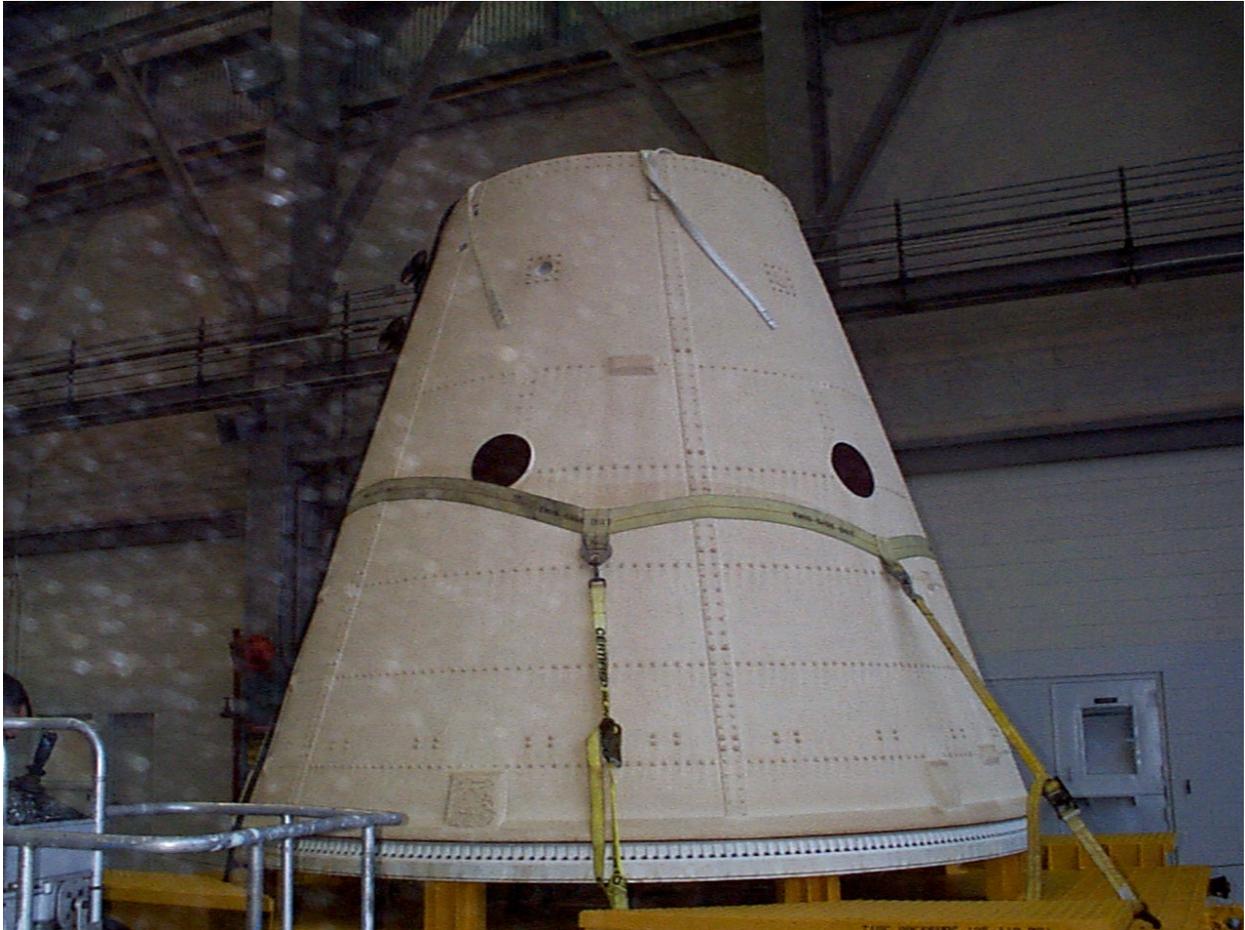
Photo 19: Frustum Post Flight Condition

The frustums exhibited no debonds/unbonds or missing TPS. All four BSM aero heat shield covers on the Right Hand, and two on the Left Hand had locked in the fully opened position. The LH BSM right side aero heat shields had not remained fully open, all covers had left linear stop marks on the nozzles.

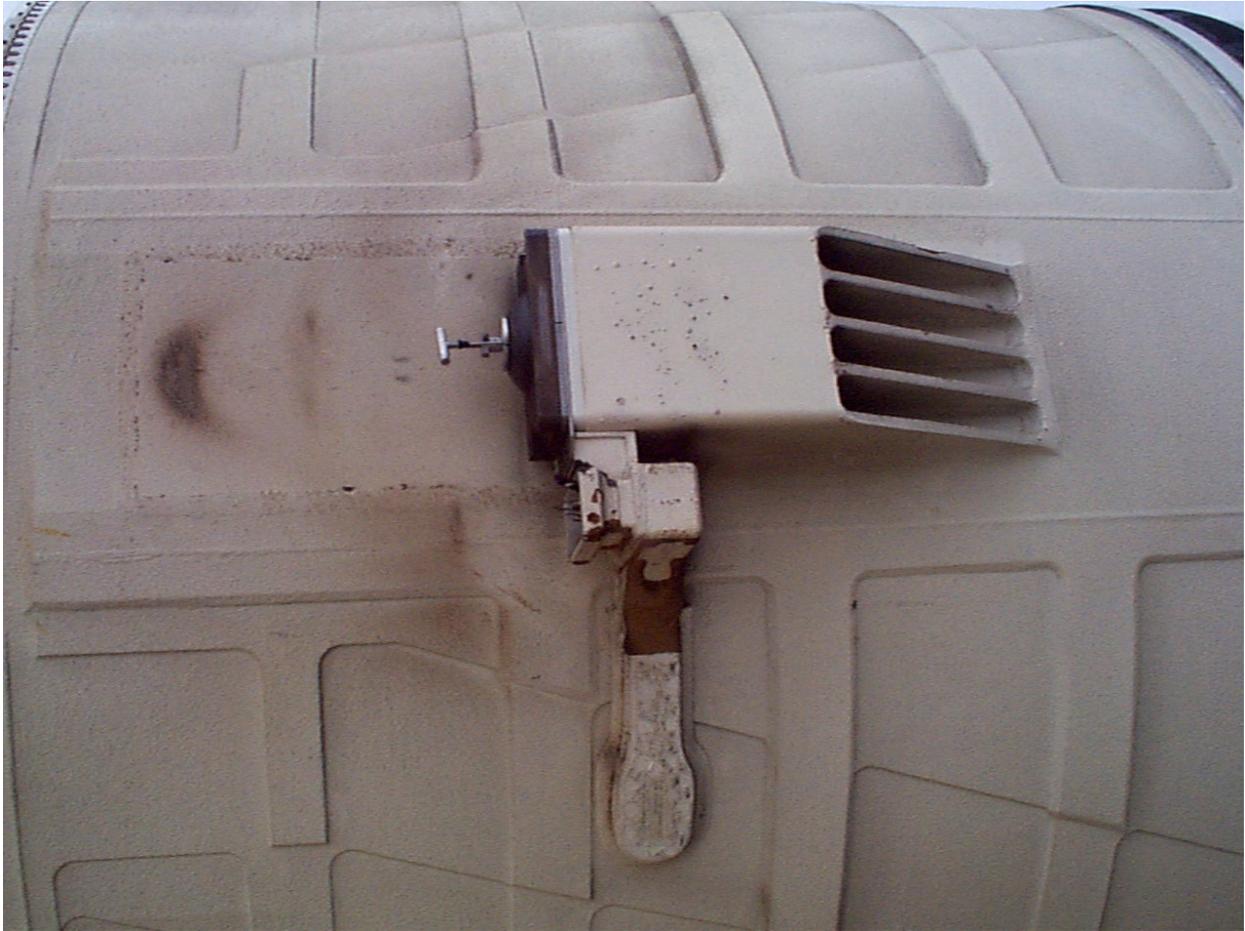
Photo 20: Forward Skirt Post Flight Condition

The forward skirts exhibited no debonds and only minor handling TPS damage sites. RSS antennae covers/phenolic base plates had minor erosion of SLA-220 and the left hand +Z phenolic base plate had minor delamination.

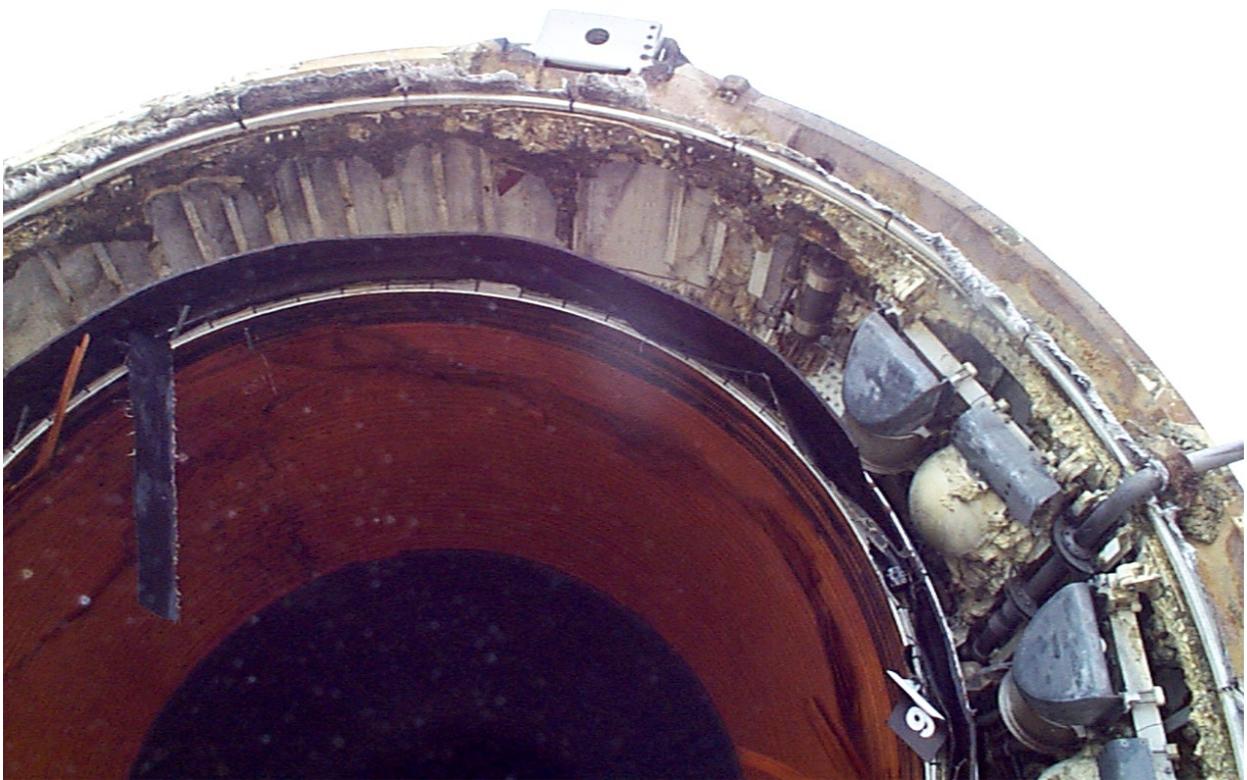
Photo 21: Aft Skirt Post Flight Condition

Aft skirt external surface TPS was in nominally good condition, two areas of missing MSA2 on the attach ring had some sooting evident.
