Debris/Ice/TPS Assessment and Integrated Photographic Analysis Of Shuttle Mission STS-98

**DEBRIS/ICE/TPS ASSESSMENT
AND
INTEGRATED PHOTOGRAPHIC ANALYSIS
OF
SHUTTLE MISSION STS-98**

February 7, 2001

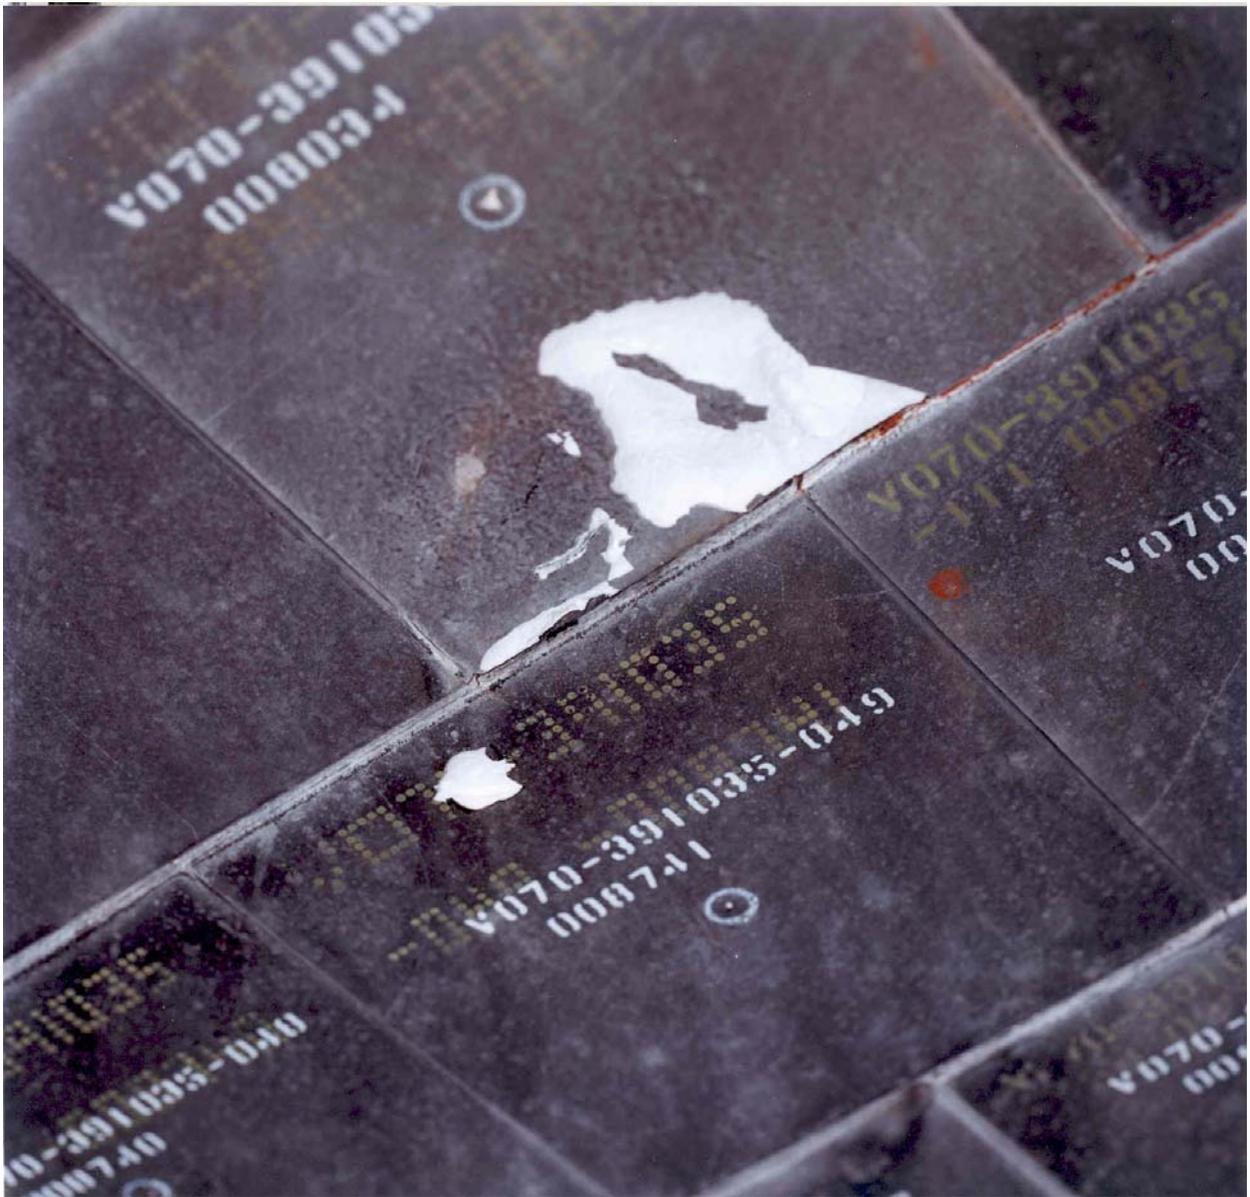
Photo 24: Damage to Lower Surface Tiles

This photo shows the largest damage site on the lower surface located just aft and outboard of the nose landing gear door measured 2.5 inches long by 2 inches wide by 0.25 deep. The cause of this damage has not been determined, an adjacent damage site had tile gap filler material embedded in it.

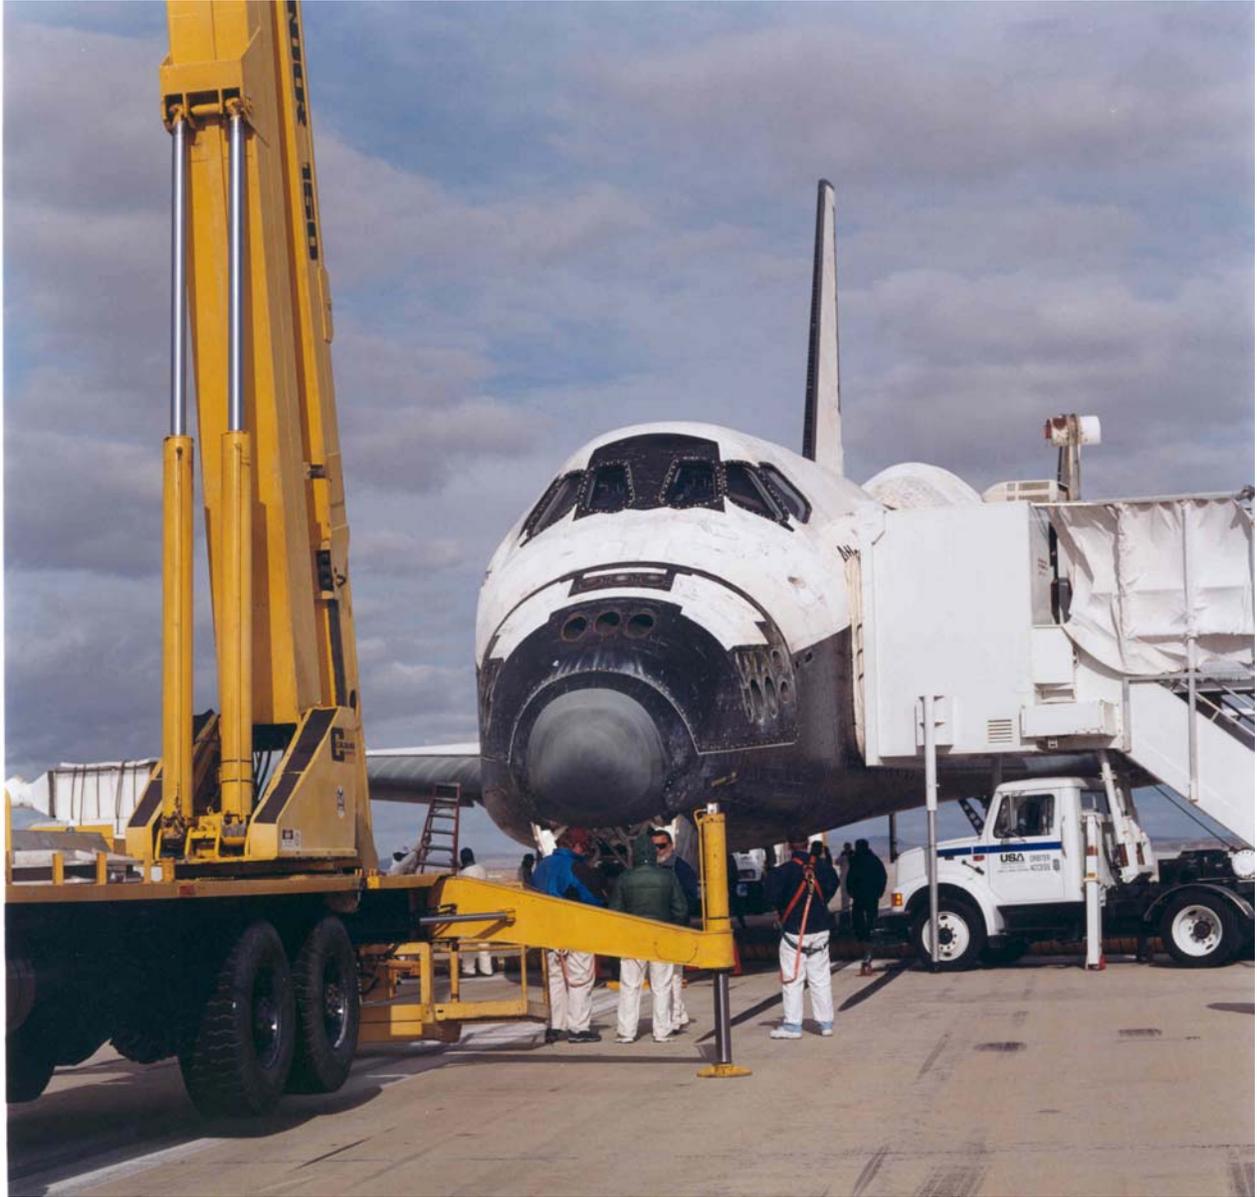
Photo 27: Windows

Damage sites on the window perimeter tiles were less than usual in quantity and size. Hazing and streaking of forward-facing Orbiter windows was less than average. The largest damage site, located between windows 3 and 4, was approximately 0.5-inches long by 2.0-inches wide. This damage may be attributed to impacts from FRCS thruster paper covers and RTV adhesive.

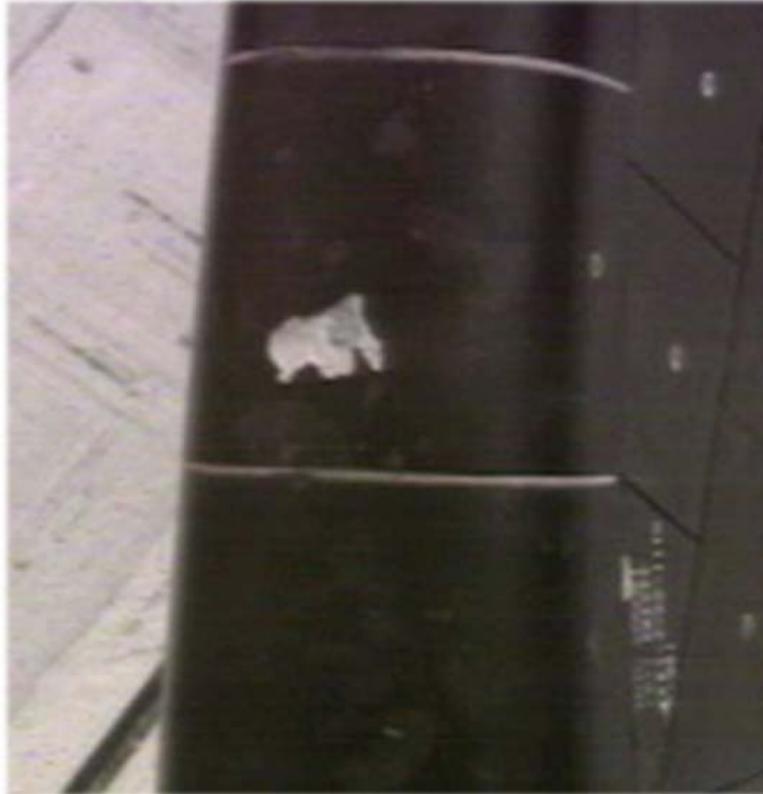
Figure 1.1.2 Vertical Stabilizer Tile Damage Seen On-orbit

No unplanned on-orbit Shuttle support tasks were requested. However, downlink video of tile damage to the Orbiter vertical stabilizer leading edge tiles and video of ice on the SSME nozzles was received.

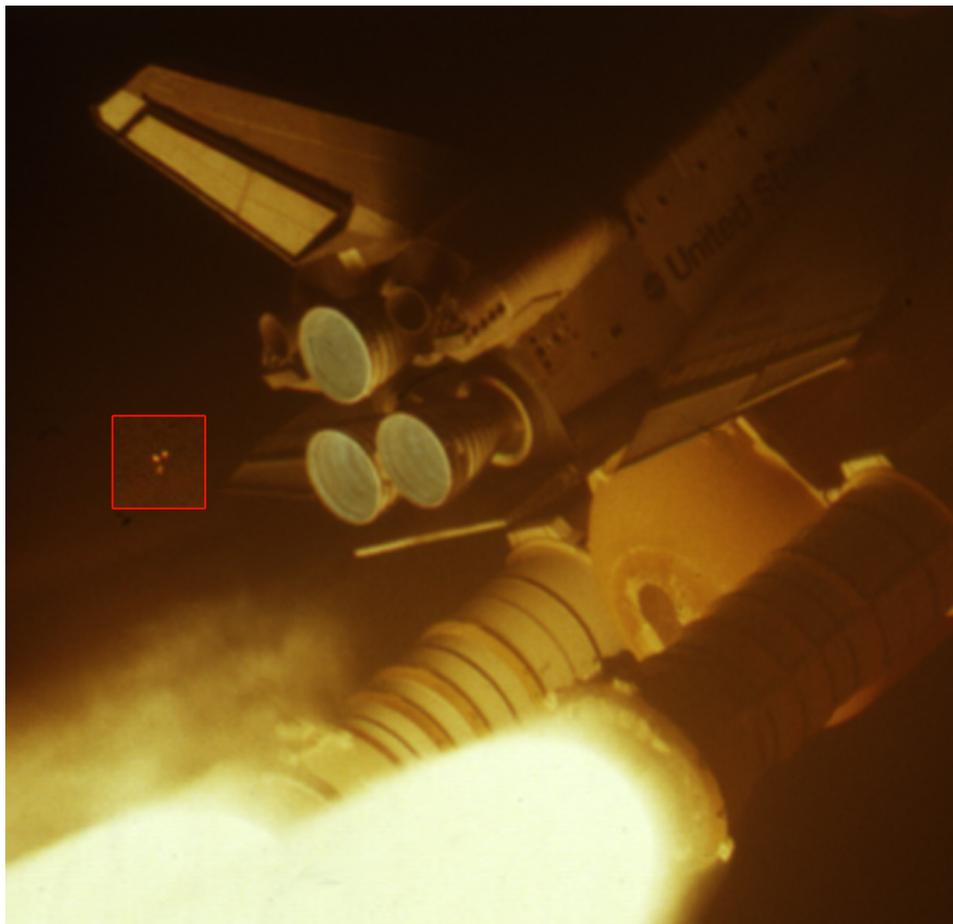
Figure 2.2.2 Debris Near SSME Exhaust Plumes (Camera E207)

Multiple pieces of debris, too numerous to count (mostly umbilical ice and RCS paper debris), were seen falling aft of the launch vehicle during ascent. Examples are:

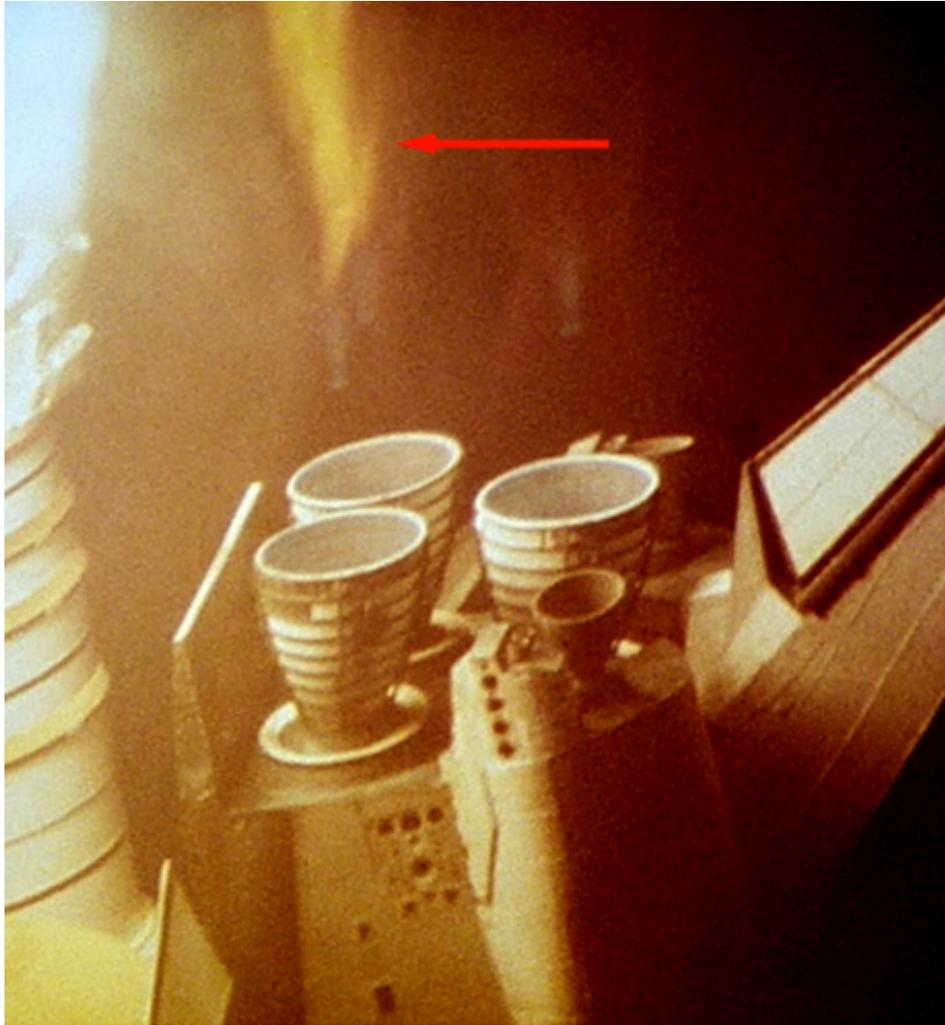
Figure 2.2.4 Flare in the SSME Exhaust Plume (Camera E222)

Light-colored flares (some seen to be debris induced) were seen in the SSME exhaust plumes during ascent on the intermediate and long range tracking camera films. Examples are:

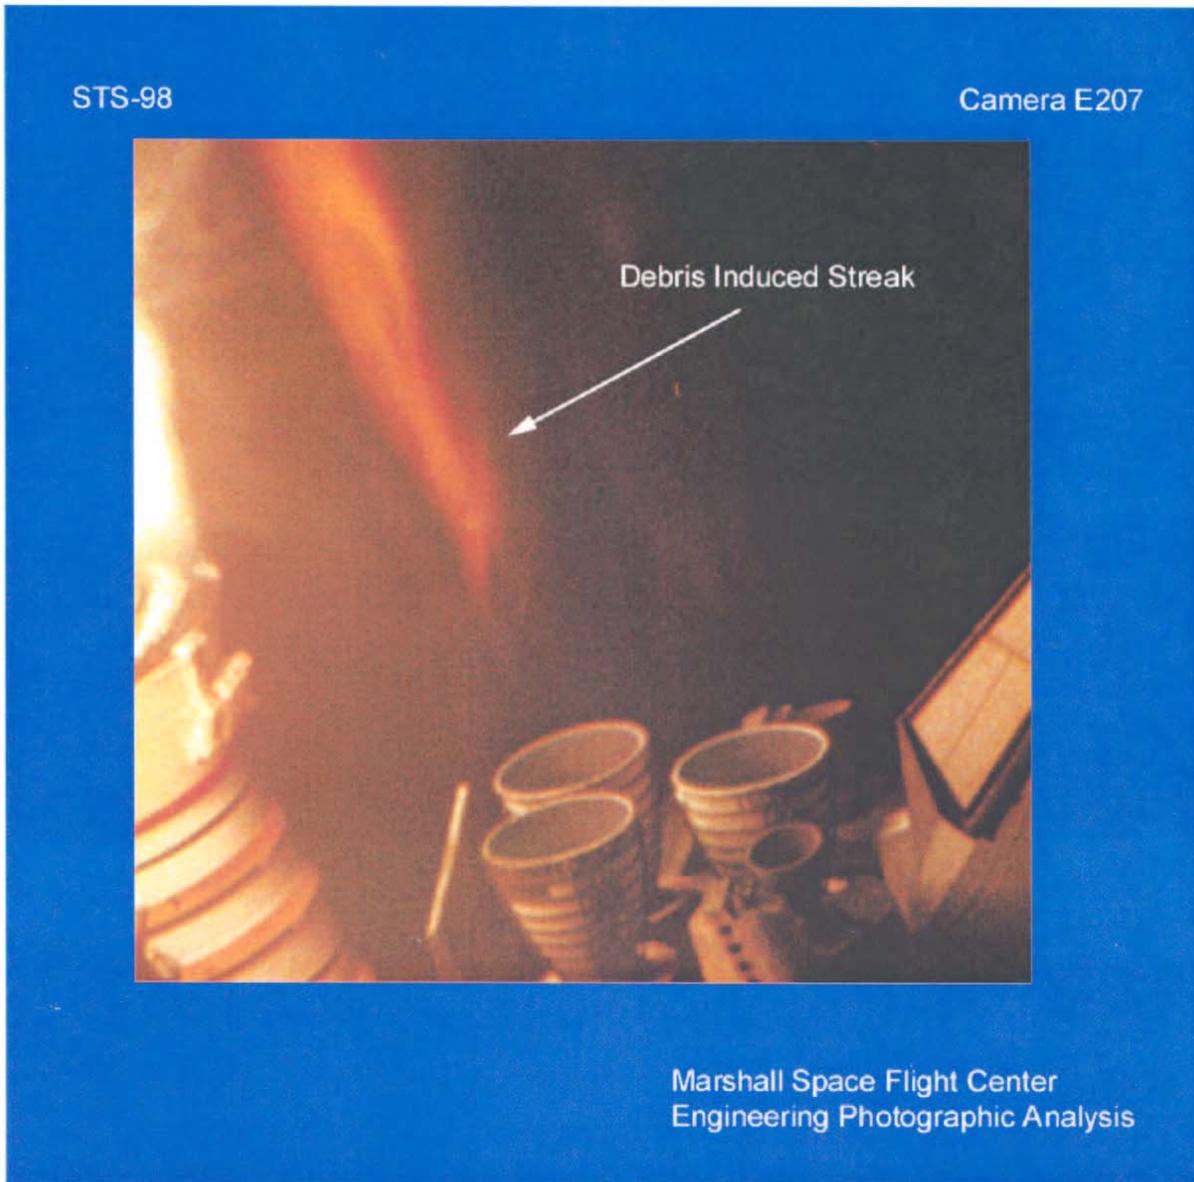
Figure 3. Debris Induced Streak in SSME Plumes

Several large debris induced streaks were observed in the SSME plumes on this mission. These streaks are common occurrences on Shuttle missions. They are a result of normal debris (RCS paper, butcher paper, purge barrier material, etc...) falling aft during ascent.

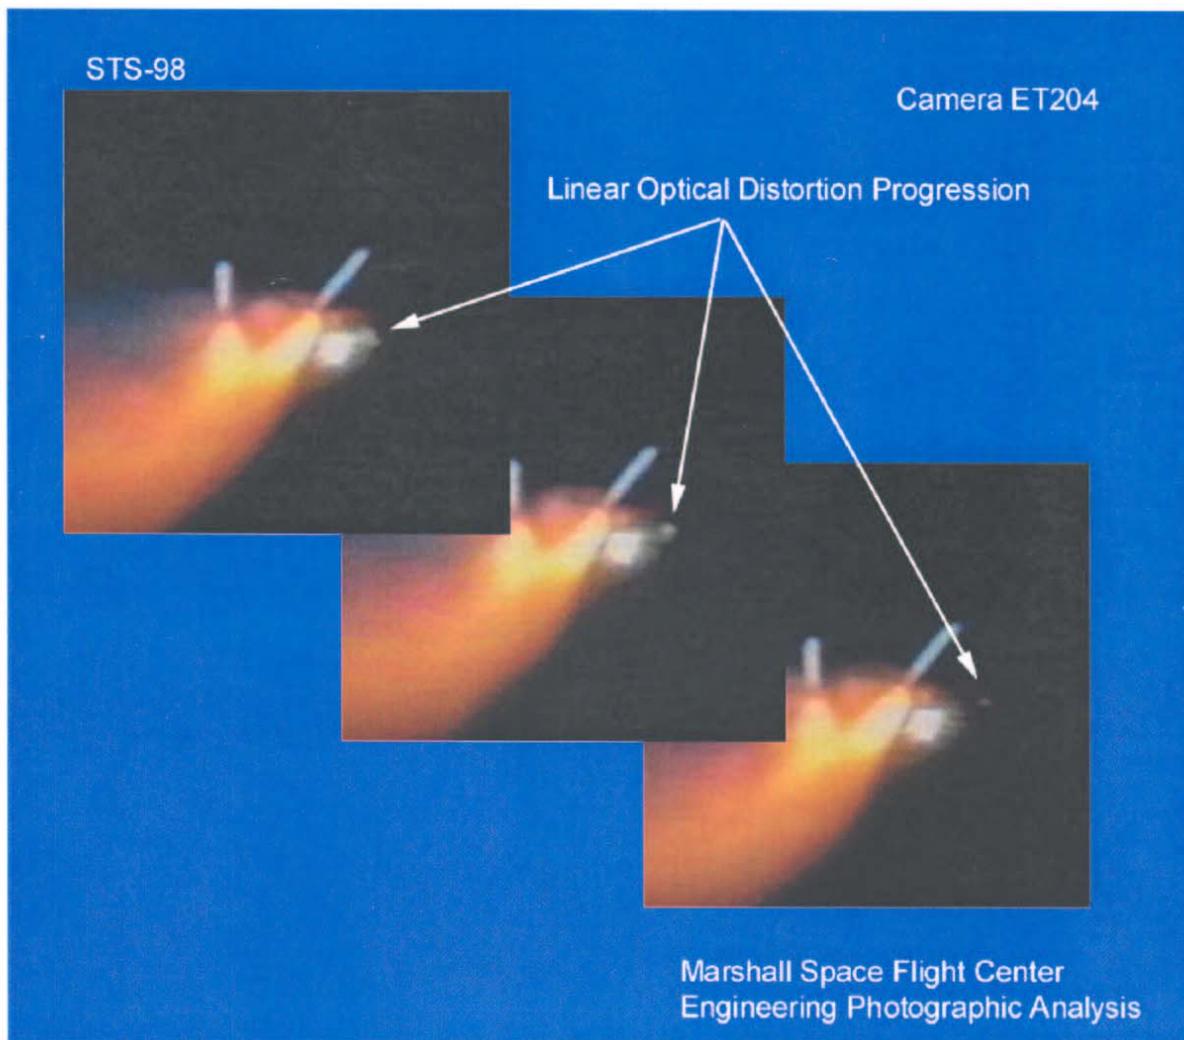
Figure 4. Linear Optical Distortion Observed After Separation

A linear optical distortion was observed just after SRB separation. This distortion produced an optical flare as it moved away from the SSME plumes.

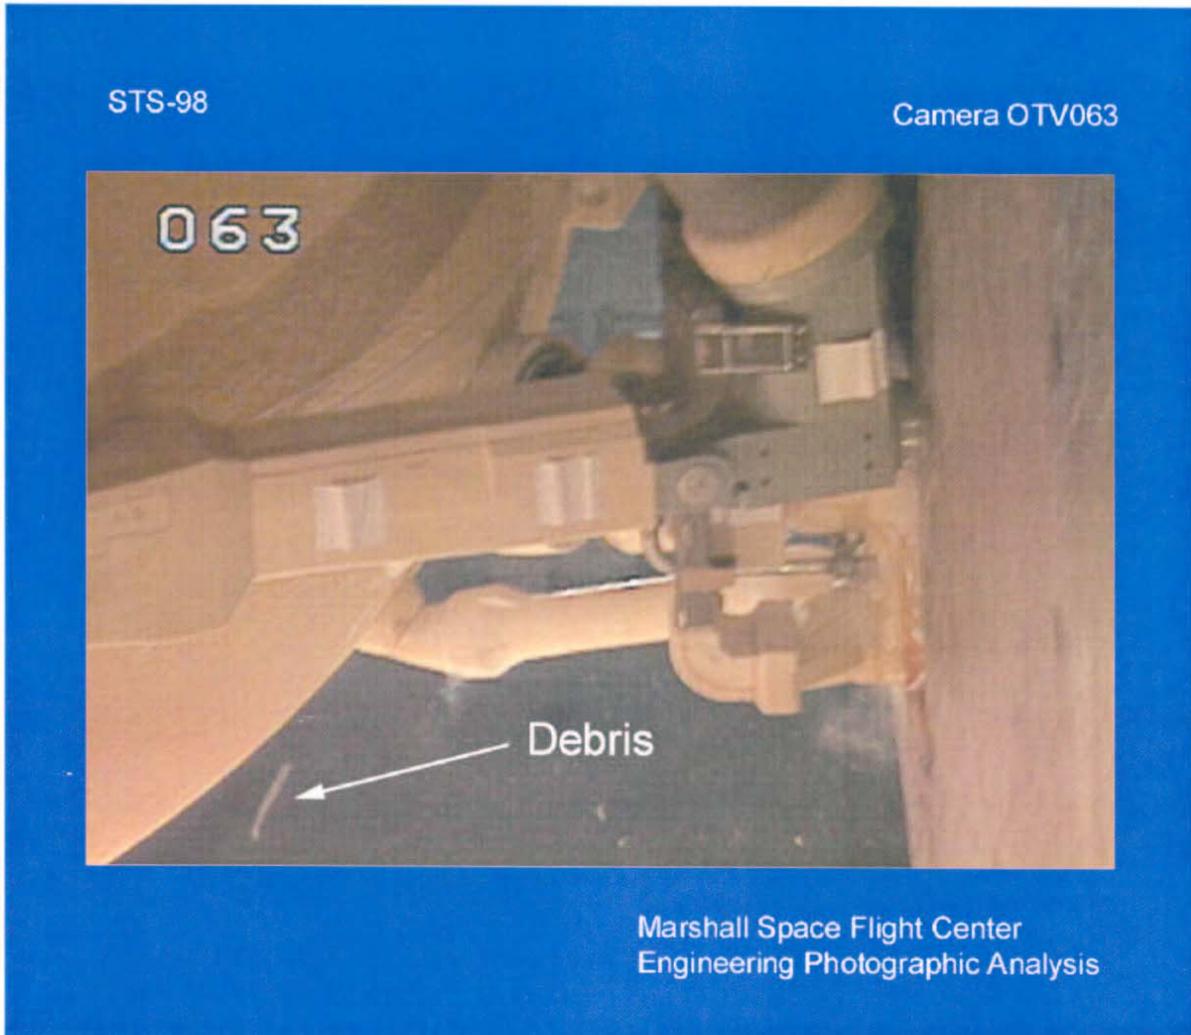
Figure 6. Debris Object Near Aft Dome

A linear debris object, probably ice/frost was observed falling through the field of view by video camera OTV063 during launch.

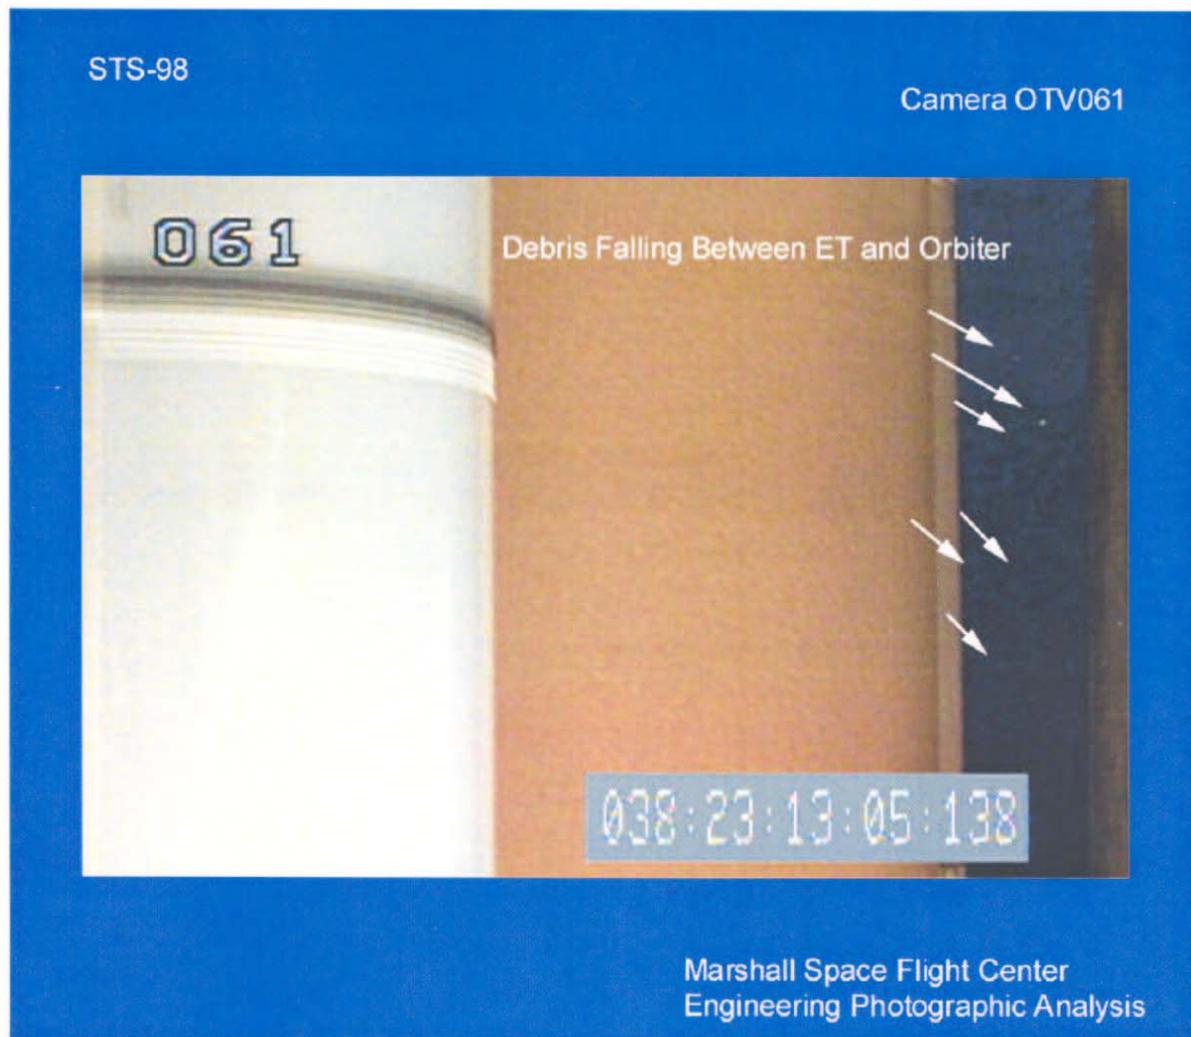
Figure 9. Debris Falling Between ET and Orbiter

Debris from LOX Feedline, originating near the ET intertank, falls between the ET and the Orbiter. The debris was observed to impact the lower surface of the Orbiter. No damage was noted.

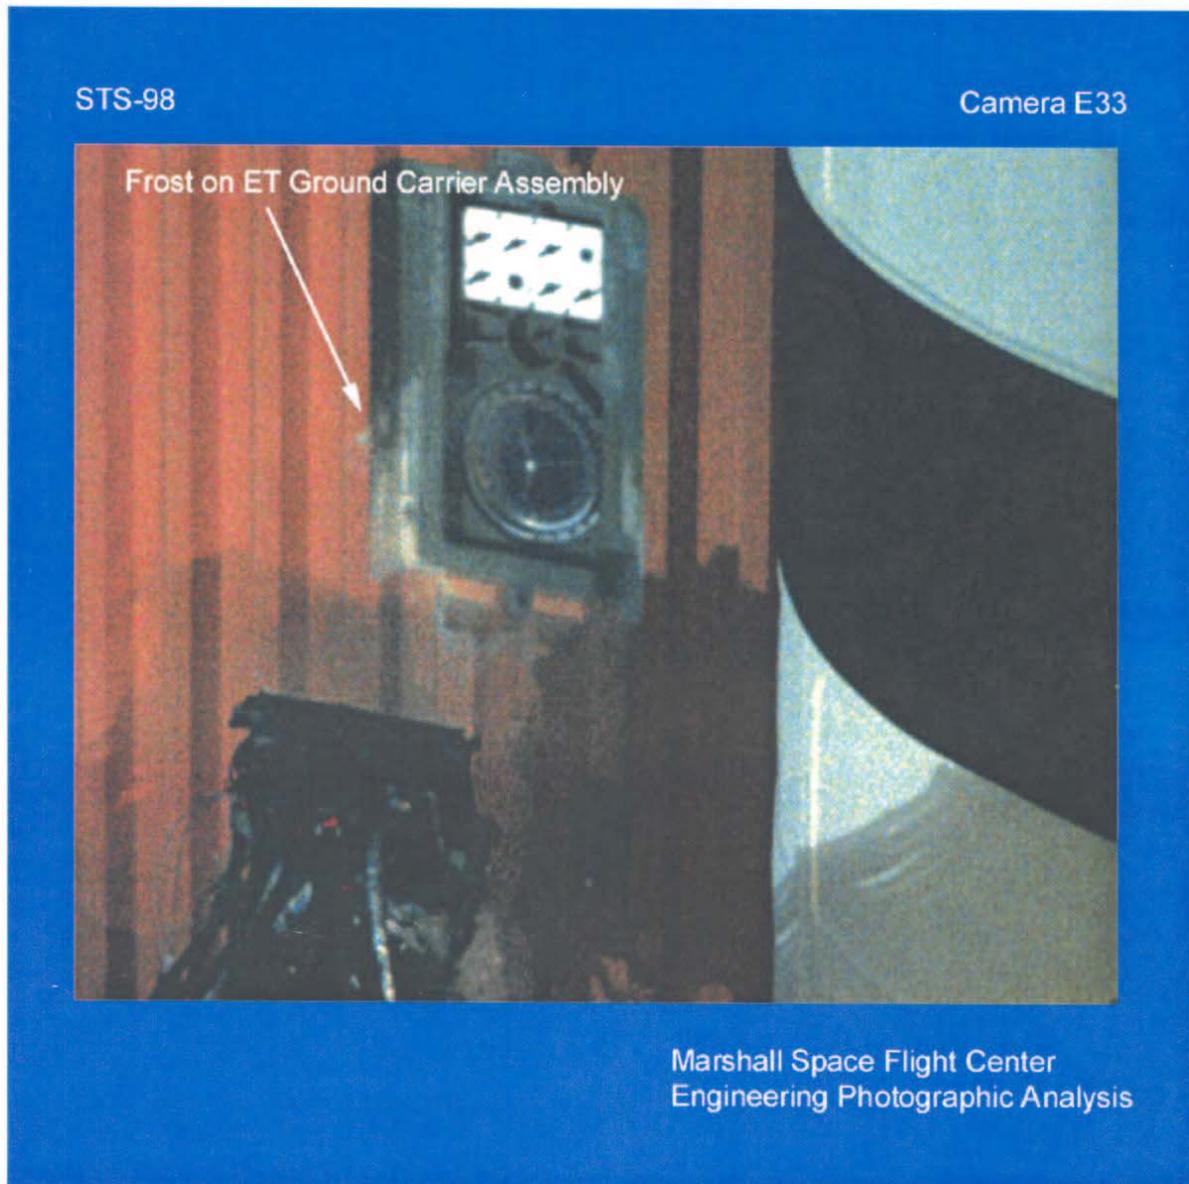
Figure 10. Frost on ET Ground Carrier Assembly

Frost was observed around the lower perimeter of the ET Ground Carrier Assembly (ETCA).

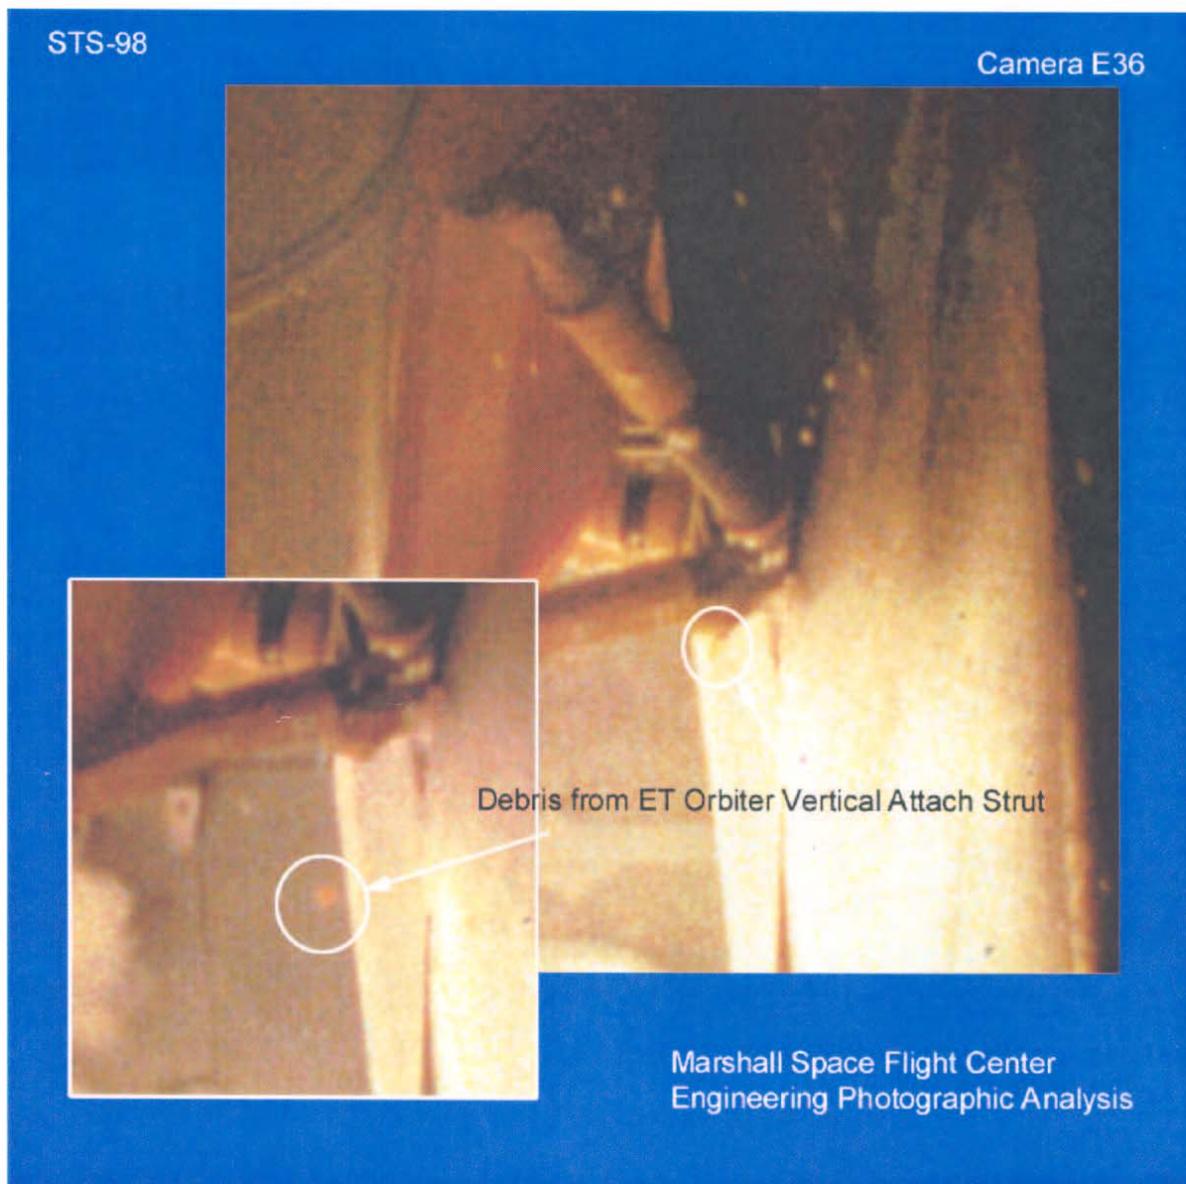
Figure 11. Debris from ET/Orbiter Vertical Attach Strut

Yellow-colored debris was observed falling from aft left ET/Orbiter attach strut at 038:23:13:04.902 UTC. The debris appeared to be detaching from the strut at the initial observation point. Through further analysis and consultation with the ET Project Office, this was determined to be Hydrogen fire detect paper fallen from above the first observable position in Figure 11.
