Rocket Propulsion Testing at NASA's John C. Stennis Space Center

E-1 Test Stand Mishap

**Rocket Test Facility Operators
Working Group
April 20-21, 2005**

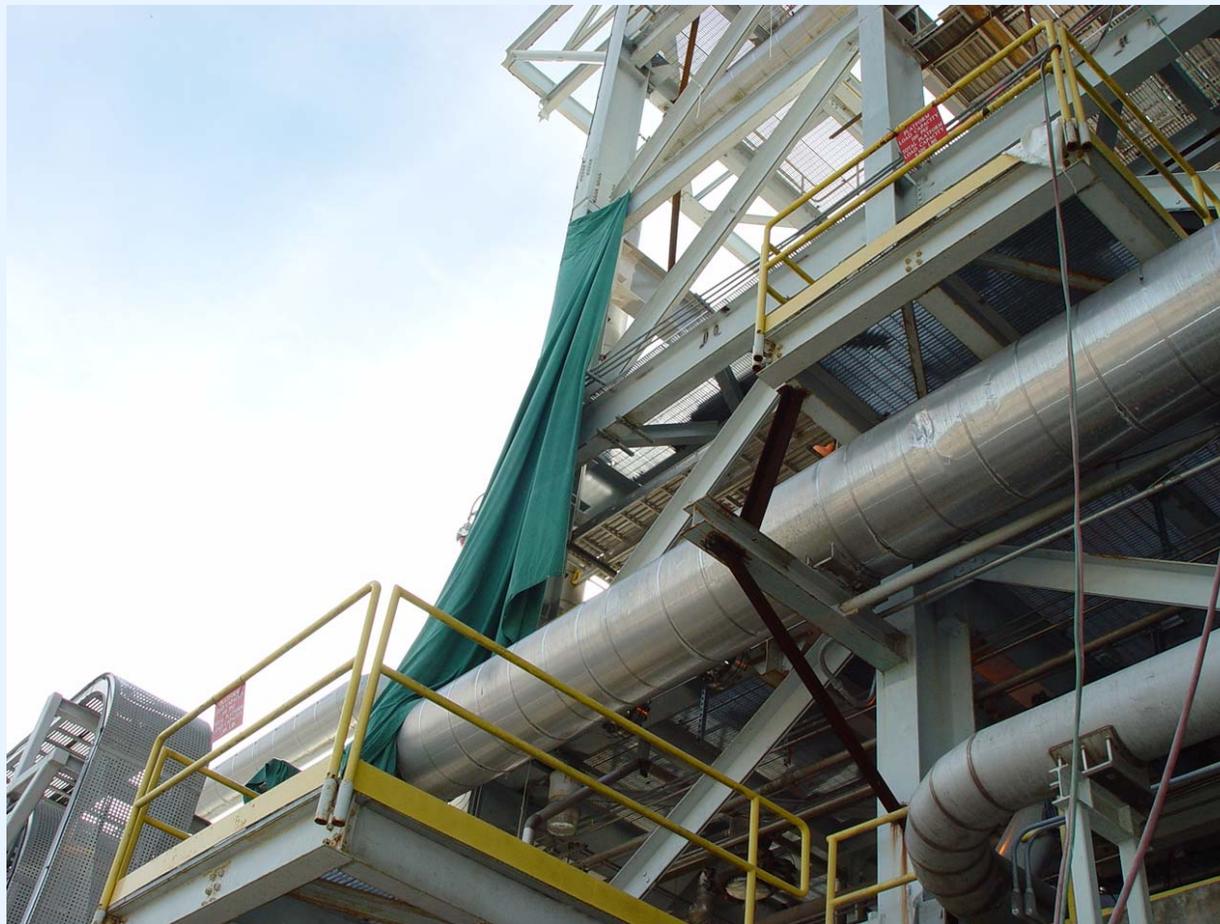
Green Tarp used as wind break

Finding # 6: Inappropriate tarps were used for a windbreak at the site of the E-1 Test Stand welding operations.

Rationale: The tarp material was analyzed at SSC's Material Analysis Laboratory and offsite at Southwest Research Institute and the material was determined to contain significant amounts of diesel fuel. The tarp material is considered to be highly flammable.

Recommendation # 6: Specifically with respect to the tarps, immediately stop using the tarps in enclosed areas and in locations where hot work operations are taking place.
