NASA/TM-2005-213231/Version 2.0
NESC-RP-04-01/03-001-E

Cloud-Aerosol LIDAR and Infrared Pathfinder Satellite Observation (CALIPSO) Spacecraft

Independent Technical Assessment

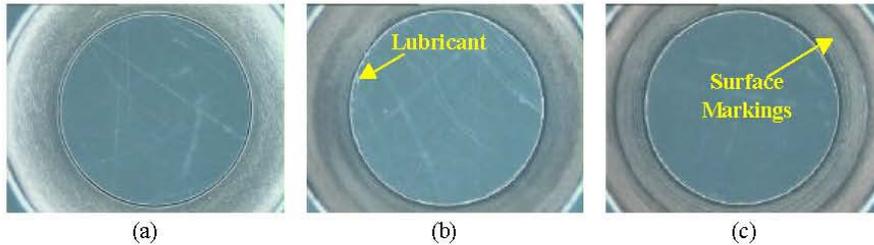
Figure 9 – Comparison of nickel seal appearance before and after hot soak test: (a) Sample seal before test, (b) fitting 1 seal after soak test, (c) fitting 3 seal after soak test. [All images x 37]

The nickel seals all had surface-scratch markings from the location where the flared tube and male threads sandwiched the seal together. Some seals had traces of residual lubricant, however no seal appeared to have pitting or evidence of corrosion. Figure 9 shows a comparison of a pre-soak seal and two seals after soak testing.

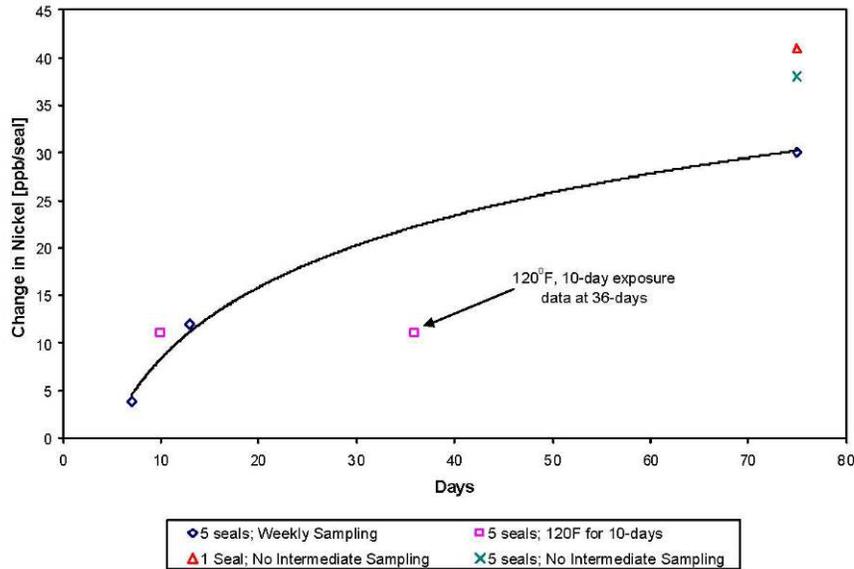
Figure 10 – Change in Nickel Levels per Seal Present in Hydrazine Sample

The data presented graphically shows the general trend of nickel levels over an extended amount of time. The trend line shown is based on the weekly sampling data and is a rough estimate due to the lack of data in the middle of the soak test. However, the trend is expected with this type of

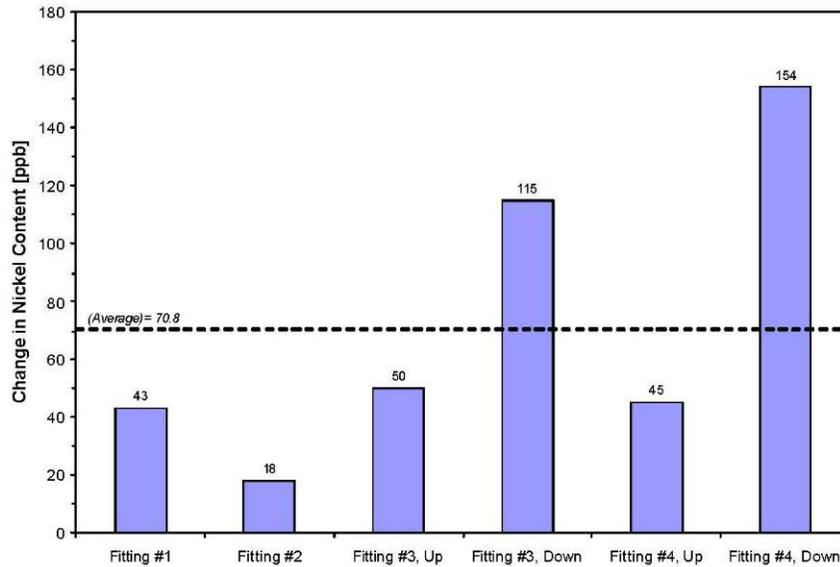
Figure 11 – Change in Nickel Levels per Used Seal

The data presented shows a wide spread of nickel levels for used seals. A maximum change was measured to be 154 ppb, while the minimum change was only 18 ppb. This spread shows the sensitivity of nickel leeching to the surface properties of the seals. All samples were tested in the same volume of hydrazine under the same temperature conditions, and were torqued to the same value for the hot soak of 3.5-days at 225°F.
