# **The Application of Electron Microscopy Techniques to the Space Shuttle Columbia Accident Investigation.**

Dr. Sandeep Shah and Greg Jerman  
Materials Diagnostics Team, NASA Marshall Space Flight Center  
[Sandeep.r.shah@nasa.gov](mailto:Sandeep.r.shah@nasa.gov), [Gregory.a.jerman@nasa.gov](mailto:Gregory.a.jerman@nasa.gov)

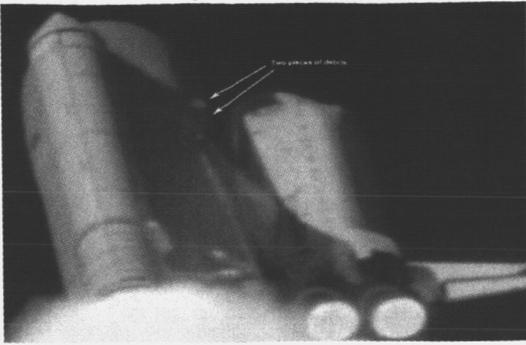
to 3000 °F, it is extremely brittle and will shatter like glass if overstressed. Because the thermocouple in the cavity behind left WLE RCC panel 9 was the first to fail, prior to any other sensors, the analysis of debris items focused on the left WLE RCC panels where launch video indicated foam from the external tank had impacted on ascent as seen in figure 3.

Figure 3: Evidence of foam hitting the shuttle's left wing.

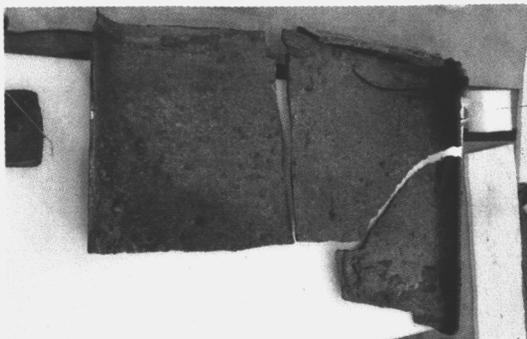
There are 22 RCC panels protecting the leading edge of each wing from hot gasses during re-entry. The gap between each panel is sealed with a short T-shaped RCC seal. The arrangement of the wing leading edge is shown in Figure 4. The highest heating during re-entry occurs in panels 7-10, right where the wing leading edge surface changes direction. After recovery and identification, the reconstructed pieces of Columbia's RCC panels and T-seals were qualitatively examined for damage patterns. The internal surfaces of left wing RCC panels 7 through 10 showed heavy deposition of material that was best described by the metallurgical term slag. The deposits on the RCC panels were expected to originate from Columbia's metal wing structures. Some RCC panels from the right wing also contained slag deposits although to a lesser degree. Figure 5 shows one example of slag deposits on the inside surface of left wing RCC panel 8. There were other visual signs of significant heat damage including melted RCC attachment hardware and knife edge erosion on broken edges of RCC panels. Most of the slag deposits, molten RCC attachments, and eroded RCC were concentrated between RCC panels 7 through 10 on the left wing.

Figure 5: Left wing RCC panel 8 with slag deposit on the inside.

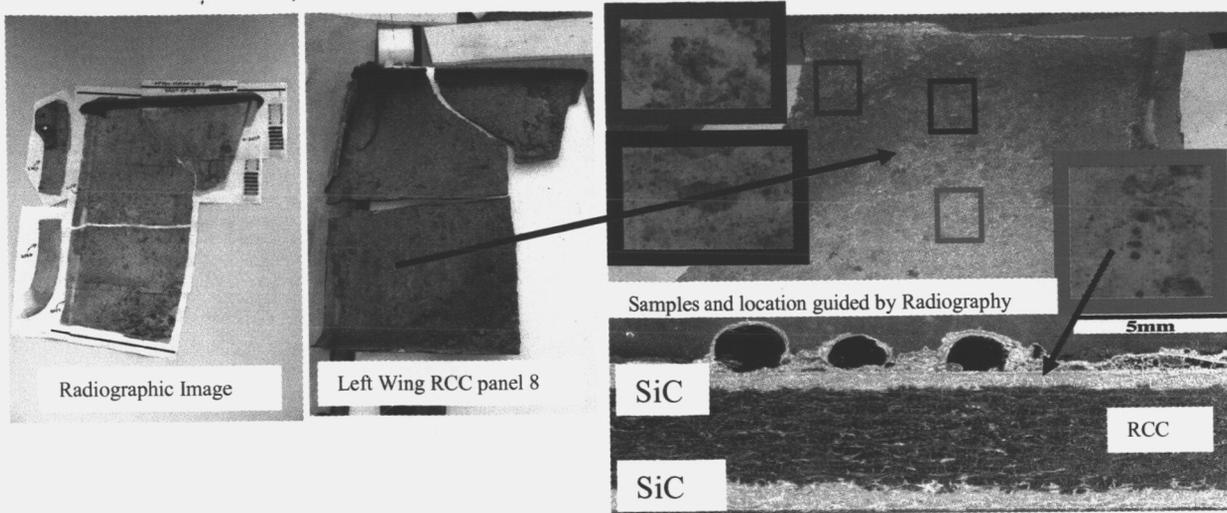
Dozens of RCC cross sections were analyzed for slag deposit chemistry and morphology generating approximately 2000 pages of chemical and morphological data. One sample analysis from the left wing RCC panel 8 is presented here to exemplify the process. In this case, unique metallic spheroids were found that were in direct contact with RCC surface as seen in Figure 7. Like a layered cake, the first slag deposits represented the first damage event, while the outer slag surface represented the last damage event. SEM x-ray dot maps in Figure 8 shows high concentrations of iron, nickel, and chromium in these spheroids. Backscattered imaging clearly showed metallic deposits versus oxide type deposits in the vicinity of the spheres. Quantitative electron microprobe results identified spheroid compositions that closely matched Inconel 718 and Inconel 601 which correspond to the metallic RCC attachment hardware and the internal insulation foil. The final layers on top of the spheroids contained oxidized and metallic aluminum with copper that uniquely identified the 2024 wing spar as the source for the final deposits as seen in figure 9.

Figure 7: Cross-section through unique spheroids in slag deposits on the left WLE RCC panel 8.

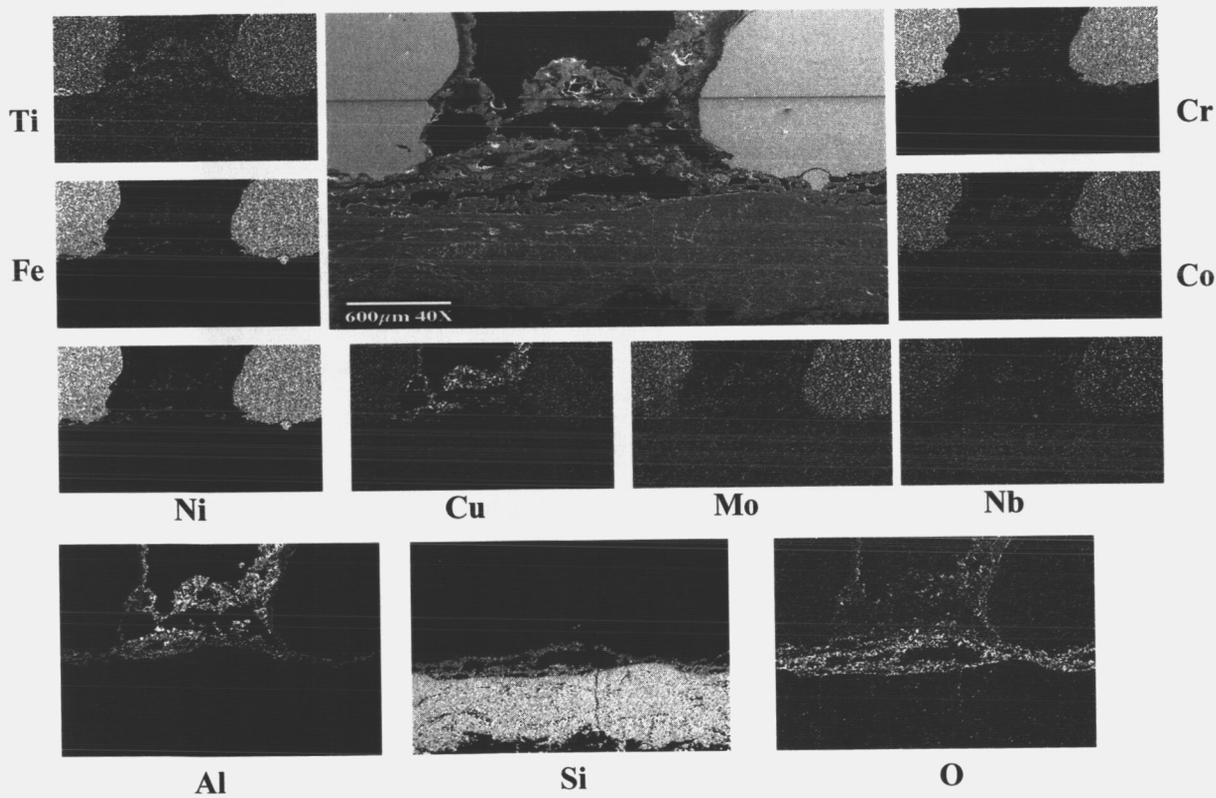
Figure 8: X-ray map showing distribution of various elements in and around spheroids of Figure 6.

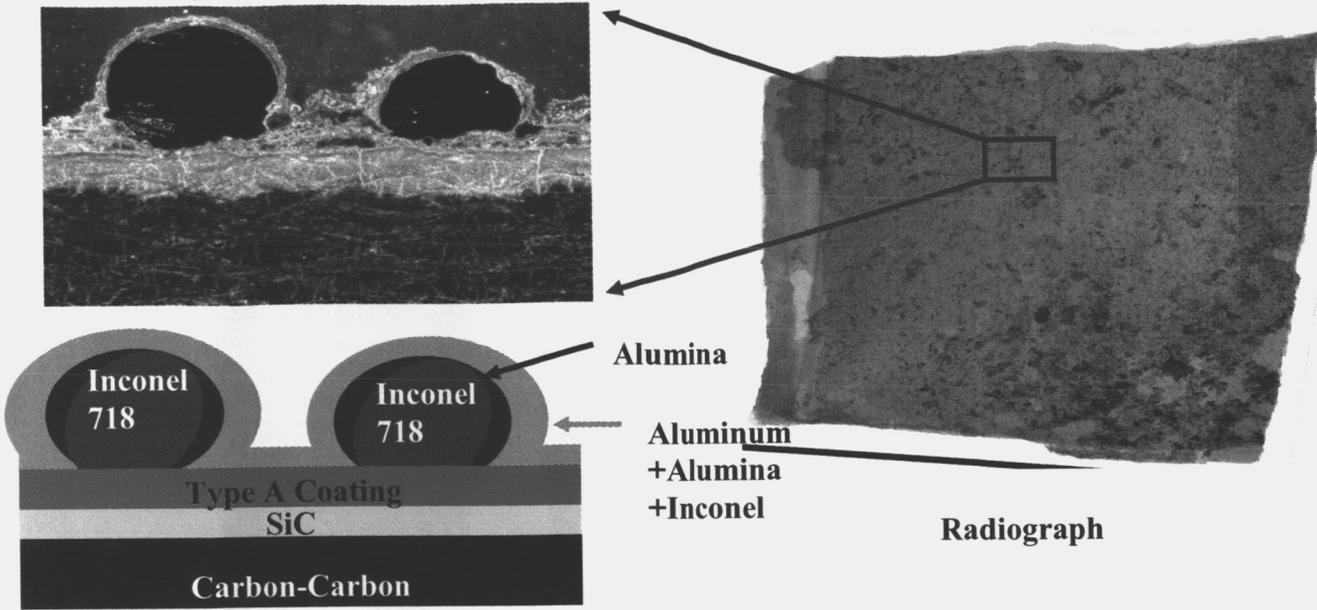
1. In left wing RCC pieces, cerachrome insulation and Inconel 718 or Inconel 601 primarily made up the first deposited slag layer. This suggests the first damage occurred by melting of RCC attachment beams and internal insulation.

2. In left wing RCC pieces, aluminum deposition was secondary suggesting the wing spar melted last.
3. In left wing RCC pieces, there was no indication of A286 wing spar attachment fittings in the first slag deposits suggesting the initial plasma impingement was through a breach near the RCC attachment points and not near the wing spar.

Figure 9: Layering of slag showing sequence of damage and deposition events.

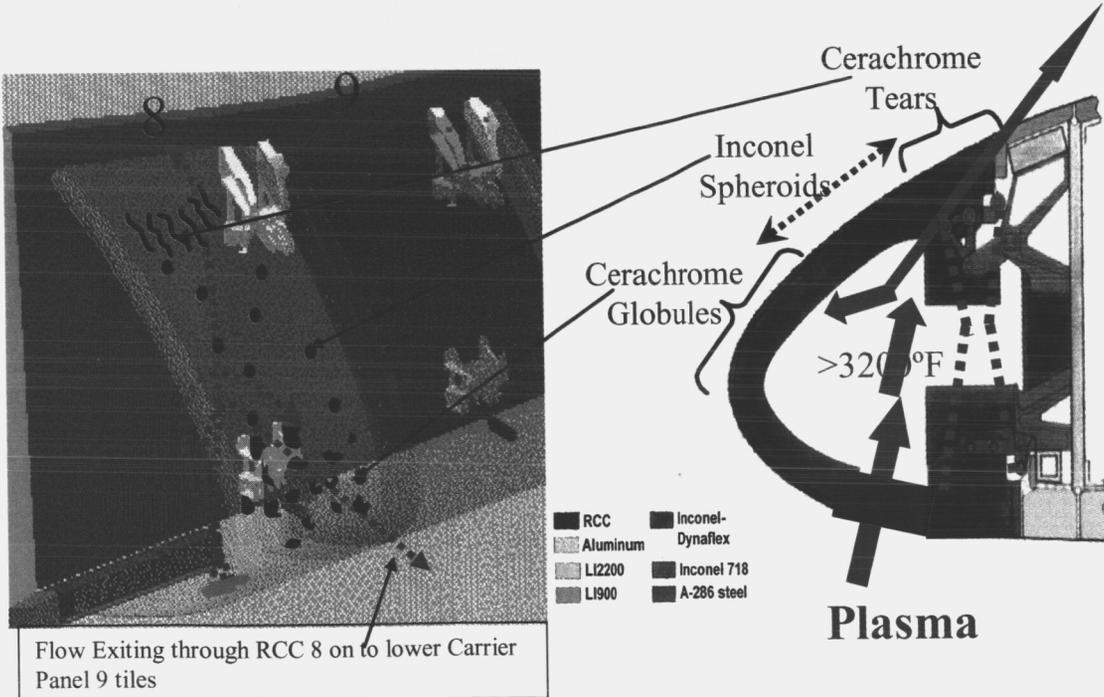
After correlating all analyses, a scenario for the progression of damage in Columbia's wing is depicted in Figure 10. The breach started on the underside of the left wing at RCC panel 8, close to the T-seal between panels 8 and 9. The plasma first impinged on the Inconel 718 attachments that held the RCC in place and insulation that protected the aluminum wing spar from overheating. The flexible insulation was not designed to contain hot flowing plasma which continued to circulate around inside the left wing at RCC panel 8 creating molten cerachrome tears and droplets. Eventually the insulation failed between panels 7 and 9 allowing plasma to move downstream and upstream from panel 8. Eventually the lower RCC attachment points for panels 8 and 9 collapsed causing massive plasma impingement on the aluminum wing spar at temperatures greater than 3200 °F.

Figure 10: Breach scenario and location based on analysis results.
