# **Materials Examination of the Vertical Stabilizer from American Airlines Flight 587**

Matthew R. Fox<sup>1</sup>, Carl R. Schultheisz<sup>1</sup>, James R. Reeder<sup>2</sup>, and Brian J. Jensen<sup>2</sup>

Keywords: Failure analysis, CFRP, composites, American Airlines Flight 587

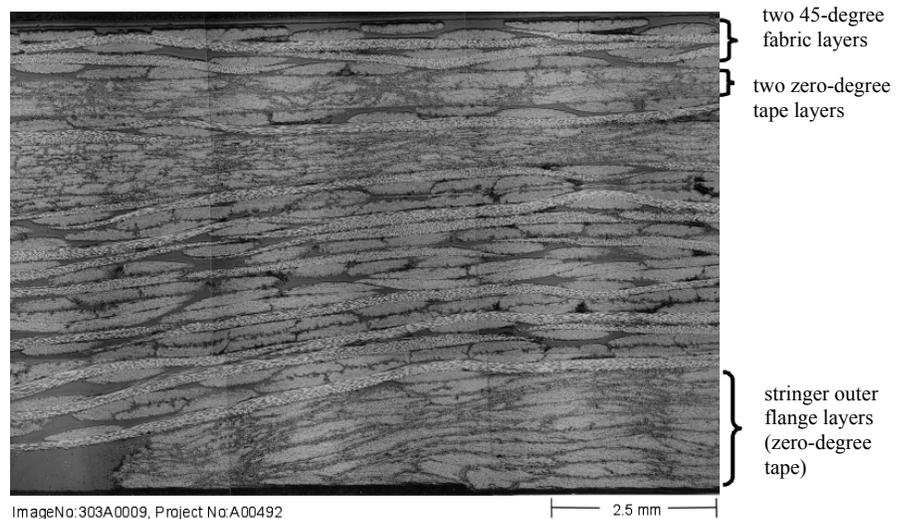
Figure 3: Microstructure of sample RS1.

Results of the microstructural examination and analysis indicated that the composite structure of the vertical stabilizer was constructed to the desired fiber volume fraction with acceptable void content. No evidence of microcracking was observed. The observed layups were compared to the engineering drawings obtained from the manufacturer, and among the 15 samples, only one sample from the right forward lug (sample RF4) showed any discrepancies. Within the 124 layers of sample RF4, 2 layers had orientations that were different from the drawing. Also, two layers appeared to be missing from one position through the thickness, but two additional layers were present at another position. The total number of layers for each orientation in sample RF4 was correct, and the discrepancies represented a small fraction of the total number of layers.

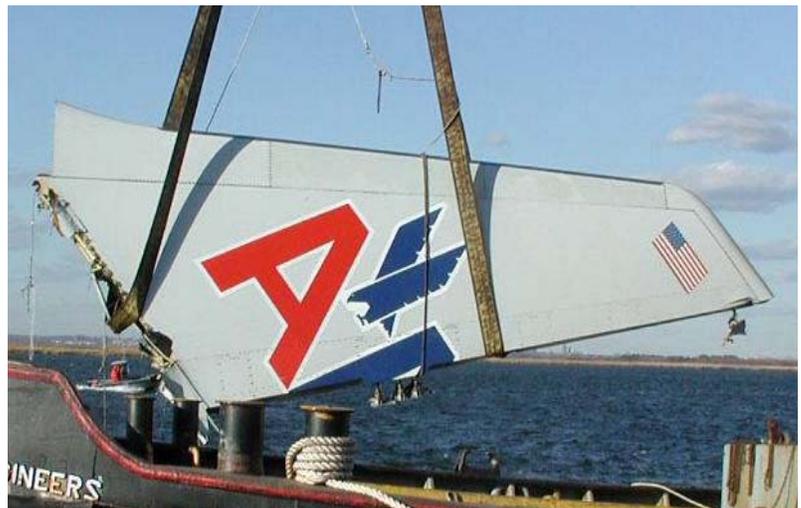
Figure 4: Vertical stabilizer as recovered from Jamaica Bay.

The vertical stabilizer was largely intact with no significant areas of skin buckling. An overall view of the vertical stabilizer as it was being recovered from the water of Jamaica Bay is shown in Figure 4. At the lower end, each of the six attachment locations were separated either by fractures that intersected the lug attach hole or by fractures through the

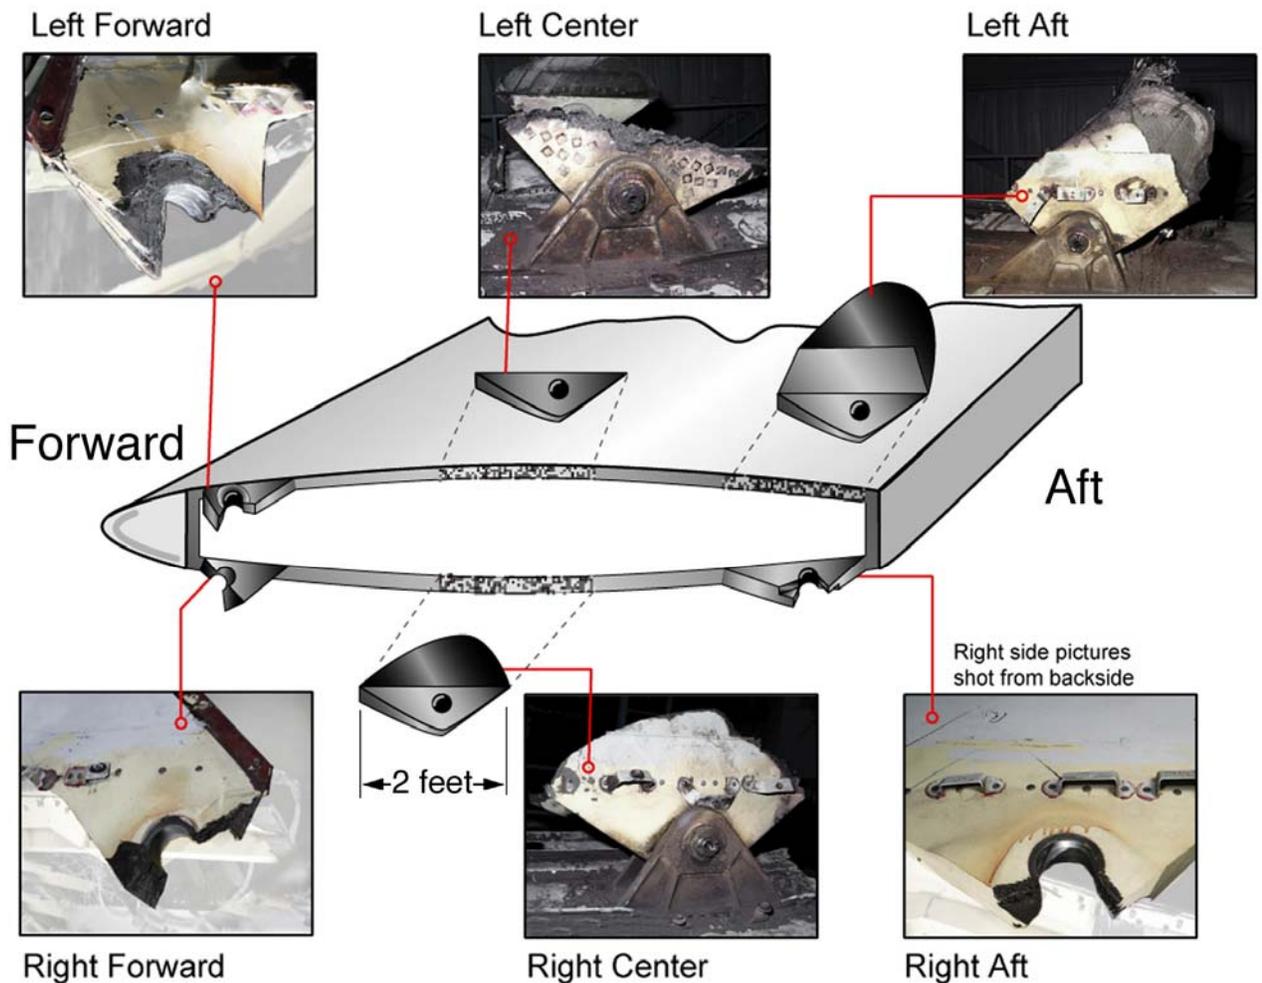
Figure 5: Overall views of main lug fractures with relative locations on vertical stabilizer.

structure above the hole. A schematic drawing of the lower end of the vertical stabilizer is shown in Figure 5, where a general fracture location for each lug is shown with overall views of each of these lug fractures. Portions of rib 1, the rib 1 rib-to-skin attach angle, and the lower end of the forward spar also were fractured. Along the trailing edge, the trailing edge panels were damaged in several locations. A more detailed description of the damage is presented in reference 6.

The right aft, right forward, and left forward main lugs had translaminar fractures that intersected the attachment hole, and the remaining three main lugs had translaminar fractures in the structure above the lug. Each of the lugs had delaminations in the lug area and/or in the structure above the lug. Details of the fractographic examination are presented in references 7 and 8. Some of the delaminations extended into the main portion of the vertical stabilizer, and the extents of these delaminations were determined using nondestructive inspection (NDI), including ultrasonic inspection and x-ray-computed tomography scanning and imaging. Results of the NDI of the vertical stabilizer are presented in references 9 and 10.

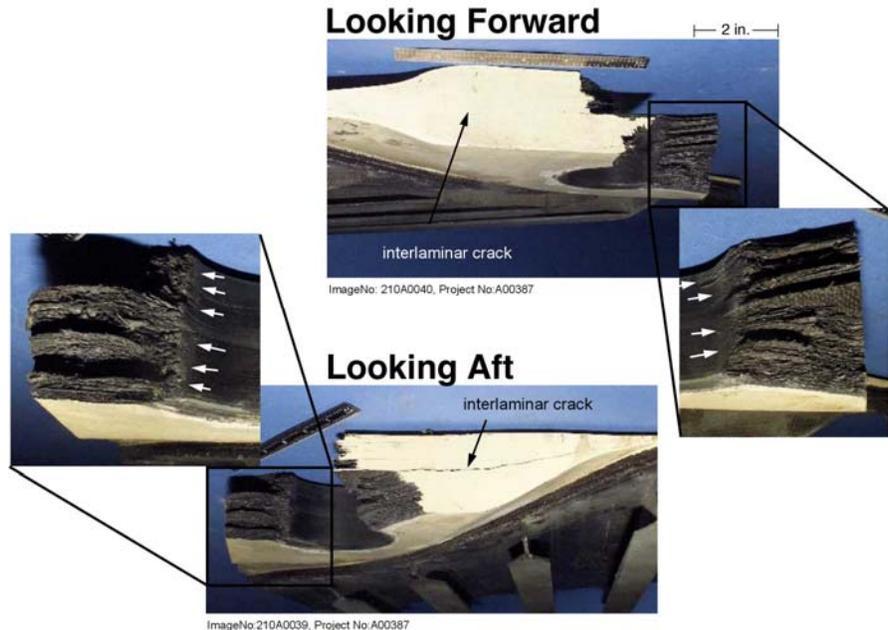
Figure 6: Right aft lug translamina fractures (pictured from below the lug).

The right aft lug failed by translamina fracture through the bolt hole as shown in Figure 6. The translamina fracture surfaces had a rough appearance consistent with fracture primarily under tensile loading. Fractures on each leg of the lug were on different translamina planes, and the change in planes occurred near the center of the lug thickness. On the aft side of the bolt hole, the outboard side of the fracture was in a plane nearly perpendicular to the zero-degree fiber direction, and the inboard side of the fracture was in a plane approximately parallel to the

45-degree fiber direction. On the forward side of the bolt hole, the outboard side of the fracture was in a plane approximately parallel to the zero-degree fiber direction, and the inboard side of the fracture was in a plane nearly parallel to rib 1. Bearing damage was observed at the bore surface near both fracture surfaces, as indicated by white unlabeled arrows in Figure 6.

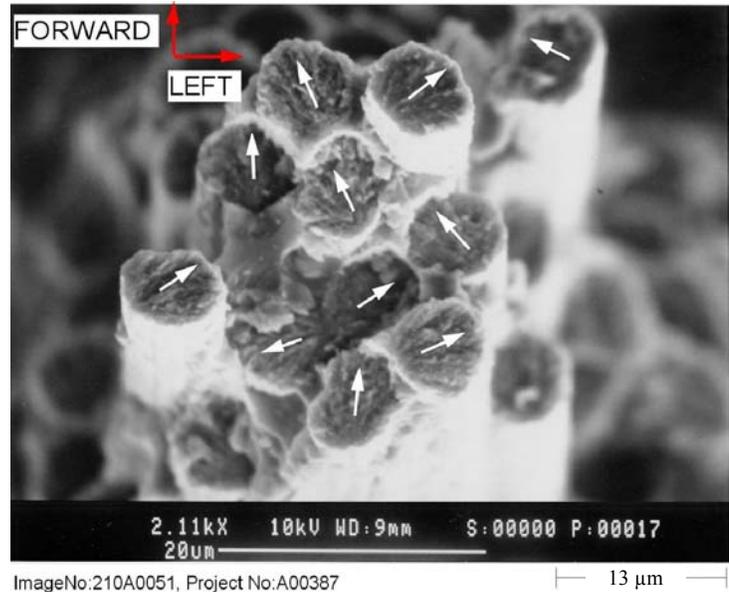
Figure 7: Fractured carbon fibers showing crack growth directions.

On translaminar fractures, the ends of some fibers were oriented roughly perpendicular to the fracture plane. A typical SEM view of these fiber ends on one of the translaminar fracture surfaces is shown in Figure 7. Fiber ends such as those shown in Figure 7 were examined using SEM to help determine the fracture mechanism and propagation direction. For fibers having radial patterns indicative of tensile fracture, the local fracture propagation direction could be determined from the direction of the radial pattern of several fibers [11, 12]. Then, general directions of fracture propagation for the translaminar fractures could be determined by averaging the directions indicated by the radial patterns across many areas of the fracture surfaces. Also, since fatigue and overstress fractures can appear similar from a macroscopic view, the microscopic examination of the fracture surfaces included looking for evidence of fatigue such as rounded edges on fiber ends [13] or striations in the matrix [5, 12, 14], however, no evidence of fatigue was observed on any of the translaminar fracture surfaces.

At high magnification, fiber end fractures for fibers oriented perpendicular to the fracture plane generally showed radial fracture features consistent with fracture under tensile loading. In an area near the outboard surface of the left center lug, fiber ends showed chop marks (lines across the fractured fiber ends), indicative of local compressive loading. Examples of these chop marks can be seen in Figure 8 on the fiber ends marked with a “C”. The combination of tension on the inside edge and compression on the outboard surface is associated with an overall lug bending to the left. Using the radial patterns on the lug translaminar fractures, fracture propagation directions were determined to be extending from the lug holes for the right aft, right forward, and left forward lugs (all lugs that had fractures intersecting the lug hole). For the right center lug, fracture propagated from aft to forward, and for the left center and left aft lugs, fracture propagated from forward to aft.

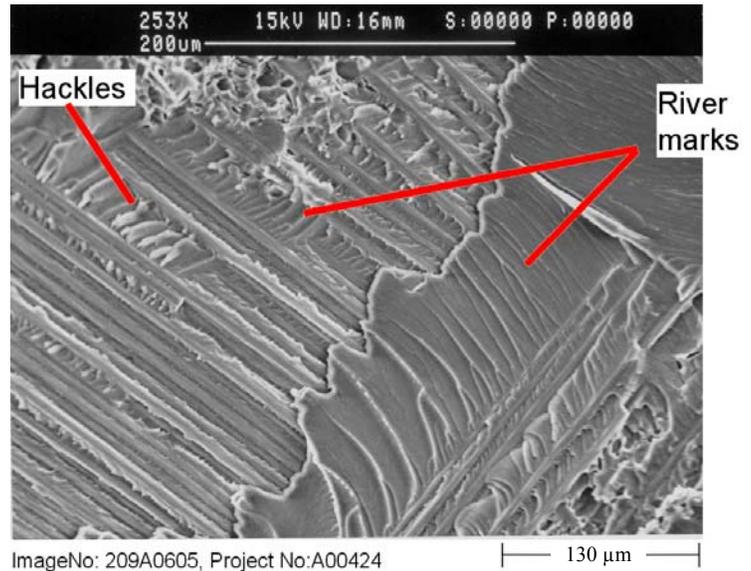
Figure 9: Delamination fracture features.

Samples of the delamination fracture surfaces were examined in the scanning electron microscope to determine the orientation of the shear stress at the fracture and to identify the direction of crack propagation. Fracture features that were used to make these determinations included hackles (thin plates of fractured matrix material between fibers oriented perpendicular to the fiber axis, with free edges that point in a general direction opposite to the local shear applied at the fracture surface) [15, 16] and river marks (related to the initiation of matrix cracks that coalesce into larger cracks, indicating the direction of propagation) [4]. A typical view of hackles and river marks observed on one of the delaminations is shown in Figure 9. The samples also were carefully examined for indications of fatigue crack propagation, such as striations in the fiber impressions in the matrix [5, 12], matrix rollers (pieces of fractured matrix material rolled into cylindrical shapes by the relative motion of the fracture surface during cyclic loading) [5, 12], or rubbed hackle formations [5], however no evidence of fatigue was observed on any of the delamination surfaces.

When hackles form in CFRP's, the hackles orient perpendicular to the fiber axes, so the hackles in the orthogonal bundles of the woven fabric would generally point in two orthogonal directions. In some cases, the superimposed imprints of unidirectional tape at 45° to those bundles also added hackles at a third direction. Hackles also point generally opposite the locally applied shear at the fracture surface, so the multiple orientations of hackles from the different fiber bundles bound the direction of the local shear within an angle of 90°.

The river marks in the matrix-rich bundle crossings were used to identify a general direction of fracture propagation upward and aftward for both of the large delaminations (at the forward left and aft left attachments). The use of the river marks at the base of the hackles to determine delamination growth direction was explored in the examination of the delaminations at the forward right lug.

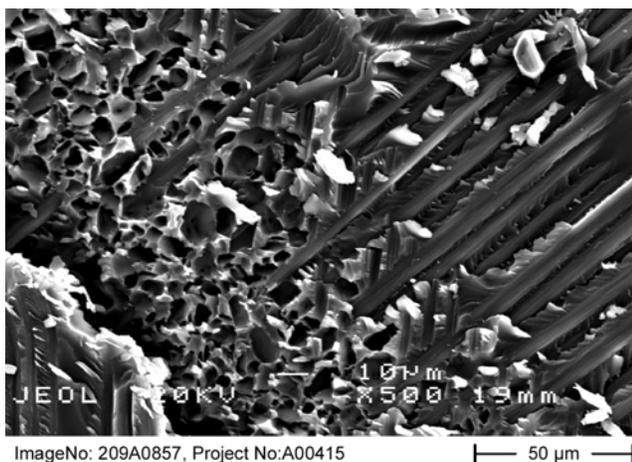
Figure 10: Porosity in matrix rich regions where bundles cross.

At the matrix-rich areas where bundles crossed, some porosity was observed having a somewhat angular appearance as shown in Figure 10. These pores were identified as arising from excess curing agent that had crystallized within the matrix. Such crystals

could have been physically removed in the fracture process or dissolved by the water from which the vertical stabilizer was recovered.

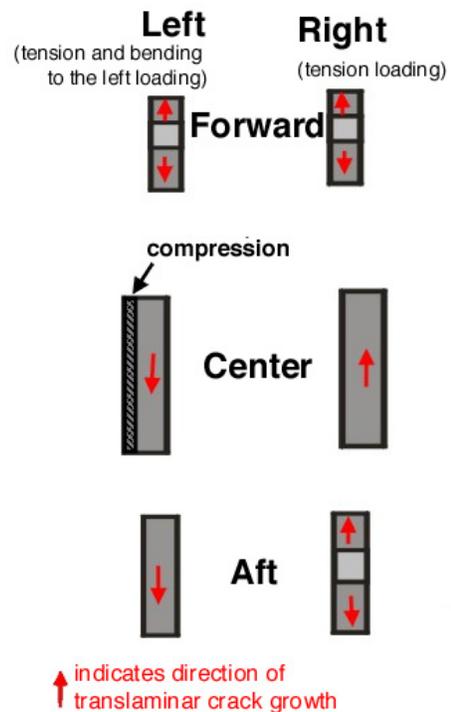
Figure 11: Main lug fracture pattern summary (viewed from above).

A summary of the observed fracture patterns is shown in Figure 11. The schematic drawing represents a horizontal cross-section of the vertical stabilizer through the main attachment lugs as viewed from above. Lug cross-sections with a light band at the center represent the lugs that failed through the bolt hole. Solid lug cross-sections represent fractures above the bolt holes. Arrows on the lug surfaces indicate the approximate direction of fracture observed on the translaminar surface. On the left center lug, the area of compression fracture features near the outboard side is indicated. The results showed that the failure pattern of fracture in tension on the right side was consistent with an overall bending of the vertical stabilizer to the left. On the left side, the failure pattern of tension and bending to the left was consistent with an overall bending of the vertical stabilizer to the left after fracture of the lugs on the right side.

It was noted that the only compression translaminar failure features were present on the vertical stabilizer at the outboard side of the center aft lug. Typically, composites have less strength in compression than tension. However, the design of the vertical stabilizer was such that the magnitude of the load needed to fail a lug in tension was less than the load needed to fail the lug in compression.

Furthermore after failure of the lugs on the right side, the curvature of the panel would cause tension loading in the forward and aft lug and compression in the center lug with continued bending to the left. Other unknown factors, such as changes in air loading as the vertical stabilizer deflected after the initial fractures on the right side, would further influence the failure patterns on the left side.

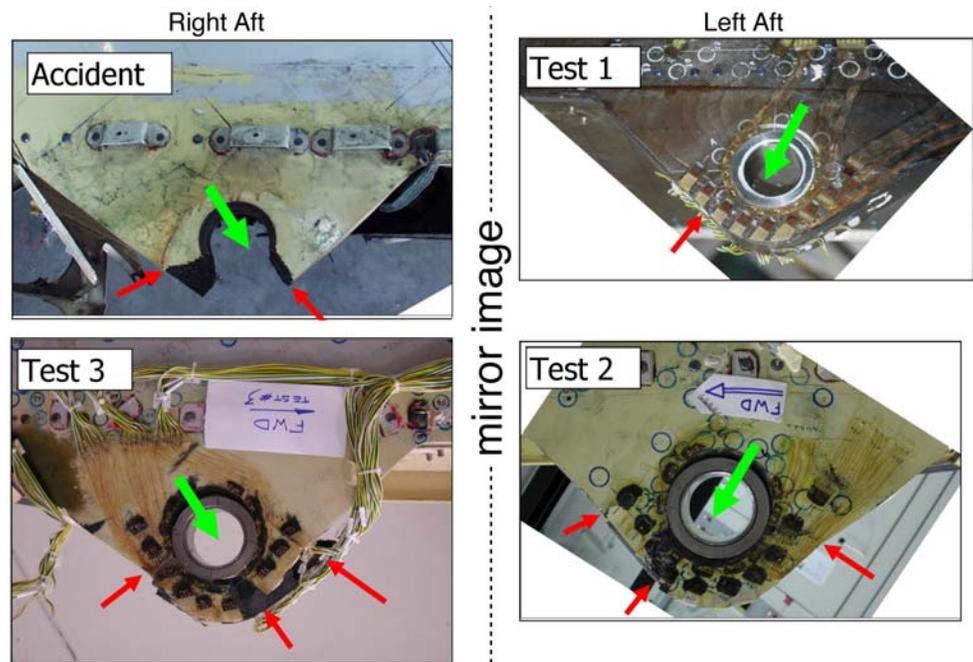
Figure 12: Aft lugs from accident and subsequent subcomponent tests.

Overall views of the lugs from each test are shown in Figure 12 (outboard surface view). A similar view of the accident right aft lug also is shown in Figure 12. Unlabeled red arrows indicate where translamina cracks or fractures intersected the outboard surfaces of the lugs, and an unlabeled large green arrow indicates loading direction (the force vector for the horizontal and vertical loading components for each lug). The lugs from the first and second tests were left aft lugs, and as such, the orientations are mirror images of the accident right aft lug and the third test lug.

Results from the fractographic examination showed that fractures in the test lugs occurred at locations similar to those on the accident right aft lug. In the first test, loading was interrupted after a translamina crack occurred at the location indicated by the red arrow in the upper right photo in Figure 12. The translamina fracture was located at a position on the forward part of the lug in a plane nearly parallel to the resultant force direction, similar to one of the translamina fractures in the accident right aft lug. Fracture features for the lugs from tests 2 and 3 were similar to each other. The outboard side of each of these lugs had a translamina fracture on the forward sides of the holes in a plane nearly

parallel to the resultant force direction, similar to one of the translamina fractures in the accident right aft lug. Fracture features for the lugs from tests 2 and 3 were similar to each other. The outboard side of each of these lugs had a translamina fracture on the forward sides of the holes in a plane nearly

parallel to the loading direction and another translaminar fracture at the aft side of the hole in a plane approximately perpendicular to the loading direction, fractures similar to that of the accident lug. In addition on the outboard sides, a compression buckling fracture was observed on the forward sides of each lug above the fracture parallel to the loading direction, which is different from features on the accident lug but was attributed to constraints of the loading fixture. On the inboard sides of lugs 2 and 3, fracture locations were on translaminar planes different from that of the outboard side of the lug. This change in fracture planes was similar to that of the accident right aft lug.

A delamination was present within the first test lug having an extent similar to that of the accident right aft lug and in a location through the thickness slightly outboard of that of the accident right aft lug. Delaminations also were detected above the translaminar fractures in lugs 2 and 3. In lugs from tests 2 and 3, the locations of the delaminations through the thickness were similar to that of the accident right aft lug, but the extents of the delaminations in the test lugs were slightly less.

Each subcomponent test lug had translaminar fractures that intersected the lug hole and had delaminations that were located within the lug, features similar to the accident right aft lug. Each lug had a translaminar fracture at the forward lower side of the hole on the outboard side of the lug, including the first test, which was interrupted and had no other translaminar fractures. The fracture at the forward lower side of the hole corresponds to one of the translaminar fracture locations on the accident lug. The second test lug showed changes in translaminar fracture planes that were qualitatively similar to that of the accident right aft lug. These results indicated that the accident right aft lug had fracture features consistent with being the first lug fracture from a substantially intact vertical stabilizer and rudder under accident load conditions.
