# Space Shuttle Body Flap Actuator Bearing Testing for NASA Return to Flight

## Abstract

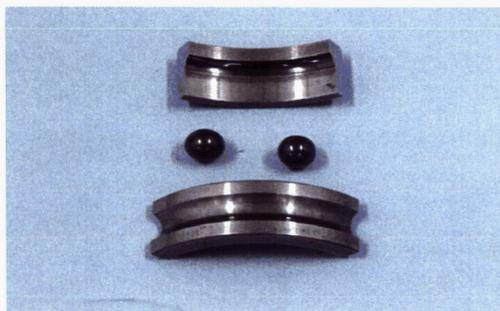
Visual inspection of P/N 5902050, S/N V6L009, revealed a black, tribological coating on the balls and race wear tracks (Figure 3). It should be noted that no other bearing in the Body Flap or Rudder/Speed Brake actuators was found to contain the black, tribological coating on the wear surfaces. Minor corrosion was noted on the inner and outer raceways. The grease present in the bearing was brown in appearance due to the tribological decomposition of the Braycote 601 grease and iron oxide wear debris. The recommendation based on microscopic examination analysis was to replace the bearing since the wear surfaces were black and it suffered Brinell damage during disassembly.

**Figure 3. Black bearing after sectioning and cleaning**

Note black balls and the dark bands present on the raceways.

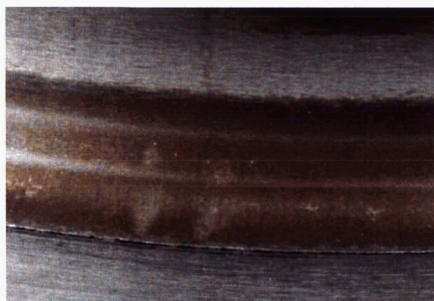
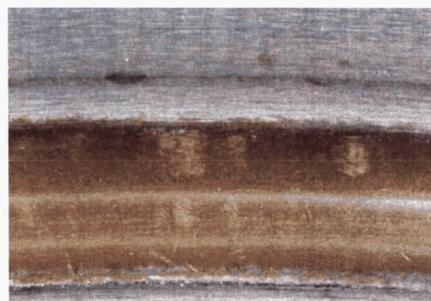
Further work performed in 2004 by Hamilton Sundstrand, Inc. reported that the inner ring contained a black tribological coated band. The black band or wear track possessed a smooth matte finish with a grain boundary like structure. Outside the black wear track, the original surface was still evident along with the original finish marks. The outer ring contained a similar black coated wear band (Figure 4). The wear surface of the outer race was similar in appearance to the wear surfaces present on the balls.

**Figure 4. Magnified views of the black wear tracks in the inner race (left) and outer race (right) are shown. Note the false brinelling marks. The dark brown color is an optical aberration of the black color.**

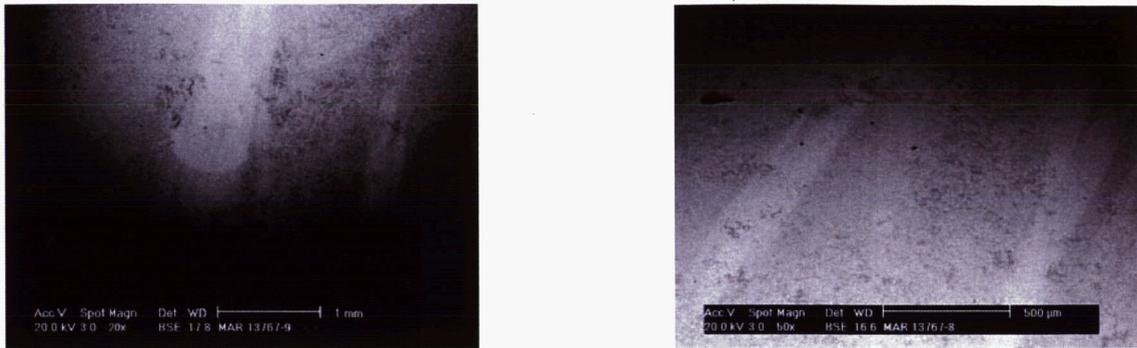
Scanning electron microscopy was performed on segments of the black ball bearing by various groups [5]. The segments examined included the balls, inner raceway and outer raceway. Analysis of the balls by energy dispersive spectroscopy (EDS) revealed that the black tribological coating was composed of carbon and iron oxide. The coating was porous and appeared to be uniform over the entire ball surface. A few skid marks were noted (Figure 5). In addition, each ball possessed a moon-shaped spot that appeared to have penetrated the burnished coating. The spot was probable caused by a drop of rain

water absorbing corrosive chemical from the degraded grease and dissolving the black coating during Shuttle storage.

**Figure 5. Scanning electron micrograph of black ball showing spot (left) and skid marks (right)**

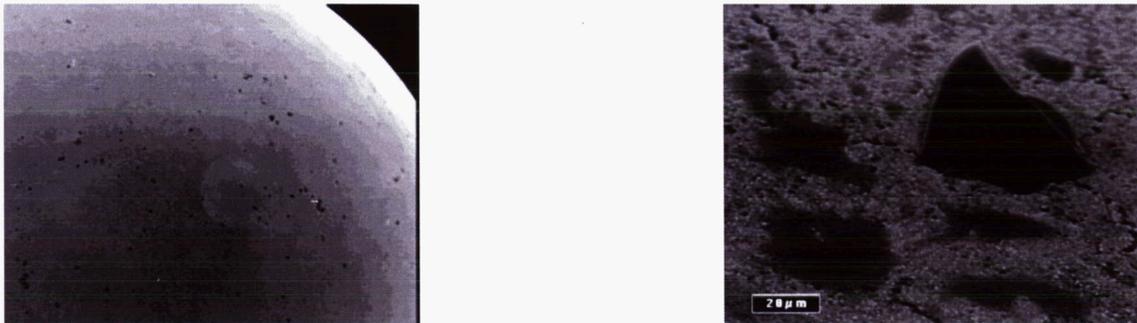
**Figure 6. Scanning electron micrographs of the black ball (left) and magnification of particle present on the ball surface (right)**

Higher magnification of the ball revealed some particles present on the ball (Figure 6). The presence of aluminum and silicon, in addition to other elements detected by EDS on these particles, were likely attributed to the bentonite clay additive present in the Braycote 601 grease and not contamination as was originally proposed. Analysis of the inner and outer raceways showed surfaces similar to the black ball. EDS performed on those surfaces detected the carbon iron oxide coating found on the black balls. Examination of the inner raceway away from the burnished band showed the original finishing marks which gradually translated into a smoother region as the burnished area was approached (Figure 7). Figure 8 shows the surface for the coating present on the black ball obtained by surface profilometry.

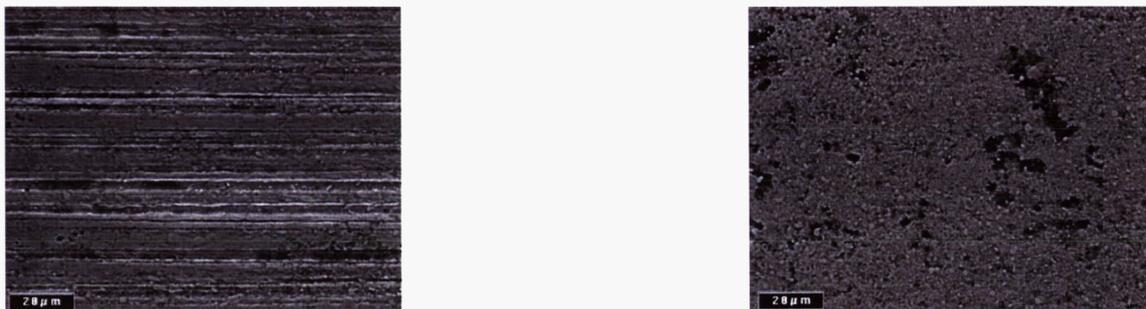
**Figure 7. Scanning electron micrograph of the outer raceway in the region above the burnished band (left), and within the burnished band (right)**

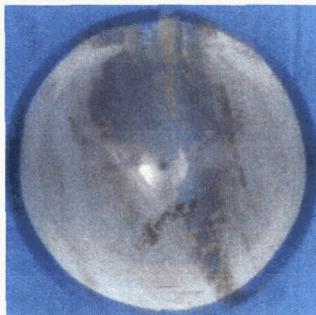
A photograph of a ball from BF-003 is shown in Figure 14. The photograph showed some banding and blue discoloration due lubricant degradation. The test lubricant was found to be in good condition. It was creamy white in color with some brown red areas caused by the early stage of lubricant degradation.

**Figure 14. Ball from BF-003 after 48 Mission life test**

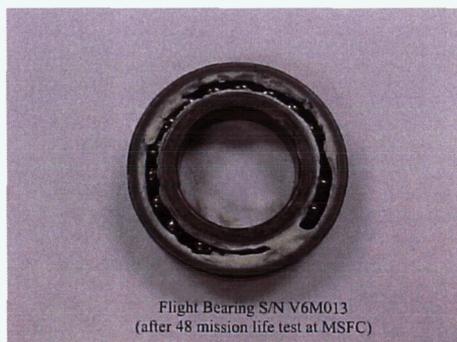
After testing, the lubricant appeared to be in good condition. The grease in the bearings was still creamy white with only a few areas of reddish brown discoloration (Figure 15). Balls from flight bearing showed significant banding due to normal wear and possible lubricant degradation (Figure 16).

**Figure 15. Flight bearing SN V6M013 after 48 mission life test**

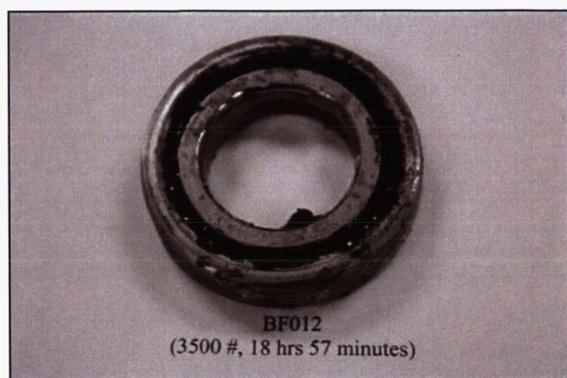
In general, failed bearings exhibited severe wear. A failed bearing is shown in Figure 17 and 18. The onset of wear started when the lubricant between the ball and race was completely consumed or degraded. Shear plastic deformation occurred between the race and ball steel to cause adhesive wear or severe wear. Due to high friction and heat generation, the local ball temperatures rapidly increased and caused oxidation and discoloration of bearing balls. In some case, the balls were highly discolored and almost black. The test lubricant in the failed bearings was very dark in color with significant degradation and metallic wear debris.

**Figure 17. Failed Test Bearing BF012**

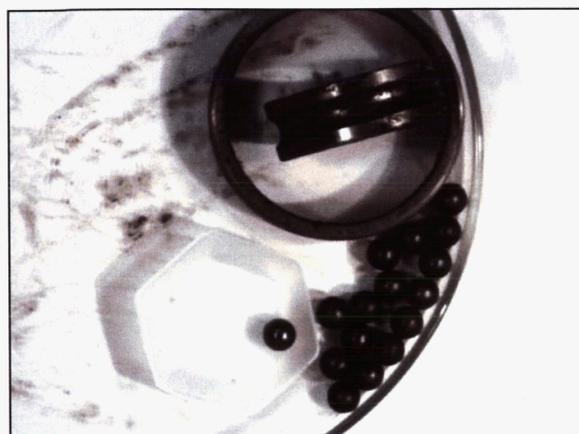
**Figure 18. Failed Test Bearing BF012 (disassembled)**
