**HIGH MISALIGNMENT CARBON SEALS FOR
THE FAN DRIVE GEAR SYSTEM TECHNOLOGIES**

Dennis Shaughnessy and Lou Dobek
United Technologies—Pratt & Whitney
East Hartford, Connecticut

2005 NASA Seal/Secondary Air Delivery Workshop

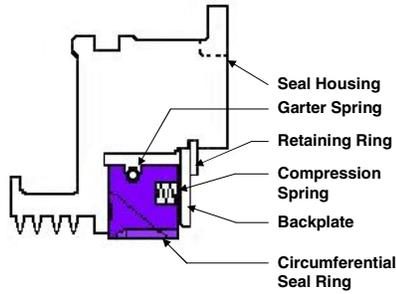
1-Piece Segmented Circumferential (Baseline Design)

- 1 Piece design resulted in wear rates that exceeded project limit goals.
- Base material (Carbon X) is suspect to be inappropriate for this application.
- Alternate design & material need to be investigated.

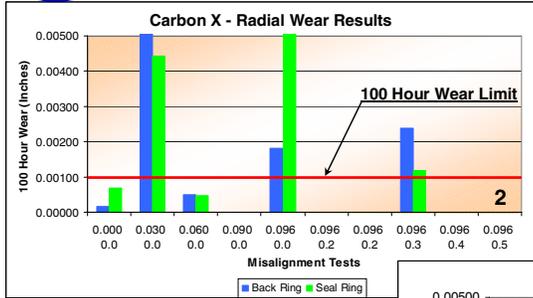
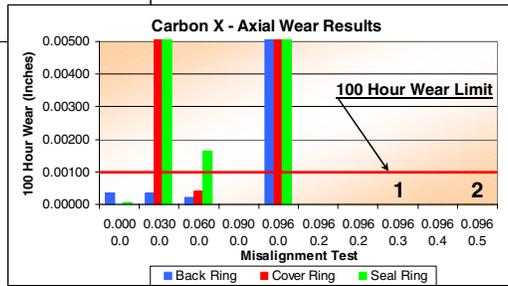
- Carbon X repeatedly exceeds 100 hour wear limit.
- 1. Excessive coking indicated negative wear.
- 2. Test terminated after two attempts resulted in broken seal segments.

Carbon X repeatedly exceeds the 100 hour wear limit goal and testing was terminated after multiple failures.

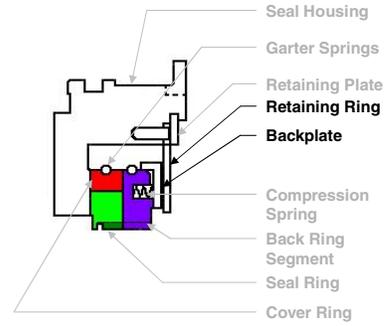
Backplate tang steadily wearing into slot of Retaining Ring. Current Seal Housing prohibited design change to increase Retaining Ring to the full thickness of the tang.

Photos of seal retaining hardware show the wear the occurred during misalignment testing.

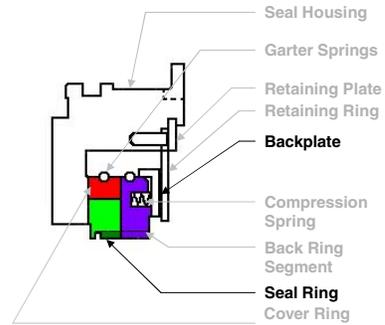
Backplate failure during test phase of advanced design misalignment tests

Backplate Key steadily wore into slot of Back Ring and Seal Ring. Modification increased the number of Keys from one to two.

Backplate stress crack identified after test with the largest combination of Radial and Angular misalignment. Modification increased the corner radii at the keys.

Photos of seal and associated retaining hardware show the wear and stress fracture that occurred during misalignment testing.

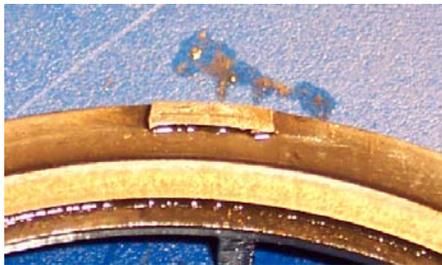
Backplate Tab Failure

Seal Ring Notch Wear

Back Ring Tab Failure

Photos of the seal assembly and signs of wear that occurred during misalignment testing.
