## Wiring Damage Analyses for STS OV-103

*Walter Thomas, III*  
*NASA Goddard Space Flight Center, Greenbelt, Maryland*

*Space Shuttle Orbiter Reaction Jet Driver*  
*Independent Technical Assessment/Inspection*

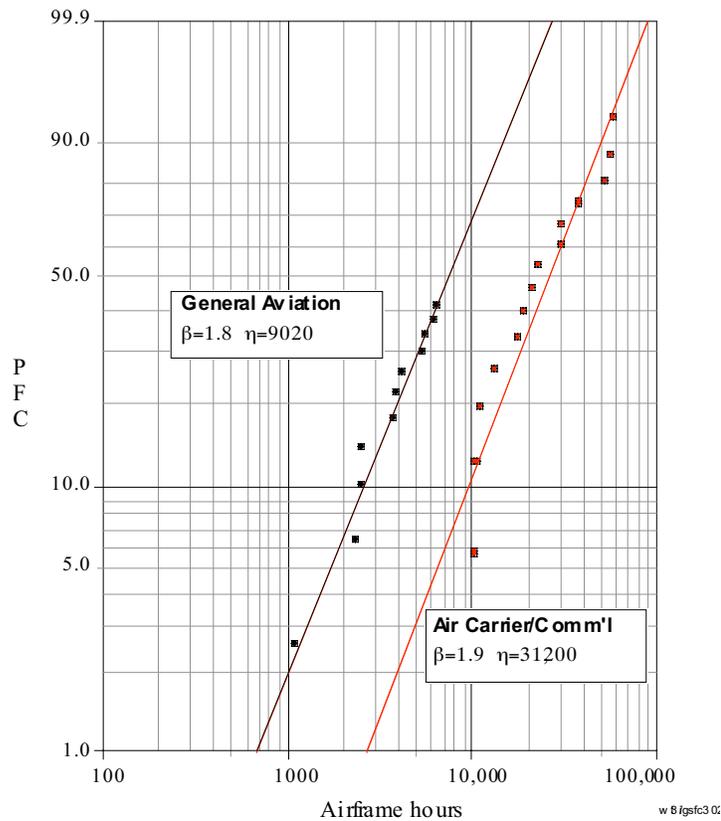
The initial analysis evaluated wiring incidents for both general aviation (GA) and air carrier/commercial (AC/C) aircraft. A Weibull plot of these data is shown in **Figure 1**. Both GA and AC/C wiring exhibited slopes (“ $\beta$ ’s”) of 1.8 and 1.9 (statistically the same at 90%

confidence). The greater-than-1 slope indicates an *increasing* failure rate; that is, wiring incidents are occurring more frequently as aircraft accumulate operating hours. The identical slopes imply failures occurred with similar modes (failure mechanisms). Characteristic lives (“ $\eta$ ”) were 9020 and 31,200 airframe hours, respectively. The behavior of characteristic lives is very interesting. Generally, AC/C aircraft accrue considerably more operating hours per calendar year than GA aircraft; thus, one would expect the AC/C failure distribution to coincide or precede that for GA aircraft. The AC/C plot, however, is displaced approximately 20,000 hours *later*. This suggests a causal factor other than aircraft operating hours, when GA and AC/C are compared. (No data were available for aircraft calendar ages at the event times). Nonetheless, these data do show that civil aircraft wiring incidents exhibit an increasing failure rate with time.

**Figure 1. Weibull plot of civil aircraft wiring “incidents.” Data for both GA and AC/C aircraft have the same slope, but are displaced along the time axis.**

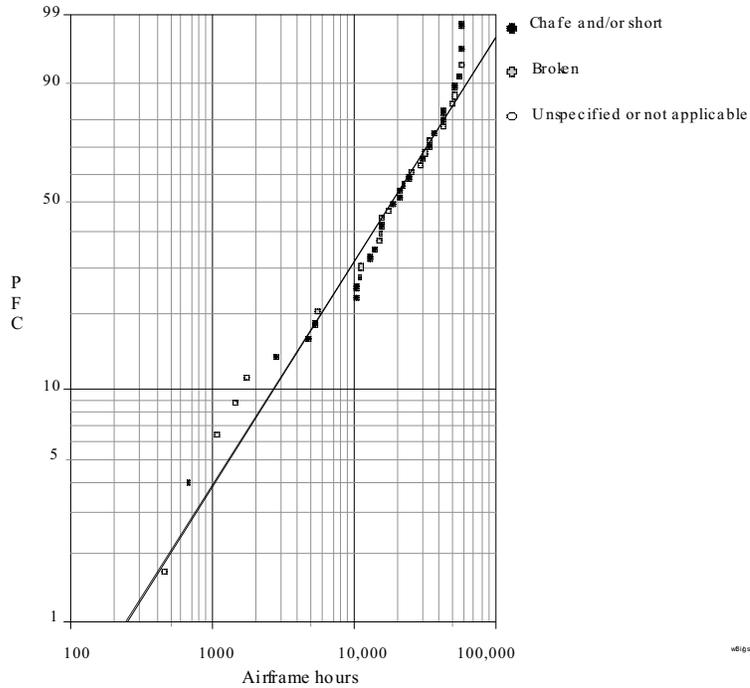
Initial analysis of these data showed an approximate fit to a constant failure rate (CFR) model, i.e., the Weibull slope was near 1.0 (see **Figure 2**); however, the data fit was poor. Abernethy [6] points out that a CFR distribution can “hide” a mixture of failure modes. That is the case for these data. Re-plotting by separating failures by mode produced the **Figure 3** plot. Here, the data fit improved. All three failure modes yielded a Weibull slope of 1.6 (“early wear-out”); they were displaced slightly along the time axis. This, again, indicates an *increasing failure rate* for civil AC/C wiring failures.

**Figure 2. Weibull plot of Air Carrier and Commercial aircraft wire failure incidents. Apparent Weibull slope ( $\beta$ —the dashed line) is  $\sim 1$ , but data clearly indicates mixture of failure modes (plot is not linear). Failures are coded according to legend in upper right.**

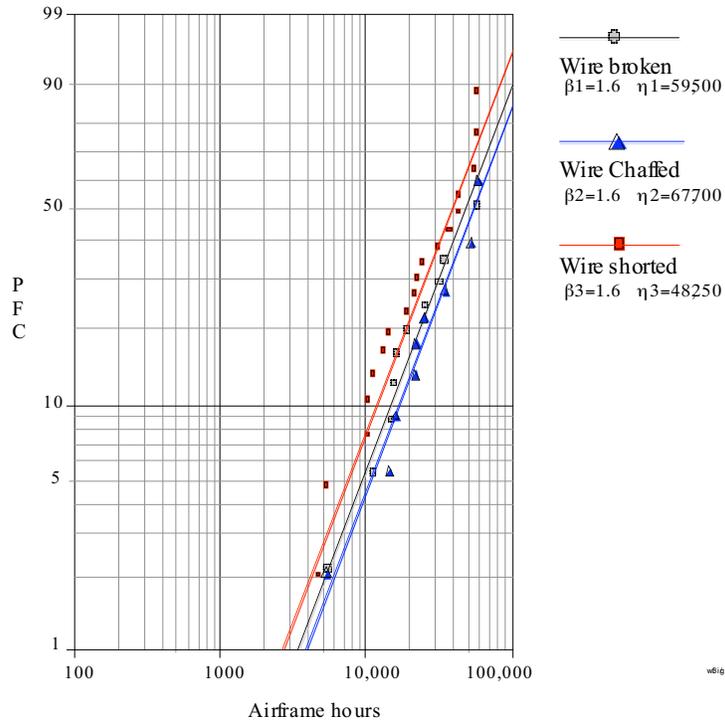
**Figure 3. Weibull plots of Air Carrier and Commercial Operations wiring failure incidents separated by failure modes. The three modes have the same Weibull slopes and are displaced slightly along the time axis. Wiring failures are *not consistent* with a constant failure rate model.**

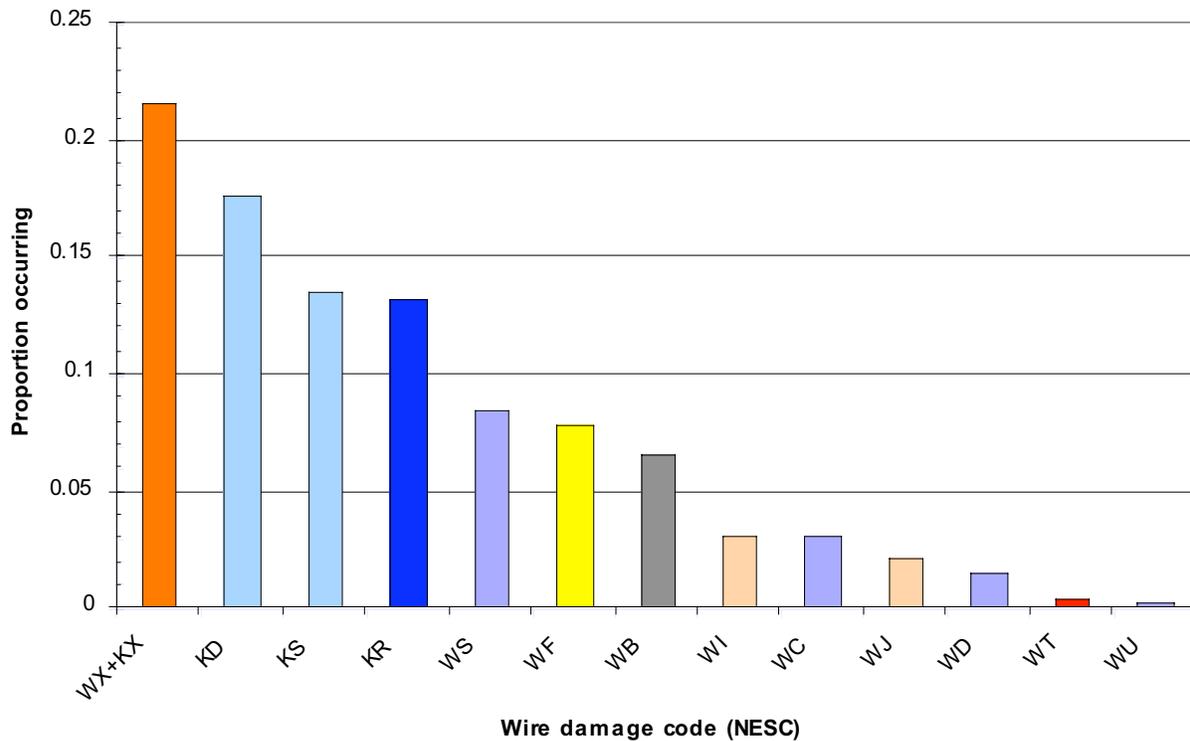
The **Table V** (“Both”) data is presented as a Pareto chart in **Figure 4**. This is simply a visual representation of the wire damage event proportions over OV-103’s lifetime—by NESC damage codes.

**Figure 4. Pareto chart for OV-103 wiring damage events over the vehicle’s lifetime. (See Table III for code descriptions).**

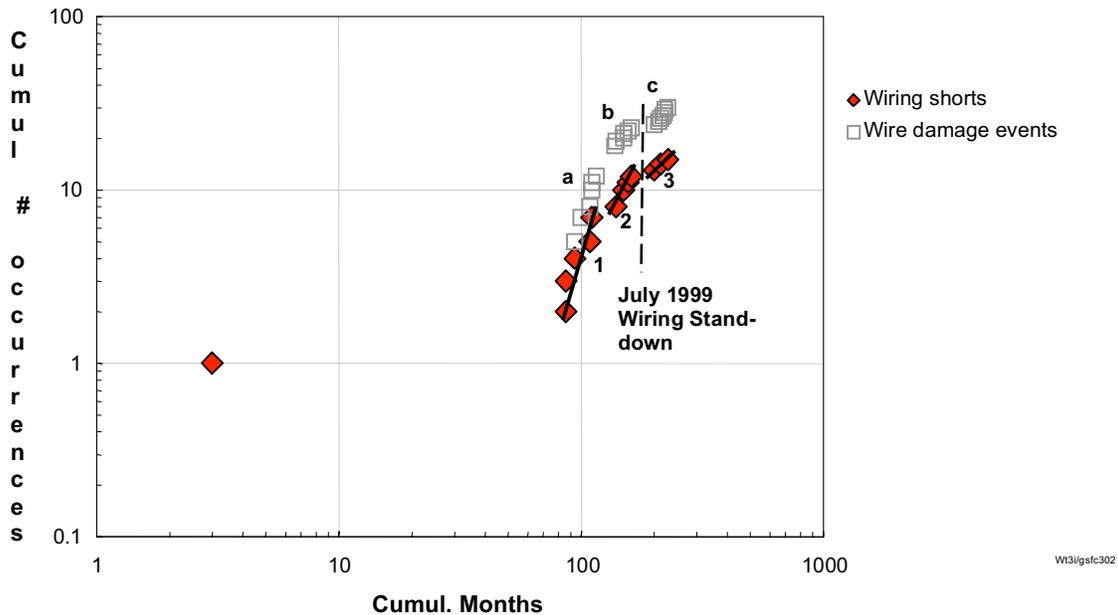
**Figure 5. Crow-AMSAA plot of STS Orbiter Interconnect Short Circuits**

The one wiring short circuit to the extreme left on the plot was a significant flight occurrence in March 1983. Other data were "missing" until approximately 86 months later. <sup>\*\*</sup> The 1983 datum was suspended for the CA statistical analyses.

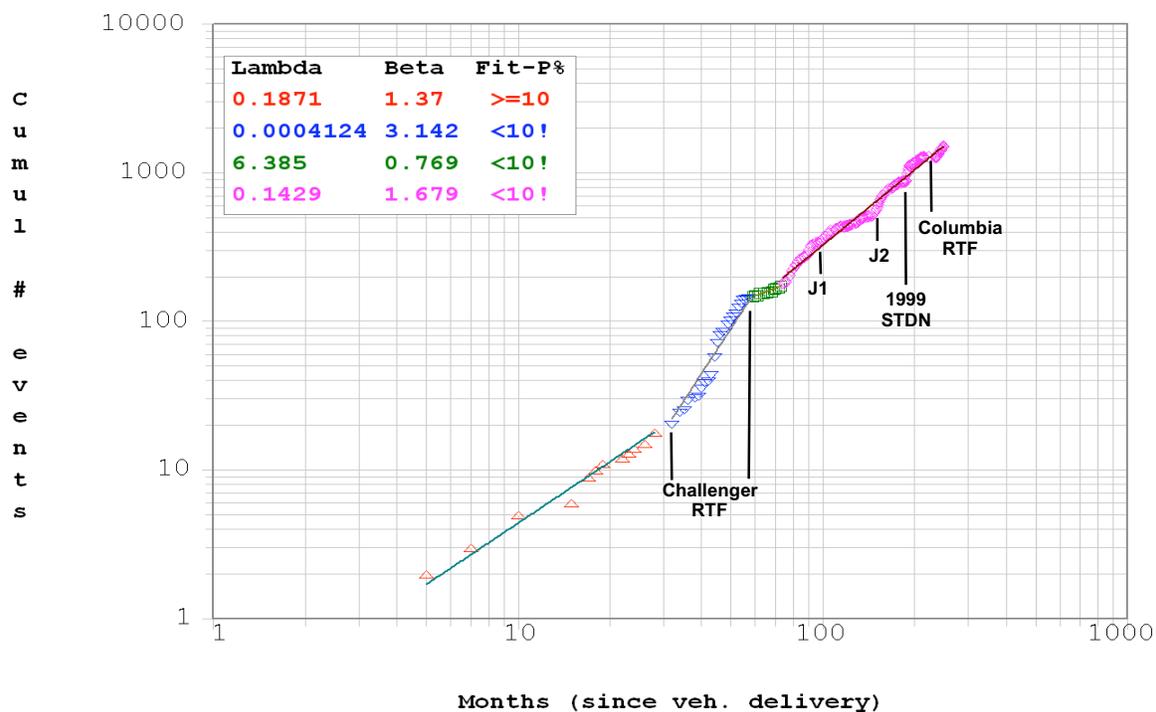
**Figure 6. Crow-AMSAA plot of all detected OV-103 wiring damage events, plotted by months since vehicle delivery**

The **Figure 6** data do not provide a good statistical basis for making any definitive conclusions (because of the poor statistical fit beyond 30–40 months).

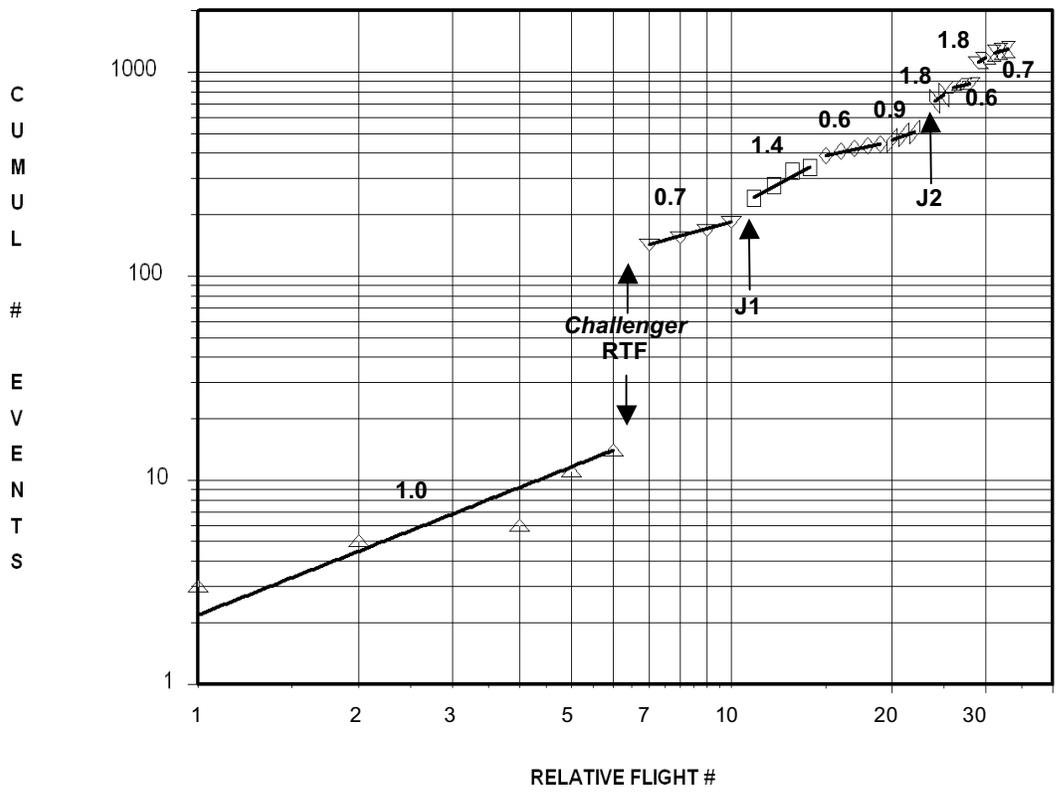
Figure 7. Crow-AMSAA plot of OV-103 detected wiring damage events by vehicle flight number. Numbers above and below lines are slopes. “Relative flight numbers” are vehicle flight numbers incremented by 1 and 2 after J1 and J2, respectively.

In this plot, one can see the jumps at *Challenger* RTF, J1, J2, and the 1999 stand-down. Post-*Columbia*-accident data was not plotted. The initial (up to *Challenger*) detection rate was static (slope ~ 1), compared to the 1.4 seen in the “by month” data. After *Challenger* RTF, the per-flight data exhibited the same slope of decreased wire damage detection (0.7 vs. 0.8 for the “by month” data) until the J1 OMM activity. After J1, detected events increased for four flights and then decreased for the next five flights (0.6 slope). There was an increase in detected events for flights 19 through 21. An expected jump occurred for J2 OMM. Then detected events changed between increased detection (slope 1.8) and decreased detection (slope 0.6) until the 1999 stand-down. It subsequently followed the same pattern after the 1999 stand-down—increased detection (1.8) then reduced detection (0.7). The inspection/detection process appears to oscillate between enhanced and diminished detection since the J1 OMM activity.

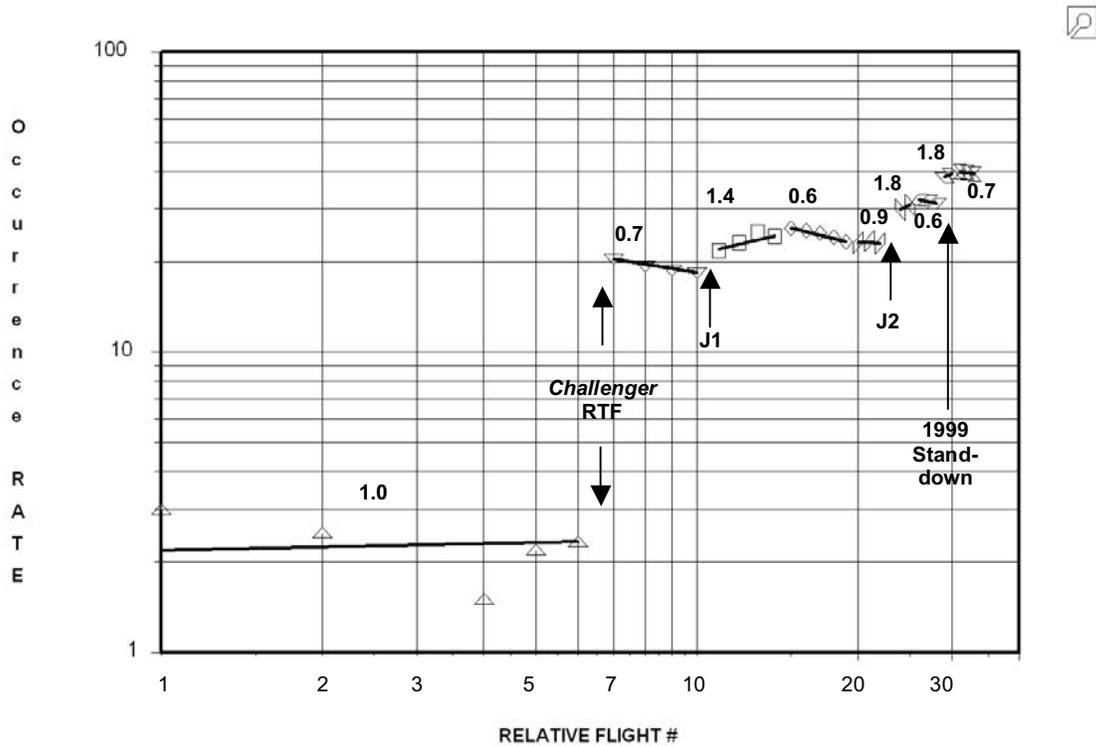
**Figure 8. OV-103 Wiring Damage Events (By Flight Cycle) Plotted as Occurrence Rates, from CA Plot**

The **Figure 8** data are the event occurrence *rates* (analogous to failure rates) plotted per (cumulative) flight cycle. For this presentation, a “flat” line means the process is static (not changing with time), an upward slope (to the right) means events are occurring more frequently with time (more events detected per flight cycle), and a downward slope means fewer events occurring with time (fewer detected per flight cycle). This plot reflects the same trends shown in the “traditional” CA plot (**Figure 7**) and it is easier to distinguish between “improvement” and “deterioration.”

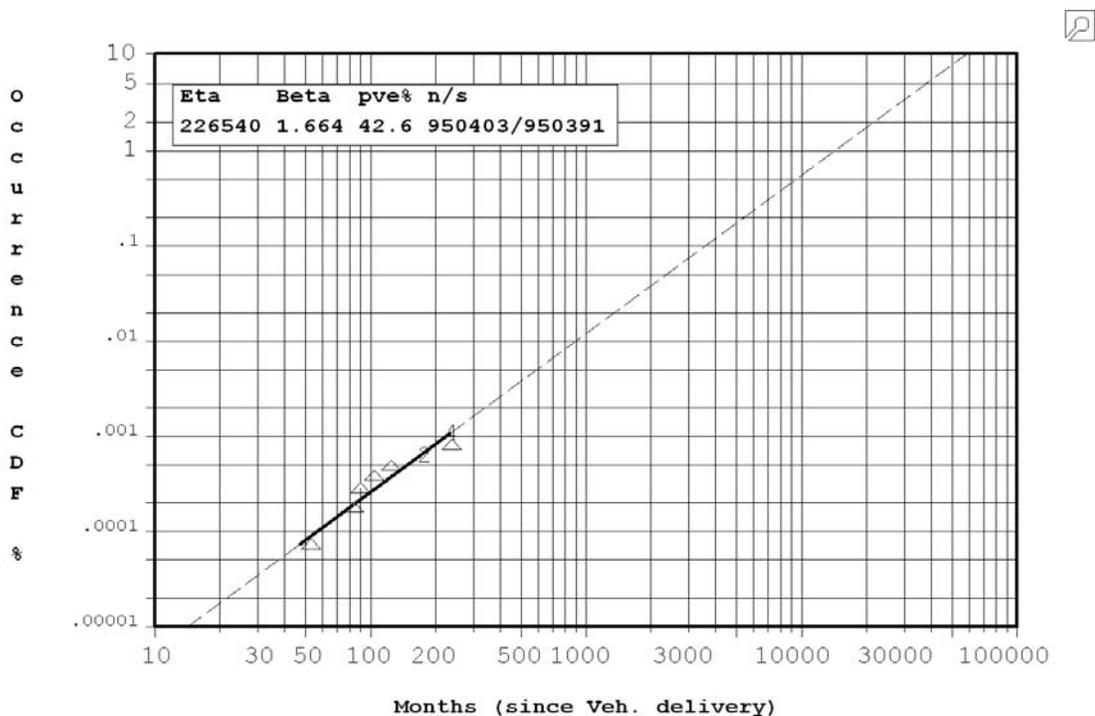
**Figure 9. Weibull plot of OV-103 wiring short-circuit events. The Weibull slope indicates early wear-out failures are occurring.**

The Weibull parameters ( $\beta = 1.7$  and  $\eta = 226,500$  months) indicate an early wear-out failure mode, that is, the failure rate is increasing with time, albeit at a slower rate than “true” wear-out ( $\beta$  greater than 4). Thus for wire short circuits, there *is* a failure (or occurrence) rate increasing with time. The above Weibull parameters can be inserted into the fault tree model to replace the existing CFR assumption; this will more accurately reflect wire short circuit occurrences, at least for OV-103.

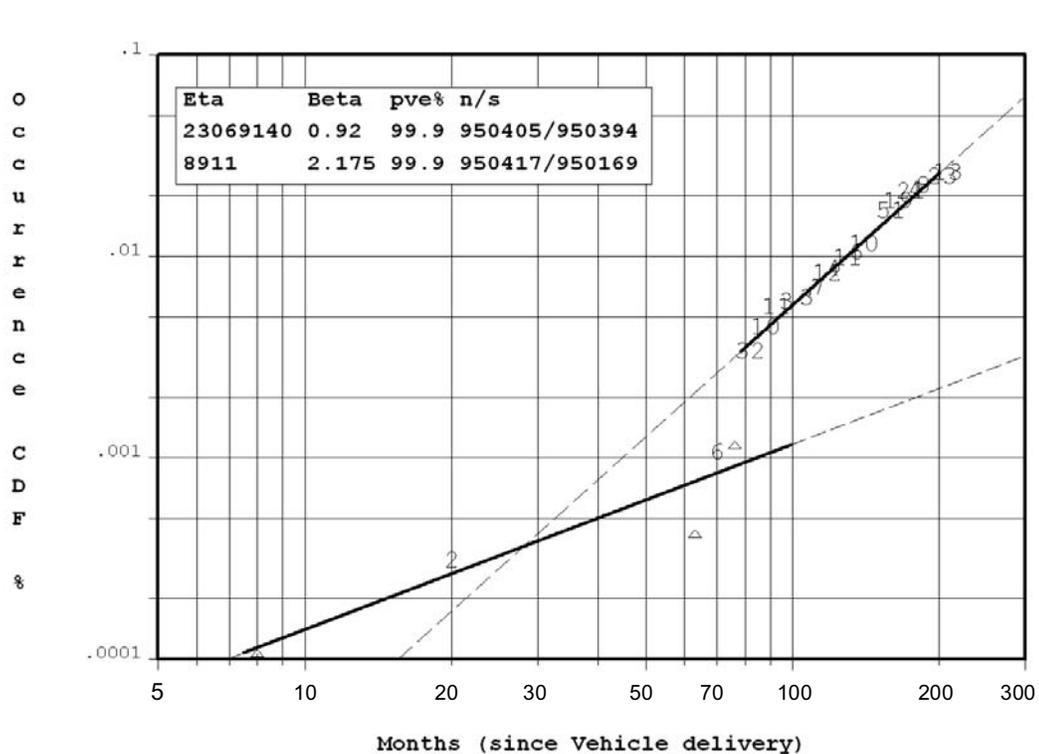
The resulting K-M Weibull fit was excellent, yielding **Figure 10**. Exposed conductors initially fail as a near-CFR distribution ( $\beta = 0.9$ ) until about 78 months (six and a half years) when early wear-out failures ( $\beta = 2.2$ ) "take over." [Exact parameters from the plot can be used in the fault tree calculations or other predictions].

**Figure 10.** Weibull plot of Kaplan-Meier data for OV-103 exposed conductor events. Earlier distribution is a near-random failure rate; later distribution is early wear-out.

Exposed conductors are a primary concern regarding the wiring contributions to inadvertent RJD firing. If the Program replaces RJD control wiring (as proposed in the NESC briefings), only randomly occurring exposed conductor failures would be expected for approximately six and a half years of vehicle life after the wiring is replaced. (This assumes that the replaced wiring is equivalent to the existing wiring in the vehicle).

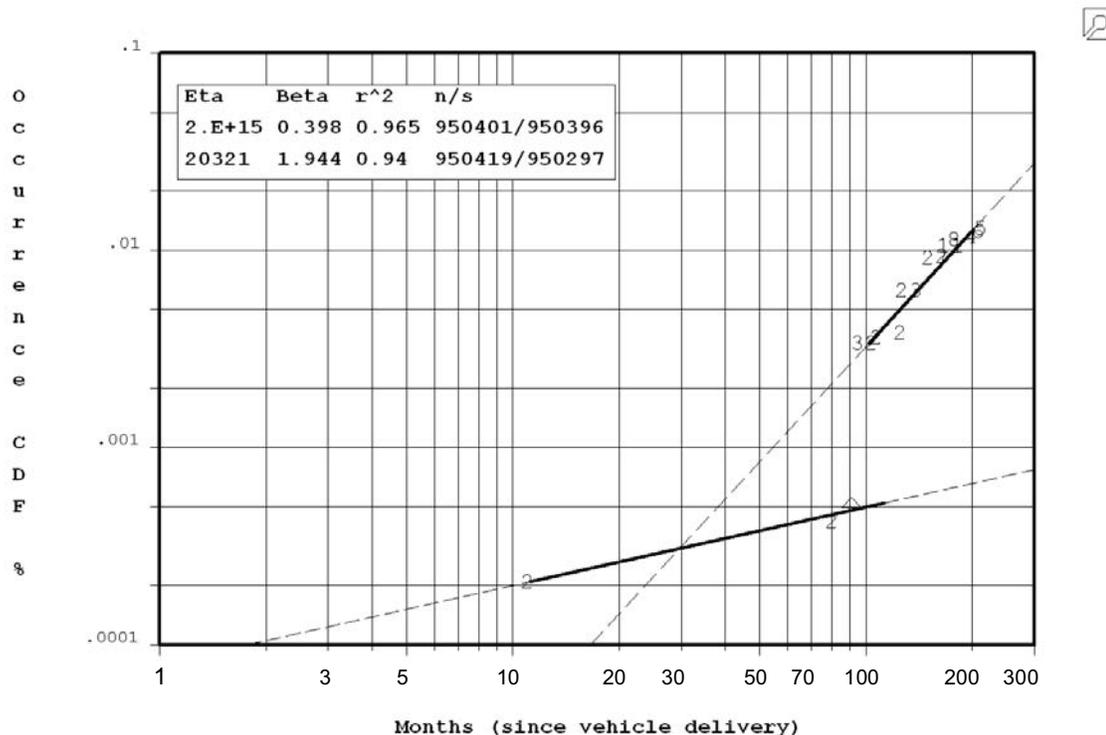
Data for Kapton™ cracks and “ring” cracks (KR code) were analyzed using the K-M function (see **B**, above). The first analysis, using all data as one set gave a poor fit ( $r^2 = 0.74$ ), however, the data pattern was similar to exposed conductors, above. There was an initial “flat” distribution ( $\beta = 0.4$   $\eta = 2 \times 10^{15}$  months) out to about 91 months followed by an early wear-out distribution ( $\beta = 1.9$   $\eta = 23,320$  months). The Weibull plot is shown as **Figure 11**.

**Figure 11. Weibull plot (K-M) for OV-103 Kapton™ cracking and ring cracks. Early failures are infant mortals; later are early wear-outs.**

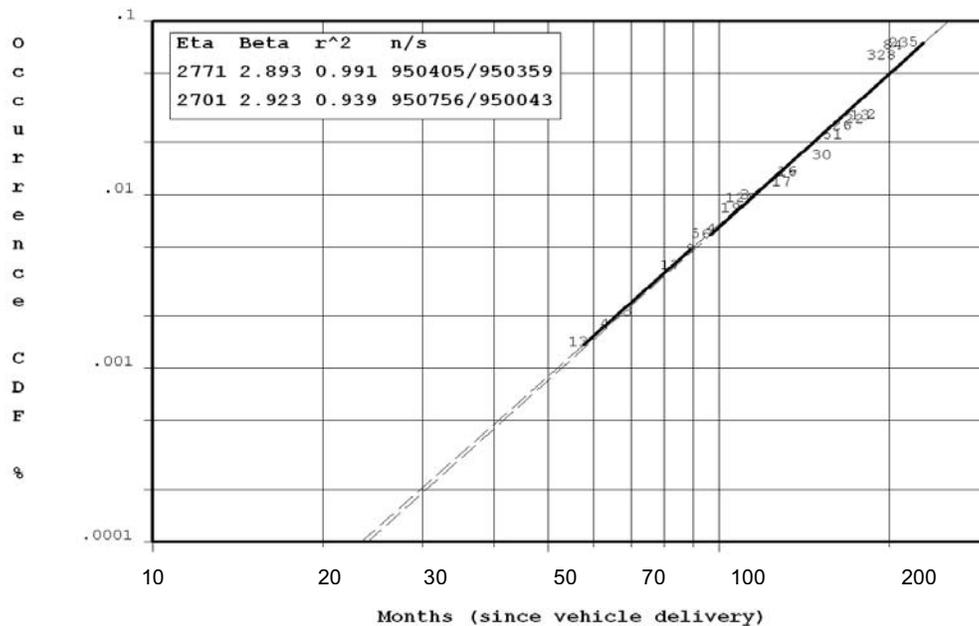
The plot using the “separated” data is shown as **Figure 12**. In this case, there was no initial “flat” distribution—early wear-out events commenced at about 60 months.

**Figure 12. Weibull Plot (K-M) of Other Kapton™ Damage Events (KD and KS)**

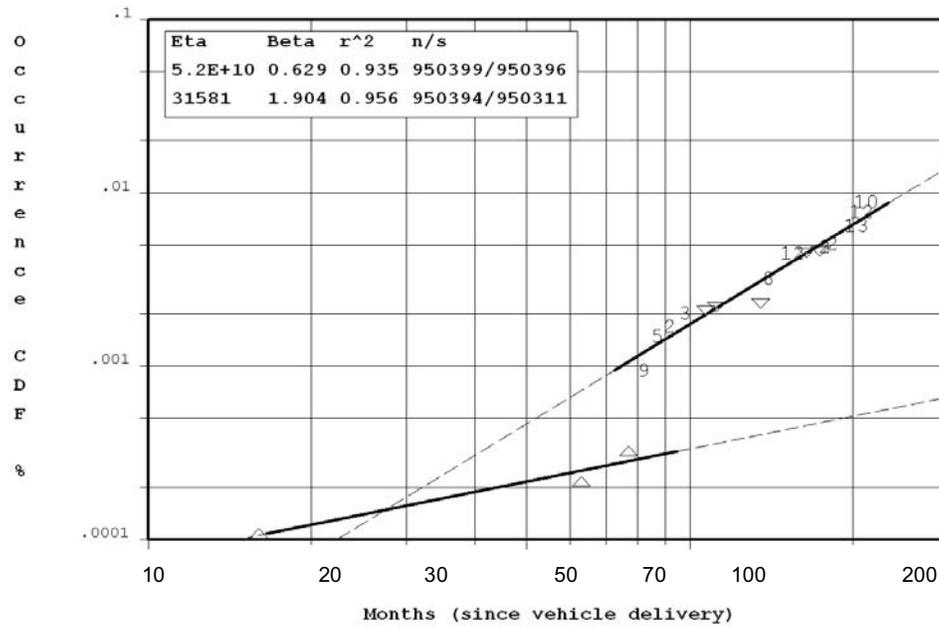
**Figure 13. Weibull Plot (K-M) of Wire Chaffing Events**

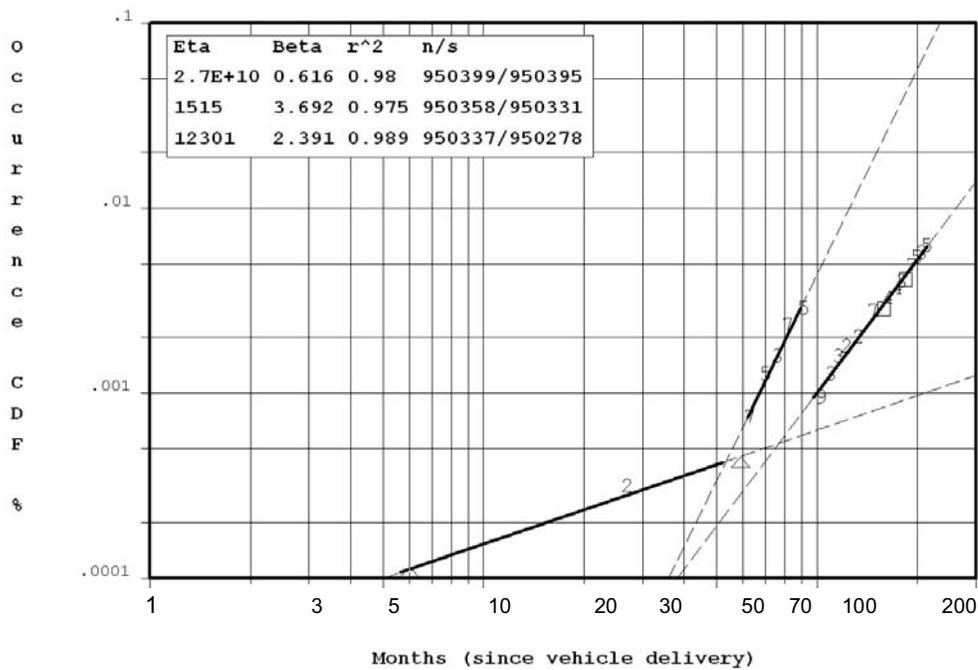
A broken wire was involved in at least one significant flight event (STS-93, see p. 7). Of 134 broken wire events, nearly half (64) were associated with ground lug or ground wire failures. All broken wires were analyzed using the K-M function and exhibited the initial “flat” Weibull seen in most other failure modes. However, during *Challenger* RTF and for subsequent flights until

the first OMM (J1), broken wire failure incidence increased significantly. These returned to the early wear-outs ( $\beta \sim 2.3$ ) seen for the other modes after J1. The plot is **Figure 14**.

**Figure 14. Weibull (K-M) Plot of Broken Wire Events**
