Helios Prototype Vehicle Mishap: Technical Findings, Recommendations, and Lessons Learned

Aerospace Control and Guidance Systems Committee Meeting No. 100

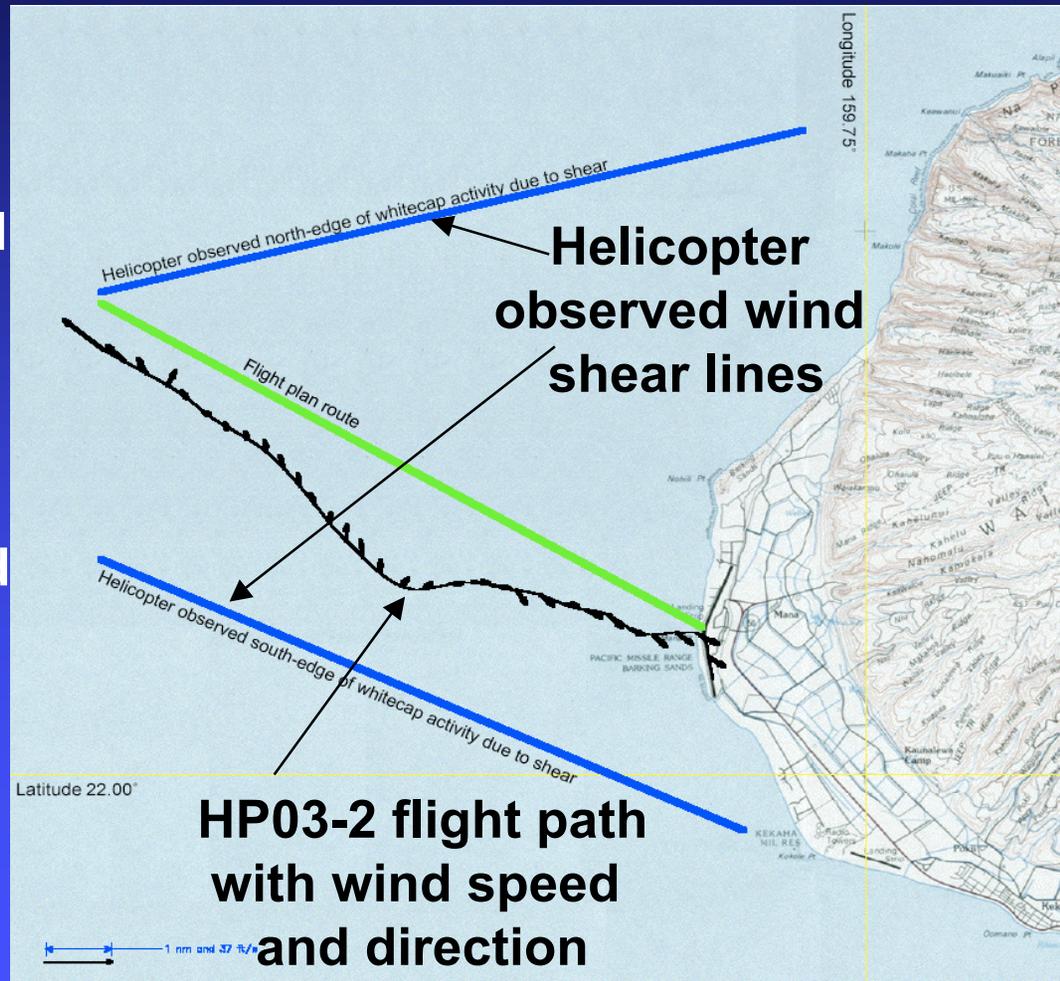
Turbulence Shear Line Observations

Northern wind shear line

Southern wind shear line

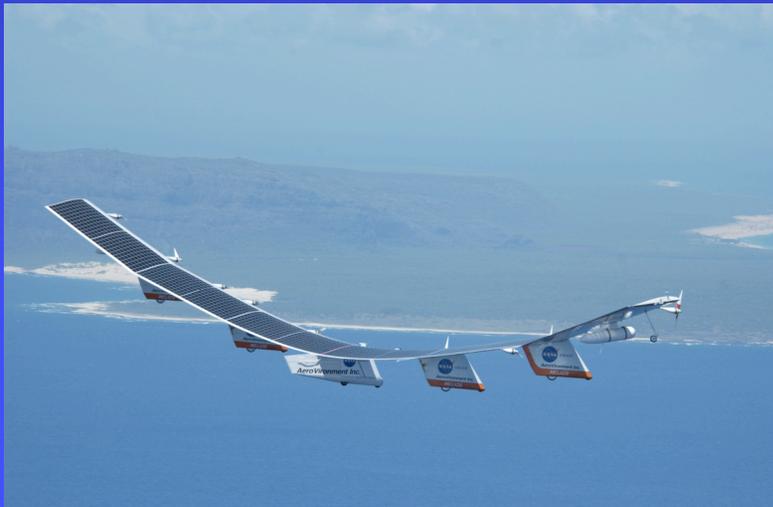
HP03-2 with normal wing dihedral

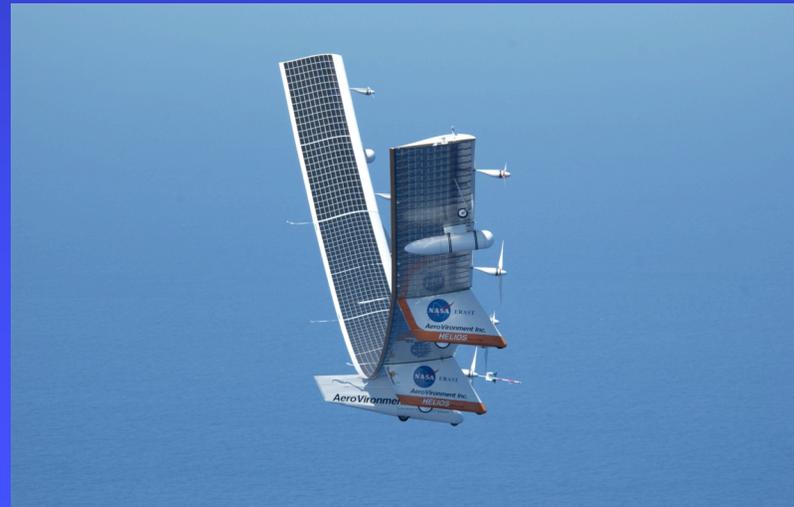
HP03-2 with persistent high wing dihedral

- On June 26, 2003 at approximately 10:35am at an altitude of about 2,800 feet, HP03-2 encountered turbulence associated with wind shear lines around the island of Kauai
- Turbulence initiated a persistent high wing dihedral causing an unstable pitch oscillation
- Airspeed excursions were around ± 2 ft/sec; main wing spar strain gauge reading 103% of limit load
- Following pilot procedures to reduce dihedral, wing dihedral decreased slightly, but then grew to over 30 feet
- Large airspeed fluctuations of about ± 10 ft/sec now observed, an indication the aircraft was experiencing large pitching motions
- Airspeed excursions began to double every cycle

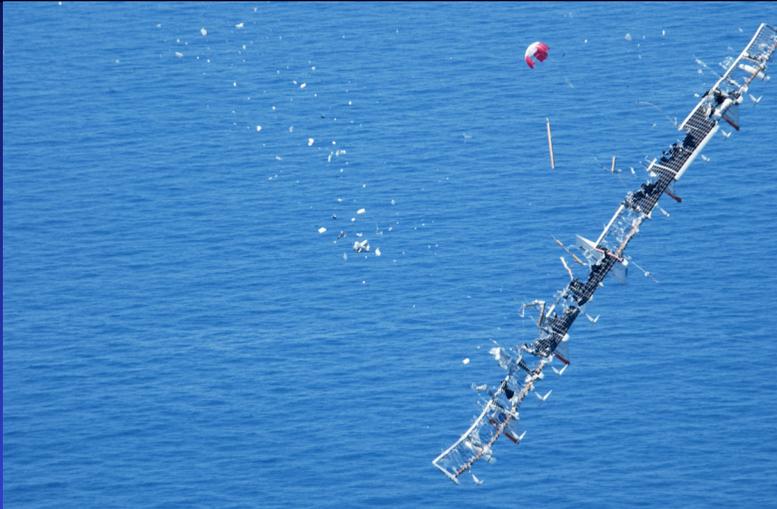
- Vehicle became oriented at extreme attitudes relative to the air stream (wing dihedral of about 40 feet with the airspeed nearing 90 ft/sec)
- High dynamic loads broke the right wing leading edge foam secondary structure near the hydrogen fuel tanks
- Solar cells and the wing skin began to rip off the upper surface of the wing resulting in loss of lift
- Vehicle entered a more severe attitude resulting in additional secondary structural failure
- Aircraft continued to come apart as it fell to the Pacific Ocean

Falling to the Pacific

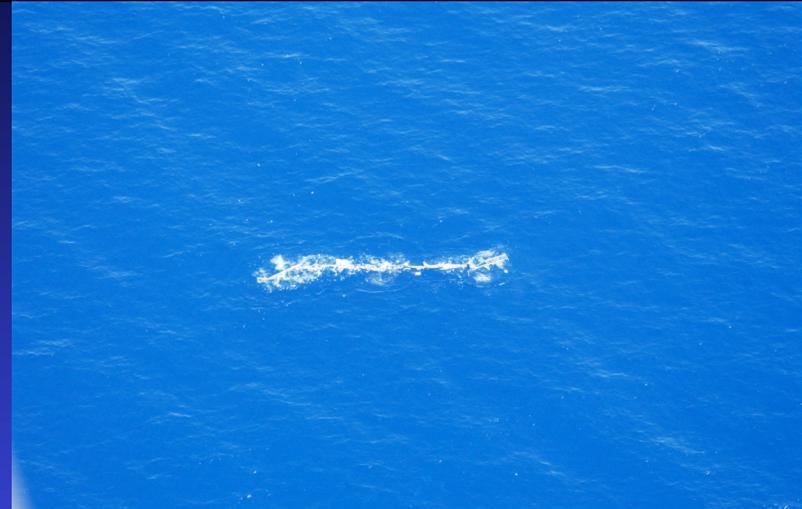
Helios upon impact with the ocean

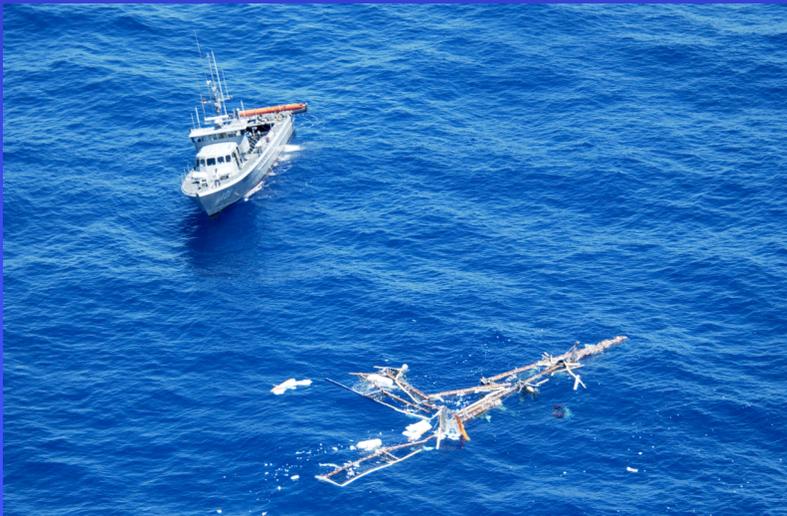
Surveillance of debris

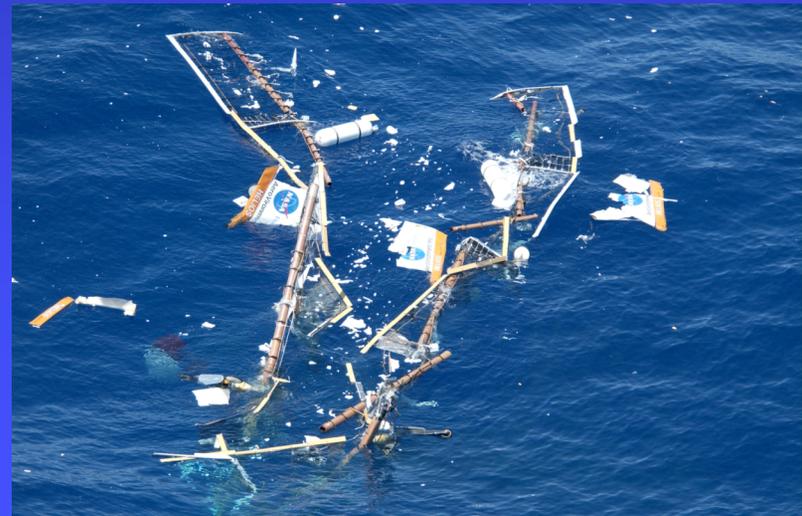
Close-up of floating debris

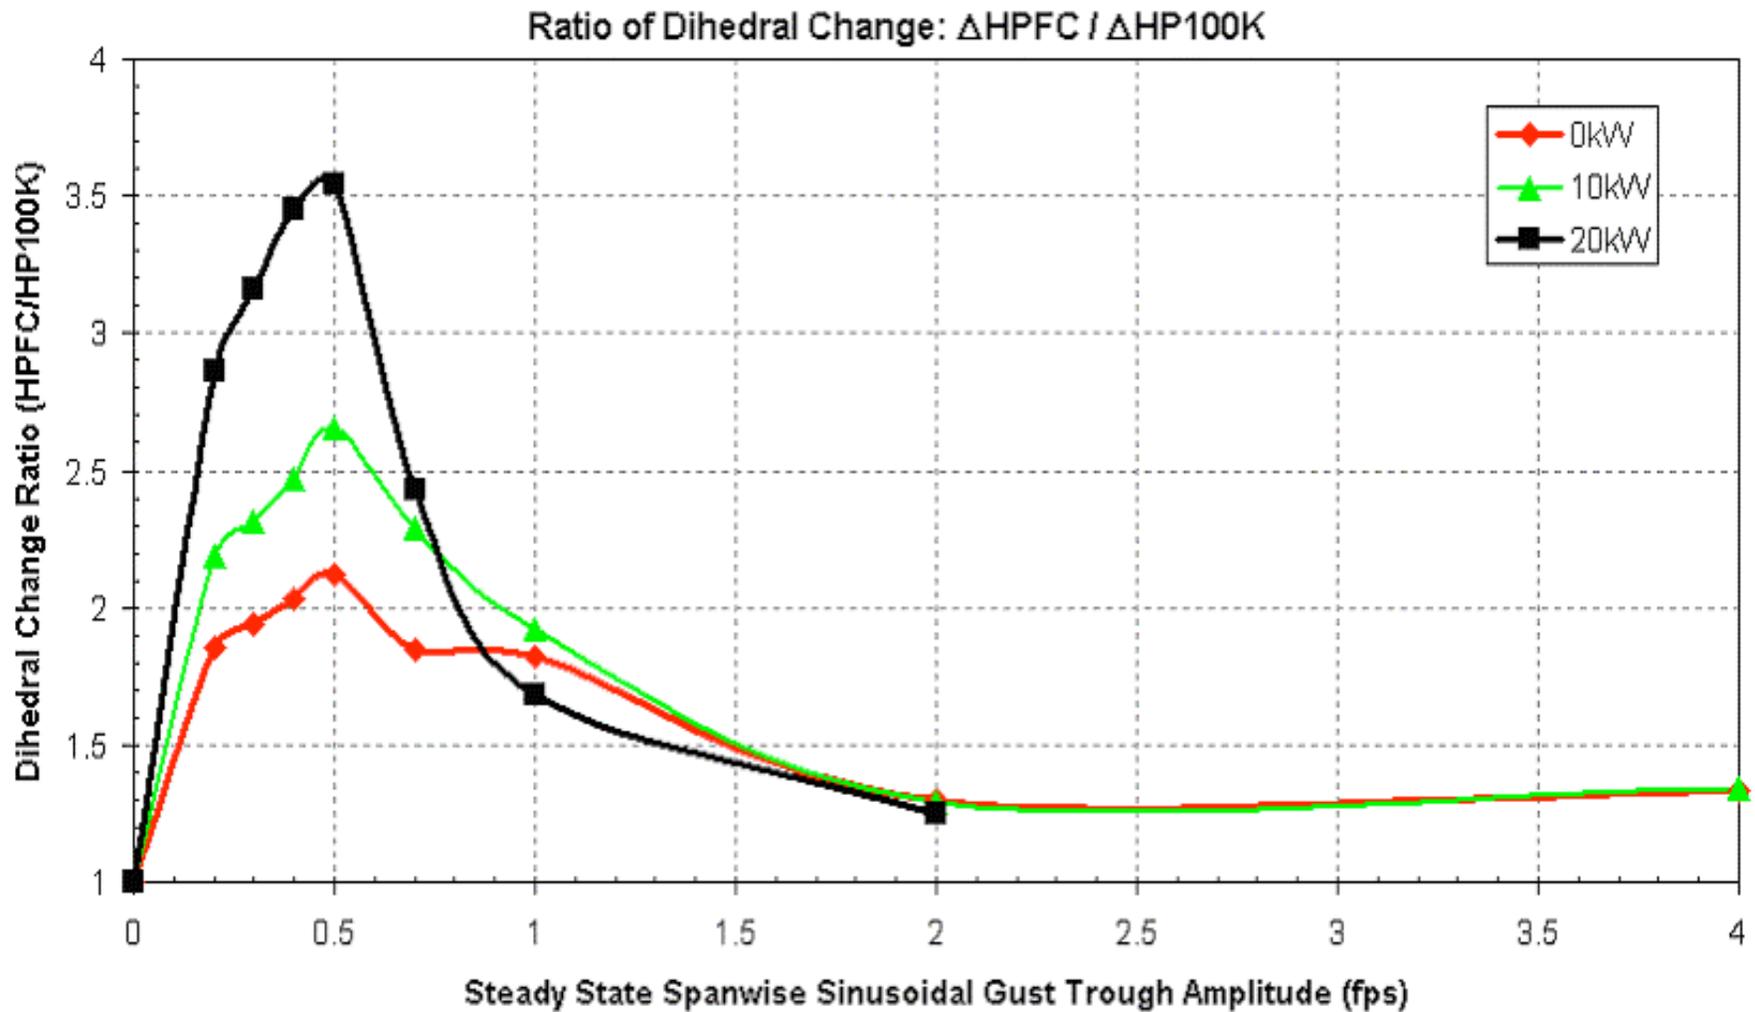
Increased Sensitivity to Small Gusts

- Strength of dihedral response to mild turbulence
- High persistent dihedral
- Wing not robust to returning to low dihedral
- Rapid divergence of pitch instability
