EVALUATION OF RISK AND POSSIBLE MITIGATION SCHEMES FOR PREVIOUSLY UNIDENTIFIED HAZARDS

William Linzey, Micah McCutchan, and Michael Traskos
Lectromechanical Design Company

Preface

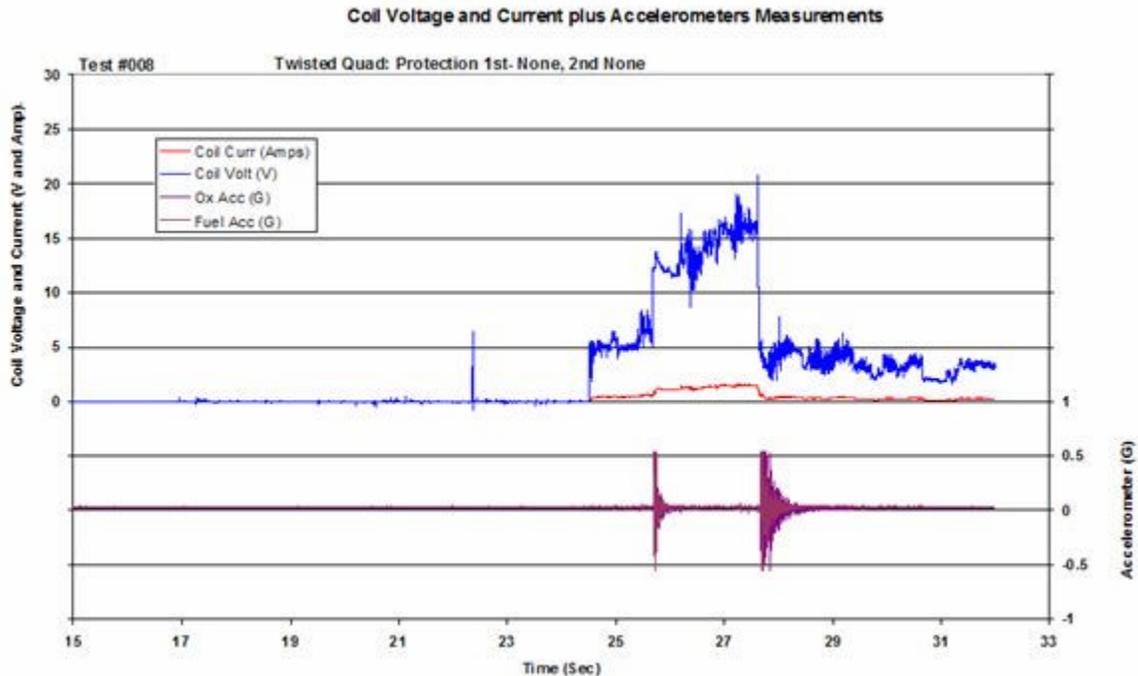
Figure 7. Coil Current and Voltage Traces along with Accelerometer Measurements for Test 008

Figure 7 shows the coil voltage and current traces along with the accelerometer reading for Test 008 in which the fuel/ox valve opened. Just before the 26 second mark, ~5 volts (blue line) was measured across the coil with an associated current, < 0.5 amps (red line), measured through the coil. This indicates that the insulation of the fuel/ox wire feeding the high side of the coil was compromised and there was arcing directly to the conductor of that wire. This arcing current returned to ground through the coil with the resistance of the coil (~11.5 ohms) limiting the current. At this voltage/current level the coil was not activated, and the valve remained closed. After ~0.5 seconds the arcing produced a higher voltage across the coil (~12 volts) and the coil activated. The valve opened as recorded by the accelerometers (violet line). Note that the second accelerometer also recorded the opening, but since the traces overlap, it cannot be seen. The voltage across the coil rose to over 15 volts and then collapsed as the fuel/ox return wires also became directly involved in the arc. It was impossible to maintain a voltage across the coil (see discussion of Figure 8 in the next paragraph). The accelerometers also recorded the closing of the valve at about 28 seconds.

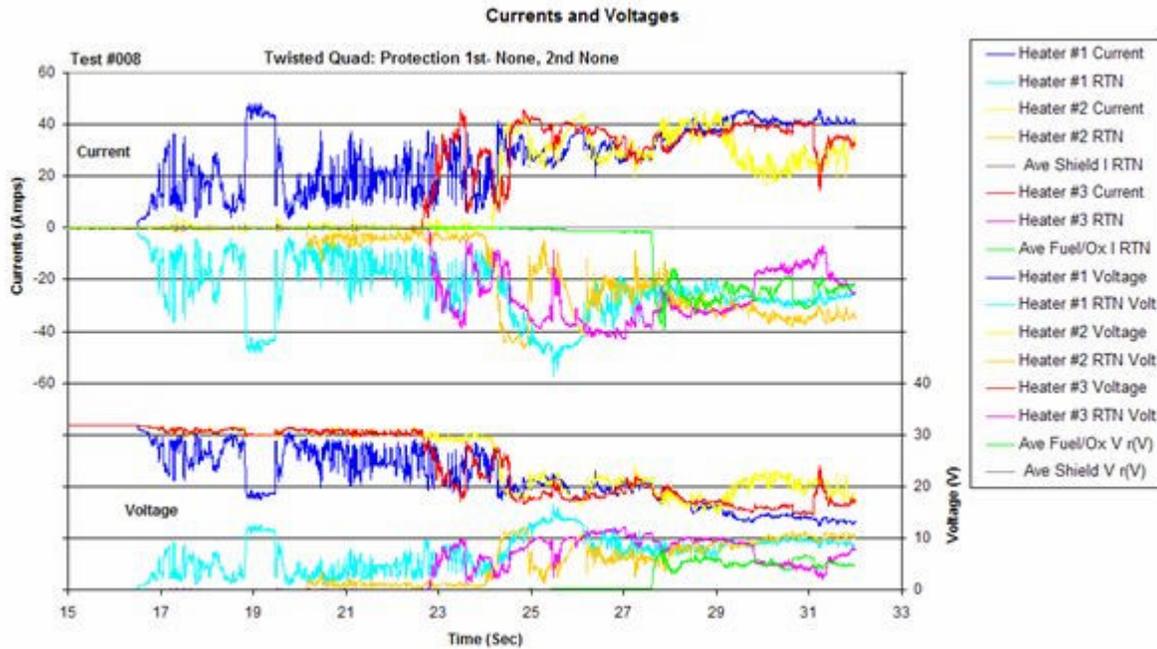
Figure 8. Current and Voltages in the Arcing Event in Test Specimen 008

Figure 8 shows the current (upper traces) and voltage (lower trace) of the arcing wires for Test 8. The darker blue line in the upper trace is the feeder current for the wire in which the arc was initiated (heater #1). The lighter blue line is the return current for heater #1, which by convention is negative. The dark blue line in the lower trace is the voltage at the point when the specimen is attached at the end of the feeder.

Figure 8 also shows the current for the first few seconds of the arc varied greatly, but that it averaged around 15 amps. At this time, the arc voltage (the difference between the dark and light blue lines in the lower traces) was ~ 20 volts. At ~19 seconds, the arc current rose to 40+ amps for 0.6 seconds as the arc propagated through the first spot-tie. Note that the arc voltage was reduced to less than 10 volts as the increased current caused a higher voltage drop in the feeders. This shows the regulatory effect of the feeder resistance because, as the arc current increases, the arc voltage is reduced. The 15 amp fuse did not open at this point because the duration of the current peak was not long enough for this to occur. At the 20-second mark, the return for heater #2 (gold line) became involved in the arc. At this point in time, the heater #1 wire arced to both the heater #1 and heater #2 returns. At about the 22.5 second mark, the heater #3 wire became involved in the arc followed a short time later by the red return. At ~24 seconds, the heater #2 wire also became involved in the event. At this time, the fuel/ox wires had not become involved in the event, but as shown in Figure 7, this changed at ~26 seconds. The activation of the coil can be seen in Figure 8 by observing the slight drip in the fuel/ox return current (green line) as the coil current is returning via the wire. The return current jumps to more than -20 amps, at just over 27 seconds, since there is arcing directly to the fuel/ox return. This causes the coil voltage to collapse and the valve to close.

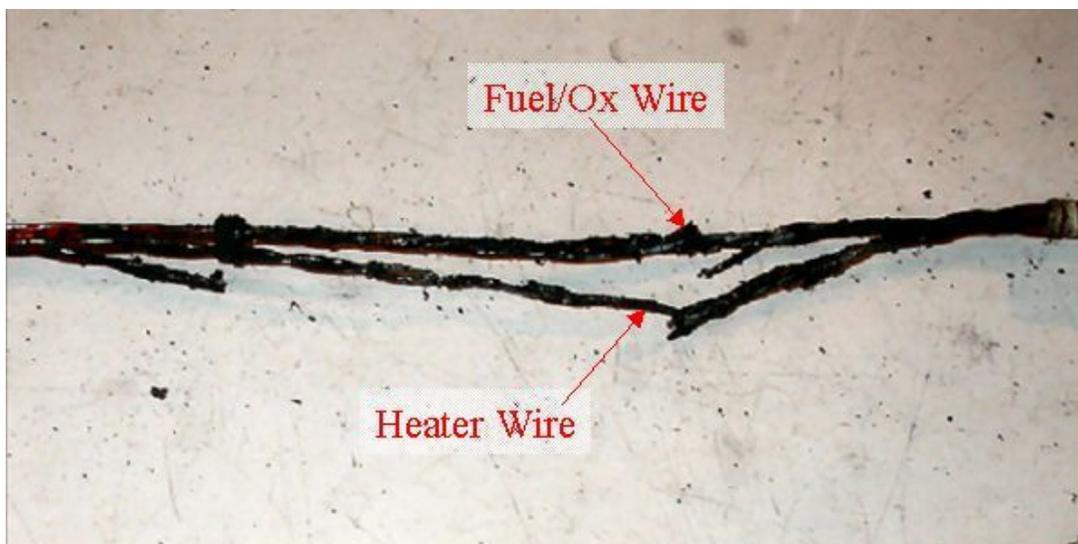
Figure 9. Post-test Photo of Test Specimen 008 (15 amp fuse)

Figure 9 is the post-test photo of Test Specimen 008 which used 15-amp fuses. The figure shows the extensive damage to both the fuel/ox wire and the heater wire. A section of several of the heater wires have been destroyed (evaporated) in the arc.

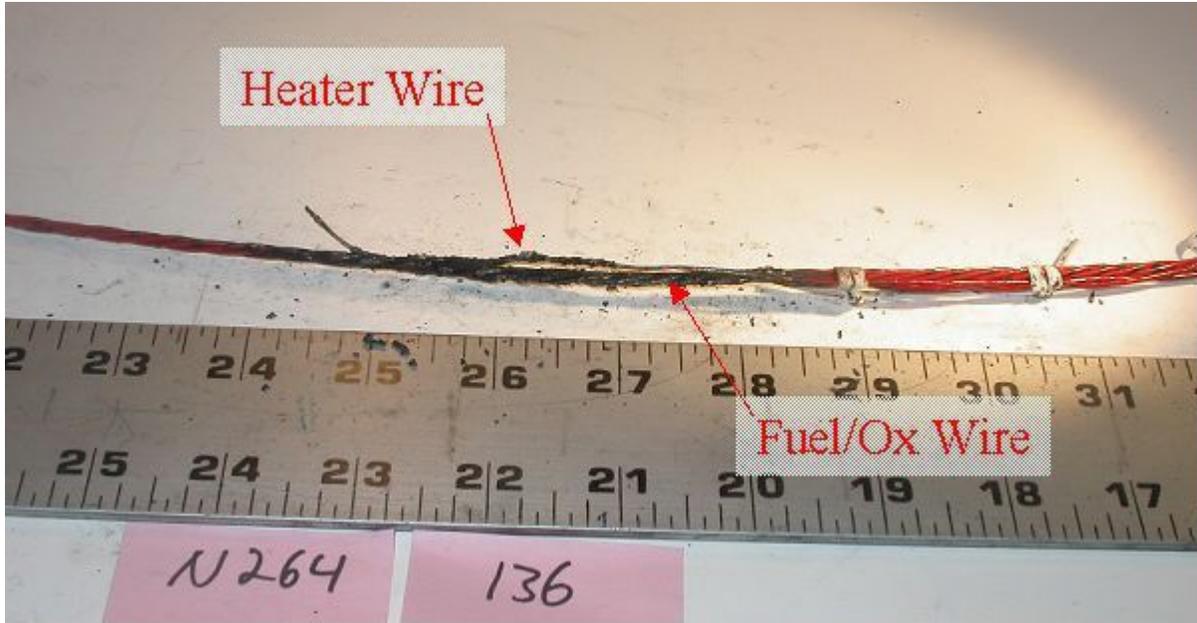
Figure 10. Post-test Photo of Test Specimen 136 (10 amp fuse)

Figure 10 shows the post-test photo from Test Specimen 136 which used 10-amp fuses. There is much less damage than in Figure 9, as the 10-amp fuse protected the test specimen. However, there still is significant damage to the fuel/ox wires.

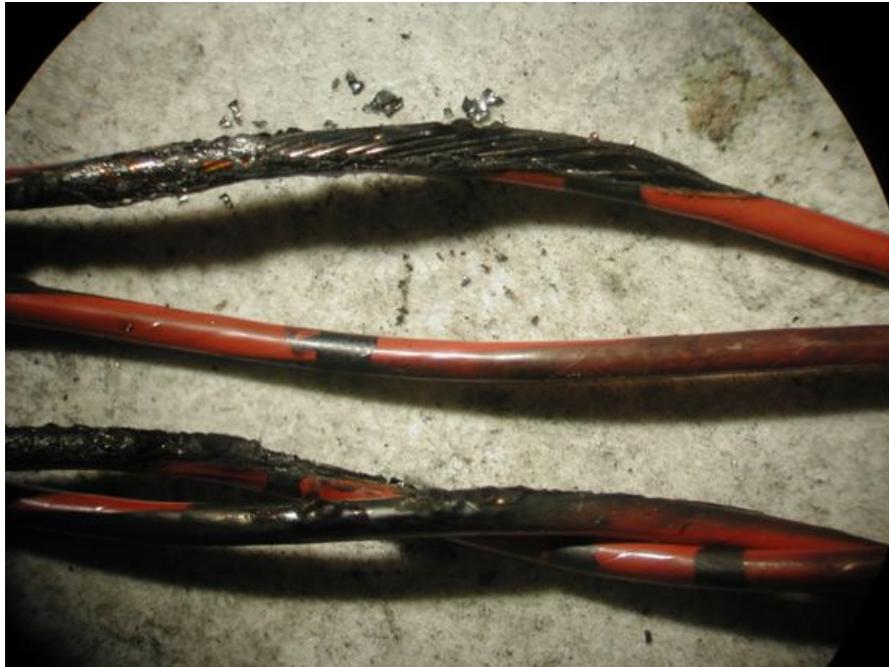
Figure 11. Photomicrograph of Damage to Fuel/Ox Wires

Figure 11 shows a photomicrograph of the damage to the fuel/ox wire of Test Specimen 004. The insulation of the upper wire has been destroyed in the arc and the conductor is exposed. This wire was connected to the high side of the coil. The lower return wires are also damaged and exhibit exposed conductors.

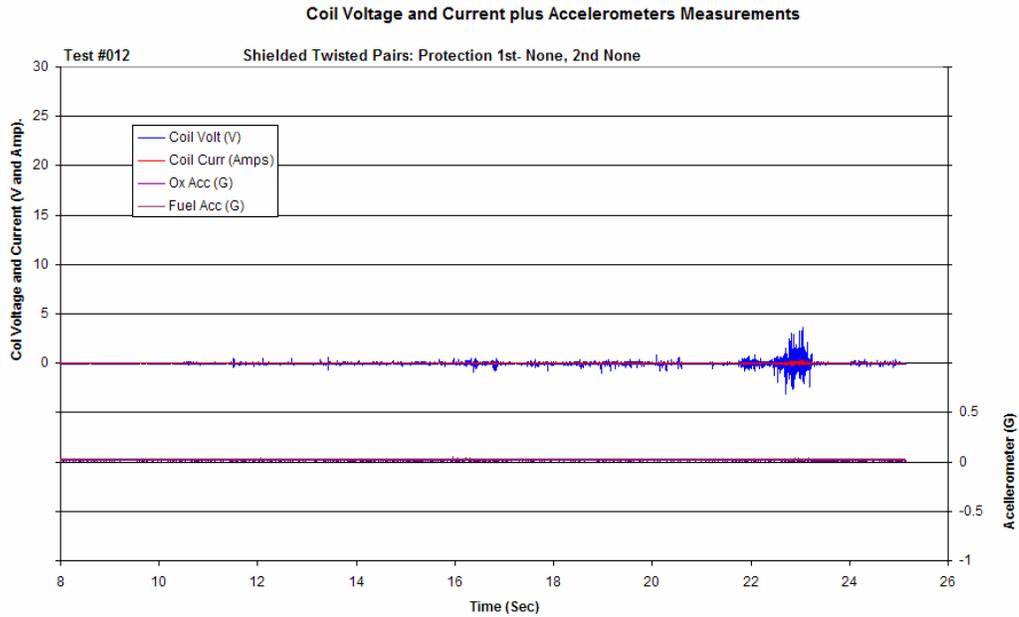
Figure 12. Voltage and Current across the Coil and Accelerometer Measurements for Test Specimen 012

Two groups (011-015 and 76-80) were placed in this category. The fuel/ox wires of the former were unprotected, shielded twisted pairs and the latter were twisted pairs (non-shielded) protected with one wrap of PTFE tape. Figure 12 shows the voltage and current across the coil for Test 012. There is no activity except oscillations of a few volts after the 22-second mark. These oscillations were most likely from electrical noise generated by the arcing event. The fuel/ox wire from Test 012 passed the wet DVW test indicating that there could not have been direct current going from the arc to the fuel/ox wire. Thus, there was only a capacitive/inductive coupled current. The sampling rate of the data logger was too low to obtain frequency information for the oscillations. There is no movement of the valve detected by the accelerometers.

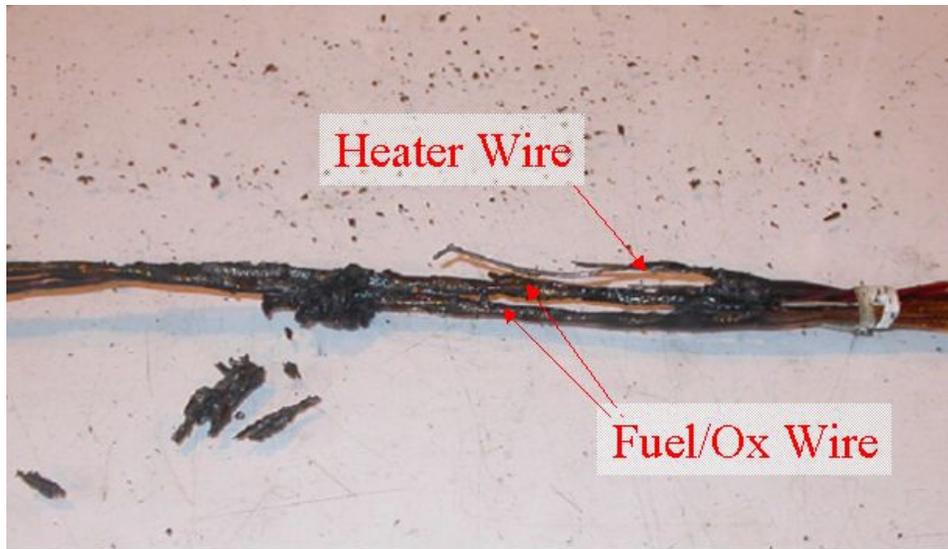
Figure 13. Post-test Photos of Test Specimen 012

Figure 13 shows the post-test photo of Test Specimen 012. There has been damage to the fuel/ox wires and the shield has been exposed in several places. Because of the heat generated by arcing to the shield, it remains possible that the fuel/ox wire inside the shield may be heat damaged. However, as long as the shield is intact, it is impossible for voltage and current to be transferred from the arc to the inner wires.

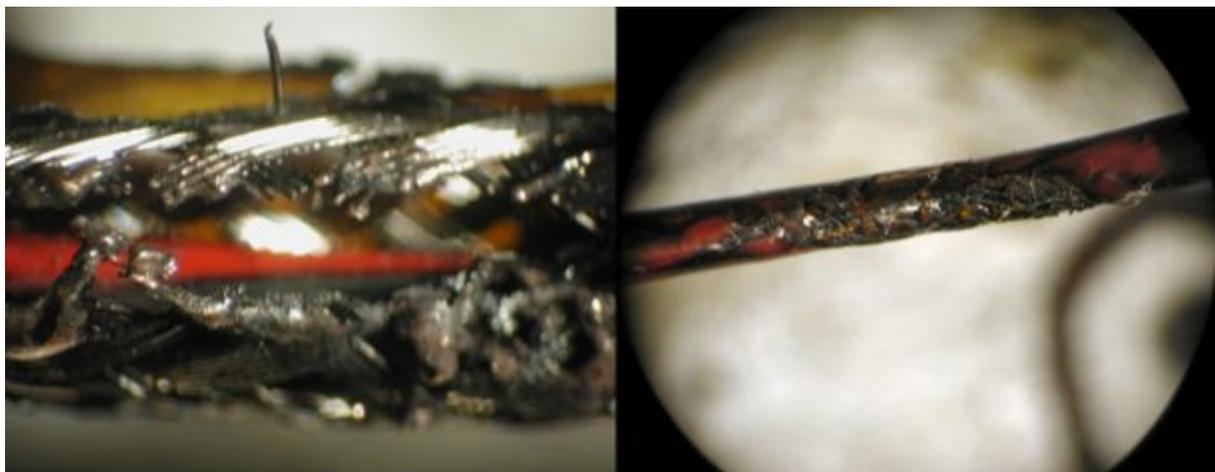
Figure 14a. Close-up of Damaged Shield (Test Specimen 011)

Figure 14a shows an example of a breach in the shield. Figure 14b shows damage to an inner fuel/ox wire at the point that it failed the wet DVW test. There is not an obvious breach exposing the conductor, but the insulation had been damage such that it could not prevent current conduction.

14b. Photomicrograph of the Fuel/Ox Wire at the spot that it failed the wet DWV (Test Specimen 011)

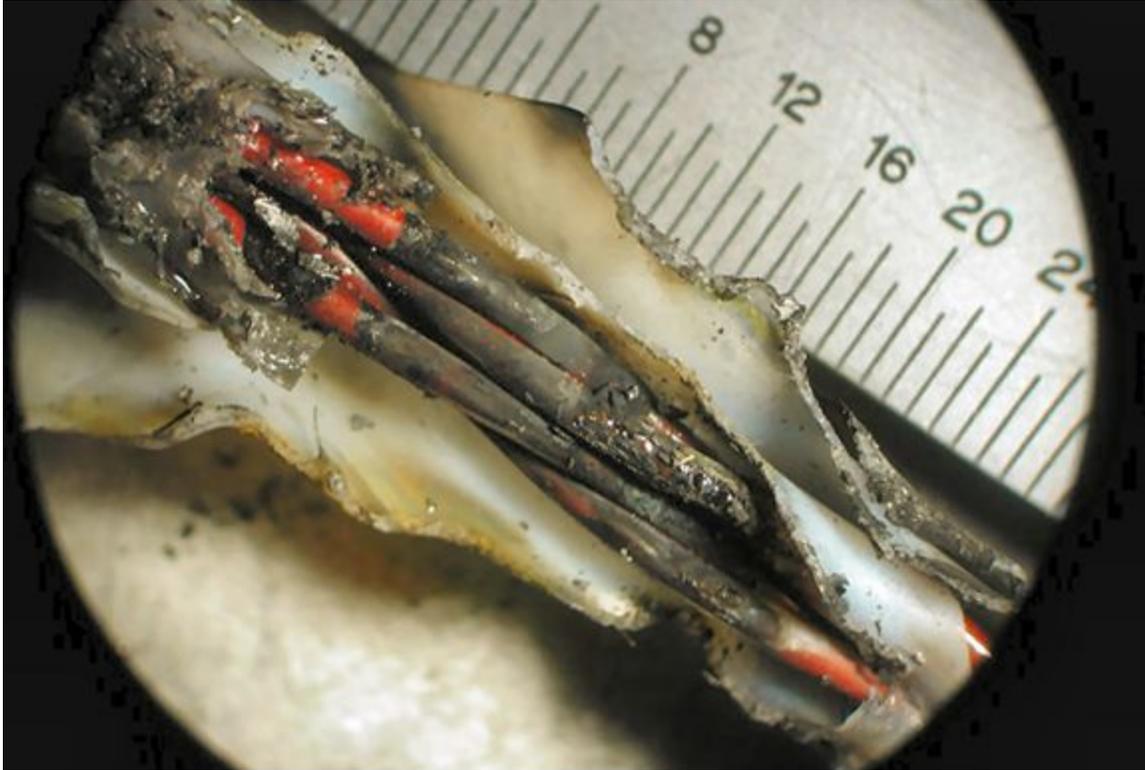
Figure 15. Post-test Photomicrograph of Fuel/Ox Wire Test Specimen 076

Figure 15 is a photomicrograph of Test Specimen 076. This was the worst-case damage to the fuel/ox wire of any of the protected specimens. Despite the damage, this wire passed the post-test wet DVW as there was still sufficient wire insulation remaining. There was no voltage or current measured across the coil of this specimen and no valve movement detected by the accelerometers.
