Friction-Stir Welding – Heavy Inclusions in Bi-metallic welds of Al 2219/2195

Ward W. Rietz, Jr., Lockheed Martin Michoud Space Systems
Department 4610, P.O. Box 29304, New Orleans, LA USA 70189
Phone: (504) 257-1636 Fax: (504) 257-4430 e-mail: ward.w.rietz@maf.nasa.gov

Heavy Inclusions (HI) were detected for the first time by radiographic examination in aluminum alloy 2219forging/2195plate (advancing/retreating side) Friction Stir Welds (FSW) for the Space Shuttle External Tank (ET) Program. Radiographic HI indications appear as either small (~0.005” – 0.025”) individual particles or clusters of small particles.

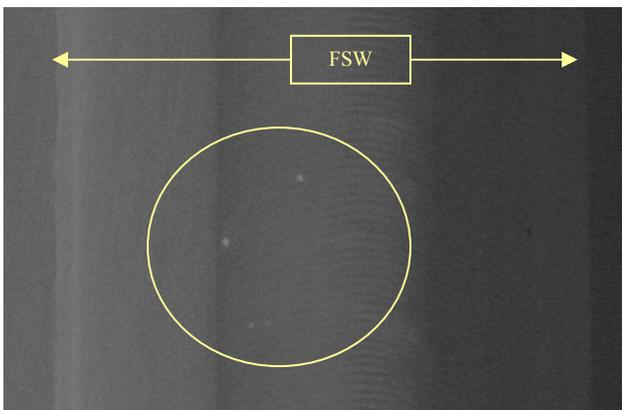
Friction stir welding is performed on longitudinal barrel welds on the ET. Two of those welds are bimetallic welds of Al2219 forging and Al2195 plate with the Al2219 on the advancing side and the Al2195 on the retreating side (2219f/2195p). A Retractable Pin Tool (RPT) is used due to tapering thickness of the weld joint. After barrels are welded, they are inspected by multiple NDE techniques, including radiographic inspection. Radiographic inspection of the Al2219f/2195p FSW has shown scattered HI indications in the thinner gauge sections in some production welds. These HI indications appear bright (higher in density) in the film and typically appear dispersed across the weld in small clusters as shown in Figure 3.

Figure 3: X-Ray film of 99HI-SST prior to machining – digitally enhanced

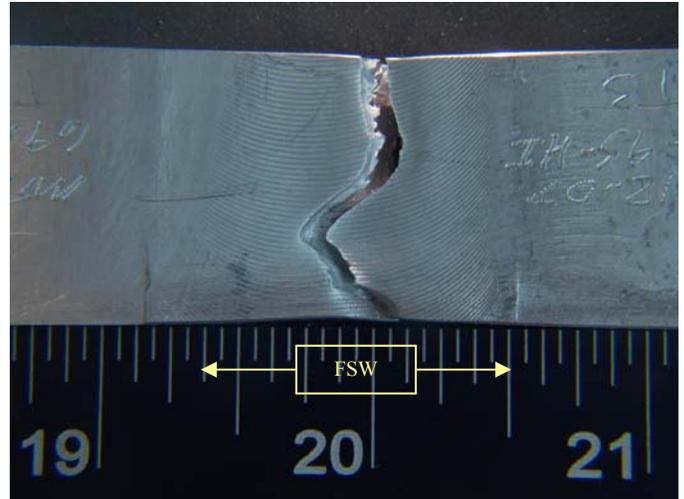
Specimen 95HI was chosen to be examined in the SEM to see if the HI was involved in the fracture path due to its fracture through the weld as shown in Figure 5. Typically aluminum alloy FSW's fracture in the Heat Affected Zone (HAZ) as in Figure 6.

Figure 5: 95HI Crown Side View Post Fracture – weld fracture

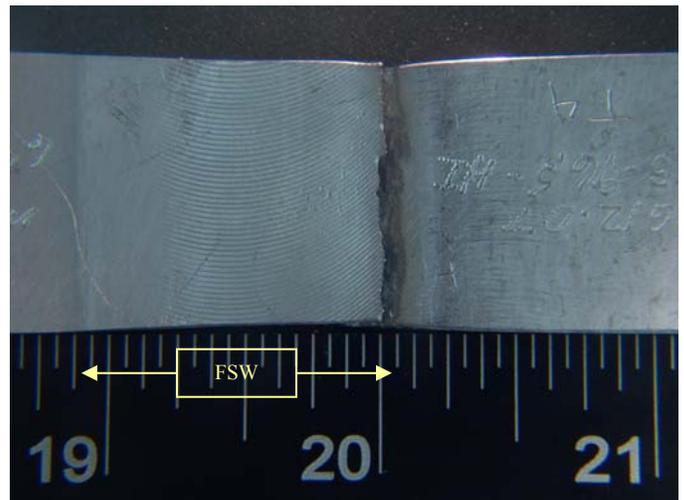
Figure 6: 95.5HI Crown Side View Post Fracture – HAZ fracture

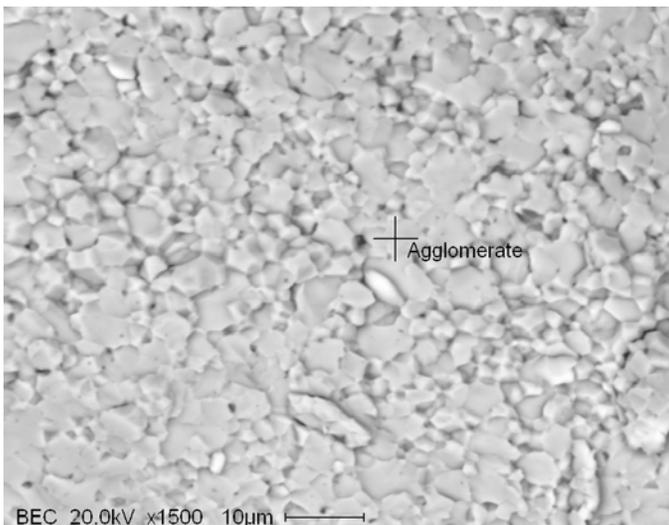
Backscattered Electron (BSE) SEM examination of the fracture surfaces of 95HI showed several regions of higher density agglomerated material that followed the FSW flow pattern as shown in Figures 7-9. EDS analysis (Figure 10) identified the agglomerated material as Al_2Cu (θ phase). However, these regions do not correspond with the radiographic indications. The larger radiographic HI (agglomerated θ phase) were not involved in the fracture. What was observed in the SEM is agglomerated θ phase that is undetectable by radiographic inspection due to its size.

Figure 9: BSE SEM image of 95HI at 1500x original magnification

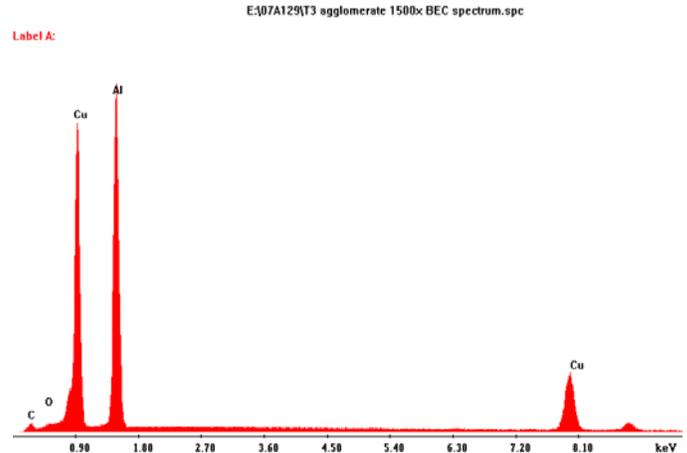
Figure 10: EDS Spectra of 95HI agglomerate (Figure 9)

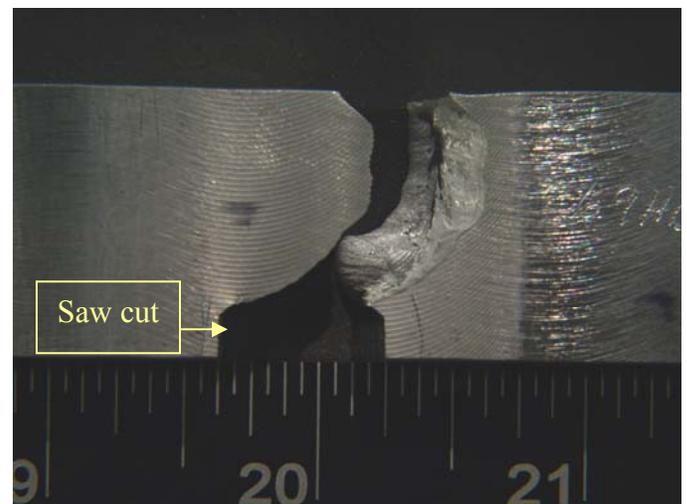
RT specimen 125.5, which had no radiographically detectable HI was machined to force a fracture through the FSW in order to use as a control for the SEM examination (Figure 11). This specimen also showed streaks of agglomerated θ phase, but to a much lesser extent as shown in Figures 12 & 13. EDS spectra were similar to those in Figure 10. Thus, a dispersion of agglomerated θ phase may be normally present throughout bimetallic FSW using Al2219 forging on the advancing side.

Figure 11: 125.5 Crown Side View Post Fracture

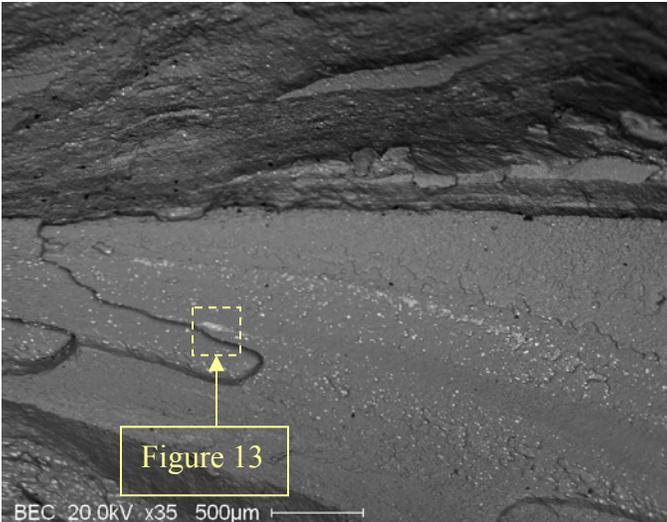
Figure 12: BSE SEM image of 125.5 at 35x original magnification

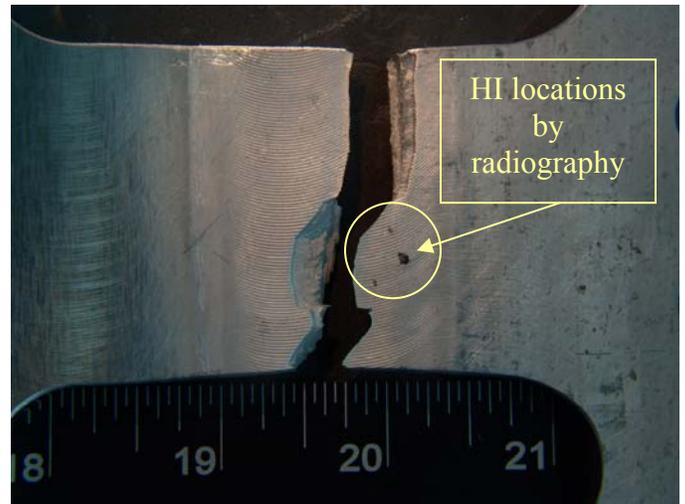
Figure 14: 99HI-SST Crown Side View Post Fracture

Simulated Service Test (SST) residual strength results were in family to typical Al2219f/2195p FSW cryogenic (-423F) results. SEM/EDS examination showed that one region of agglomerated θ phase on the fracture face correlated to the radiographically detected HI as seen in Figures 14-17.

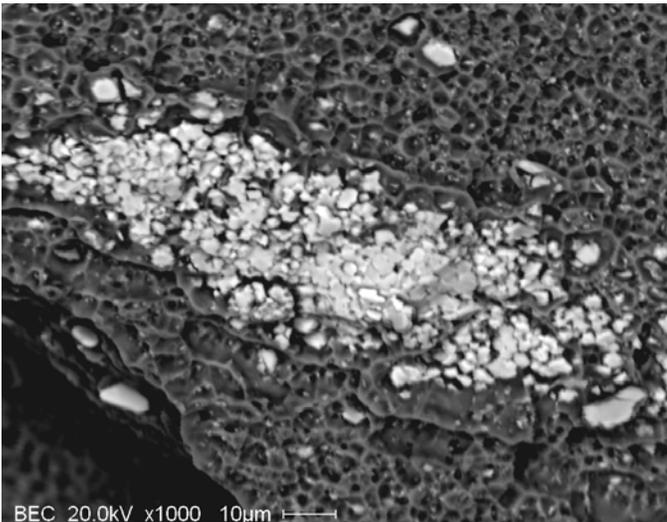
Figure 13: BSE SEM image of tensile 125.5 at 1000x original magnification

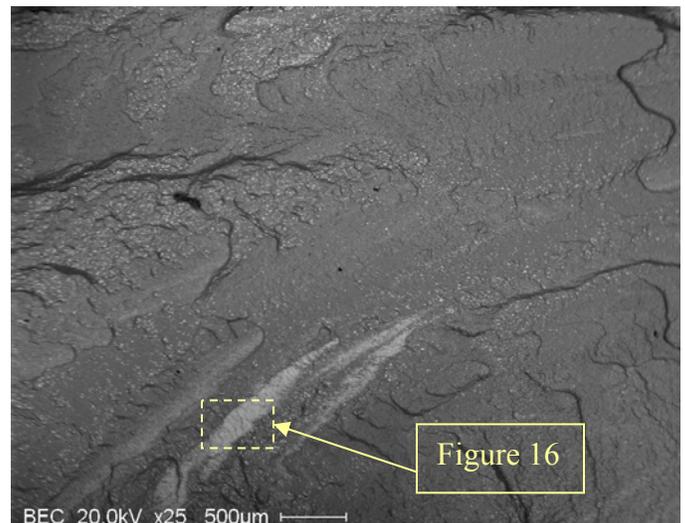
Figure 15: BSE SEM image of 99HI-SST at 25x original magnification

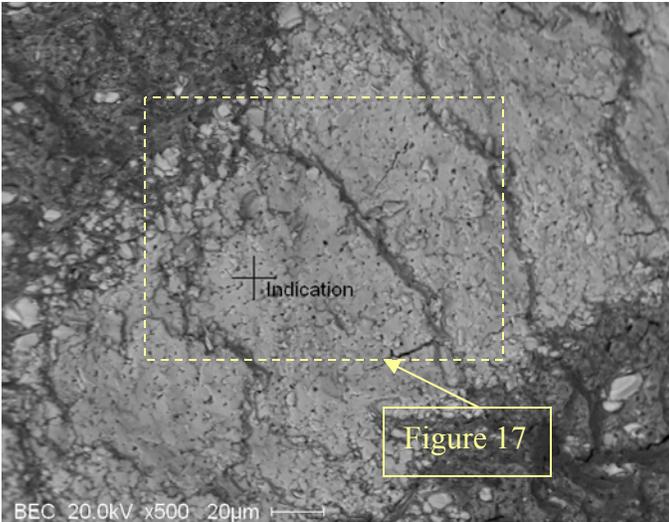
Figure 16: BSE SEM image of 99HI-SST at 500x original magnification

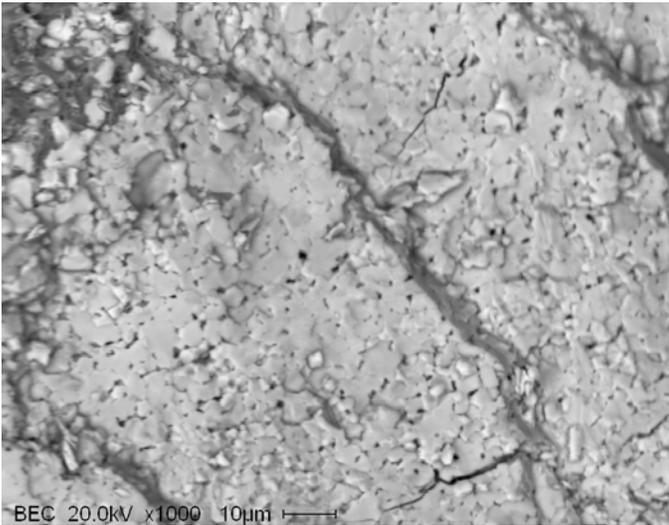
Figure 17: BSE SEM image of 99HI-SST at 1000x original magnification

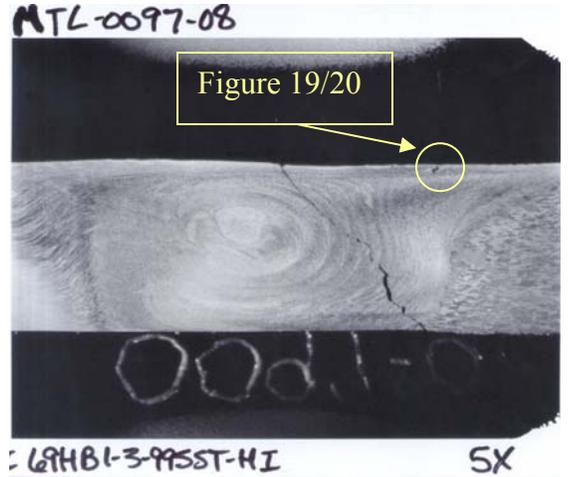
Metallurgical examination revealed that other radiographically detected HI were not involved in the fracture, but created a secondary surface crack as shown in Figures 18-20. Since no post proof or post-cycle indications were noted by penetrant, the surface crack likely initiated at stresses close to ultimate fracture of the FSW.

Figure 18: Macro cross section of 99HI-SST post fracture – Keller’s etch 5x

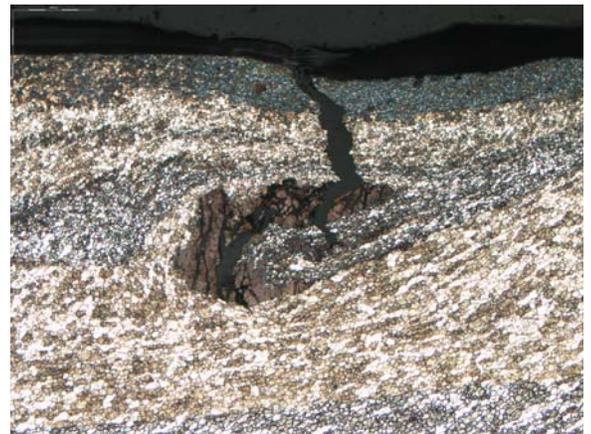
Figure 19: cross section of 99HI-SST post fracture showing HI near crown surface – Scale is 0.005” – Keller’s Etch 100x

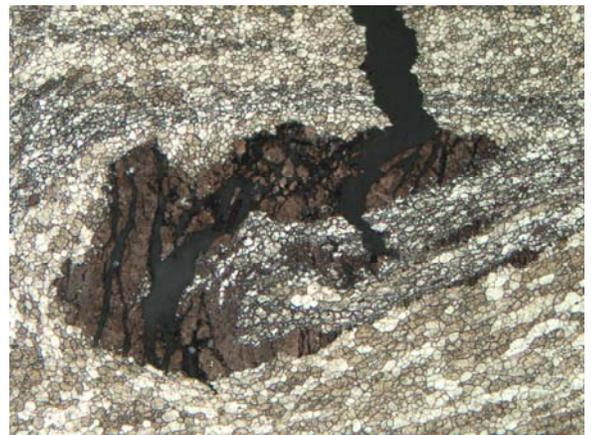
Figure 20: cross section of 99HI-SST post fracture showing HI near crown surface – scale is 0.002” - Keller’s Etch 200x

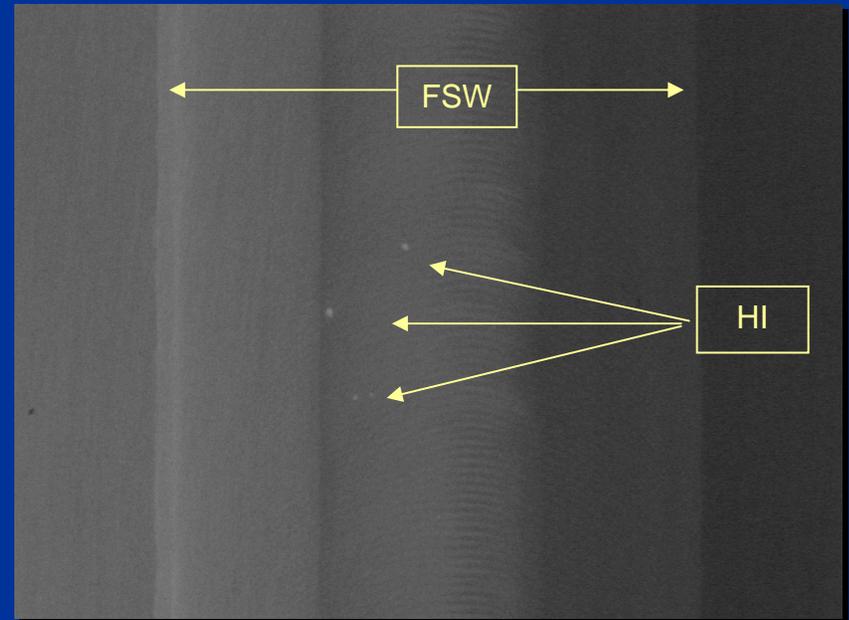
- **PROBLEM:** scattered heavy inclusions (~0.005" – 0.025") were detected in our first production 2219f/2195p welds by X-Ray
- HI are rejectable in FSW on the ET program
- HI were not pin tool / foreign debris
- Never detected HI on 2219plate/2195plate FSW development work

Digitized X-ray Film showing HI

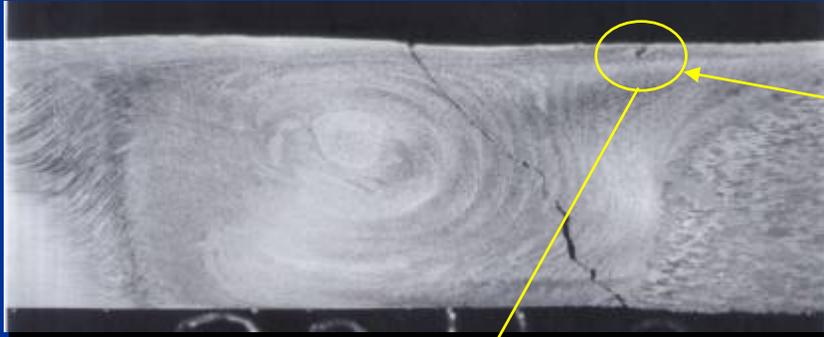
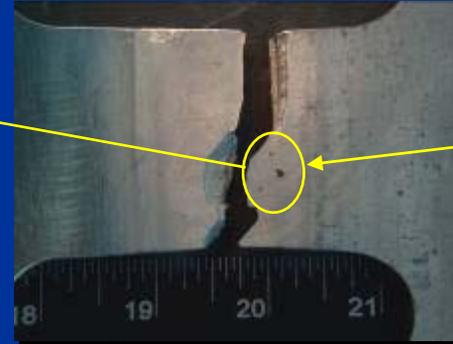
X-Ray HI's

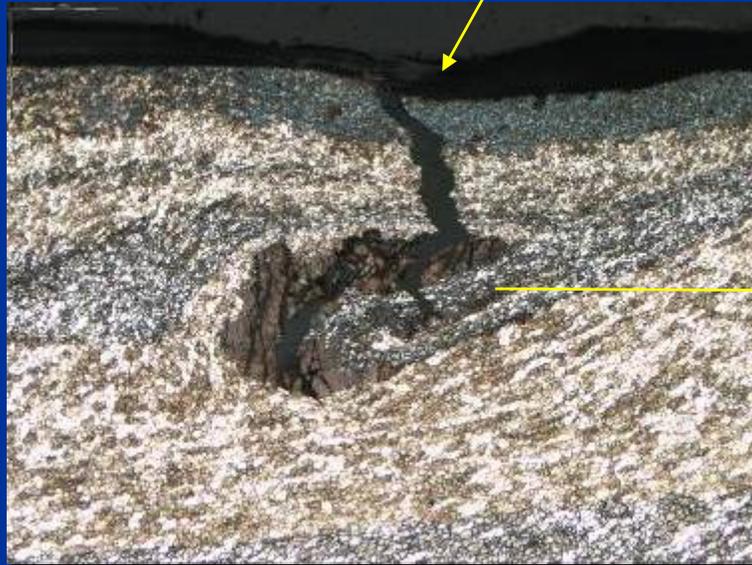
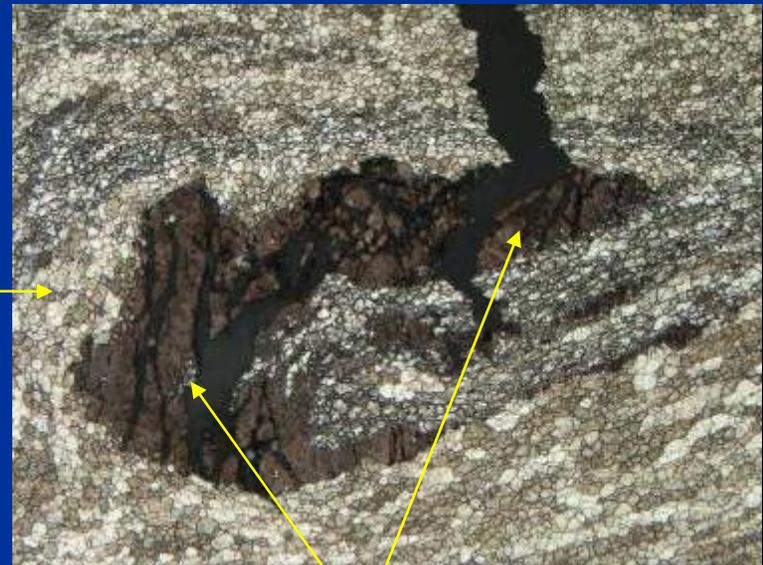
Agglomerated θ phase

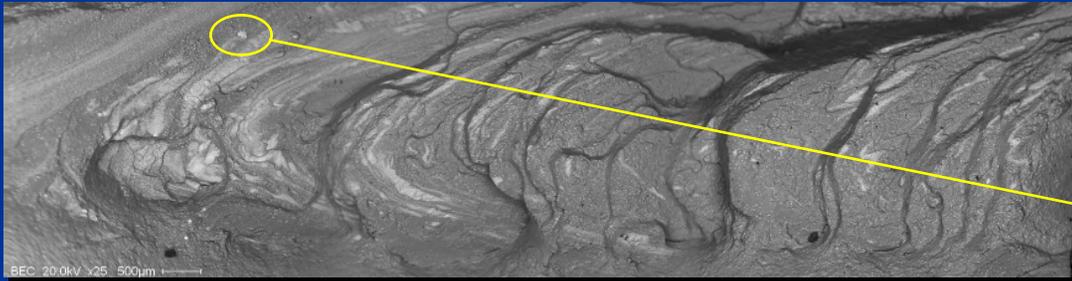
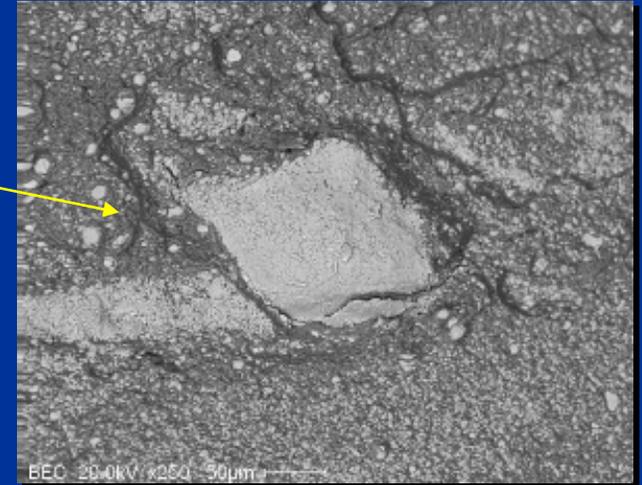
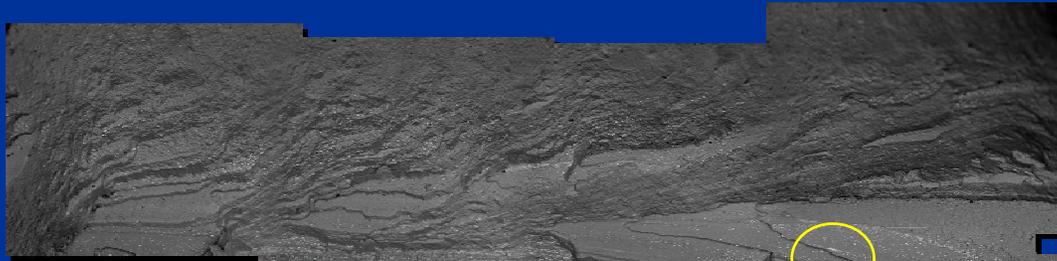
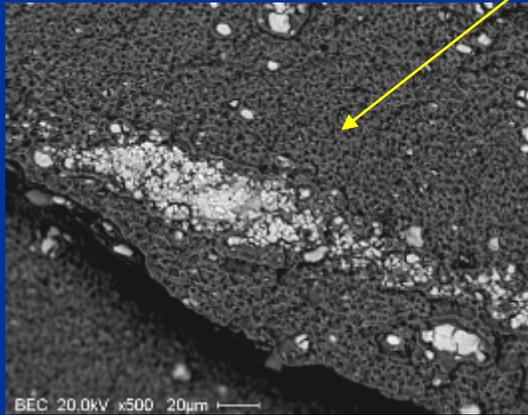
• Agglomerated θ phase (to a lesser extent) in fracture surface with no corresponding X-ray indication!
