NASA/TM-2008-215531

Failure Analysis of Electrical Pin Connectors

A failure investigation was initiated to determine the cause of circuit board failure that occurred during vibration qualification testing for the Mars Science Laboratory Entry Descent and Landing Instrumentation (MEDLI) project. MEDLI is an instrumentation suite installed within the heat shield of the Mars Science Laboratory (MSL) Entry Vehicle. The vehicle was designed to collect data about the Martian atmosphere, Thermal Protection System (TPS) performance, and aerodynamic characteristics of the MSL Entry Vehicle during entry and descent, to provide engineering design data for future Mars missions.

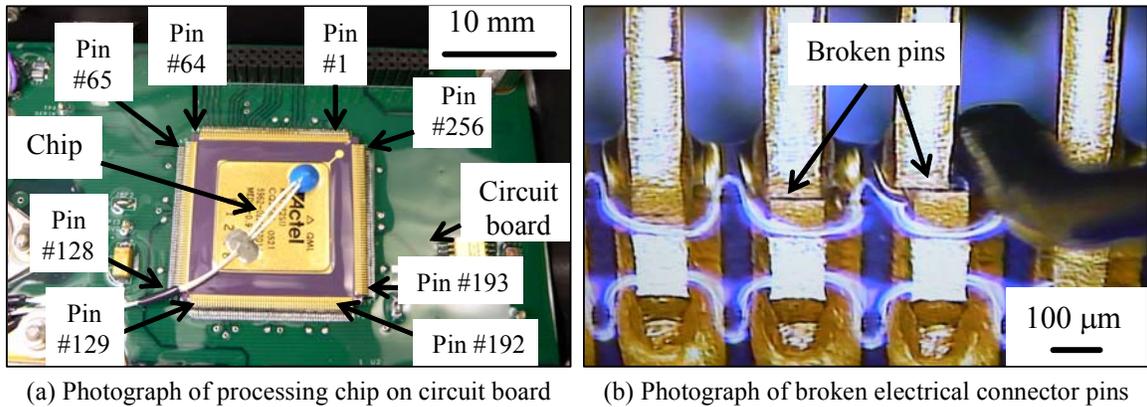
A total of five failed connector pins were analyzed that were selected for analysis due to slight macroscopic differences in the appearance of the pins (some were more severely deformed than others) and to analyze pins at different circuit board locations. The cross-section of these pins was nearly square with sides approximately 100 μm long. The pins consisted of Kovar cores that were coated twice, first with pure nickel, followed by an outer layer of gold. These pins were examined at high magnification in a scanning electron microscope (SEM), and chemical composition of selected failure surface features were determined using Energy-Dispersive X-ray spectroscopy (EDX).

Figure 1. Photographs of failed electrical connector pins.

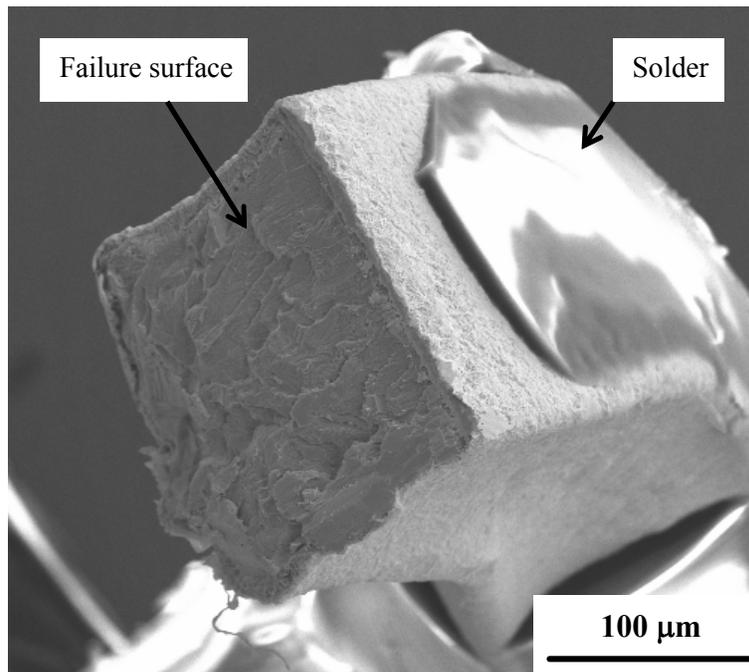
SEM examination revealed that all failure surfaces had very similar microstructural features despite any macroscopic differences observed. A typical SEM image of a pin failure surface (in this case, corresponding to Pin #130) is shown as Figure 2. Here, the pin is shown at an angle of approximately 45° to the failure surface to allow the sides of the pin, and the solder used to connect the pins, to be seen. The lack of obvious ductility (such as, reduction in area at failure) suggests that failure was due to a brittle mechanism such as fatigue crack growth. Detailed examinations of five pin failure surfaces (Pins #63, #64, #129, #130, and #131) have been conducted and results are presented in the following sections.

Figure 2. SEM micrograph of typical electrical pin failure surface (Pin #130).

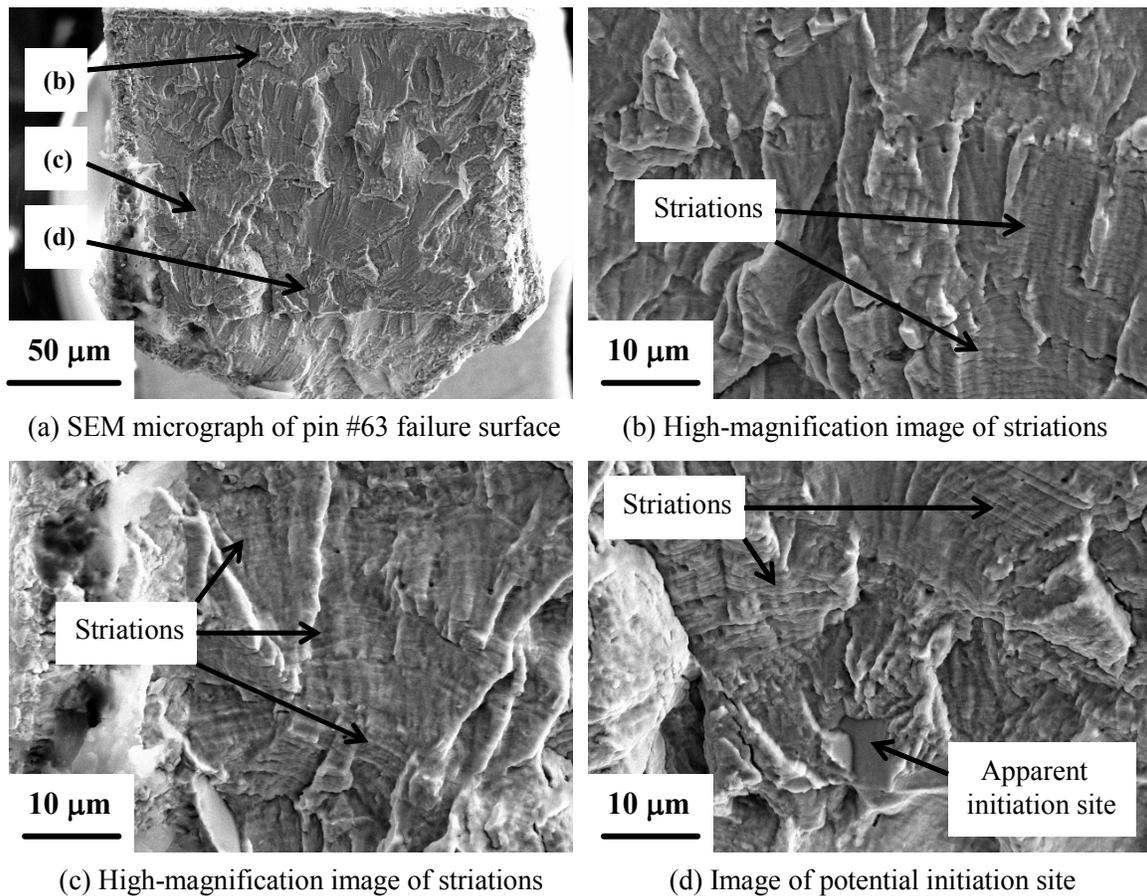
SEM images of the failure surface for Pin #63 are shown in Figure 3. The entire failure surface is shown at relatively low magnification in Figure 3a, along with locations (b, c, d) of regions examined at higher magnification and supplied in Figures 3b, 3c, and 3d, respectively. Fatigue striations are observed in Figures 3b and 3c and are compelling evidence that crack propagation was driven by fatigue loading. By tracing these fatigue striations, which are indications of the crack front location at a given moment in time, back to a starter location, the apparent crack initiation location can be determined. For the failure surface of Pin #63, the apparent crack initiation location is shown in Figure 3d. Here, the apparent crack initiation site appears to have a smooth and faceted morphology relative to the surrounding crack surface.

Figure 3. SEM images of the failure surface for Pin #63.

The difference in crack surface morphology of the apparent crack initiation sites, compared with the surrounding crack surfaces, suggested that a different damage mechanism may have occurred in these regions. The crack initiation sites identified for Pins #63 and #130 were chemically analyzed using Energy Dispersive X-ray (EDX). The results of this chemical analysis are presented in Table 1, along with the nominal composition of Kovar for comparison (ref. 1). Of the main alloying element of Kovar (iron, nickel, and cobalt), these crack initiation sites had very low nickel content relative to the nominal composition of Kovar. The nominal composition of Kovar presented in Table 1 is for the gamma (γ) phase of this alloy, an FCC condition that is widely used in the electronics industry (ref. 1). However, an

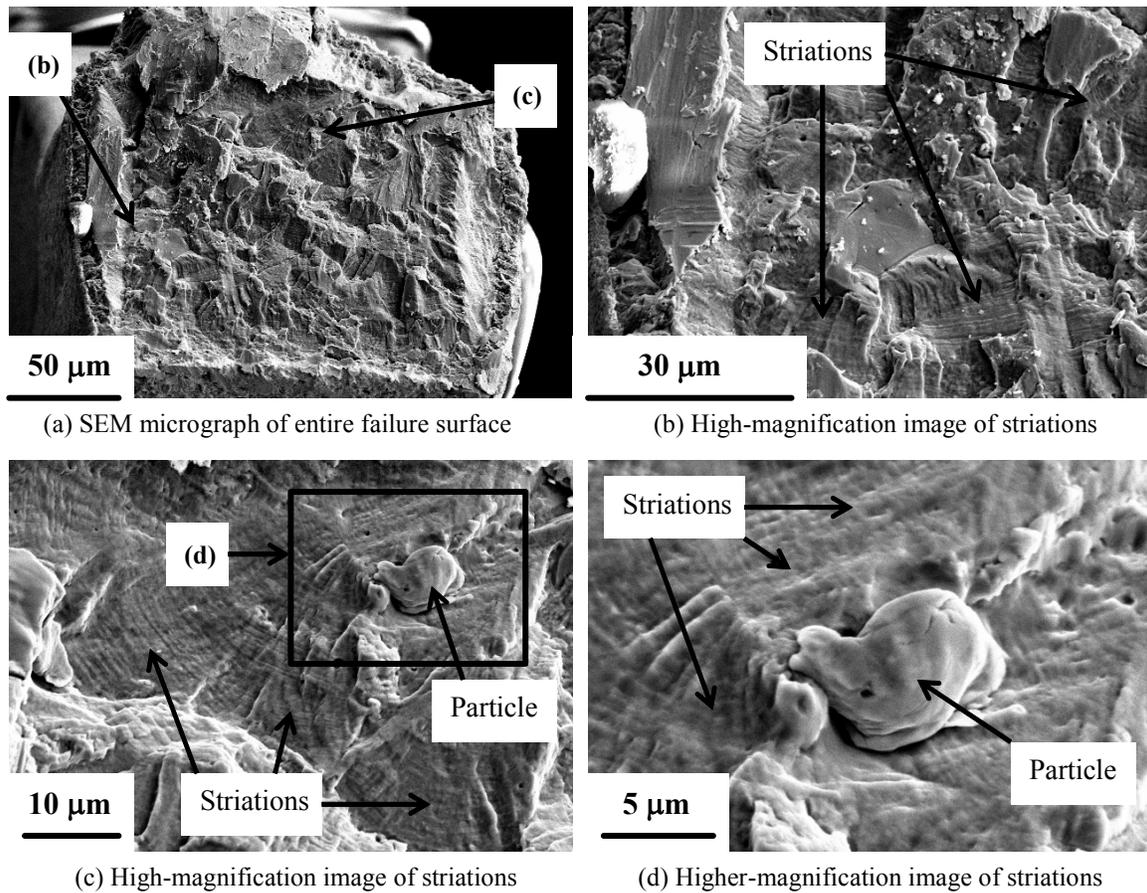
SEM images of the failure surface for Pin #64 are shown in Figure 4. The entire failure surface is shown at relatively low magnification in Figure 4a. Locations shown at higher magnification in Figures 4b and 4c are indicated (shown in Figure 4a as locations (b) and (c), respectively). Fatigue striations are observed in Figures 4b and 4c and are compelling evidence that crack propagation was driven by fatigue loading. An interesting feature observed in Figure 4c (indicated as location (d)) is shown at higher magnification in Figure 4d. This feature appears to be a particle, but the crack surface features do not suggest that this is a crack initiation site. No obvious crack initiation site was found on this crack surface.

Figure 4. SEM images of the failure surface for Pin #64.

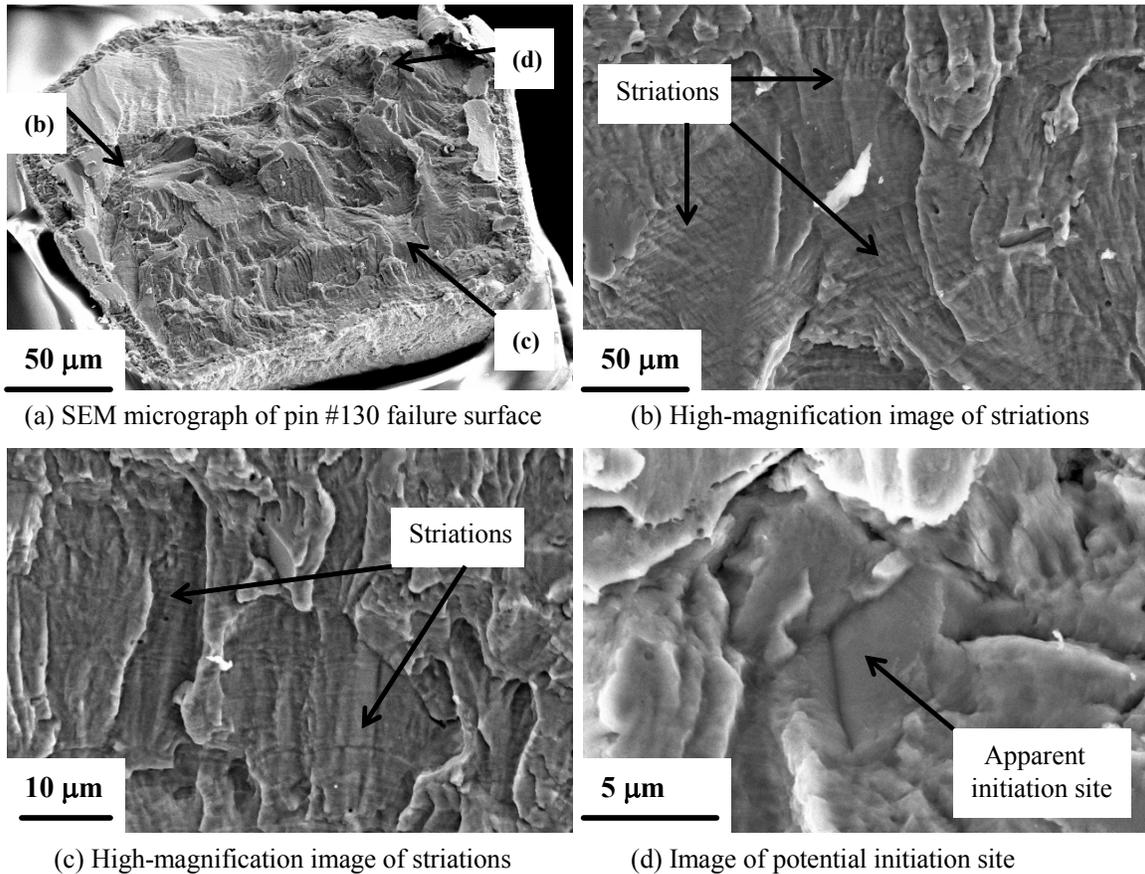
SEM images of the failure surface for Pin #129 are shown in Figure 5. The entire failure surface is shown at relatively low magnification in Figure 5a. Locations indicated in Figure 5a as (b), (c), and (d) are shown at higher magnification in Figures 5b, 5c, and 5d, respectively. Fatigue striations are observed in Figures 5b and 5c and are compelling evidence that crack propagation was driven by fatigue loading. These crack surface features can be used to determine the apparent crack initiation region, which is shown in Figure 5d. Similar to the findings for Pin #63, the apparent crack initiation site appears to have a smooth and faceted morphology relative to the surrounding crack surface.

Figure 5. SEM images of the failure surface for Pin #129.

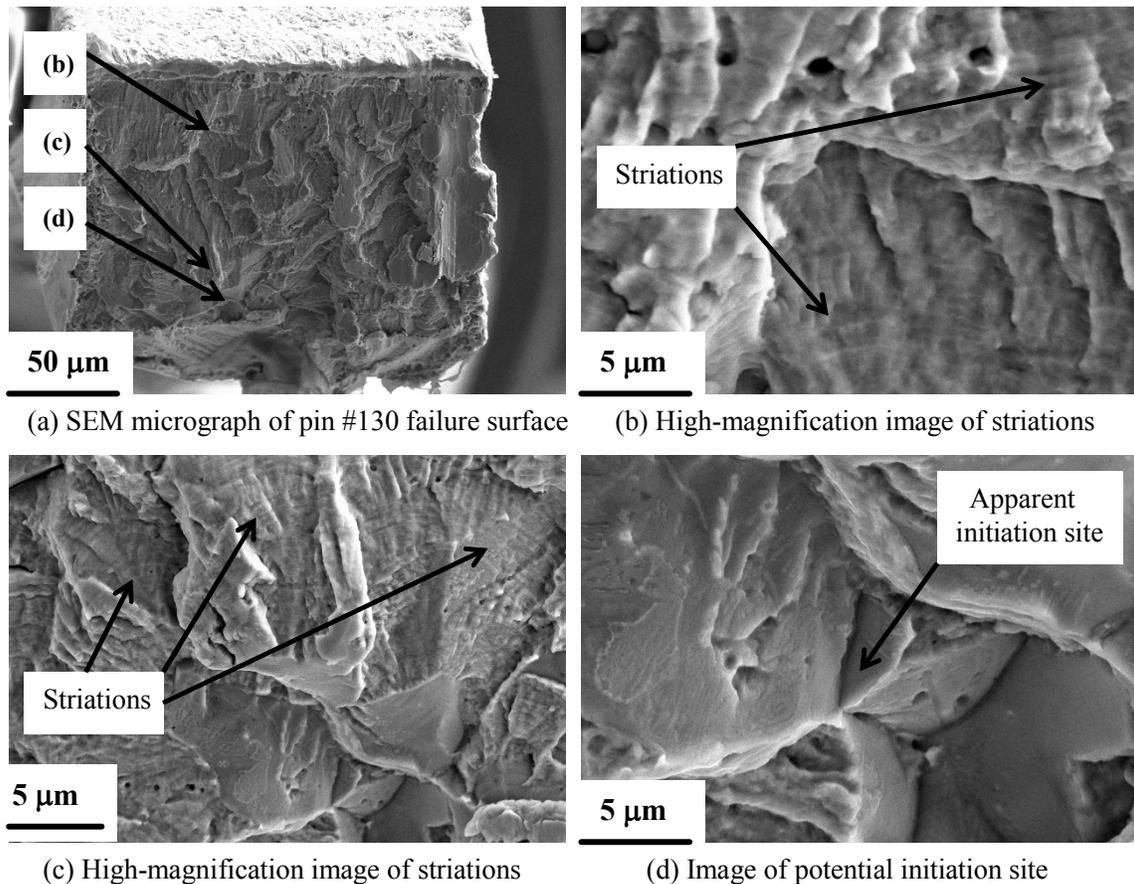
SEM images of the failure surface for Pin #130 are shown in Figure 6. The entire failure surface is shown at relatively low magnification in Figure 6a. Locations indicated in Figure 6a as (b), (c), and (d) are shown at higher magnification in Figures 6b, 6c, and 6d, respectively. Fatigue striations are observed in Figures 6b and 6c and are compelling evidence that crack propagation was driven by fatigue loading. These crack surface features can be used to determine the apparent crack initiation region, which is shown in Figure 6d. Similar to the findings for Pins #63 and #129, the apparent crack initiation site appears to have a smooth and faceted morphology relative to the surrounding crack surface.

Figure 6. SEM images of the failure surface for Pin #130.

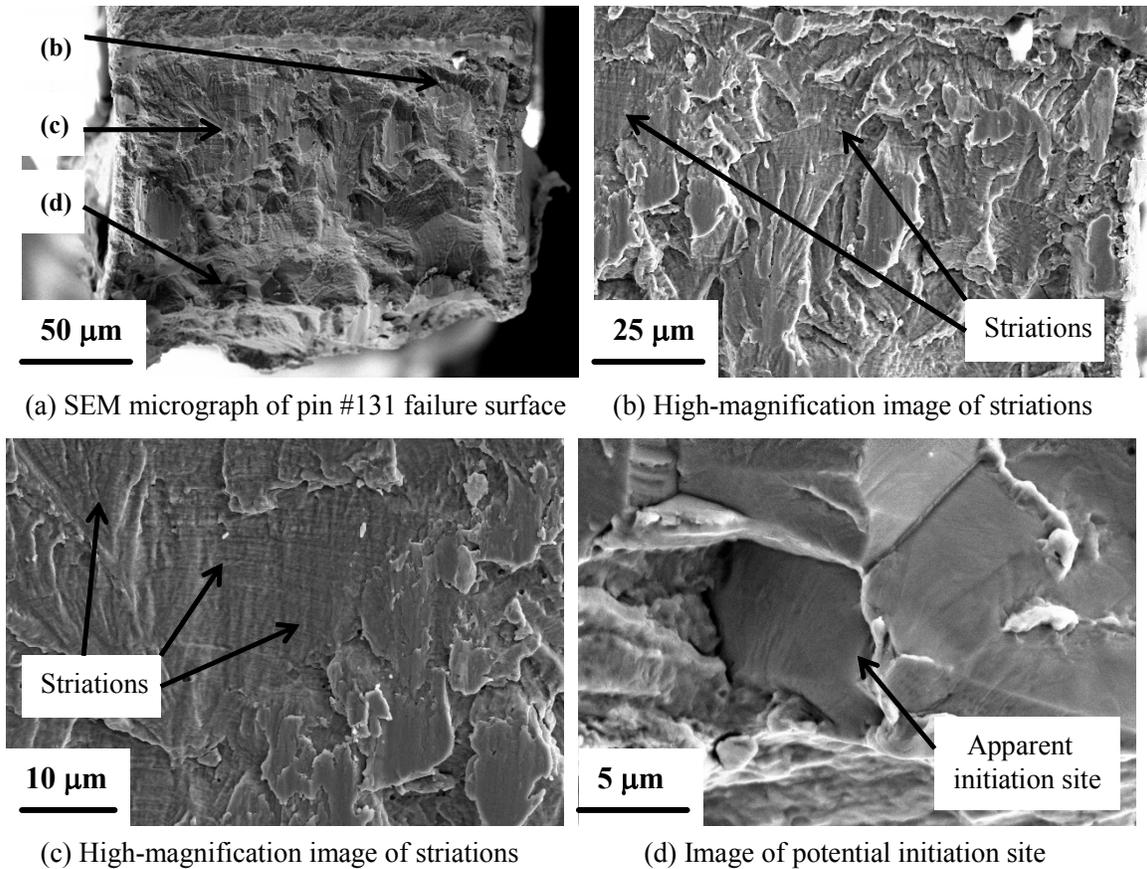
SEM images of the failure surface for Pin #131 are shown in Figure 7. The entire failure surface is shown at relatively low magnification in Figure 7a. Locations indicated in Figure 7a as (b), (c), and (d) are shown at higher magnification in Figures 7b, 7c, and 7d, respectively. Fatigue striations are observed in Figures 7b and 7c and are compelling evidence that crack propagation was driven by fatigue loading. These crack surface features can be used to determine the crack initiation region, which is shown in Figure 7d. Similar to the findings for Pins #63, #129, and #130, the apparent crack initiation site appears to have a smooth and faceted morphology relative to the surrounding crack surface.

Figure 7. SEM images of the failure surface for Pin #131.
