NASA/TM-2008-215530

# Fracture Testing of Integral Stiffened Structure

*Laboratory testing was conducted to evaluate safety concerns for integrally-stiffened tanks that were found to have developed cracks during pressurization testing. Cracks occurred at fastener holes where additional stiffeners were attached to the integrally-stiffened tank structure. Tests were conducted to obtain material properties and to reproduce the crack morphologies that were observed in service to help determine if the tanks are safe for operation. Reproducing the cracking modes observed during pressurization testing required a complex loading state involving both a tensile load in the integrally-stiffened structure and a pin-load at a fastener hole.*

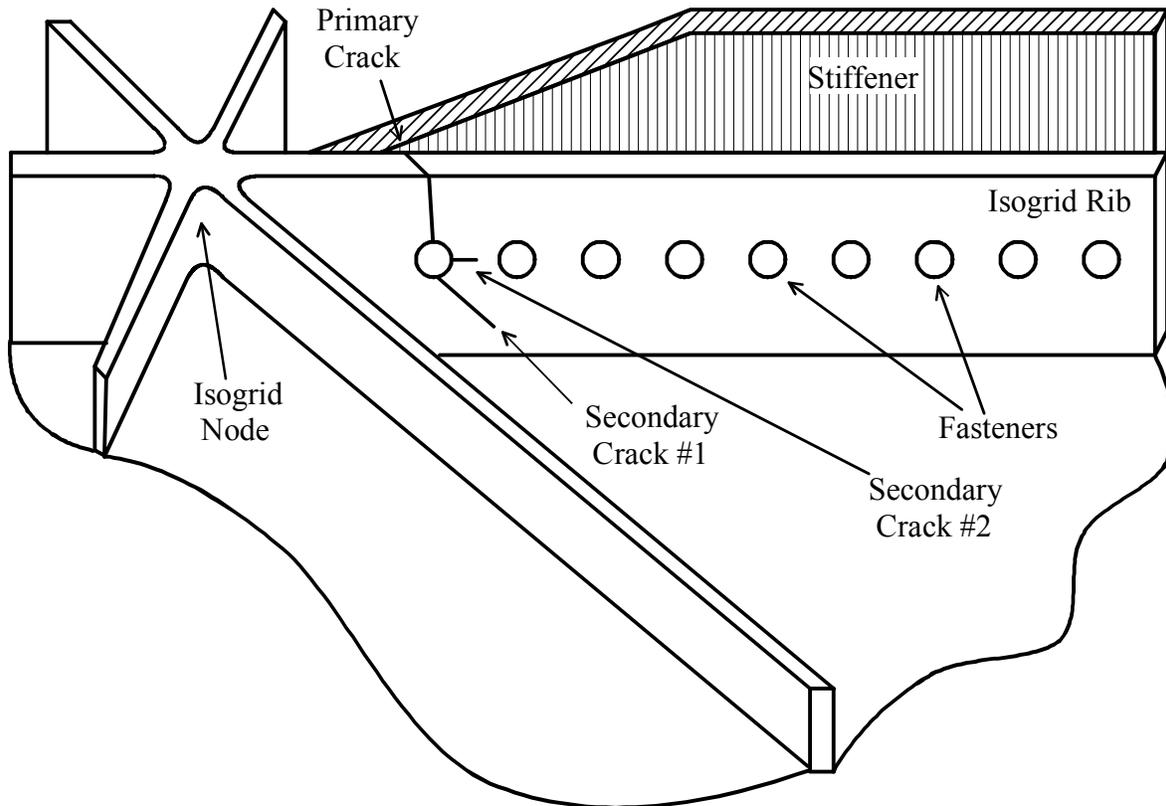
All of the cracks found emanated from the fastener hole at the end of the stiffener and cracked through the rib thickness, propagating towards the center of the tank. (See Figure 1.) (Note that the exterior surfaces of these fuel tanks are smooth and the isogrid ribs are contained within the tanks.) Generally, these cracks were normal (perpendicular) to the tank wall (labeled as primary crack in Figure 1). Some of these end holes also contained cracks that propagated towards the outer skin of the tank; however, these cracks grew at an angle of approximately  $18^\circ$  to the tank (labeled as secondary crack #1 in Figure 1). Cracks running parallel to the tank wall emanating from the end fastener hole (nearest isogrid node) toward the next fastener hole were also observed in some tanks (See secondary crack #2 in Figure 1). Considering that all holes contained cracks growing towards the inside of the tank, it was believed that this cracking mode occurred first and, thus, these cracks were called “primary” cracks. Cracks growing towards the outer skin or from fastener hole to fastener hole of the tank were called “secondary” cracks. Although primary cracks are damaging and alter the local loading at the stiffener end, these cracks were considered to be less threatening than secondary cracks because they will not result in a breach of the outer tank skin, thereby, producing a leak.

Figure 1. Configuration of primary and secondary cracks.

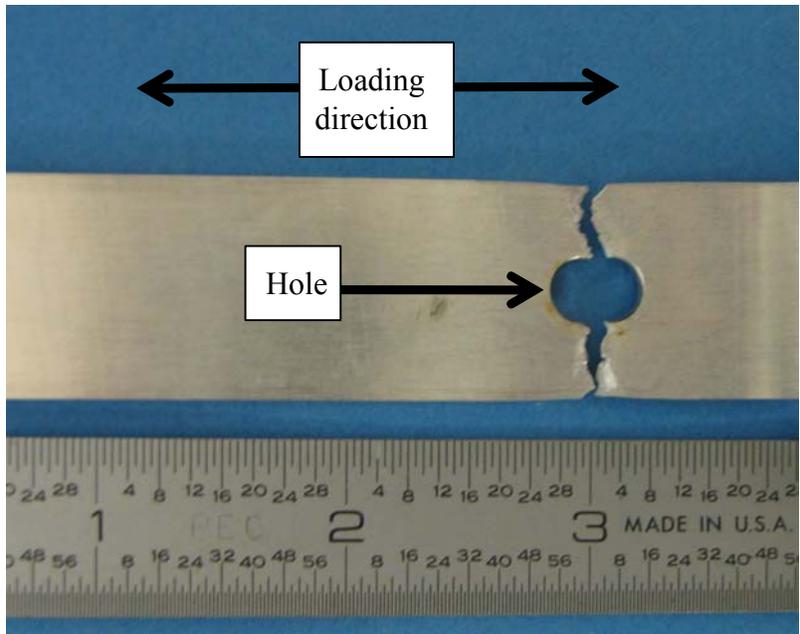
Initial attempts to simulate service cracking by performing uniaxial tension specimens with a hole in the center of the specimen, as indicated in Figure 5a, resulted in catastrophic failure at the holes normal to the loading axis. Due to the symmetry of these specimens, the stress state on each side of the holes was identical and failure occurred nearly simultaneously on both sides of the specimen. (See Figure 11) However, this is not what was observed during tank testing where asymmetric cracking and significant post-cracking load carrying capability occur.

Figure 11. Photograph of failed uniaxial tension specimen with center hole.

Reproducing service cracking with a uniaxial specimen with a centered hole was believed to have failed because of specimen symmetry. Further, this specimen was believed to be an overly simplified representation of the tank structure because it contained a single hole and did not permit hole-to-hole cracking or loading through the holes. Therefore, a non-symmetric two-hole specimen was designed, as shown in Figure 12. The specimen was loaded in a servo-hydraulic test machine with the specimen axis oriented  $18^\circ$  from the loading axis as shown in Figure 13. One end of the specimen was cut at an  $18^\circ$  angle to help ensure consistent specimen alignment. Specimens were angled in an attempt to reproduce observed cracking in tank structures which occurred at an angle of approximately  $18^\circ$  with respect to the isogrid rib. Aluminum stiffeners were attached on each side of the specimen, connected through two pins. The stiffeners could be adjusted by tightening the end caps to ensure a small pre-load before loading the specimen. As the specimen is loaded the spacing between the two holes is expected to increase, however, the stiffeners will constrain this displacement and carry additional load.

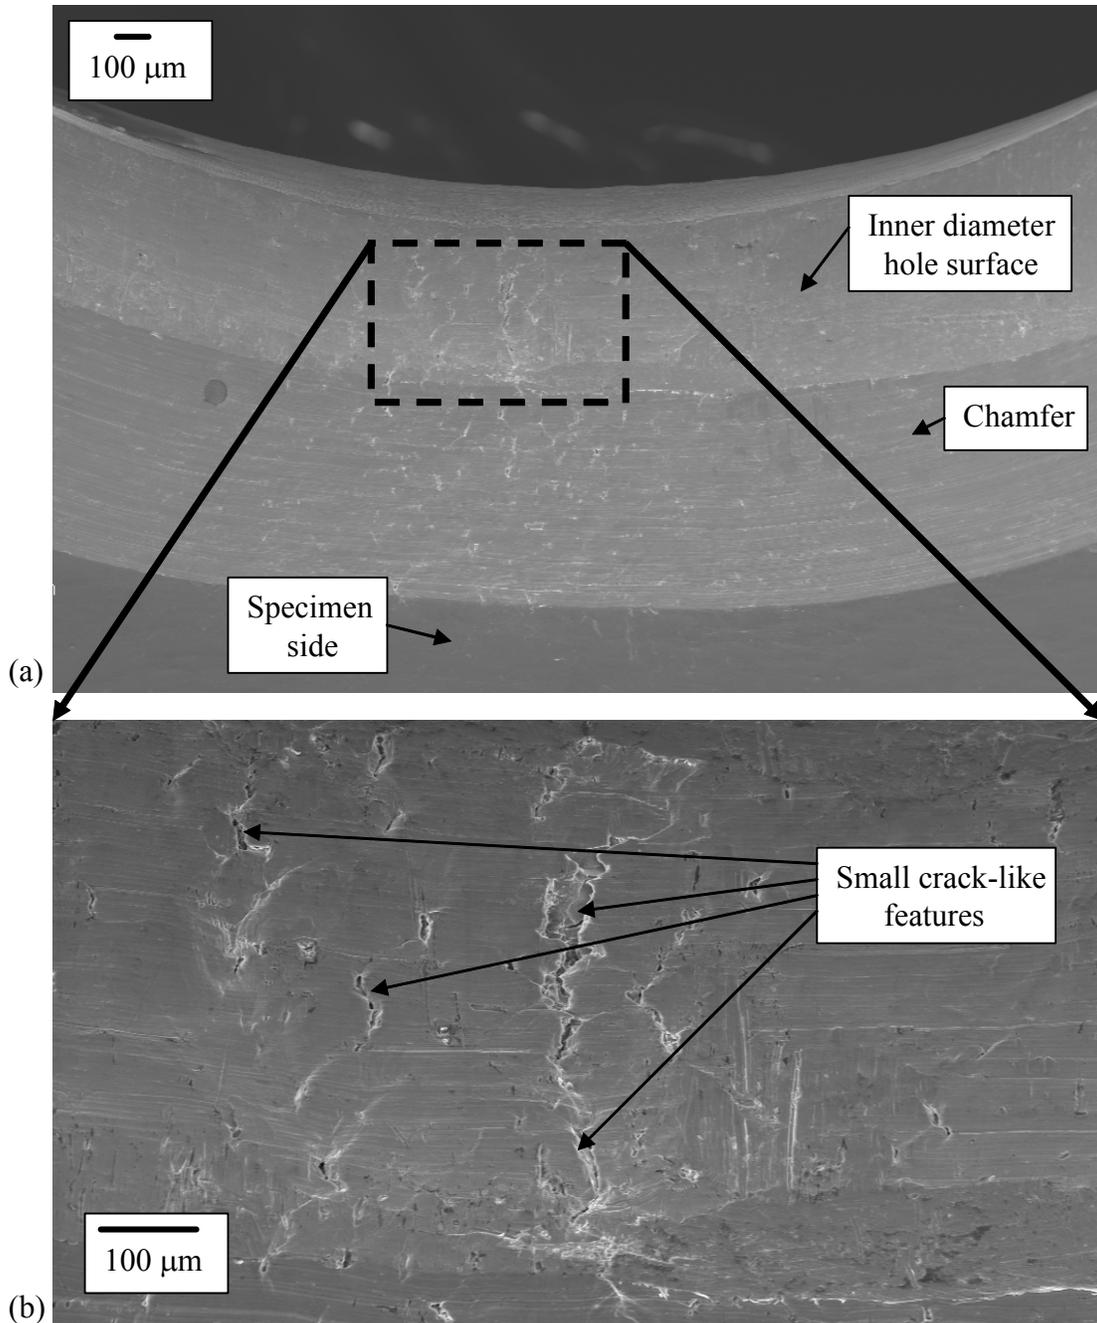
Cyclic loading under high plastic strain was performed to determine if severe cyclic loading, similar to what occurs during pressurization testing, could initiate cracks. The motivation for this testing was to challenge the presumption that no significant cracking occurs prior to the formation of a primary crack. A plot of load versus extension is shown in Figure 14. Here, one specimen was loaded under monotonic loading to failure. A second specimen was loaded cyclically with limited strain (severe plastic deformation, but well below the strain at which failure would be expected based on the results of the first specimen tested) applied during each cycle. A total of 29 cycles was applied to the specimen. The specimen was removed from the load frame periodically (a total of 13 times) and the interior of the hole surfaces was examined in a scanning electron microscope (SEM) to inspect for damage progression (See X symbols in Figure 14). Here, damage consistent with that indicated in Figure 15 is observed by the first inspection of the hole surfaces. While some limited damage progression has been observed with increased loading cycles, a clear determination of damage evolution could not be developed through the serial SEM observations.

Figure 15. SEM micrographs of holes during fatigue loading; (a) Photograph of hole ID; (b) High-magnification image of crack-like damage on hole ID.

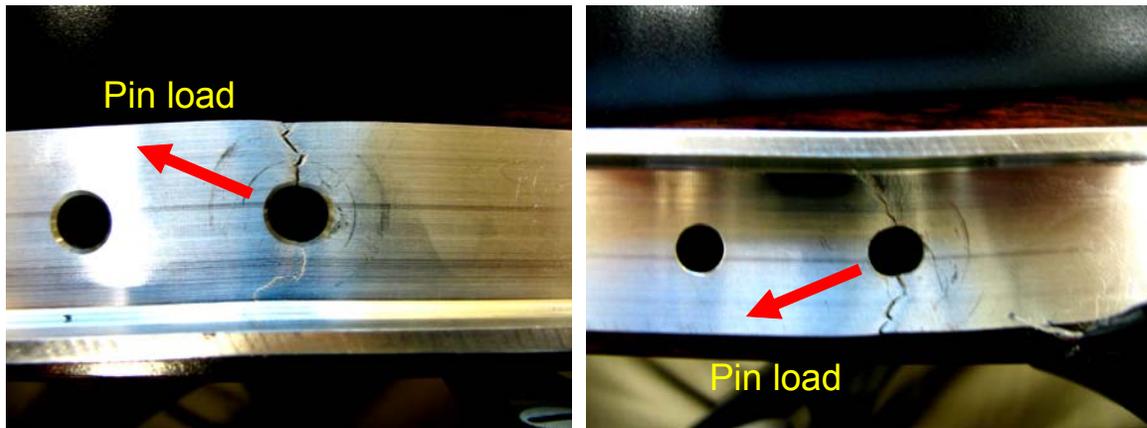
Mechanical testing of the 3D specimens in the ATB facility was performed at three different displacement ratios (5:1, 10:1, and 20:1, axial to transverse displacement ratio). Loading of the first 3-D test specimen at a 5:1 displacement ratio was terminated well before fracture due to insufficient pin loading. As the specimen was loaded, the axial-to-pin load ratio rapidly approached 10:1 (due to the specimen having a transverse compliance significantly greater than the integrally-stiffened tank structure). This result indicated that a higher displacement ratio was required. Data for a 10:1 displacement ratio is supplied in Figure 18. Here, the loads measured from the load cells for the axial and transverse actuators and the load determined for the pin loading increase with increasing displacement until a fracture event occurs at a transverse displacement slightly greater than 0.42 inch. The maximum axial load was 6.89 kip (30.6 kN), while the maximum transverse and pin loads were 0.36 kip (1.60 kN) and 0.79 kip (3.51 kN), respectively. The primary crack ruptured through to the free surface, while the secondary crack propagated to the web formed by the simulated skin (See Figure 19). On one of the surfaces, the secondary crack propagated at an angle from the loading axes, similar to that observed in service (See Figure 19a), however, on the other side of the specimen, the secondary crack initially propagates normal to the axial direction (See indicated region in Figure 19b), which is inconsistent with the crack morphologies observed in service. This specimen was loaded to failure to observe the complete fracture morphology. An optical metallograph of both fracture surfaces is shown in Figure 20. The secondary crack propagated through the entire rib section and has nearly penetrated the 0.115-inch skin material.

Figure 19. Specimen surfaces of fractured 3-D specimen tested at a transverse to axial displacement ratio of 10:1. For the photographs shown, the axial loading direction is horizontal.

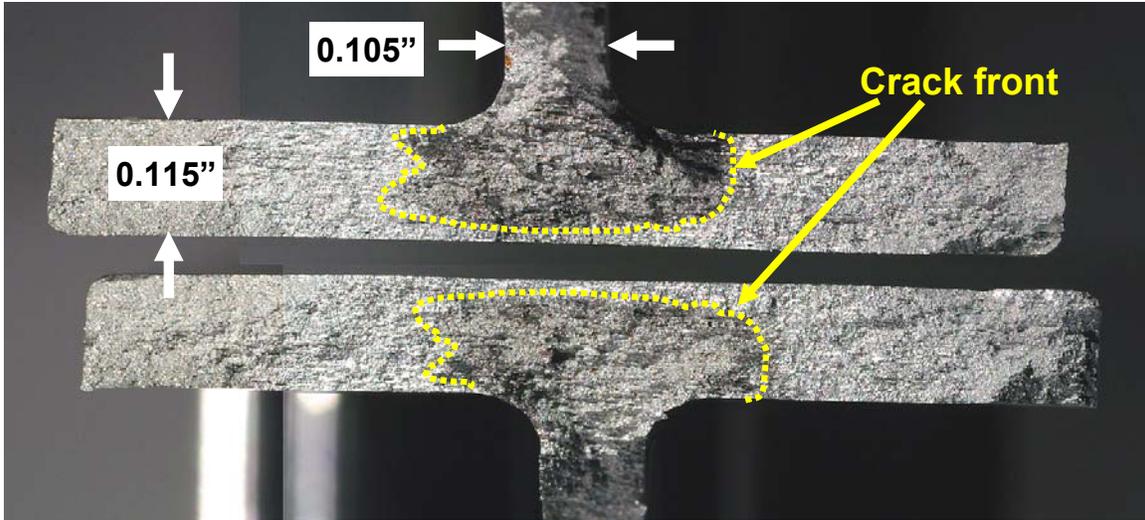
Figure 20. Optical metallograph of secondary-crack fracture surfaces of 3-D specimen tested at a transverse to axial displacement ratio of 10:1.

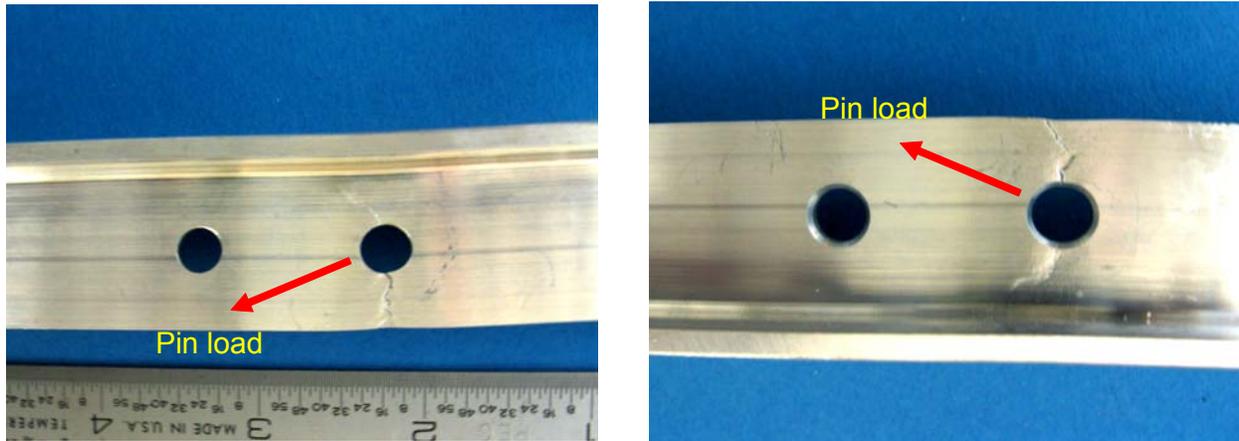
Due to the relatively high axial-to-pin displacement ratio (8.7:1) required to reproduce the crack configuration in the failed tanks, and the crack morphology realized at a displacement ratio of 10:1, additional tests at a displacement ratio of 20:1 were performed. Data for one of the 20:1 tests are supplied in Figure 21. Here, the loads measured from the load cells for the axial and transverse actuators and the load determined for the pin loading increase with increasing displacement until a fracture event occurs at a transverse displacement slightly greater than 0.60 inch. The maximum axial load was 4.94 kip (22.0 kN), while the maximum transverse and pin loads were 0.39 kip (1.73 kN) and 0.96 kip (4.27 kN), respectively. Therefore, the pin loading was more than 20% greater for the 20:1 tests than was observed for the 10:1 test in Figure 18. Images of the specimen surfaces are shown in Figure 22. Here, the secondary crack was observed to grow at an angle to both the axial and transverse load lines, and the crack did not penetrate the simulated skin surface. For two specimens tested under this condition, the secondary cracks were greater than 0.050 inch (1.3 mm) from the skin material. This means that for the 20:1 axial-to-pin displacement loading, the secondary cracking was less severe than for 10:1 axial-to-pin displacement testing. A summary of data for the 10:1 and 20:1 tests are listed in Table 5.

Figure 22. Specimen surfaces of fractured 3-D specimen tested at a transverse to axial displacement ratio of 20:1. For the photographs shown, the axial loading direction is horizontal.

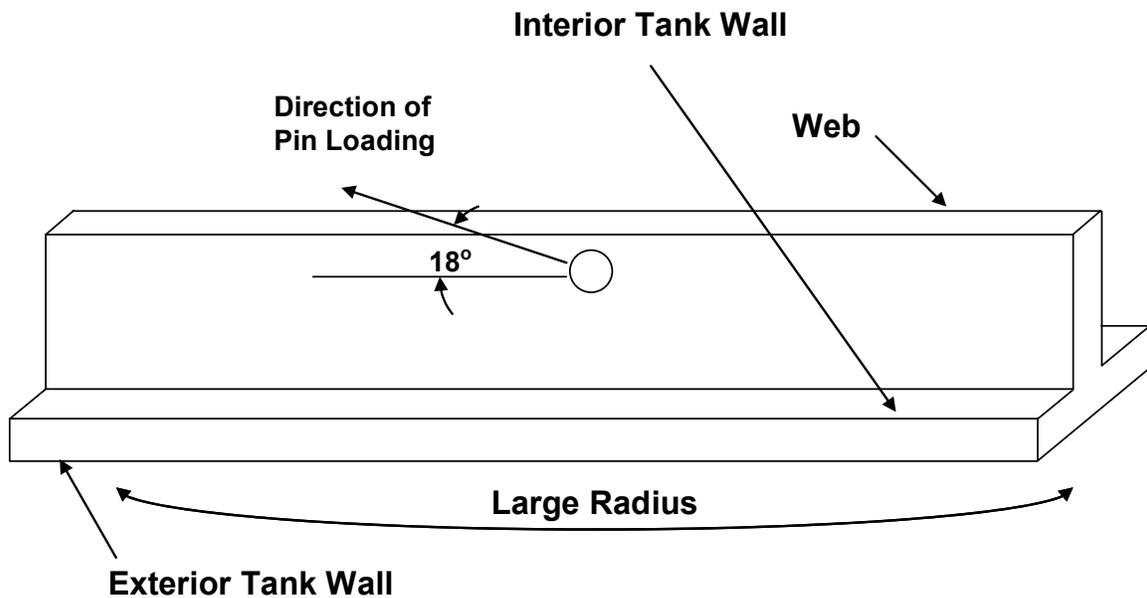
Cracks were detected propagating from pin loaded holes in the internal web of an integral stiffener tank. The tank was loaded by internal pressure with the hoop stress component acting on the web. An internal stiffener is attached to the web with mechanical fasteners and pin loading of the web is believed to occur at an angle of  $18^\circ$ , as shown in Figure A-1. The ratio of pin loading to total load is unknown, but believed to be significant (40-60%). The cracks were believed to have initiated on the side of the hole closest to the free edge first (primary crack) and propagated to the free edge before the initiation of a crack on the opposite side of the hole (secondary crack). The secondary crack is believed to arrest before reaching the external tank wall.

Figure A-1. Schematic of cracking location.
