# Lunar Module Environmental Control System Design Considerations & Failure Modes Part II

# Objectives

- ❑ Describe the Lunar Module (LM) Environmental Control System (ECS) subsystem testing and redesign.
- ❑ Summarize the Lunar Module (LM) Environmental Control System (ECS) in-flight failures.

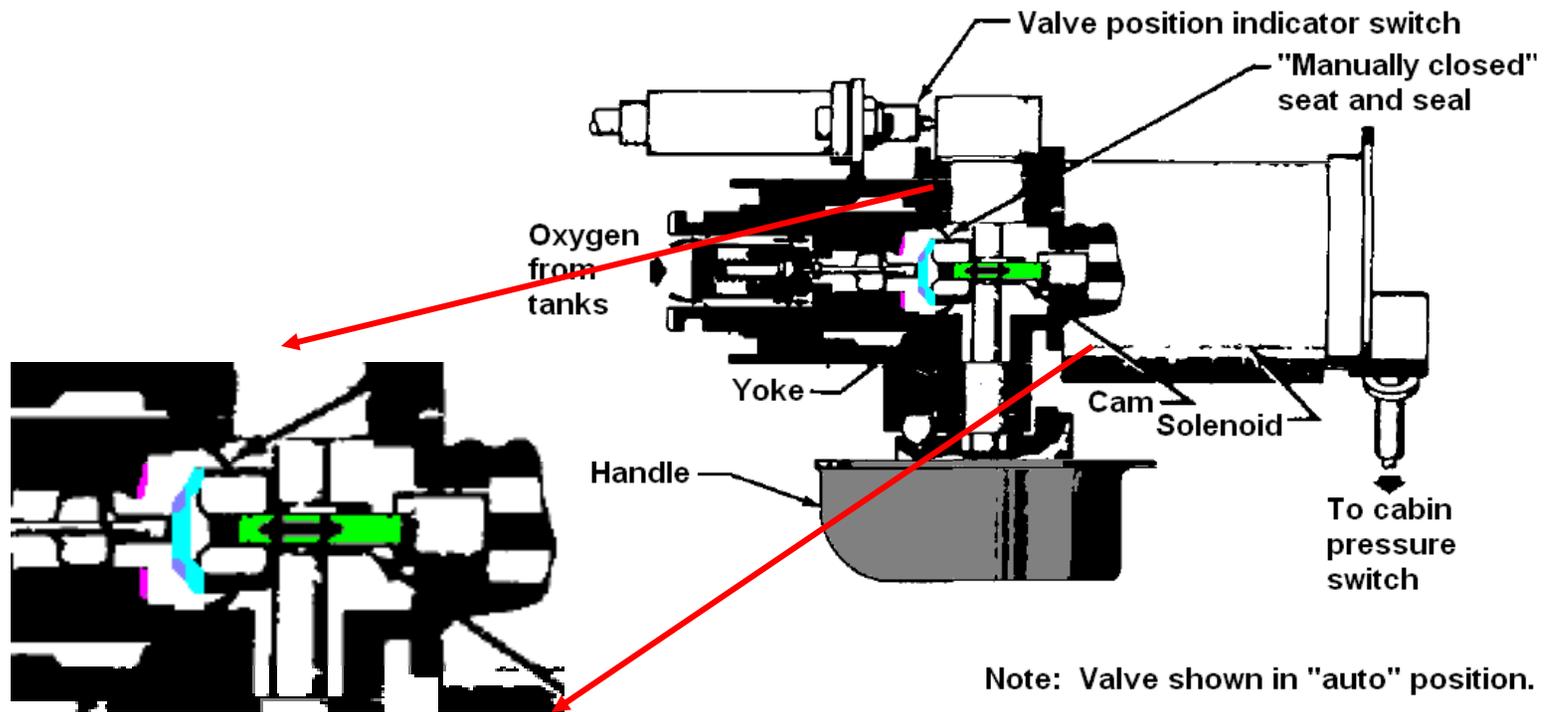
Cabin Repressurization and  
Emergency Oxygen Valve

- The Cabin Repress and Emergency Oxygen Valve had some problems during feasibility testing, showing the valve seat to be susceptible to permanent seating.

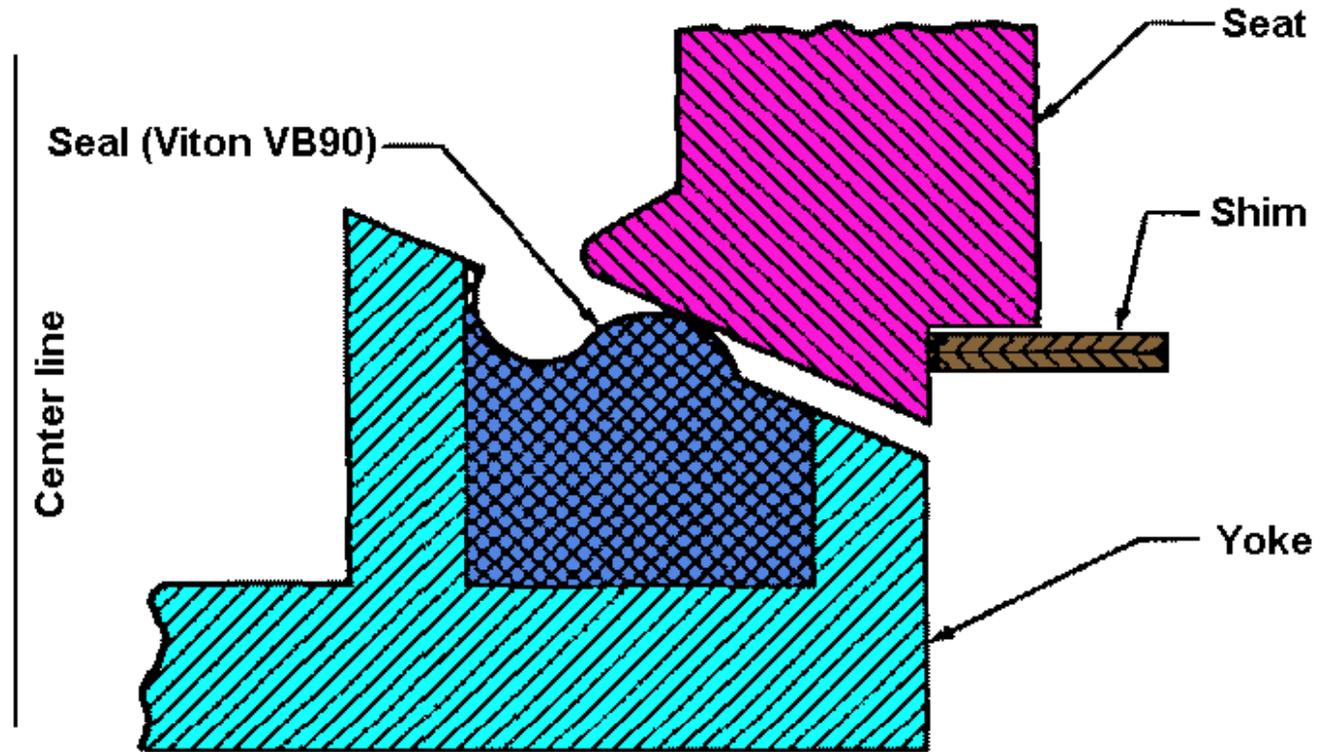
Configuration B

- During acceptance testing, the new seats were seen to crack. The shape of the seat and seal were changed.

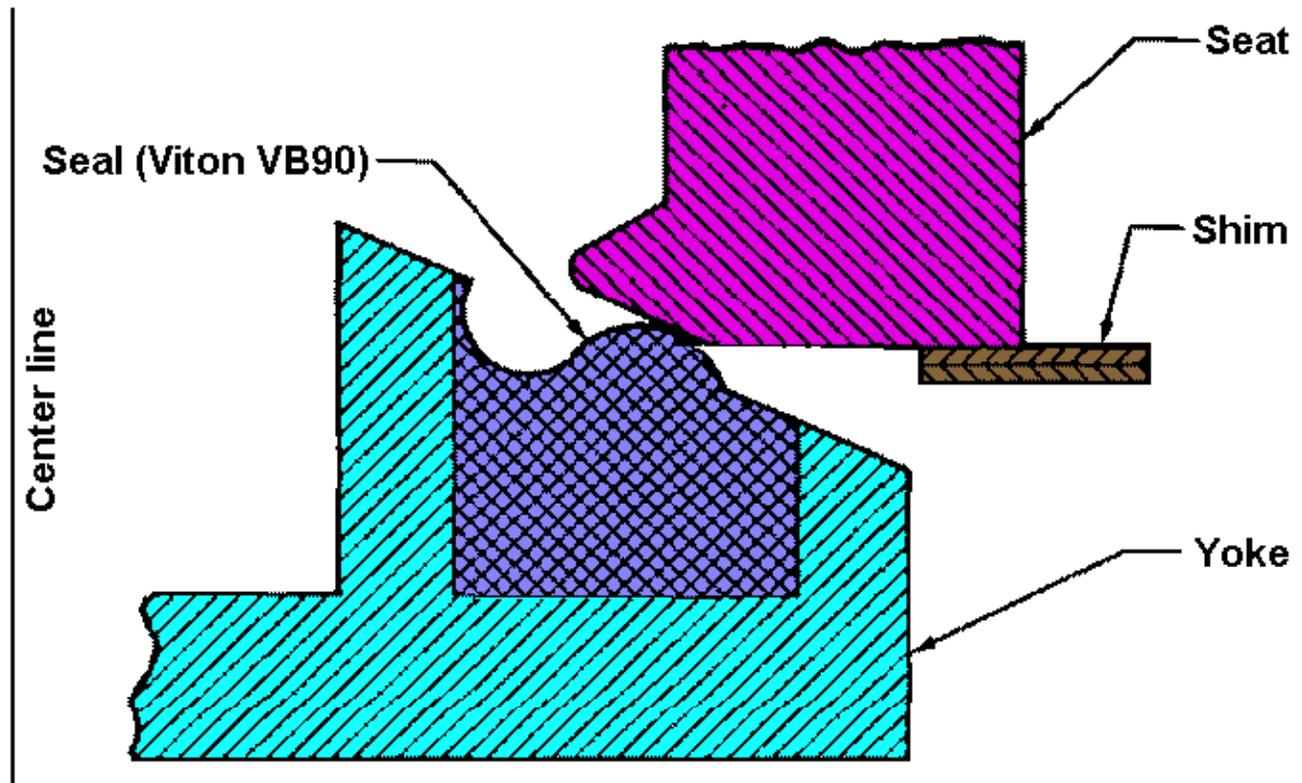
Configuration C

- The new design failed vibration-temperature testing. The seat was again changed to provide better centering and resist lateral movement.

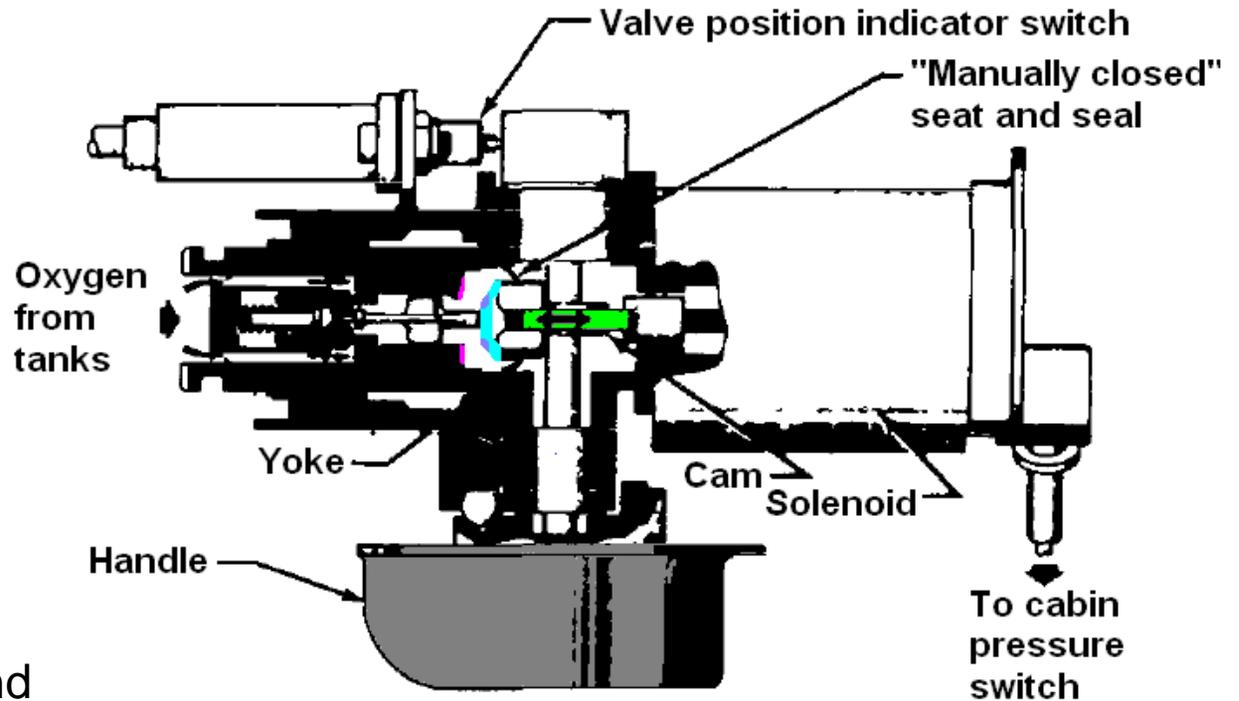
Cabin Repressurization and  
Emergency Oxygen Valve

- ❑ Nominal operation of the valve was accompanied by a very loud “bang” from the high-pressure gas expanding to produce a shock wave.
  - ◆ valve was not actually being damaged
  - ◆ decision was made not to change the design again

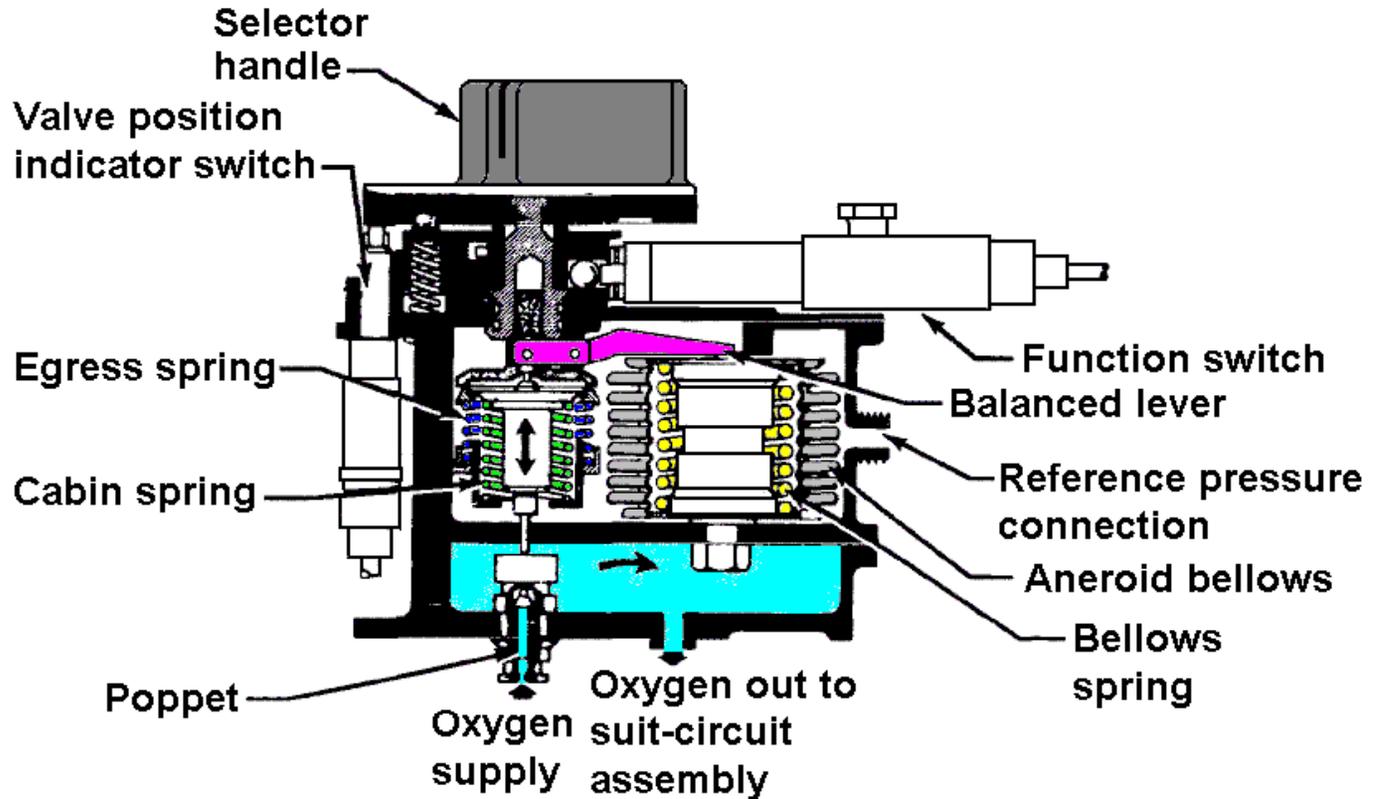
Cutaway View of Oxygen Demand Regulator

- ❑ The **Oxygen Demand Regulators** provided suit loop pressure regulation.
  - ♦ original design sensitive to vibration
  - ♦ various aneroids and mass-balancing techniques reduced the leakage to acceptable levels

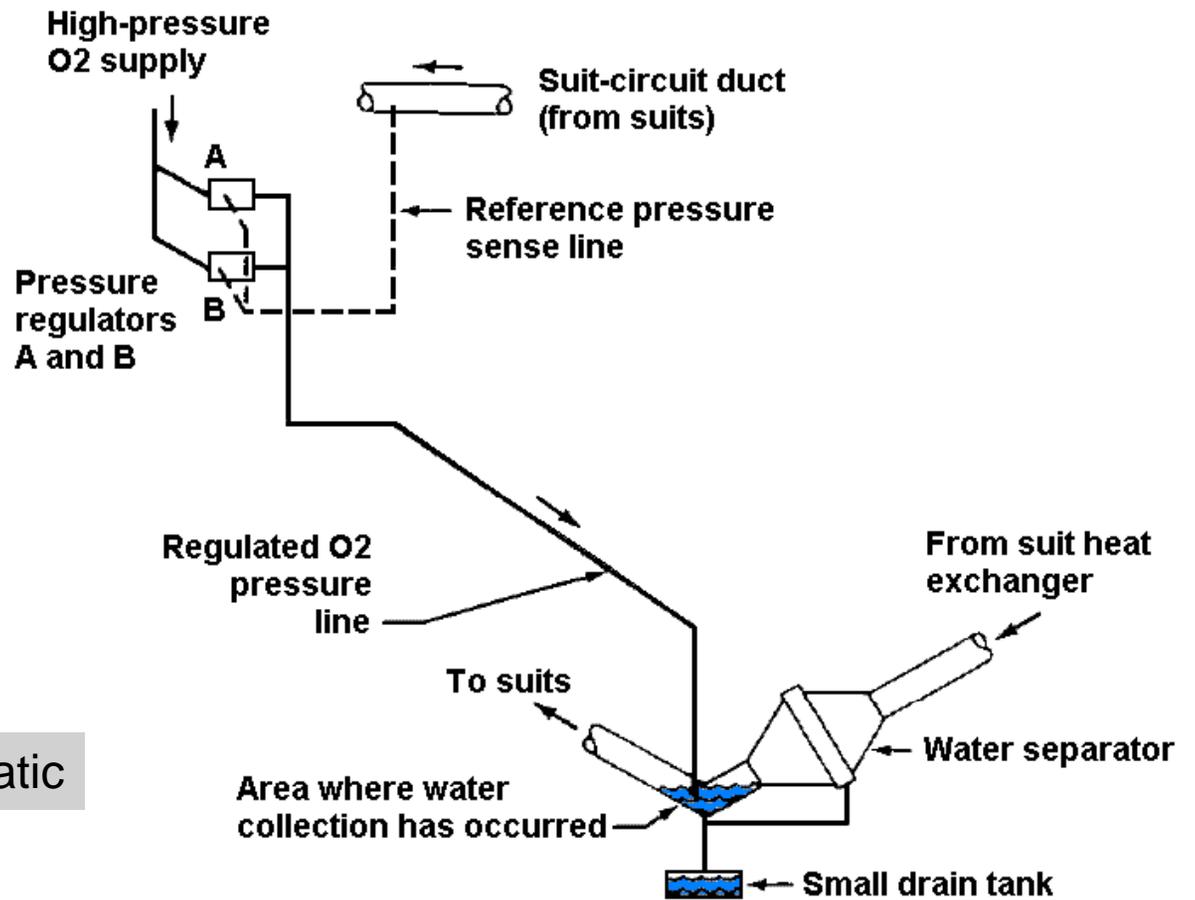
LM Suit Line Elevation Schematic

- The regulators were contaminated by water when steam was injected into the system for tests.
  - ♦ water collected at the point shown in the system
  - ♦ blown up into the regulators when the 34.5 KPa (5 psia) system was returned to sea level

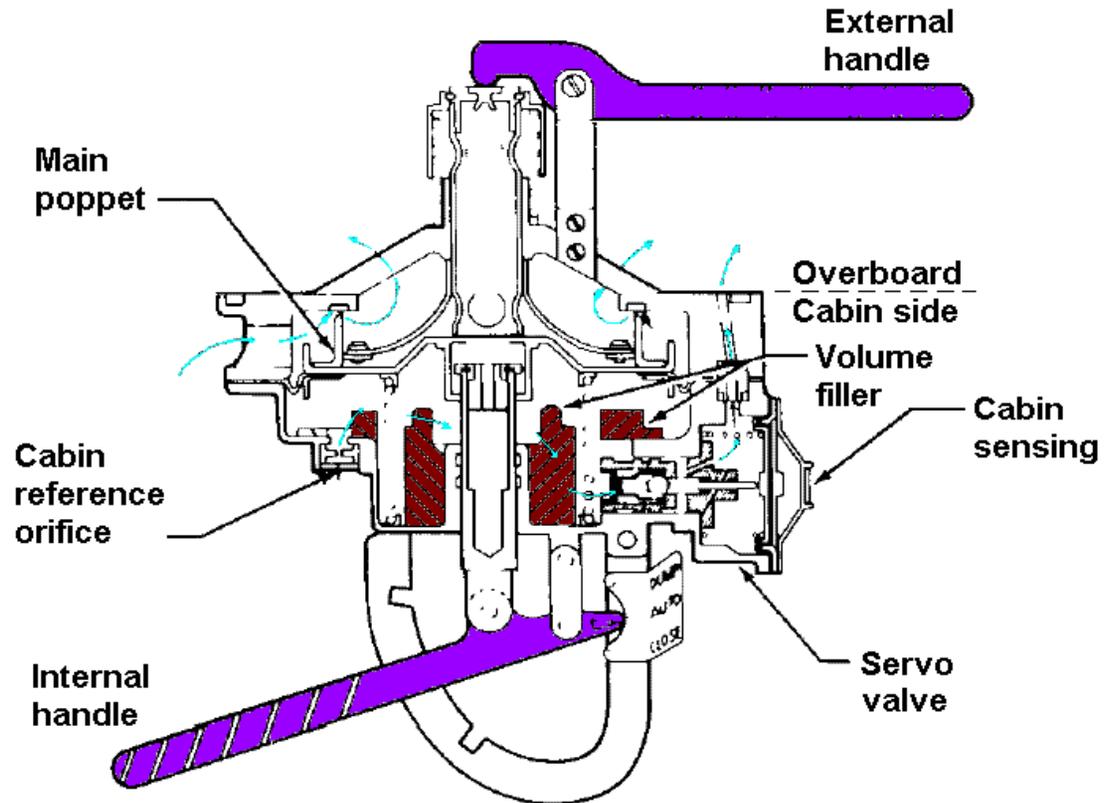
Cabin Dump Relief Valve

- The **Cabin Dump and Relief Valves** provided cabin pressure relief at 38.9 KPa (5.6 psi) and allowed manual cabin depress.
  - ♦ vibration testing -- the valves leaked
  - ♦ volume filler in the servo chamber generating particle contaminants
  - ♦ filler was changed to molded silicone rubber gaskets

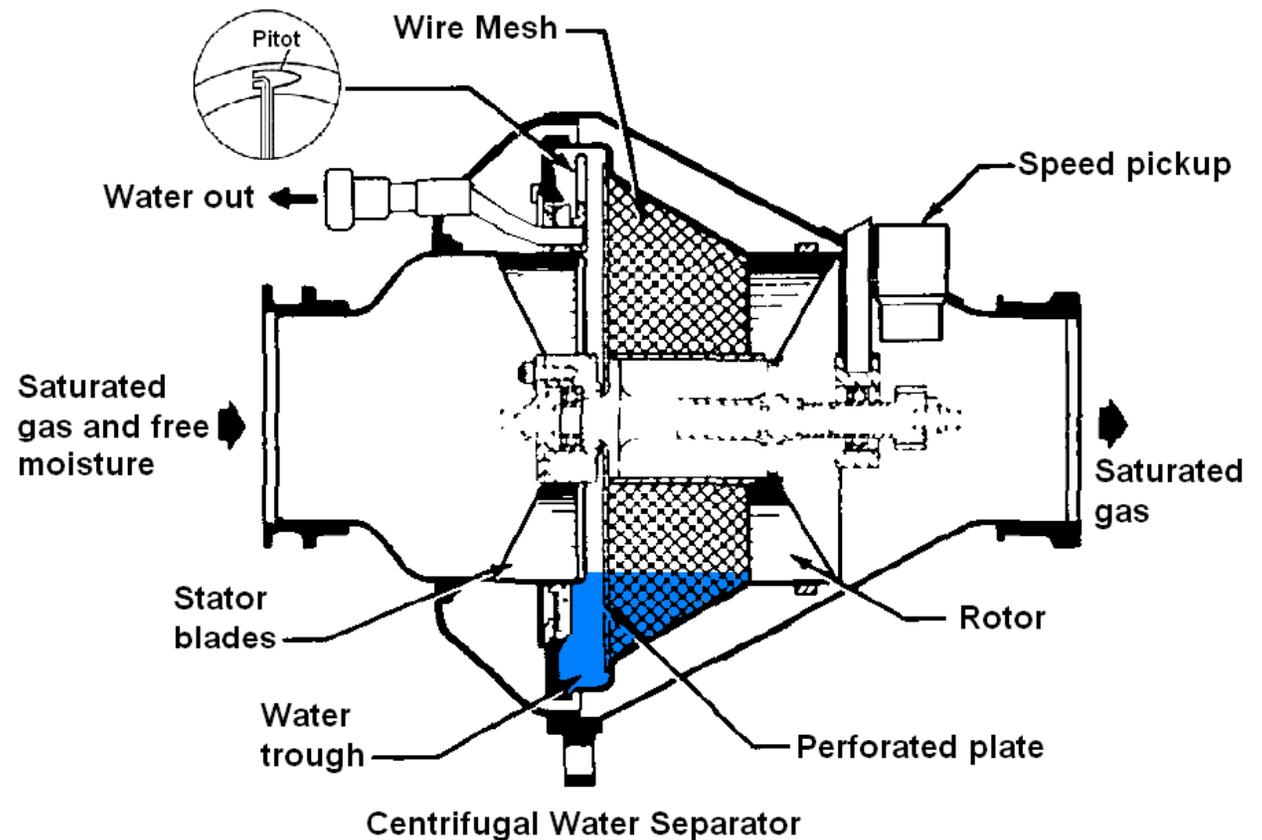
- ❑ Changes aimed at improving the pumping capability with lower total gas flow. During qual testing, the unit failed to restart after shutdown. Ullage water retained in the unit had settled to the bottom and created resistance.
  - ◆ clearances revised
  - ◆ drains added
  - ◆ additional stator blades blocked

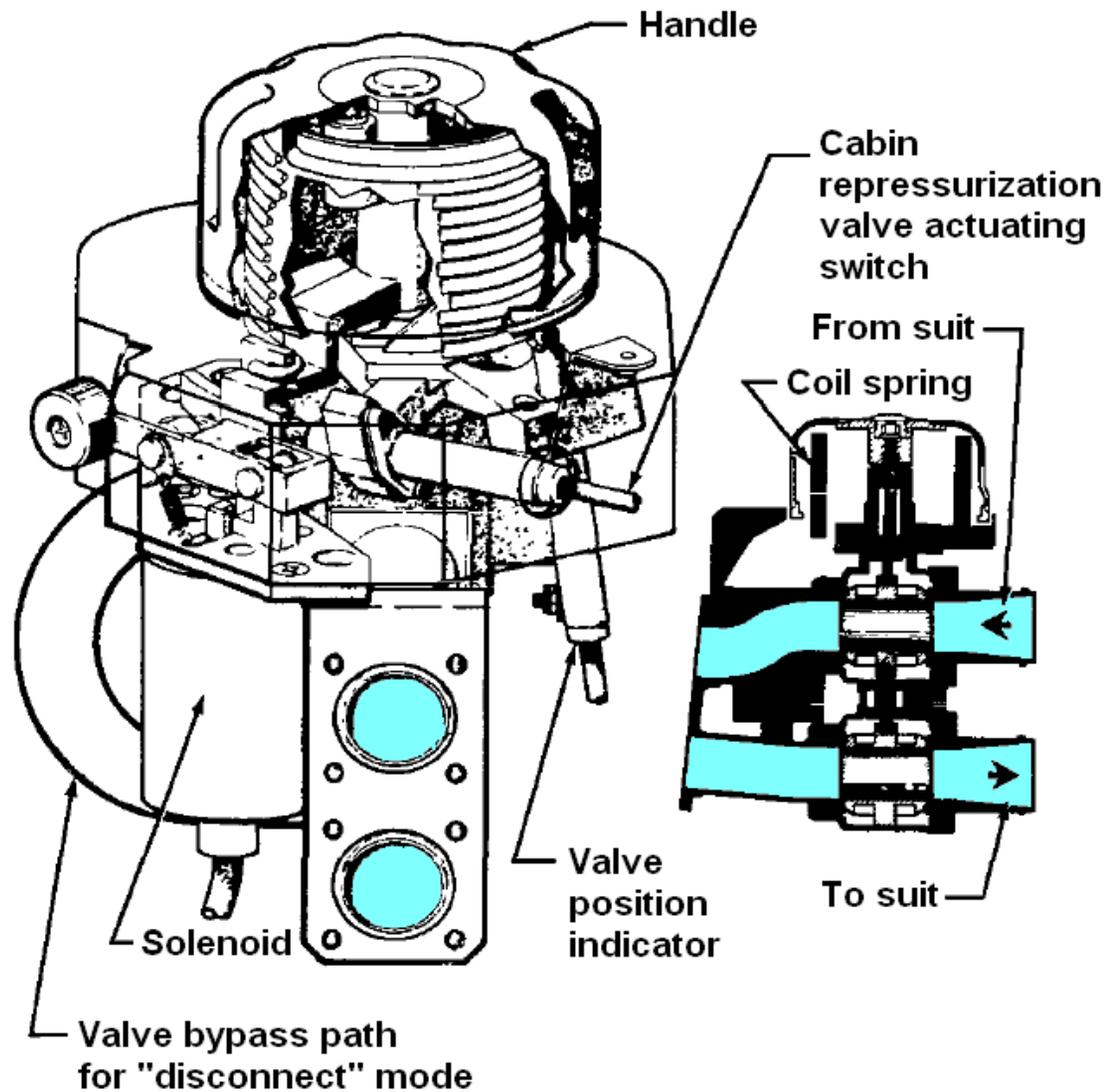
❑ Post the Apollo 1 fire, the **Suit Isolation Valve** changed to a fast-acting automatic electric valve.

- several units became sluggish after repeated actuations
- minor materials change was required

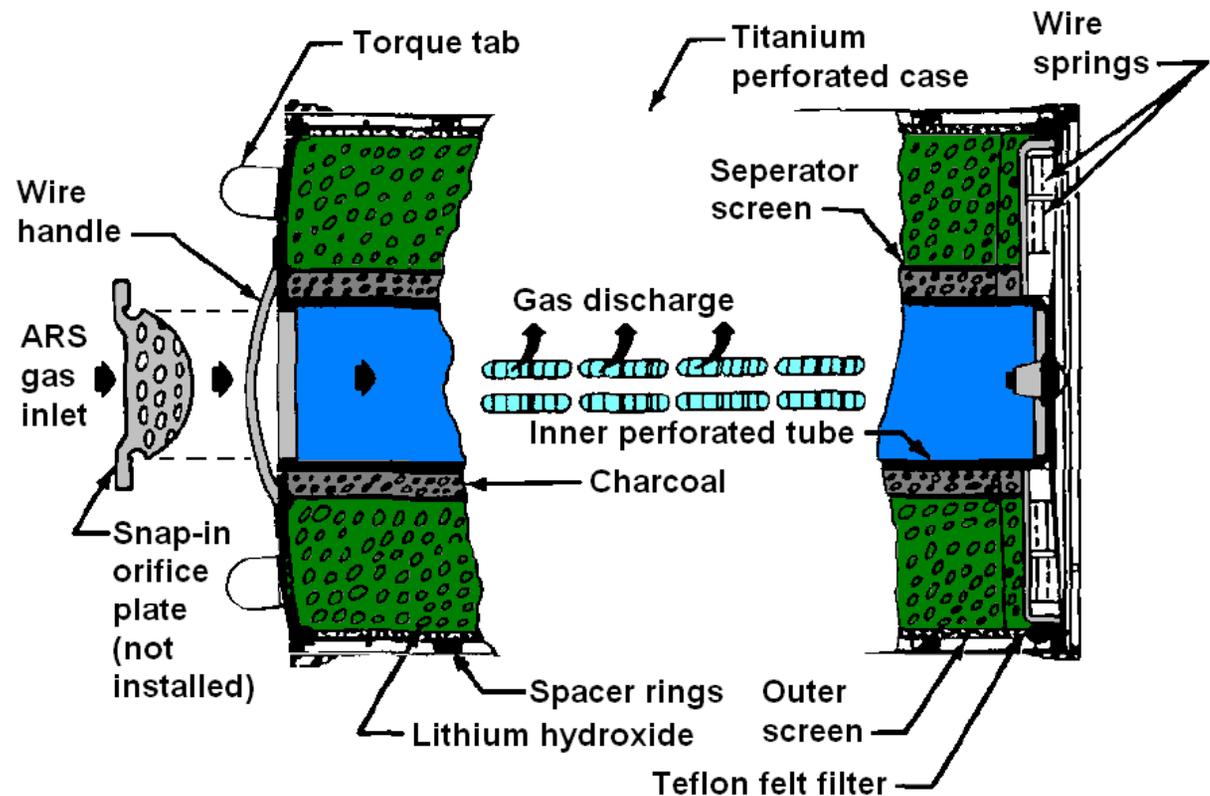
Primary LiOH Cartridge

- ❑ The original LiOH Cartridge design had granular LiOH that abraded under vibration and released “dust”, which was very caustic to eyes, nose, and throat.
  - improved manufacturing techniques
  - compressing the granules (originally with polyurethane foam, but changed to a metallic spring design after the Apollo 1 fire)
  - cartridge filler material changed from Dacron to Teflon
  - snap-in orifice was added after Apollo 11 to regulate air flow rate and prevent water separator overspeed

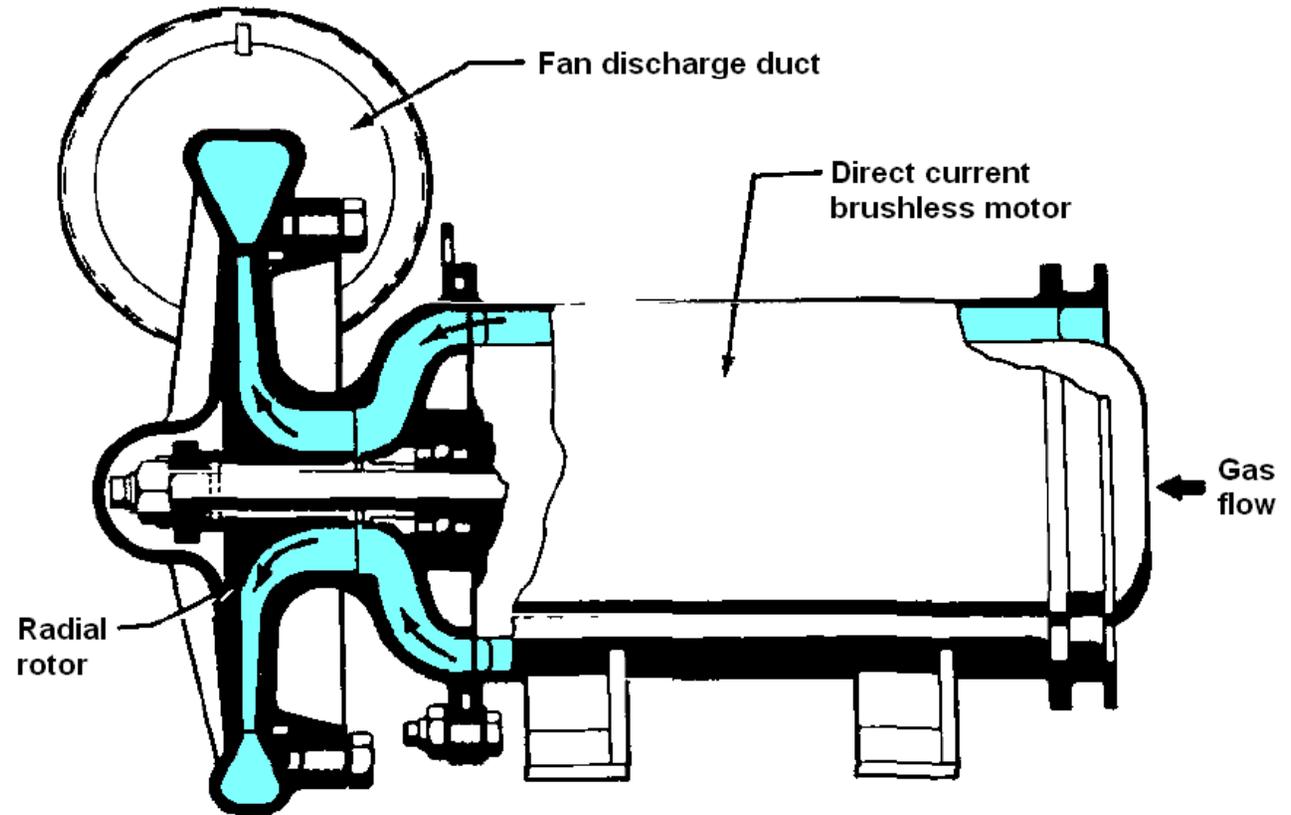
LM Suit Fan Motor

- failures of power transistors
- a tendency to start rotating the wrong direction
- fan wheel rubbed during testing and the clearances were changed

- bearing problems from contamination, inadequate lubrication, and bearing race brinelling. These were fixed by:

- better cleaning

- a different grease

- an improved bearing pull fixture

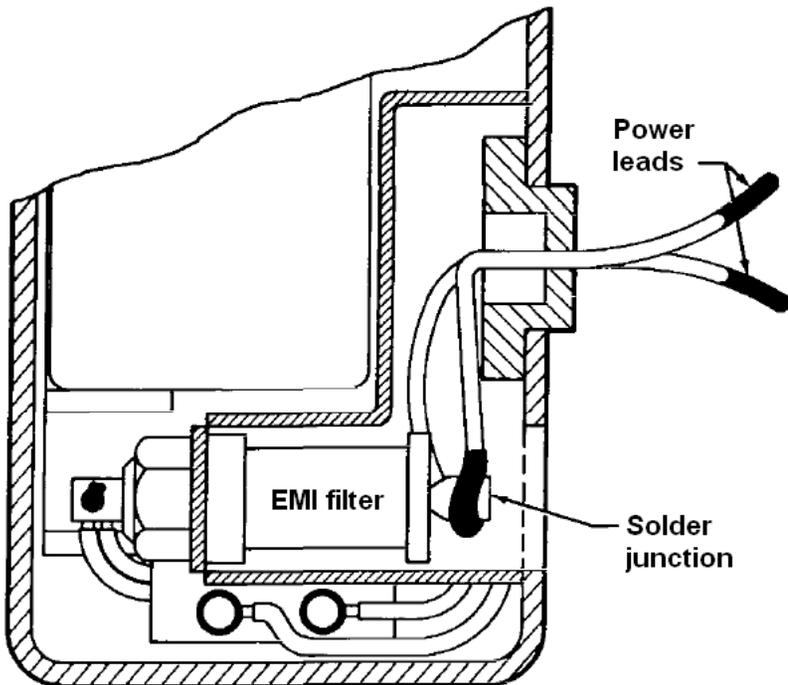
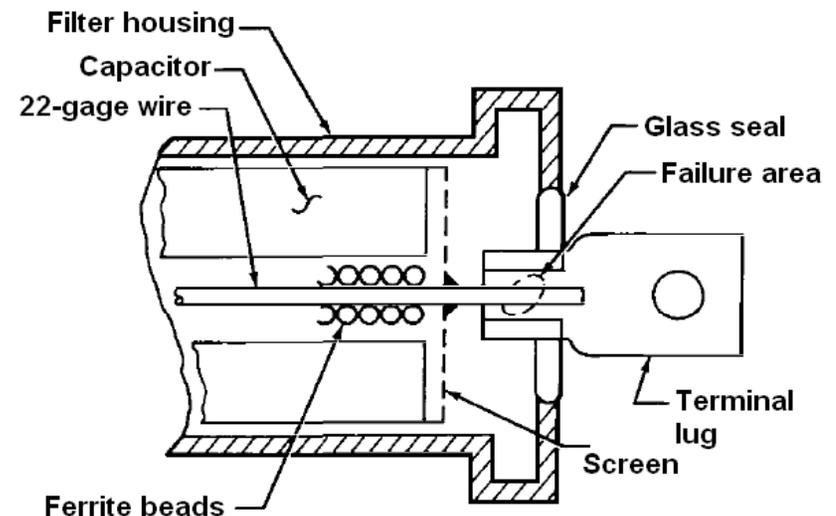
**Suit Fan EMI Filter Configuration**

- ❑ Shimming was used to prevent inducing EMI into the fan ductwork, and the fans had to have an **EMI filter**
  - filters were getting damaged by the soldering process
  - to fix this, moved the heavy wire solder connection point farther away from the capacitor lead

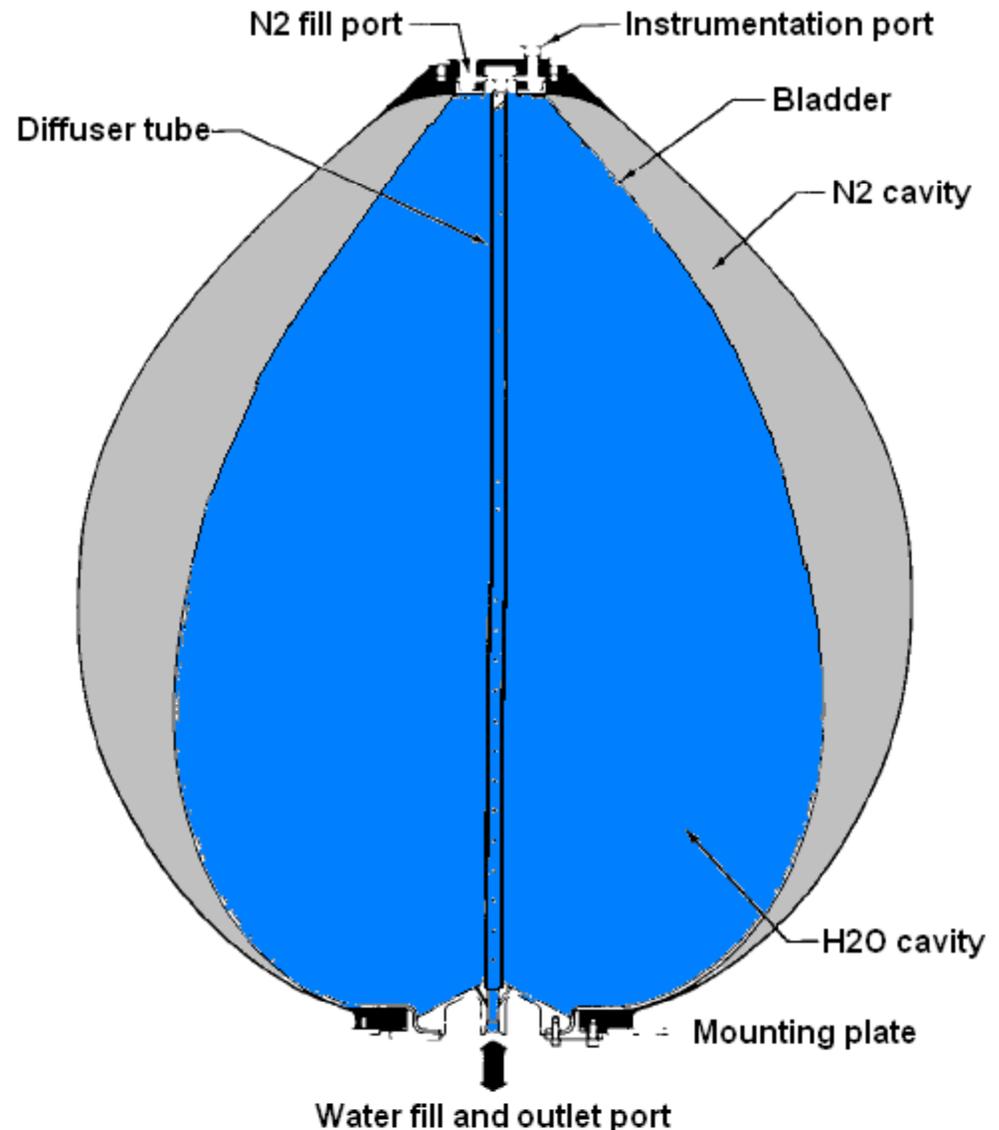
**Descent Water Tank**

- ♦ found to adhere between folds when stored collapsed
- ♦ prevented by storing the tanks with the water side pressurized with several psi of dry nitrogen
- ♦ a bladder tear was found on LM-7 (no specific cause ever identified)
- ♦ X-rays and gas leakage tests were used after that

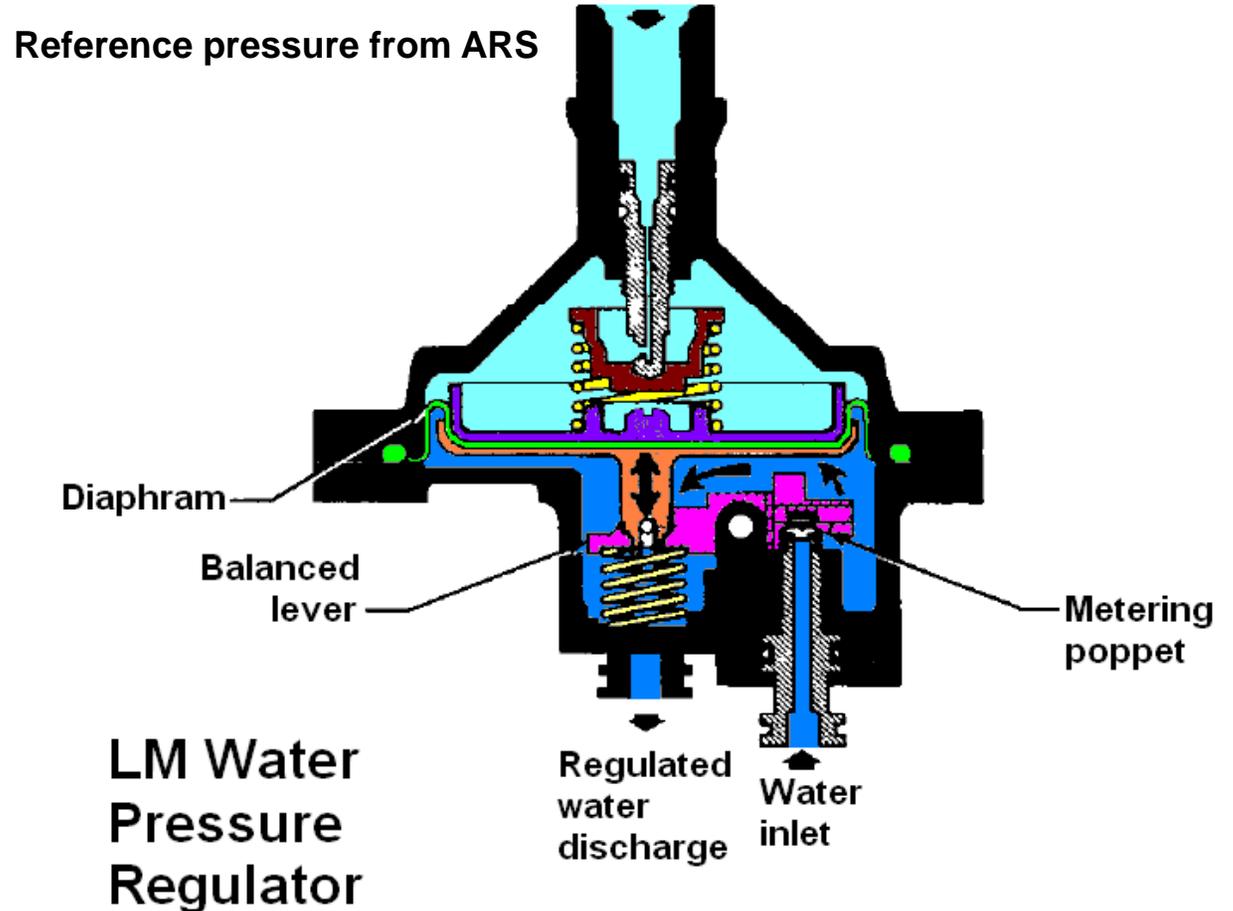
- During checkout of LM-4, one regulator failed, due to corrosion and particulates
  - redundant regulator added to the backup system for subsequent vehicles

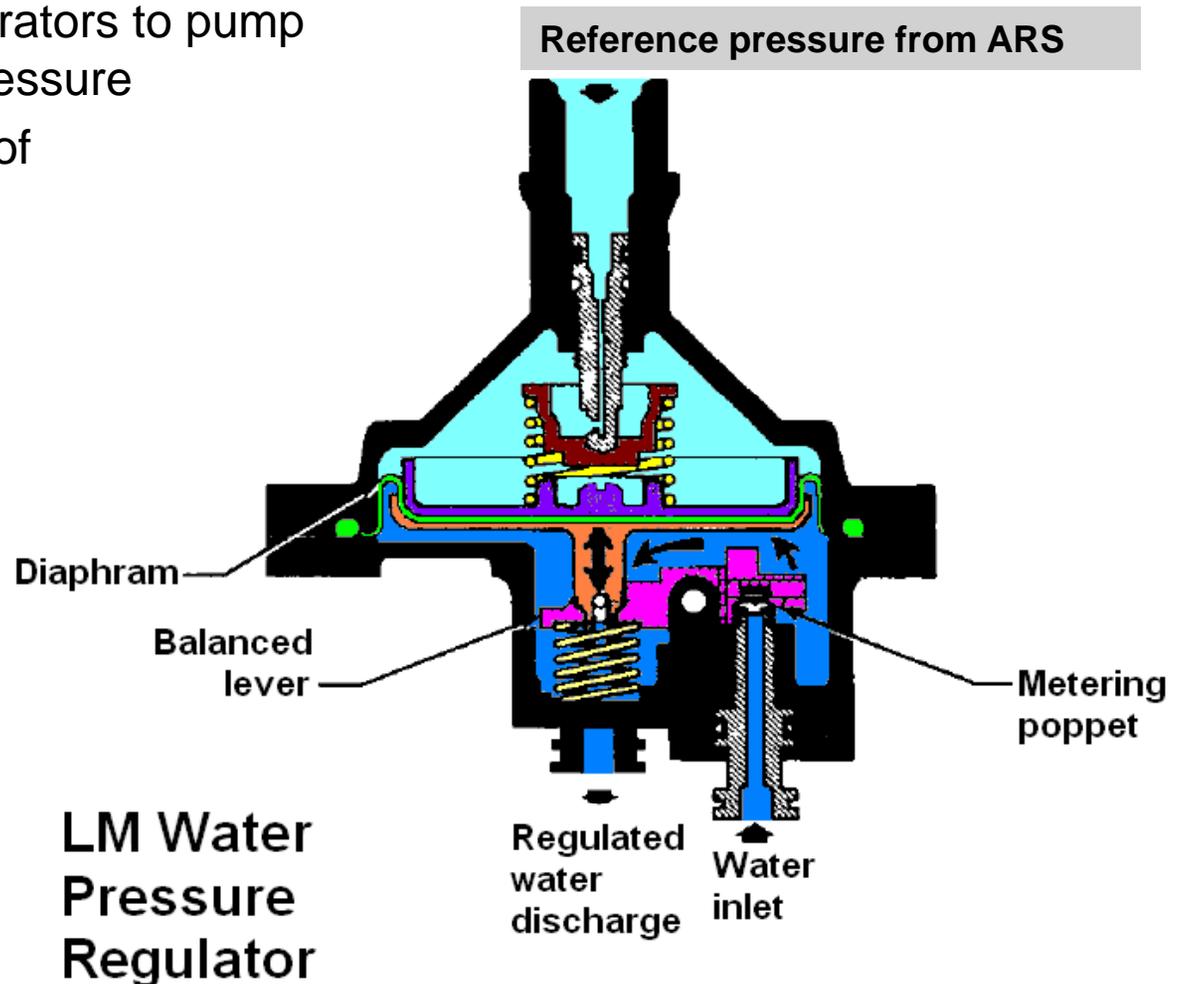
- ❑ The orifices became plugged.
  - caused an improper reference pressure and a high water pressure to the sublimators
  - caused the water separators to pump against a high head pressure
  - water not pumped out of the suit circuit
  - orifices were removed

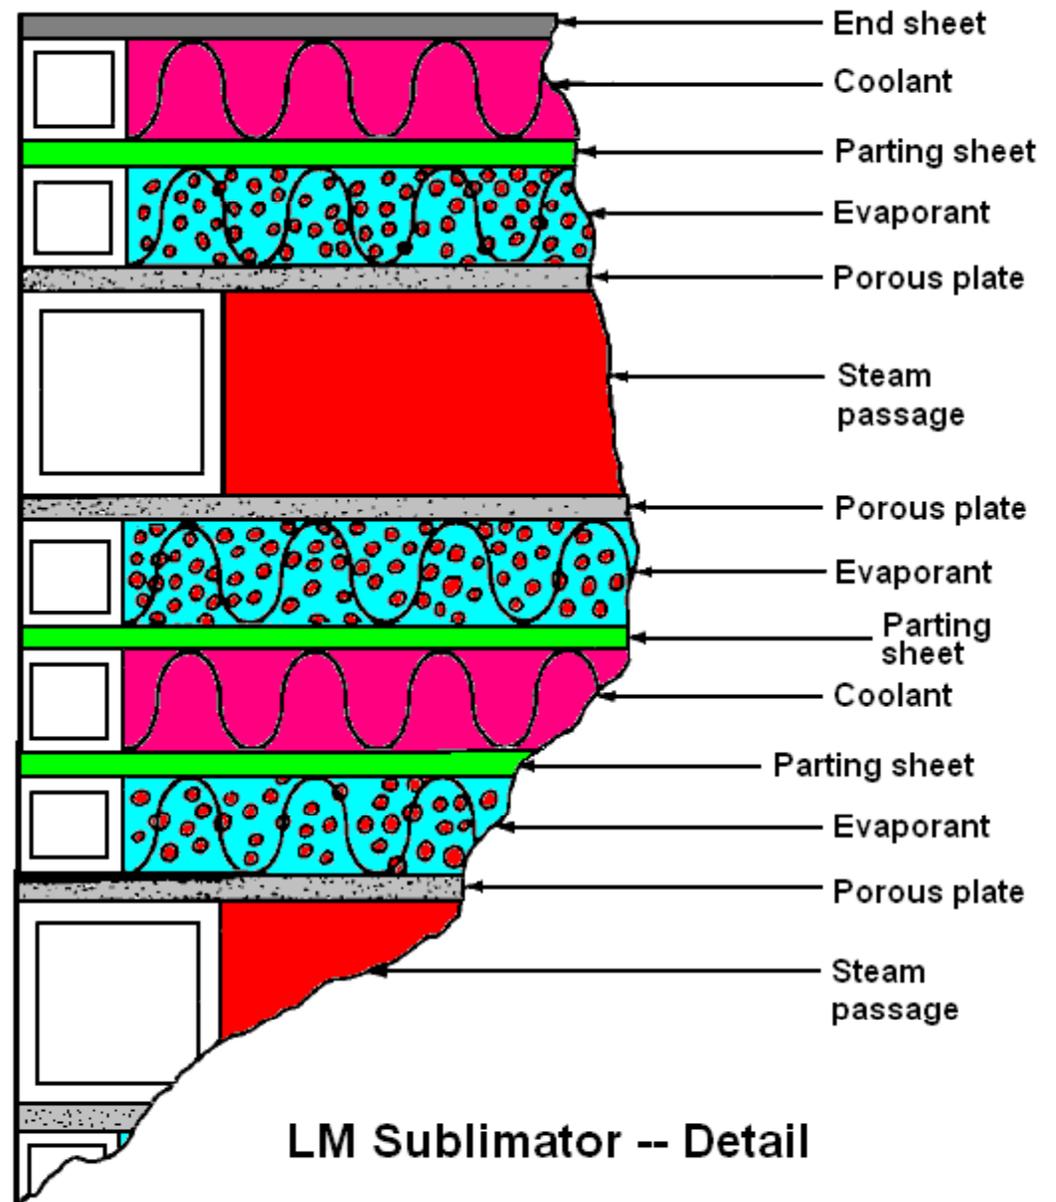
LM Sublimator -- Detail

- ◆ Difficulty was encountered in brazing the porous plates without plugging the pores
- ◆ the early units degraded with usage time and had insufficient total capacity
- ◆ tried porous plates with higher porosity
- ◆ welded fins to the plates to eliminate brazing problems
- ◆ increased the density of the heat-transfer fins in the coolant passages
- ◆ implemented better quality controls to ensure that the porous plates were installed facing the right direction

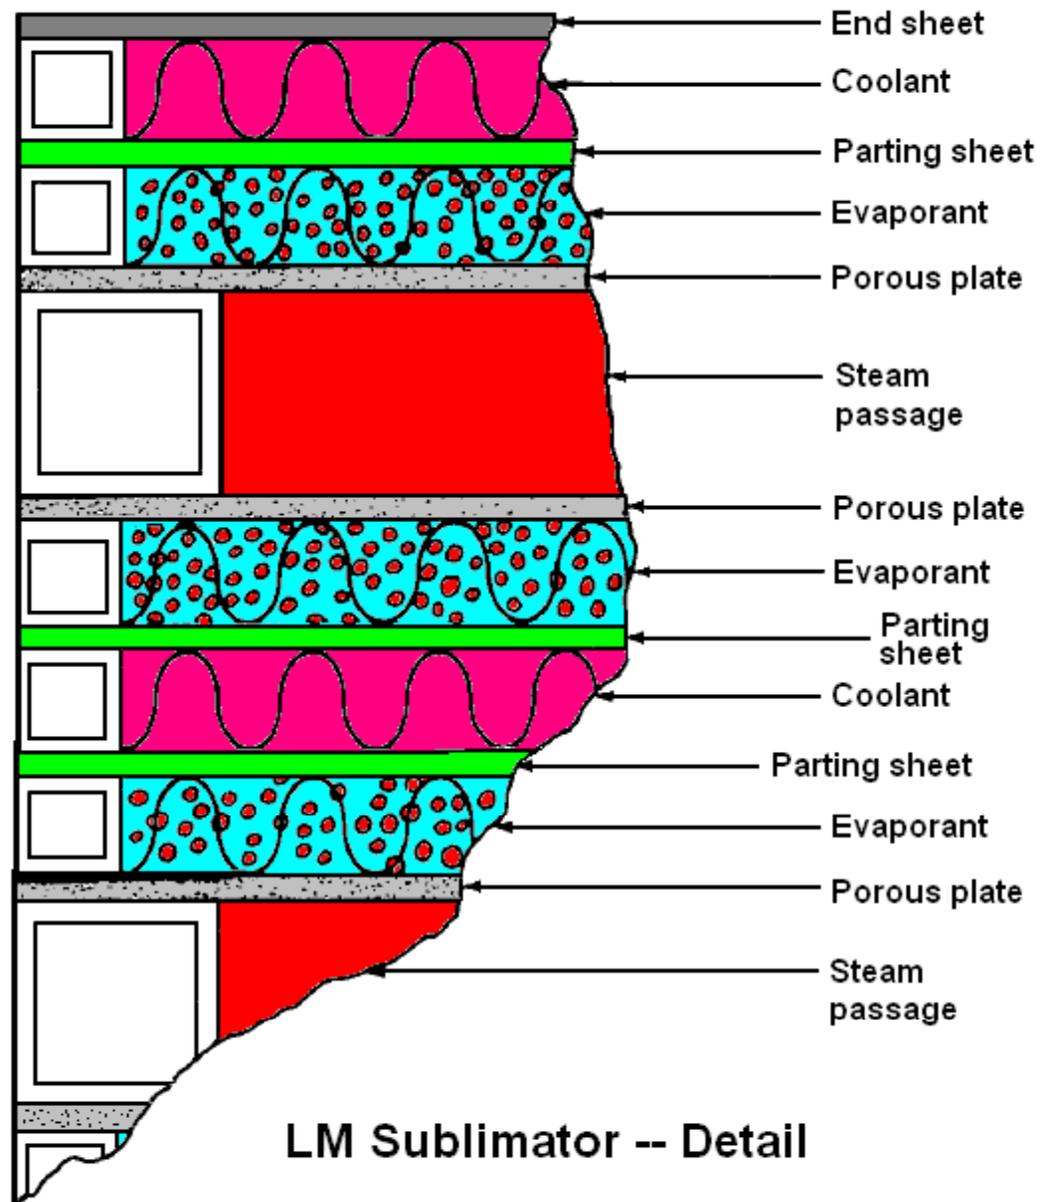
- ❑ Originally, **chlorine** was being added to the water as a bactericide.
  - ♦ caused a buildup of a residue on the steam passage side of the porous plates
  - ♦ resulted in a depression of the freezing point and water breakthrough
  - ♦ forced the LM program to go to iodine as the biocide in the water system

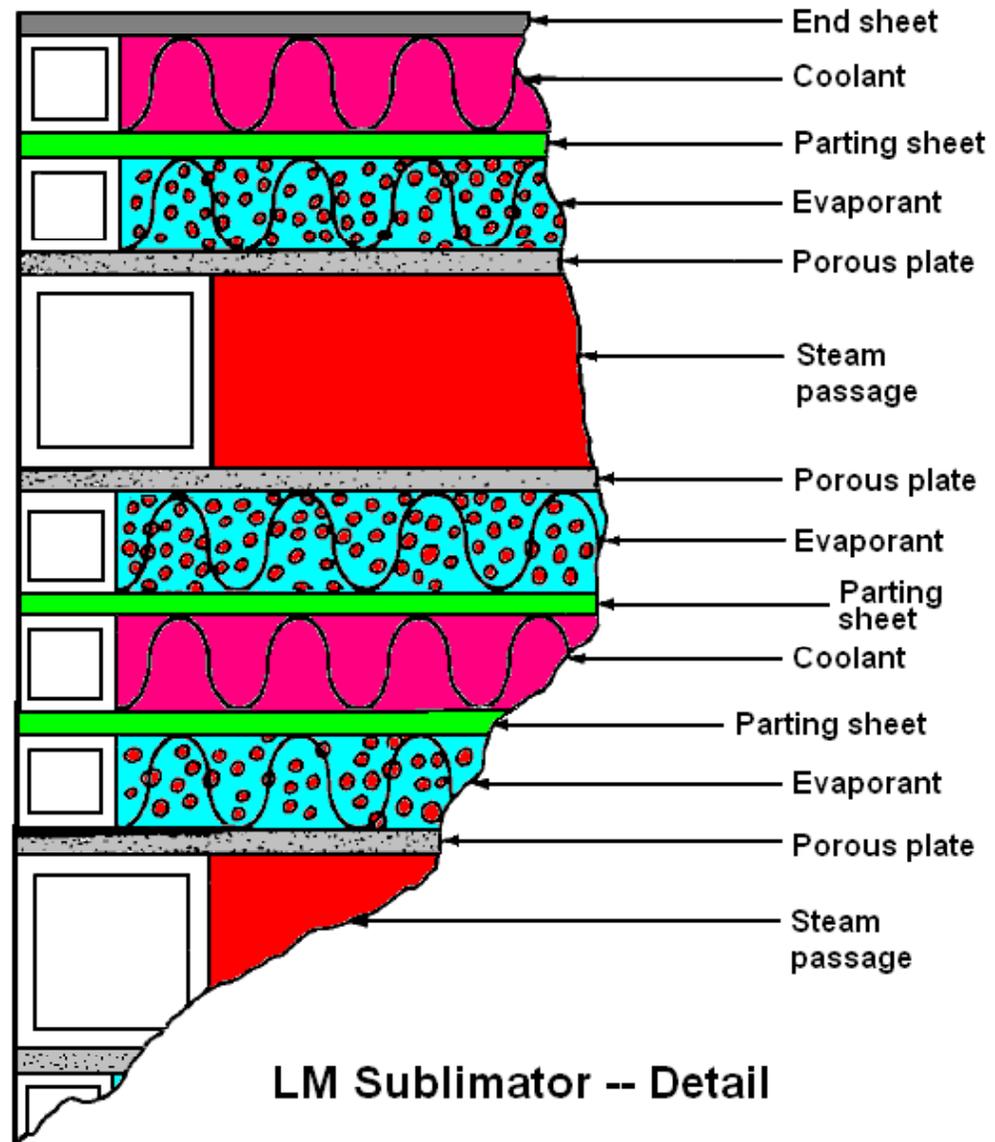
- The units tended to degrade by accumulating corrosion products during storage.
  - ◆ also during use from blockage of pores by contaminants
  - ◆ a higher performance was required at acceptance than the units would need in flight
  - ◆ the units were stored in a dry N<sub>2</sub> environment

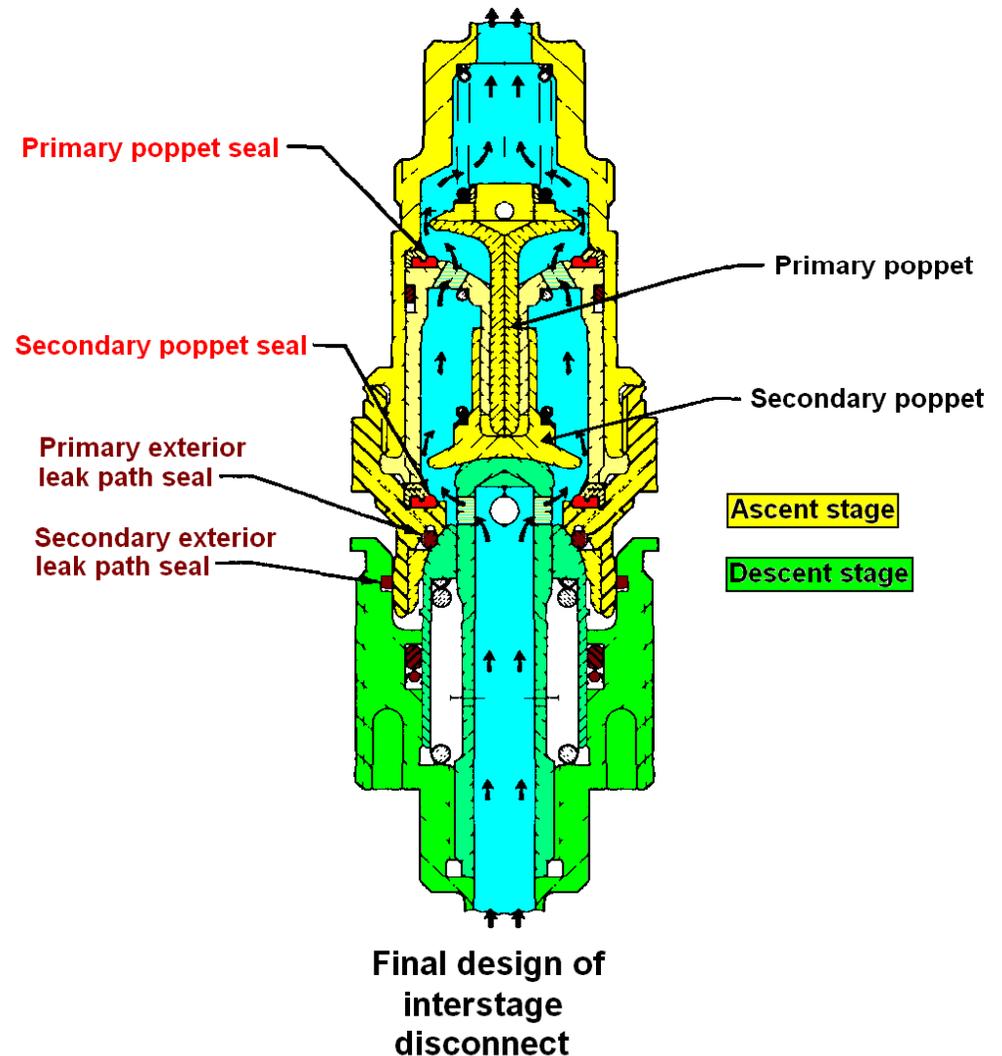
- ❑ Loss of lubricant was a problem whenever the system was drained.
  - isopropyl alcohol was used to flush the system
  - it dissolved the lubricants
  - prevented free action of the moving parts and leakage in gas leak checks
  - GSE QDs were modified to allow reapplication of lubricants
  - no QD that ever showed such a leak was allowed to fly
