# Lunar Module Environmental Control System Design Considerations & Failure Modes Part II

# Objectives

- ❑ Describe the Lunar Module (LM) Environmental Control System (ECS) subsystem testing and redesign.
- ❑ Summarize the Lunar Module (LM) Environmental Control System (ECS) in-flight failures.

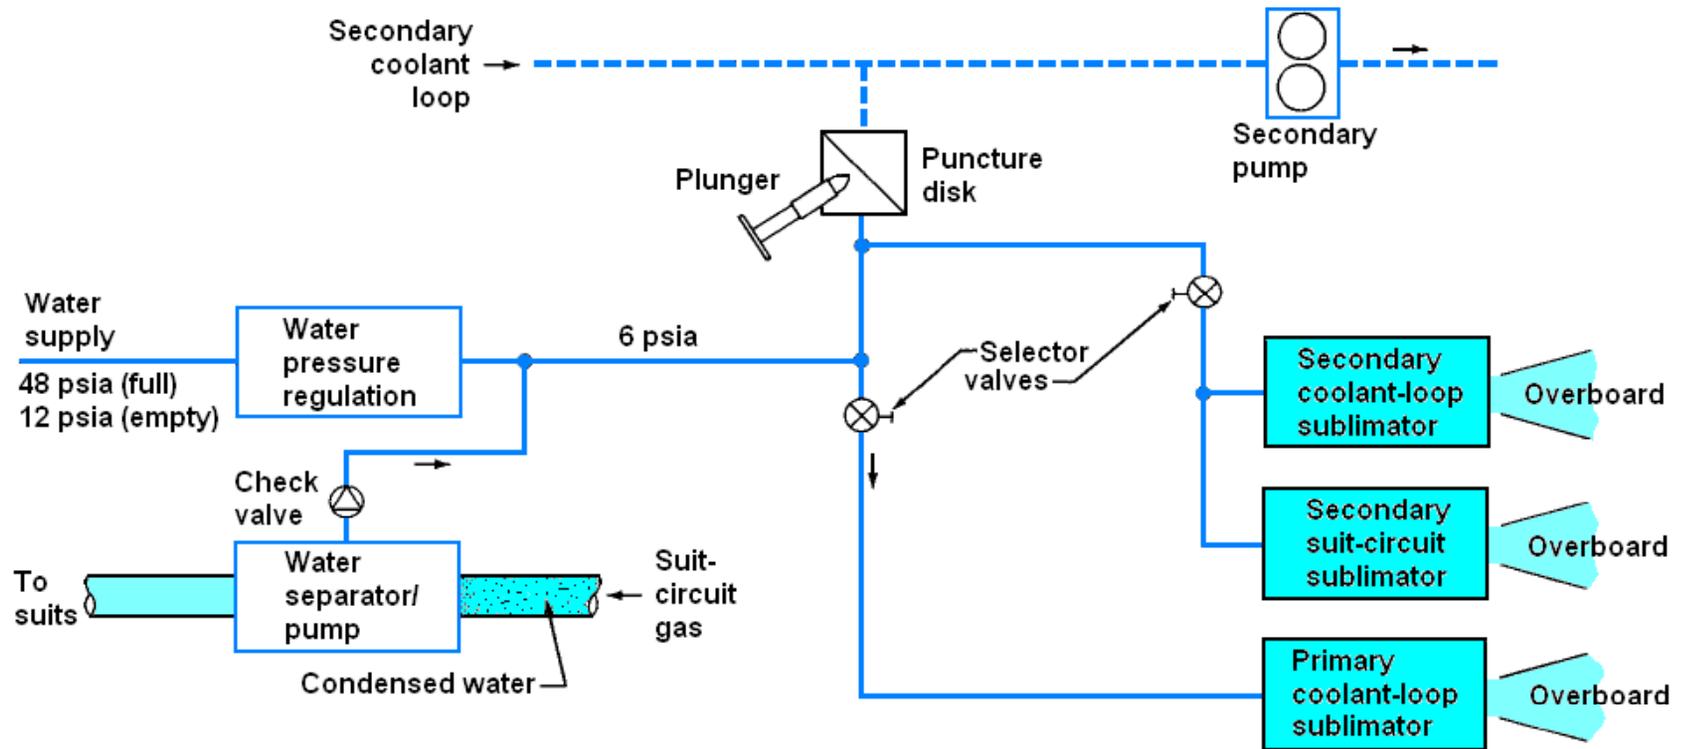
Original Design of Cooling Loop System

- The configuration after puncture allowed glycol to enter the water line feeding the sublimators (depending on relative pressures).
  - ♦ caused a problem in the LTA-8 Hot Case test by lowering the freezing point of the sublimator water to the point that ice would not form (sublimator breakthrough)

- The configuration after puncture allowed glycol to enter the water line feeding the sublimators (depending on relative pressures).
  - ◆ accumulator was added to the glycol system

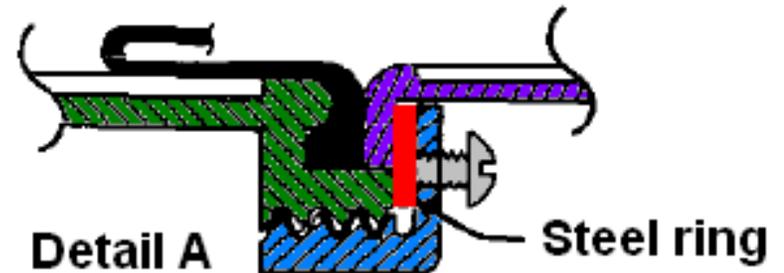
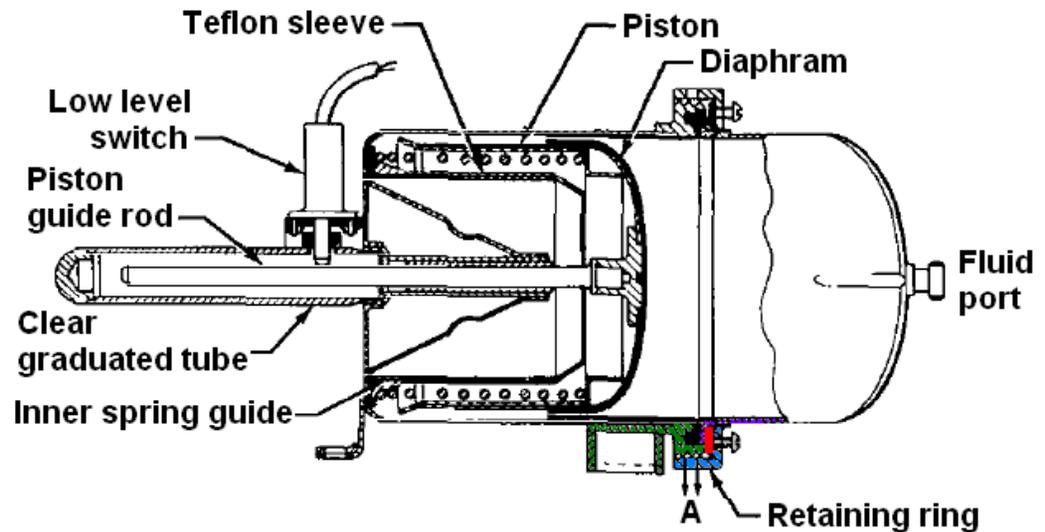
**Coolant Accumulator**

- ❑ The **Coolant Accumulators** proved difficult to build.
  - ♦ diaphragm was the sealing gasket, and irregularities caused inadequate sealing forces
  - ♦ size of the flange groove was reduced to achieve proper bead squeeze
  - ♦ flange had to be redesigned to control the amount of squeeze
  - ♦ torquing the retaining ring to high values caused the diaphragm to wrinkle
  - ♦ had to add screws
  - ♦ finally stopped the leakage

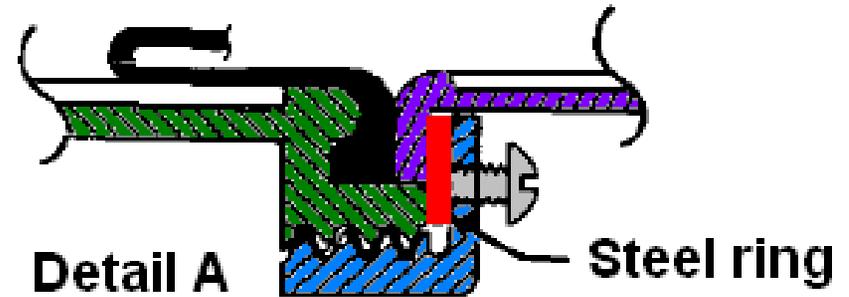
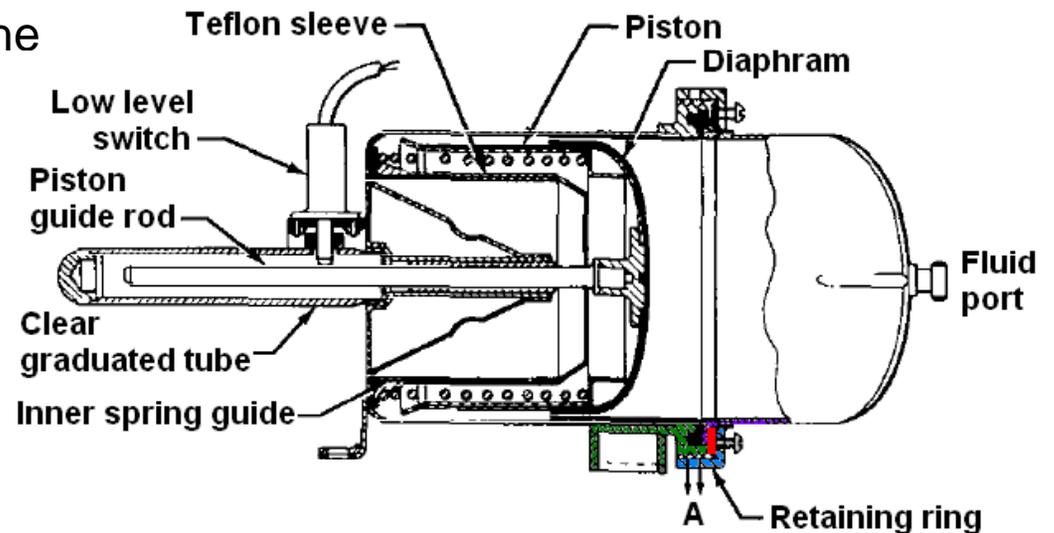
Coolant Accumulator

❑ After the leakage problems with the **Coolant Accumulators** was fixed, a large crack was found at the angle section of a retaining ring (blue in the diagram).

- ♦ the material (aluminum 2024T4) was being subjected to stresses greater than allowed for stress corrosion control
- ♦ alloy had to be changed and the cross-section increased.

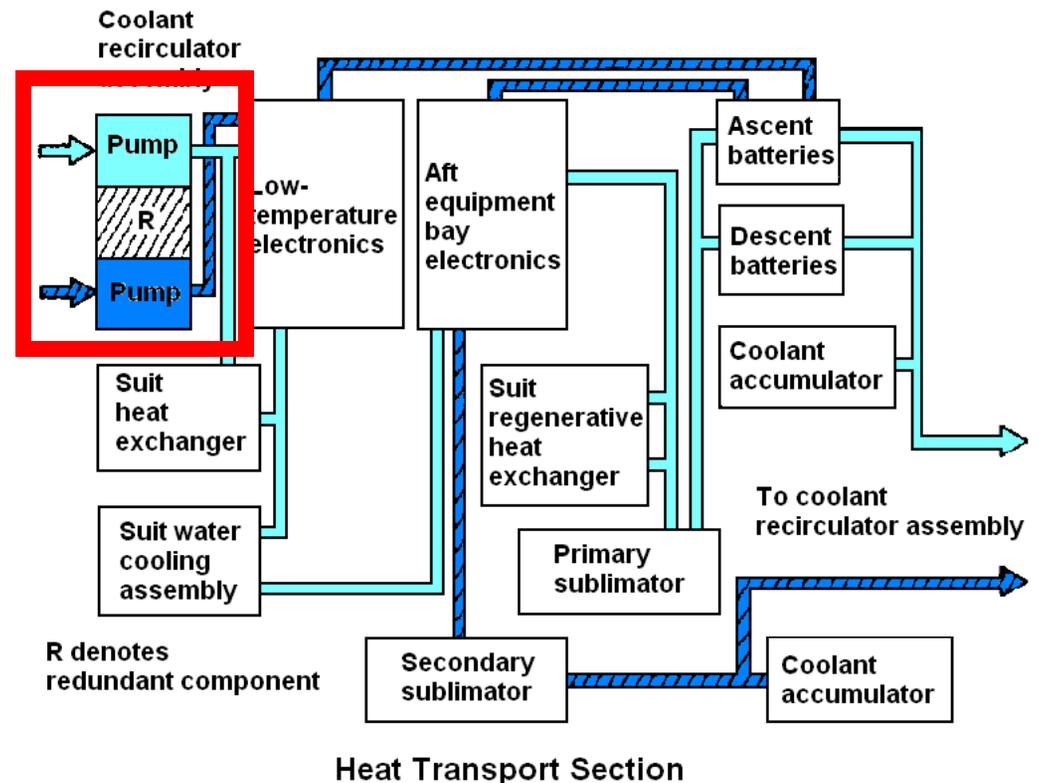
- ❑ The coolant pumps were located in the cabin and produced high noise levels.
  - noise was not from the pumps themselves resonances within the lines and structures
  - expansion device (muffler) that first flew on LM-8 (Apollo 14) downstream of the pumps

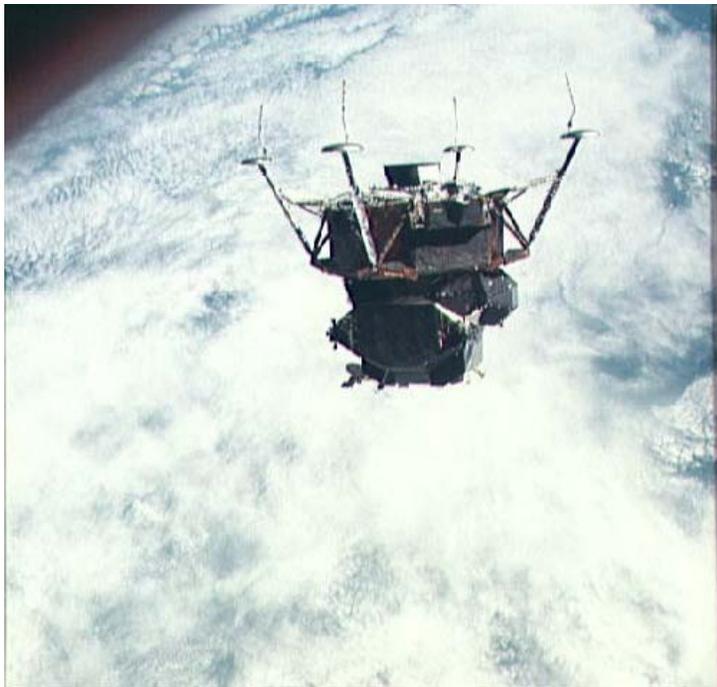
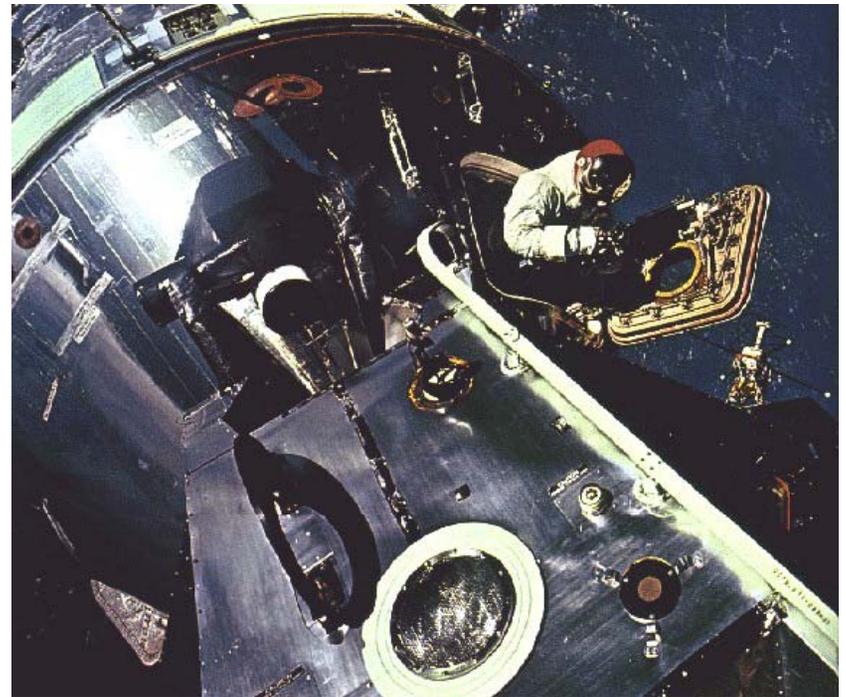
- ◆ High cabin noise level
- ◆ One crewman improvised earplugs
- ◆ Testing in another LM ID'd the glycol loop pumps
- ◆ Acoustic coupling into the lines and the pressure vessel

- ◆ Cabin fans were also contributors
- ◆ Subsequent missions used only one fan at a time
- ◆ Crew were fitted with earplugs with 10 dB noise suppression

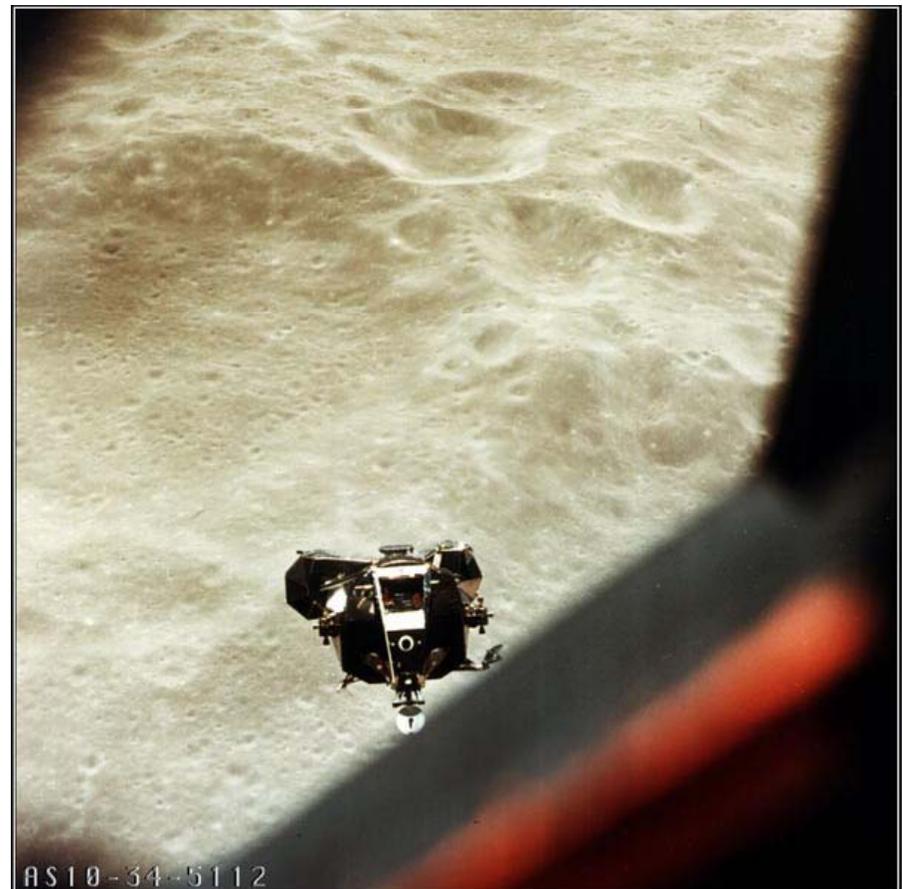
- ♦ A drop in cabin pressure at jettison,
- ♦ Indicated upper hatch opened (confirmed by flapping material in the same video)
- ♦ Docking tunnel was pressurized at the time the separation pyrotechnics were fired
- ♦ Added pressure from the pyros failed the hatch latch, allowing cabin venting
- ♦ Air outflow slammed the hatch mostly closed, except for a small area that continued to vent the cabin slowly

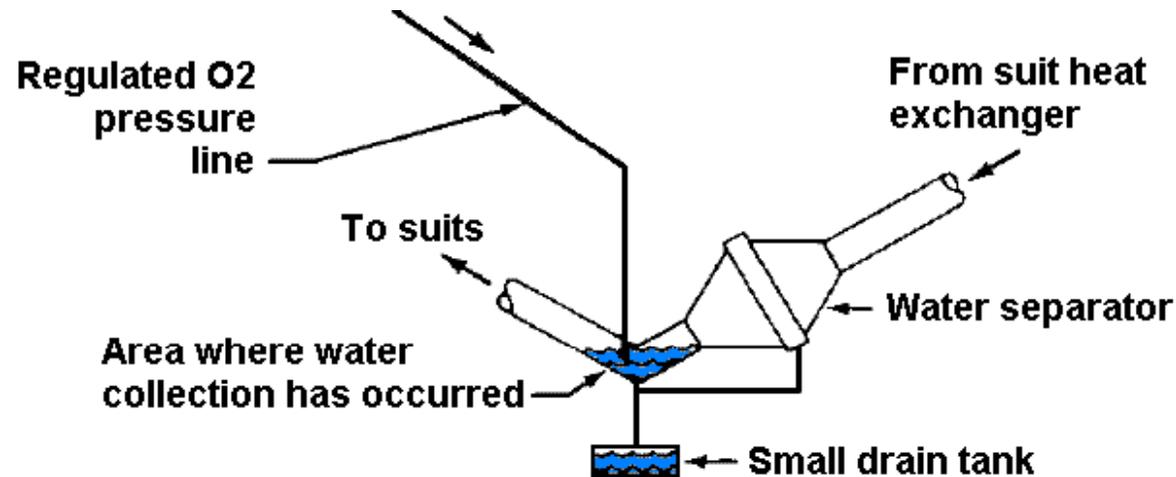
- ♦ **High CO<sub>2</sub> indicated** shortly after lunar module ascent
- ♦ Selection of secondary LiOH canister did not help
- ♦ C&W indication when primary LiOH was reselected
- ♦ Prior to lunar EVA, the ECS had been stopped
- ♦ Allowed condensate in the separator to drain into a tank
- ♦ If the tank was not quite big enough, water could enter the suit loop (CDR noted water in his suit)
- ♦ Any liquid in the line would adversely affect CO<sub>2</sub> measurements

High CO<sub>2</sub> indications – continued. To preclude this, the vent line was relocated upstream of the fans, effective for Apollo 13.

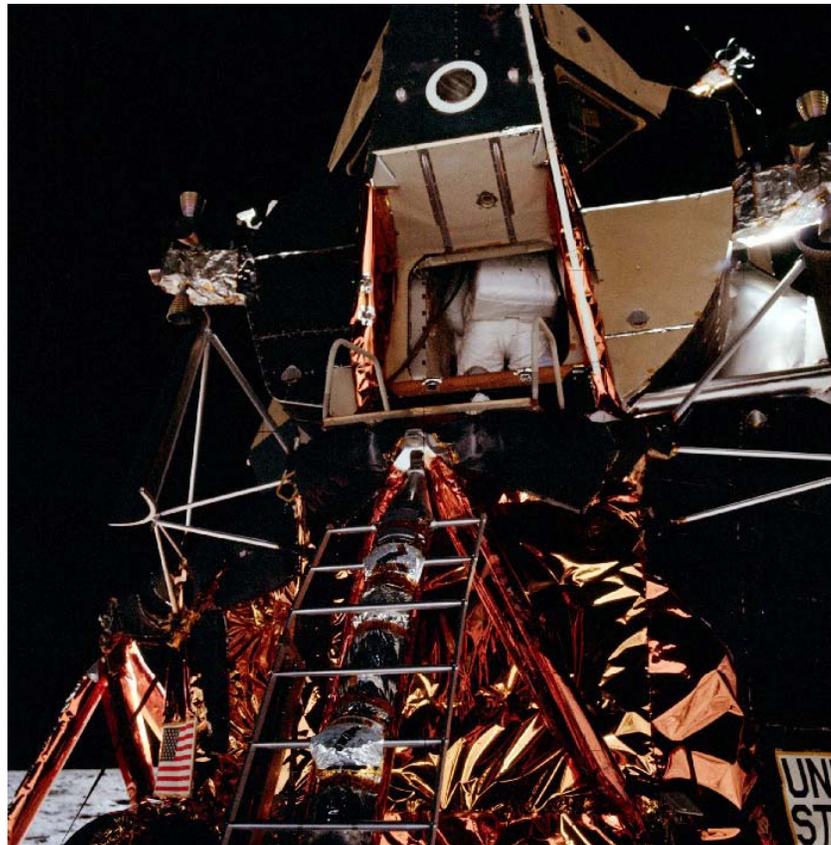
- ◆ **Slow cabin decompression** observed prior to EVA
- ◆ For subsequent flights, the bacteriological filter omitted
- ◆ Decompression time reduced from about 5 minutes to 2 minutes
