Investigation of Orbital Debris Impacts on Shuttle Radiator Panels

Abstract

This paper documents the data collected from two hypervelocity micro-meteoroid orbital debris (MMOD) impact events where the shuttle payload bay door radiator sandwich panel was completely perforated. Scanning Electron Microscope/Energy-Dispersive x-ray Spectroscopy (SEM/EDS) analysis of impact residue provided evidence to identify the source of each impact. Impact site features that indicate projectile directionality are discussed, along with hypervelocity impact testing on representative samples conducted to simulate the impact event. The paper provides results of a study of impact risks for the size of particles that caused the MMOD damage and the regions of the orbiter vehicle that would be vulnerable to an equivalent projectile

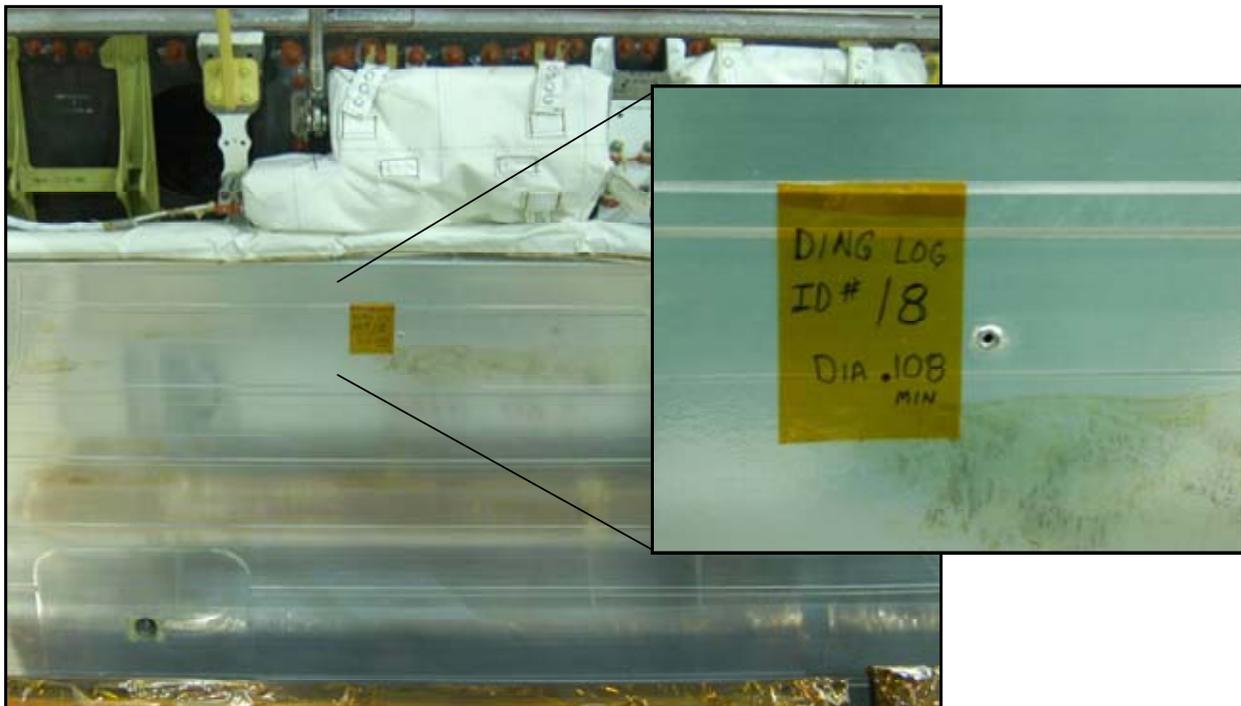
Postflight inspections of shuttle OV-104 (Atlantis) at the Kennedy Space Center (KSC) following the STS-115 mission revealed a face sheet perforation near the hinge line on the RH4 payload bay door radiator panel (Figure 5). This was the largest of five MMOD impacts found on the radiators during the post STS-115 refurbishment flow. The general location of the damage site and the adjacent radiator panels can be seen in Figure 6.

Figure 5. STS-115 Radiator MMOD impact damage (front side).

Measurements showed a 3.2 mm x 2.7 mm diameter entry hole in the face sheet. Figure 5 shows the initial front side damage, while figure 7 shows the front face sheet with the thermal tape removed in the area of damage. The right hand image in Figure 7 Ultrasonic testing indicated a maximum face sheet debond extent of approximately 25 mm from the entry hole. X-ray examinations revealed damage to an estimated 31 honeycomb cells with an extent of approximately 22 mm x 28 mm. Boroscope imaging through the entry hole (Figure 7) shows the orientation of the rear face sheet damage. Subsequent boroscope observations on the rear face sheet (Figure 8) show impact damage features including a 0.79 mm diameter hole, a ~1.3mm tall bulge and a larger ~5.1mm tall bulge that exhibited a crack over 6.8mm long.

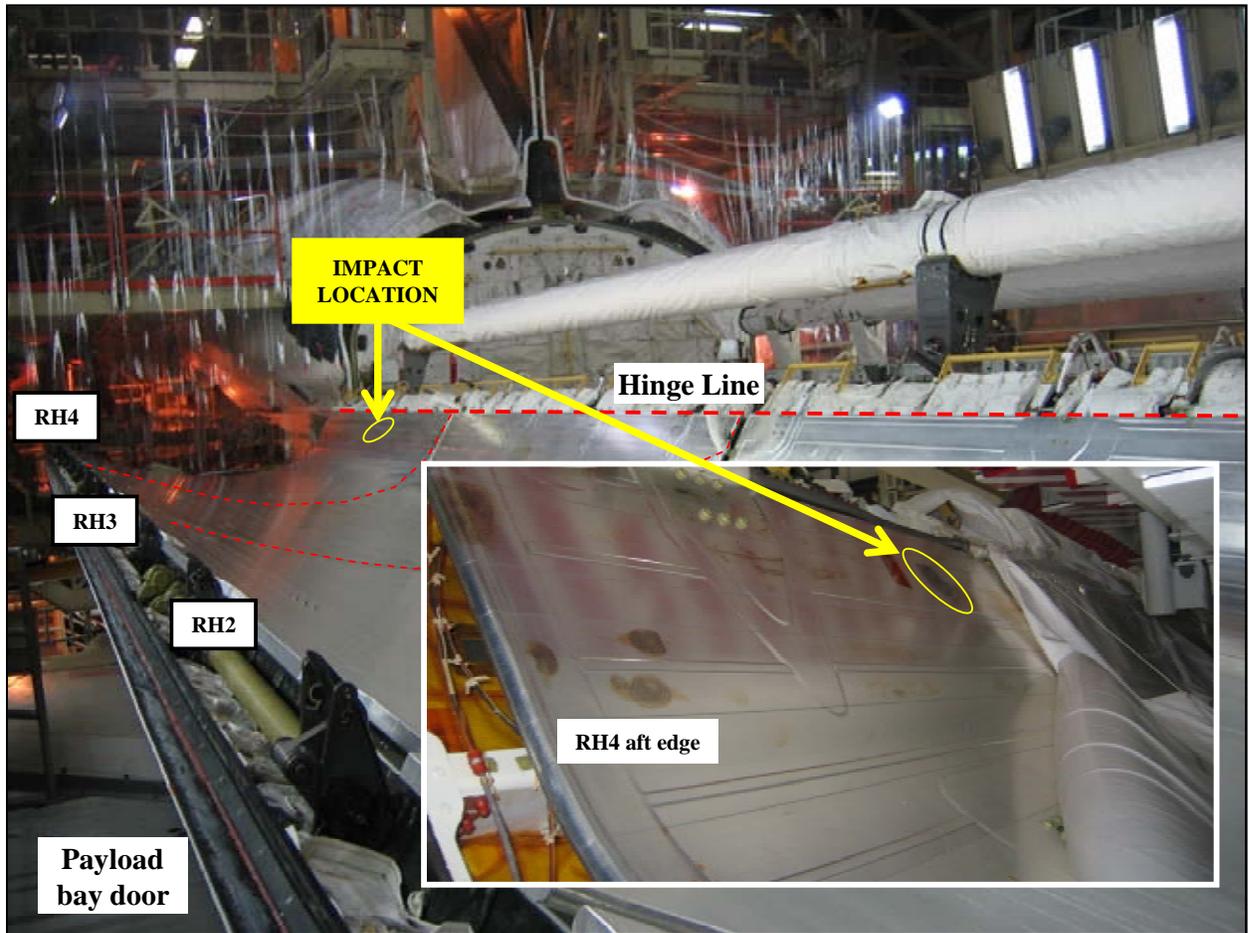
Figure 6. STS-115 panel RH4 impact location.

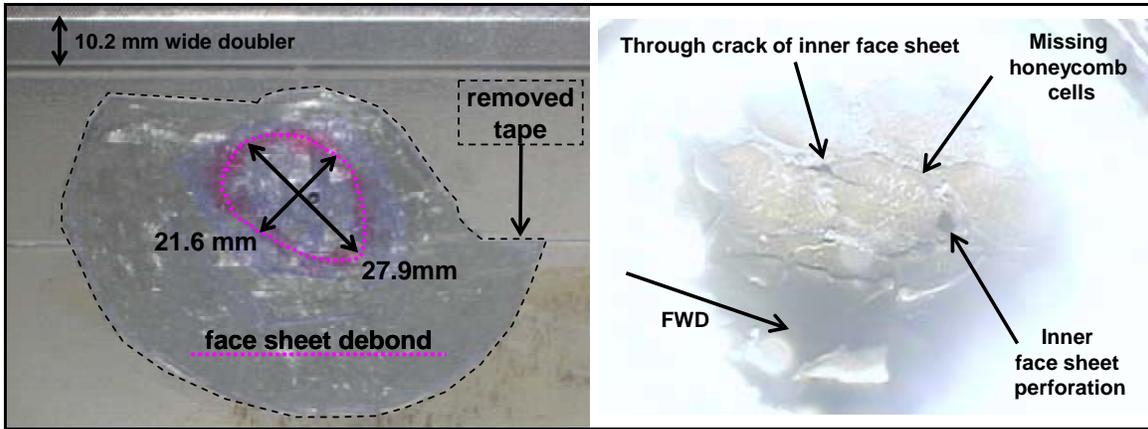
Figure 7. Front face sheet with thermal tape removed (left), view through entry hole into honeycomb panel (right).

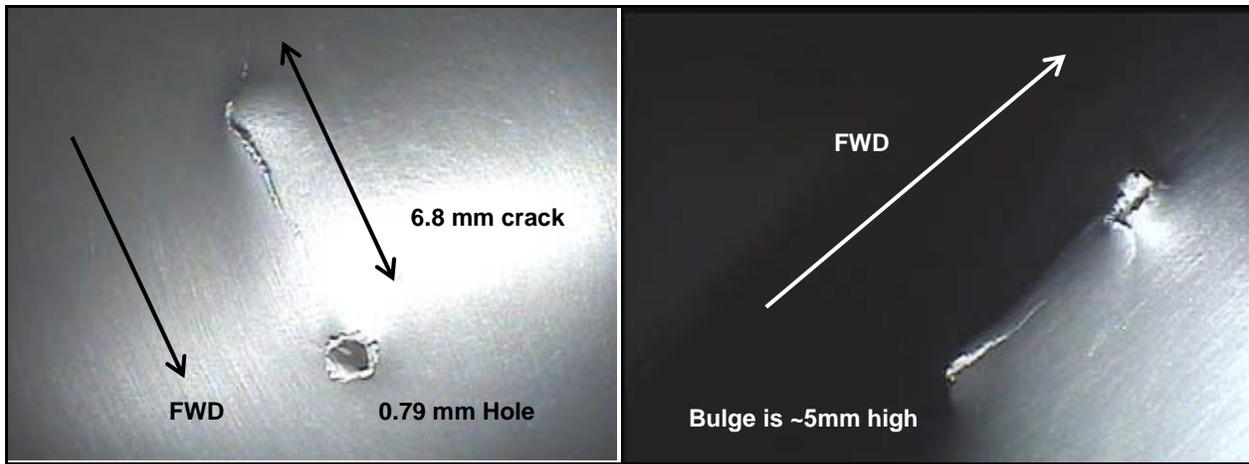
Figure 8. Two views of STS-115 RH4 rear face sheet damage.

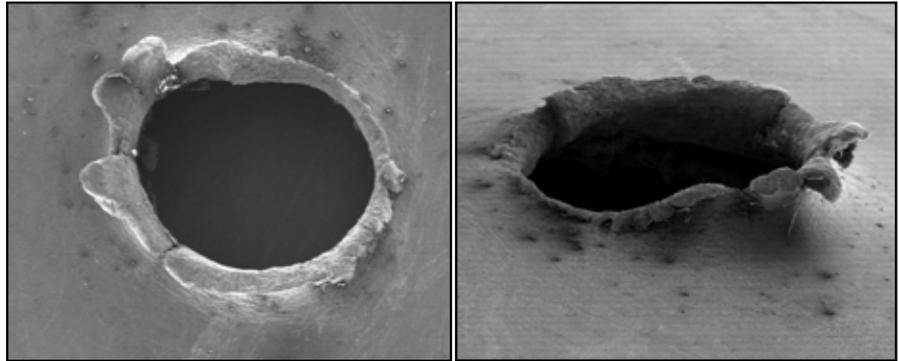
Figure 9. SEM images of hole in front face sheet. Asymmetric nature of lip can be seen in the oblique view.

Figure 9 shows SEM images of the entry hole in the face sheet. The asymmetric height of the lip may be attributed to projectile shape and impact angle. Numerous instances of a ceramic fiber organic matrix composite were observed in the face sheet tape sample. The fibers were approximately 10 micrometers in diameter and variable lengths.

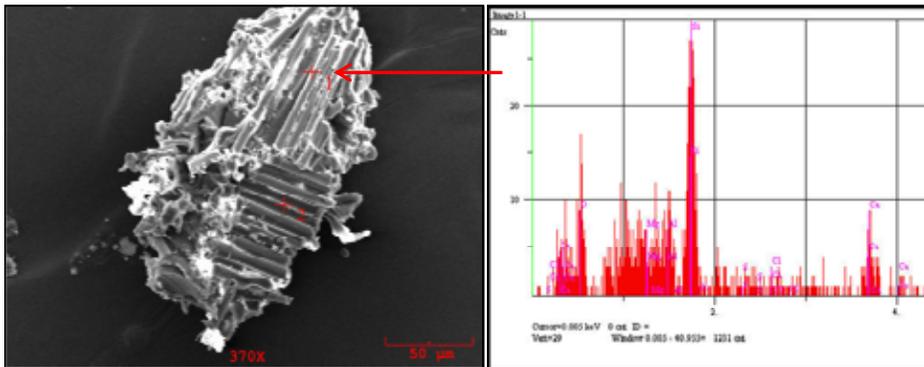
Figure 10. Example SEM image and EDS spectra of circuit board fragment.

EDS analysis indicated a composition of Mg, Ca, Al, Si, and O. Figures 10 and 11 present images of the fiber bundles, which was believed to be circuit board material.

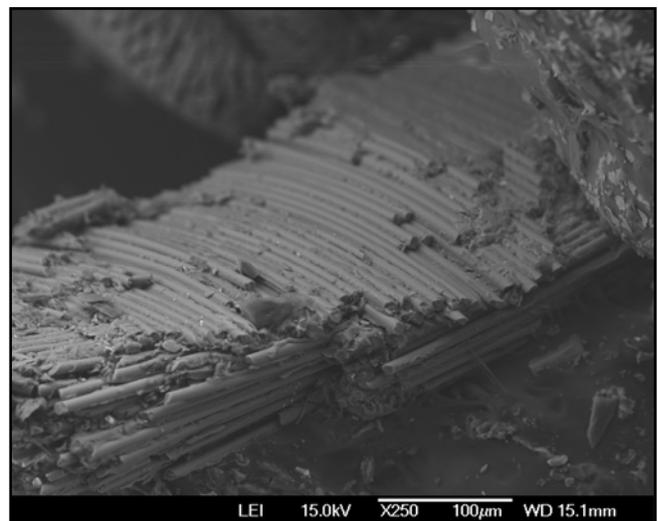
Figure 11. SEM image of circuit board fragment.

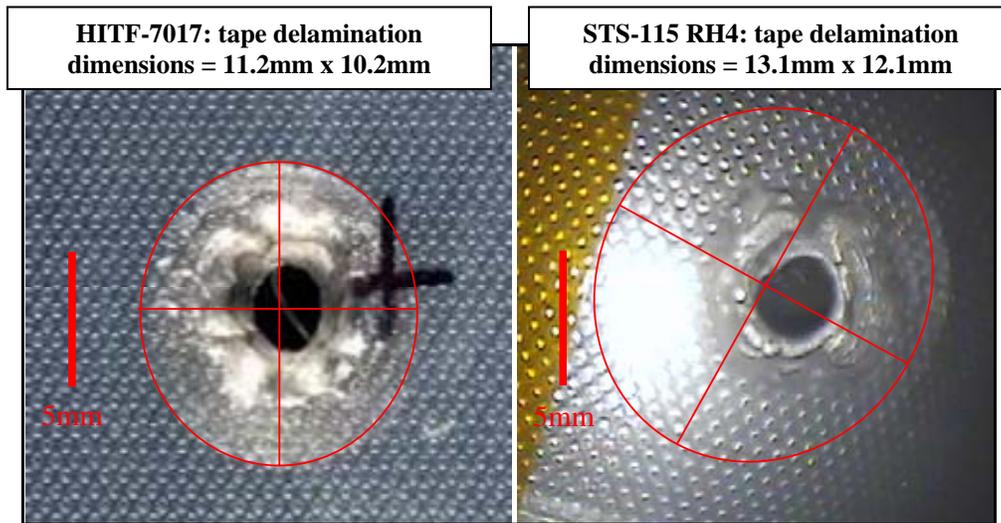
A test program was conducted to simulate the observed damage to the radiator face sheet and honeycomb. Twelve test shots were performed using projectiles cut from a 1.6mm thick fiberglass circuit board (3). Results from test HITF07017, shown in figures 12 and 13, compares reasonably well with the observed impact features on the STS-115 radiator. The test was performed at 4.14 km/sec with an impact angle of 45 degrees using a 1.25 mm diameter cylindrical projectile with a length of 1.25 mm and mass of 2.53 mg. The fiberglass circuit board material has a density of 1.65 g/cm³.

Figure 12. Entry hole in upper face sheet of NASA test HITF-7017 compared to STS-115 entry hole.

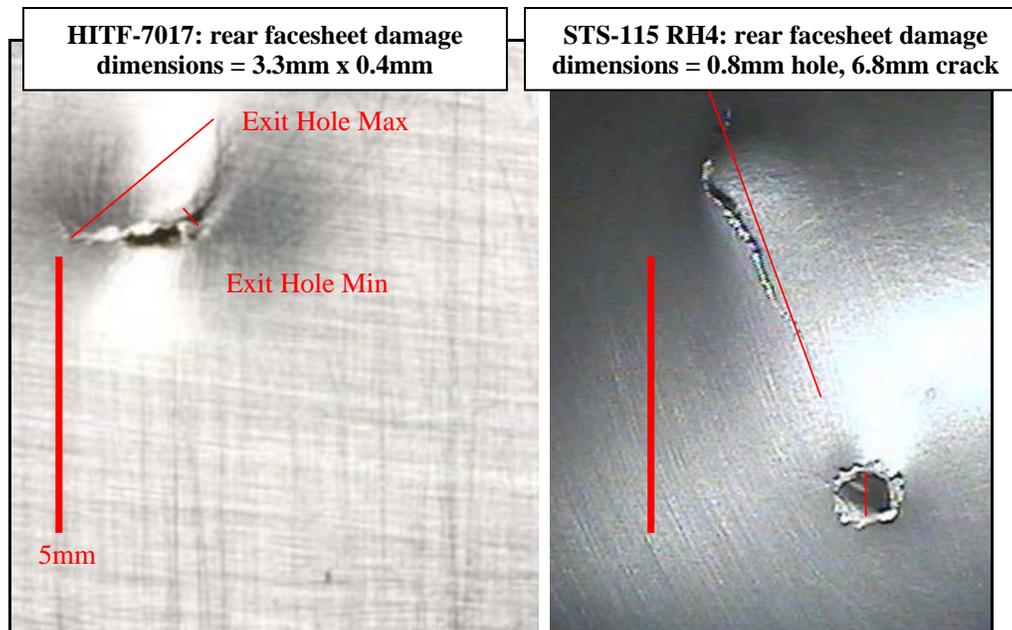
Figure 13. Exit hole in lower face sheet of NASA test HITF-7017 compared to STS-115 exit damage.

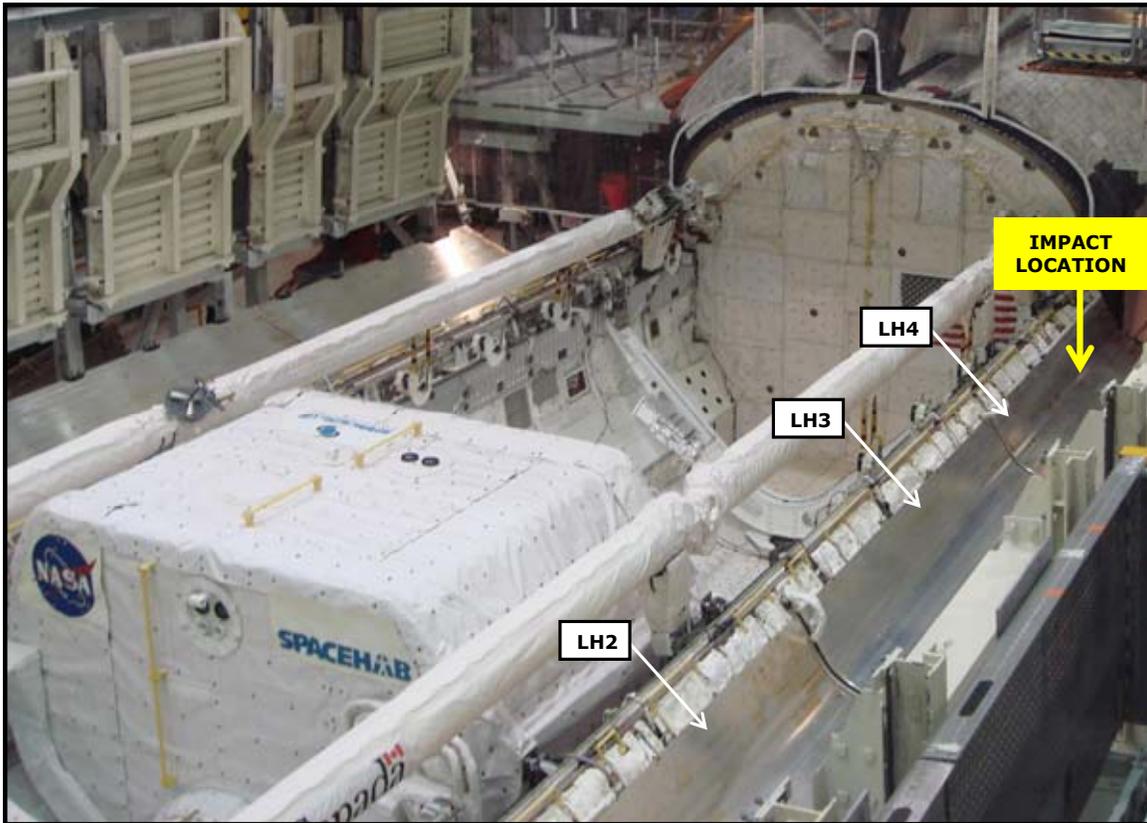
During the August 2007 STS-118 mission to the International Space Station, an MMOD particle impacted and completely penetrated a radiator panel and the underlying TCS blanket of shuttle OV-105 (Endeavour), leaving deposits on (but no damage to) the graphite epoxy sandwich panel payload bay door. Figure 14 illustrates the approximate location of the impact near the hinge line on the port side aft radiator panel (LH4). While it is not unusual for orbiters to be impacted by small MMOD particles, the damage from this impact is larger than any previously documented on the shuttle radiator panels.

Figure 14. STS-118 panel LH4 impact location.

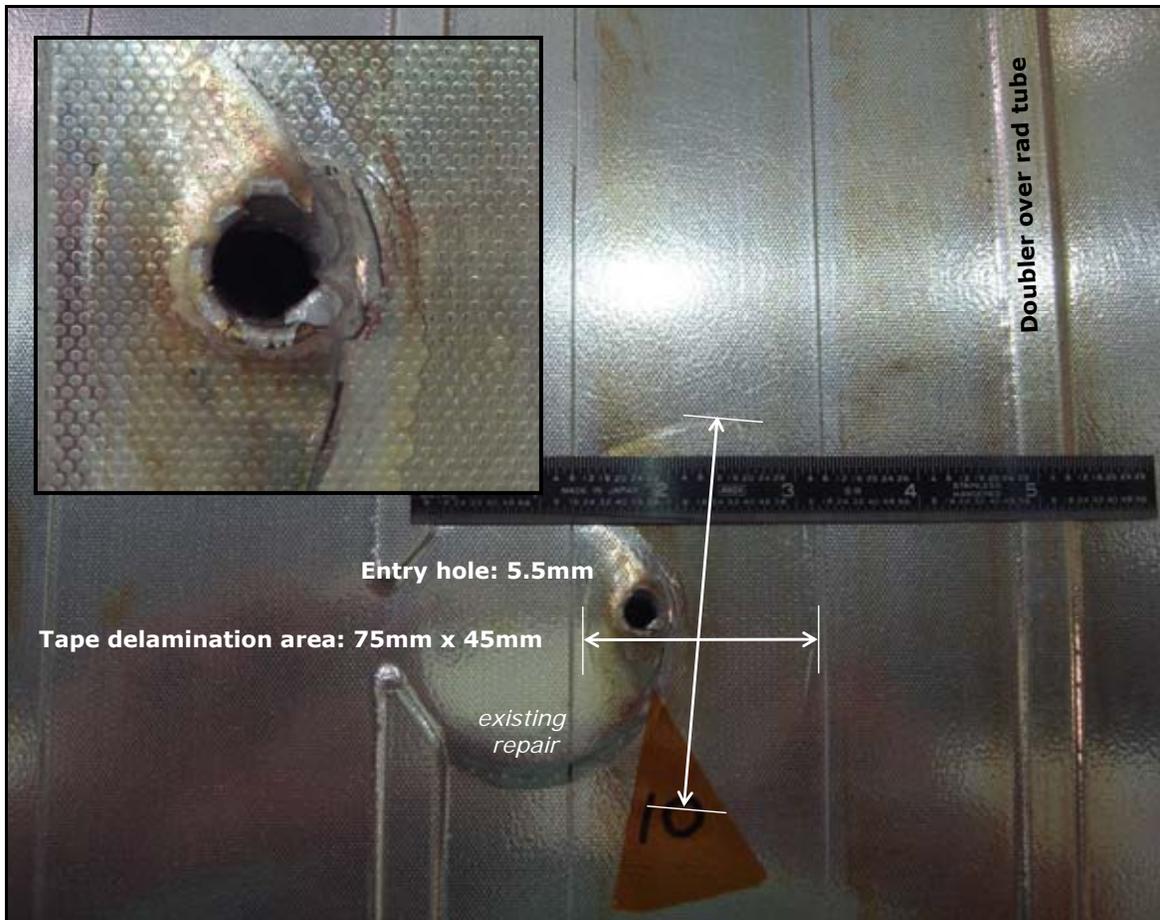
Figure 15. STS-118 LH4 entry hole.

A close-up photograph of the radiator impact entry hole is shown in Figure 15. The entry hole in the outer radiator face sheet measured 5.5 mm in diameter. The impactor also perforated an existing 0.305 mm doubler that had been bonded over the face sheet to repair previous damage. The resulting debris cloud caused considerable damage to the internal honeycomb core with approximately 20 honeycomb cells having been either completely destroyed or damaged.

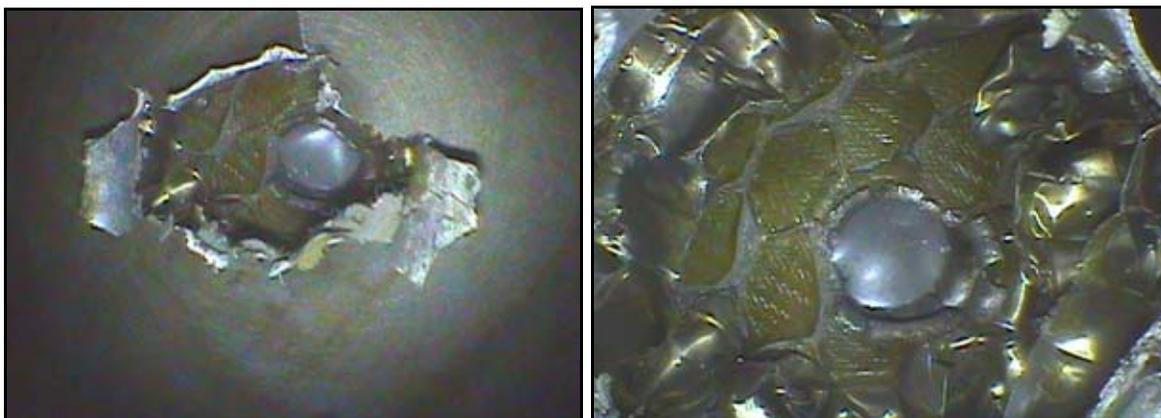
Figure 16. STS-118 LH4 exit hole.

Figure 16 is a view of the exit hole in the rear face sheet, and partially shows the extent of the honeycomb core damage and clearly shows the jagged “petaled” exit hole through the backside face sheet. The rear face sheet exit hole measured approximately 12 mm by 19 mm. The remnants of the impacting particle and radiator panel material transported through the rear face sheet hole perforated the TCS blanket approximately 125 mm behind the rear face sheet.

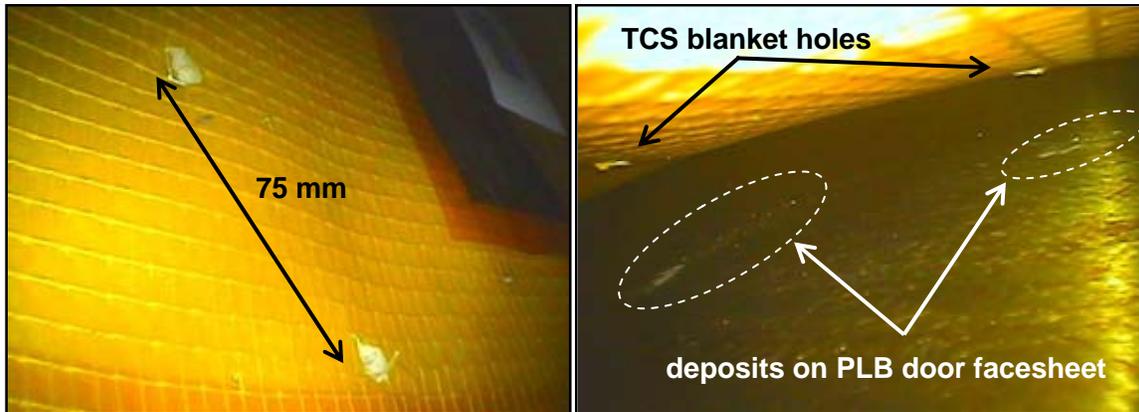
Figure 17. TCS blanket damage under STS-118 LH4.

Figure 17 shows these two impacts, which are located approximately 75 mm apart. The boroscope image on the left shows the area under the exit hole in radiator sandwich panel. The boroscope image on the right was acquired on the opposite side of the blanket between the TCS blanket and the payload bay door sandwich panel face sheet. Two exit holes can be seen in the blanket and residue can be seen on the graphite/epoxy face sheet of the payload bay door beneath the TCS blanket, but no additional damage was detected on the face sheet.

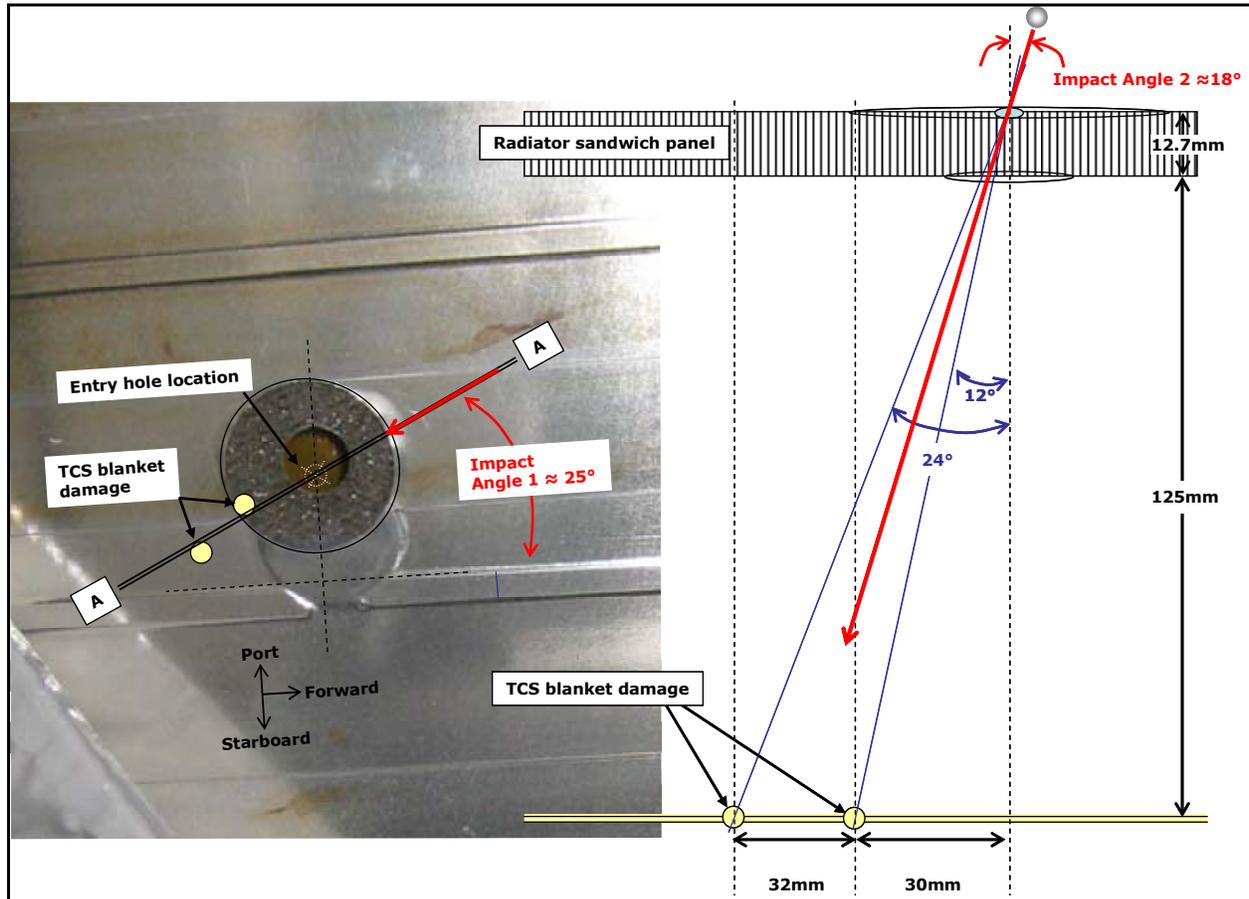
Figure 18 illustrates the relationship of the face sheet entry hole to the TCS blanket damage, which may indicate the direction of the impacting particle. The image on the left side of figure 18 shows an overhead view of the damaged radiator after the face sheet holes were cored out of the panel. The entry hole location and the two underlying TCS blanket damage sites are annotated on the image. Section A-A, running through the entry hole and TCS blanket damage locations, describes a 25° angle from the longitudinal axis of the shuttle. The 2nd impact angle can be seen in section A-A on the right side of figure 18. An average 18° angle of impact to the surface normal was derived by measuring the angles of the two damage sites in TCS blanket to the entry hole. The damage offset between panel damage and blanket damage indicates impact direction was forward to aft of vehicle (with a 25° impact angle bias to the longitudinal axis). However, the 18° impact angle from surface normal was likely influenced by channeling effects of the honeycomb, and a more oblique impact angle could be possible.

Figure 18. STS-118 LH4 estimated impact angles.

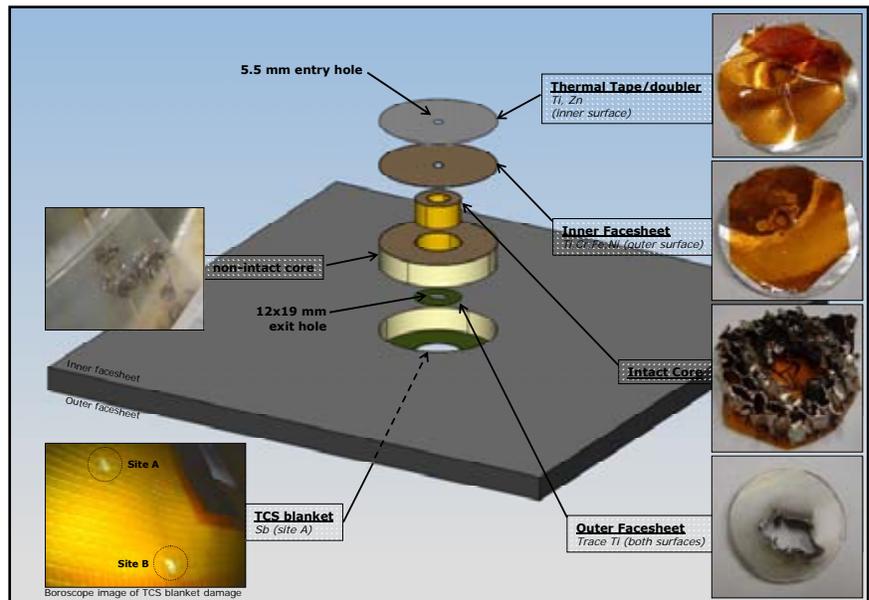
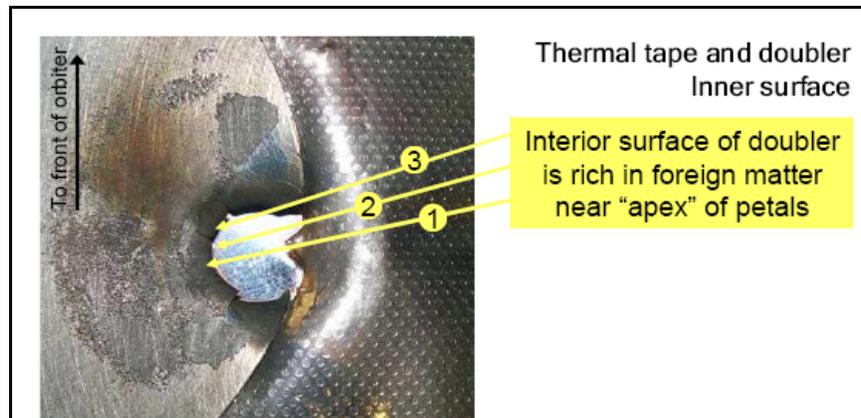
Sample collection steps were inserted into the repair procedure. Six different areas were sampled during the repair operation (Figure 19). Intact samples were collected of the outer thermal tape, outer face sheet, honeycomb core, and rear face sheet. Swabs of the two impact damage areas on the TCS blanket were also collected. Micro-meteoroid and orbital debris impacts usually leave residual particulate from the impactor material in and around the damaged area. This residue is collected, analyzed, and in many cases, a determination can be made as to the impactor source as micro-meteoroid or orbital debris. In some cases, specific types of orbital debris particles can be identified, such as rocket propellant or electrical components. To perform this analysis, the samples were transferred to the NASA Johnson Space Center (JSC) Hypervelocity Impact Technology Facility (HITF) in Houston, Texas. Scanning Electron Microscope (SEM) equipped with energy-dispersive x-ray spectroscopy (EDS) tools were used to identify potential residue material from the impactor and to identify the elemental makeup of the impactor. Results from the analysis indicate that the impacting particle was a titanium-rich orbital debris particle containing traces of zinc and antimony (Figure 19).

Figure 19. Sample collection and results of SEM/EDS analysis.

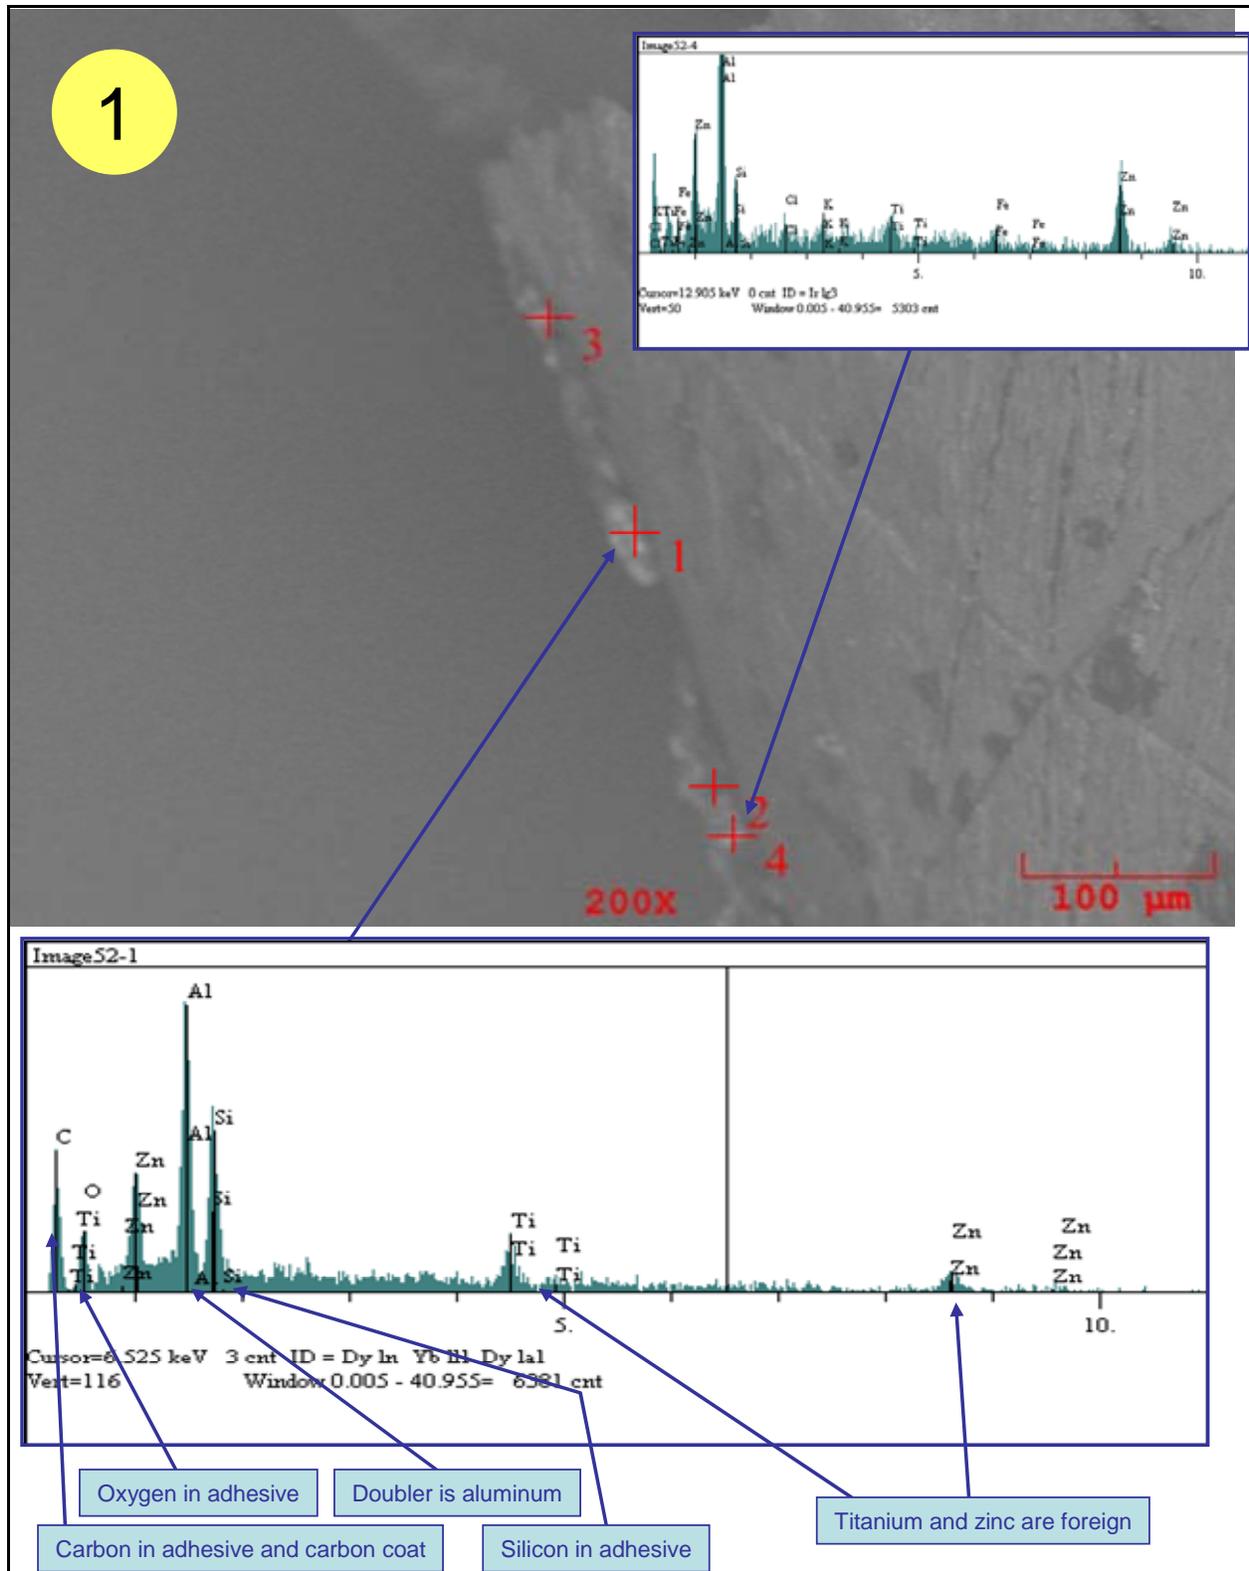
Figure 21. SEM/EDS analysis results of tape and inner surface of doubler (Area #1).

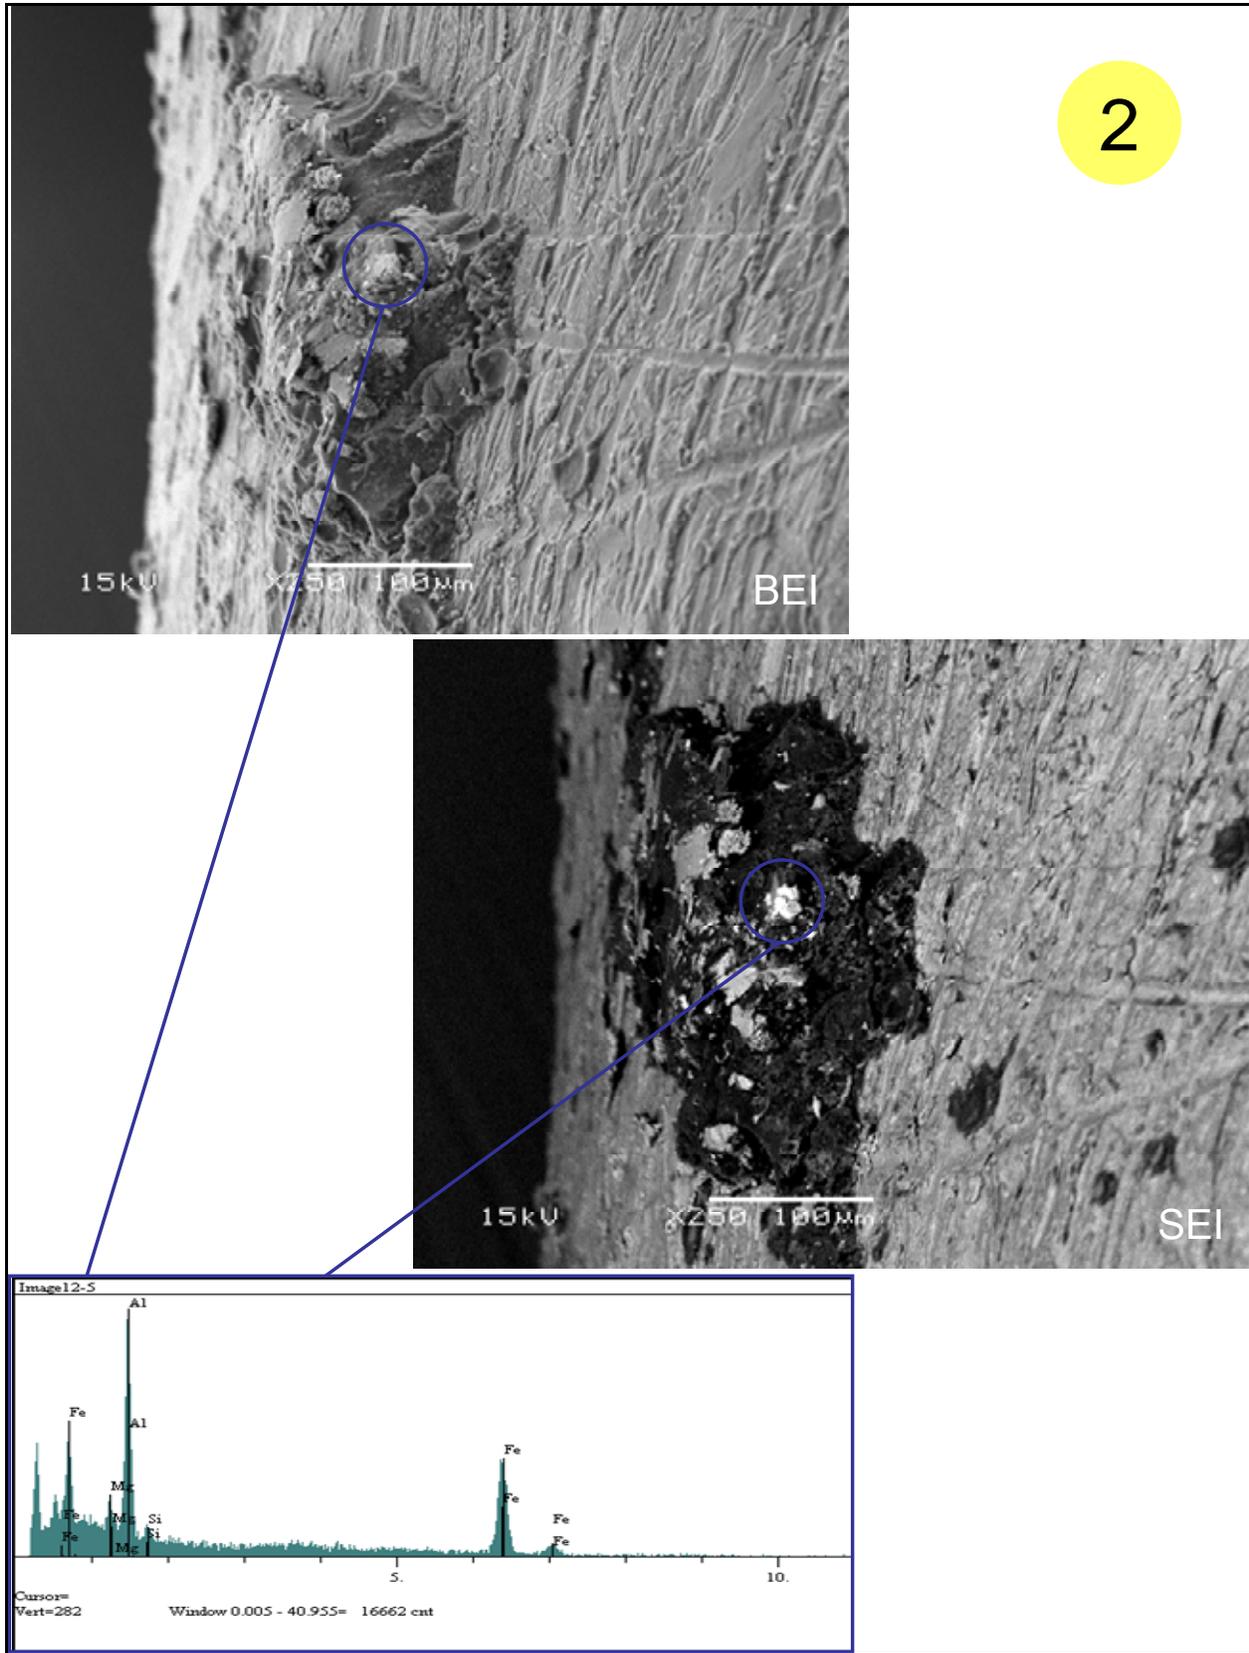
Figure 22. SEM/EDS analysis results of tape and inner surface of doubler (Area #2).

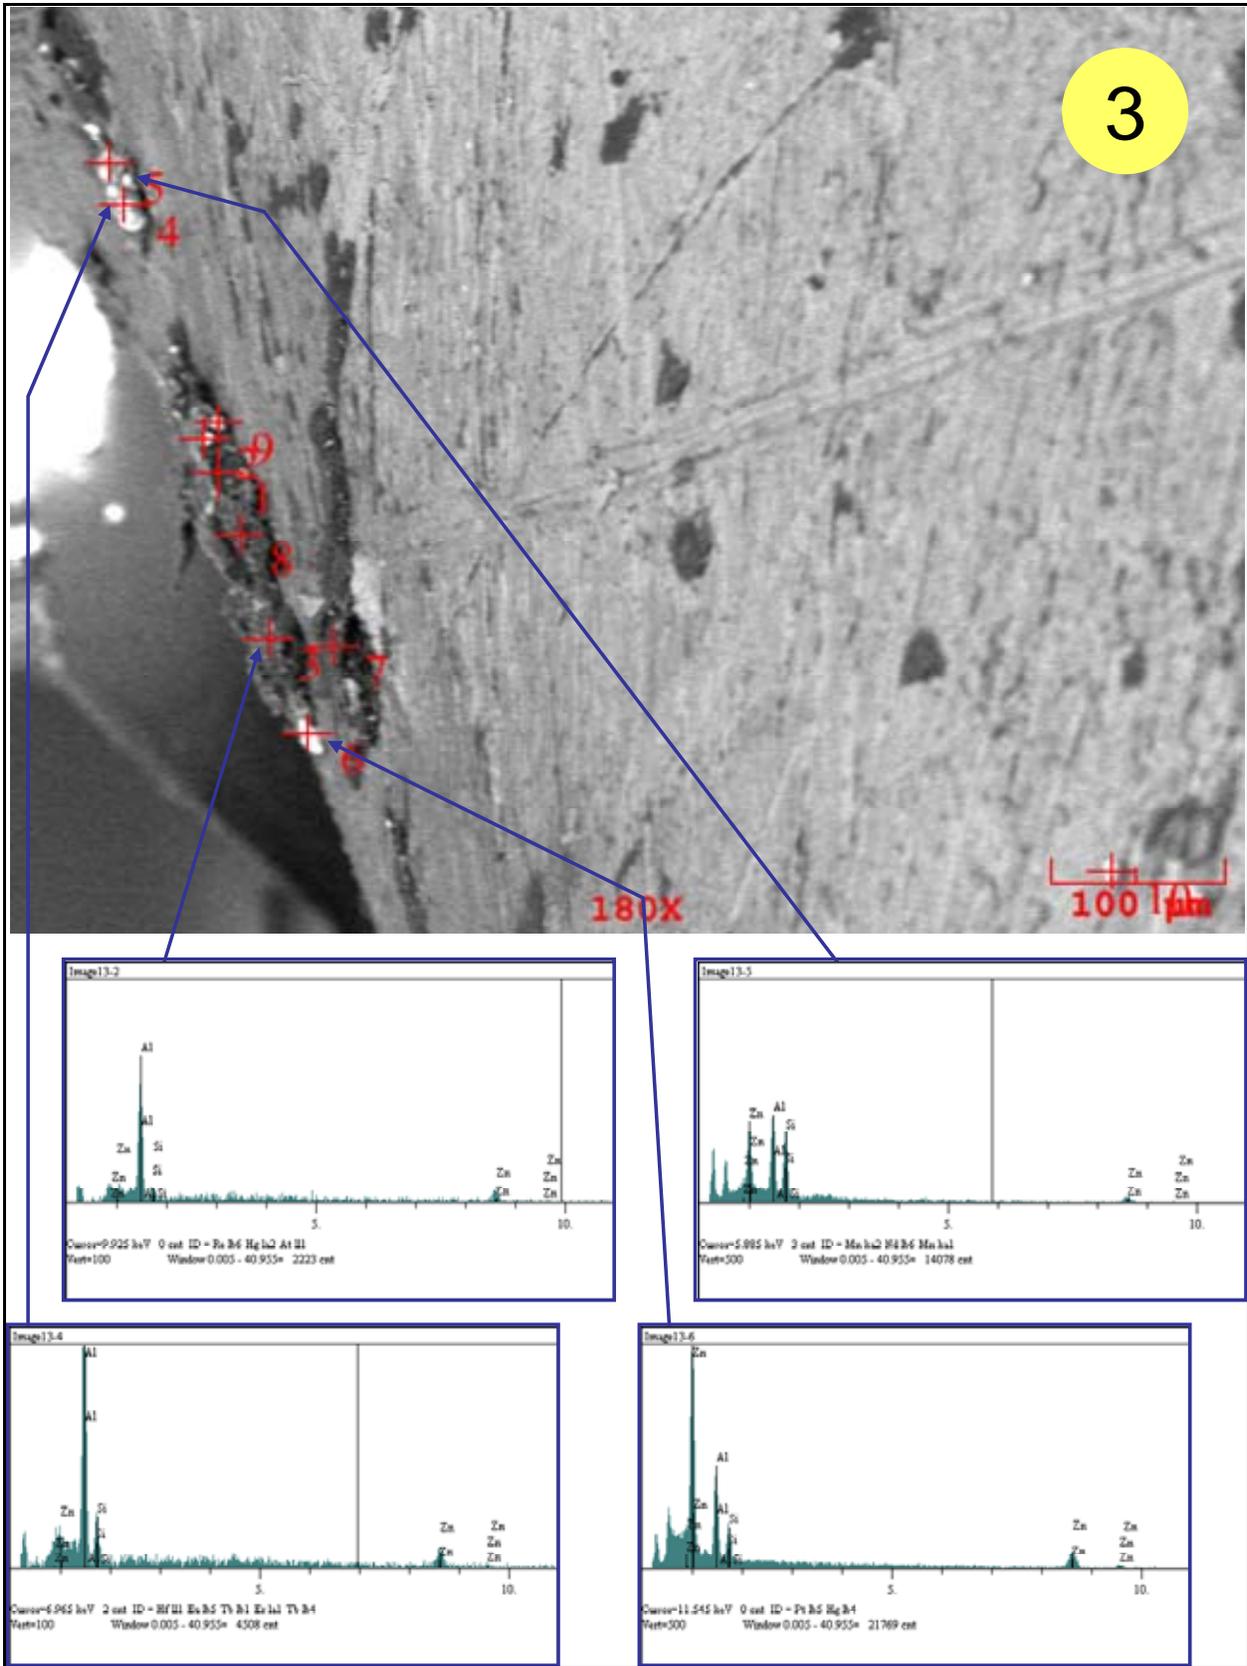
Figure 23. SEM/EDS analysis results of tape and inner surface of doubler (Area #3).

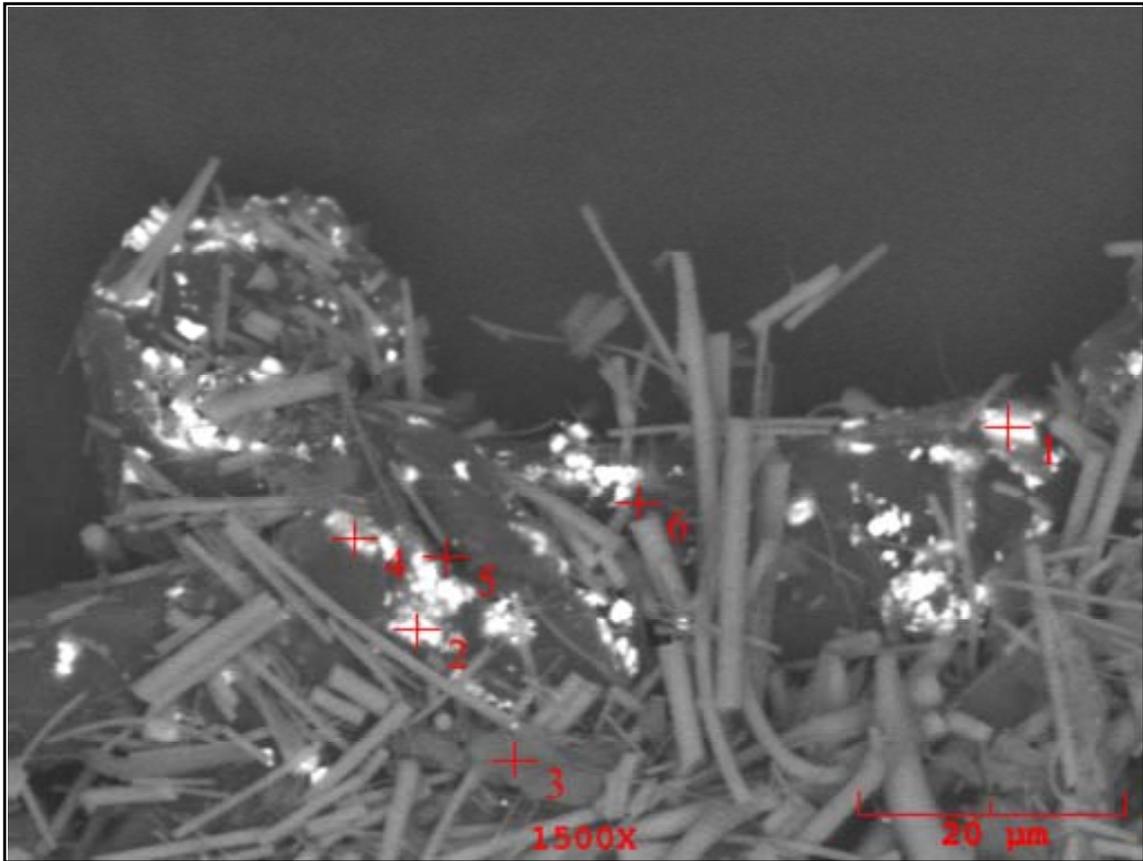
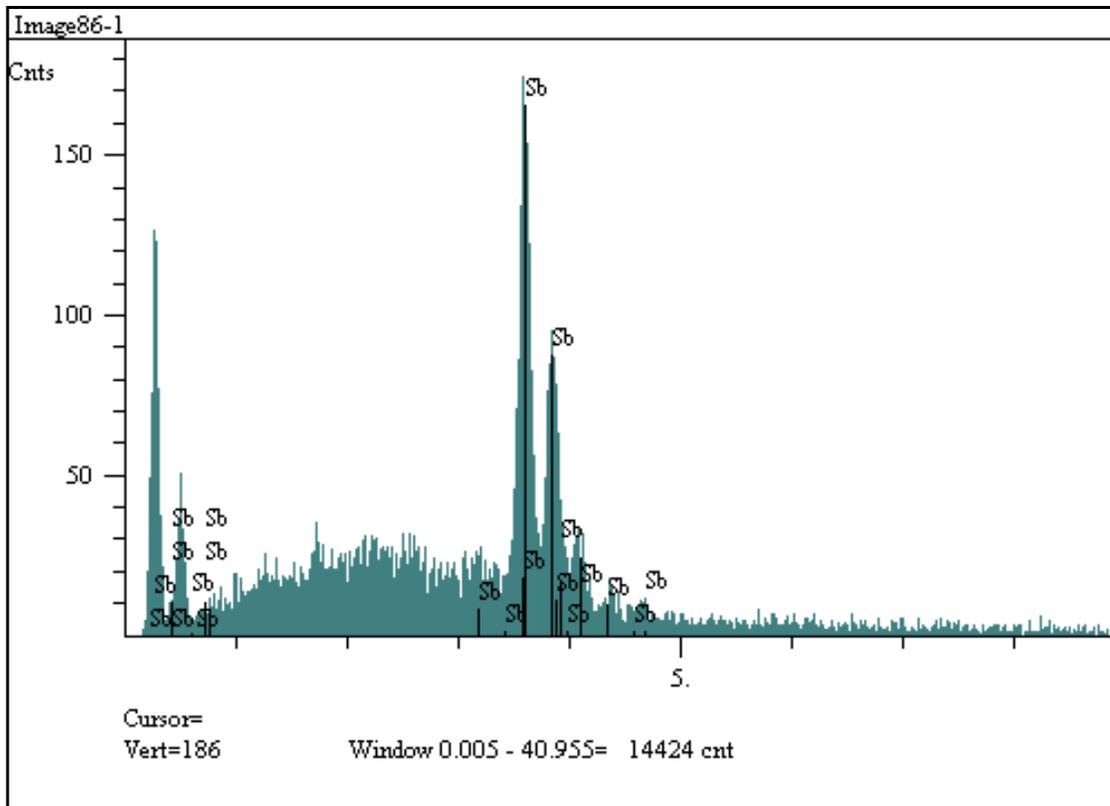
Figure 24. SEM/EDS analysis results, showing Sb intermingled with TCS blanket fibers.

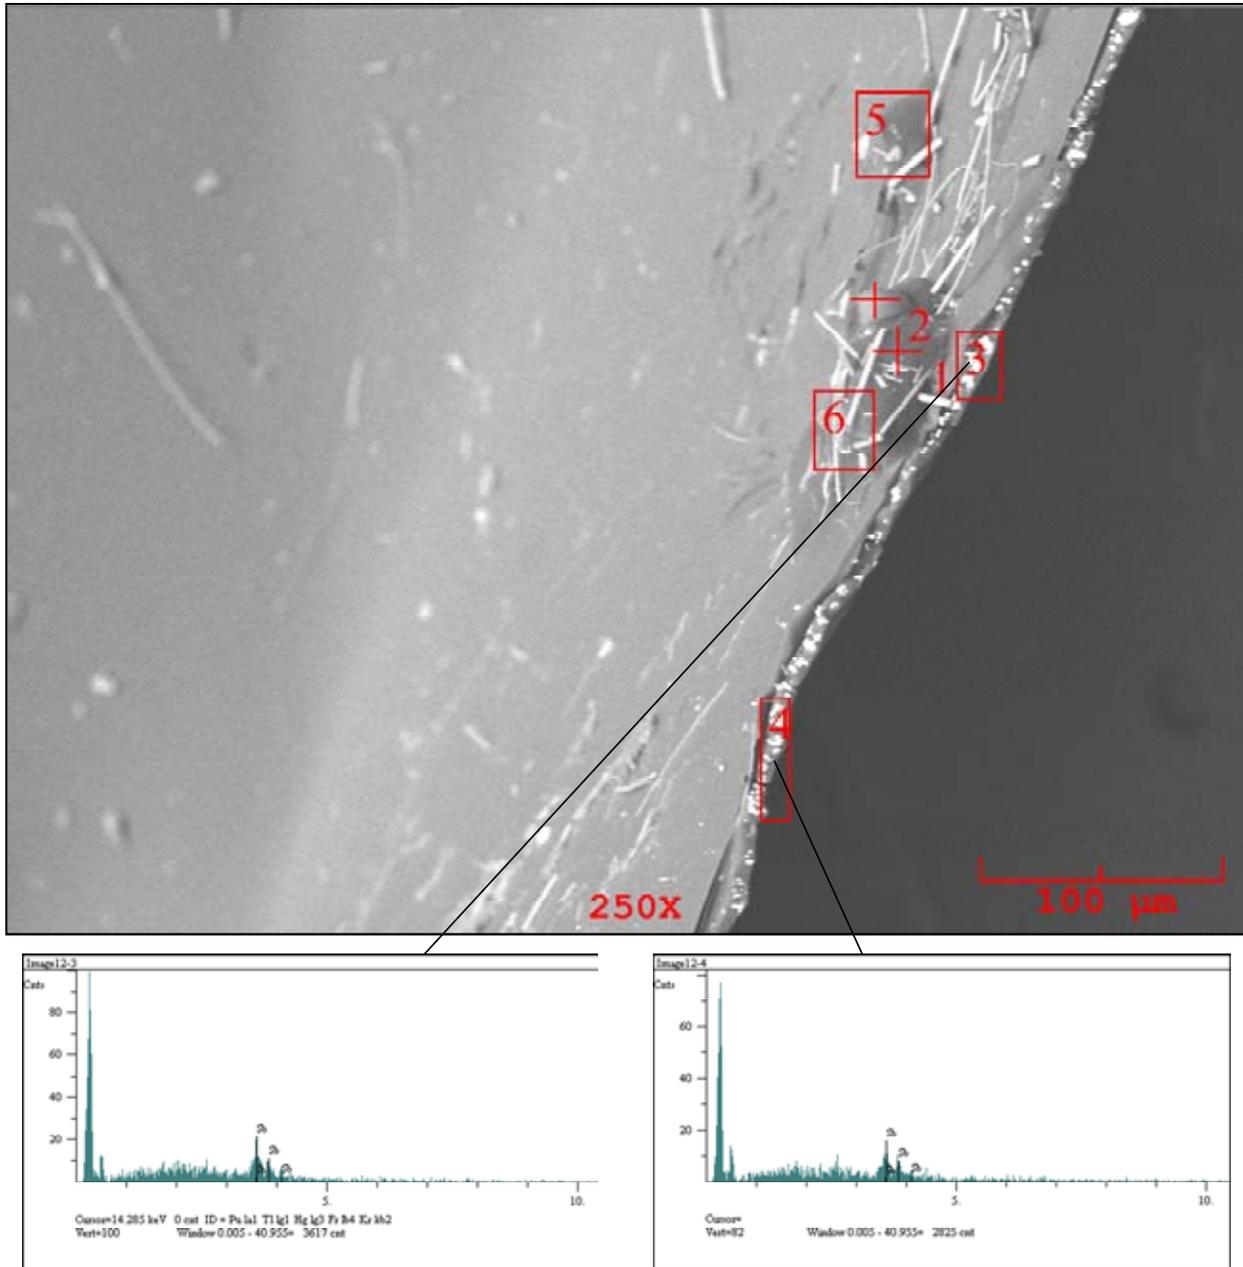
Figure 25. SEM/EDS analysis results of TCS blanket, showing Sb concentrations along some edges of surface layer.
