Investigation of Orbital Debris Impacts on Shuttle Radiator Panels

Abstract

This paper documents the data collected from two hypervelocity micro-meteoroid orbital debris (MMOD) impact events where the shuttle payload bay door radiator sandwich panel was completely perforated. Scanning Electron Microscope/Energy-Dispersive x-ray Spectroscopy (SEM/EDS) analysis of impact residue provided evidence to identify the source of each impact. Impact site features that indicate projectile directionality are discussed, along with hypervelocity impact testing on representative samples conducted to simulate the impact event. The paper provides results of a study of impact risks for the size of particles that caused the MMOD damage and the regions of the orbiter vehicle that would be vulnerable to an equivalent projectile

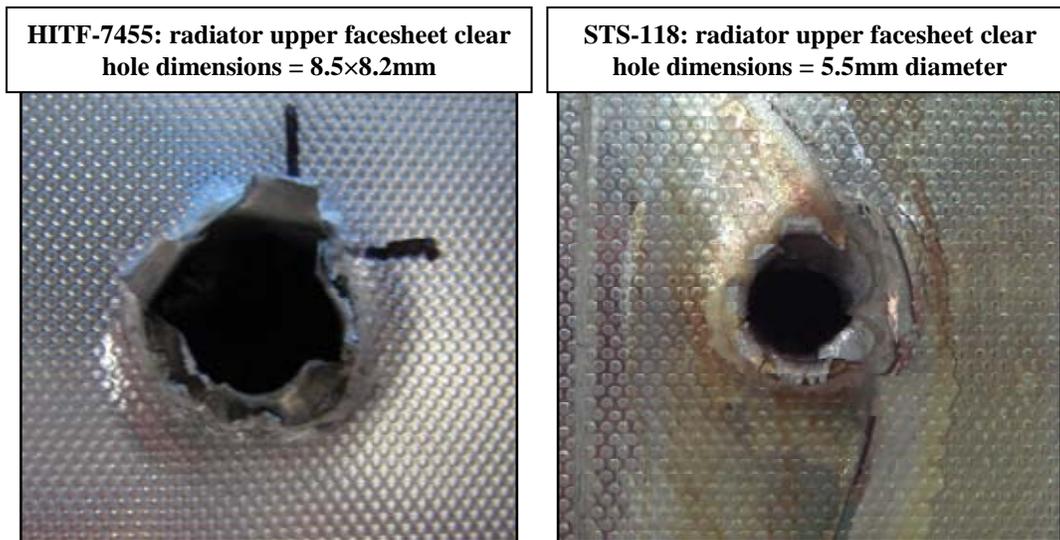
As with the STS-115 RH4 panel, a hypervelocity impact test program was performed in order to simulate the damage observed on the LH4 radiator panel of STS-118. A series of five impact tests were performed at the White Sands Test Facility (WSTF) using spherical aluminum (2017-T4) projectiles with a density of 2.79 g/cm². This density was considered representative of the titanium-heavy impactor material determined from the SEM analysis. All tests were performed at 45° incidence with velocities ranging from 6.79-7.09 km/s. Results from test HITF-7455 show the most favorable comparison with the RH4 radiator impact damage features. This test was performed at 6.79 km/s with a 1.42mm diameter projectile. The entry hole in the test (Figure 26) measured 8.5 mm × 8.2 mm, 50% larger than the entry hole observed on the flight hardware. There were three independent exit holes in the test, the largest of which measured 4.0 mm × 4.9 mm, less than a third of the size of the observed damage. About the perforation holes, the rear face sheet is bulged over an area measuring ~19 mm × 24 mm (Figure 27). It is considered that with a small increase in impact kinetic energy, the face sheet would exhibit a similar tearing failure mode as that observed on the flight hardware. The aluminum witness plate used in the test (Figure 28) showed a small number of fragment deposits and one 150µm deep crater which is comparable to the deposits found on the payload bay door.

Figure 26. Entry hole in upper face sheet of NASA test HITF-7455 compared to STS-118 entry hole.

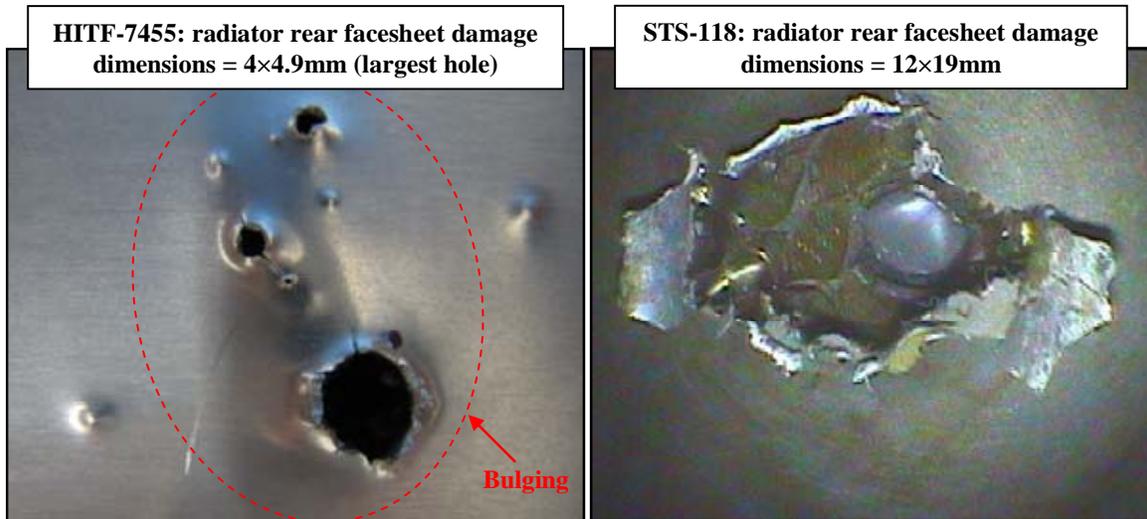
Figure 27. Exit damage in lower face sheet of NASA test HITF-7455 compared to STS-118 exit damage.

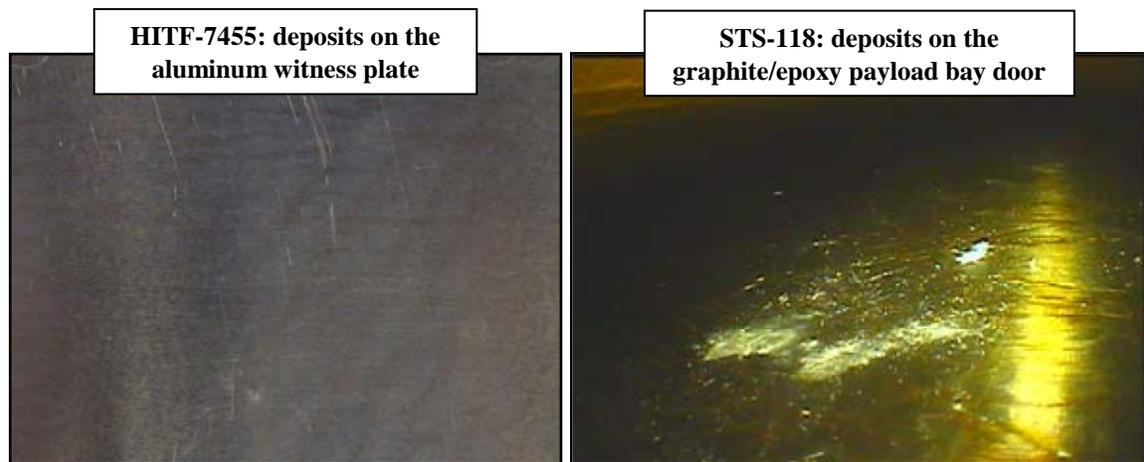
Figure 28. Witness plate damage of NASA test HITF-7455 compared to STS-118 graphite/epoxy payload bay door damage.
