# RESEARCH MEMORANDUM

## CYCLIC ENGINE TEST OF CAST VITALLIUM TURBINE BUCKETS - I

Aircraft Engine Research Laboratory  
Cleveland, Ohio

NACA RM No. E7B07

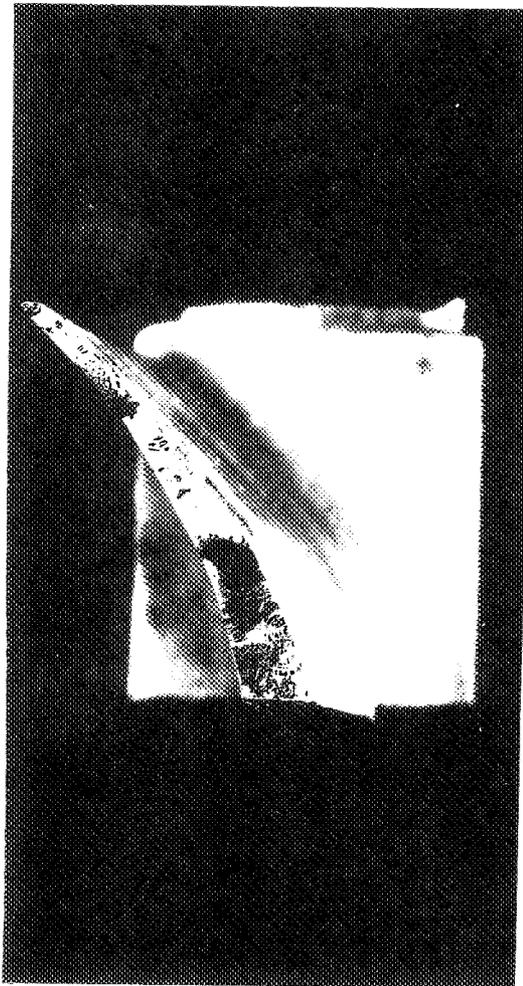
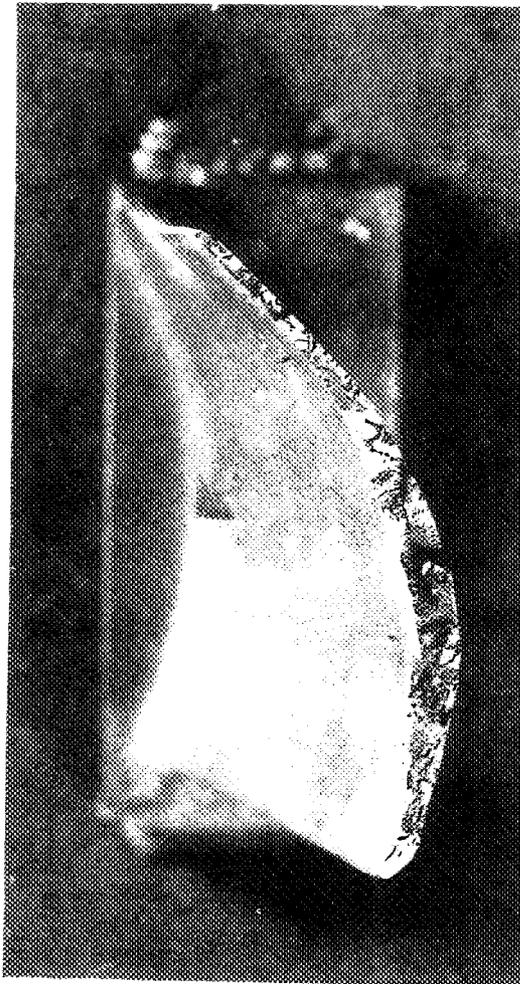
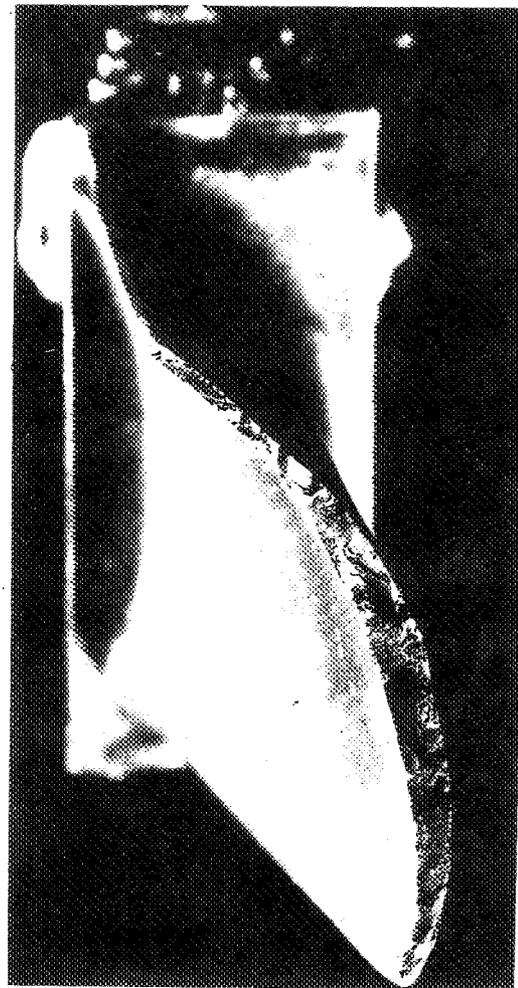
The macroexamination did not disclose any significant differences either between the three samples or between broken and unbroken buckets from the same wheel. The grains at the trailing edge were much smaller than in the body of the bucket probably due to variation in the cooling rate in the mold. (See fig. 3.)

Figure 3. - End views of broken cast Vitallium turbine buckets from 1-40 engines.

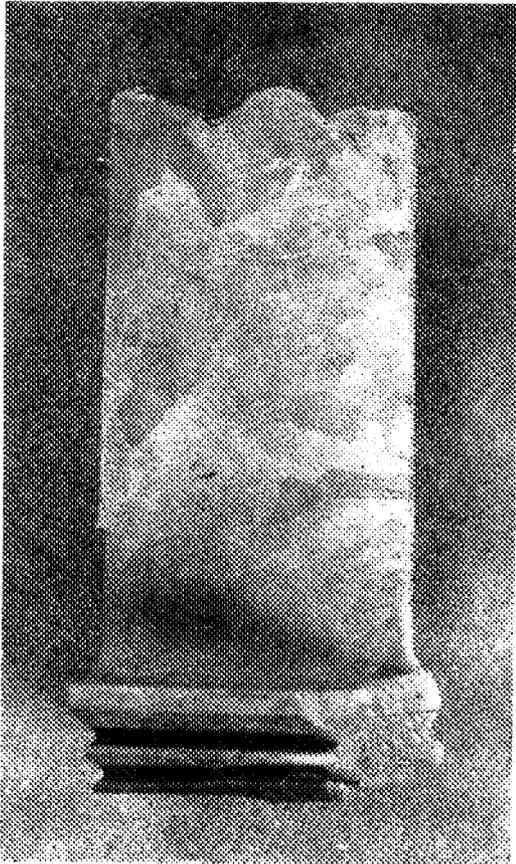
Figure 4. - Side views of broken cast vitallium turbine buckets from I-40 engines. Buckets were electrolytically etched in 10-percent hydrochloric acid to show grain size.

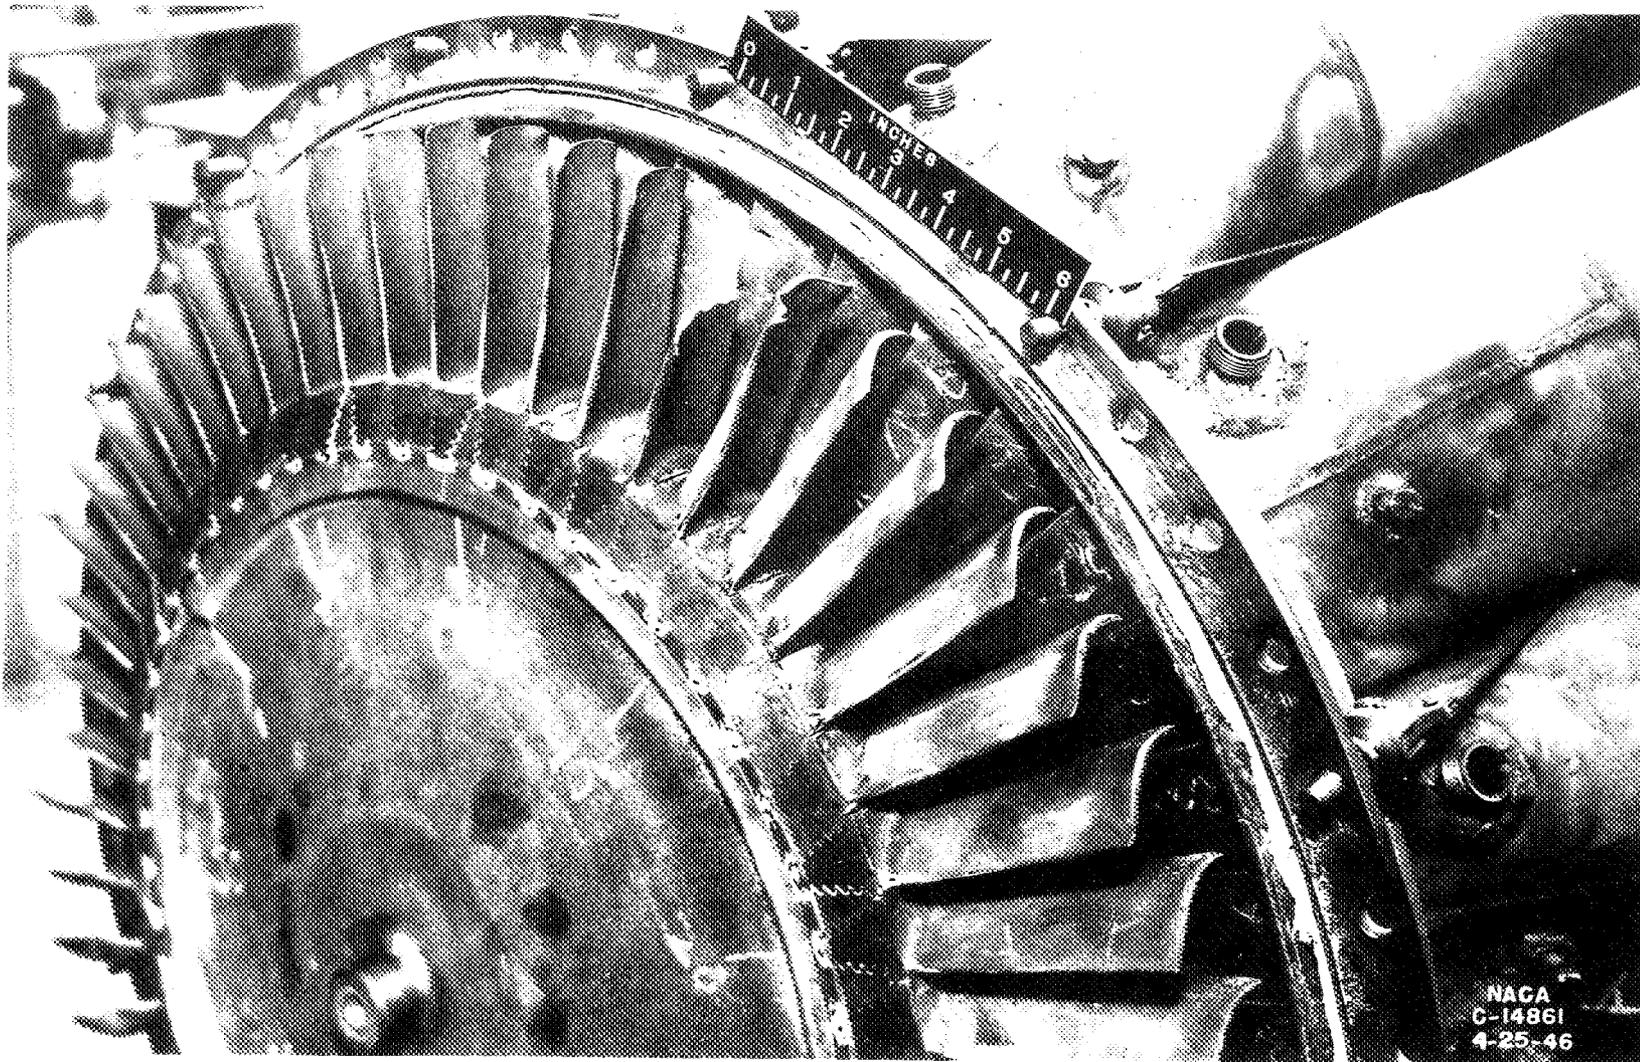
Wheel 1. - Wheel 1 was installed in an engine and was run-in by the engine manufacturer prior to the tests at the Cleveland laboratory. The first failure on wheel 1 occurred during cycle 22 after 7 hours and 20 minutes. The broken bucket (bucket 1-13), shown in figure 6, was replaced, the wheel rebalanced, and the runs continued. Bucket 1-2 failed three cycles later during cycle 25 after a total running time of 8 hours and 12 minutes (fig. 7). Buckets 1-12 and 1-14 were removed for comparison with the broken buckets.

Figure 6. - Wheel 1 after first bucket failure (bucket 1-13), which occurred during cycle 22 (7 hr, 20 min).

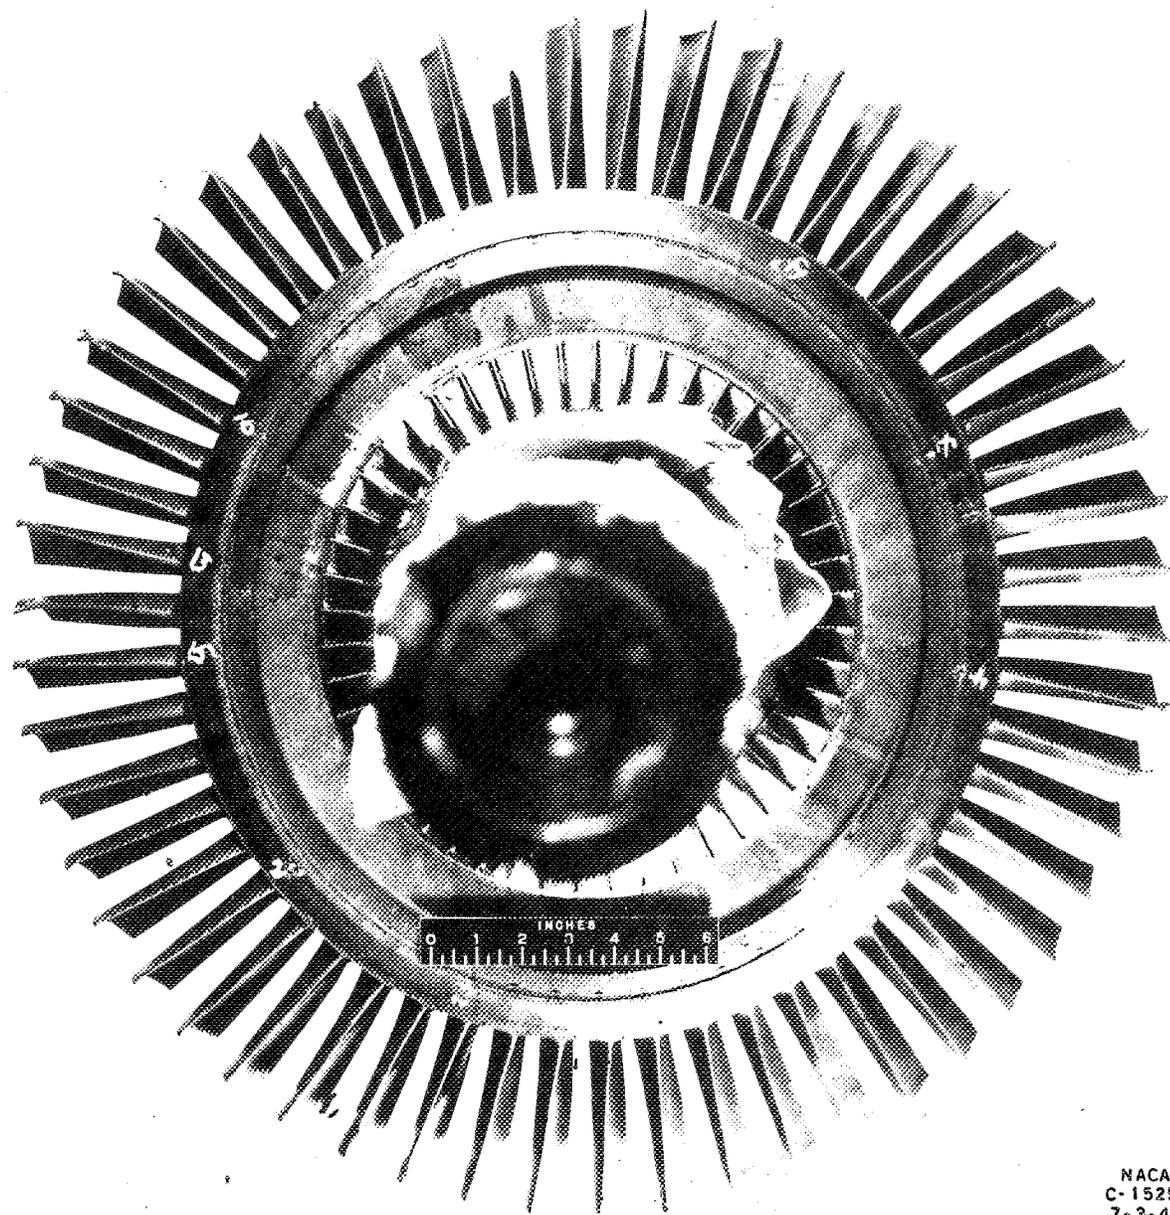
Figure 7. - Wheel 1 after second bucket failure (bucket 1-2), which occurred during cycle 25 (8 hr, 12 min).

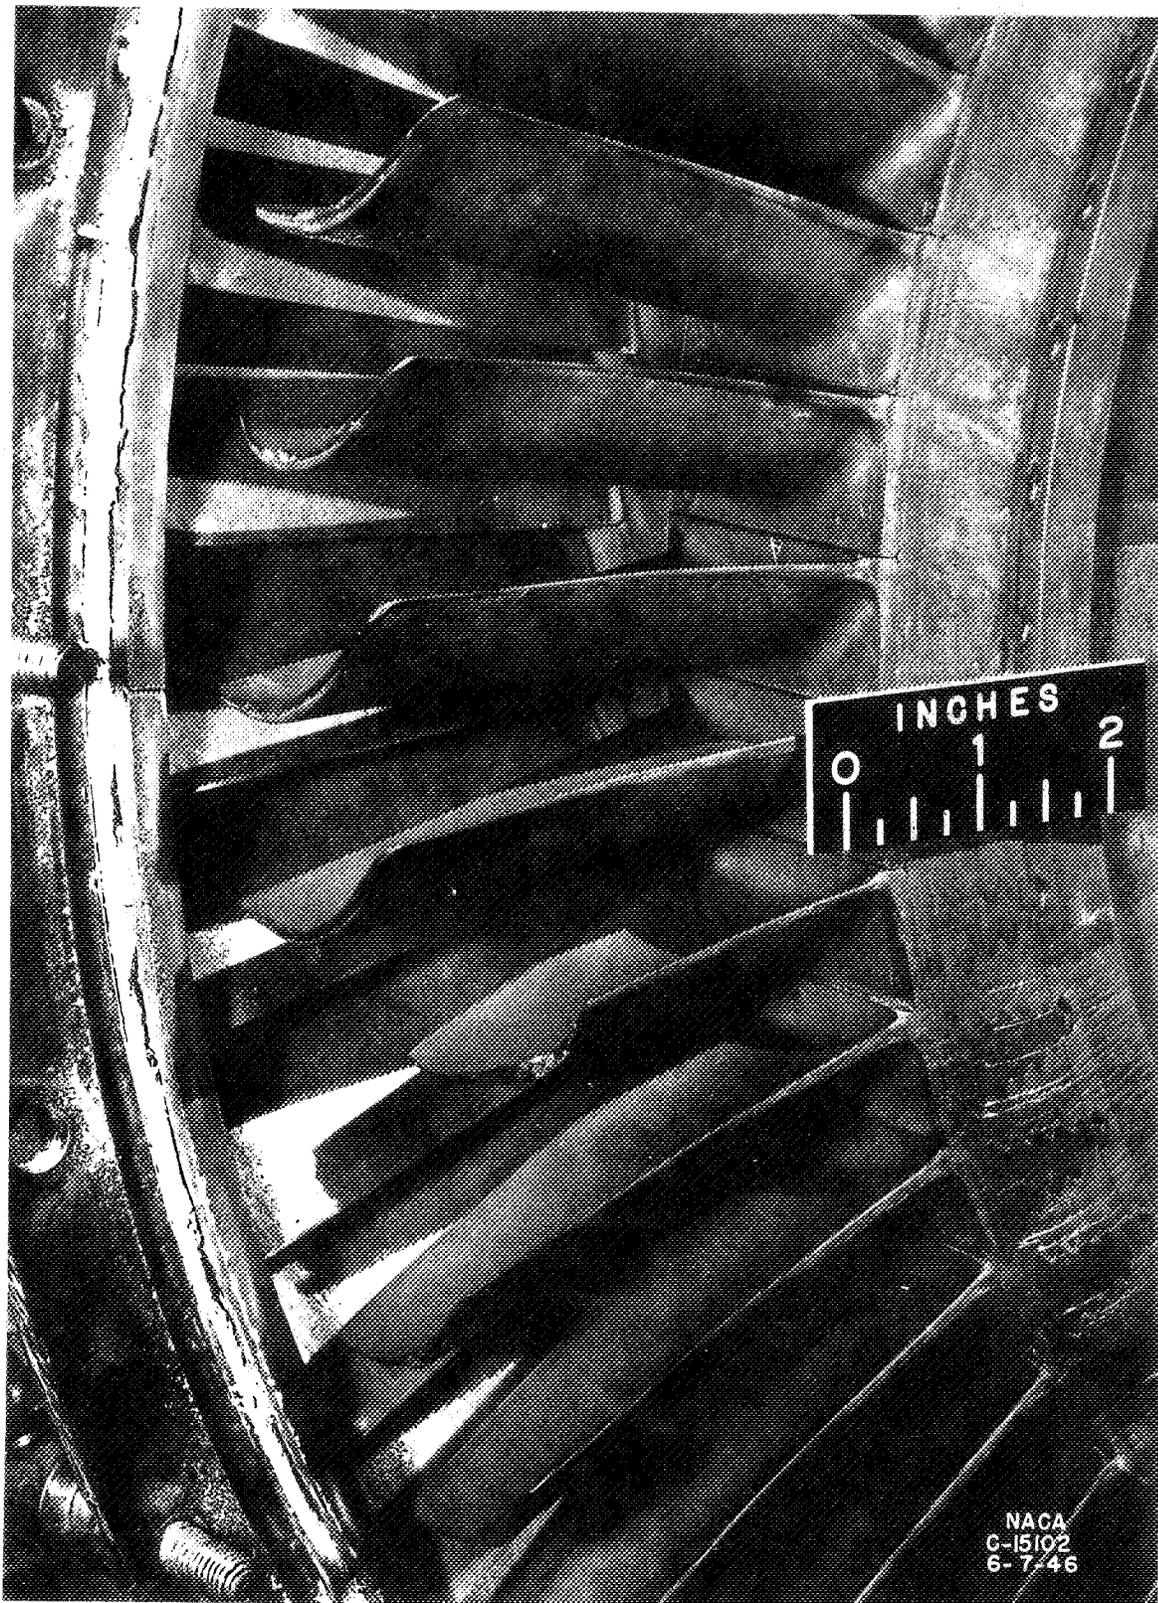
Wheel 2. - Wheel 2 had not been run prior to this investigation. The first bucket failure on wheel 2 (bucket 2-18) occurred in cycle 29 after 9 hours and 28 minutes (fig. 8). The broken bucket was replaced, the wheel rebalanced, and the run continued. After 95 cycles (31 hr, 40 min total running time), the test was stopped to repair the rear-compressor-inlet guide vanes and the ring-and-tube assembly.

Figure 8. - Wheel 2 after first bucket failure (bucket 2-18), which occurred during cycle 29 (9 hr, 28 min).

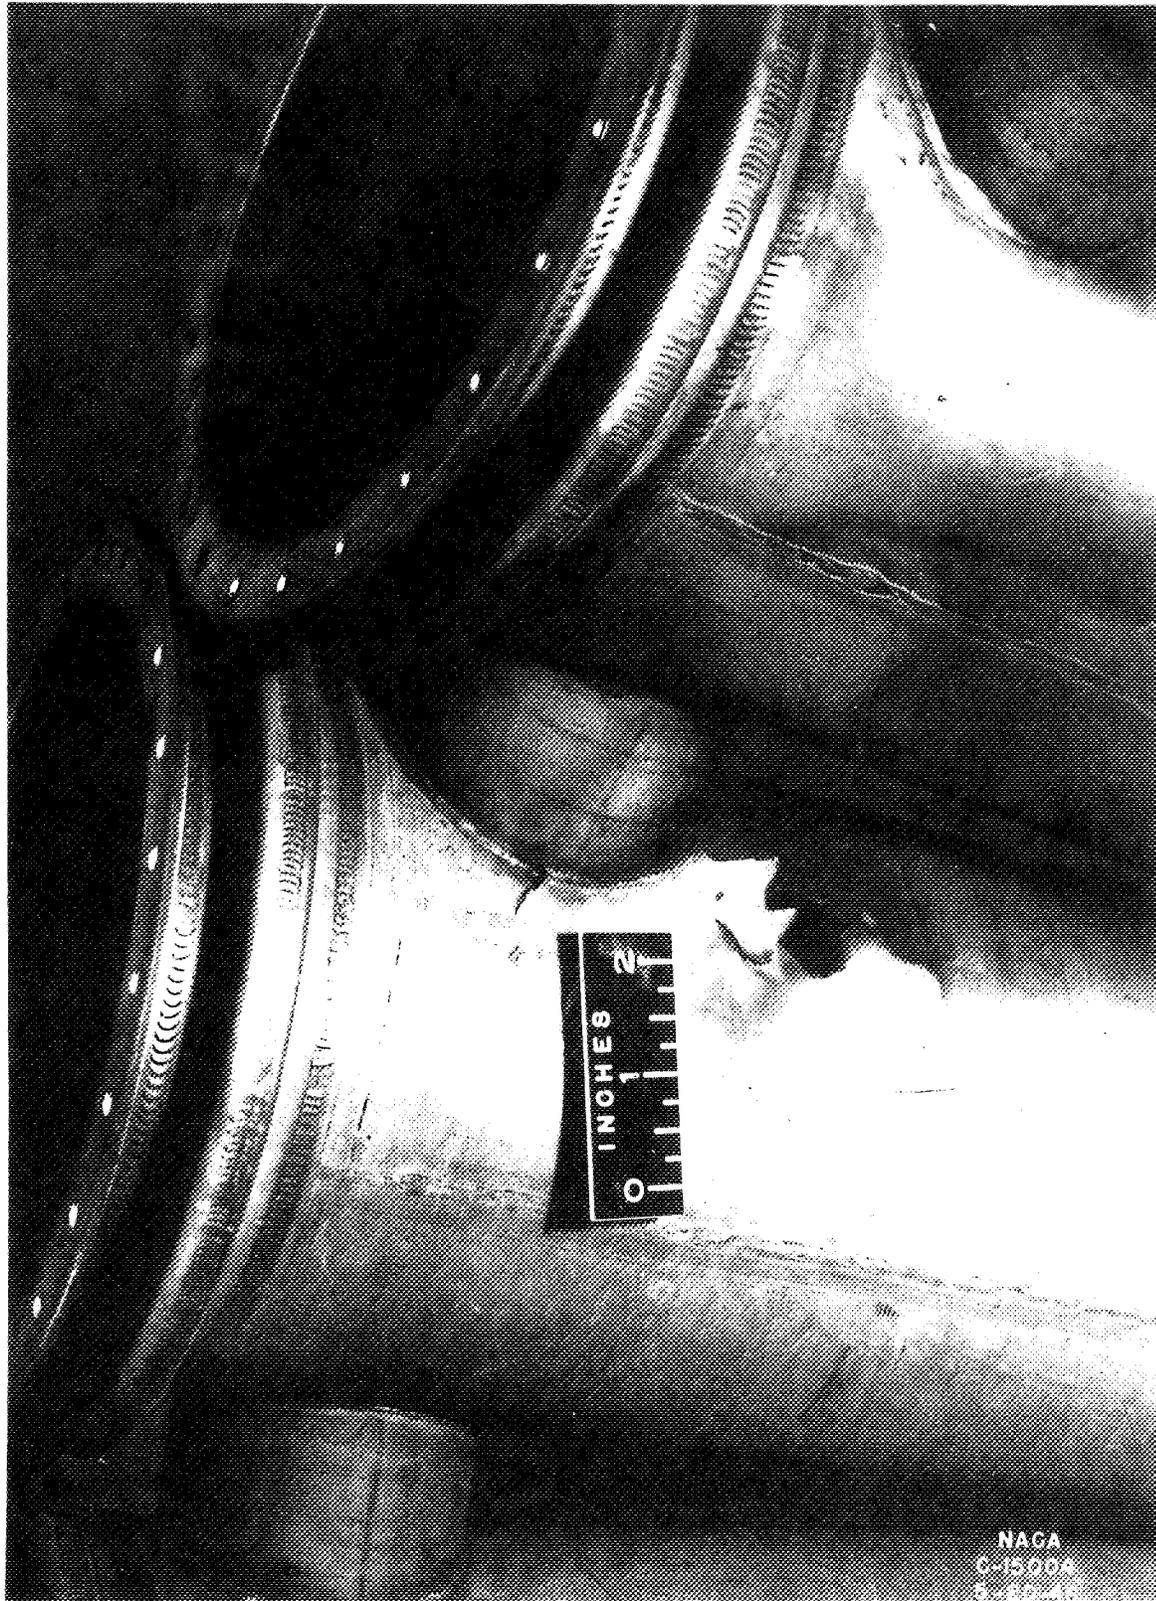
After 11 hours and 8 minutes, the ring-and-tube assembly was found to be so badly damaged that the engine could not be run. The damage sustained by one of the outer flame tubes is shown in figure 9. Operation was resumed after the ring-and-tube assembly had been replaced. An inspection after a total running time of 28 hours and 44 minutes showed that the nozzle diaphragm had been badly eroded (fig. 10) and that the stiffeners on the compressor cover plate were cracked.

Figure 9. - Damaged outer burner tube after 11 hours and 8 minutes.

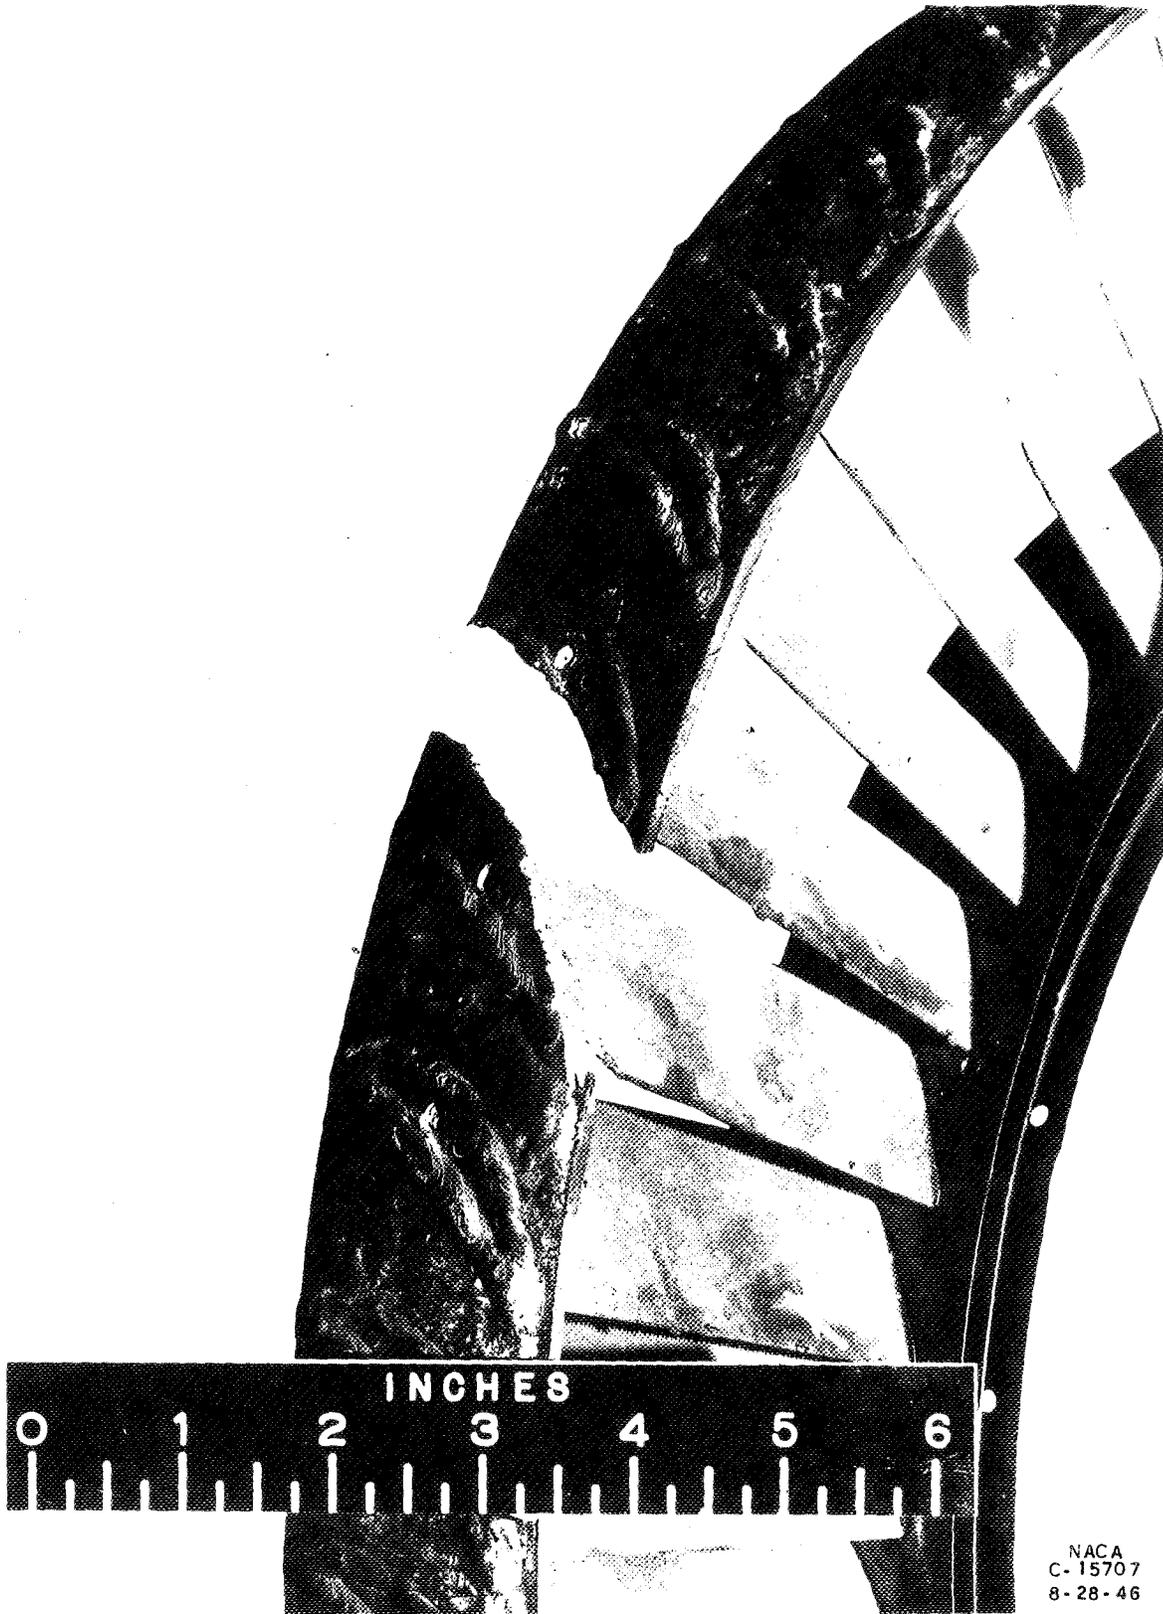
Figure 10. - Damaged turbine-nozzle diaphragm from engine after 28 hours and 44 minutes.

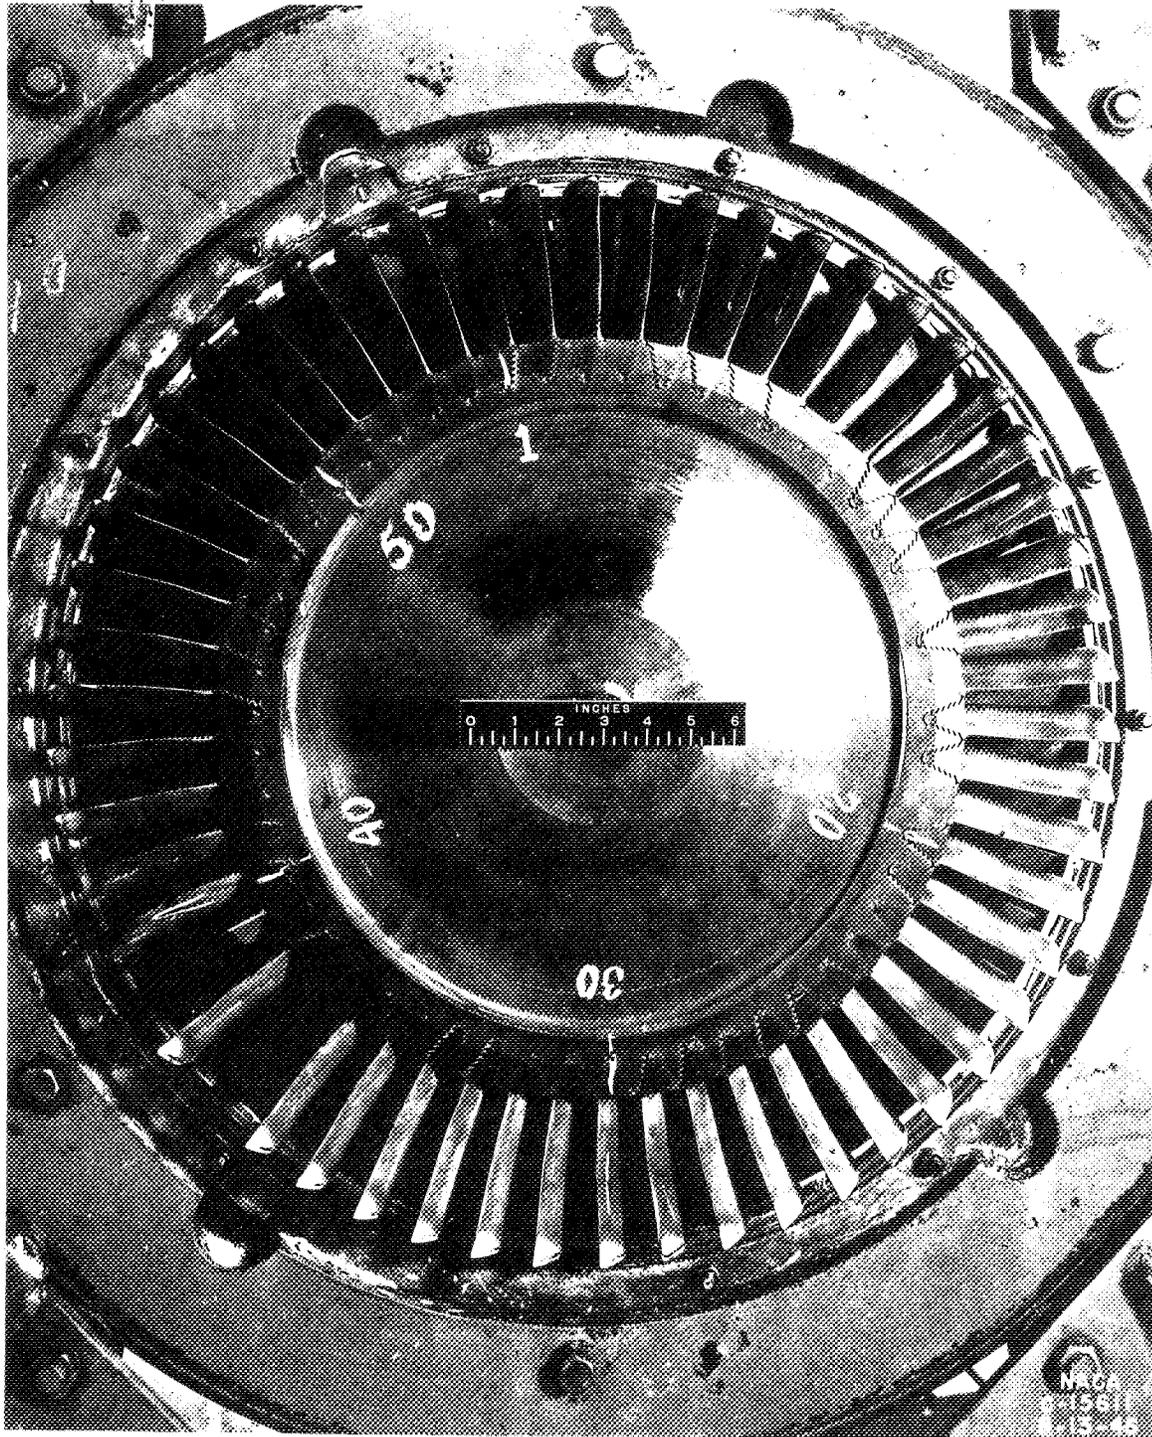
The turbine wheel was therefore removed, installed in another engine, and the running resumed. After cycle 229 (76 hr, 20 min total running time), the nozzle diaphragm was again found to be in bad condition and the engine was removed from the test cell for overhaul. No bucket failure had occurred. Many of the buckets had shifted in the axial direction, six of them sufficiently to rub on the gas baffle in the exhaust cone (fig. 11). Two buckets (buckets 3-16 and 3-43) were removed from wheel 3 for comparison with the broken buckets from the other wheels.

Figure 11. - Wheel 3 after a total running time of 76 hours and 20 minutes showing axial shift of buckets.

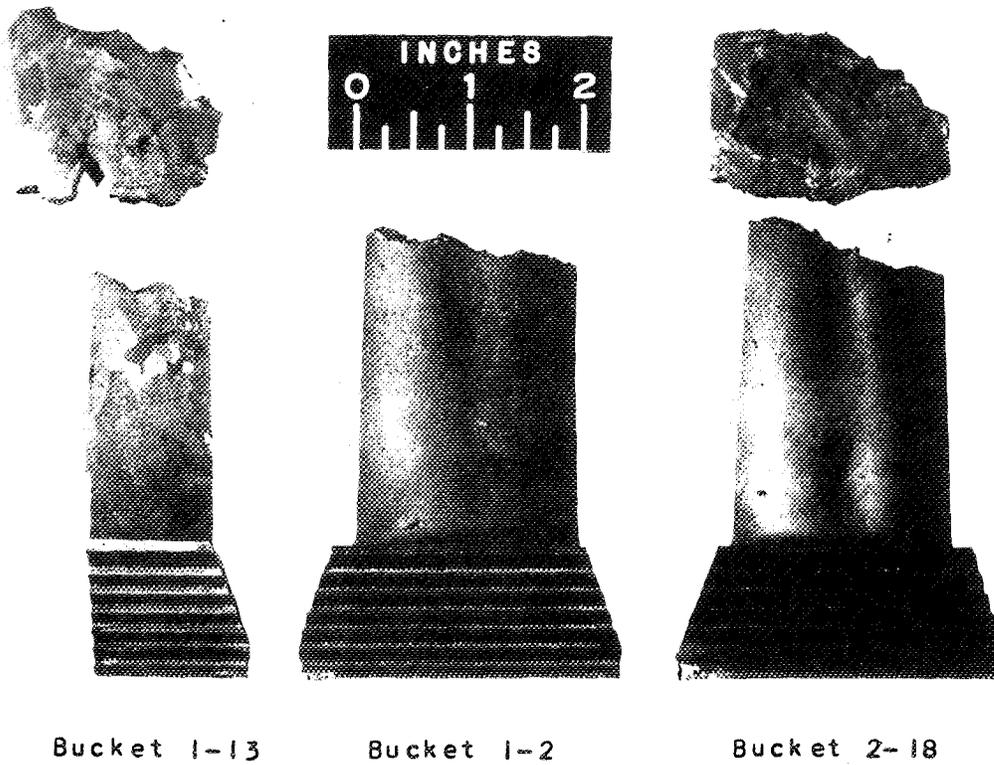
Turbine-bucket elongation. - The elongation of the turbine buckets for the four wheels is plotted in figure 12; the bucket failures are also indicated. The first bucket failures on wheels 1 and 2 so damaged the tips of all the other buckets that further measurements could not be made. The elongation data on wheels 3 and 4 are more complete; no bucket failures, however, have yet occurred on these wheels. All failures occurred at about the same distance from the bucket roots and the type of failure was the same in all cases (fig. 13).

1. The appearance of the failure is the same in all samples.
2. The fracture exhibits two definite zones, which are quite different in appearance. From the trailing edge to about the middle of the bucket, the fracture has a conchoidal surface similar to those of fractures obtained in the failure of brittle materials. This part of the fracture is referred to as the "brittle" fracture. The brittle fracture has a dark gray coat of oxide. The rest of the crack has a fibrous appearance very similar to that exhibited by tensile-test specimens that have failed with a cup-and-cone fracture. This portion of the fracture is referred to as the "ductile" fracture. The ductile fracture has a bright blue oxide coating.

These observations lead to the conclusion that the failures are due to fatigue cracks that start at the trailing edge and progress until the centrifugal-force stress on the remaining portion of the blade becomes equal to the ultimate strength and the material

Figure 13. - Broken cast Vitallium turbine buckets. Bucket 1-13 was sectioned for metallographic examination.

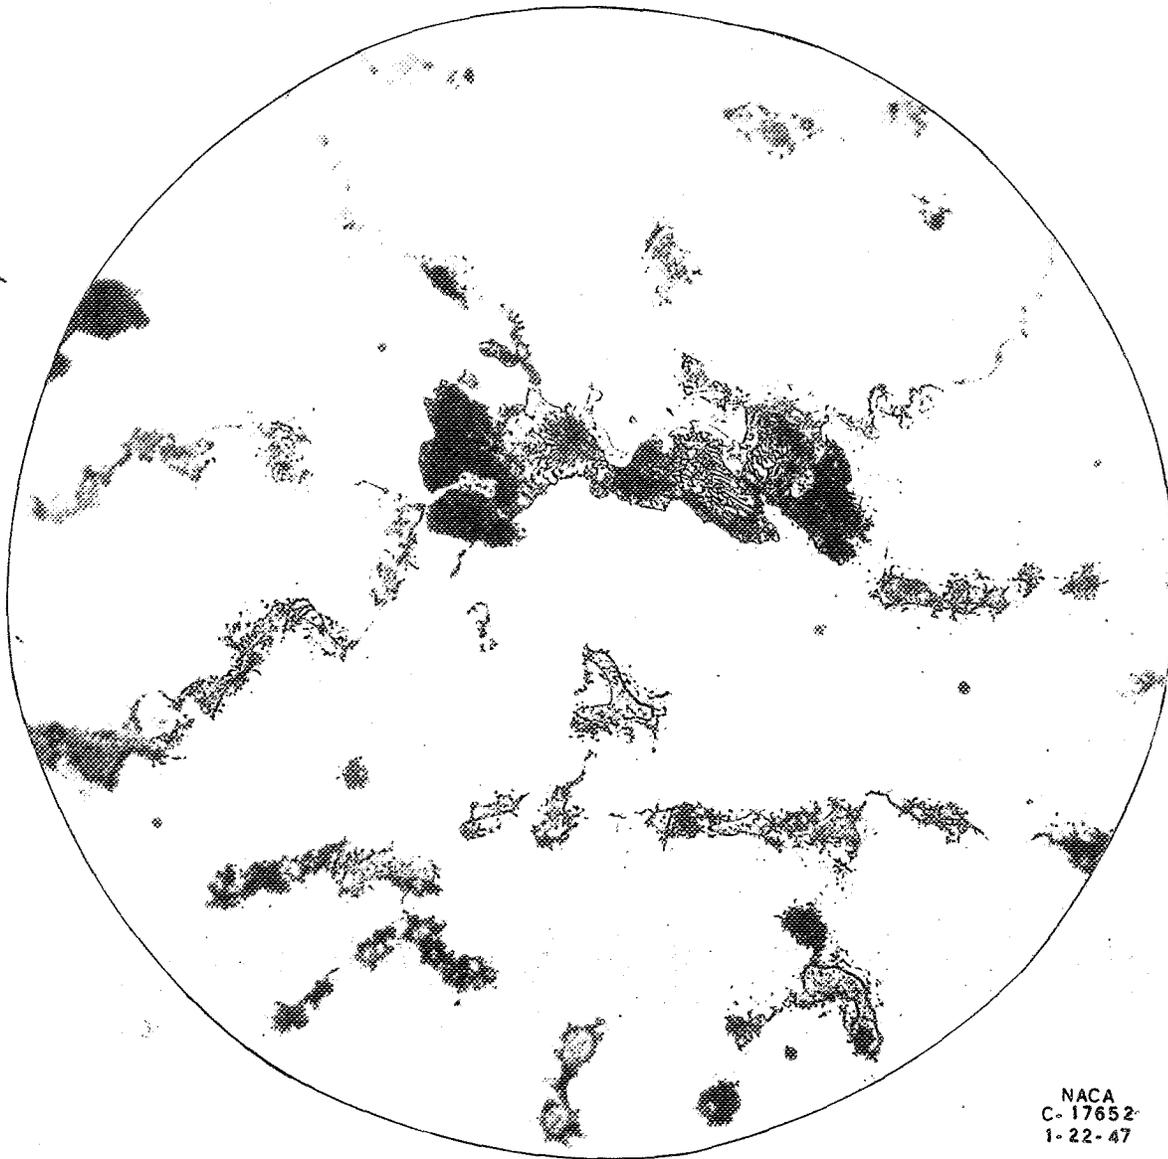
Microscopic investigation did not definitely establish the cause of the bucket failures. Well-defined eutectic areas at the dendritic boundaries and some carbide precipitation existed (fig. 15). These eutectic areas (figs. 16 and 17) are very prominent at the trailing edge, where it is believed the crack started. A view of a comparable area at the leading edge (fig. 18) shows a small amount of eutectic material. Such a concentration of eutectic areas at the trailing edges may be a factor contributing to the start of fatigue cracks.

Figure 15. - Microphotograph of sample from location 3 (fig. 5) one-half inch from crack showing eutectic area and precipitated carbides. Aqua-regia etch, 5 percent; magnification, 500X.

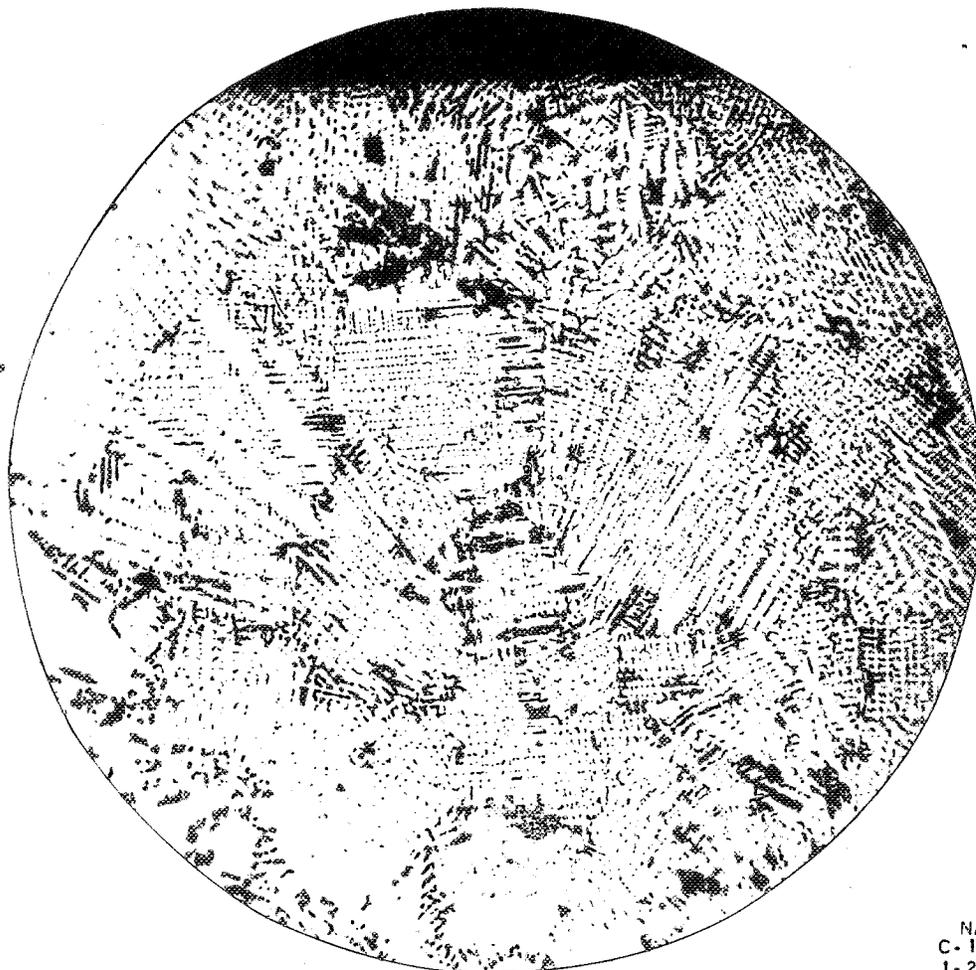
Figure 16. - Microphotograph of sample from location 1 (fig. 5) close to brittle portion of crack showing large amounts of eutectic material at grain boundaries. Chromic-acid and potassium-permanganate etch; magnification, 50X.

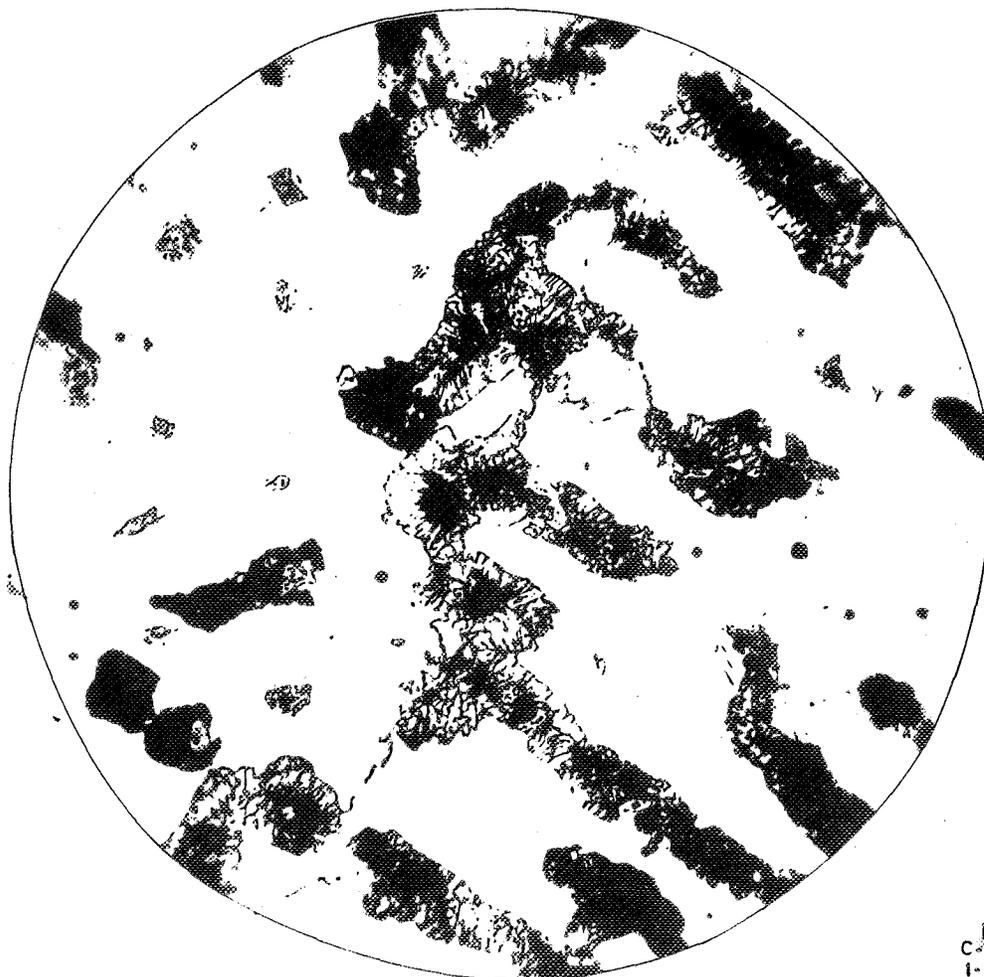
Figure 17. - Microphotograph of sample from location 2 (fig. 5) close to brittle portion of crack showing large amounts of eutectic material at grain boundaries. Aqua-regia etch, 5 percent; magnification, 500X.
