International Space Station USOS Potable Water Dispenser On-Orbit Functionality vs. Design

The International Space Station (ISS) currently provides potable water dispensing for rehydrating crewmember food and drinking packages. There is one system located in the United States On-orbit Segment (USOS) and one system in the Russian Segment. Shuttle mission STS-126 delivered the USOS Potable Water Dispenser (PWD) to ISS on ULF2; subsequent activation occurred on November 2008. The PWD is capable of supporting an ISS crew of six, but nominally supplies only half this crew size. The PWD design provides incremental quantities of hot and ambient temperature potable water to US food and beverage packages. PWD receives iodinated water from the US Water Recovery System (WRS) Fuel Cell Water Bus, which feeds from the Water Processing Assembly (WPA). The PWD removes the biocidal iodine to make the water potable prior to dispensing. A heater assembly contained within the unit supplies up to 2.0 L of hot water (65 to 93 °C) every 30 min. During a single meal, this quantity of water supports three to four crewmembers' food rehydration and beverages. The unit design has a functional life expectanc

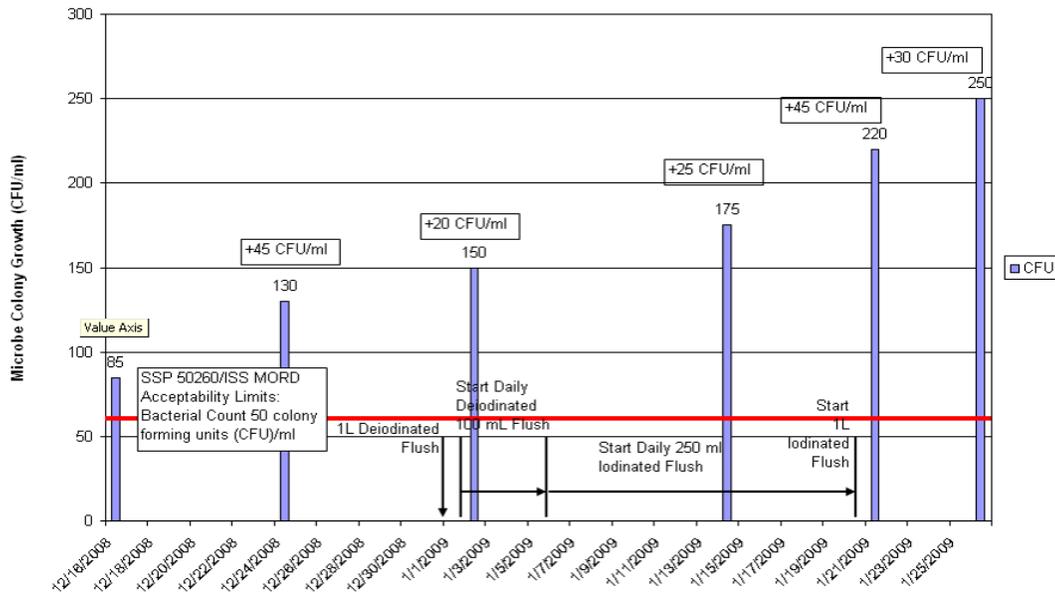
PWD - Test results from Ambient Leg water measurements

Figure 5. PWD Flush Iodine Mode, Ambient

Despite the known issues, the Mission Operations Directorate (MOD) and the PWD team tried the flush option, as it was the quickest and most cost-effective solution to the PWD contamination issue. After the Flush Iodine Mode took place, the crew ran another MCD microbial test, which revealed yet another increase in microbial growth. The Flush Iodine Mode did nothing to help remediate the PWD contamination issue (see Fig. 5). This method of remediation failed because of a low concentration of iodine, in addition to the possibility of a iodine-resistant bacterium contamination.

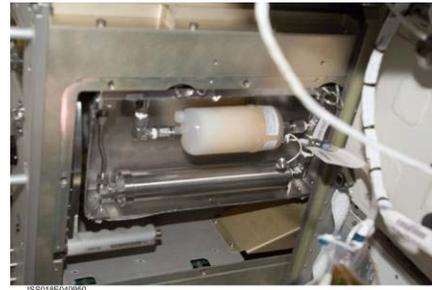
The PWD Disinfection Kit consisted of the Teflon bag of 40 ppm I₂ solution; the PWD Filter Flush Assembly; the PWD Filter Tube Assembly; and three extra QD sterile caps for the PWD Filter ORU QDs. The QDs caps were delivered to place on the PWD Filter ORU QDs in case the Filter was removed from the PWD unit. The PWD Disinfection Kit launched on STS-119/15A in March 2009. The crew used the PWD Disinfection Kit (excluding the PWD Filter Tube Assembly) as planned during 15A docked operations in March 2009 (see Fig. 10). The initiative was a success and the microbial counts from the ambient leg of the PWD dropped from 250 CFU/mL to 0 CFU/mL, after the 10 L flush of water. Additionally, the PWD desorbed all of the I₂ and I from the microbial filter, making the effort a complete success. Since the use of the Disinfection Kit, the PWD continues to sustain low bacteria counts.

Figure 10. On-orbit Use of Iodine Shock Kit

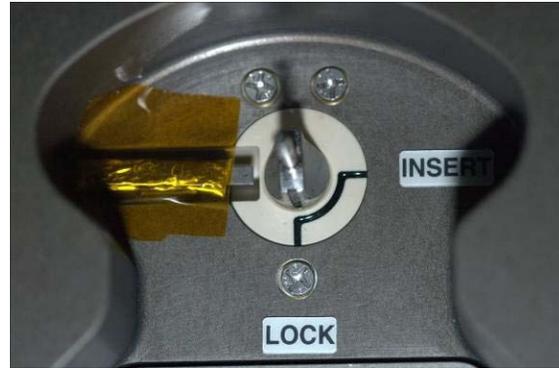
Although the temporary workaround was a good short-term fix, team concerns remained regarding the untested and unknown stresses induced on the PIP Switch, due to the off-nominal configuration of the layer of tape on the switch. The team requested a stress analysis to verify that the tape configuration on the switch was safe for continued use. The stress analysis found that the life of the PIP Switch potentially reduced from 1,000,000 cycles to less than 5000, if the switch continued in this off-nominal configuration. The PWD team created instructions for tape removal and a return to nominal switch configuration, while continuing to research the length of the Beverage Adapter plunger more closely.

Figure 14. Behind the Beverage Adapter (PIP Switch with Tape)

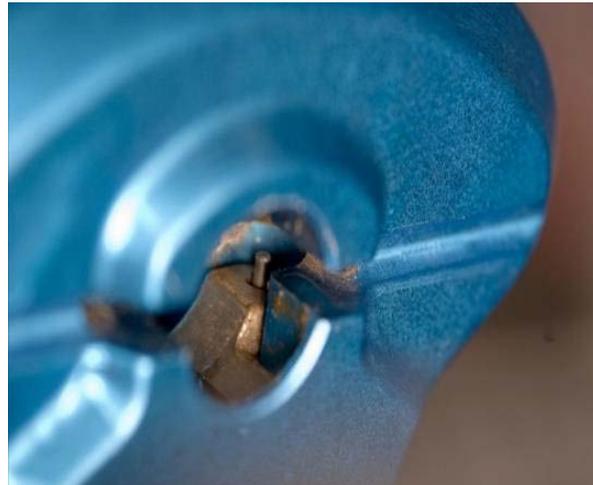
On July 3, 2009, during the Beverage Adapter Plunger investigation, the crew reported to Houston MCC that the PWD Package Insert Port appeared rusty (see Fig. 15) and that the Beverage Adapter Slide Assembly was sticking (see Fig. 16). The crew took apart the Beverage Adapter Assembly on July 4, 2009, finding a water leak within the adapter. The crew also found apparent food debris or possible corrosion around the capture pins on top of the Slide Assembly within the Beverage Adapter Assembly (see Fig. 17). The PWD team instructed the crew to wipe down that area of the assembly with Povidone Iodine wipes to remove as much residual debris as possible.

Figure 15. On-orbit photo of PWD Package Insert Port with Food Residue/Corrosion within the Beverage Adapter the PIP Switch with Tape

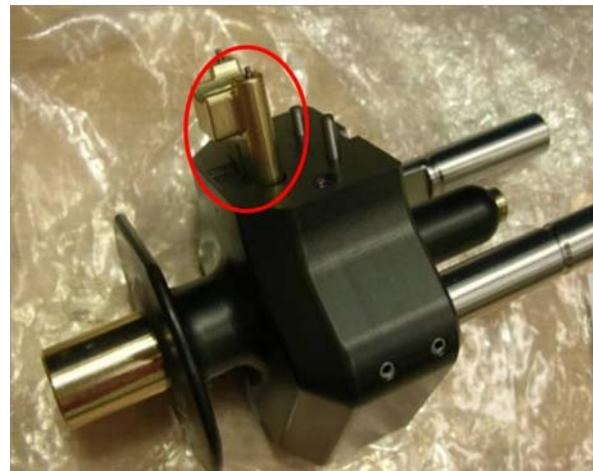
Figure 16. Beverage Adapter Opened, Showing the Slide Assembly (RED)

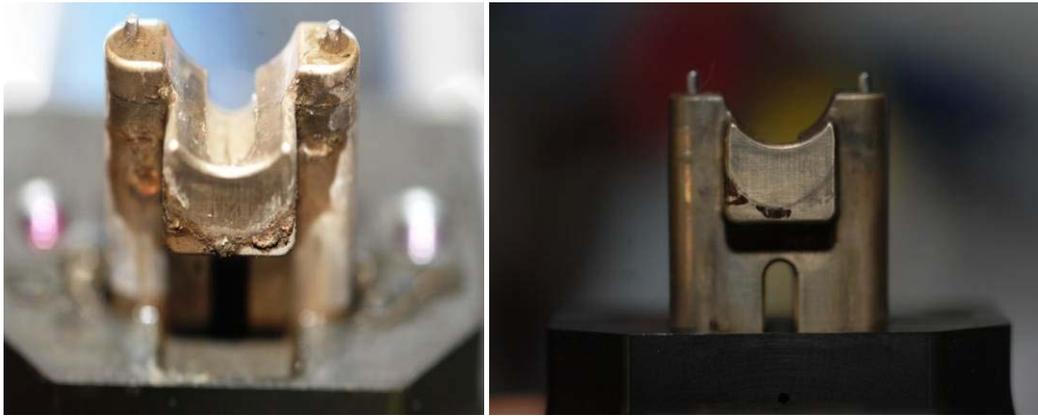
Figure 17. Precleaning (left) Postcleaning (right): On-orbit Photos of the Food Residue/Corrosion on the Slide Assembly Internal to the Beverage Adapter

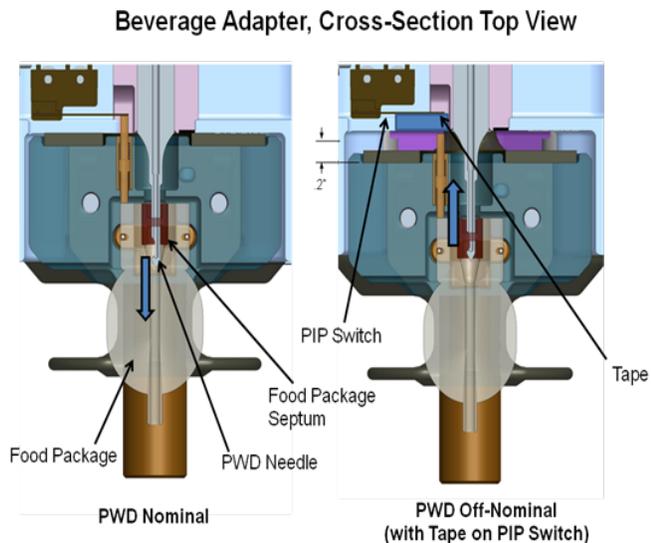
The PWD team determined that a water leak from the dispense point of the Needle was back-flowing into the interior of the Beverage Adapter (see Fig. 18). The off-nominal configuration of the tape on the PIP Switch like exacerbated this scenario. The tape on the switch did not allow the PWD food and/or drink packages to seat properly within the Beverage Adapter, leaving a small gap where the Needle did not fully insert into the food or beverage package (see Fig. 18). With this understanding of the water leak within the Beverage Adapter, the team finalized the procedure to return the PWD to the nominal configuration. The procedure tasked the crew to lubricate the Beverage Adapter Plunger with Braycote 601 and remove the tape from the switch. Lubricating the plunger allowed it to loosen enough to fully extend and actuate the PIP Switch to activate a dispense. The crew performed the tasks successfully. The root cause for the plunger not fully extending, however, remained undetermined.

Figure 18. Beverage Adapter Cross Sectional View, Leakage Path (blue arrow)

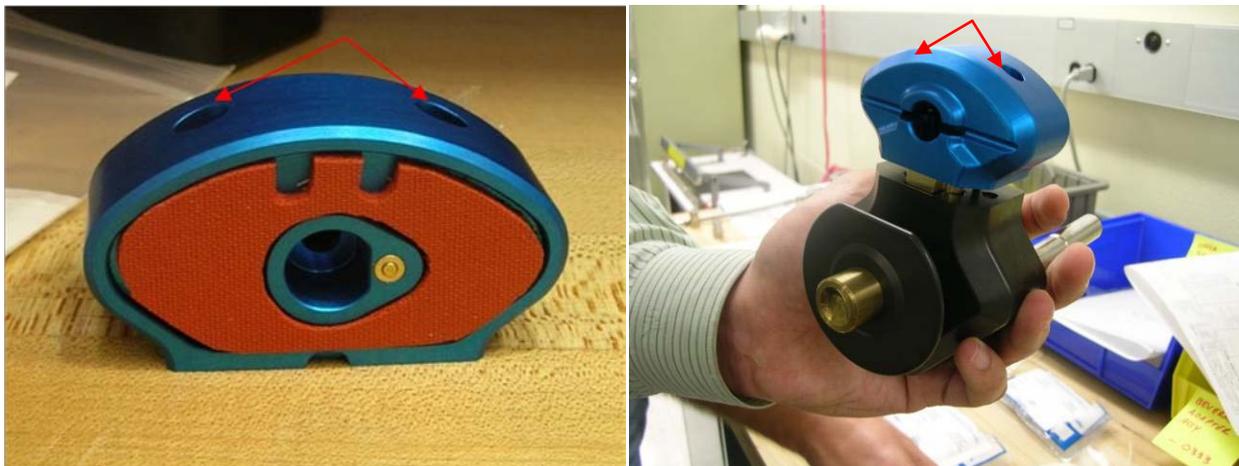
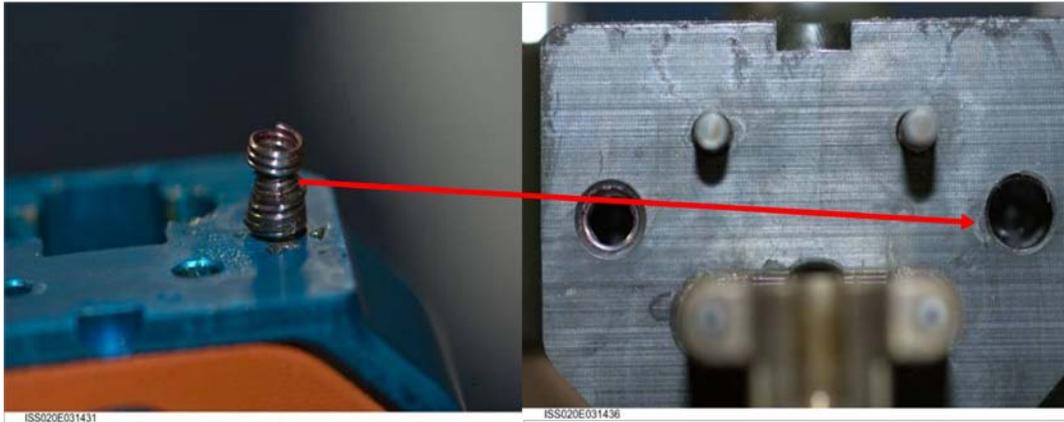
Figure 20. Stripped Helical Insert from the Beverage Adapter

disassembly for cleaning, as it was not foreseen that a leak would occur in this area. On August 24, 2009, due to repetitive off-nominal cleaning of the Beverage Adapter, one of the two locking inserts failed on orbit (see Fig. 19 and 20). Over-torque during Beverage Adapter reassembly stripped out the helical insert. The Beverage Adapter can function with one fastener. If the crew damaged the other insert, however, nothing would hold the two pieces of the Beverage Adapter together. The PWD team quickly engineered short- and long-term solutions to address the problem. The short-term solution recommended the crew to wrap Kapton tape around the parameter of the Beverage Adapter. The recommended long term solution was for the PWD team to redesign and deliver a new Beverage Adapter capable of withstanding repetitive cleaning. Within 3 months of the initial request, the redesigned Beverage Adapter was delivered to the ISS on ULF3.

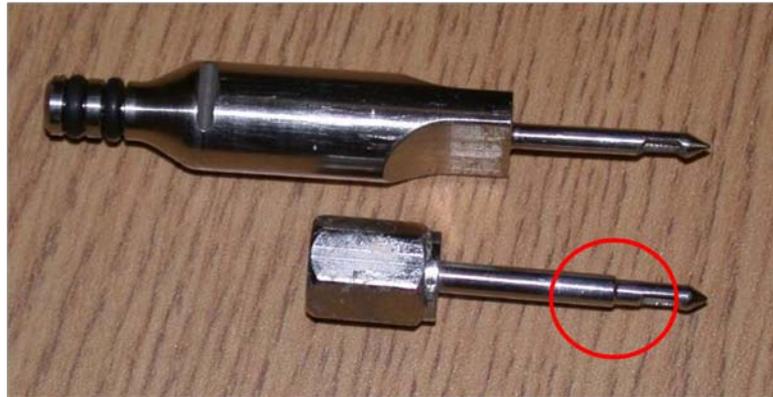
Figure 21. (Top) PWD Needle, (Bottom) Shuttle Galley Needle

The leak issue is still undergoing investigation by the team. The team's inability to duplicate the leak may stem from the zero gravity atmosphere in which the leak occurred. The PWD Needle design is one of the possible causes for the leak. The team found that the Shuttle Galley Needle design differed from the PWD Needle design by a small shoulder feature found on the Shuttle Galley Needle. (see Fig. 21). It is believed that the shoulder on the Shuttle Galley Needle provides an additional sealing surface at the septum interface on the food/drink package, which prevents potential water backflow. Since the team could not replicate the leakage found on orbit, the PWD team could only replicate the Shuttle Galley's Needle design, but could not verify that the new Needle design fixed the leakage problem. The newly designed PWD Needle, matching the Shuttle Galley Needle, was delivered to ISS on 20A, February 2010. Once the redesigned PWD Needle is on orbit, the team will assess whether the theory of the shoulder resolves the leak issue with the Beverage Adapter.

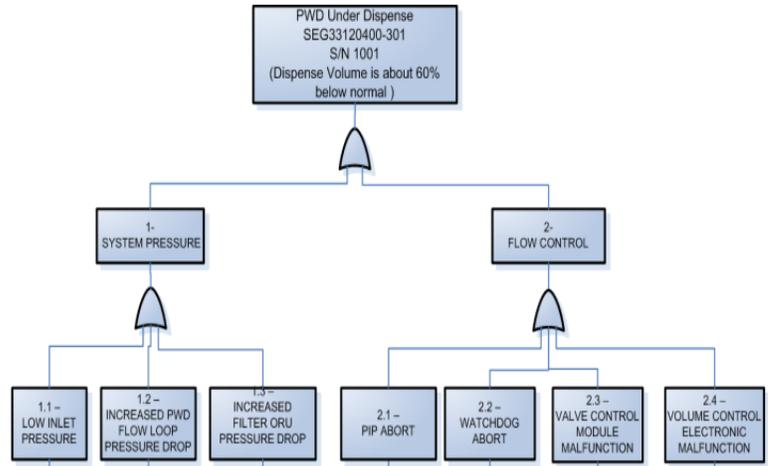
Root cause analysis indicated that a low dispense volume is a function of one of two scenarios (see Fig. 22). Possible causes follow: 1) The system pressure is lower than expected at the inlet or there is an internal pressure drop to the PWD; and/or 2) there is a malfunction within the flow control of the PWD System electronics. The low system pressure could come from the inlet and/or the increased pressure drop within the PWD Flow Loop or the

The most likely root cause for the increase in pressure drop is due to an obstruction within the Filter ORU Assembly. The under dispensing occurred after approximately 8 months of filter use. This was the same Filter ORU that the crew used the Disinfection Kit on in March 2009. The 0.2 micron microbial filter can trap debris and even air, which means the PWD may become obstructed over time, causing blocked water flow and an under-dispense scenario.

Figure 22. Root Cause Under Dispense Fault Tree

The PWD team gave the crew several troubleshooting courses of action as solutions to the under-dispense issue: 1) Check the PWD System for obvious visual obstructions, including a pinched water hose; 2) check, clean, or replace the needle; and 3) replace the PWD Filter ORU. Although the under-dispense is a nuisance to the ISS crew, it is not a safety issue to date. The need to continue to dispense additional times to achieve the desired hydration is acceptable.
